U. S. NUCLEAR REGULATORY COMMISSION  
OFFICE OF INSPECTION AND ENFORCEMENT

Report No. 50-184/79-05

Facility Name: NBS Reactor

Report on the Nature and Source of  
Radioactive Material Found at the  
NBS Reactor Site

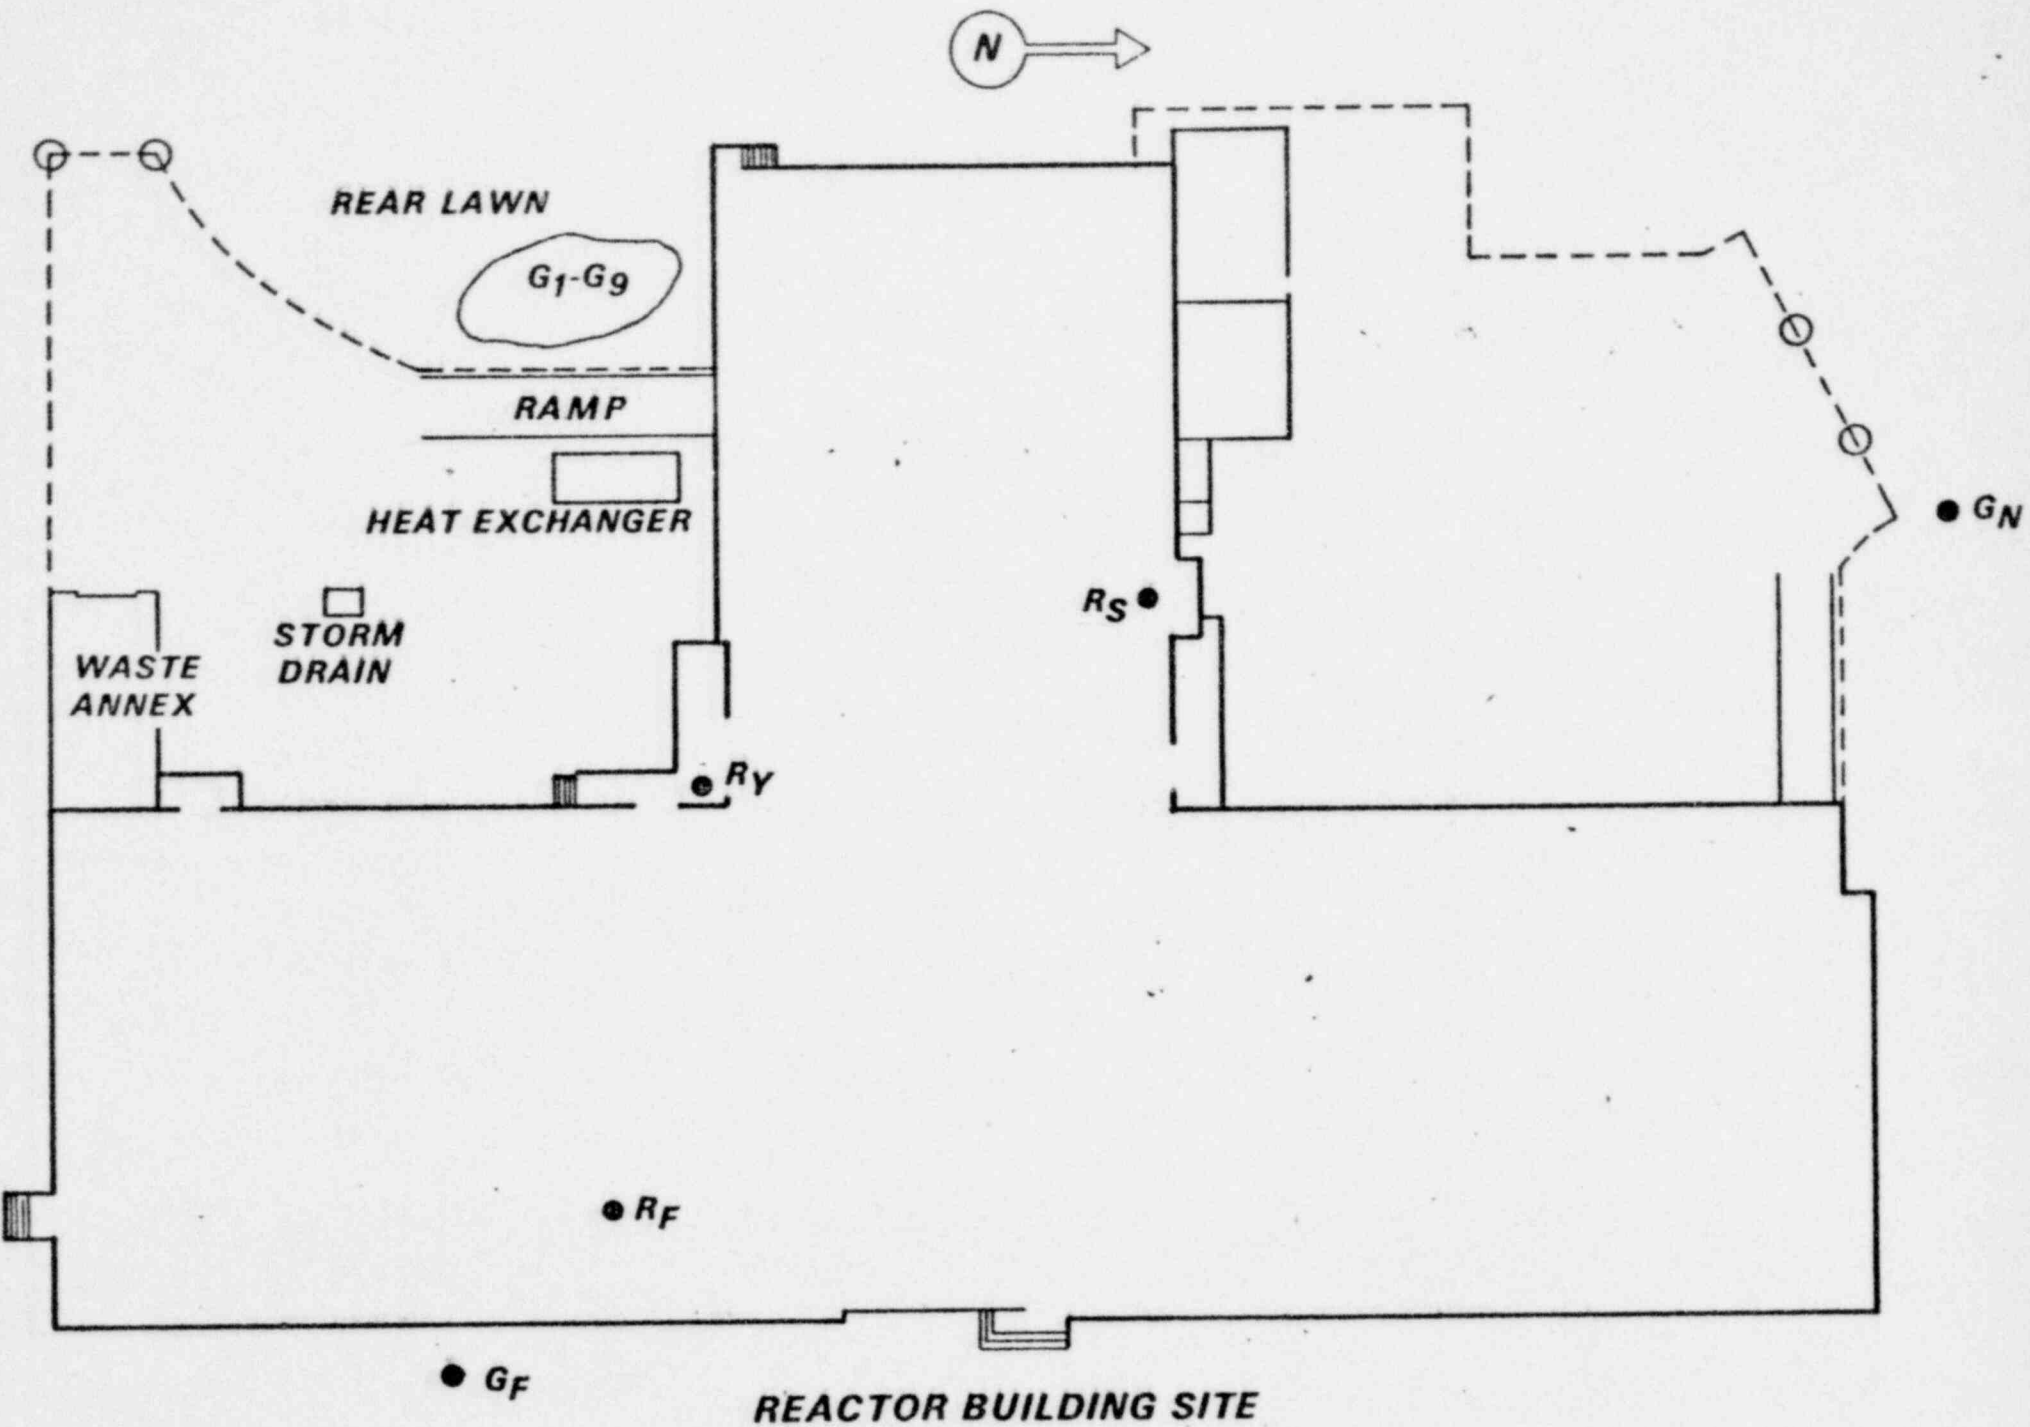
Figure 1

In order to make clear the topography of the area and the location of the radioactivity found, it is necessary to give a description of the reactor site. A plan view of the reactor building and the immediately adjacent site is shown in Fig. 1. To the rear of the building and at the left on the diagram is a fenced in area restricted to authorized personnel. In the south east corner of this area is an entrance to the annex to the reactor building used to store low-level radioactive waste from a'l of NBS prior to shipping. This area contains the heat exchanger removed from the reactor in 1974. It was stored beside a ramp that leads into the reactor building. This area will be referred to as

These are shown in Fig. 1. The front lawn of the reactor showed one spot (GF on map) (the original one found by the NRC inspector); the rear lawn adjacent to the enclosed area showed 9 spots ( $G_1$ - $G_9$ ); and one single spot was found on the north lawn (GN). Exhaustive survey as part of the monitoring survey found eleven more very low-level spots in the lawns. This will be described in the section under "monitoring survey."

The reactor roof yielded three spots of radioactivity. These are shown in Fig. 1. One of these spots ( $R_S$ , near the reactor stack) was broken into three samples, yielding a total of five samples. One particle was separated from  $R_F$ ,  $R_S^1$ , and  $R_S^3$ . Each contained one particle. The other samples have not been separated.

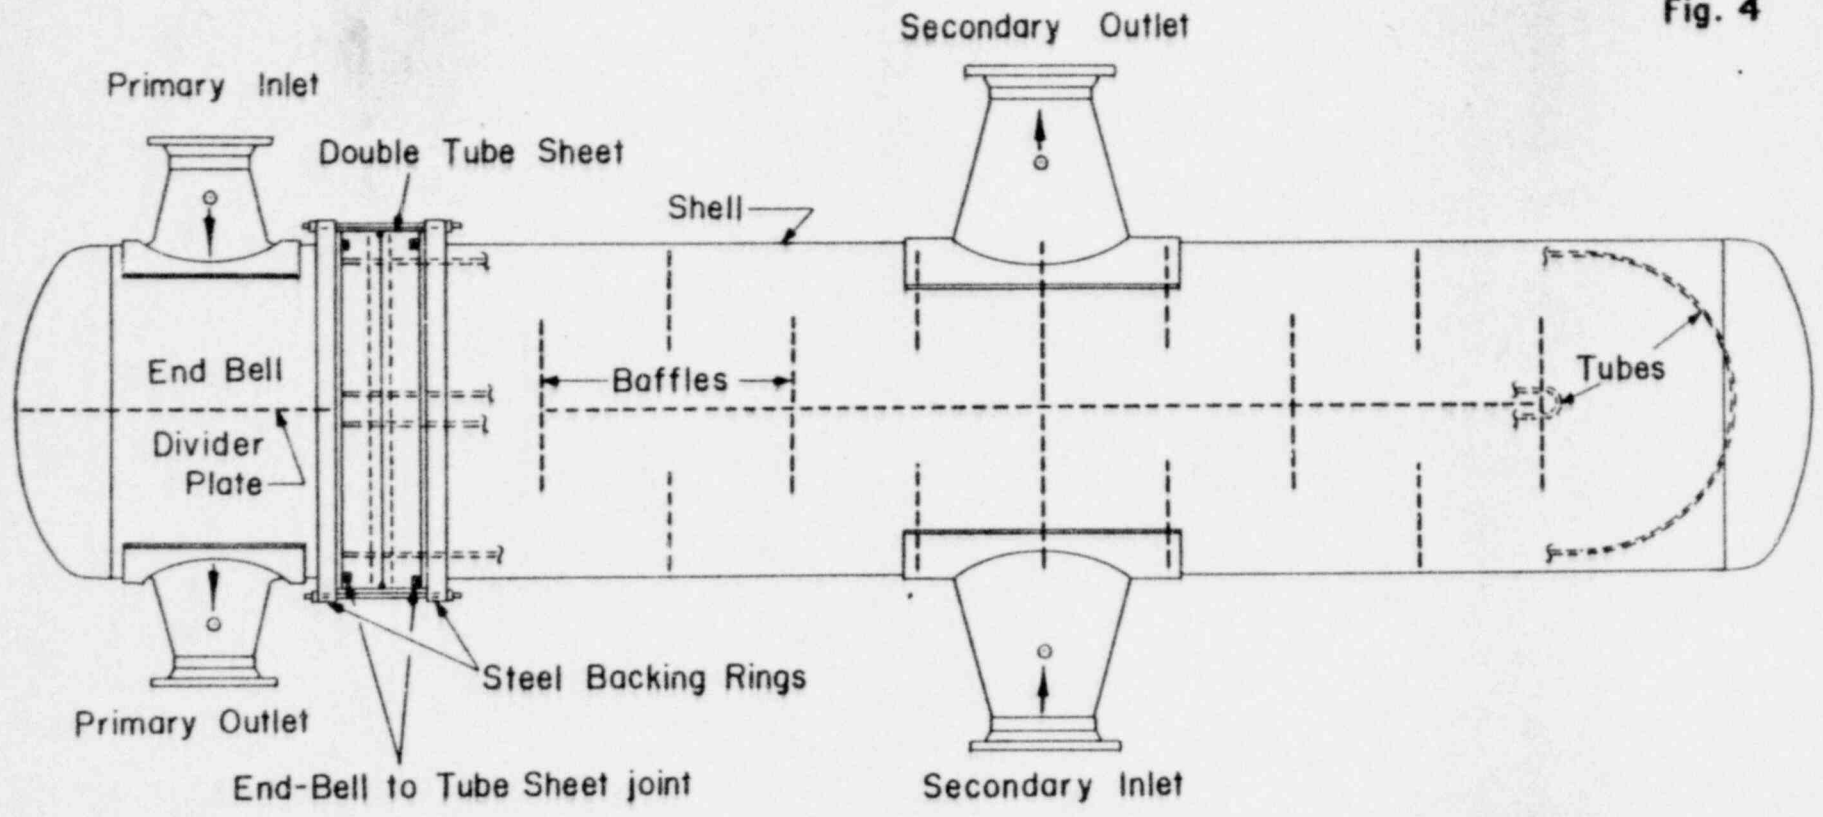
Fig. 4

With this in mind, the primary side of the heat exchanger was opened by removing the head (Fig. 4). Extremely fine, almost colloidal material showing  $^{60}\text{Co}$  activity was found. Three particles were separated from this colloidal material. Two were found at the flange connecting the head to the body of the heat exchanger. One of these, found at the seven o'clock position when facing the heat exchanger was labelled HEX 7-1. In addition, two particles were found in the water of the pool directly under the reactor core. This pool is used to store the spent fuel elements prior to shipping. These particles were analyzed along with a number of representative particles from outside the heat exchanger. The analysis of these particles, analysis of pump components, and the specific activity of the particles are discussed in subsequent sections.

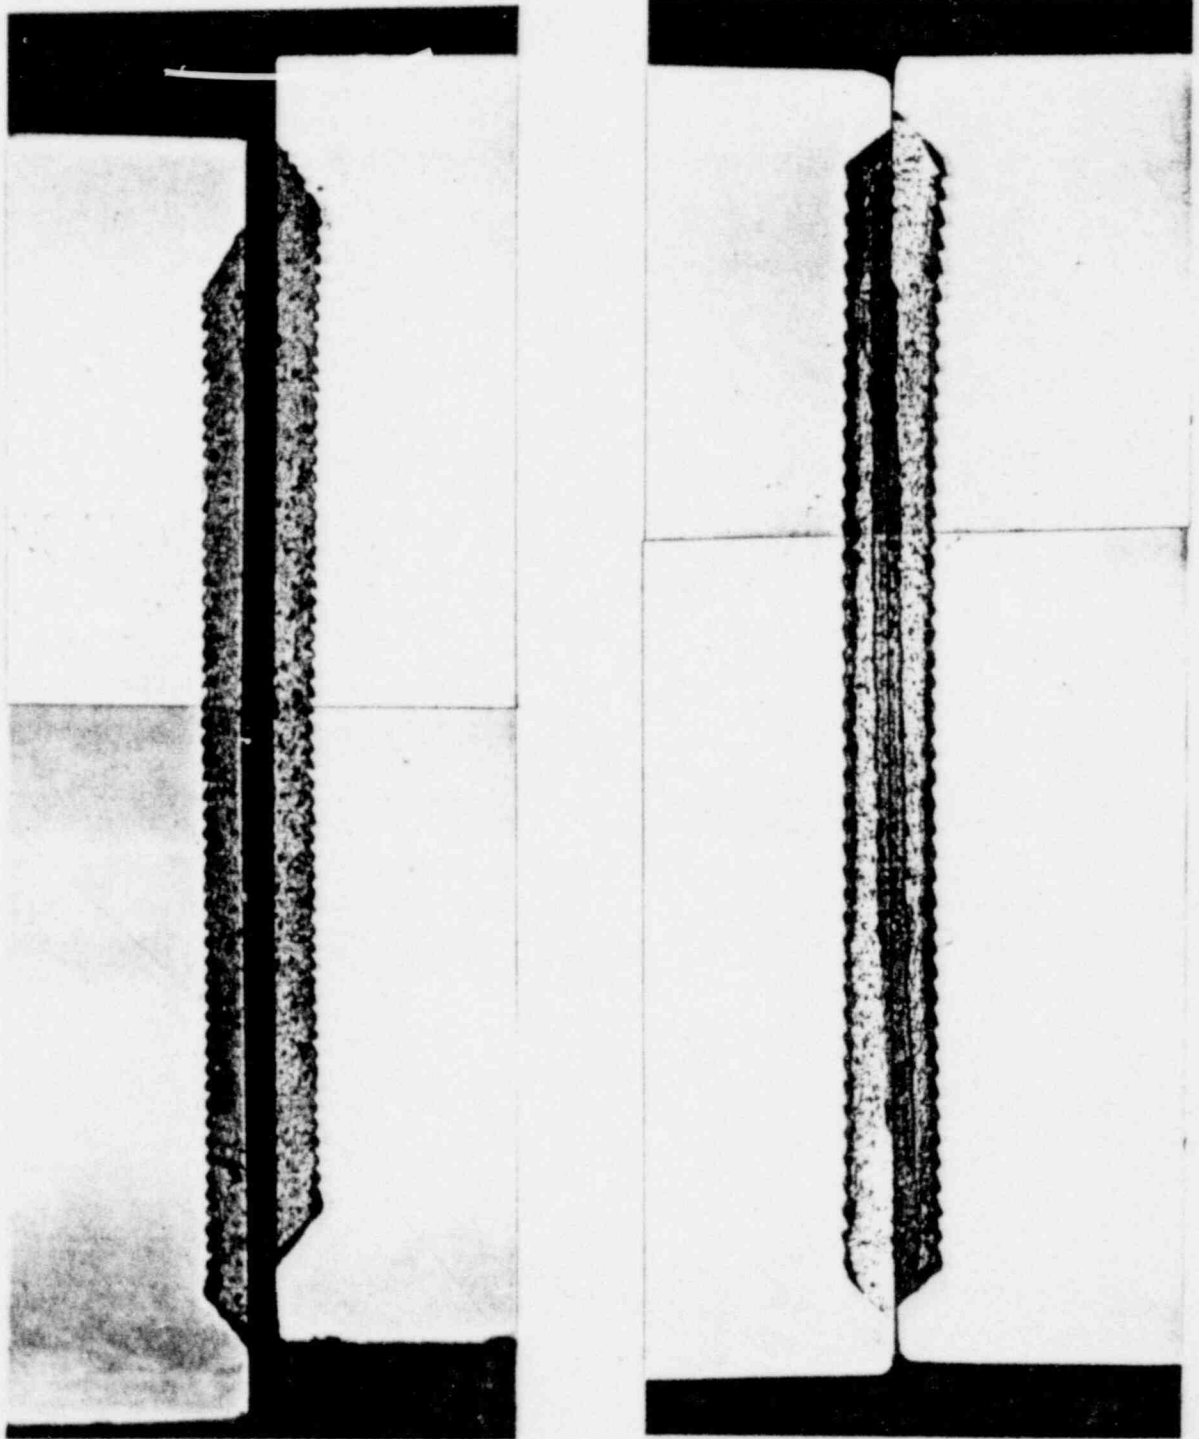
Figure 7.

Cross sections of both the new and the worn ring at a magnification of 6X are shown in Fig. 7. From these it can be seen that the wear surface itself was deposited in a groove approximately 1mm deep in the body of the wear ring. The worn impeller wear ring, as described in Appendix A, has a composition that is high in cobalt, chromium and nickel, with regions of a cobalt-chromium type of alloy. The Co-Cr-Ni phase has a composition very close to Stellite alloy SF 6, while the other phase has a composition corresponding to Stellite 157. Both these alloys are made for flame spraying.

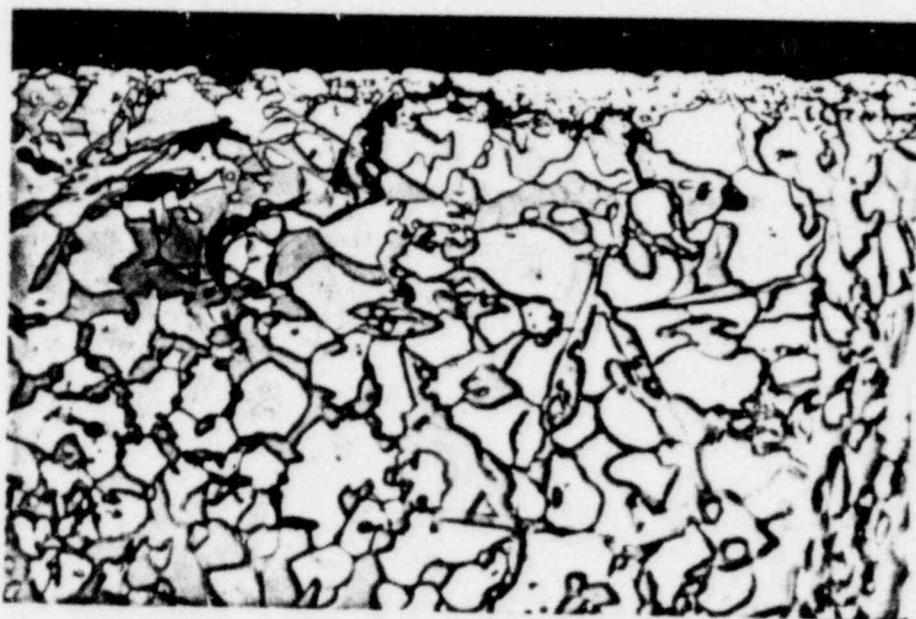
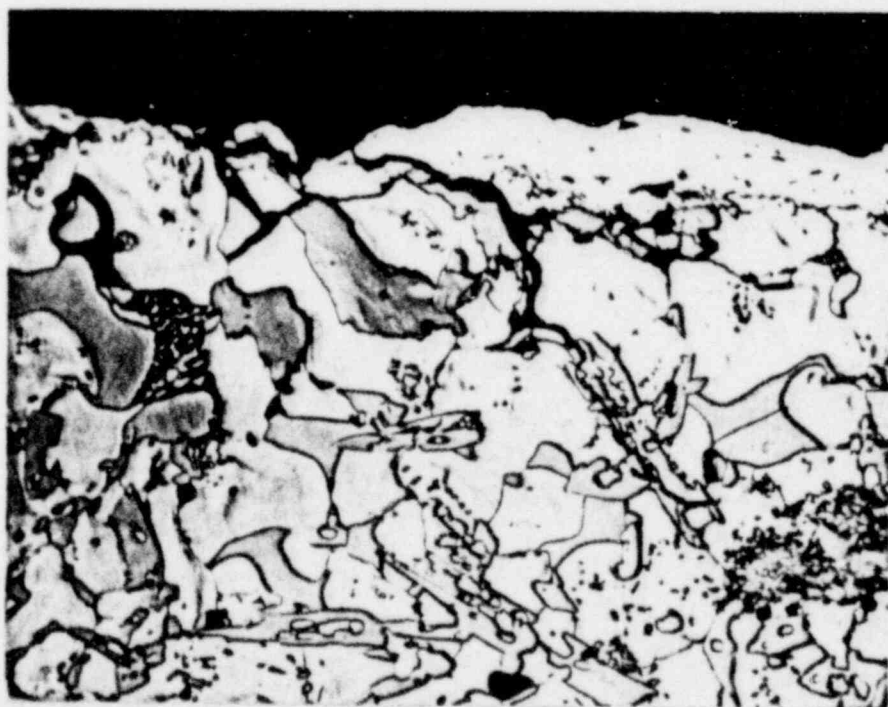
Figure 8.

Examination of the cross section of the worn impeller wear ring at high magnification (Fig. 8) leads to an interesting observation. There is a thin (10-20  $\mu\text{m}$ ) surface layer that appears to be a different material from the base material. It in fact appears to be material transferred from the opposing ring surface, as would occur during wear. This surface layer was analyzed extensively, and the results are given in Appendix B. The composition at a representative location is 39% Fe, 13.1% Co, 18.5% Cr and 25.7% Ni. The significance of these results is discussed below in Section 2.3.

- Fig. 8 Two views of the cross section of the worn wear ring, showing a deposited layer on the surface. This layer is variable in composition but contains a high concentration of iron (up to 40%). The matrix material is multi-phase, but contains a low concentration of iron (~2%). X500 upper, X1000 lower.

- 3) Fig. 8 in Sec. 2.2 very clearly shows a layer on the surface of the wear ring that appears quite separate from the matrix. Indeed, in the process of putting hardness indentations in this layer, it separated by fracture from the matrix. This is clearly seen in Fig. 1, Appendix B. It is high in iron content, and contains Cr, Ni and Co as the main alloying constituents. (See Table 4, Appendix A, Table 1, Appendix B).

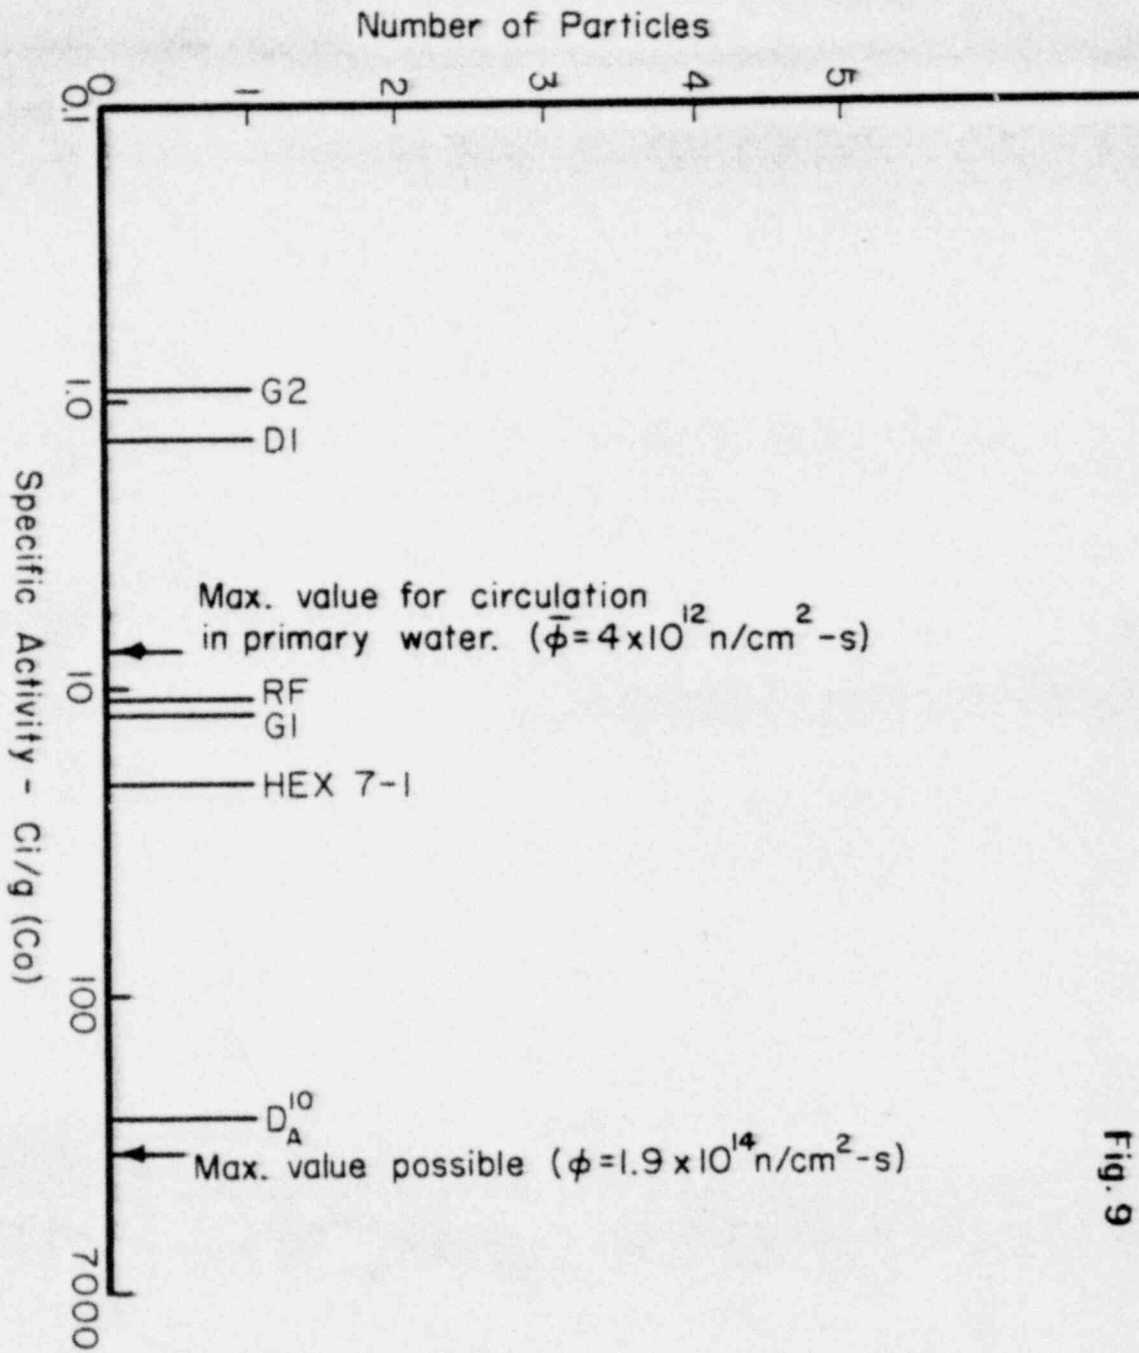
- Fig. 9 Distribution of specific activity of six particles. Arrows indicate specific activity corresponding to the maximum achievable for a particle circulating with the primary water and for a particle residing in the maximum flux region of the reactor.

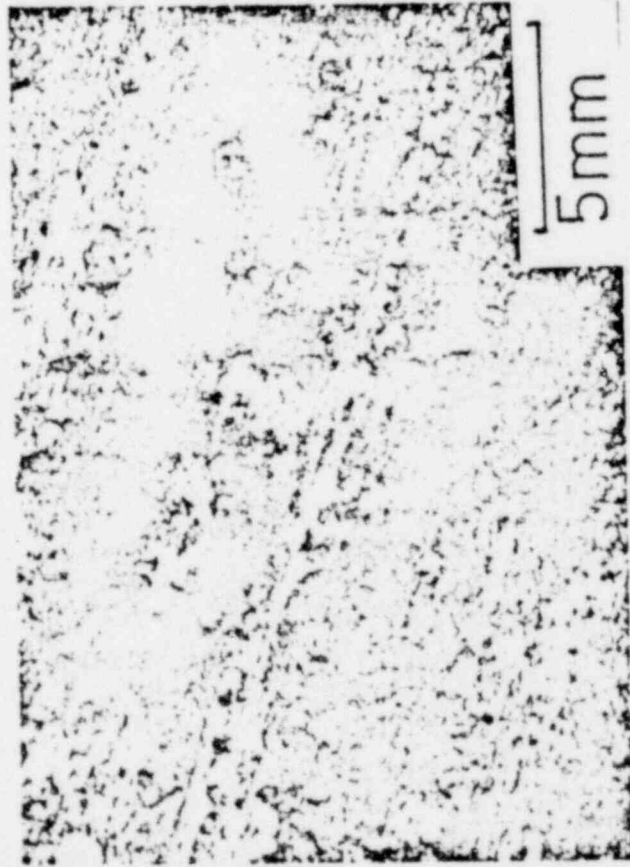
8(b)

- (d) Cobalt x-ray area scan corresponding to (c)
- 8(a) Optical micrograph of wear ring showing transition from fresh to worn region
- (b) Wear ring showing high wear area
