TEST OF CABLE PENETRATION FIRE STOPS FOR  
PILGRIM I NUCLEAR POWER GENERATING STATION

FRC Final Report  
F-C5159-3

To determine the fire resistance of cable tray penetration fire stops  
fabricated to simulate existing fire stops in the Pilgrim I Nuclear Power  
Generating Station located in Plymouth, MA.

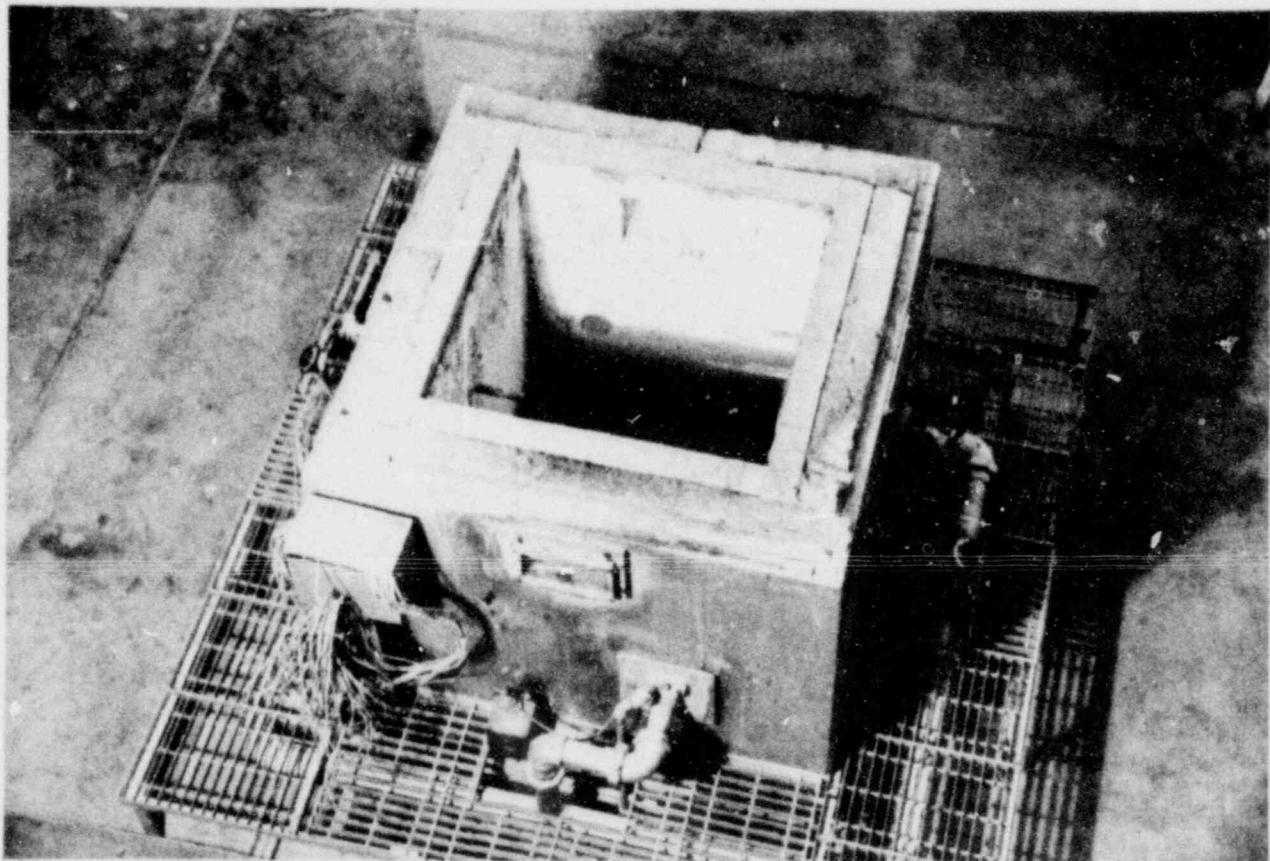
Figure B-1. 4 Ft by 4 Ft Floor Test Furnace

The fire stop test was performed at the Fire Test Laboratory of Portland Cement Association, in Skokie, Illinois. The 4 ft by 4 ft "floor test" furnace, pictured in Figure B-1, was used for the fire stop test. This gas-fired furnace produces a "standard" fire, as defined by IEEE Std 634-1978, (Ref. 1), beneath a horizontal concrete test slab (the test slab simulating a "floor" section in a building). In operation, the test slab itself forms the upper surface of the furnace test volume, with an area 32 in by 32 in being exposed to the fire test conditions.

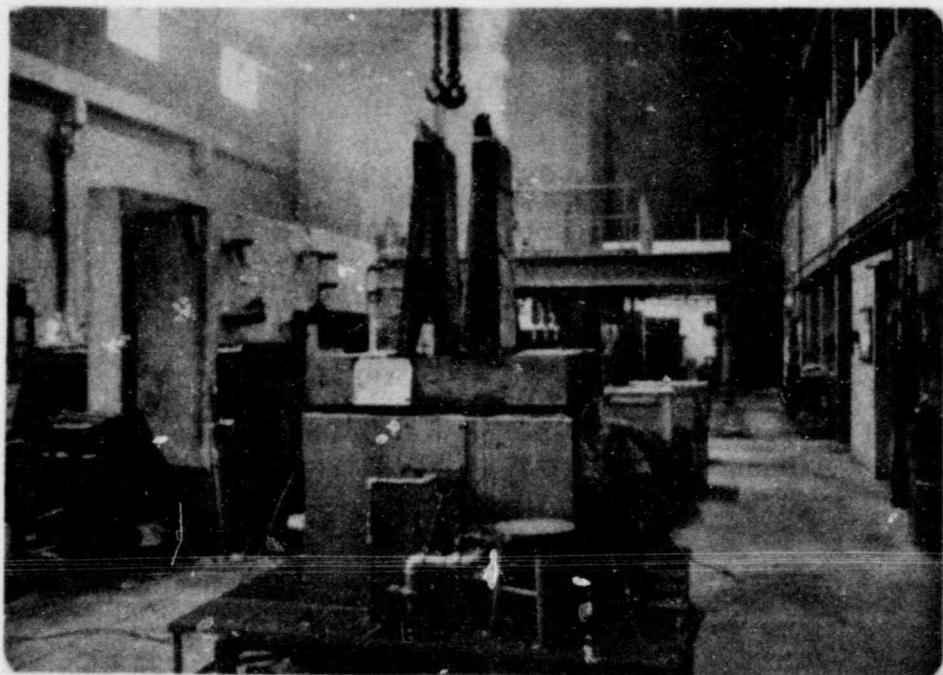
Figure B-2. Fire Stop Test Slab Prior to Test

The test slab was of reinforced concrete construction with dimensions of 4 ft by 4 ft by 9 in thick, and was constructed in accordance with SWEC instructions. Figure B-2 is a picture of the test slab just prior to the fire stop test.

Detailed representations of the six fire stops tested are presented in Figures B-3 and B-4 of Appendix B. A picture of the completed tray penetration installation is included in Figure B-2.

After all QA requirements had been met, in accordance with FRC Refs. 4 and 5, the test slab was placed in position on top of the floor furnace. The test slab in position just prior to test initiation is shown in Figure B-2. Thermocouple leads were then connected to the thermocouples mounted on the penetrations, and the furnace was ignited. The time of furnace ignition was recorded. Within the Control Lab, the furnace operators adjusted furnace draft as required to obtain optimum burning conditions. The furnace servo-controller started tracking the required temperature profile, defined beforehand by the curve of IEEE Std 634-1978 (Ref. 1). The average of the three servo TC temperatures was recorded over a plot of the Ref. 1 curve to give a direct visual presentation of furnace temperature variations from the specified profile for the 3-h test.

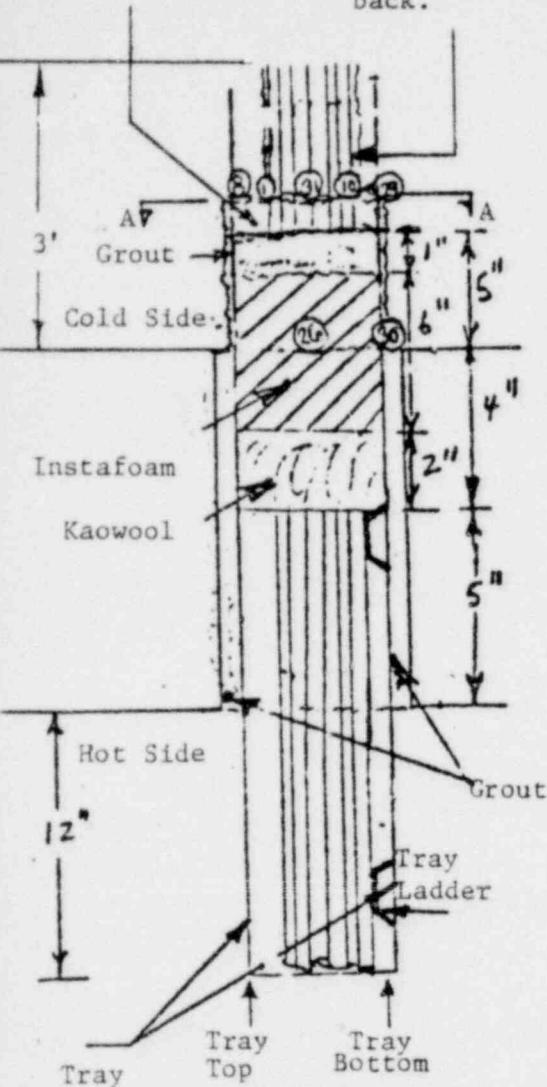
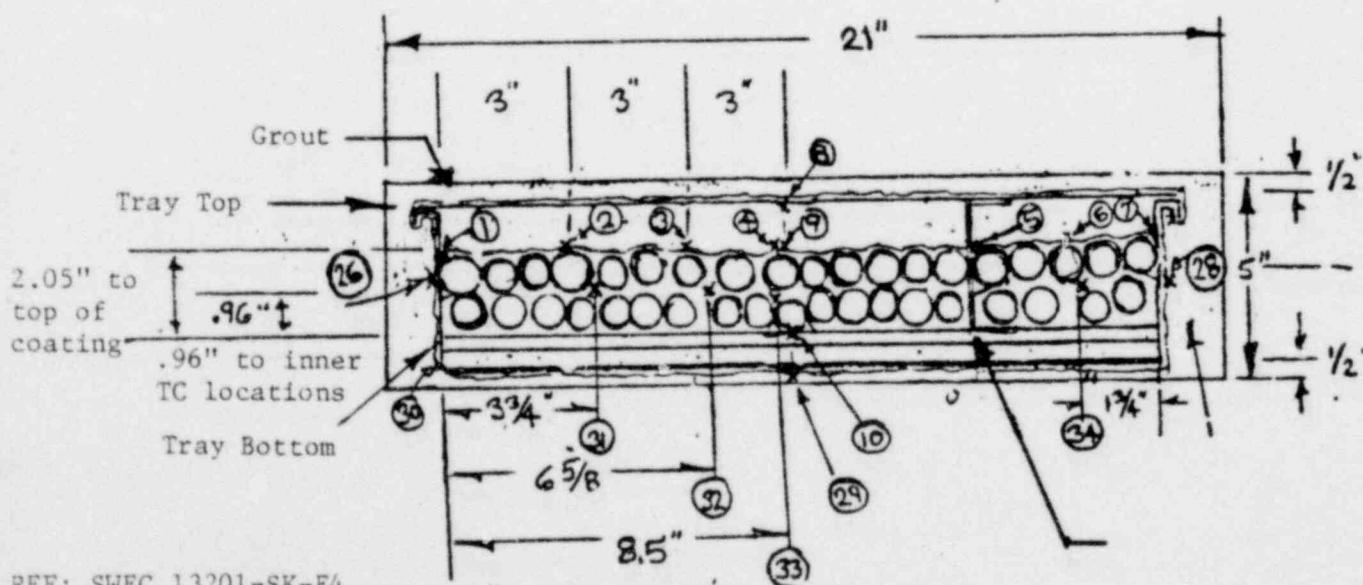
Figure 3-3. Tray Penetration #1 Construction Details and Thermocouple Locations.

1" coating of  
Flamemastic 77  
over grout

1/8" coating of  
Flamemastic over  
wires in tray 3'  
back.

Cable fill: 17 cables of C12  
22 cables of 912-27

1. On the cold side of the penetration a 1" thick coating of Flamemastic 77 applied over 1" grout layer, as shown.
2. TCs 2, 3, 4, & 6 are wired to cable jackets in positions shown at level of the 1" Flamemastic-to-cable interface.

3. TC 9 is mounted 3" above TC 4 on the same cable, for temp. gradient information.
4. TCs 1, 5, 7, & 10 are wired to cable jackets, and cable-plus-TCs are wired to adjacent tray metal through two adjacent holes drilled into tray metal for mounting purposes, i.e., TC is firmly sandwiched between metal and cable. This is done at level of the 1"-Flamemastic-to-cable interface.

5. TC 8 is mounted to the inside of tray top with wire thru two mounting holes.
6. All cables to be coated 1/8" wet all the way back to the cold end of the tray (3').

7. The sides, bottom, and top of the tray itself are to be coated 5" from the face of the slab, 1/8" wet.
8. There was no TC#27 included in the test.
9. TCs 26, 28, 29 and 30 are wired to the surface of the dry coating of Flamemastic 77 applied to the outer surface of the tray.

10. TCs 31, 32, 33, and 34 were mounted at the level between the two cable layers at positions indicated in the drawing.

Figures B-3 and B-4 of Appendix B show the arrangement of fire stop components used in the two tray penetrations.

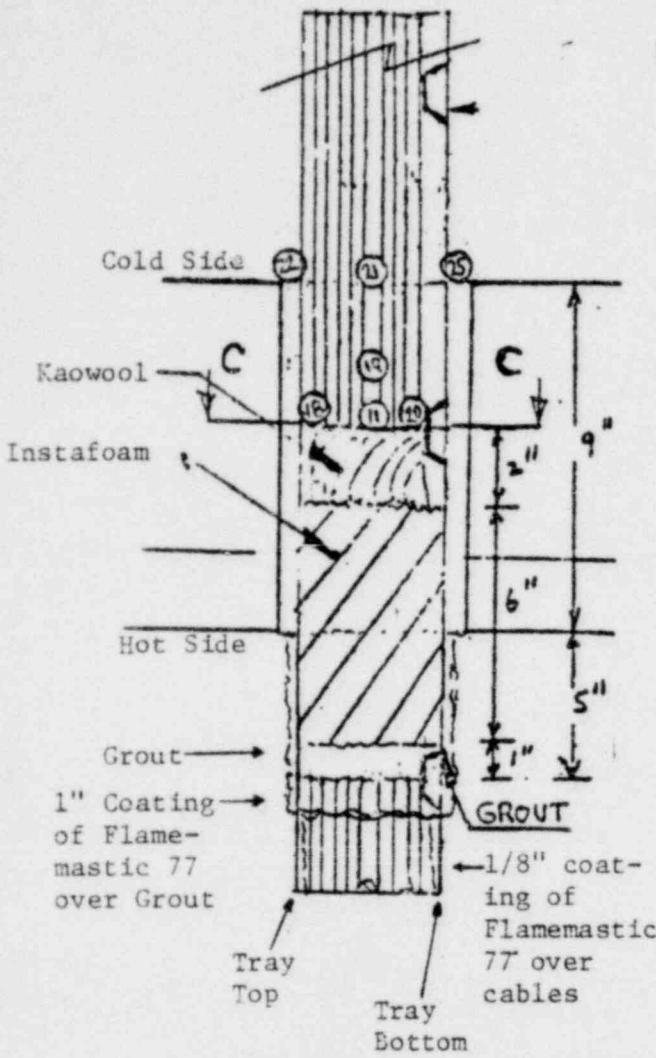
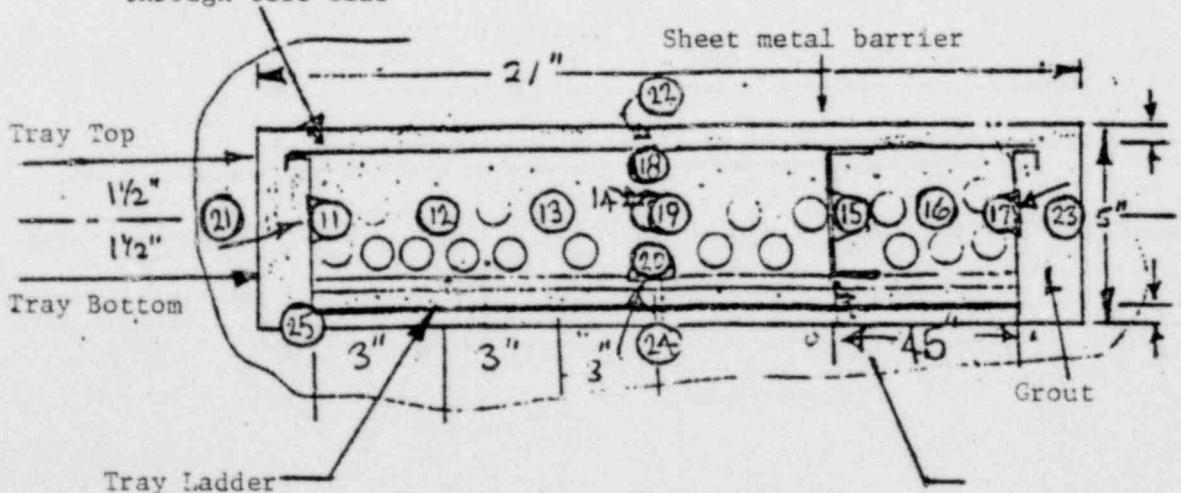
Figure 8-4. Tray Penetration #2 Construction Details and Thermocouple Locations

Cable fill: 17 cables of C12  
 : 22 cables of 912-27

1. On the hot side of the penetration a 1" thick coating of Flamemastic 77 applied over the 1" grout layer, as shown.
2. All cables to be coated 1/8" wet on the hot side, as shown.

3. The sides, bottom, and top of the tray itself are to be coated 5" from the face of the slab on the hot side.
4. TCs 12, 13, 14 and 16 are wired to cables inside cable bundles in positions shown, at level of grout-to-air-interface.

5. TC 19 is mounted in the same manner, however 3" above TC 4 for temperature gradient information.
6. TCs 11, 15, 17 and 20 are wired to outermost cable surfaces, and cable-plus-TC are wired to adjacent cable metal through two adjacent holes drilled into the tray metal for mounting purposes, i.e., TC is sandwiched between metal and cable, at Kawool/air interface.

7. TC 18 is mounted to inside of tray top with wire through two mounting holes.
8. TCs 21, 22, 23, 24, and 25 are located on outside of tray at grout-to-tray interface. Each TC is wired to outside of tray through two adjacent mounting holes added for this purpose.

9. TC 22 is mounted with wire through two mounting holes on the top cover at the level of the surface of the cold side of the slab.
10. TC 25 is mounted in the above manner at the corner of the tray, at the same level.

End view of tray through test slab

Section C-C: View from cold side.

Minimal activity was observed on the cold side of the slab throughout the test. At 1 h and 10 min after test initiation a small amount of smoke was seen to seep through Tray Penetration #2. At 1 h and 47 min after test initiation, Tray Penetration #2 was observed to burn through to the cold side. By the end of the test, portions of the central area of the bottom and top of Tray Penetration #2 were seen to be buckled inward approximately a maximum of 3/8 to 1/2 in due to the intense heat. Tray Penetration #1 appeared to be totally unaffected.

Cold side thermocouple temperatures for the two tray penetrations were observed to climb slowly throughout the 3-h fire stop test. At 1 h 40 min after test initiation TC 16 of tray penetration #2 exceeded the 700°F temperature limit of IEEE Std 634-1978. Shortly thereafter, at 1 h 53 min, TC 14

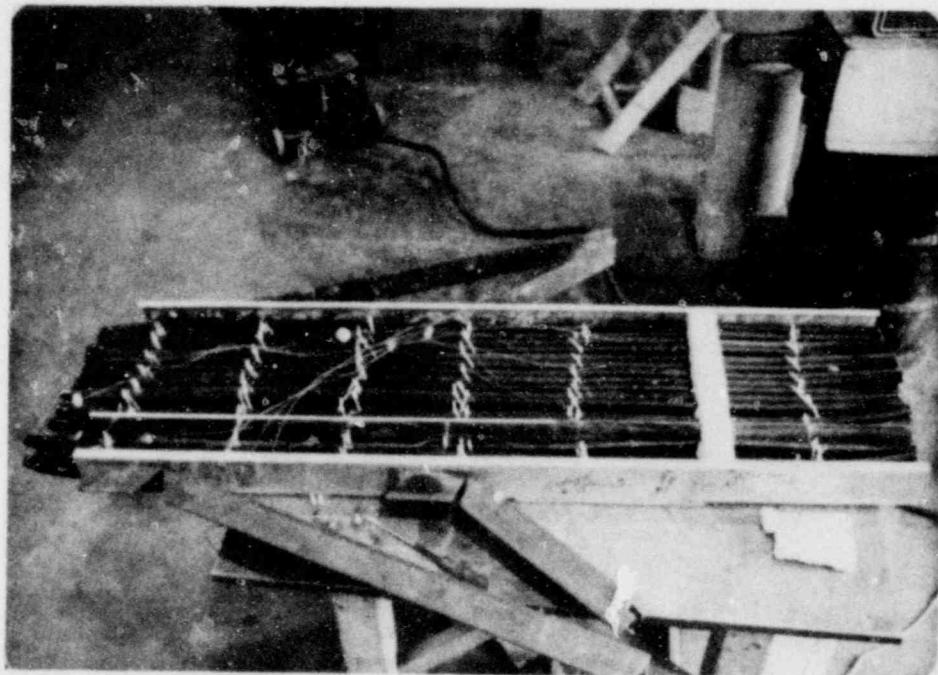
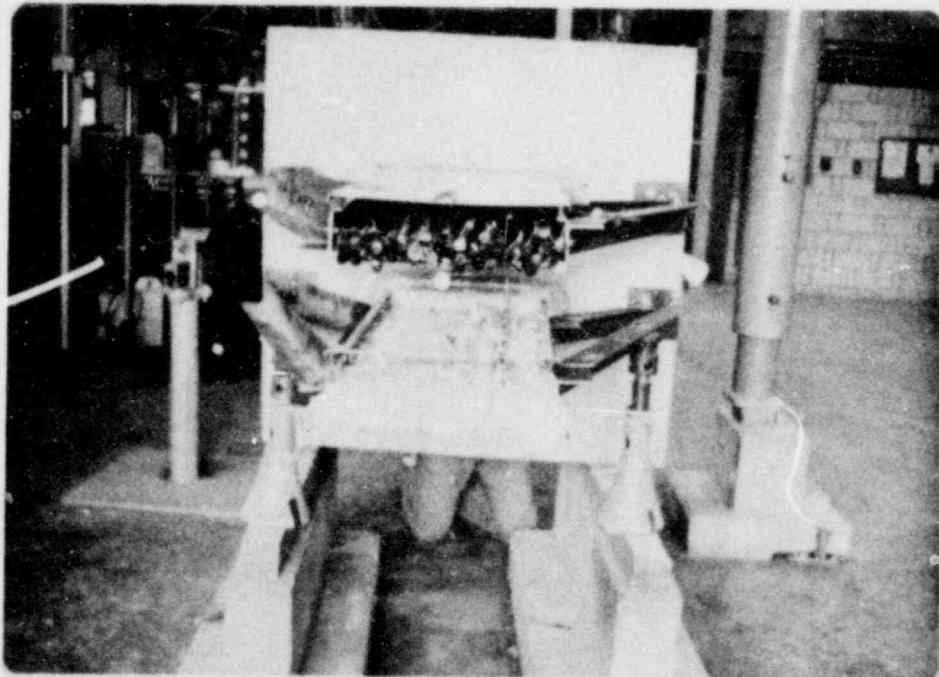
Figure B-5. Tray Supports on Cold Side of Test Slab

The cables were supported by a welded structure of 3-in angle iron bolted to the cold side of the slab, as shown in Figure B-5. The tray and cables extended 3 ft 6 in beyond the cold side of the test slab. On the hot side of the slab the tray and cables extended 12 in into the furnace.

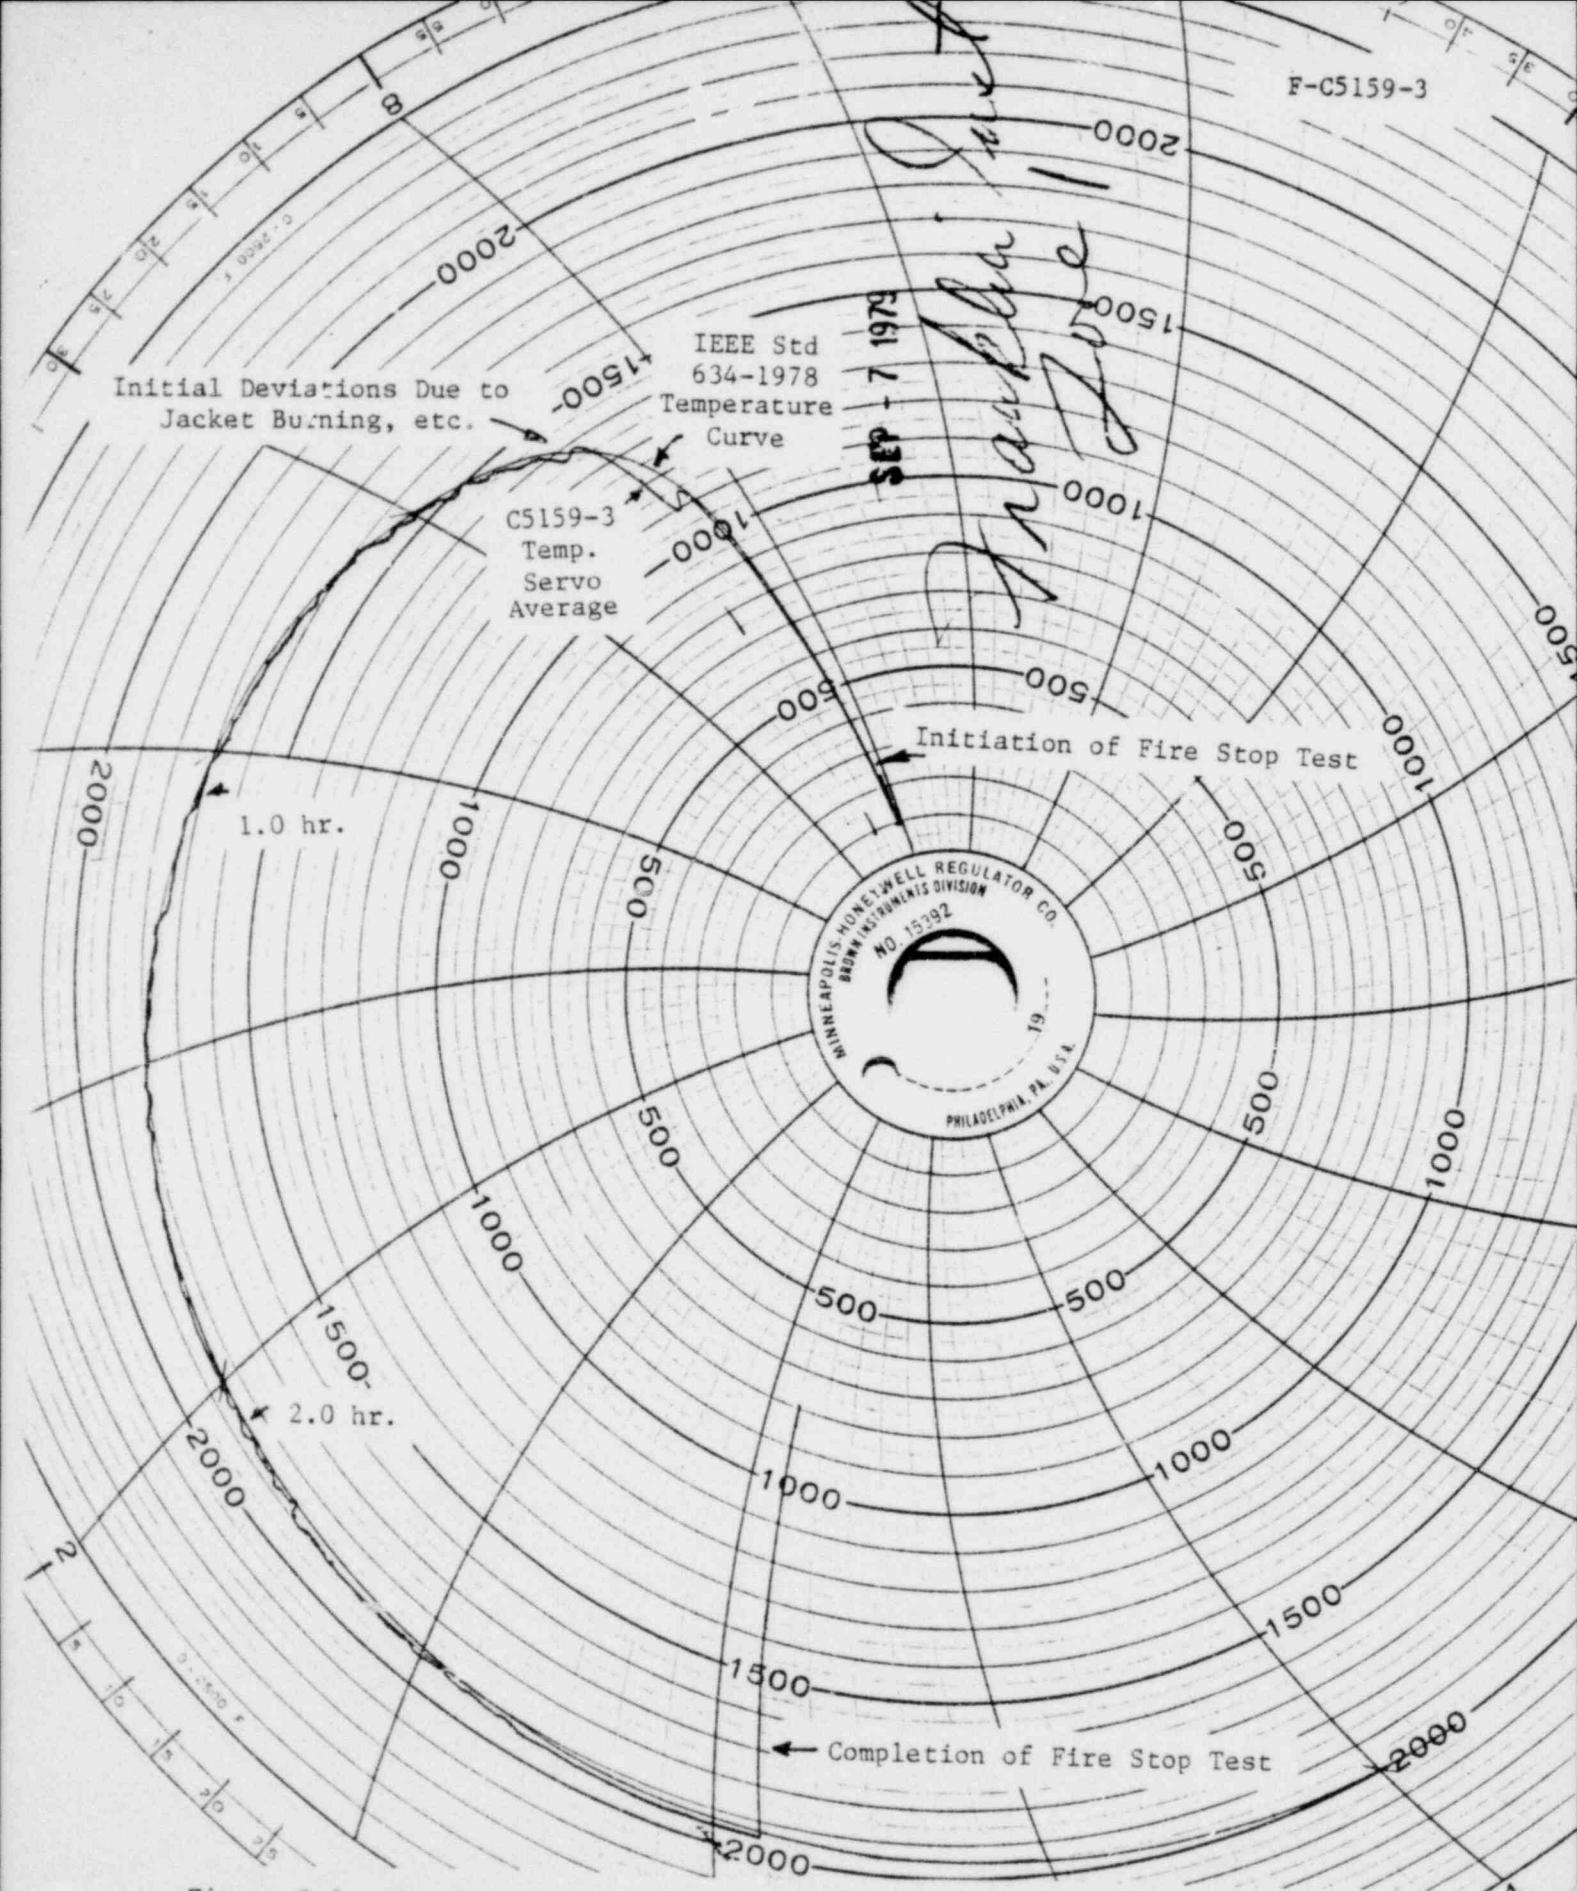
Figure B-6. Furnace Temperature vs. Time Profile Obtained for Fire Stop Test C5159-3, September 1979

Figure B-6 presents the furnace temperature profile obtained for the test, recorded over the IEEE Std 634-1978 temperature profile. Furnace temperature variations during the 3-h fire stop test were within IEEE Std 634-1978 requirements.

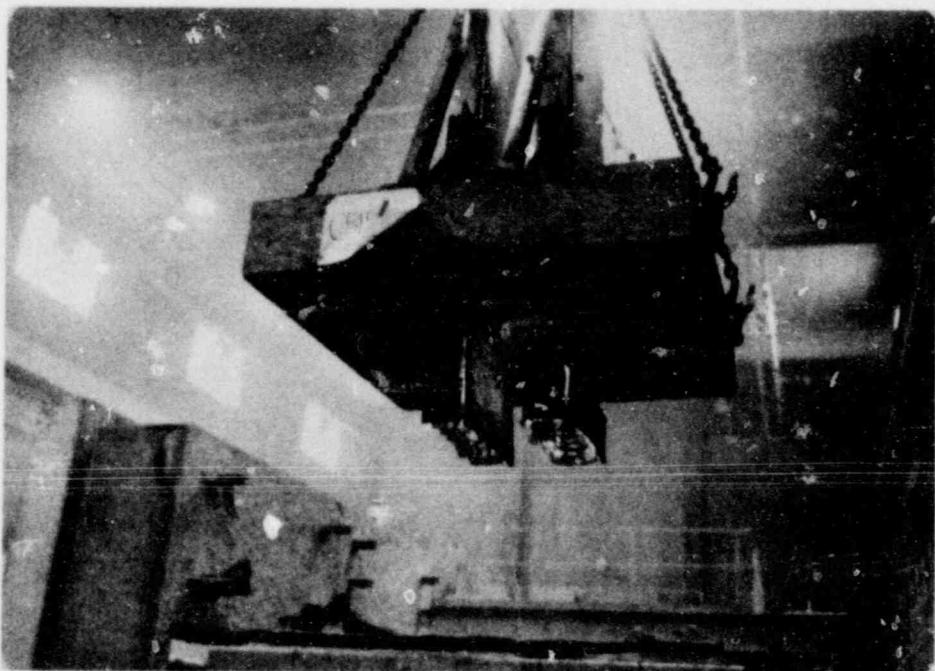
Figure B-7. Test Slab in Raised Position Just After Completion  
of IEEE Std 634 - 1978 3 Hour Fire Test

After the IEEE Std 634-1978 fire test was completed, the furnace was extinguished, and the still-hot slab was lifted from the furnace with an overhead crane. A view of the test slab in this position can be seen in Figure B-7. The slab was then placed on its side outside the test building. A 1-1/2-in, high-pressure (75 psig, 75 gal/min) water hose was directed at the cold side of the slab from a distance of 10 ft, in accordance with the requirements of IEEE Std 634-1978 for the nuclear generating station hose stream test. A picture of the hose stream test is shown in Figure B-8.

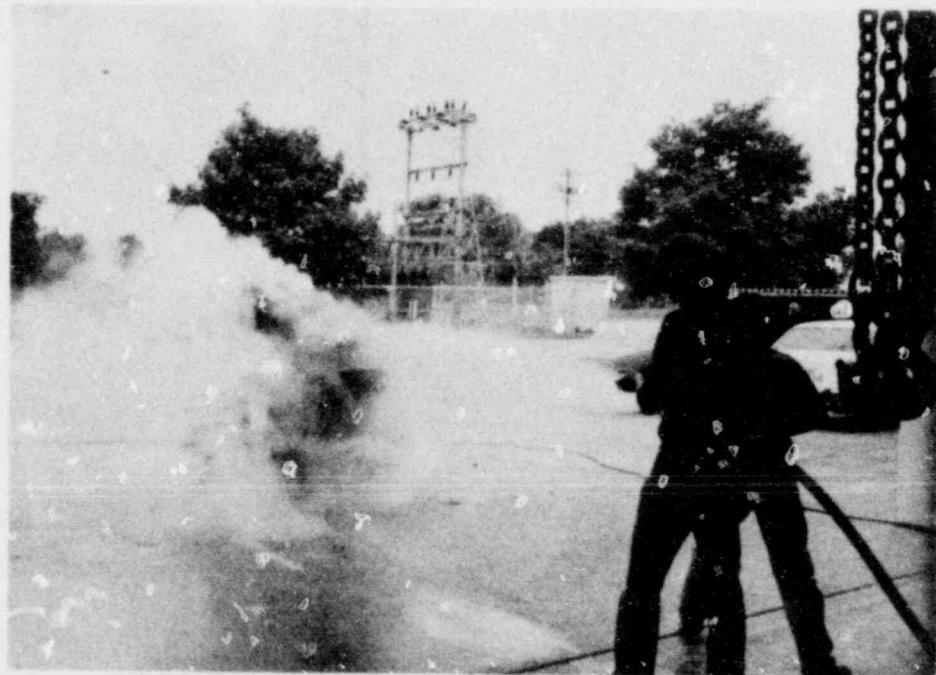
Figure B-8. Hose Stream Test of Test Slat C5159-3,  
September 7, 1979

After completion of the 3-h fire test the test slab was removed from the furnace and the IEEE Std 634-1978 hose stream test was performed outside the building. Elapsed time between the end of the fire test and initiation of the hose stream test was approximately 5 min. There was no observable projection of water through the penetrations in the test slab during the hose stream test.

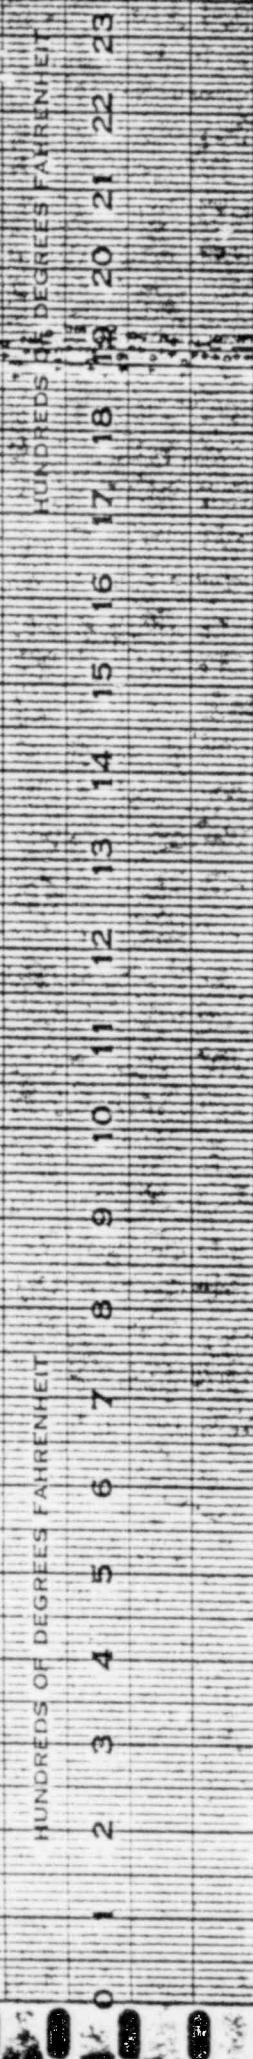
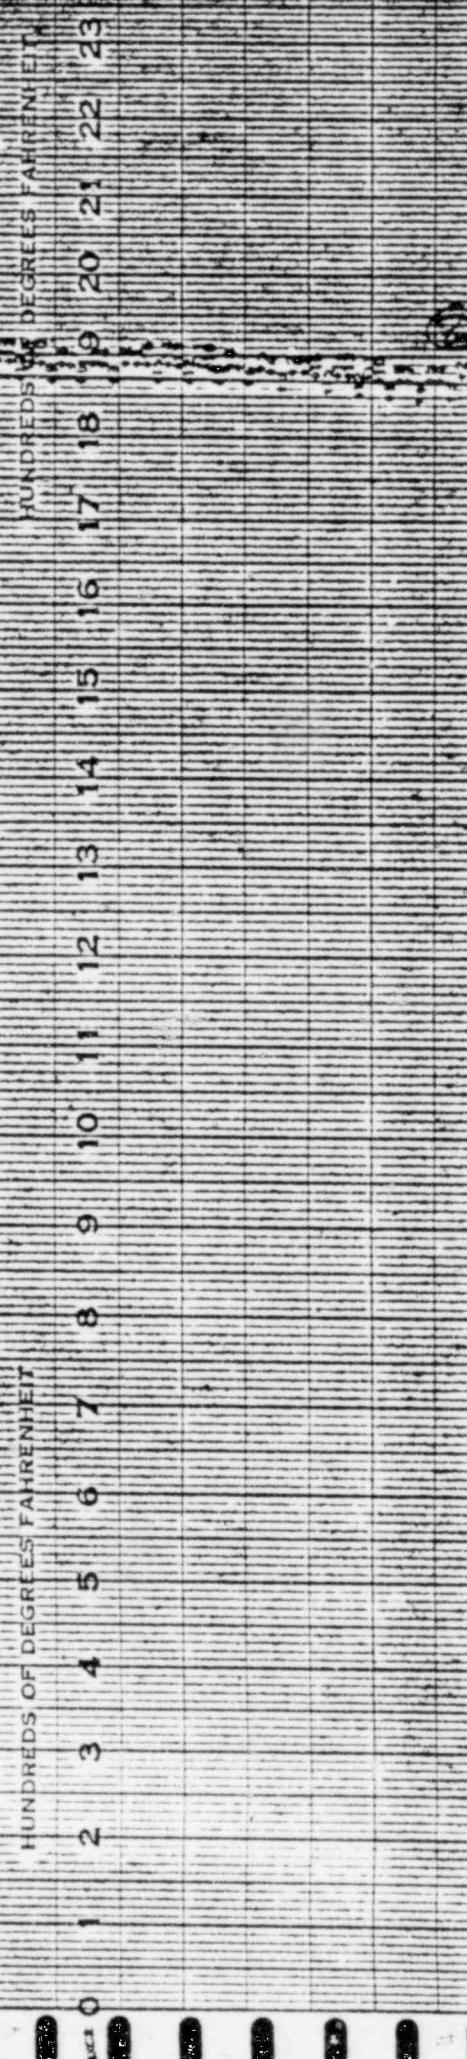
HUNDREDS OF DEGREES FAHRENHEIT

1    2    3    4    5    6    7    8    9    10    11    12    13    14    15    16    17    18    19    20    21    22    23
