INTERIM REPORT

Stress Corrosion Cracking of Alloy 600 Using the Constant Strain Rate Test

March 1980

## STRESS CORROSION CRACKING OF ALLOY 600 USING THE CONSTANT STRAIN RATE TEST\*

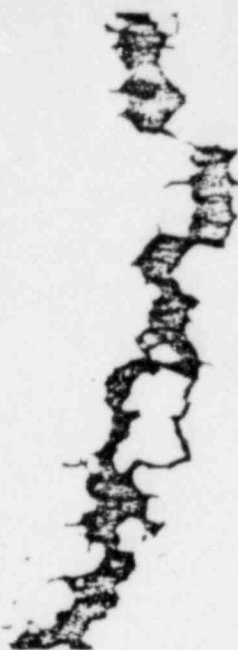
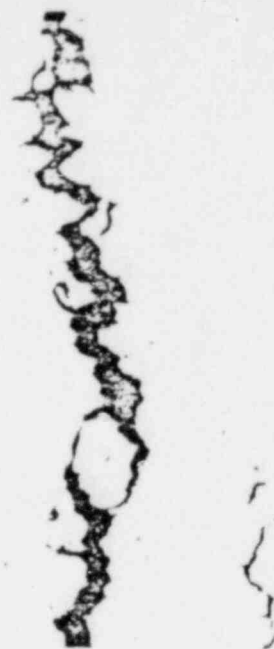
Figure 2 Micrographs of U-bend Specimen from Heat #2 after 2 Weeks Exposure @3365°C

Microscopic examination of the failed specimens showed that SCC was intergranular and generally along the axis of the U-bend near the apex. This would seem to indicate that a considerable hoop stress was applied during the bending process. Occasionally the cracks would deviate from this path and run for a short distance at nearly right angles before resuming the axial path. Micrographs of cracked specimens (Figs. 2, 3, and 4) and specimens which did not fail (Figs. 5 and 6) both show very little chromium carbide particles when etched electrolytically in phosphoric acid. Therefore, it appears that an accurate prediction of U-bend performance cannot be based on microstructural analysis alone.

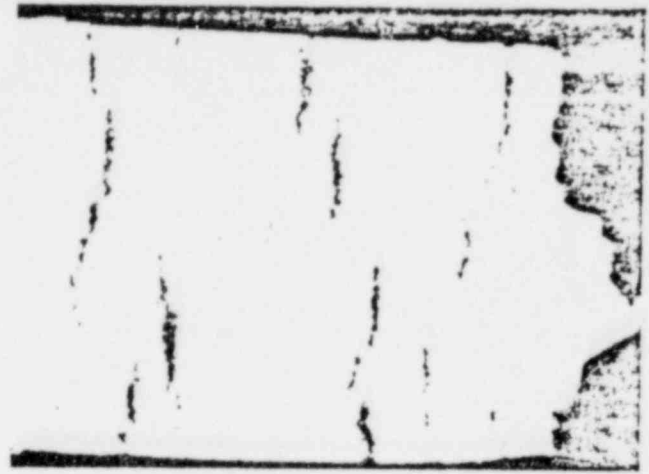
Figure 11 Heat #4 Fractured in Constant Extension Rate Test 3.35°C with a Strain Rate of  $3.0 \times 10^{-2} \text{ sec}^{-1}$

10X Photo. of Fracture Surface

1 X S.E.M. of Fracture Surface

All of the fractured surfaces were examined by SEM to determine the presence of intergranular SCC even though most specimens exhibited varying degrees of secondary cracking. Intergranular penetrations originated in the specimen faces corresponding to the original ID or OD of the tubing rather than the machined surfaces. They were not, however, confined to a particular side; the inside surface of the tubing appears to be as susceptible as the outside.

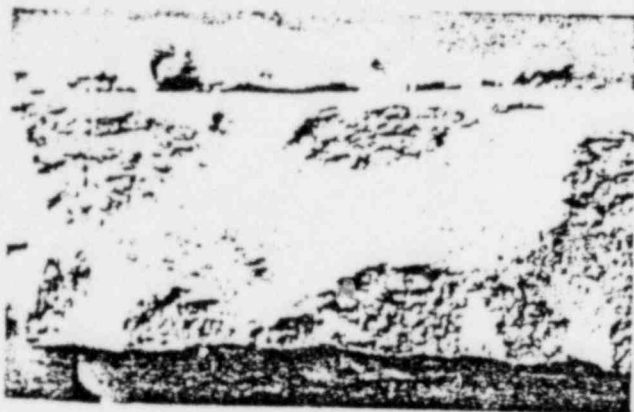
Figure 12 Heat #4 Fractured in Constant Extension Rate Test 8345°C with a Strain Rate of  $2.6 \times 10^{-7} \text{ sec}^{-1}$

3X Photo of Fractured Gauge Section

8.5X Photo of Fractured Gauge Section

15X S.E.M. of Fracture Face

500X S.E.M. of Intergranular Area

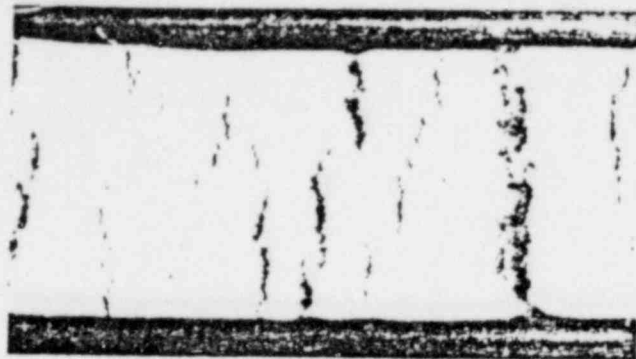
Figure 15 Heat #4 Fractured in Constant Extension Rate Test @325°C with a Strain Rate of  $3.9 \times 10^{-8} \text{ sec}^{-1}$

7.5X Photo of Fractured Gauge Section

20X S.E.M. of Fracture Face

500X S.E.M. of Intergranular Area
