EVALUATION OF TRANSIENT BEHAVIOR
AND SMALL REACTOR COOLANT SYSTEM BREAKS
IN THE 177 FUEL ASSEMBLY PLANT

MAY 7, 1979

VOLUME II
APPENDICES

APPENDIX I

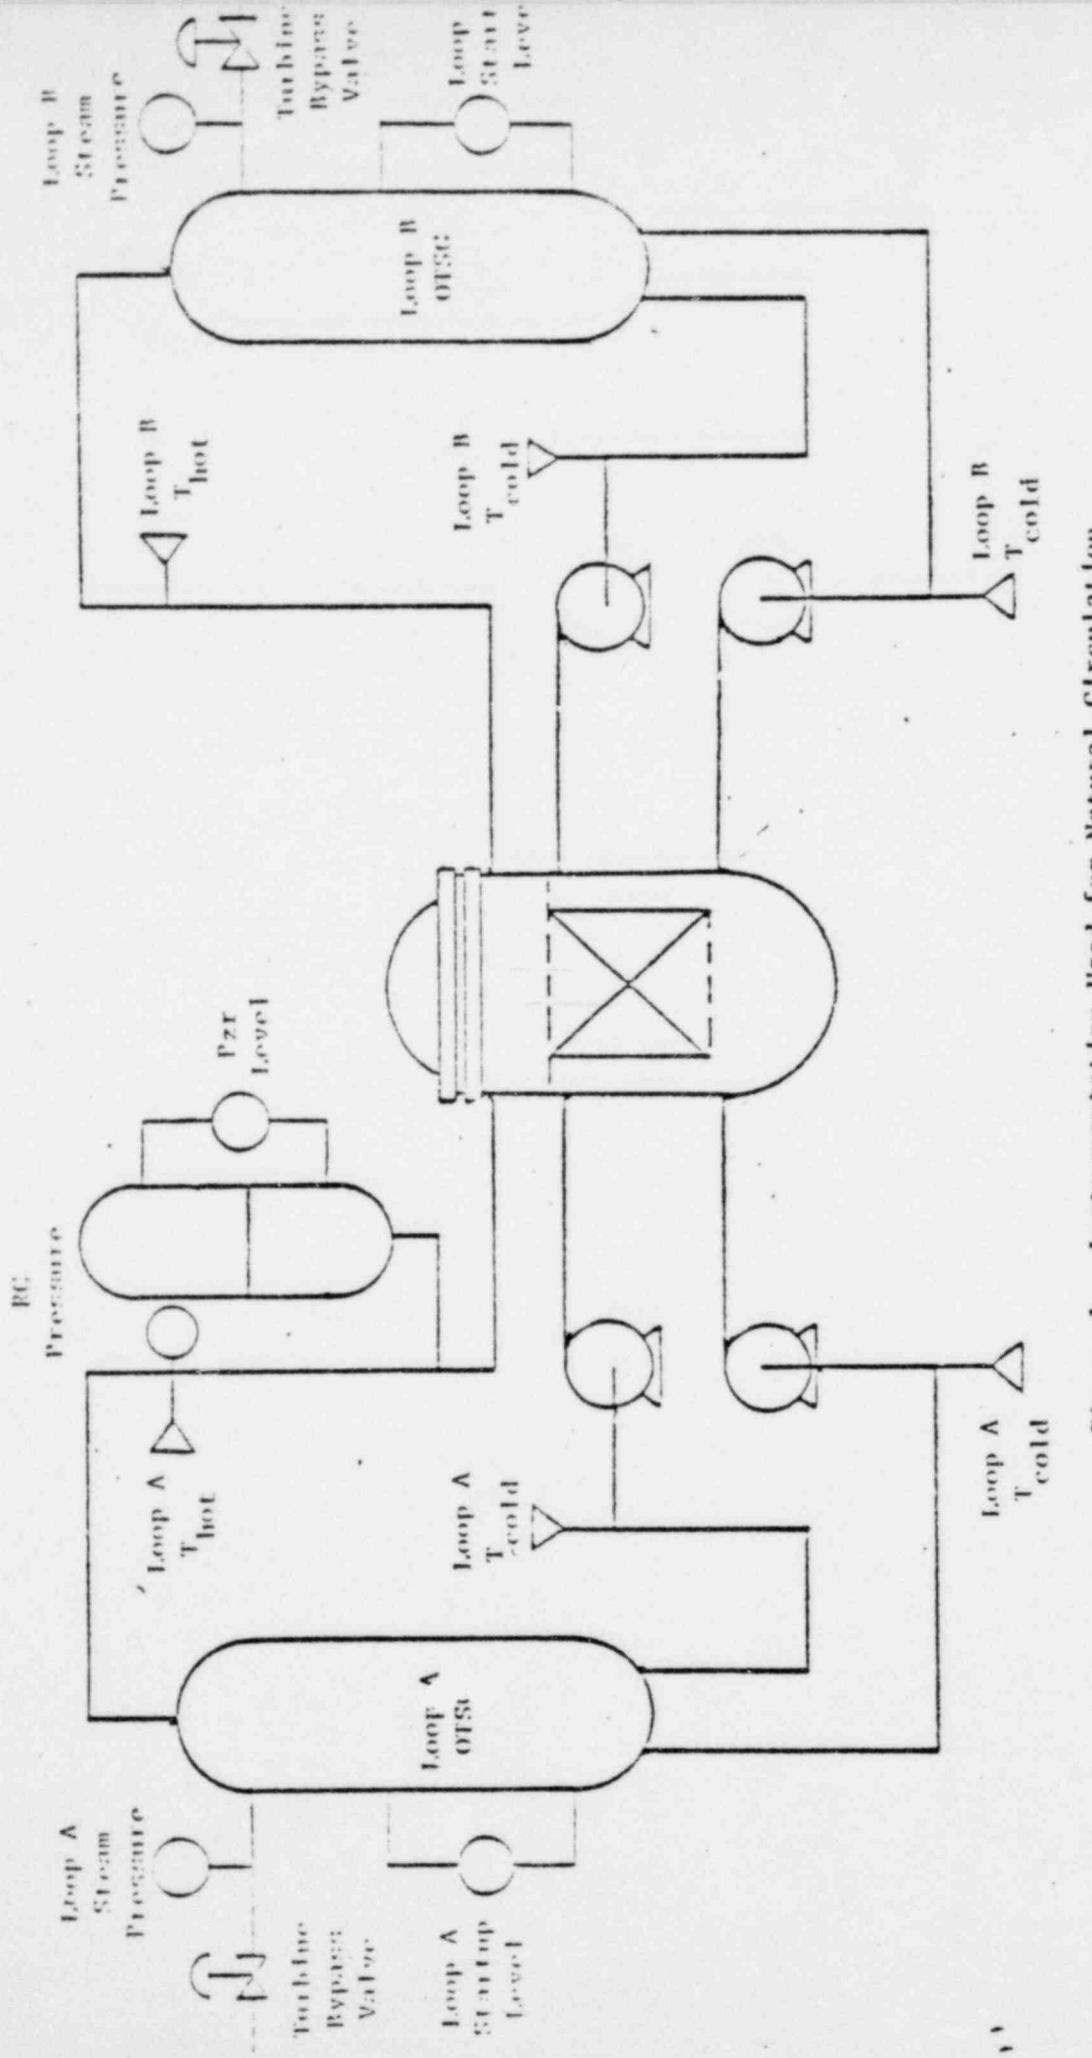
Figure 1. Instrumentation Used for Natural Circulation Flow Rate Measurements at B&W 177-Fuel Assembly Plant

Test data from this simulated natural circulation flow rate test are presented in Figures 1 through 5. Figure 1 is a schematic of the B&W 177-fuel assembly lowered-loop plant. The location of the instrumentation used to measure the behavior of the reactor coolant system during natural circulation is shown in Figure 1. Figure 2 displays loop B hot leg and cold leg RC temperatures during the first test described above. RC pressure and pressurizer level are shown in the lower graph. RC pressure varied \pm 60 psi about the normal operating value of 2150 psig.

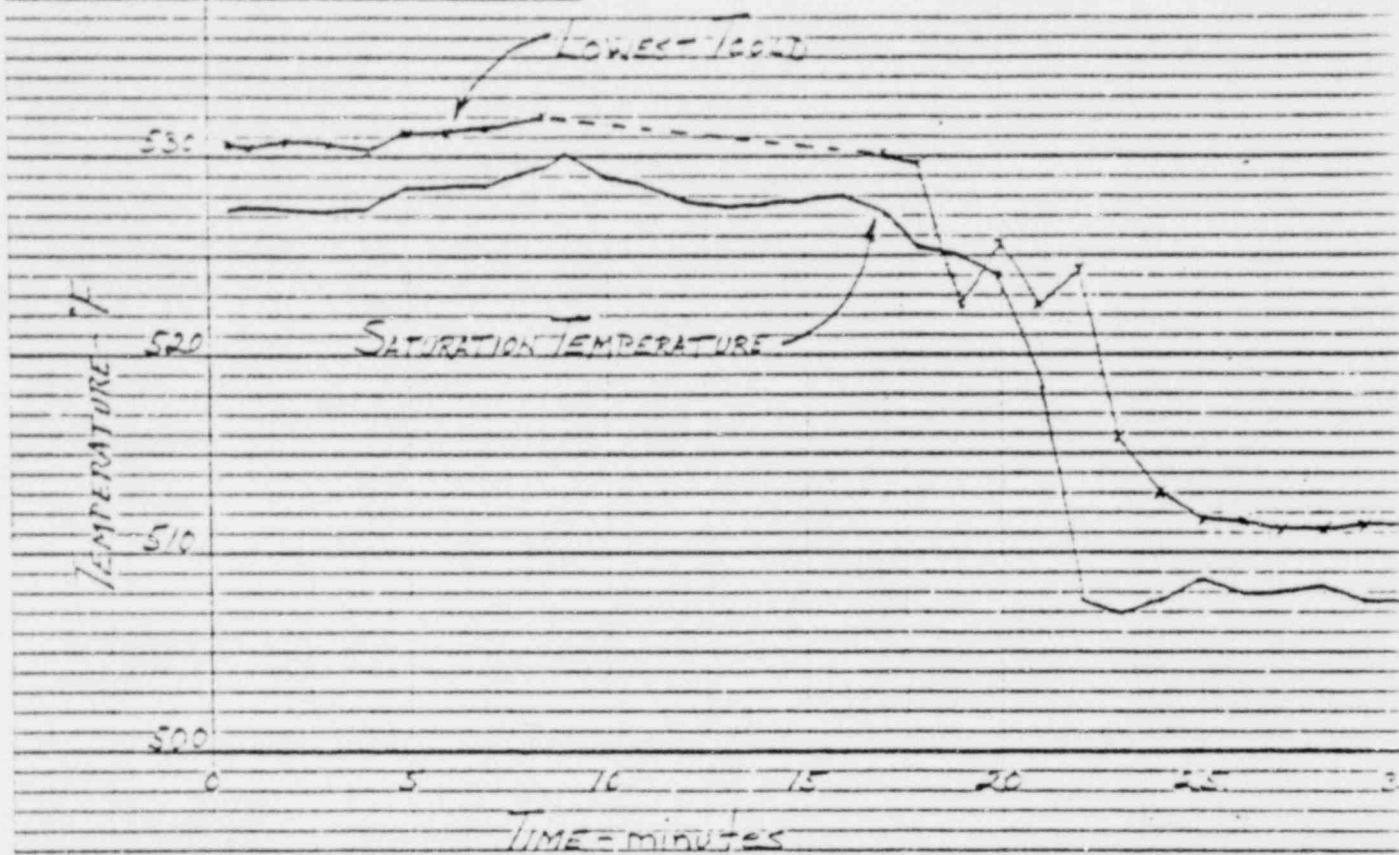
Figure 6. RC System Parameters During Level Increase-Induced Natural Circulation at Ocnele Unit 1

Test data from the second test, natural circulation by raising water level, are presented in Figures 6 through 9. Figure 6 shows hot leg and cold leg temperatures in loop A. The lower graph displays RC pressure and pressurizer level with changes nearly equal to the first test.

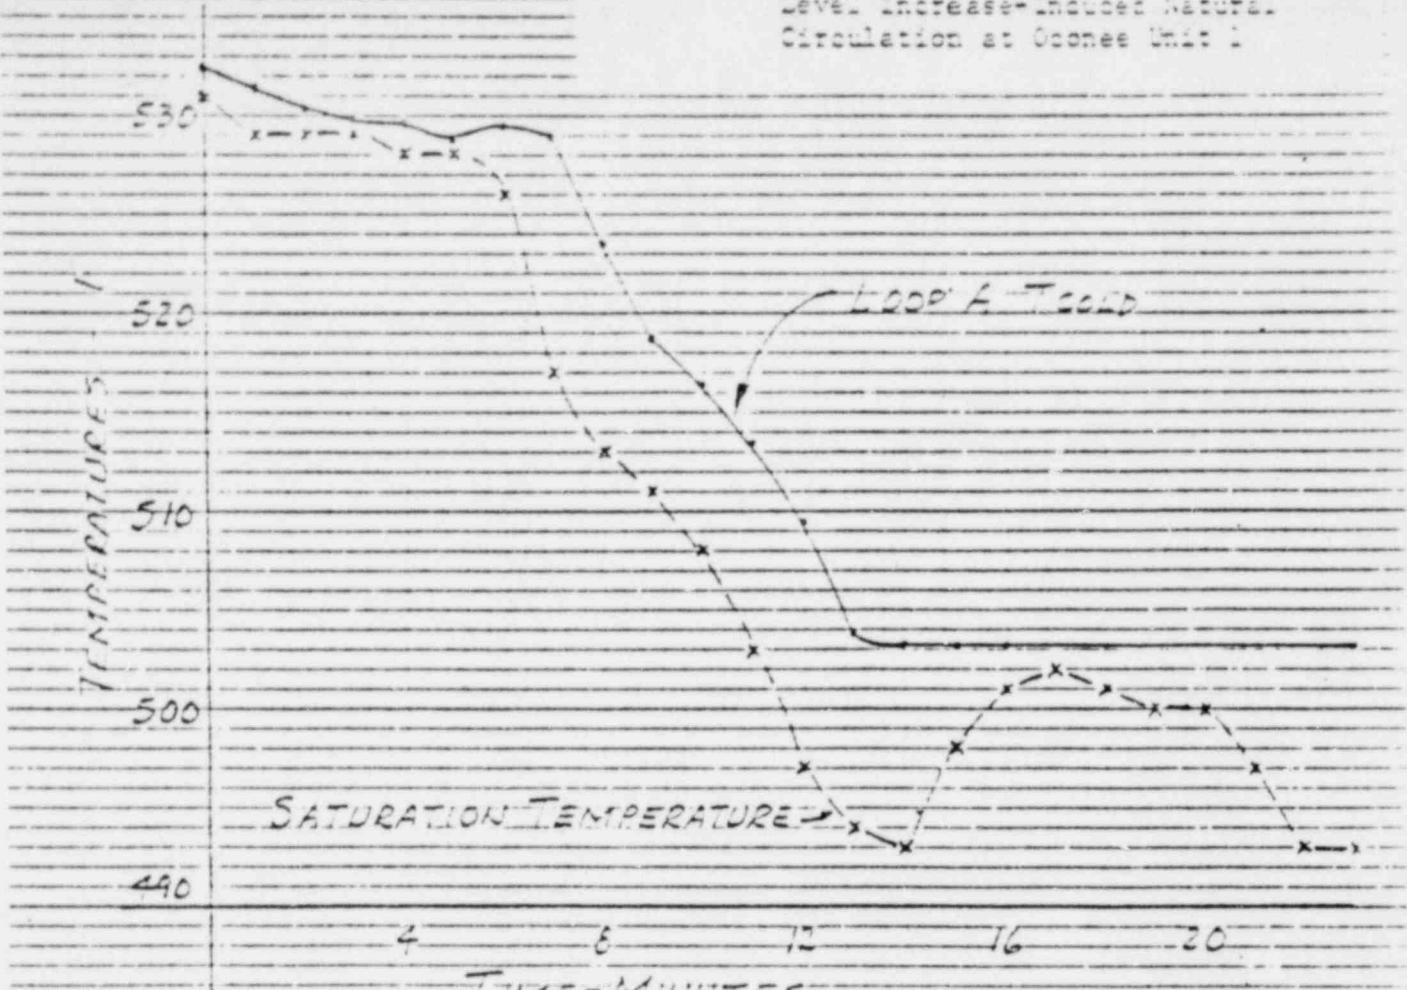
Figure 10. Loop A and B RC Temperatures
During Natural Circulation
at Oconee Unit I

On November 4, 1973, Duke Power Company conducted a loss-of-offsite-power test at Oconee Unit 1. The only data available are shown in Figure 10. Loop A and B hot and cold leg temperatures are very well matched, and the core temperature difference is about 30F. The maximum value of hot leg temperature was only 560F.

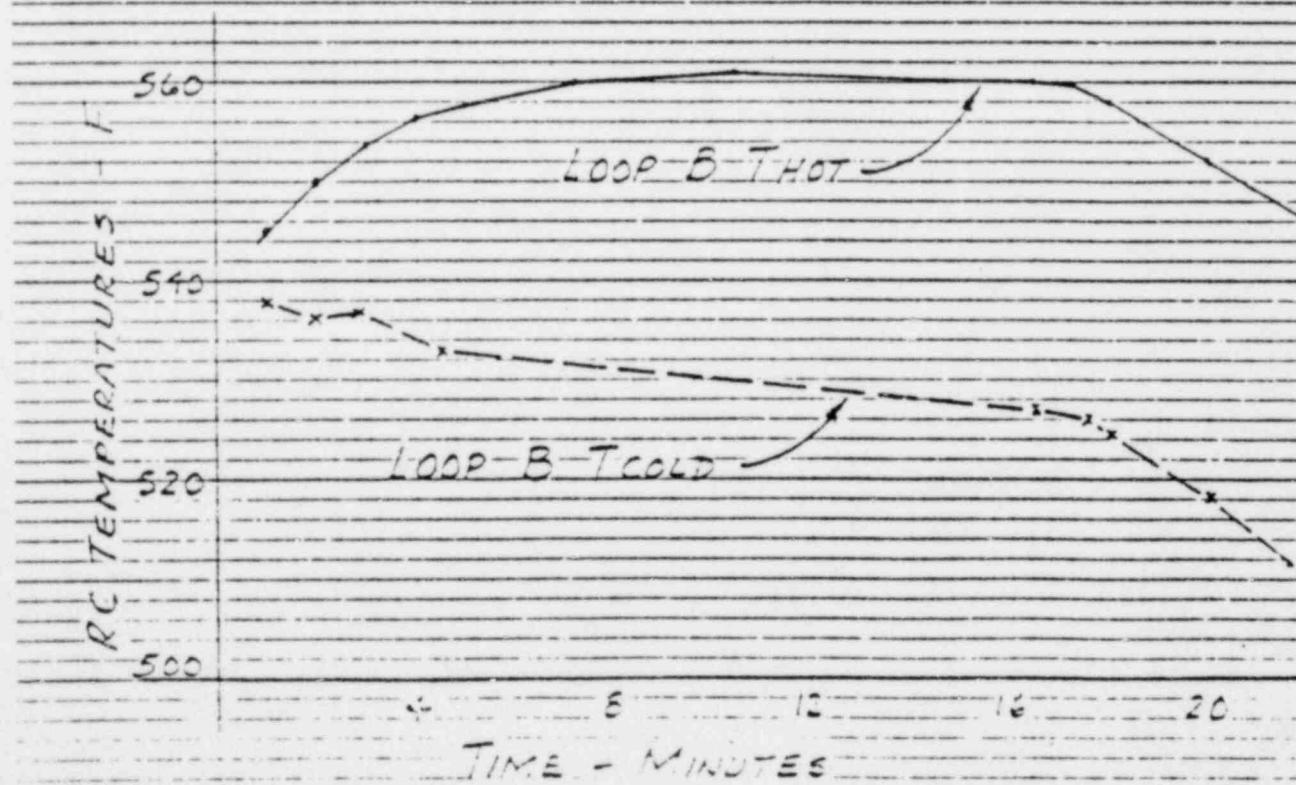
Figure 11. Loop A and B RC Temperatures During Planned Test of Natural Circulation at Damme Unit 1

Figure 11 displays the loop A and B cold leg and hot leg temperatures. The core temperature difference on loop B is slightly larger than that on loop A - 25F compared to 22F. The highest hot leg temperature was only 558F.

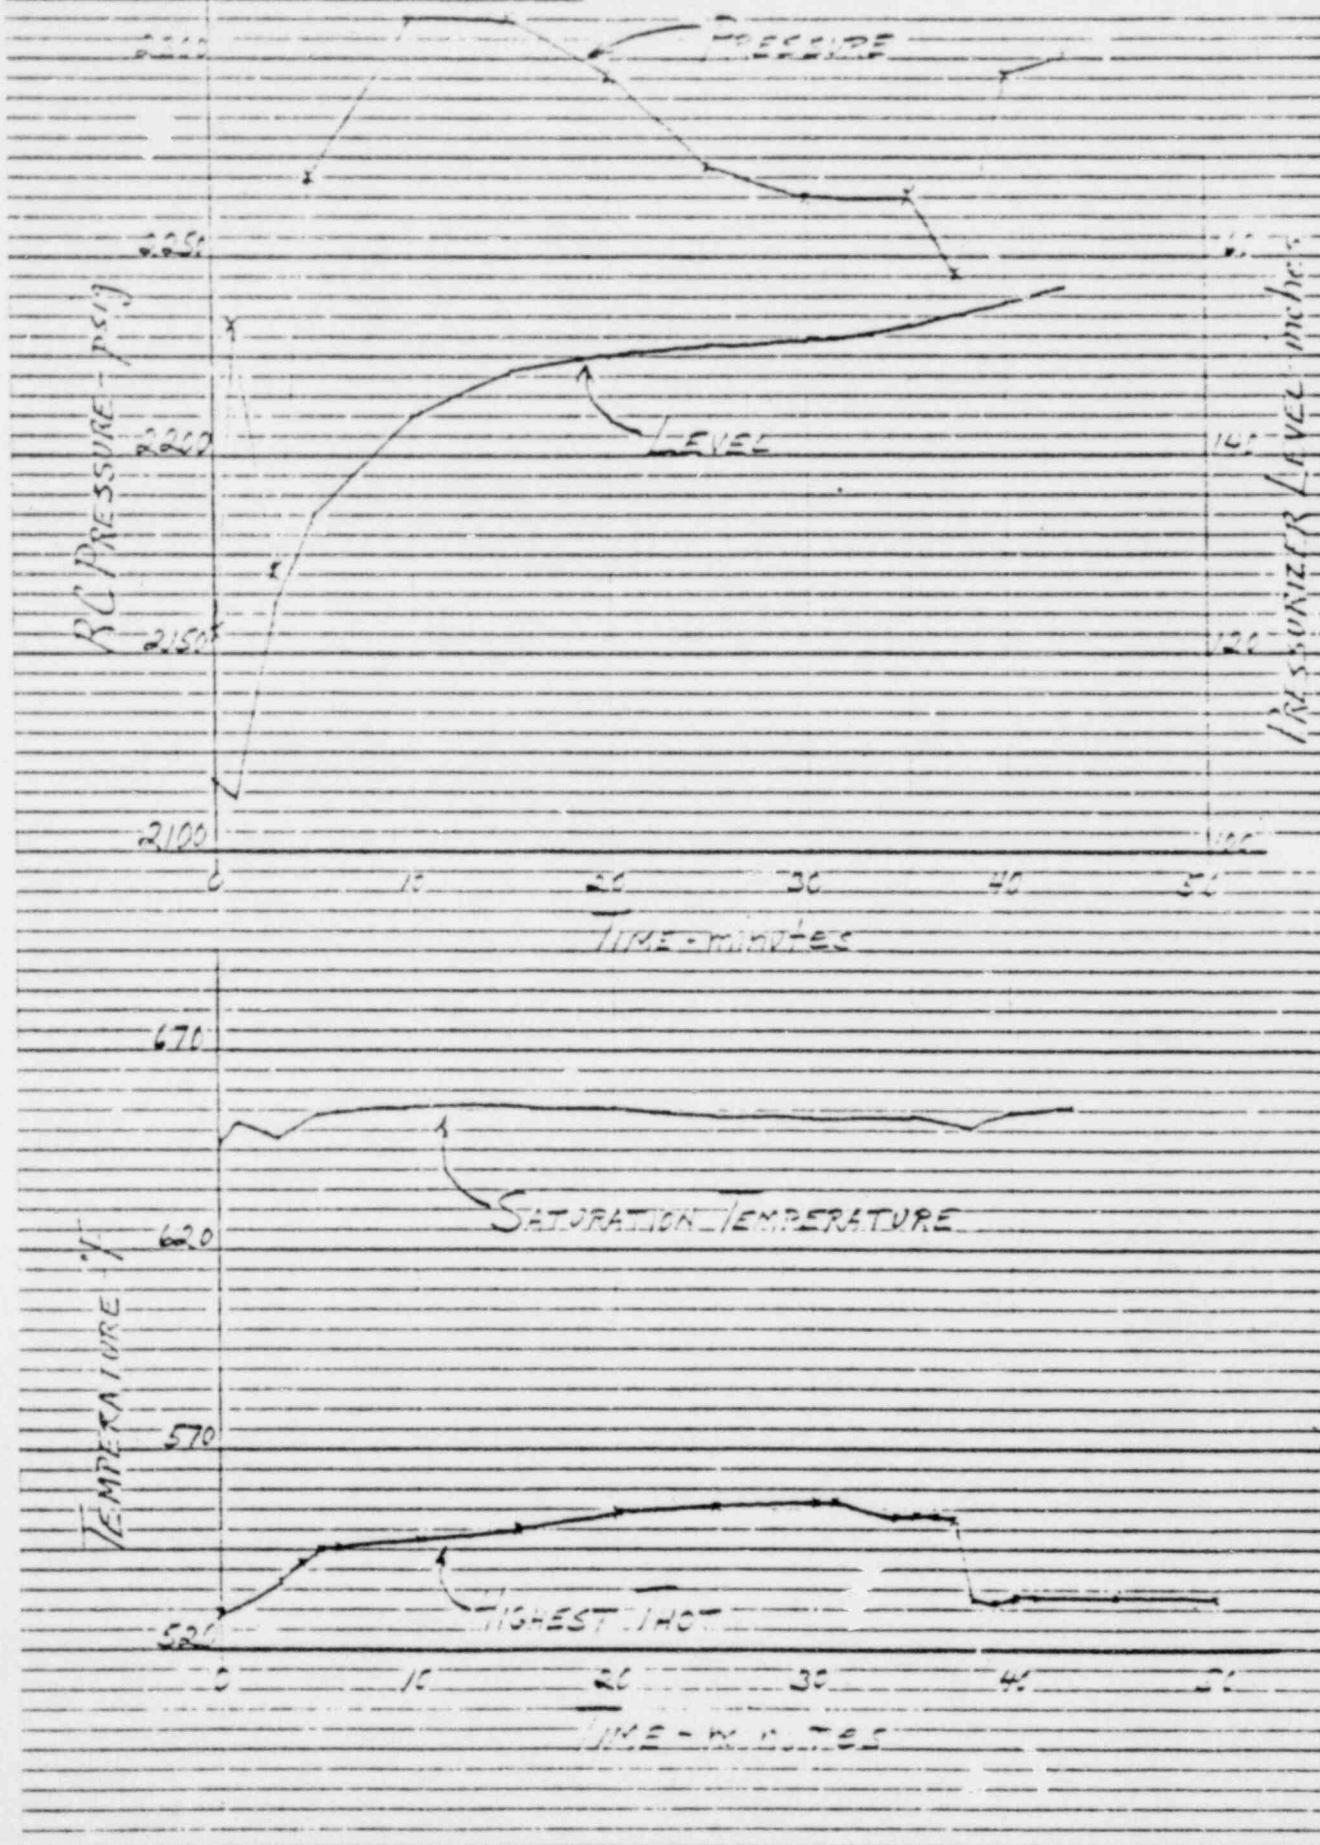
Figure 13. Steam Generator Conditions During Planned Test of Natural Circulation at Oconee Unit 1

Figure 13 shows an increase in both loop A and loop B steam pressure during the period of natural circulation and is the reason why both loop A and B cold leg temperatures were increasing rather than decreasing during this test.

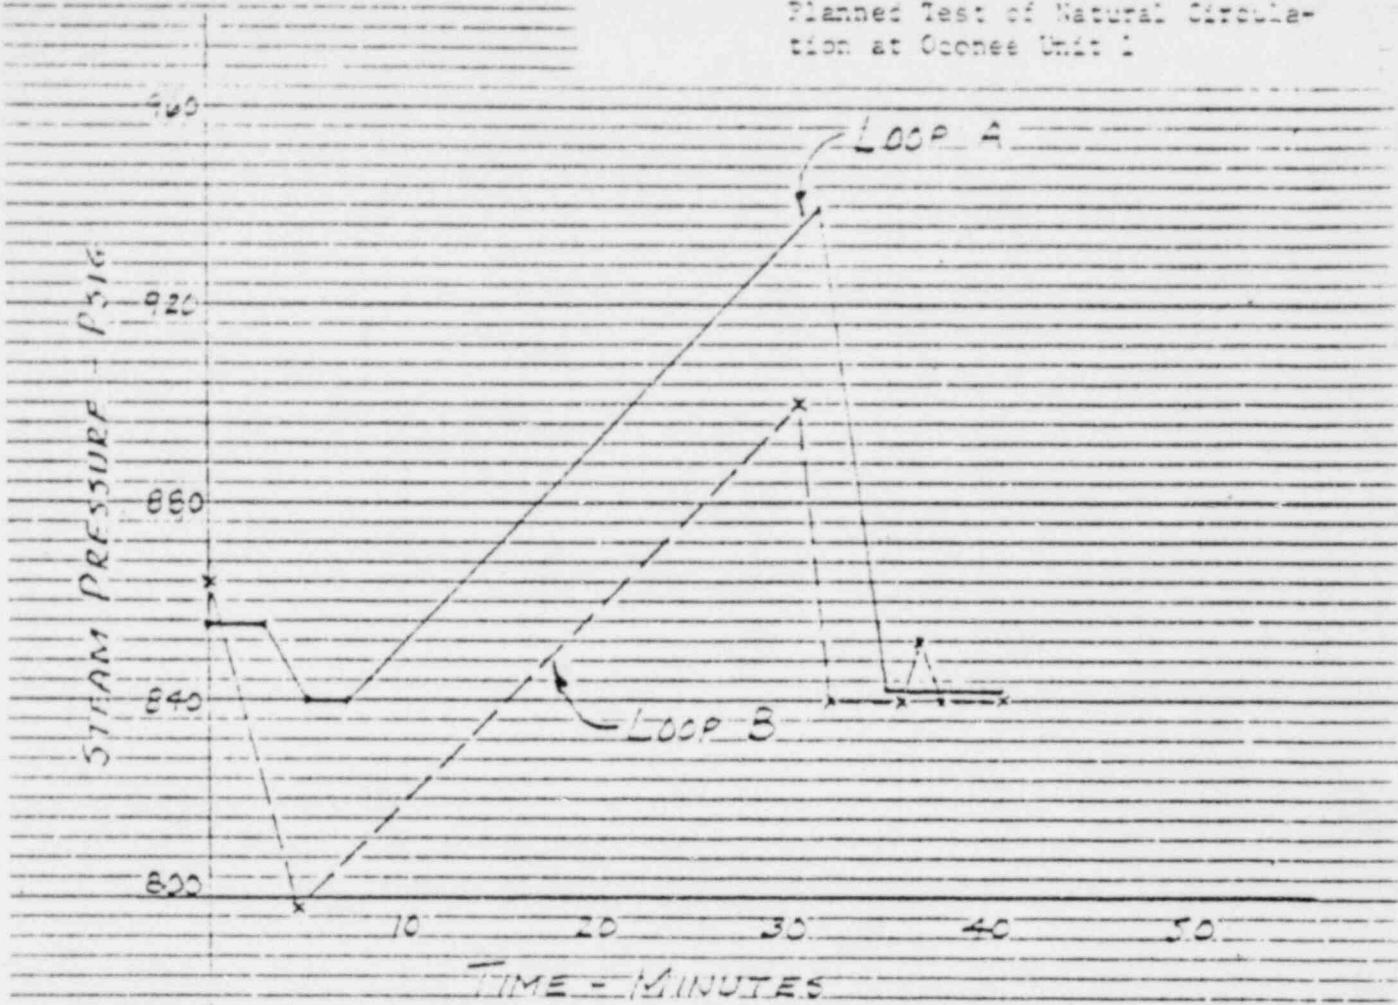
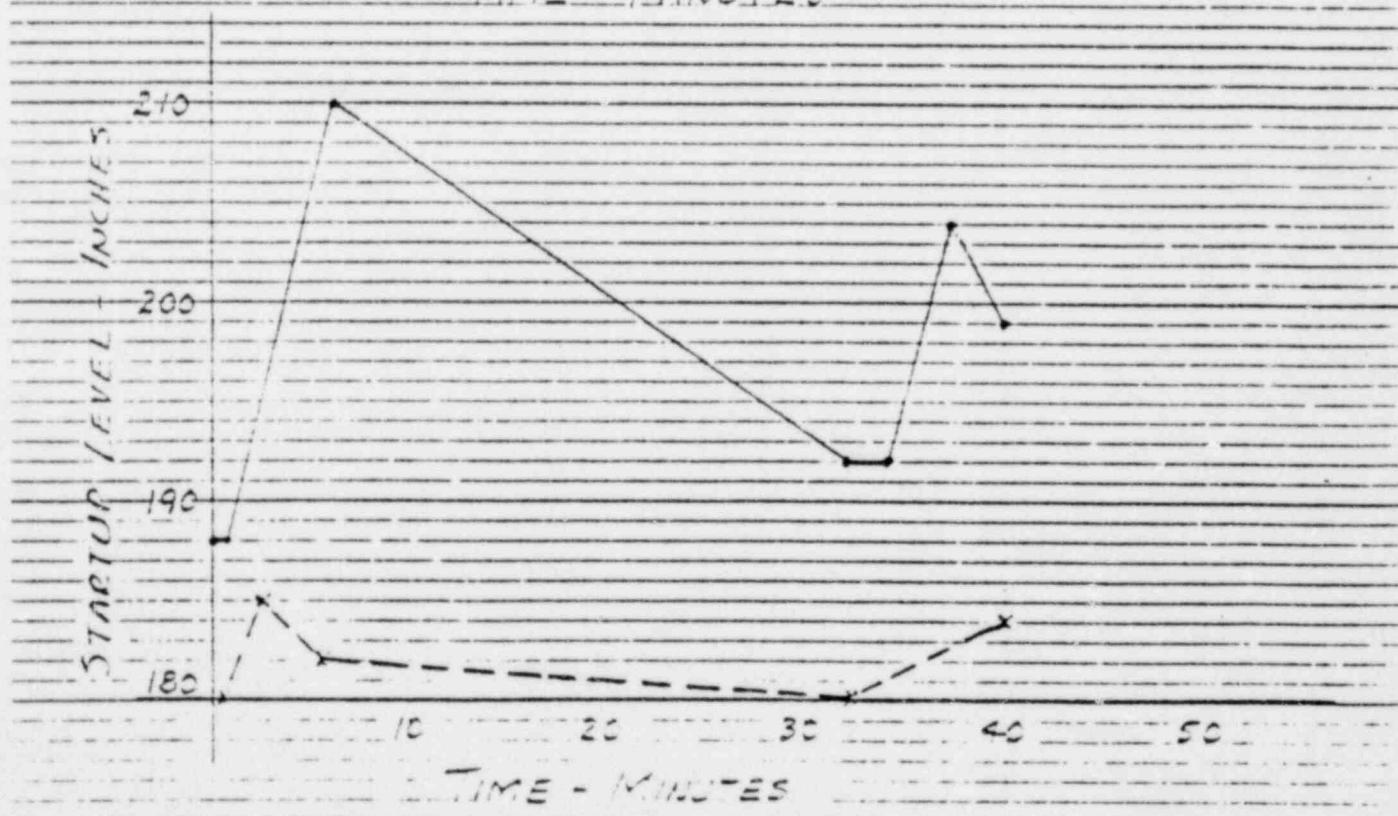
Figure 1-- RC System Parameters During
Unplanned Occurrence of Natural
Circulation at Cooled Unit 2

Figure 14 shows the rapid decrease in the cold leg temperature without the concurrent reduction in RC pressure and pressurizer level. This was due to the operator's use of High Pressure Injection, as required, to maintain RC pressure and pressurizer level.

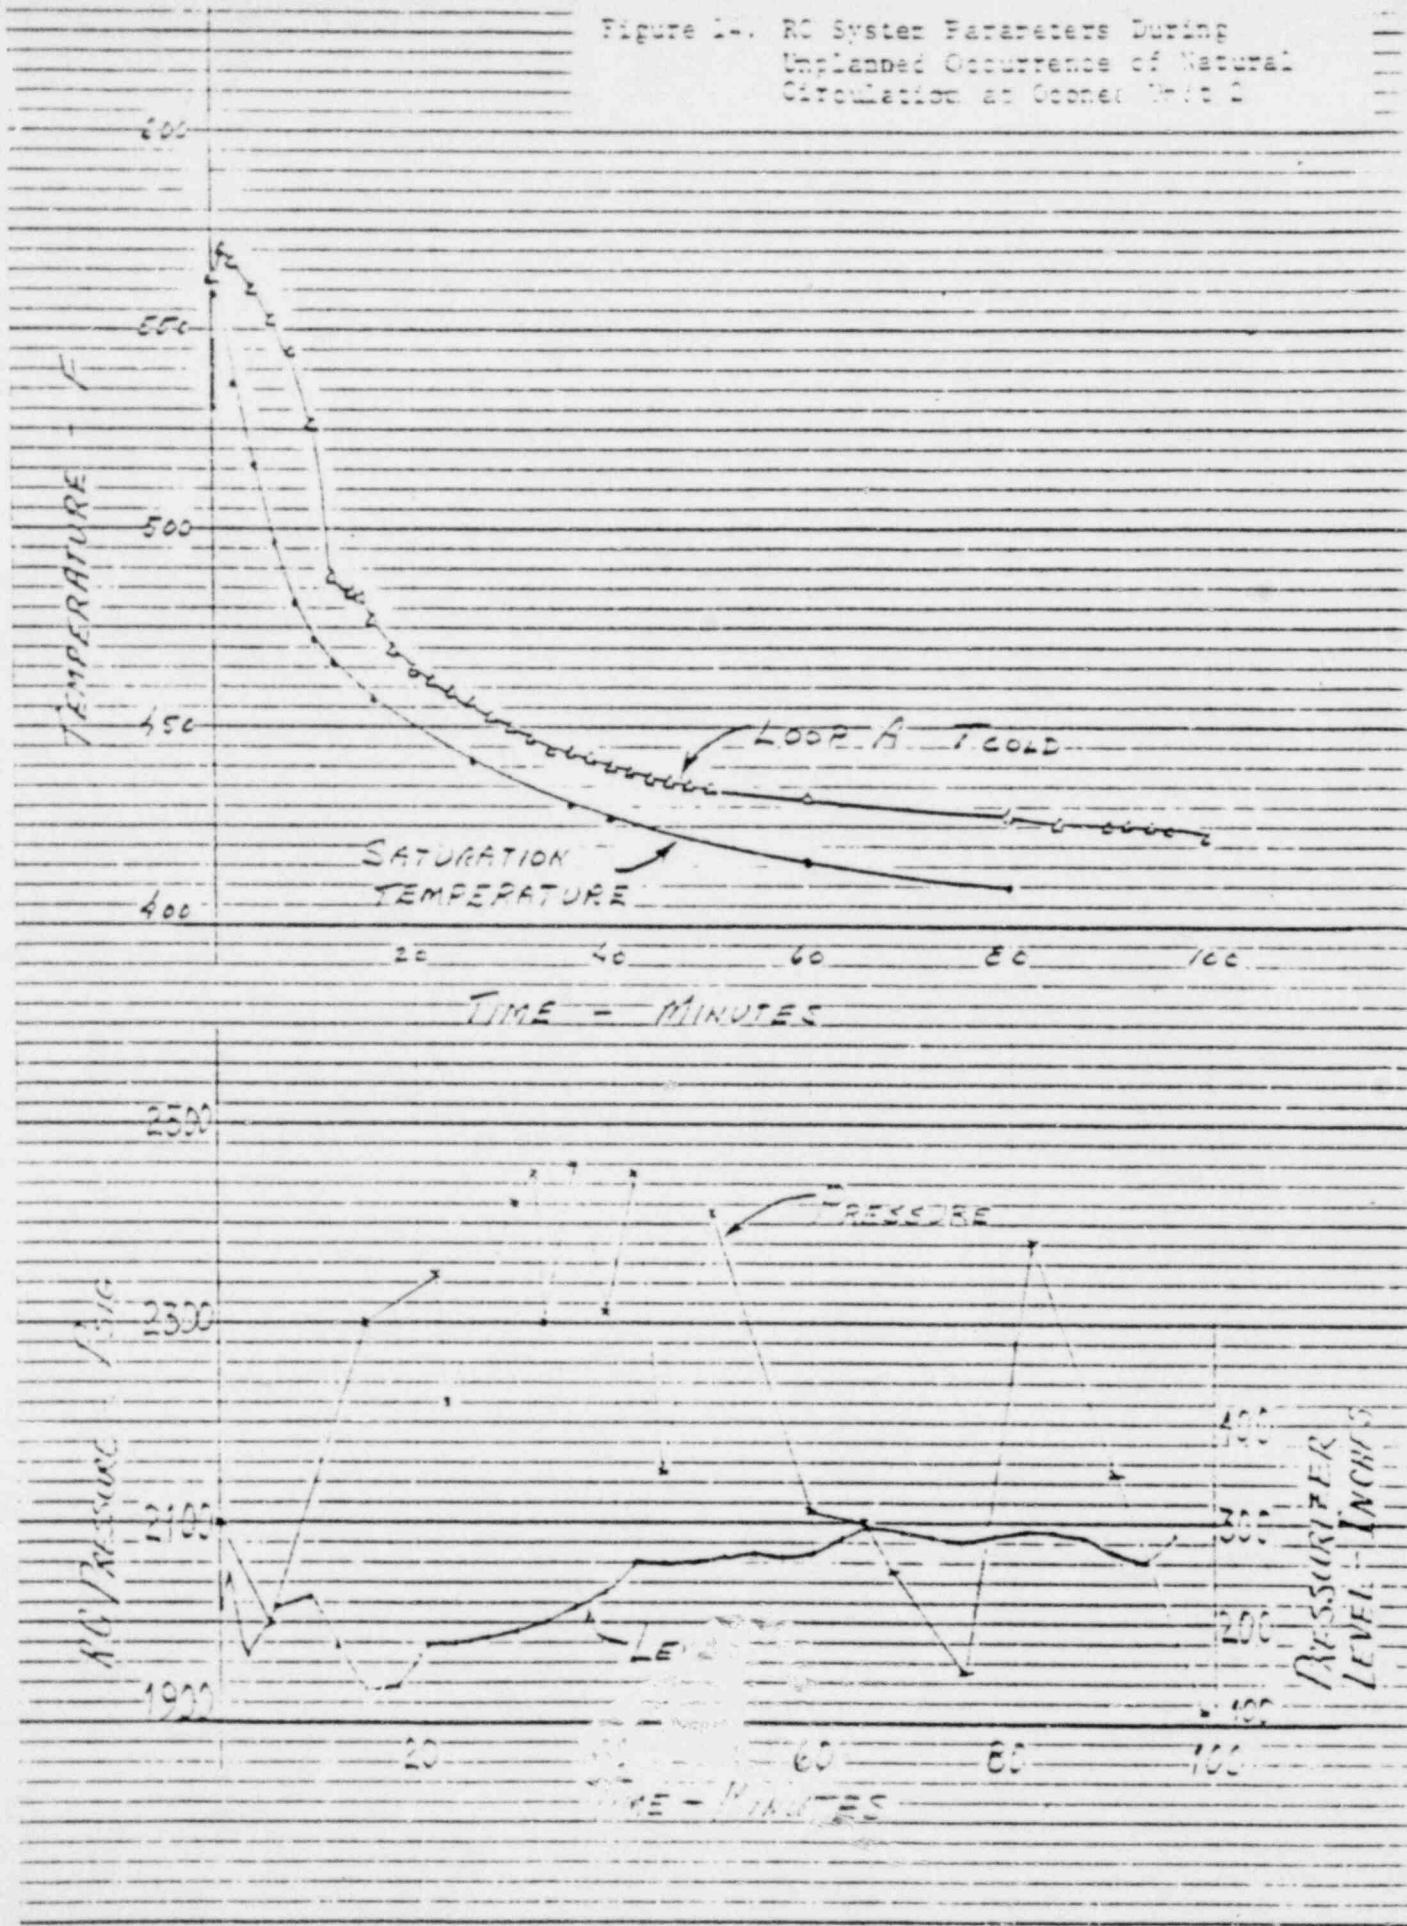
Figure 11. RC System Parameters and Saturation Temperature During Unplanned Occurrence of Natural Circulation at Oceanee Unit 1

Figure 15 displays RC system temperatures and the saturation temperature corresponding to the RC pressure during this occurrence of natural circulation.

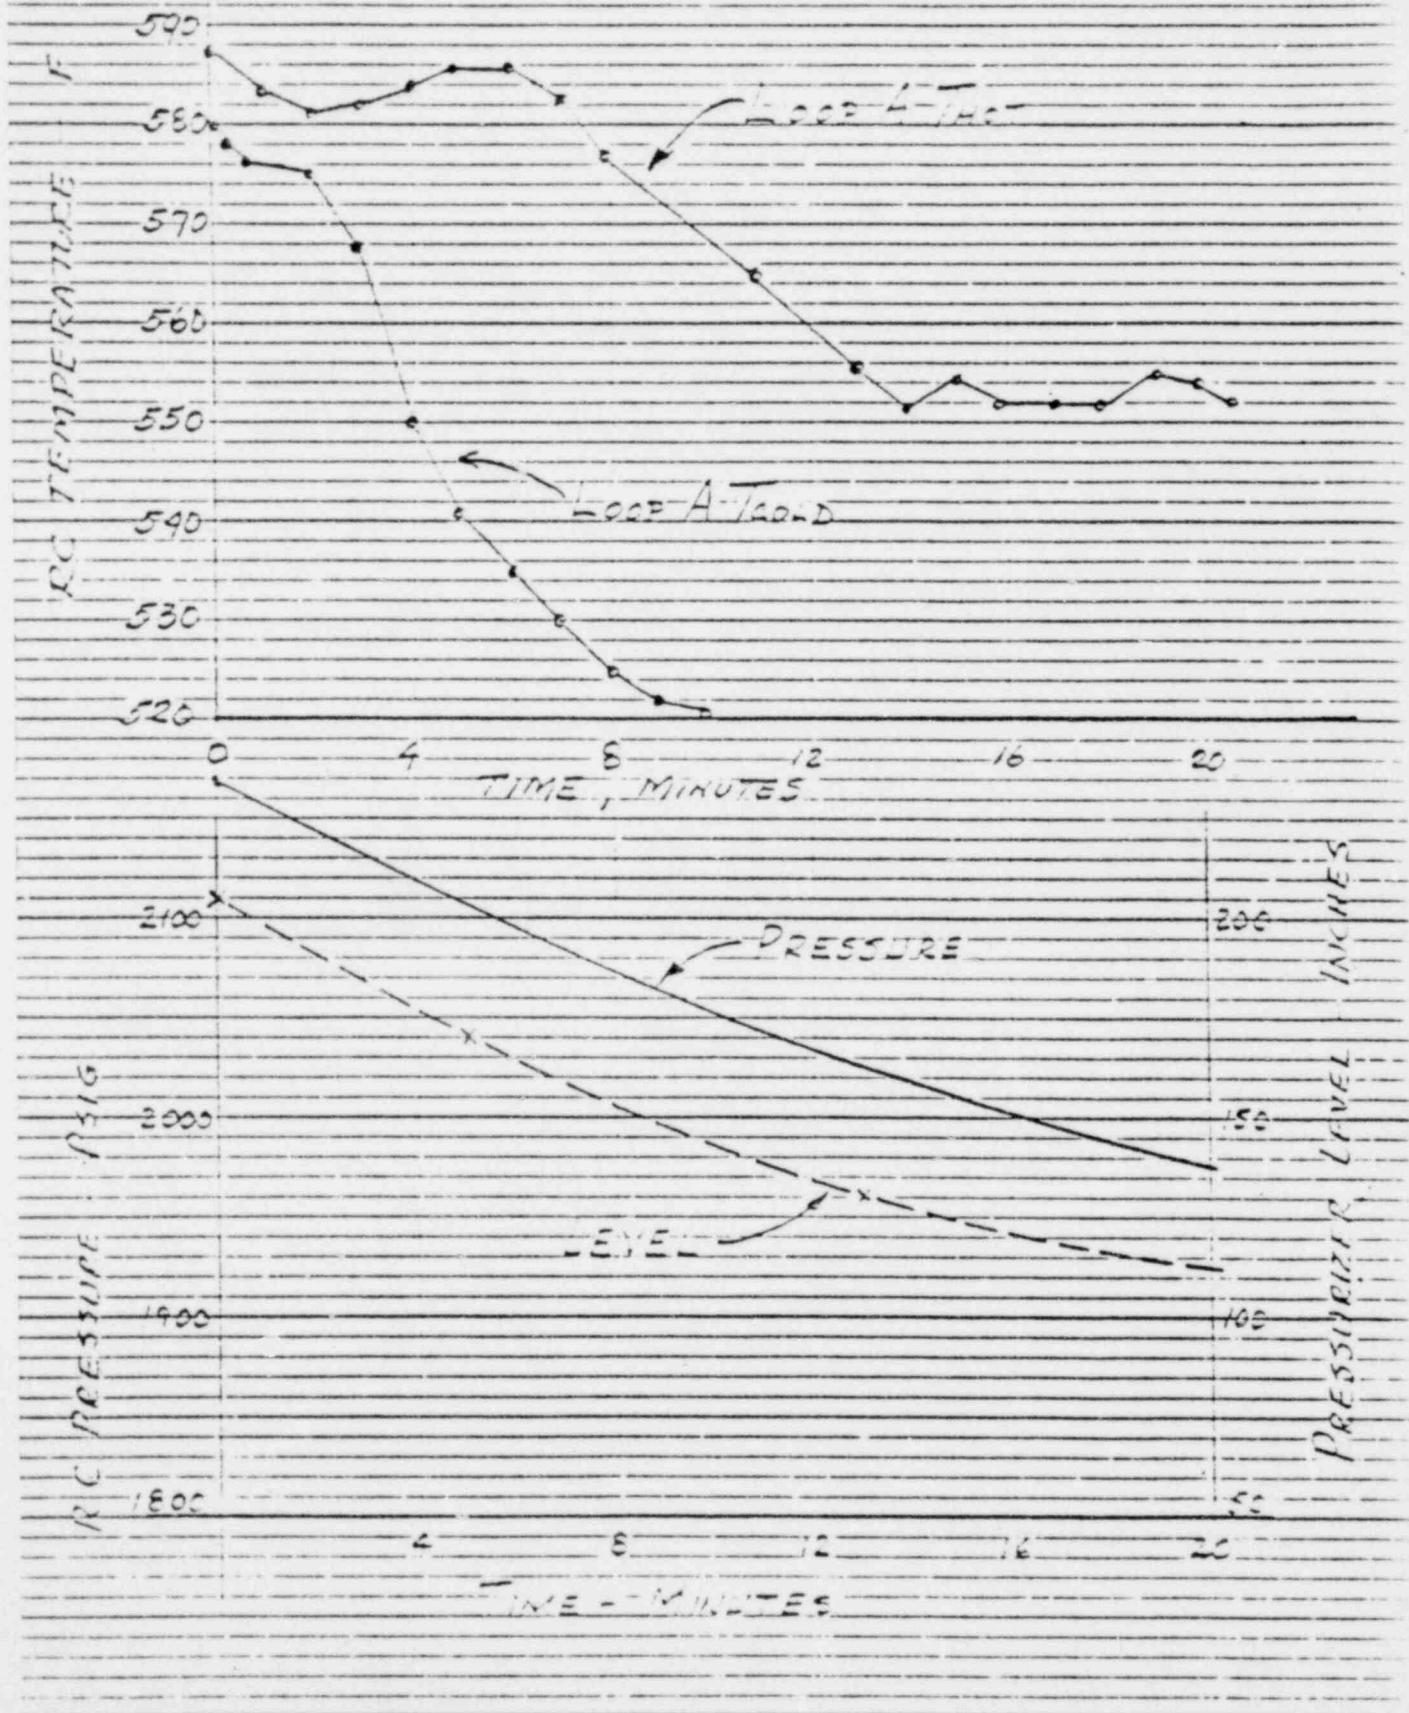
Figure 19. RC System Temperatures and Saturation Temperature During Loss of Offsite Power Test With Natural Circulation at Crystal River I

Figure 19 shows several other RC system temperatures during the same time. The largest core temperature difference recorded for loop B was 35F, whereas the margin of subcooling exceeded 60F.
