STRESS CORROSION CRACKING OF INCONEL 600 TUBING IN DEAERATED HIGH TEMPERATURE WATER

T.S. BULISCHECK, Y.S. PARK, AND D. VAN ROOYEN

Date Published - June 1979

CORROSION SCIENCE GROUP
DEPARTMENT OF NUCLEAR ENERGY, BROOKHAVEN NATIONAL LABORATORY
UPTON, NEW YORK 11973

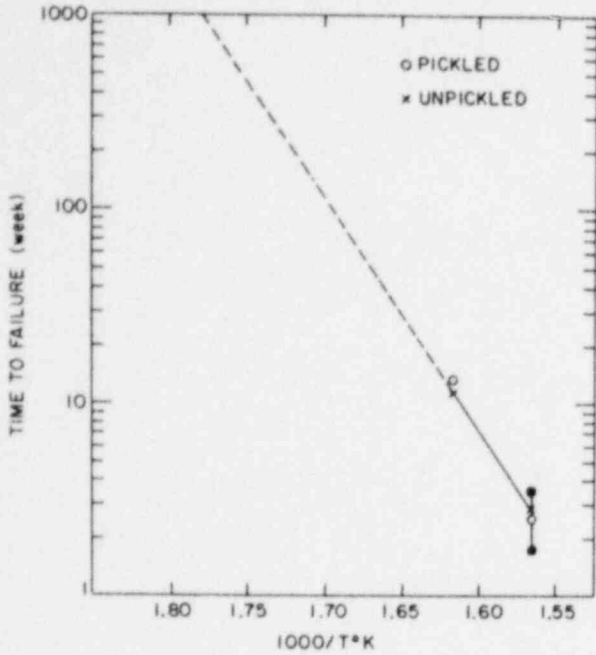
The general temperature trends are shown in Figs. 5,6 and 7. A T_F increase by a factor of up to 5 accompanies the 20°C drop from 365°C to 345°C. Tentatively, in the middle of the range covered by the sets of curves, the

Figure 5. Failure time vs. temperature for SCC of heat #2 U-bend specimens in pure deaerated water.

Figure 6. Failure time vs. temperature for SCC of low carbon (.01c) heat #5 U-bend specimens in pure deaerated water.

Figure 7. Failure time vs. temperature for SCC of U-bend specimens in pure deaerated water.

activation energy is 30 to 40 Kcal/mole; it will be better calculated when more points are obtained, so that we can ascertain the existence of a straight line semi-log plot and, if so, improve the value to be used for its slope. With the scatter and narrow temperature difference so far, it is not too surprising that the results cannot be more quantitative. Another aspect that will be clarified by more data points is the present trend for lower carbon samples to show a smaller temperature dependence, i.e. a lower activation energy.

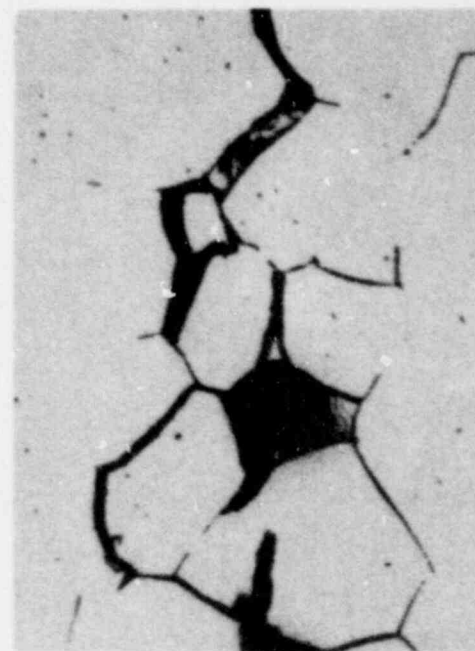
Figure 10

SPECIMEN No. 2 HEAT No. 5
D.I. H₂O WITH [O₂] <5 ppb
8 WEEKS @ 360°C + 2 WEEKS @ 365°C

2. The microstructures of the cracked specimens (Figs. 8-12) typically showed poorly defined grain boundaries after an electrolytic phosphoric acid etch, suggesting that there were very few intergranular chromium carbide particles present. At the same time, however, it was observed that the microstructures of some of the more resistant heats had similar features (Figs. 13,14 & 15). Therefore, it appears that an accurate prediction of U-bend performance

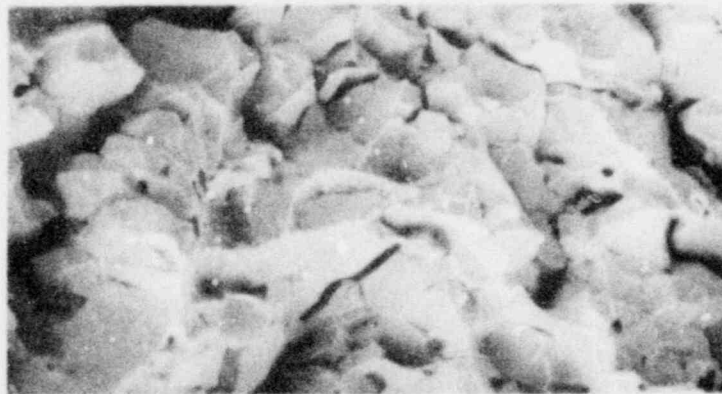
10X Photo of Fractured Gauge Section

20X S.E.M. of Fracture Face

200X S.E.M. of Intergranular Area

Figure 17. Heat #4 fractured in constant extension rate test @ 365°C in D.I. H₂O with a strain rate of 3.0×10^{-7} .

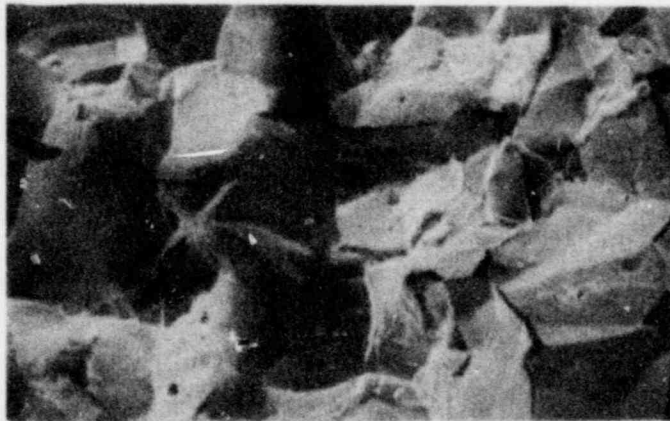
3X Photo of Fractured Gauge Section

15X S.E.M. of Fracture Face

500X S.E.M. of Intergranular Area

Figure 18. Heat #4 fractured in constant extension rate test @ 345°C in D.I. H₂O with a strain rate of 2.6×10^{-7} sec⁻¹.

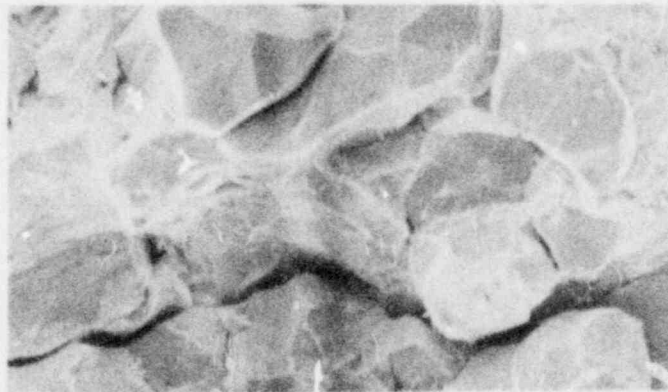
8.5X Photo of Fractured Gauge Section

15X S.E.M. of Fracture Face

500X S.E.M. of Intergranular Area

Figure 19. Heat #4 fractured in constant extension rate test @ 325°C in D.I. H₂O with a strain rate of 2.9×10^{-7} sec⁻¹.
