NUREG/CR-1197
ORNL/NUREG/TM-370

Heavy-Section Steel Technology Program Quarterly Progress Report for July-September 1979

**HEAVY-SECTION STEEL TECHNOLOGY PROGRAM
QUARTERLY PROGRESS REPORT FOR
JULY-SEPTEMBER 1979**

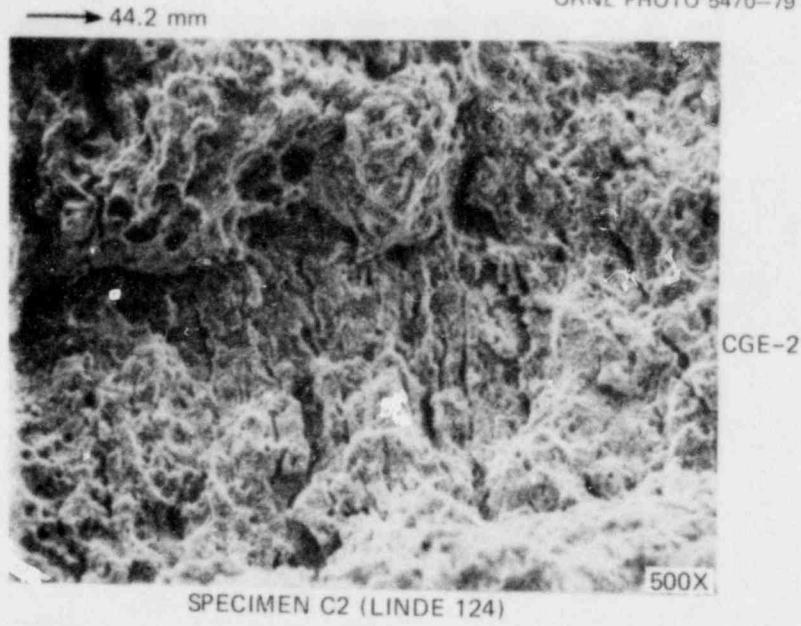
ORNL PHOTO 5470-79

Fig. 3.6. Comparison of fracture surfaces; Linde 124 vs Linde 80 welds; $R = 0.2$.

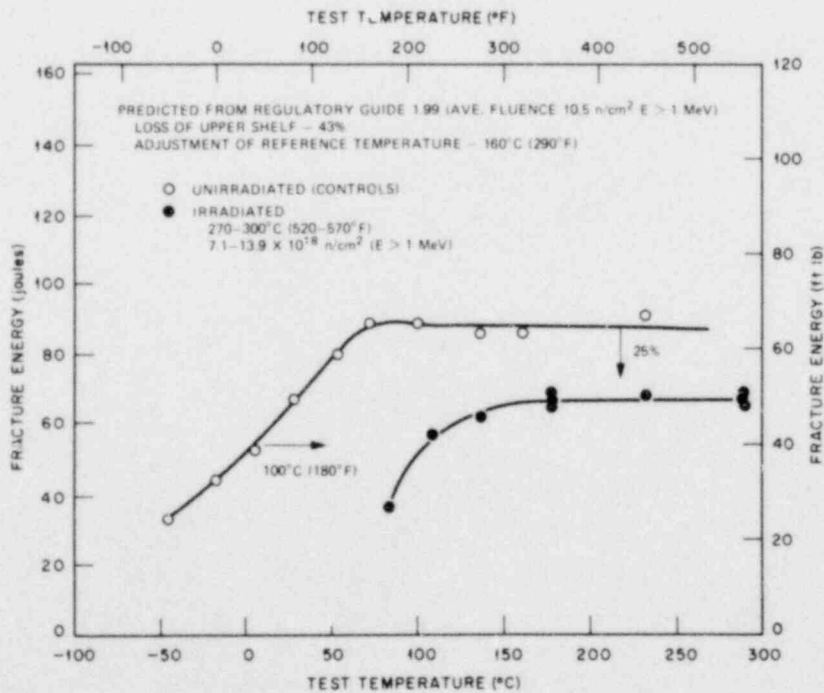
Fig. 4.3. Charpy V-notch impact data from weld 63W. Average copper content = 0.30%.

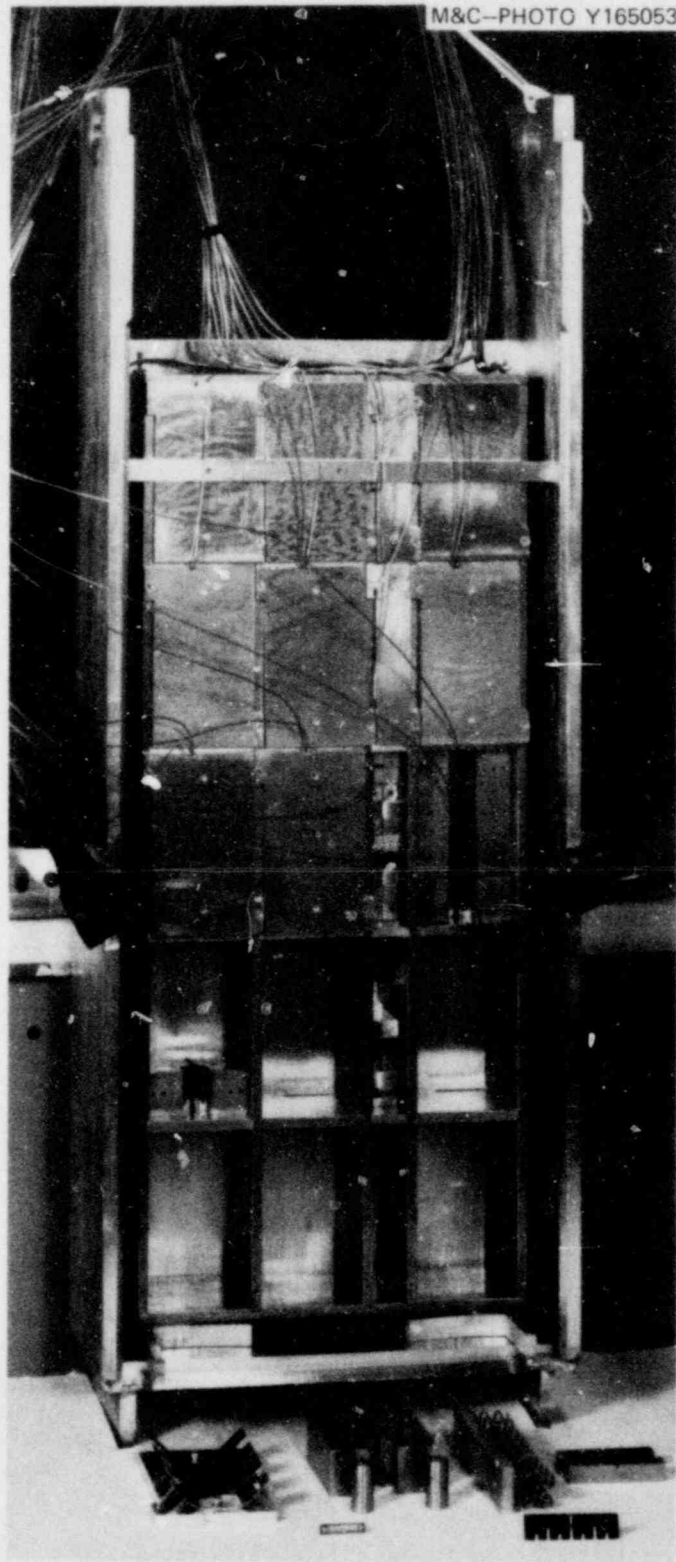
Fig. 4.5. Assembly of capsule for fourth HSST irradiation series.

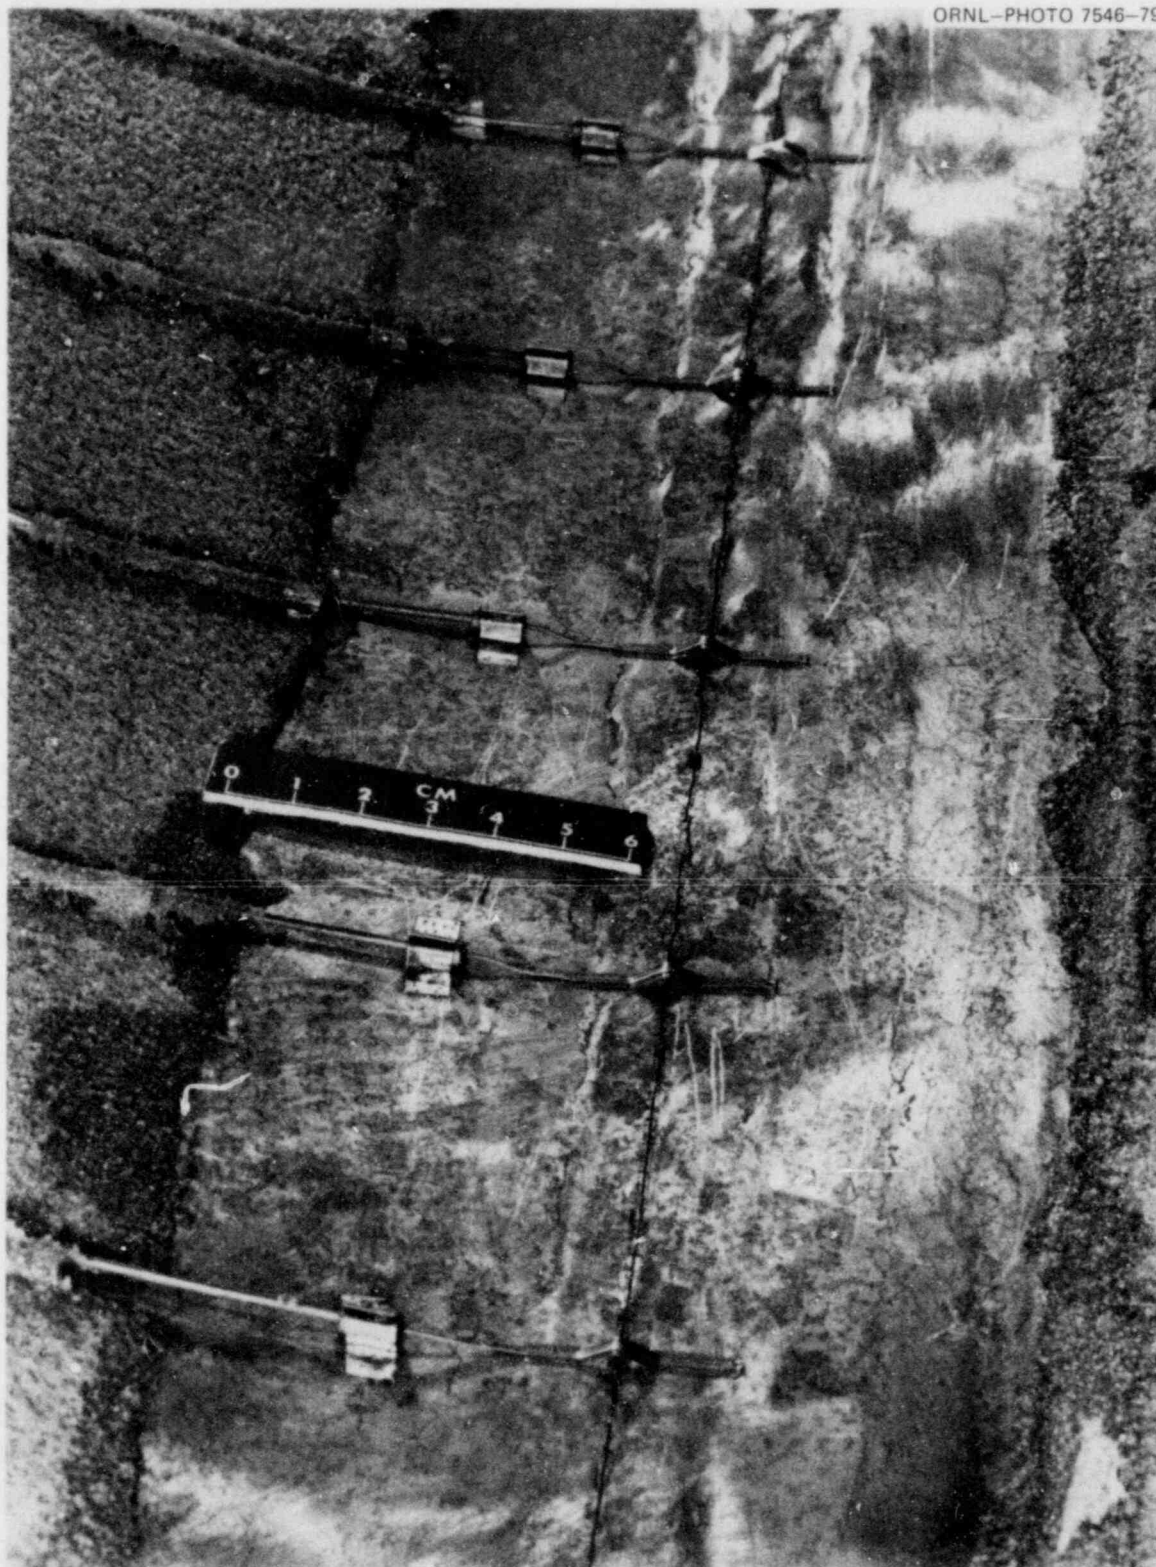
Fig. 6.4. Close-up view of flaw and COD gages in TSC-1 following TSE-5.

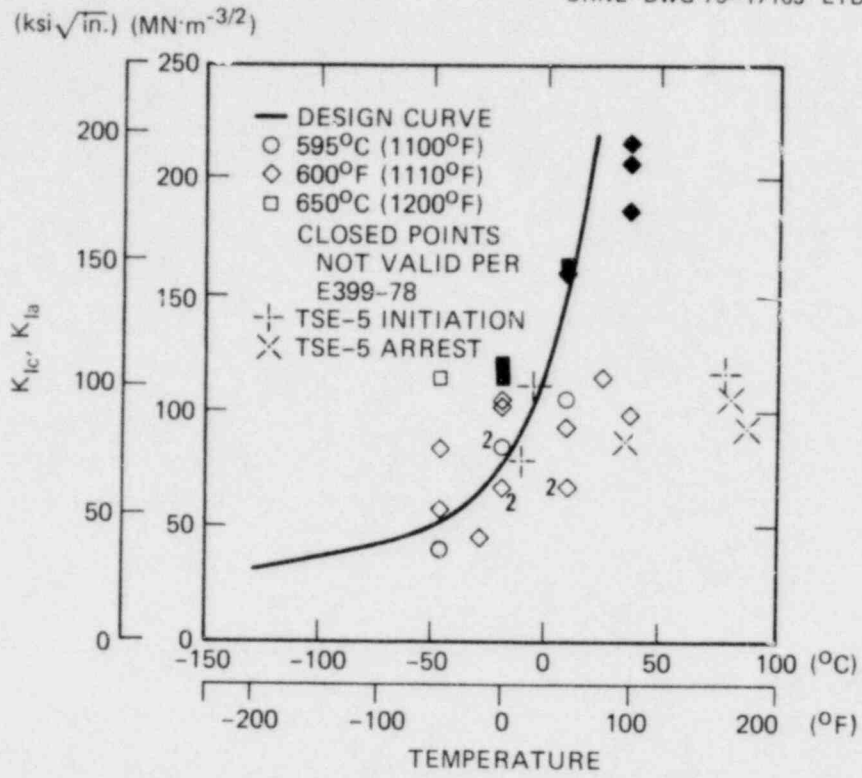
Fig. 6.9. K_{Ic} vs temperature data obtained from the TSC-1 prolongation (pretest) and from TSE-5.

Figure 6.10 indicates that the second initiation event (point 4) was delayed relative to what would be expected on the basis of this particular analysis, and this delay, which results in a further increase in K_I , would account for the large second crack jump. What caused the delay is not clear, although it might be crack-tip blunting, inhomogeneities, or simply statistical variations in K_{Ic} . There are arguments against each of these, but a long crack jump did take place. Regarding the possibility of a statistical variation, note that the K_{Ic} value corresponding to the second initiation event is $\sim 38\%$ higher than the toughness curve (Fig. 6.9) used in the analysis.

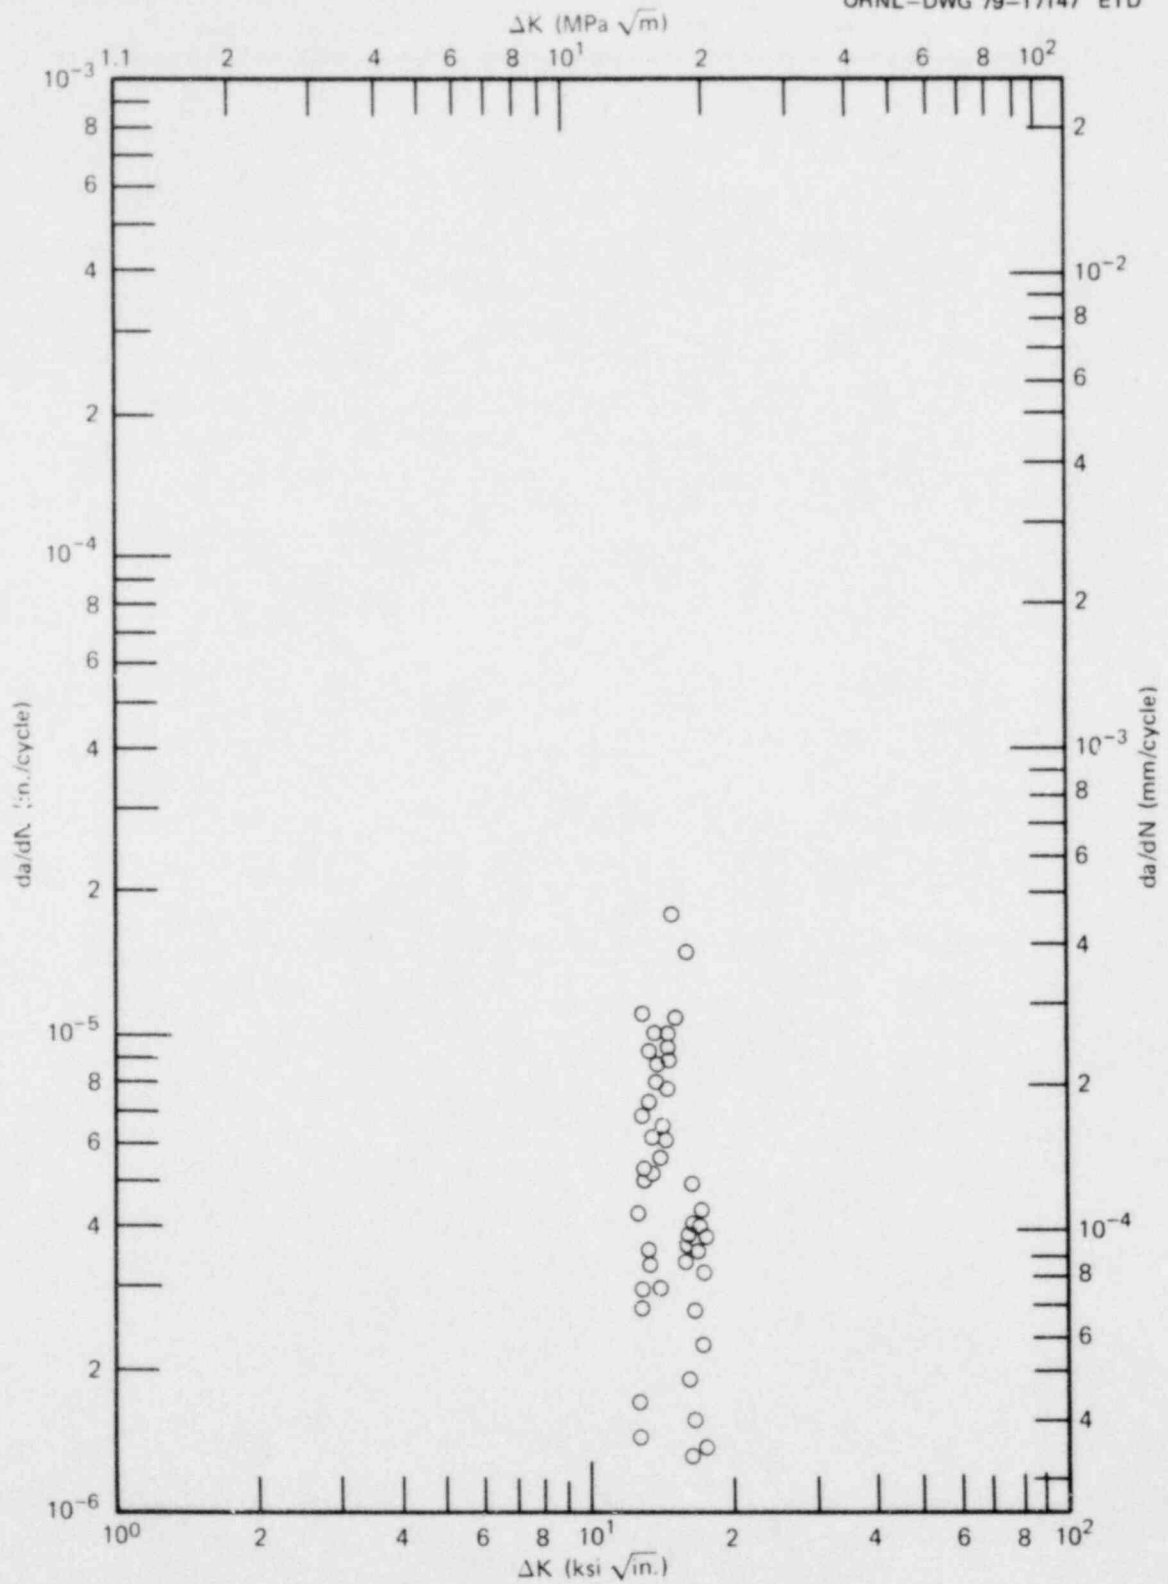
Fig. A.1. Crack growth rate test results for specimen C8.
