Irradiation Effects upon Selected Ceramic Cements and Ceramic Insulated Wires for Radiation-Resistant Transducers

April 1980

Prepared for the
U.S. Nuclear Regulatory Commission
Under DOE Contract No. DE-AC07-76IDO1570

**EG&G Idaho, Inc.
Idaho Falls, Idaho 83415**

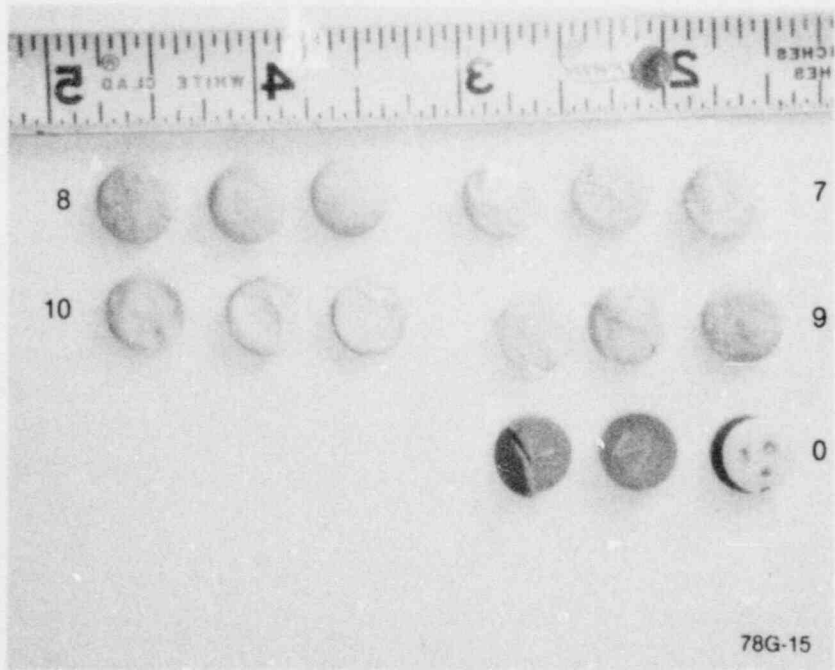
Figure 2. Condition of irradiated ceramic discs with various cement coatings.

Figure 2 shows photographs of the irradiated ceramic discs with various cement coatings. The condition of the irradiated stainless steel discs which were coated with ceramic cements is shown in Figure 3. Table 6 identifies the various irradiated cement samples and provides a brief summary of sample condition after irradiation. In general, all of the cements maintained their bond to the ceramic discs with the exception of Dylon C-3. Five of the ceramic discs fractured during irradiation. The Yellow Cerro cement

developed some additional hairline cracks during irradiation. Only three of the coatings maintained their bonds to the 304 stainless steel discs during irradiation. These included Denex No. 2, Yellow Cerro, and the flame sprayed coating. Yellow Cerro had developed some fine hairline cracks on the surface, while the surface condition of both Denex No. 2 and the flame sprayed coating appeared similar to preirradiation samples.

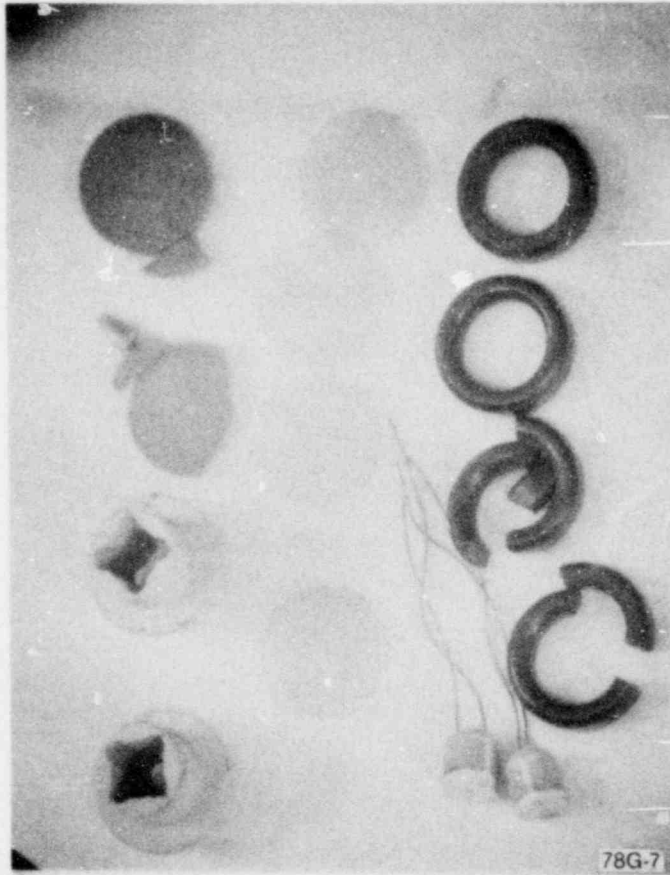
Figure B-1. Irradiated contents of capsule A including ceramic transducer components (2 each), machinable ceramic (2 each), mica (4 each), Kaman coils (2 each), and ceramic line guides (4 each).

The condition of the irradiated contents of Capsule A which included the components supplied by Kaman as well as the mica and the machinable ceramic can be seen in Figure B-1. No apparent physical damage occurred to the small coils, the transducer components, or the mica during irradiation; however, half of both the machinable ceramic items and the line guides fractured during irradiation.

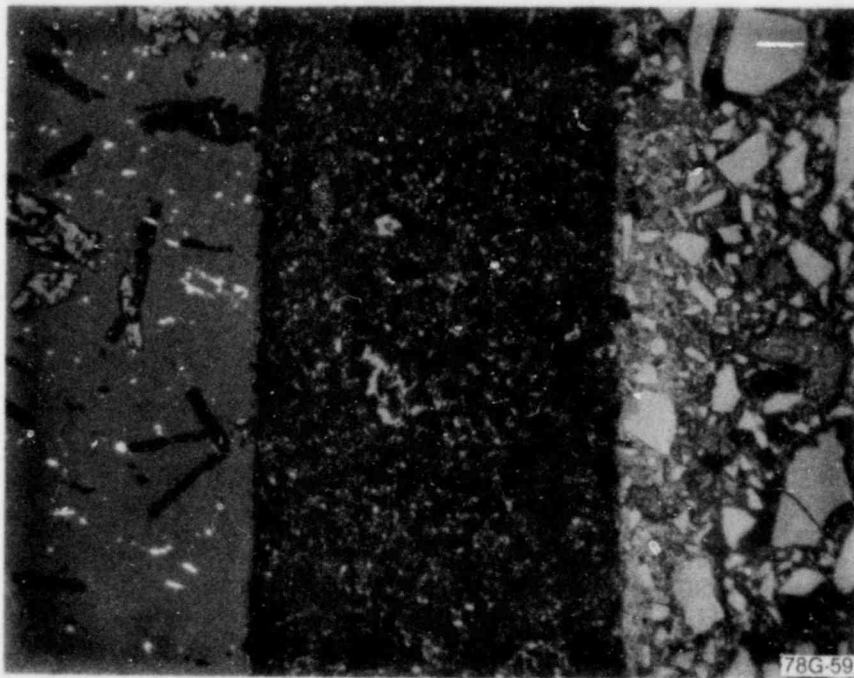
Figure F-7. Interface of ceramic disc, Ceramabond 503, and Sauereisen No. 8 after irradiation (200X).

Figures F-7 through F-10 show cross sections of the ceramic discs with two layers of ceramic cements.

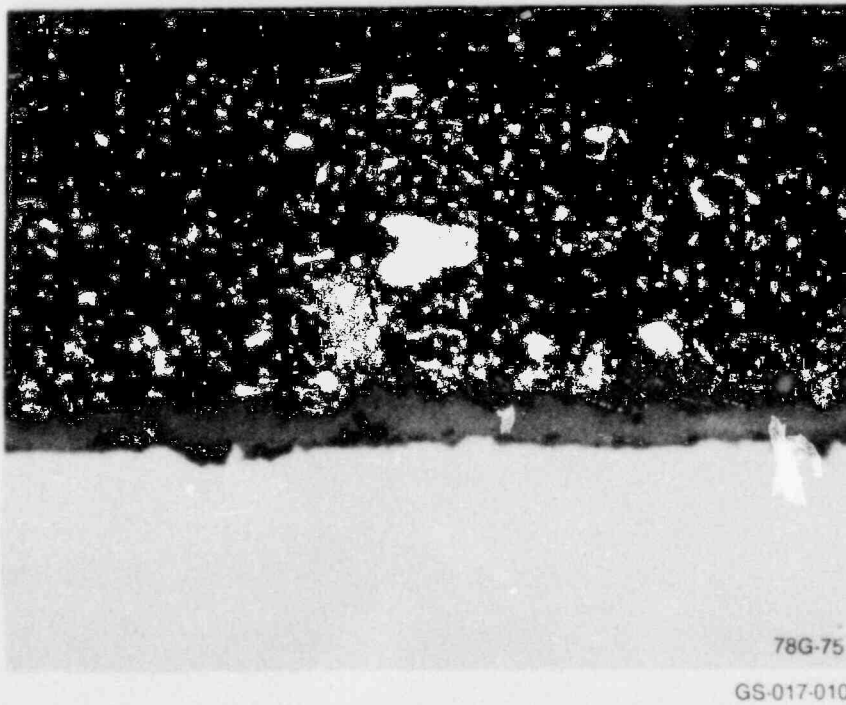
Figure F-14. Interface of 304 stainless steel disc with Dylon C-7 after irradiation (200X).

A cross section of the four samples which maintained their bond to the stainless steel discs is shown in Figures F-11 to F-14.

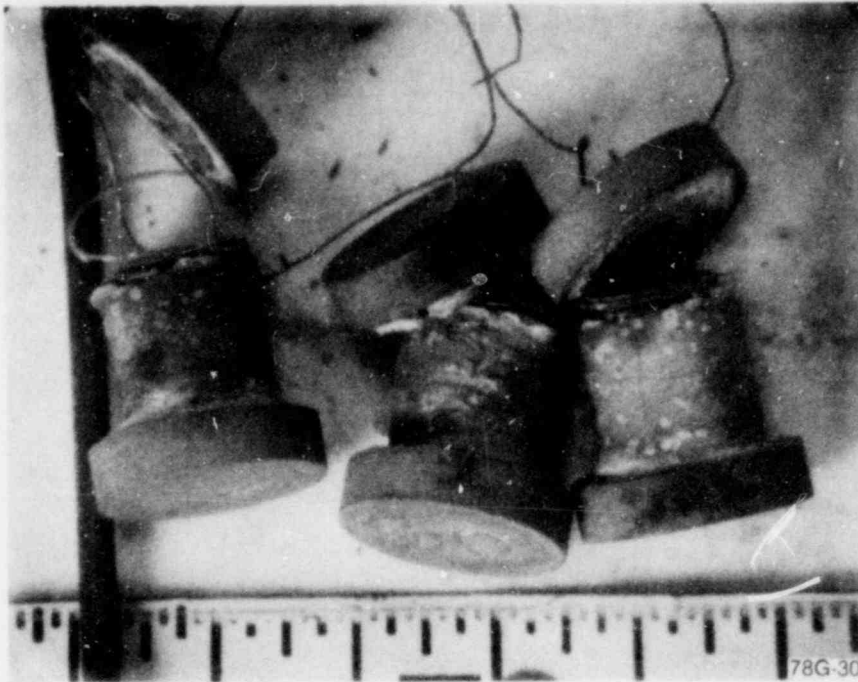
Figure G-1. Irradiated coils prepared on ceramic forms using Alloy 406 wire and Yellow Cerro cement.

coil forms fractured during irradiation, including all three of the coils coated with the Yellow Cerro cements. The coils coated with Yellow Cerro showed some surface cracking upon irradiation. The three coils wound on the flame sprayed stainless steel forms and coated with Ceramabond 503 showed some surface cracking with the coating on one of the coils actually flaking off the windings. Photographs showing the condition of the various coils as they were removed from the capsules after irradiation are shown in Appendix G.

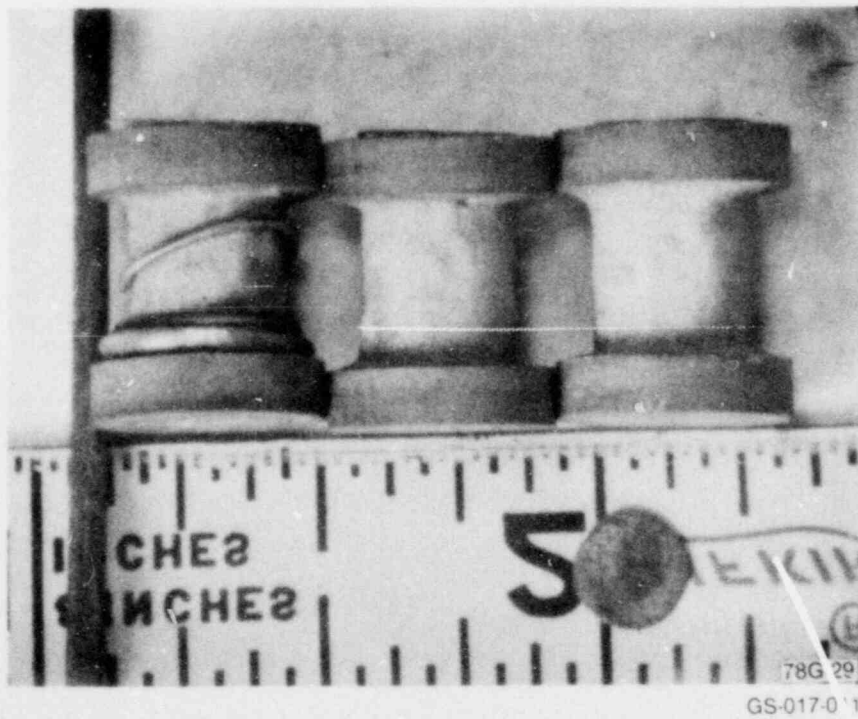
Figure G 2. Irradiated coils prepared on ceramic forms using Alloy 406 wire and Denex No. 2 cement. Three flux monitors are shown on one of the coils.

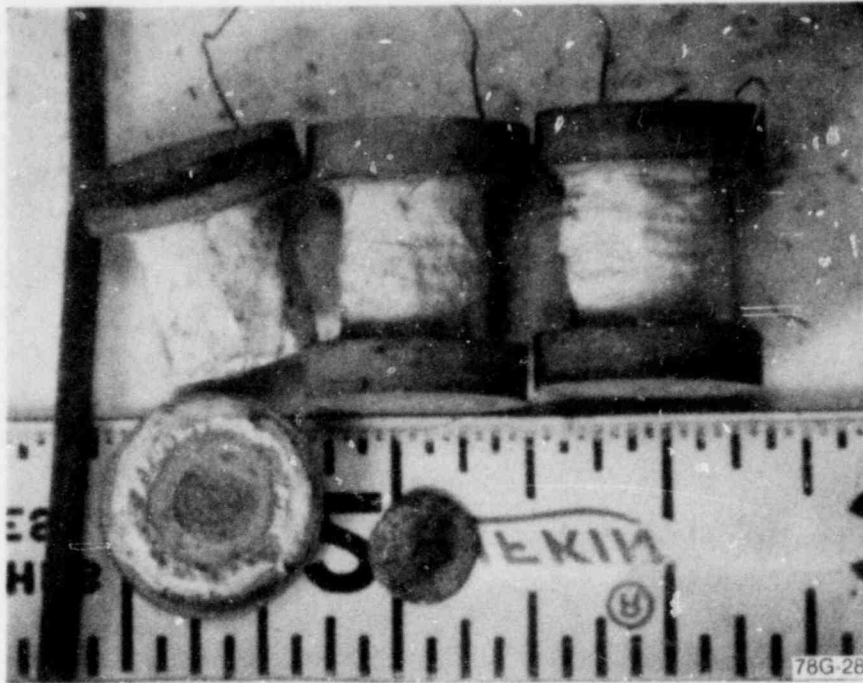
Figure G-5. Irradiated coils prepared on ceramic forms using Alloy 406 wire and Dylon C-7 cements.

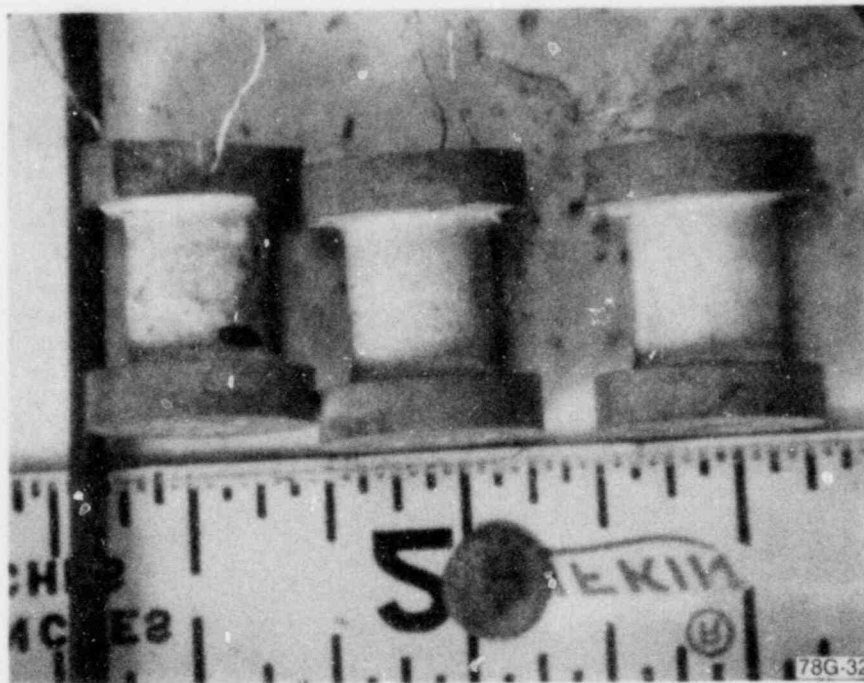
Figure G-6. Irradiated coils prepared on ceramic forms using platinum wire and Ceramabond 503 cement.
