NUREG/CR-1359
ORNL/NUREG-65

Fabrication of Sensors for High-Temperature Steam Instrumentation Systems

METALS AND CERAMICS DIVISION

Manuscript Completed — February 2nd, 1980

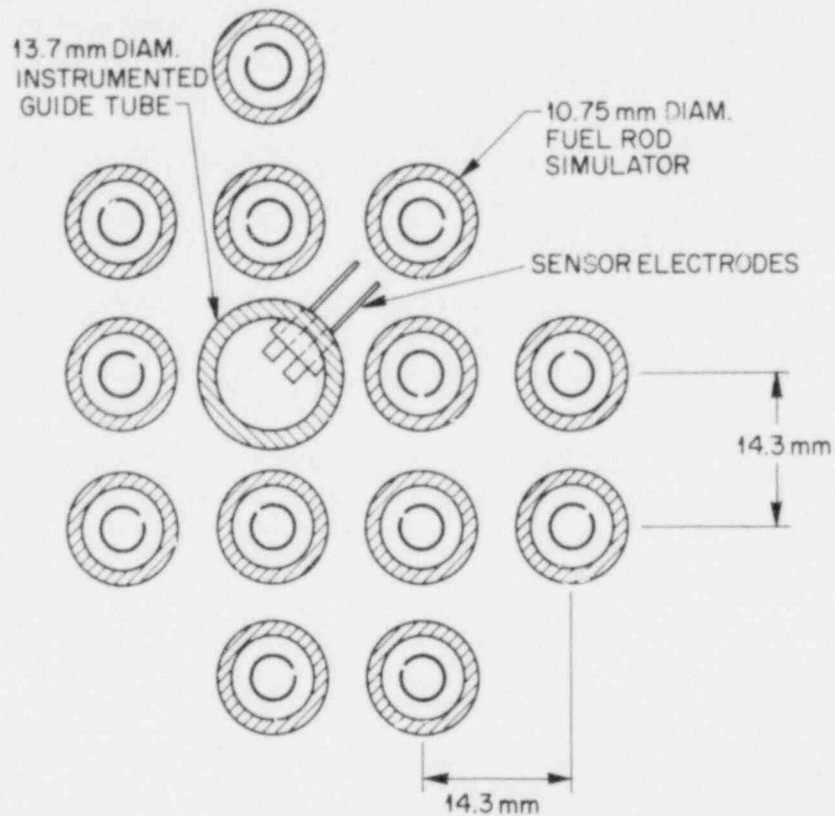
Fig. 1. Plan View of a Portion of the PKL II Test Bundle Showing the Orientation of the Impedance Sensors with Respect to Three Heated Fuel Rod Simulators.

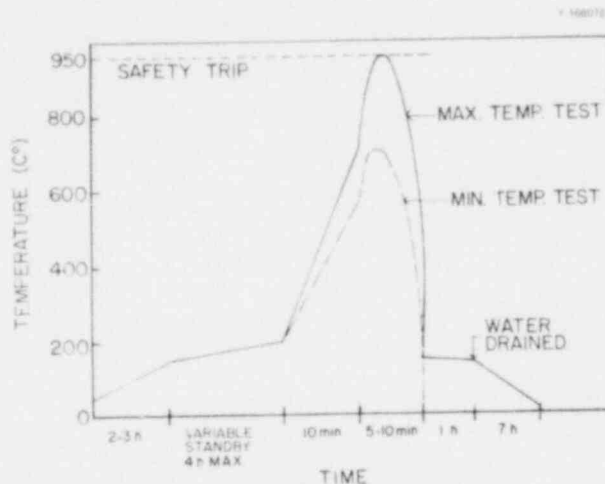
Fig. 2. Typical Test Cycle in the PKL Reflood Facility. The temperatures shown are the maximum core temperature, whereas the impedance rod temperatures will be approximately 200°C (360°F) less.

Time at 800–900°C:	5 h total (50 cycles)
Thermal Shock:	50 cycles of 2 s each [300°C/s (540°F) for 0.5 0.5 s]
Time at 200°C:	200 h total
Time at >150°C:	600 h total
Time loop water filled:	50 h total at about 150°C (300°F)

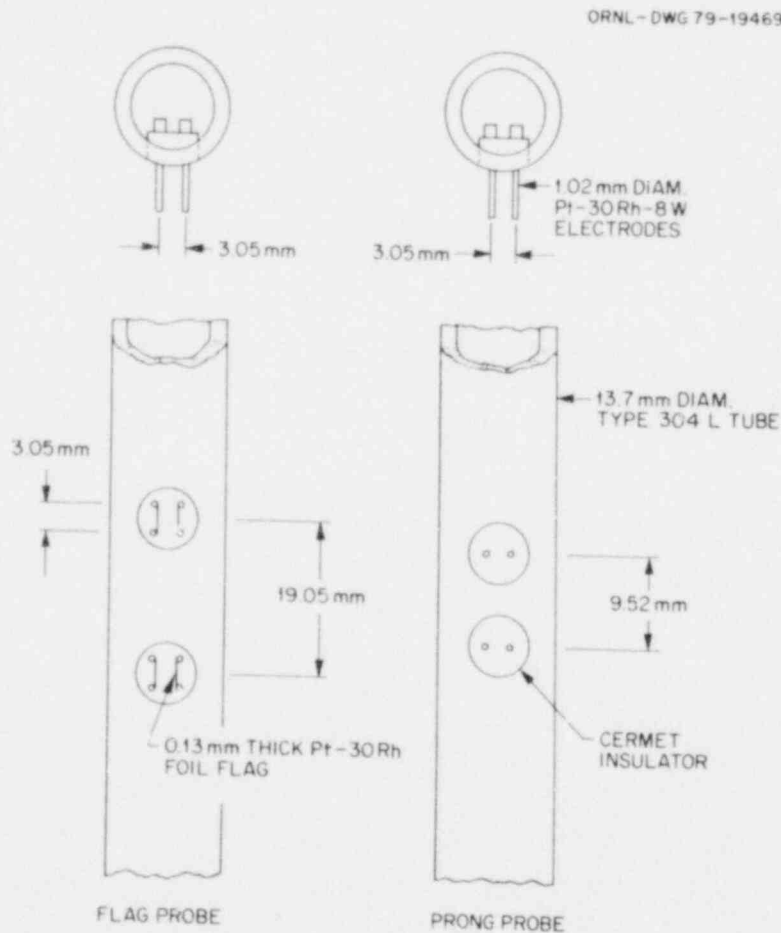
Fig. 3. Configurations of Two Types of Impedance Probe Sensors Fabricated for the PKL Reflood Facility.

both types of probe is shown in Fig. 3. Note that one electrode in each pair in a flag probe serves only to support an end of the sensor, so that both types require a total of four electrical leads to monitor the output signal. Thus in most respects the probes are very similar and in general will be discussed below as one.

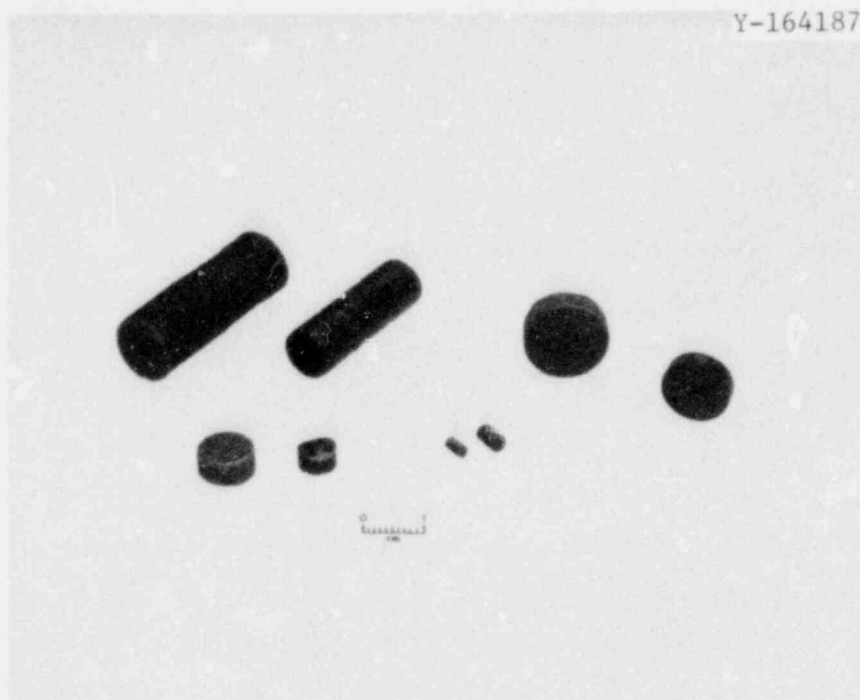
Fig. 6. Hot-Pressed Blanks of Platinized Alumina Cermet Both Before and After Grinding into Insulator Parts.

been quenched up to 50 times, it generally shows some helium bubble formation in the alcohol immersion test, but the overall integrity of the material is still excellent. Several of the hot-pressed blanks of platinized alumina are shown in Fig. 6.

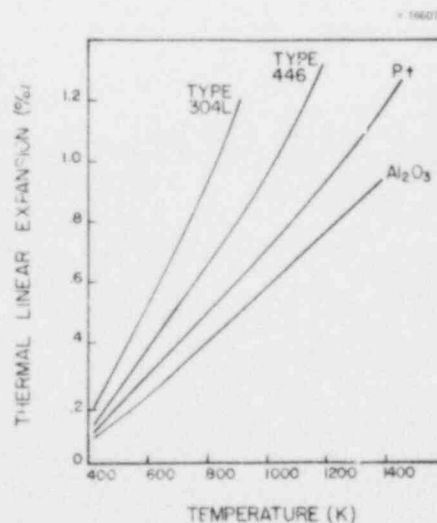
Fig. 7. Thermal Expansion of Several Metals Compared with Alumina.

Before a brazing filler metal is selected the materials to be joined are generally known. However, because of the extreme tightness of our schedule the insulator material had not been selected at the time we initiated our brazing study. As far as the other side of the joint was concerned, all that was known was that the ultimate housing was a type 304L stainless steel tube. A major problem in any brazement between dissimilar materials is the difference between the coefficients of thermal expansion of the two materials. If the braze gap increases significantly on heating because of a large mismatch in coefficient the brazing filler metal may not be drawn into the joint by capillary flow. On the other hand, if the materials and configuration are such that the gap becomes too small, the alloy may not be able to penetrate the joint. In normal practice in brazing of dissimilar materials, the material having the greater coefficient of expansion is made the outer member of the joint, and joint tolerances are held such that the gap between the surfaces does not become too great for capillary flow. The general problem of brazing of dissimilar materials is generally more difficult when one part of the joint is a ceramic. Although this is not always the case, metals usually have a greater coefficient of thermal expansion than ceramics, as can be seen in Fig. 7. The problem in metal-to-ceramic joints is compounded by the little or no ductility of ceramics and their relative weakness under tensile loading. These two characteristics are generally accommodated for in commercial ceramic-to-metal seals by using a metal having relatively low

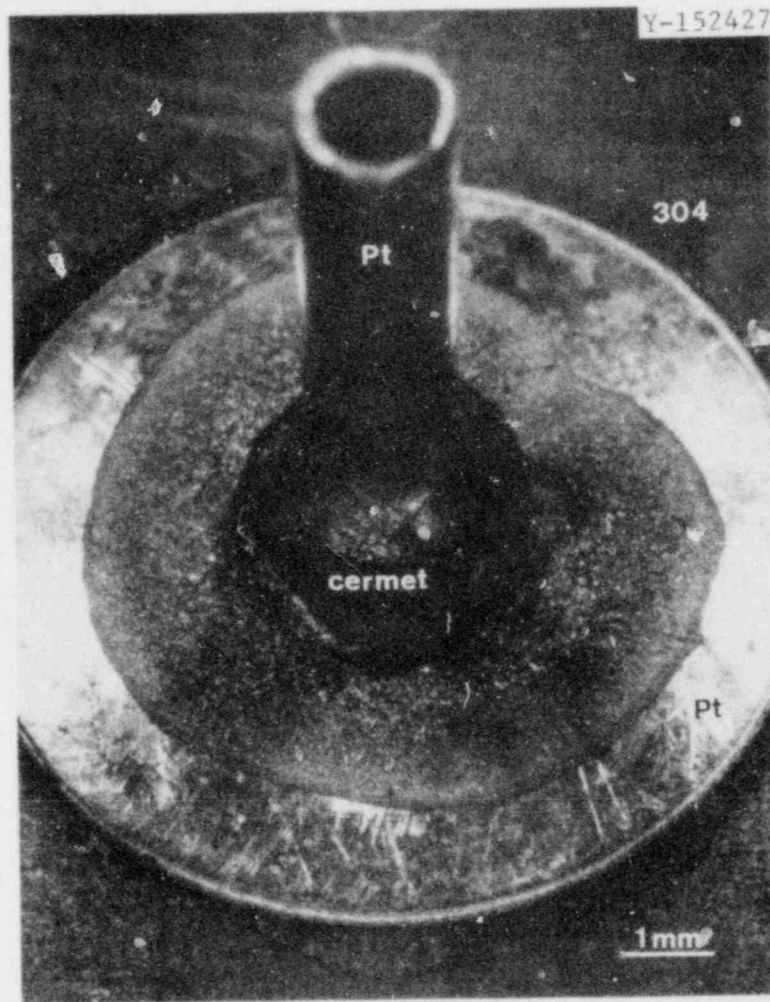
Fig. 20. One of the First Sensor Subassembly Development Test Pieces After Brazing with Nickel-Clad Titanium (72Ti-28Ni) Filler Metal.

cracking on the underside after the third cycle. The second part had no cracks visible at a magnification of 30 \times after ten quenches from 520°C (970°F) air.

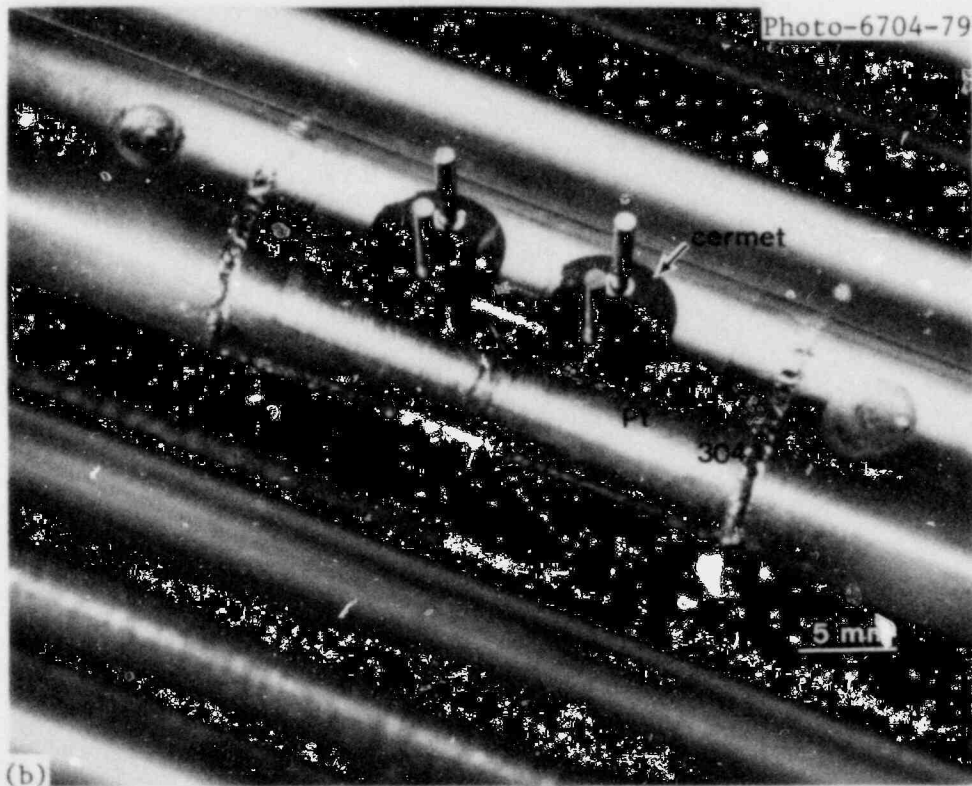
Fig. 31. Sensors on Instrumented Guide Tube Rods Shown Before 175°C (350°F) Steam-Water Tests at ORNL. (a) Flag-type probe on rod IF48-5. (b) Prong probe on level 7 of rod IP67-13.
