Re: Zircaloy Clad  
Conversion  
ISAP Topic 2.17

Haddam Neck Plant  
Additional Information  
Small-Break Loss of Coolant Accident Analysis--  
Zircaloy Clad Fuel

Attachment  
Haddam Neck Plant  
Additional Information

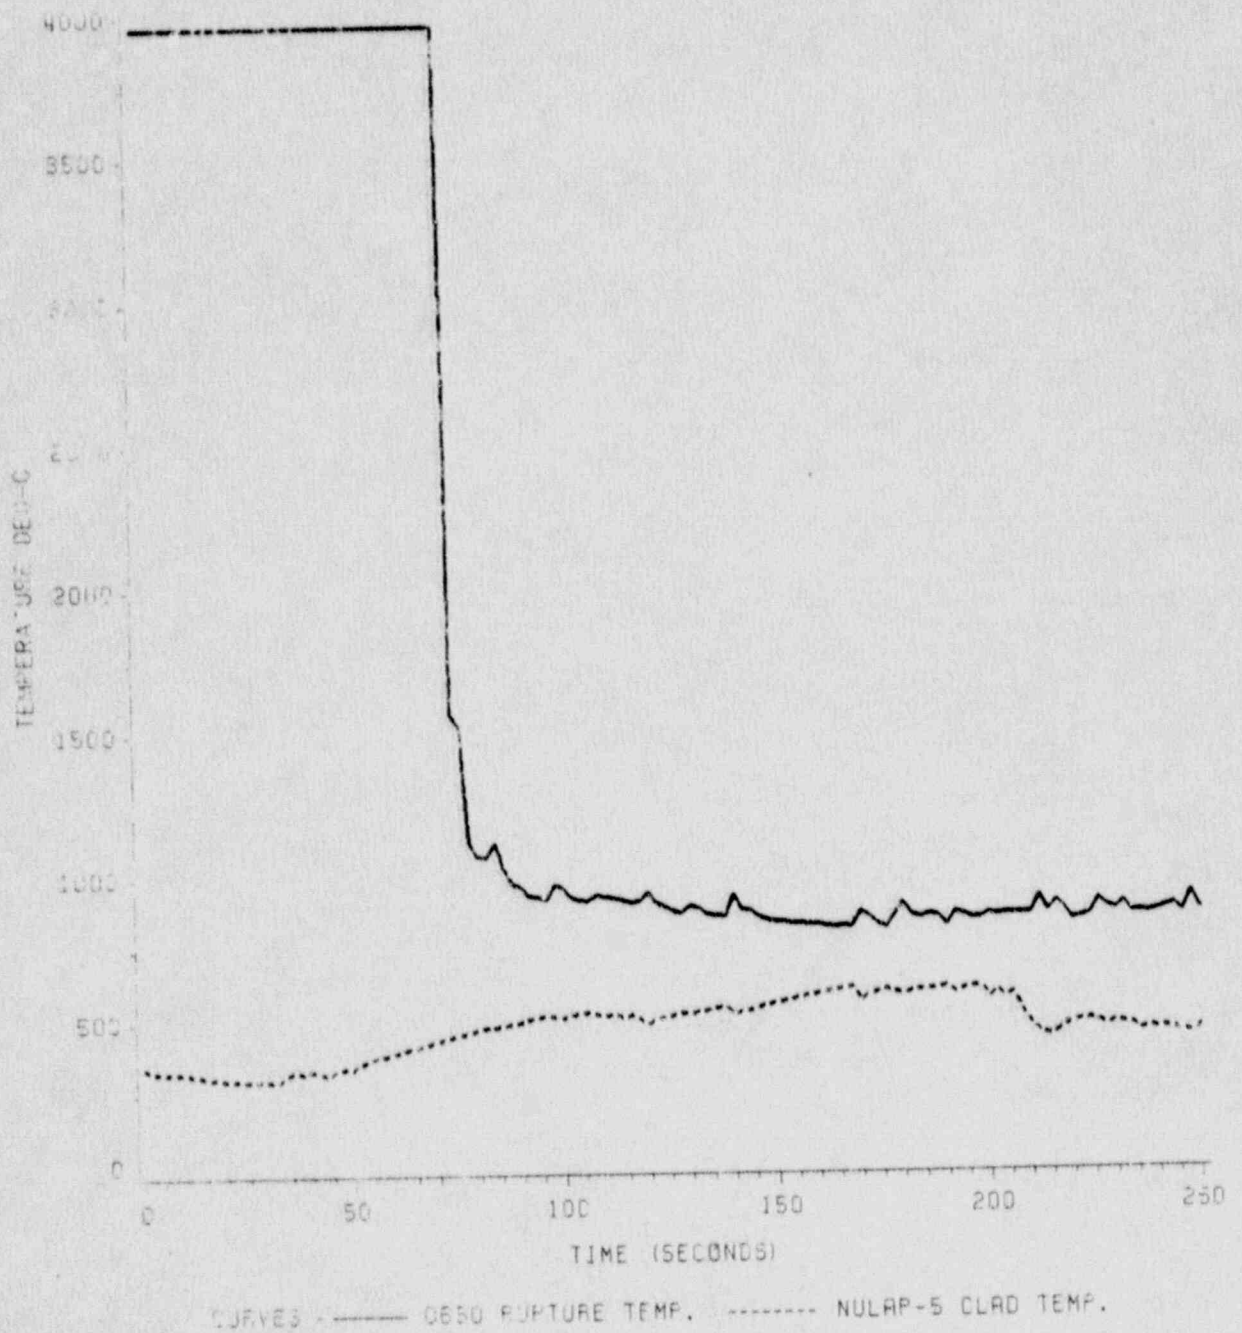
FIGURE 1-1  
HADDAM NECK PLANT ZIRCALOY SBLOCA  
NUREG-0630 RUPTURE TEMPERATURE VS.  
NULAP-5 PEAK CLAD TEMPERATURE  
HOT ROD 1ST UPPER NODE OF 24

The clad behavior model in NULAP5 conservatively bounds NUREG 0630 for the NUSCO 163 break spectrum. The 0.4 ft<sup>2</sup> break was the maximum cladding temperature case (1410 degF) and the only case for which any swelling was calculated to occur by the NULAP5 method. The 0.4 ft<sup>2</sup> case has been repeated, imposing NUREG 0630 methods for calculating rupture. NUREG 0630 Equation 3-2 for TR, rupture temperature, and 3-1 for hoop stress were solved throughout the transient using NULAP5 transient data for clad differential pressure and heating rate. As shown in the attached 7 figures of clad temperature and rupture temperature vs. time for the top 7 of 24 hot rod nodes, NUREG 0630 rupture conditions are never achieved. NUREG 0630 deformation in the form of reduction of flow area follows only from rupture. Thus, using the NUREG 0630 data, no swelling would be predicted. Therefore, any calculation of swelling, as NULAP5 did calculate for the 0.4 ft<sup>2</sup> break, conservatively bounds NUREG 0630 data.

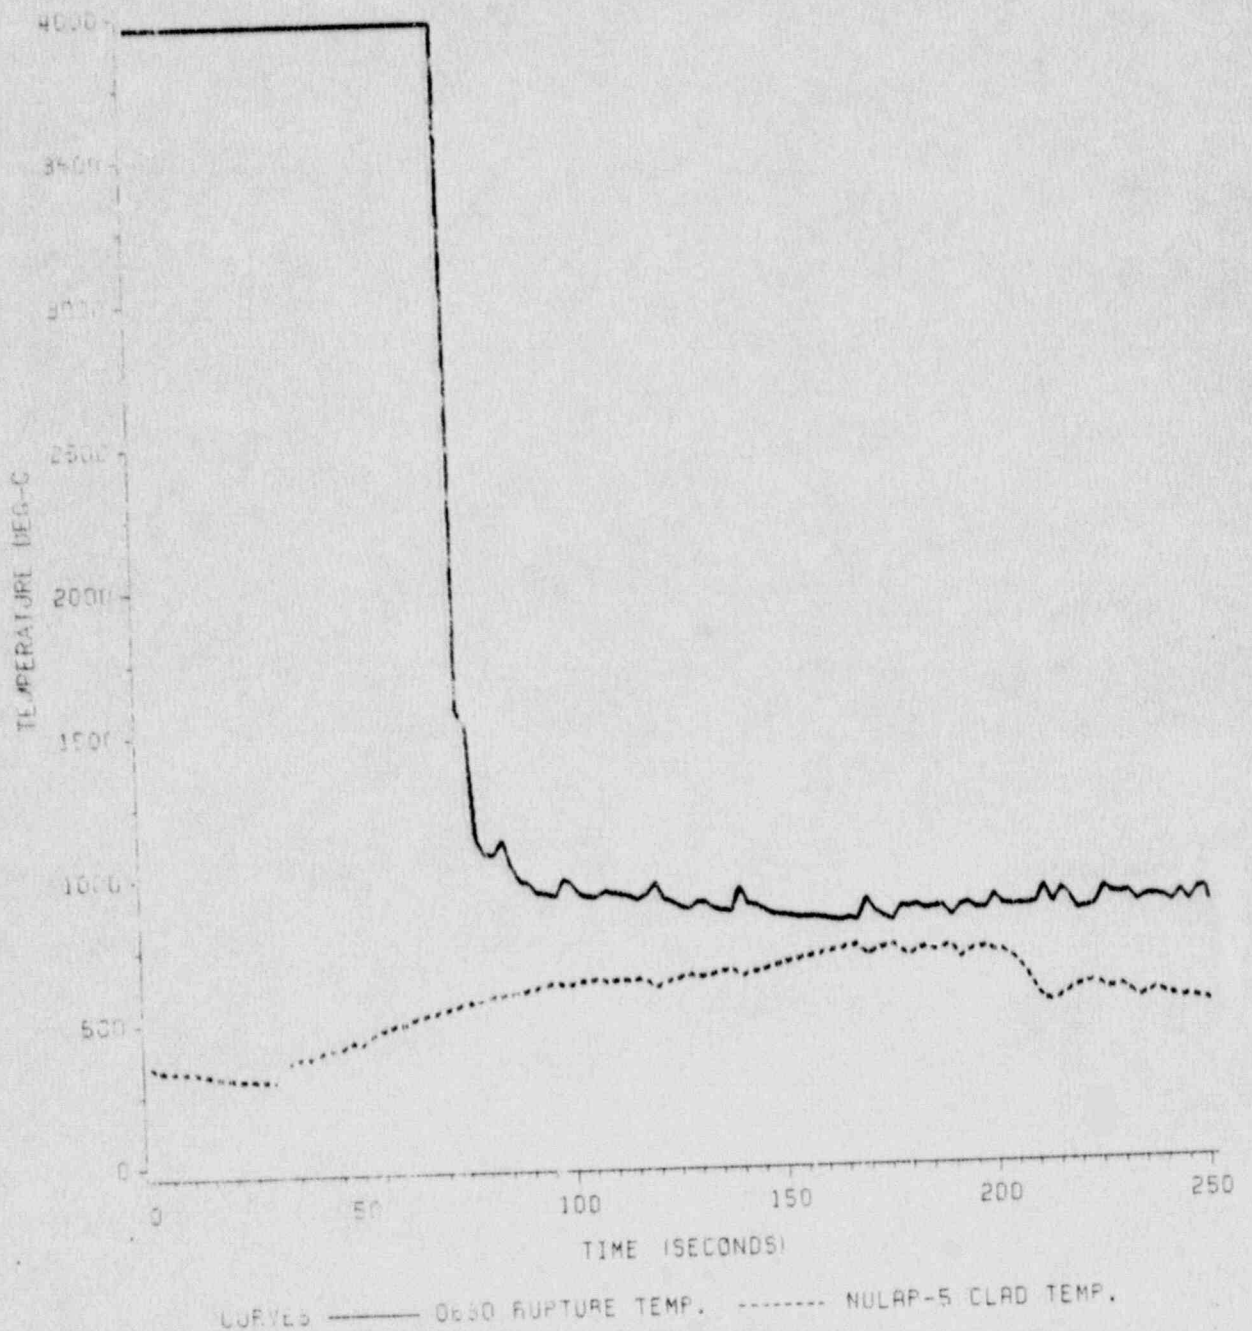
FIGURE 1-2  
HADDAM NECK PLANT ZIRCALOY SBLOCA  
NUREG-0630 RUPTURE TEMPERATURE VS.  
NULAP-5 PEAK CLAD TEMPERATURE  
HOT ROD 2ND UPPER NODE OF 24

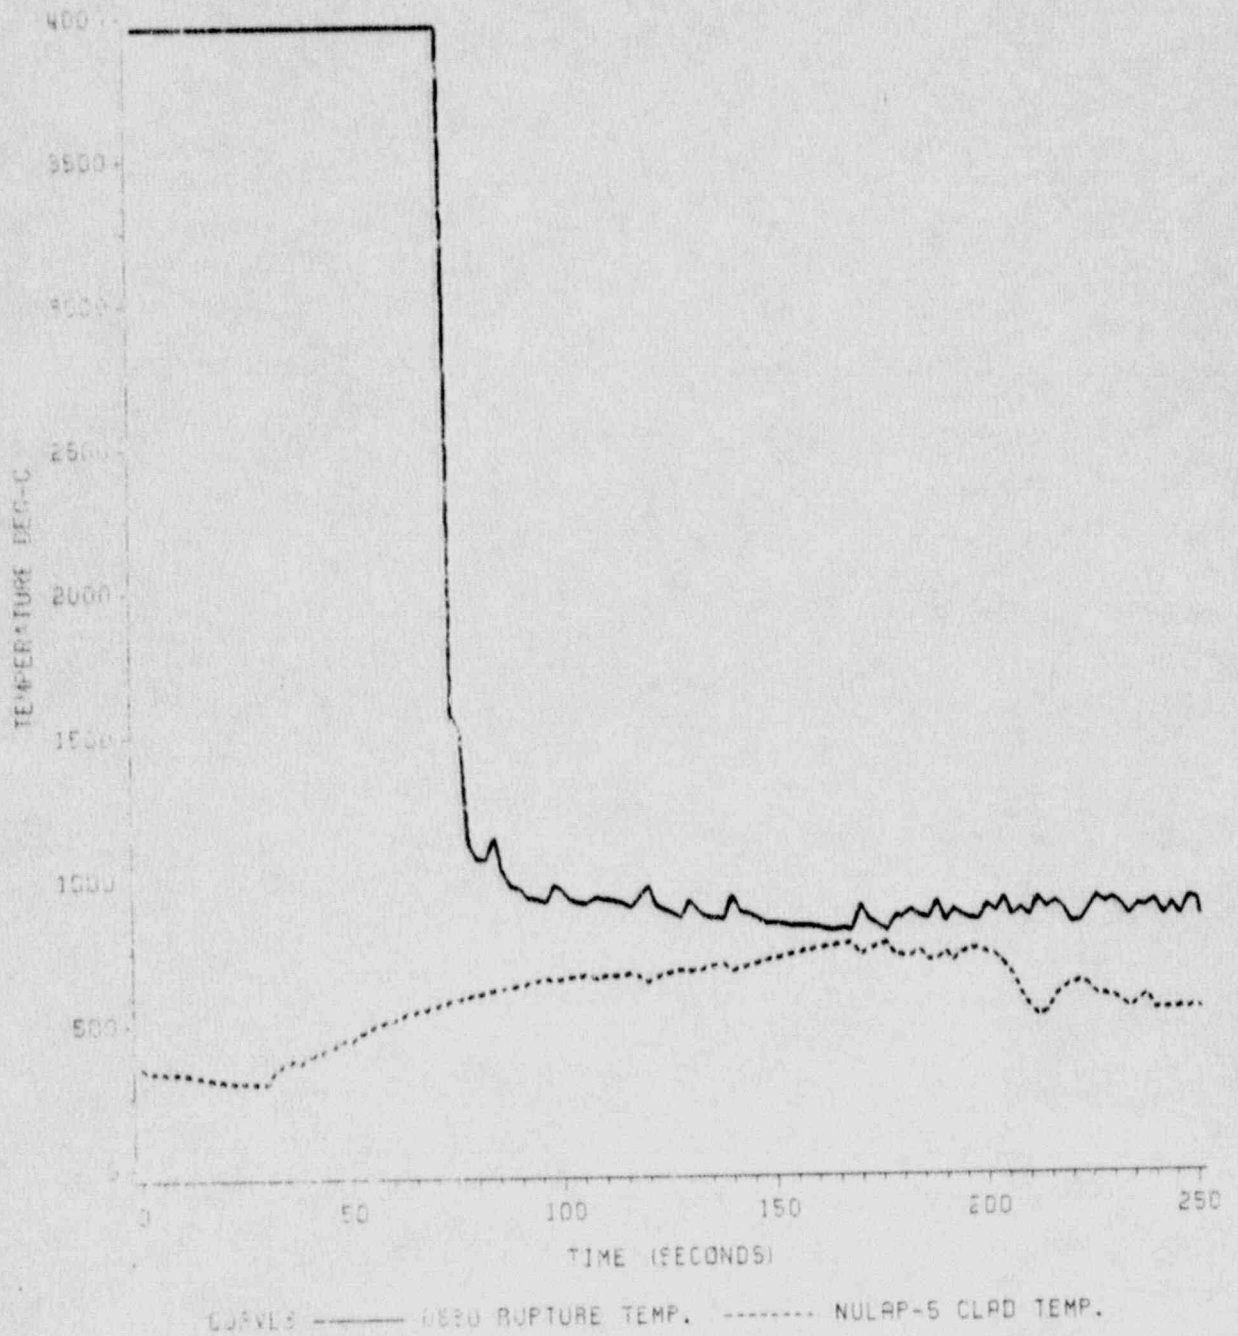
**FIGURE 1-3**  
**HADDAM NECK PLANT ZIRCALOY SBLOCA**  
**NUREG-0630 RUPTURE TEMPERATURE VS.**  
**NULAP-5 PEAK CLAD TEMPERATURE**  
**HOT ROD 3RD UPPER NODE OF 24**

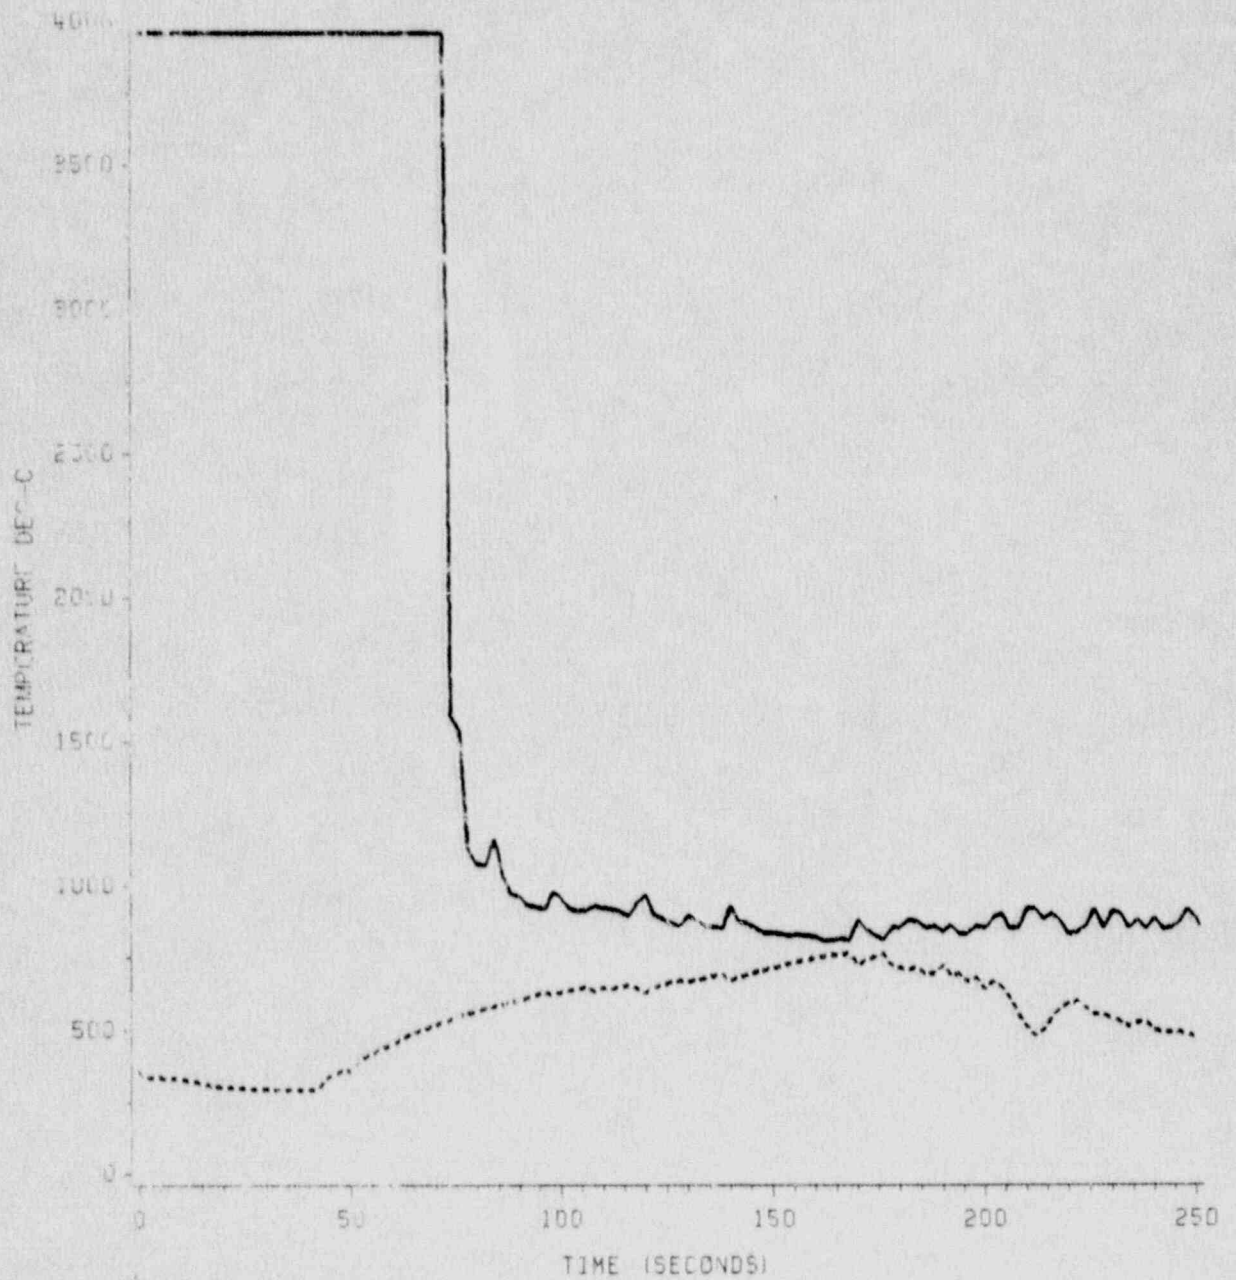
**FIGURE 1-4**  
**HADDAM NECK PLANT ZIRCALOY SBLOCA**  
**NUPEC-0630 RUPTURE TEMPERATURE VS.**  
**NULAP-5 PEAK CLAD TEMPERATURE**  
**HOT ROD 4TH UPPER NODE OF 24**

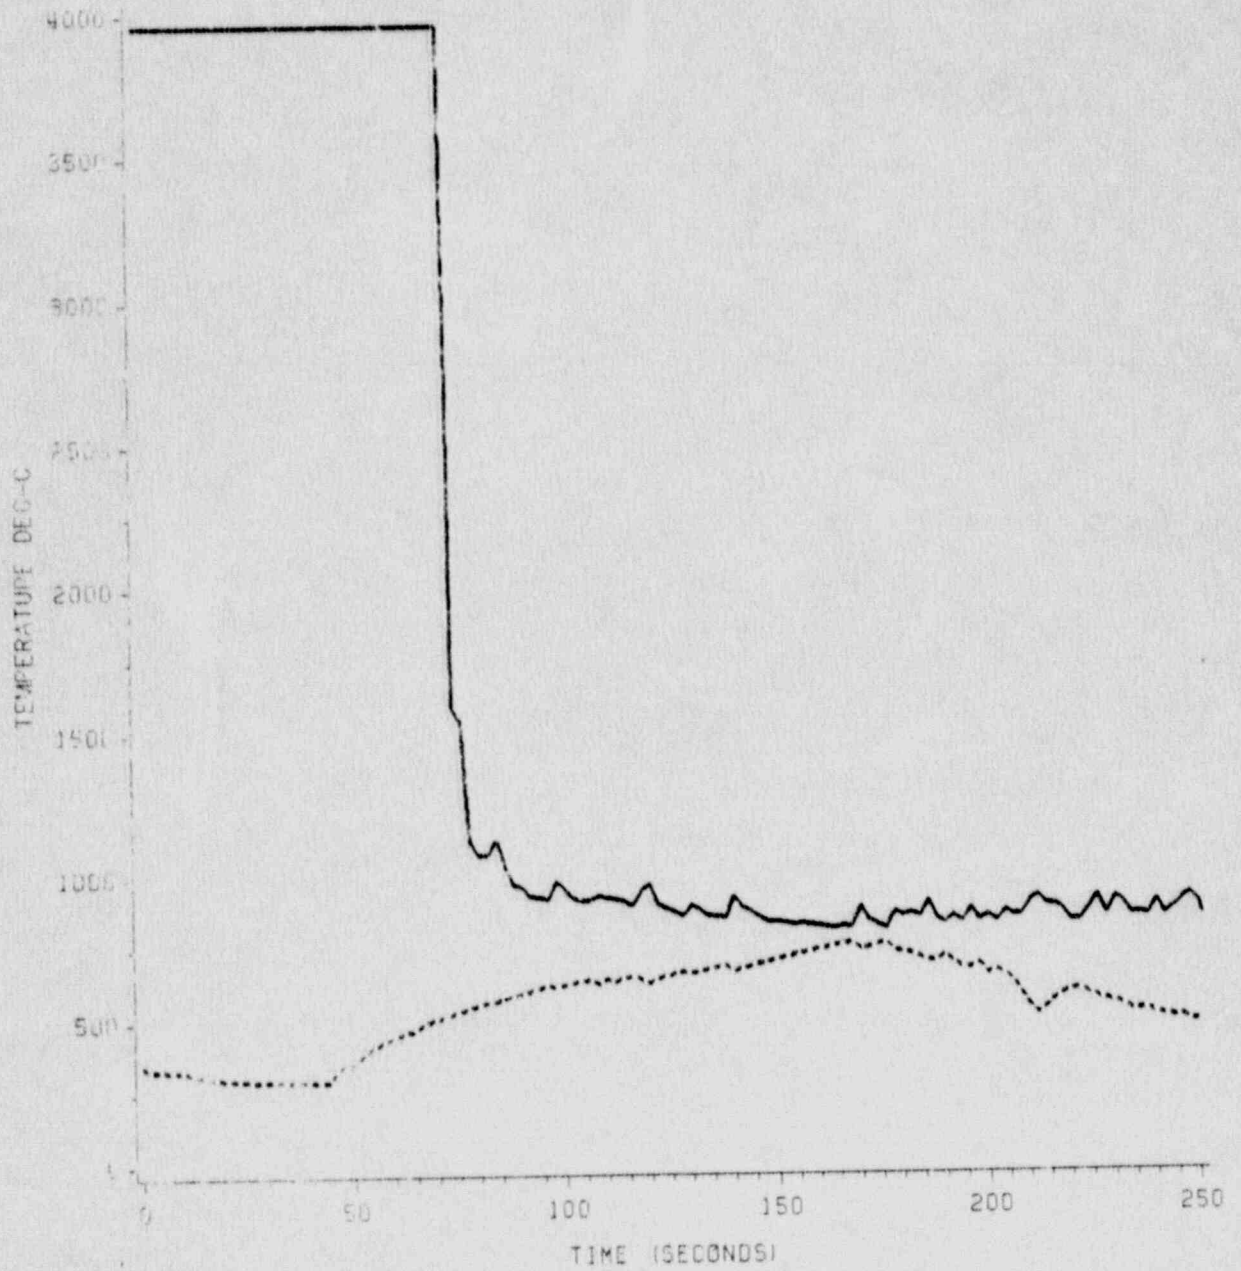
FIGURE 1-5  
HADDAM NECK PLANT ZIRCALOY SBLOCA  
NUREG-0630 RUPTURE TEMPERATURE VS.  
NULAP-5 PEAK CLAD TEMPERATURE  
HOT ROD 5TH UPPER NODE OF 24

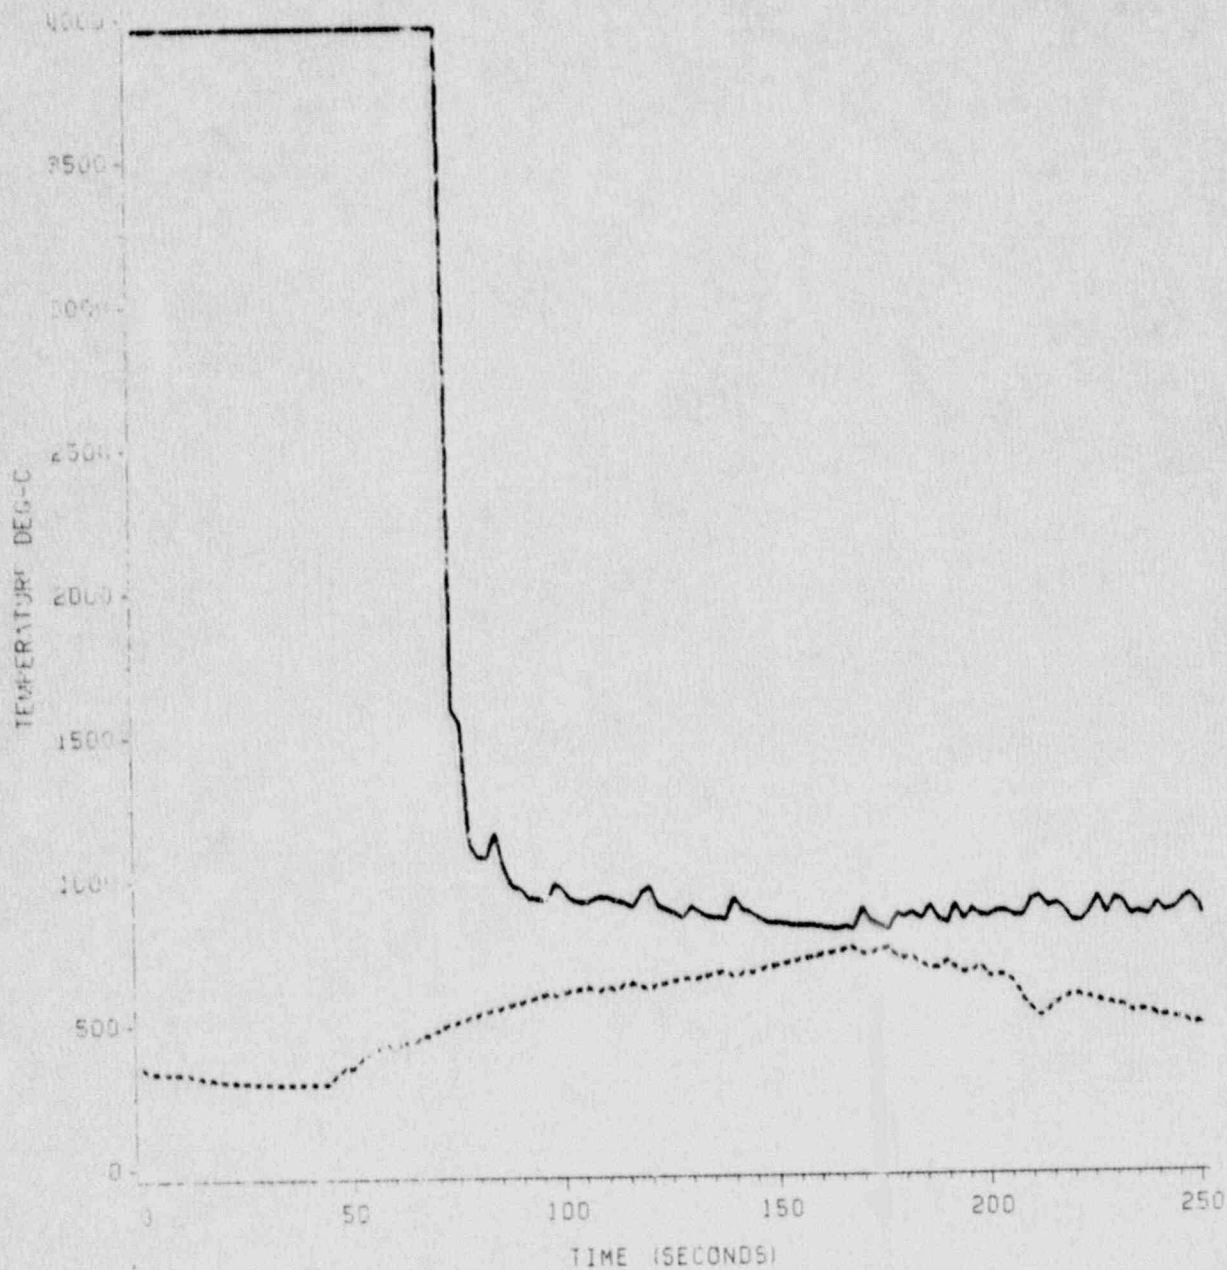
FIGURE 1-8  
HADDAM NECK PLANT ZIRCALLOY SBLOCA  
NUREG-0630 RUPTURE TEMPERATURE VS.  
NULAP-5 PEAK CLAD TEMPERATURE  
H01 ROD 6TH UPPER NODE OF 24

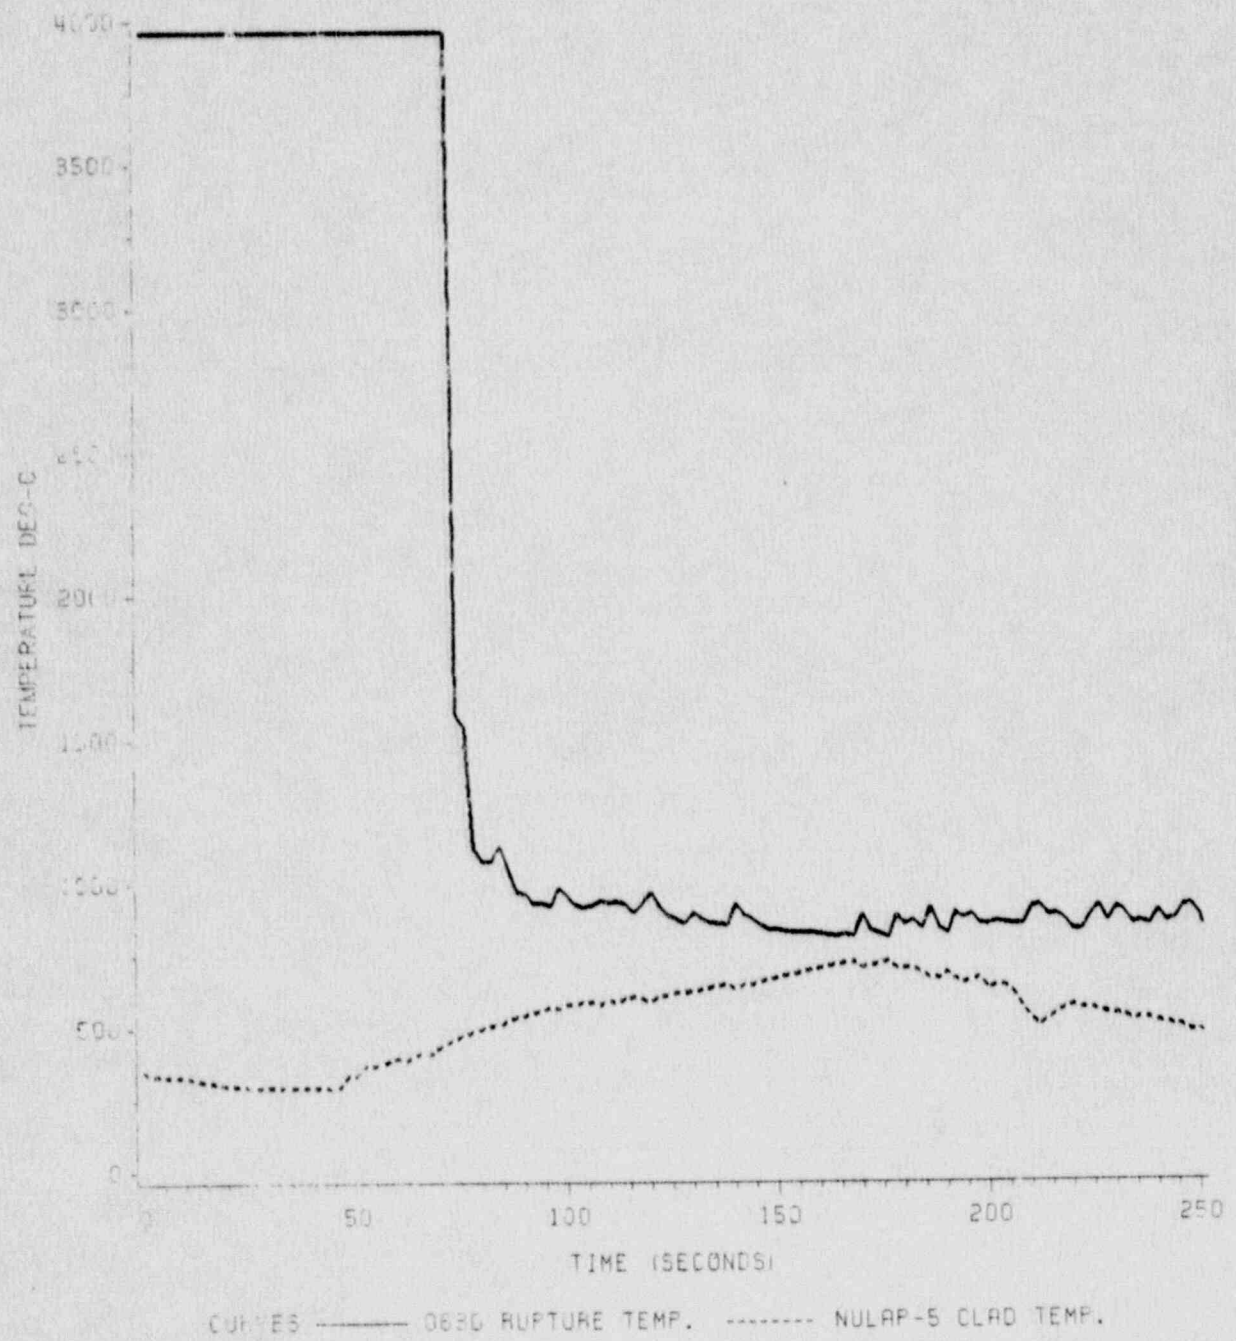
FIGURE 1-7  
HADDAM NECK PLANT ZIRCALOY SBLOCA  
NUREG-0630 RUPTURE TEMPERATURE VS.  
NULAP-5 PEAK CLAD TEMPERATURE  
HOT ROD 7TH UPPER NODE OF 24

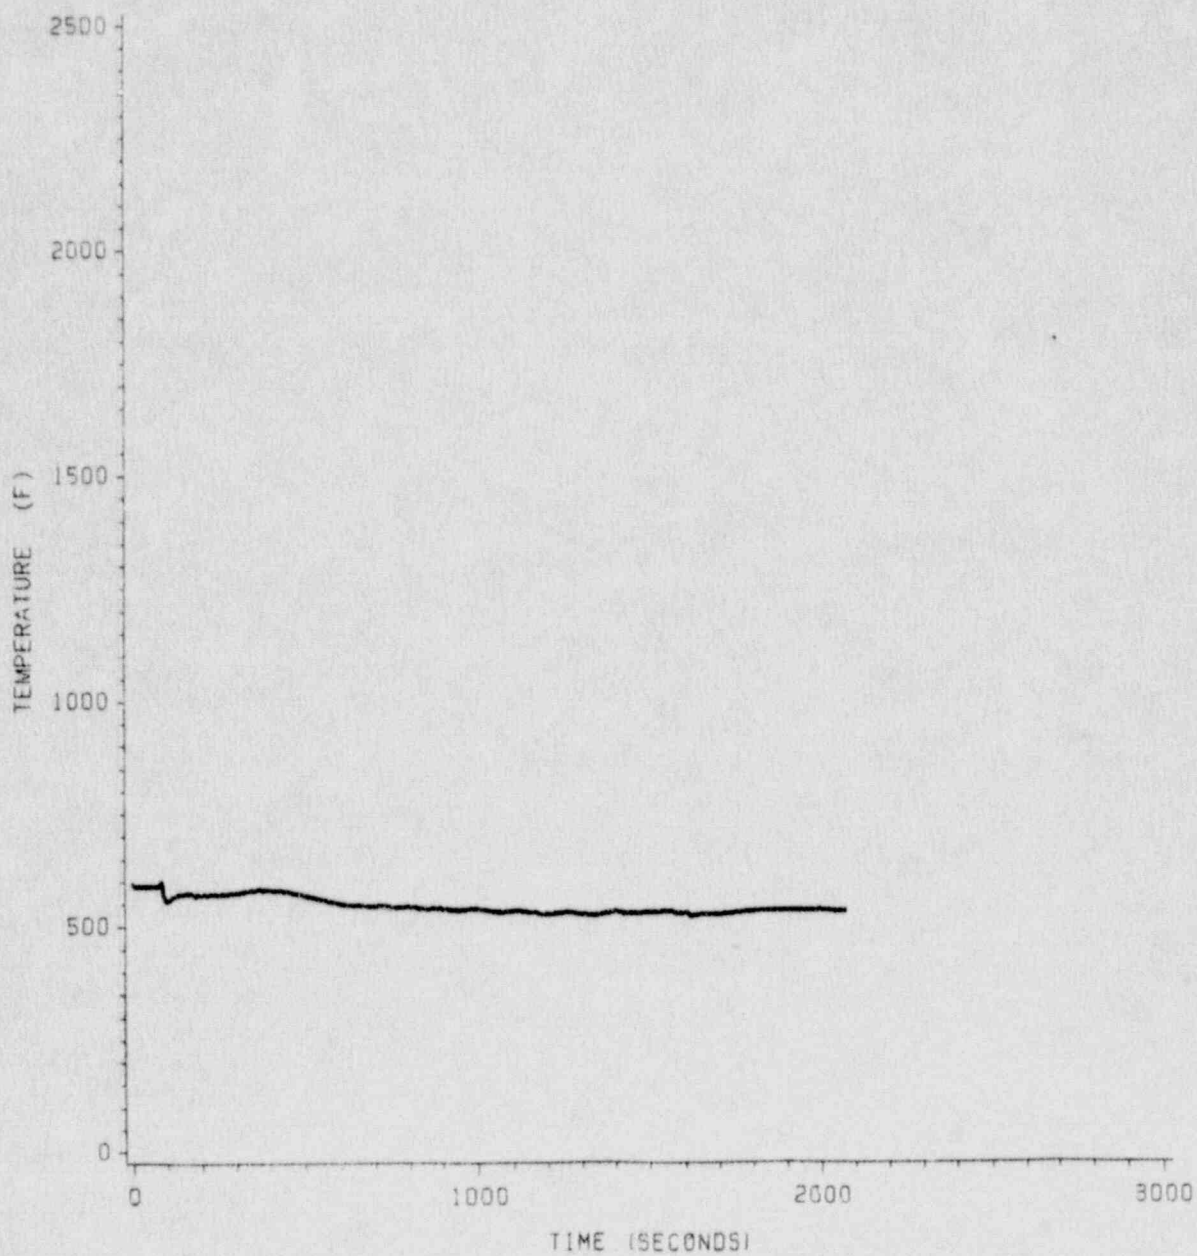
**FIGURE 6-1**  
**HADDAM NECK PLANT ZIRCALOY SBLOCA**  
**0.01 FT2 DISCHARGE LEG BREAK**

VAPOR TEMPERATURE - HOT SPOT  
——— TEMPG 343210000  
----- TSAT 343210000

Figures 6-1 through 6-6 provide the requested information.

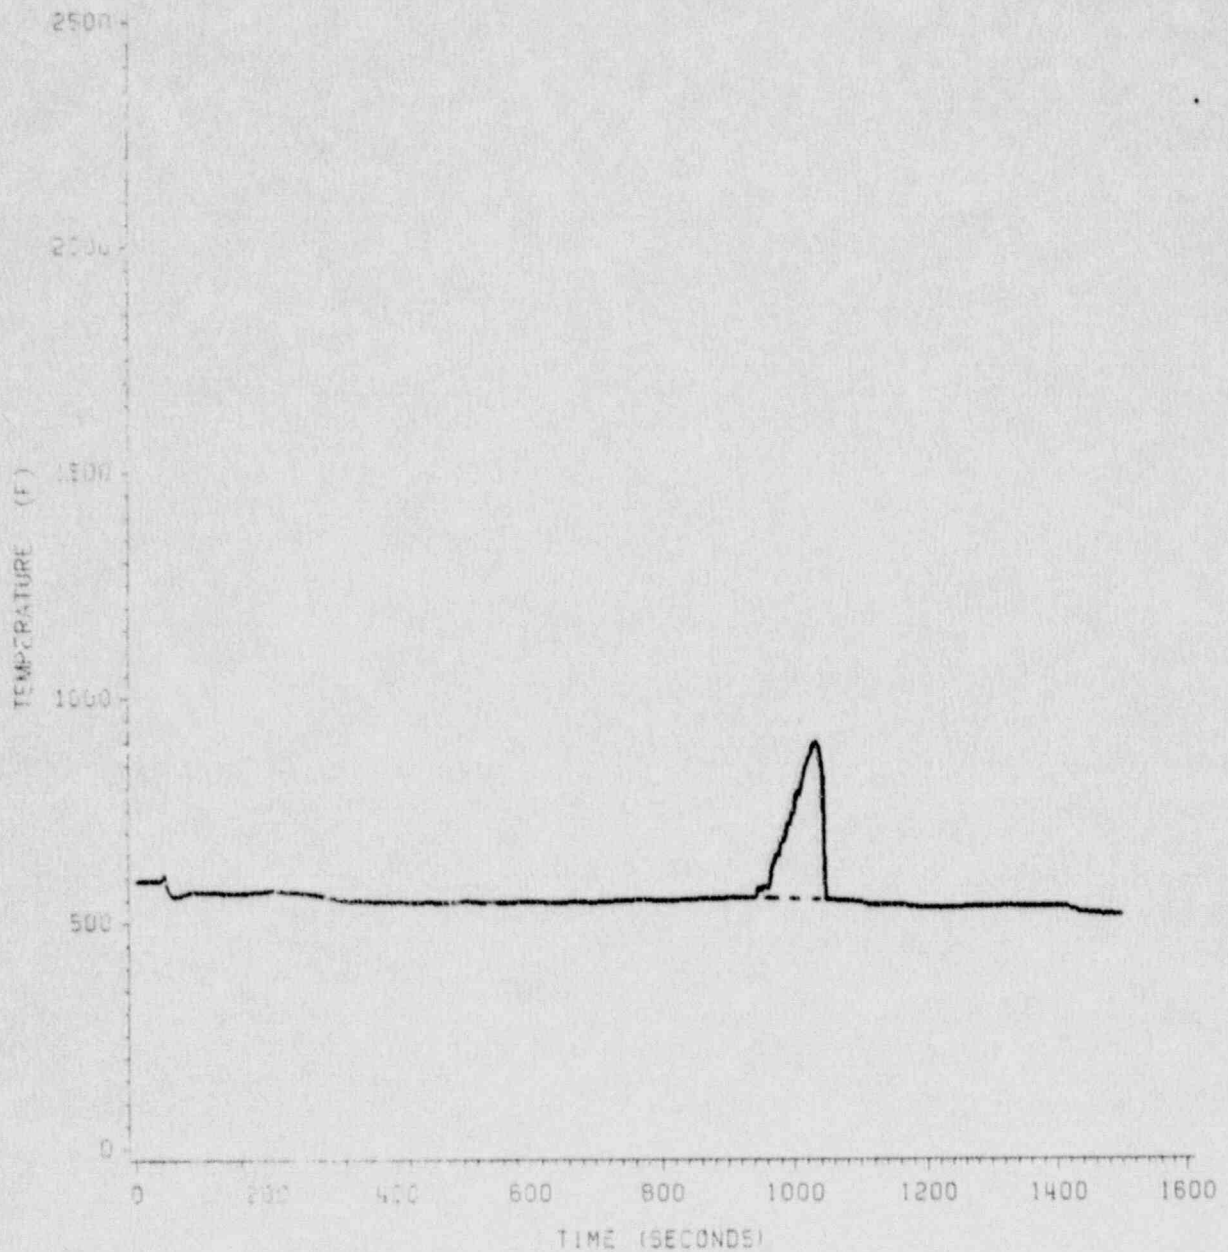
**FIGURE 6-2**  
**HADDAM NECK PLANT ZIRCALOY SBLOCA**  
**0.02 FT<sup>2</sup> DISCHARGE LEG BREAK**

VAPOR TEMPERATURE - HOT SPOT  
——— TEMPG 343220000  
----- TSAT 343220000

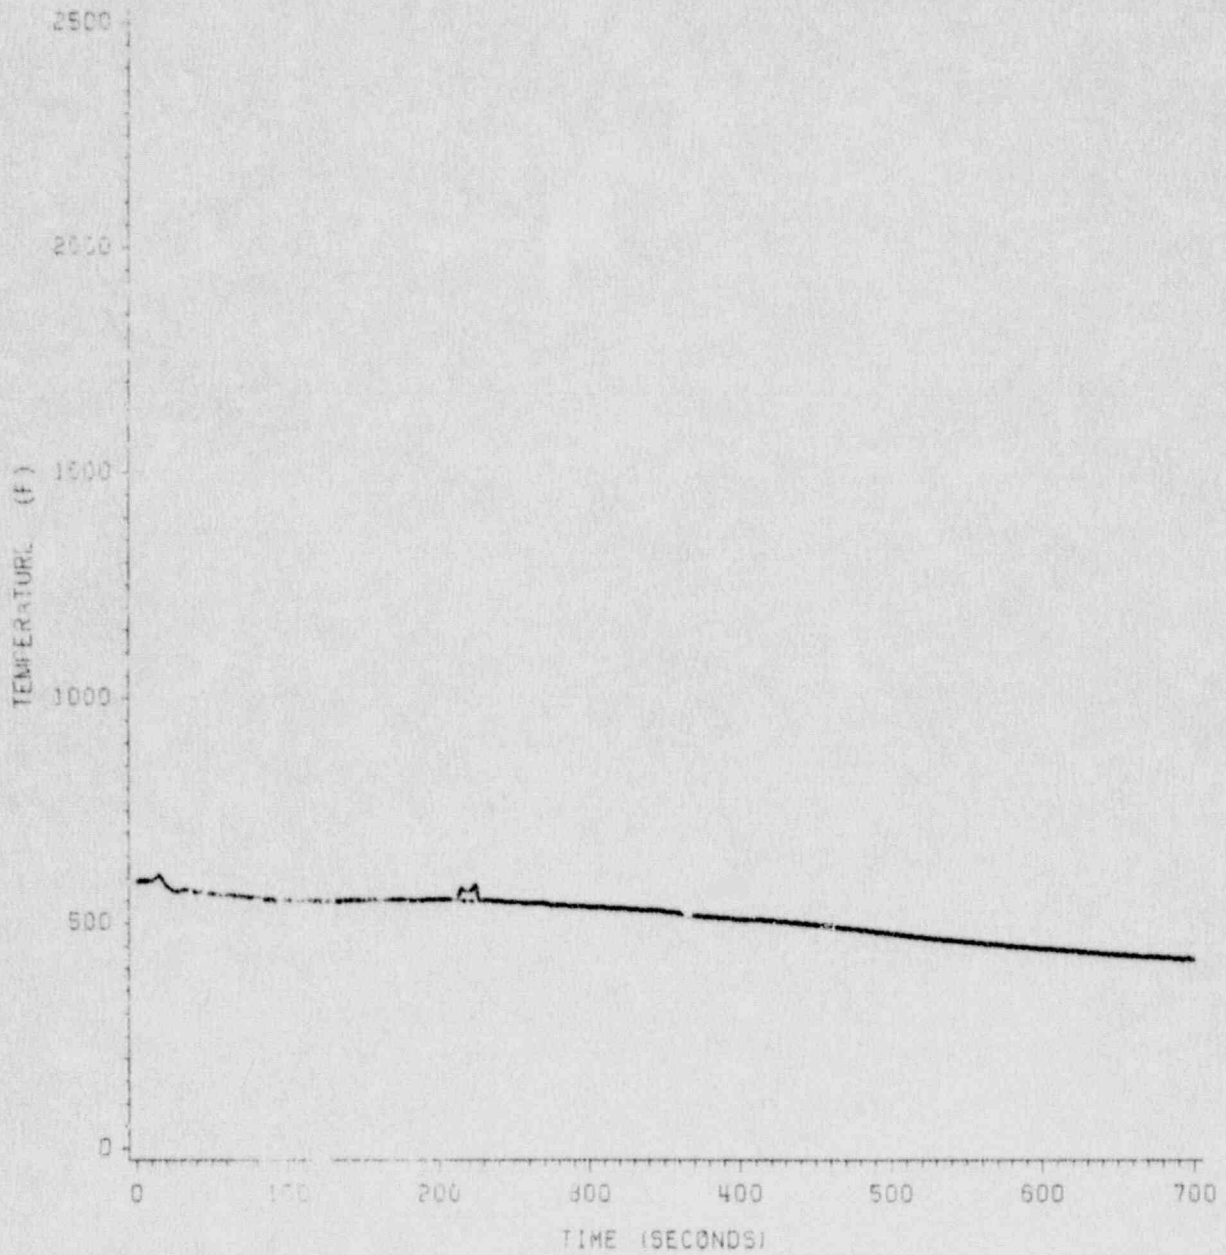
**FIGURE 6-3  
HADDAM NECK PLANT ZIRCALOY SBLOCA  
0.075 FT2 DISCHARGE LEG BREAK**

VAPOR TEMPERATURE - HOT SPOT  
—— TEMPG 343220000  
---- TSAT 343220000

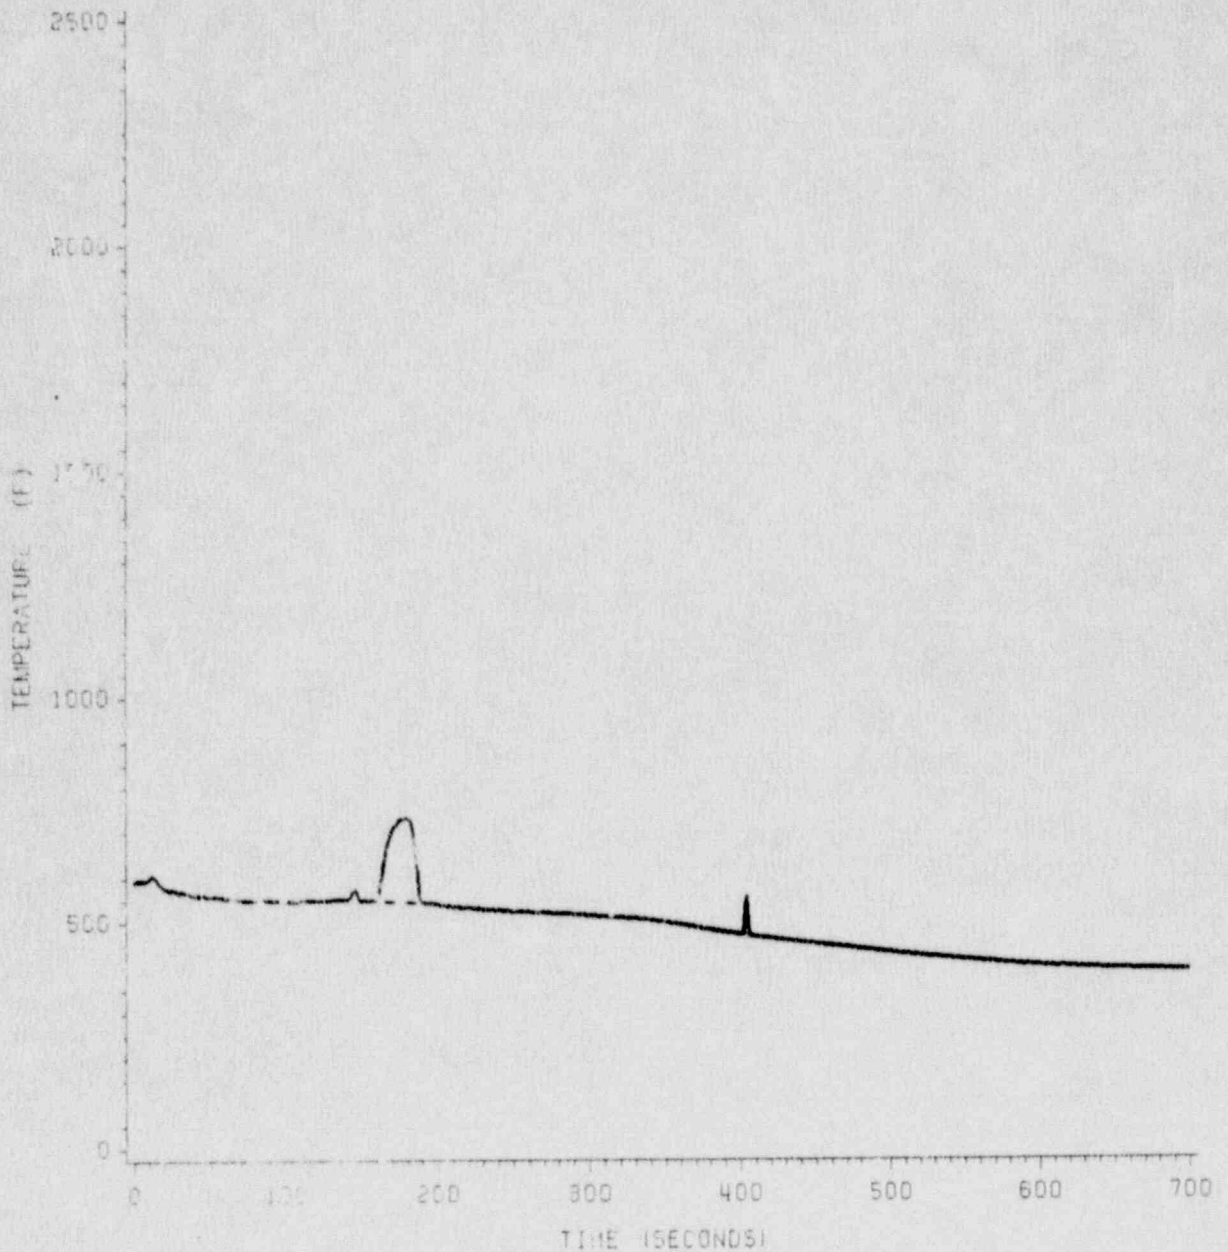
**FIGURE 6-4  
HADDAM NECK PLANT ZIRCALOY SBLOCA  
0.1 FT2 DISCHARGE LEG BREAK**

**VAPOR TEMPERATURE - HOT SPOT  
—— TEMPG 343220000  
----- TSAT 343220000**

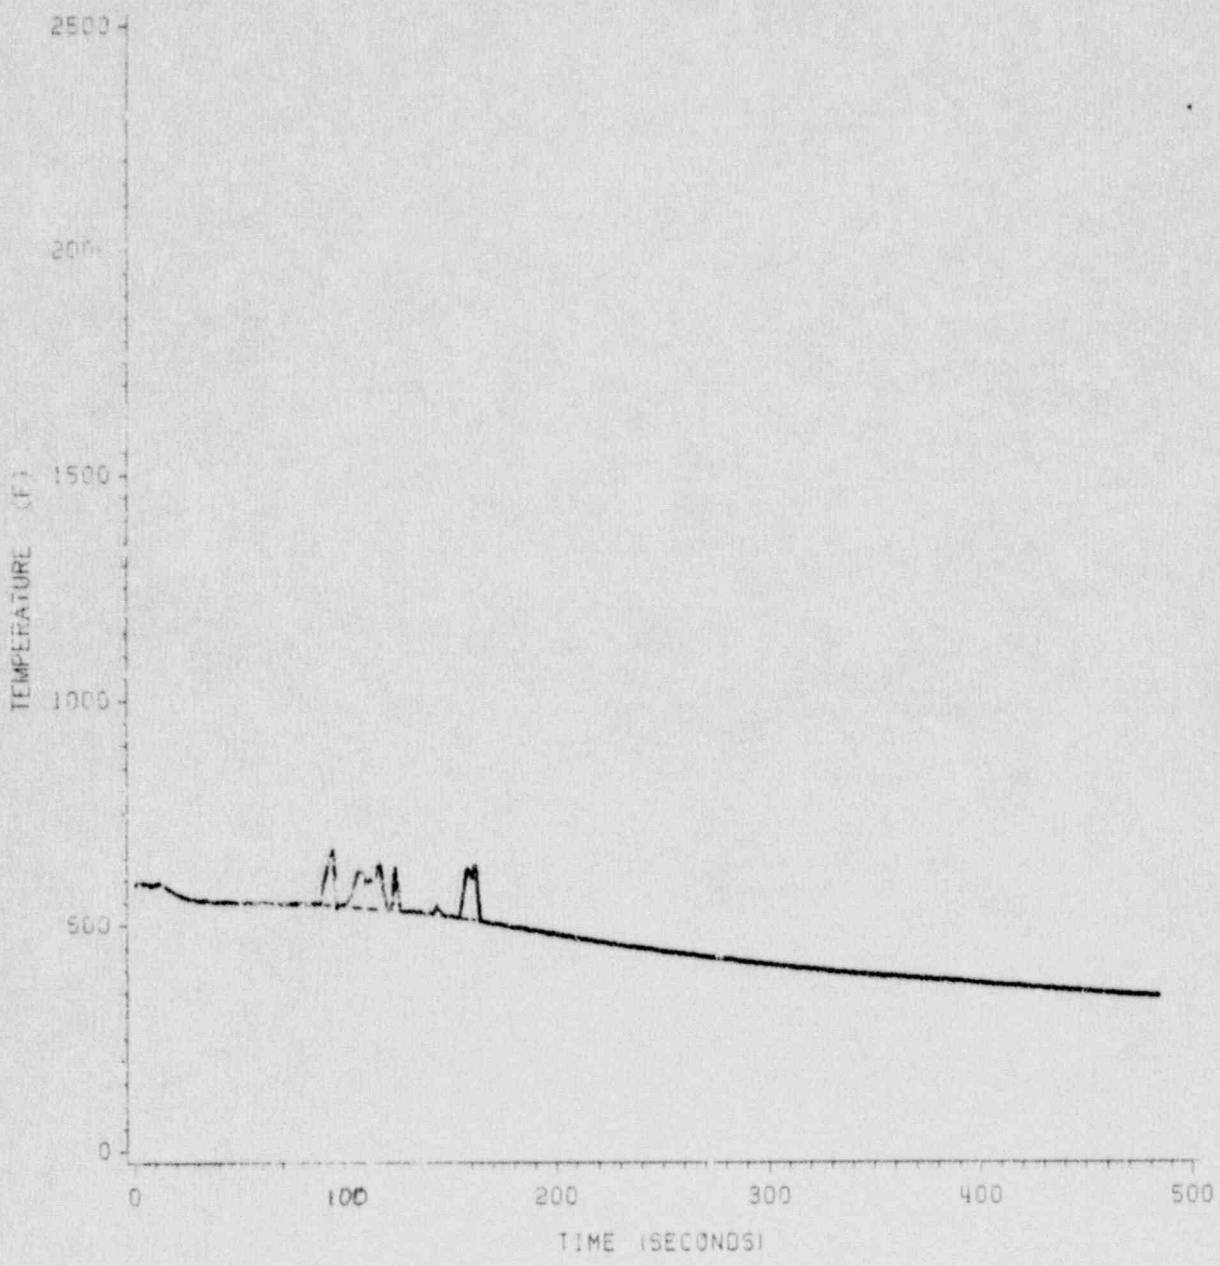
**FIGURE 6-5**  
**HADDAM NECK PLANT ZIRCALOY SBLOCA**  
**0.2 FT2 DISCHARGE LEG BREAK**

VAPOR TEMPERATURE - HOT SPOT  
—— TEMPG 343220000  
---- TSA\* 343220000

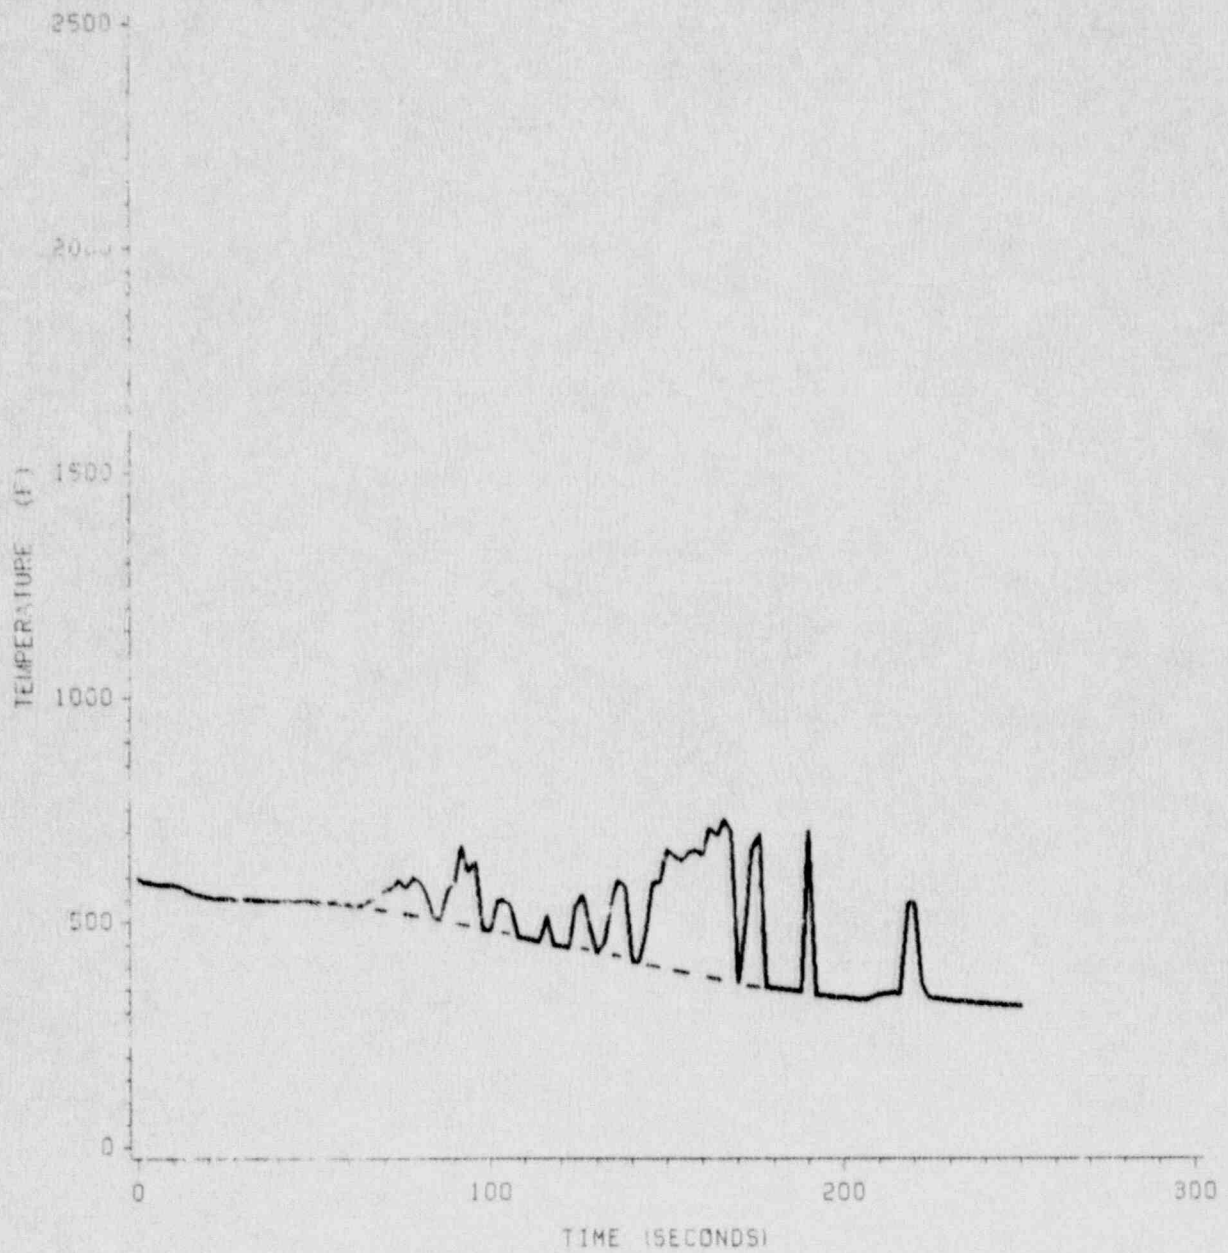
**FIGURE 6-6**  
**HADDAM NECK PLANT ZIRCALOY SBLOCA**  
**0.4 FT<sup>2</sup> DISCHARGE LEG BREAK**

VAPOR TEMPERATURE - HOT SPOT  
—— YEMPG 343210000  
----- TSAT 343210000
