Re: Zircaloy Clad  
Conversion  
ISAP Topic 2.17

Haddam Neck Plant  
Additional Information  
Small-Break Loss of Coolant Accident Analysis--  
Zircaloy Clad Fuel

Attachment  
Haddam Neck Plant  
Additional Information

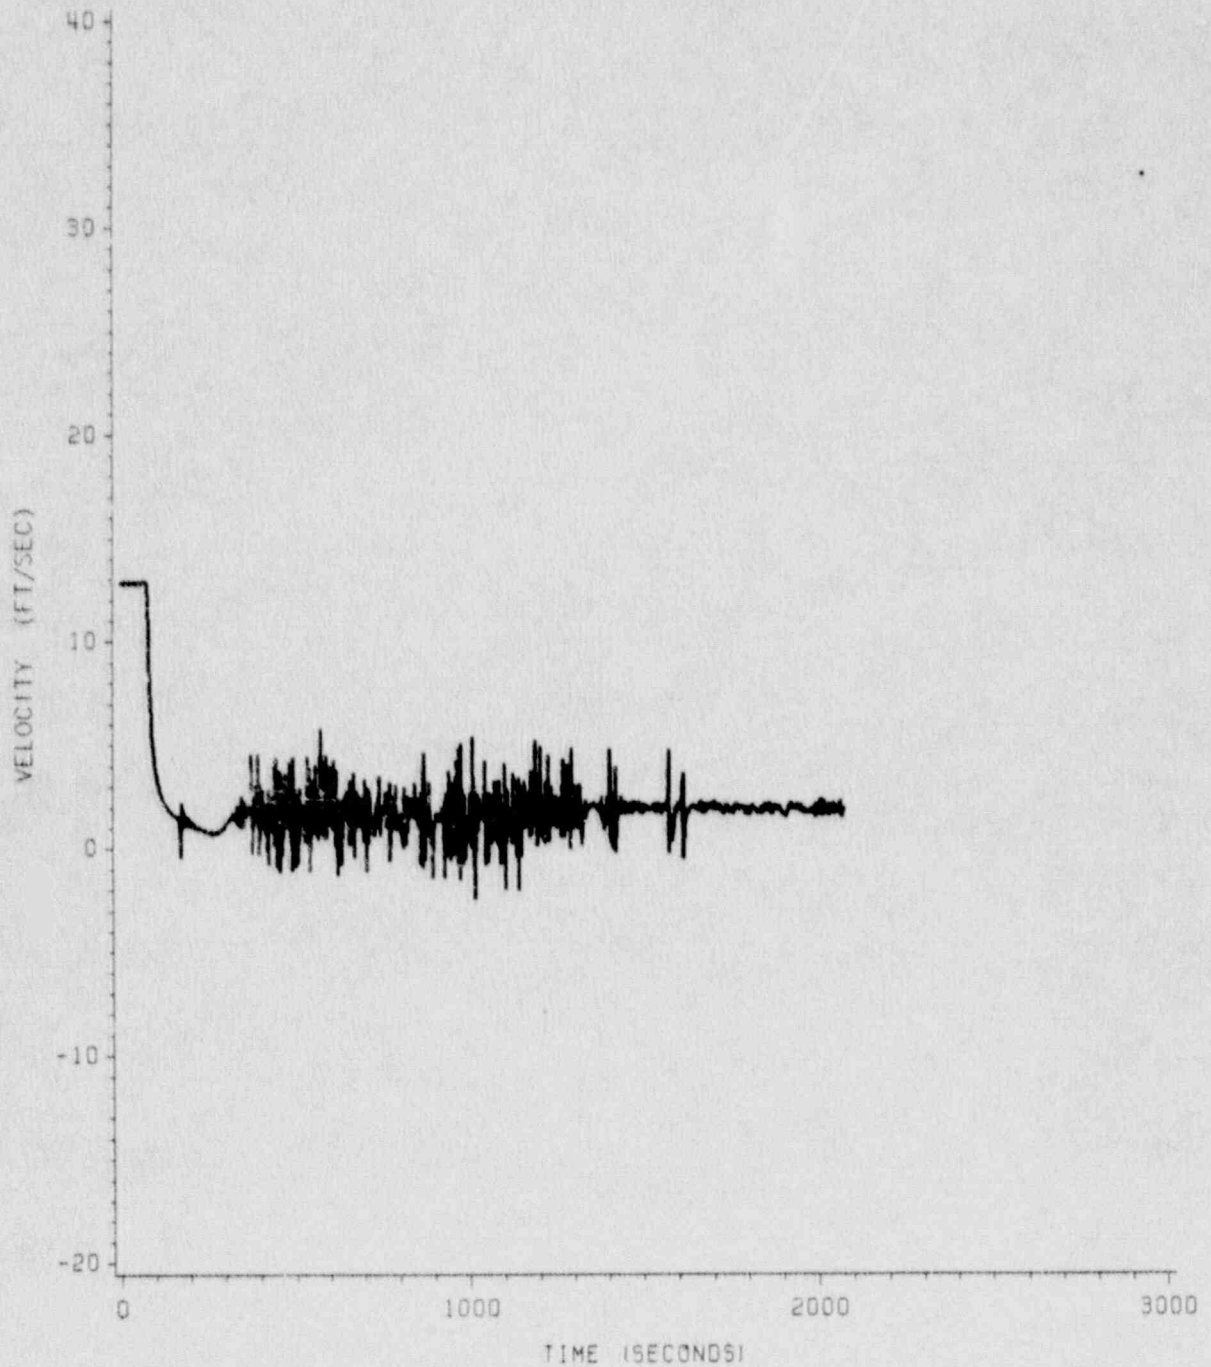
FIGURE 7-1

HADDAM NECK PLANT ZIRCALOY SBLOCA  
0.01 FT2 DISCHARGE LEG BREAK

HOT SPOT VAPOR VELOCITY  
VELGJ 343200070

The clad surface temperatures are provided in NUSCO 163. Collapsed and two-phase level plots are provided in the response to Question 8. Figures 7-1 through 7-12 provide the hot spot vapor velocity and void fraction in lower plenum volume 335 for each of the breaks analyzed in NUSCO 163.

The collapsed and two-phase level plots provide the time frame for the loop seal clearing uncovering period. It can be seen from the clad temperature responses that the clad temperature increase is terminated during or subsequent to the core level recovery period following loop seal clearing for each of the breaks analyzed. In order to terminate the clad temperature increase during the loop seal clearing uncovering period, a sudden increase in hot spot vapor velocity would have to occur resulting in an increase in heat transfer coefficient. An increase in hot spot vapor velocity could potentially be calculated to occur if the lower plenum volume 335 significantly voided as core level approached the minimum value. Generally, the void fraction in volume 335 would have to be greater than approximately 0.6 for this phenomenon to occur. The lower plenum volume 335 void fraction plots provided verify that the void fraction never approaches 0.6 during the loop seal clearing uncovering period.

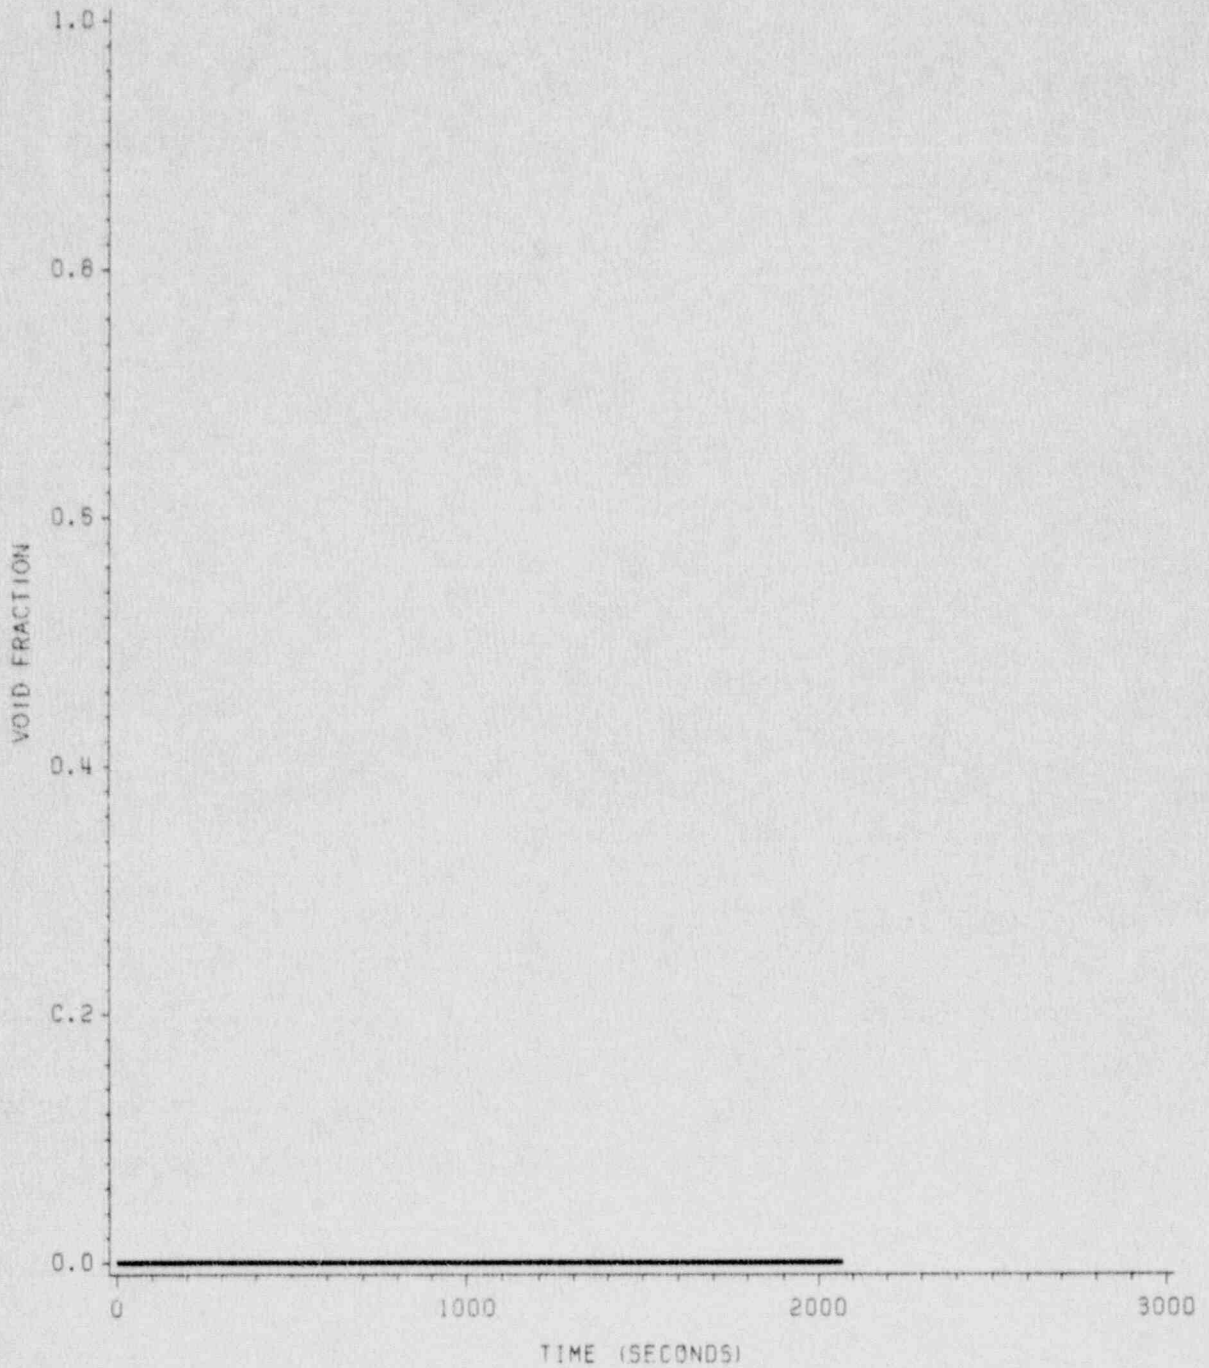
FIGURE 7-2

HADDAM NECK PLANT ZIRCALOY SBLOCA  
0.01 FT<sup>2</sup> DISCHARGE LEG BREAK

VOID FRACTION - VOLUME 33801  
—— VOID 338010000

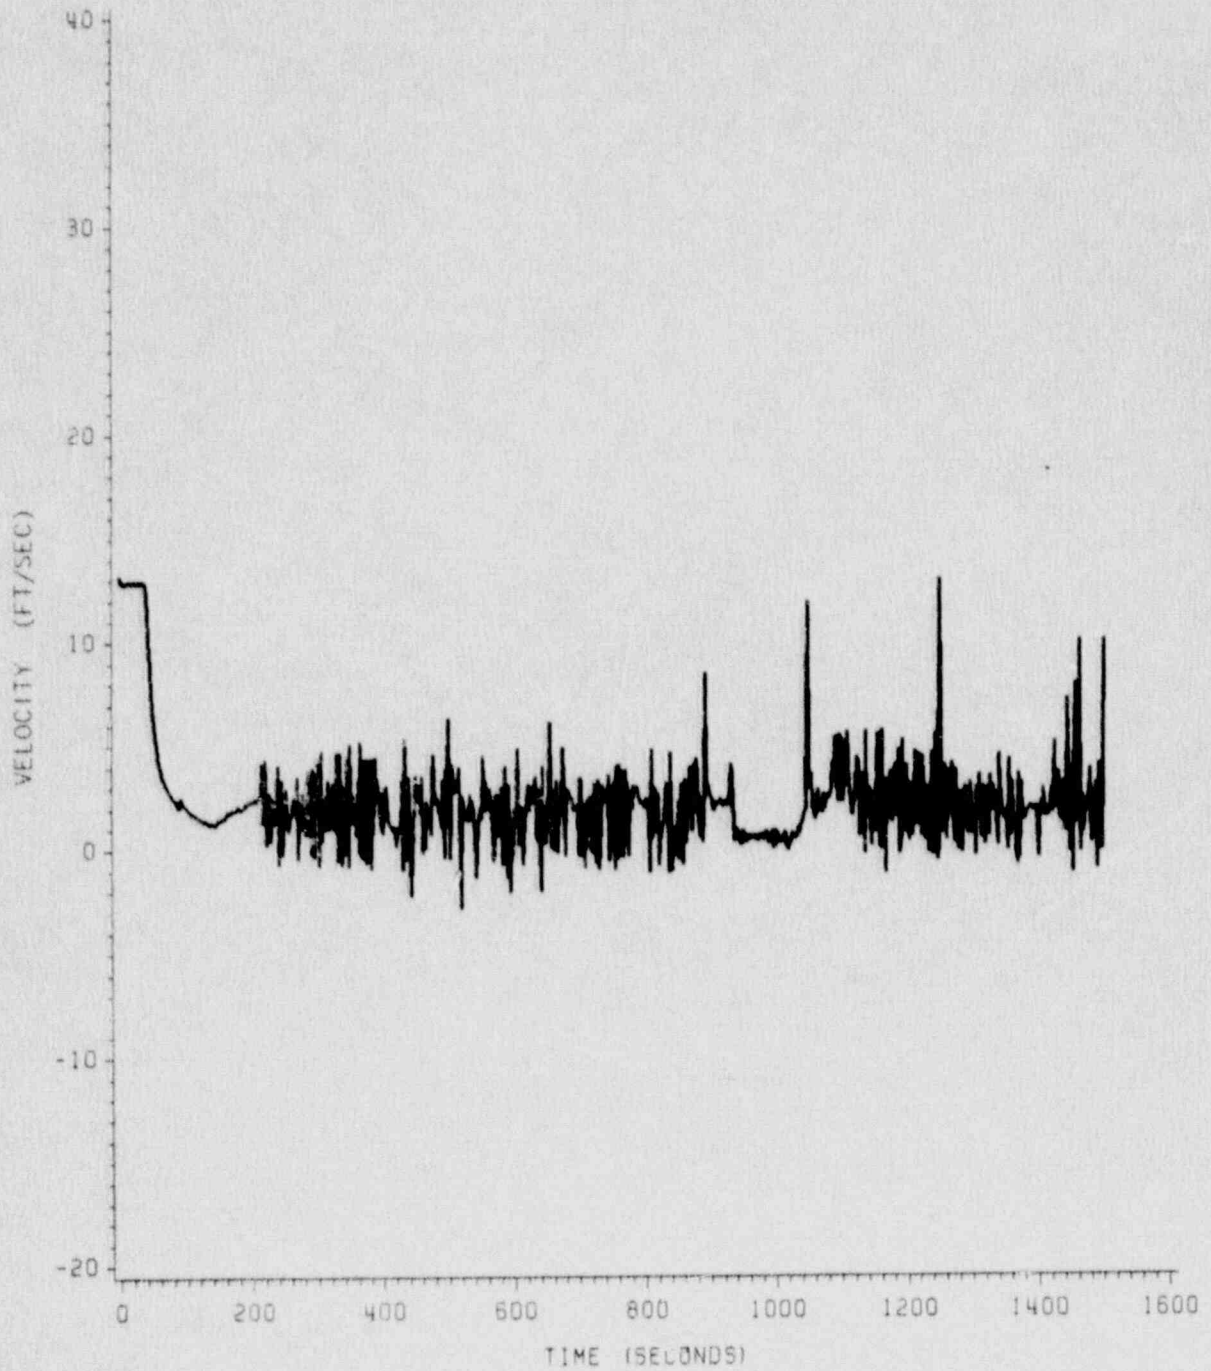
**FIGURE 7-3**  
**HADDAM NECK PLANT ZIRCALOY SBLOCA**  
**0.02 FT<sup>2</sup> DISCHARGE LEG BREAK**  
HOT SPOT VAPOR VELOCITY  
— VELGJ 343210000

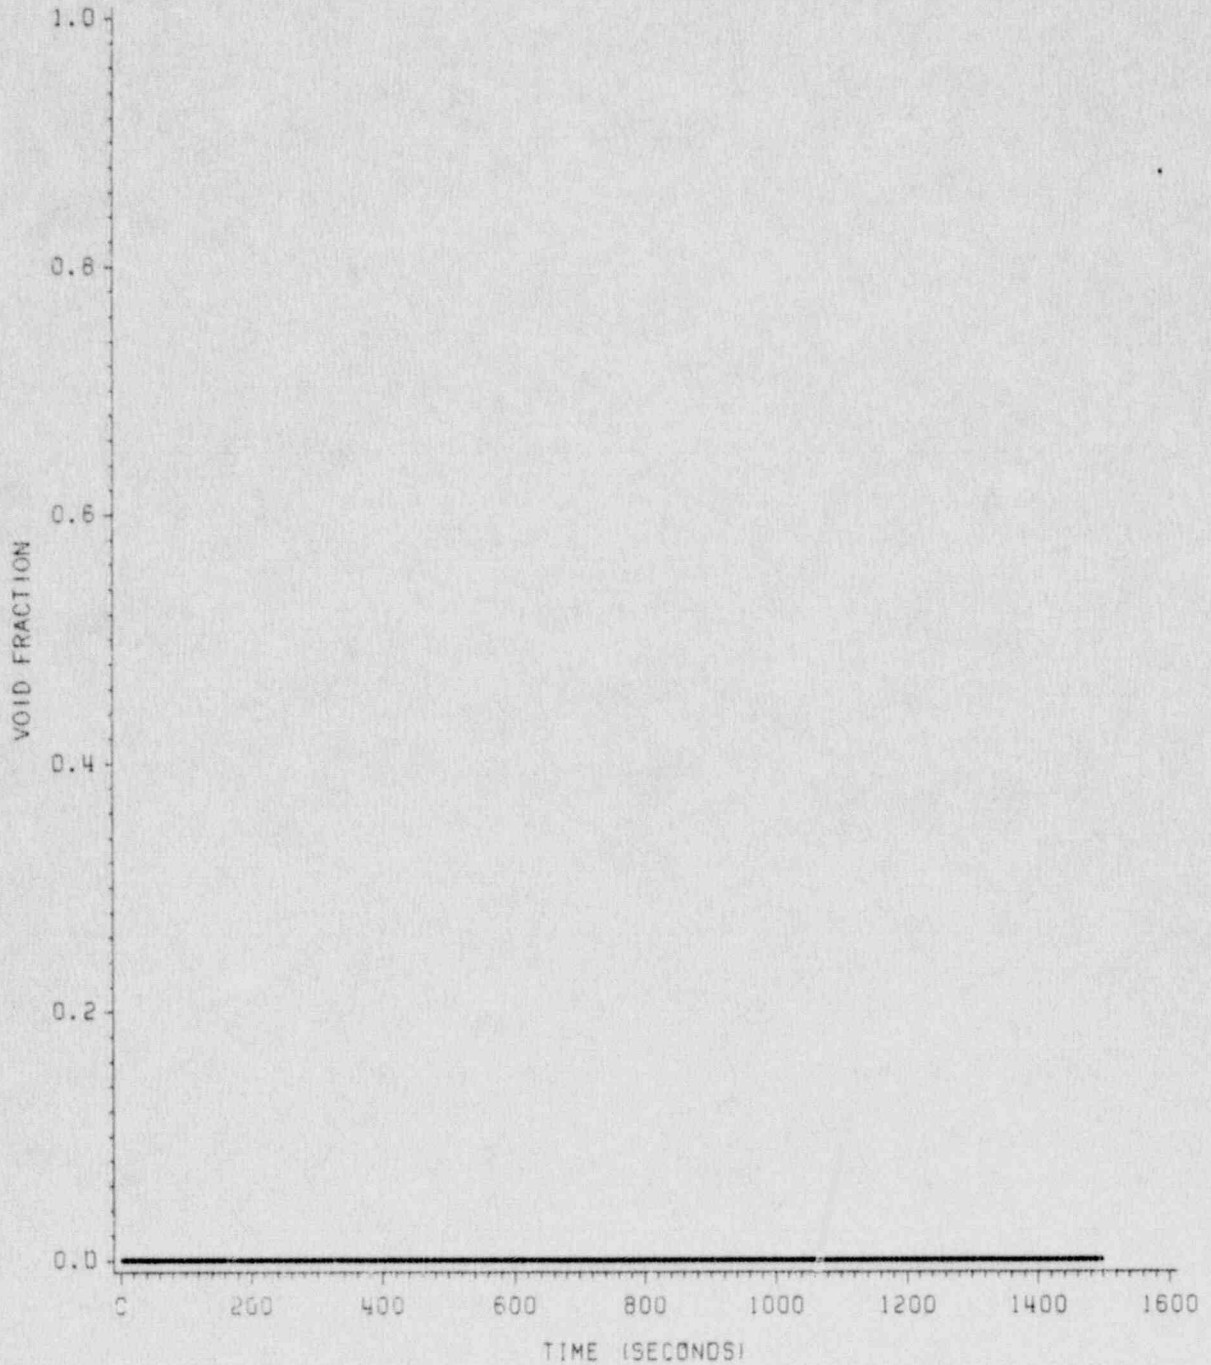
FIGURE 7-4

HADDAM NECK PLANT ZIRCALOY SBLOCA  
0.02 FT<sup>2</sup> DISCHARGE LEG BREAK

VOID FRACTION - VOLUME 33601  
—— VOID 336010000

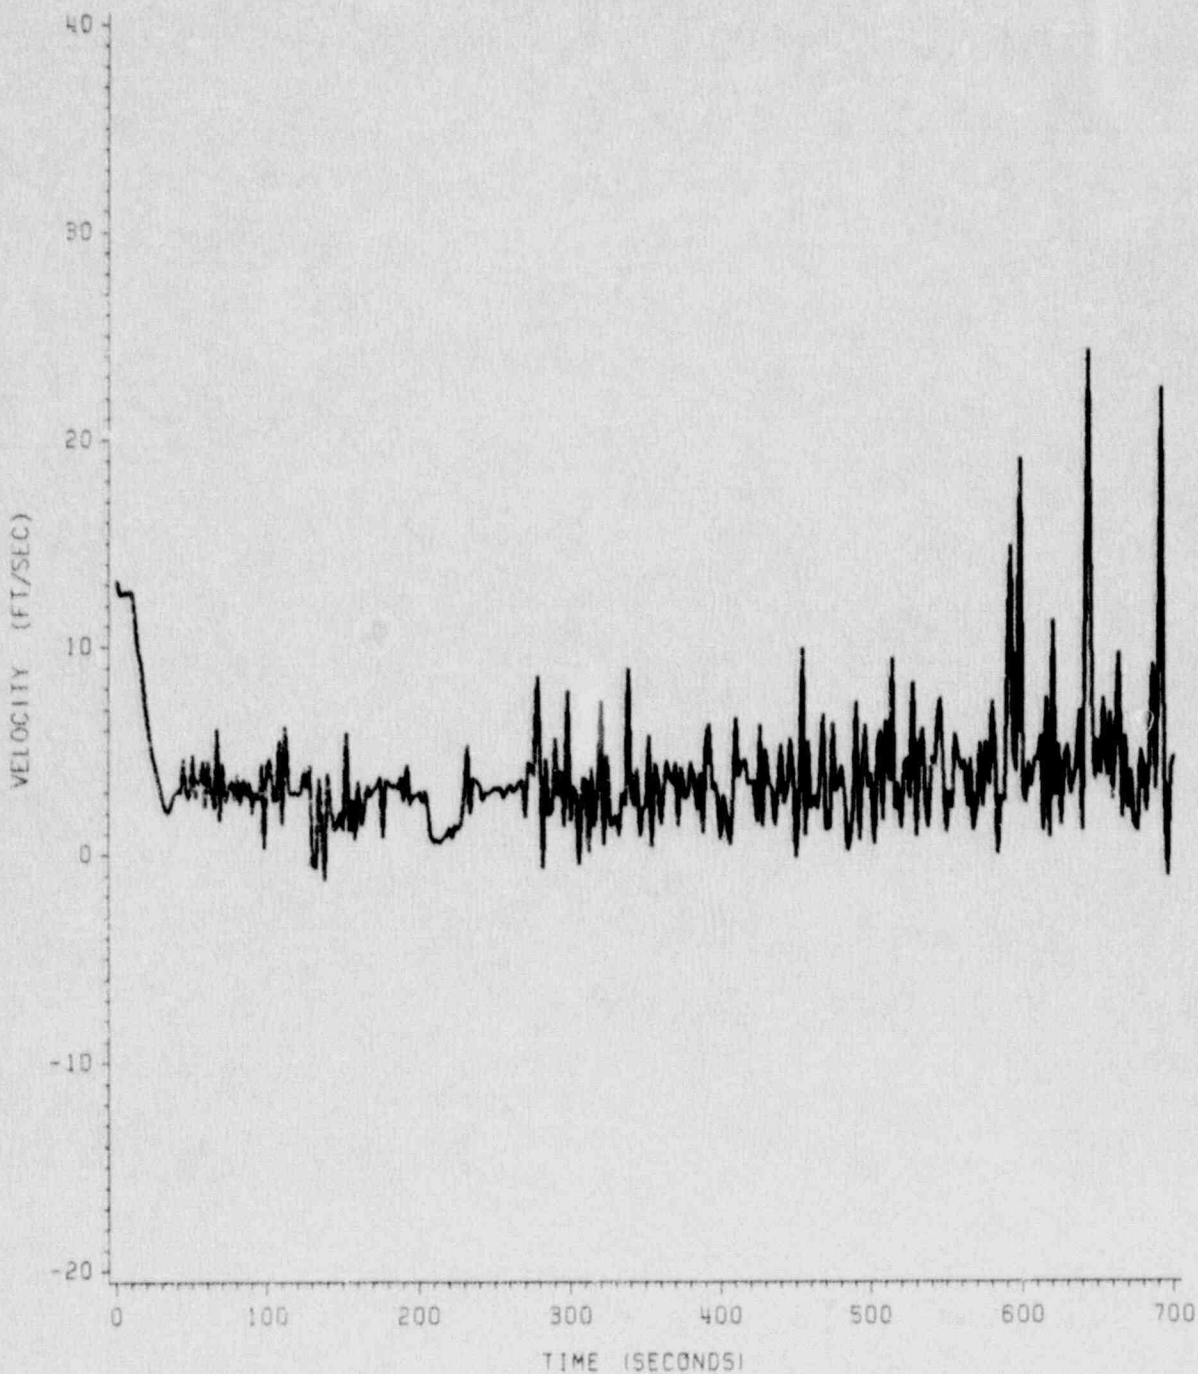
FIGURE 7-5

HADDAM NECK PLANT ZIRCALOY SBLOCA  
0.075 FT<sup>2</sup> DISCHARGE LEG BREAK

HOT SPOT VAPOR VELOCITY  
——— VELGJ 345210000

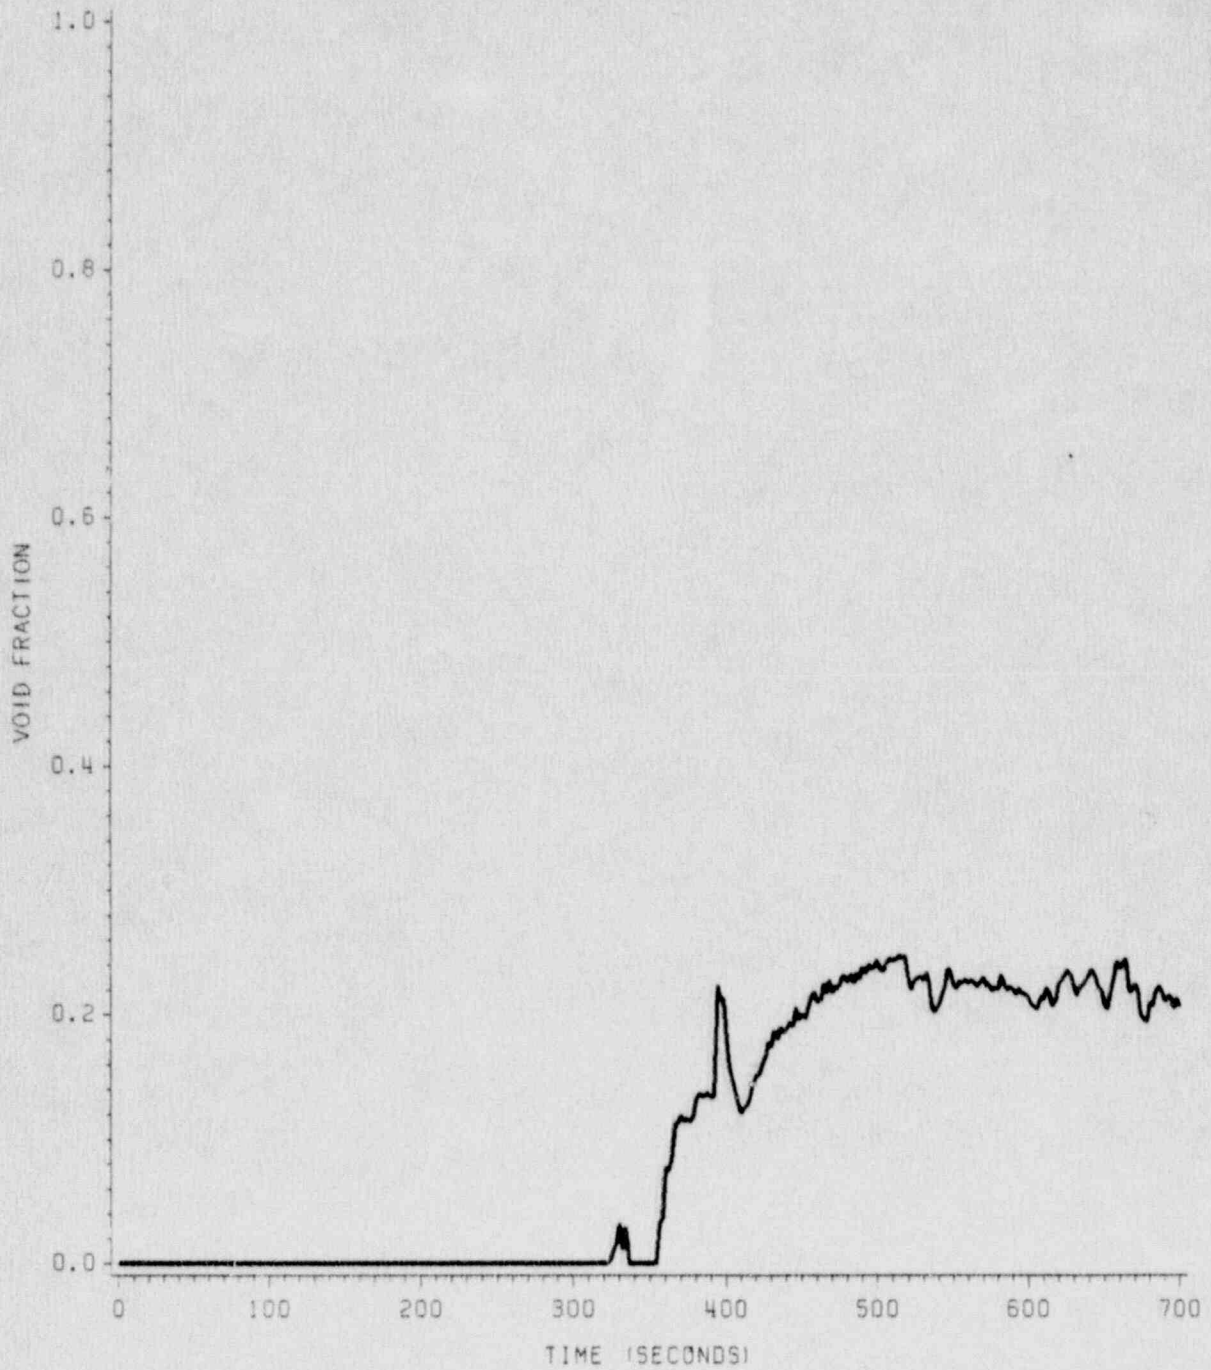
FIGURE 7-6

HADDAM NECK PLANT ZIRCALOY SBLOCA  
0.075 FT<sup>2</sup> DISCHARGE LEG BREAK

VOID FRACTION - VOLUME 33801  
—— VOID 338010000

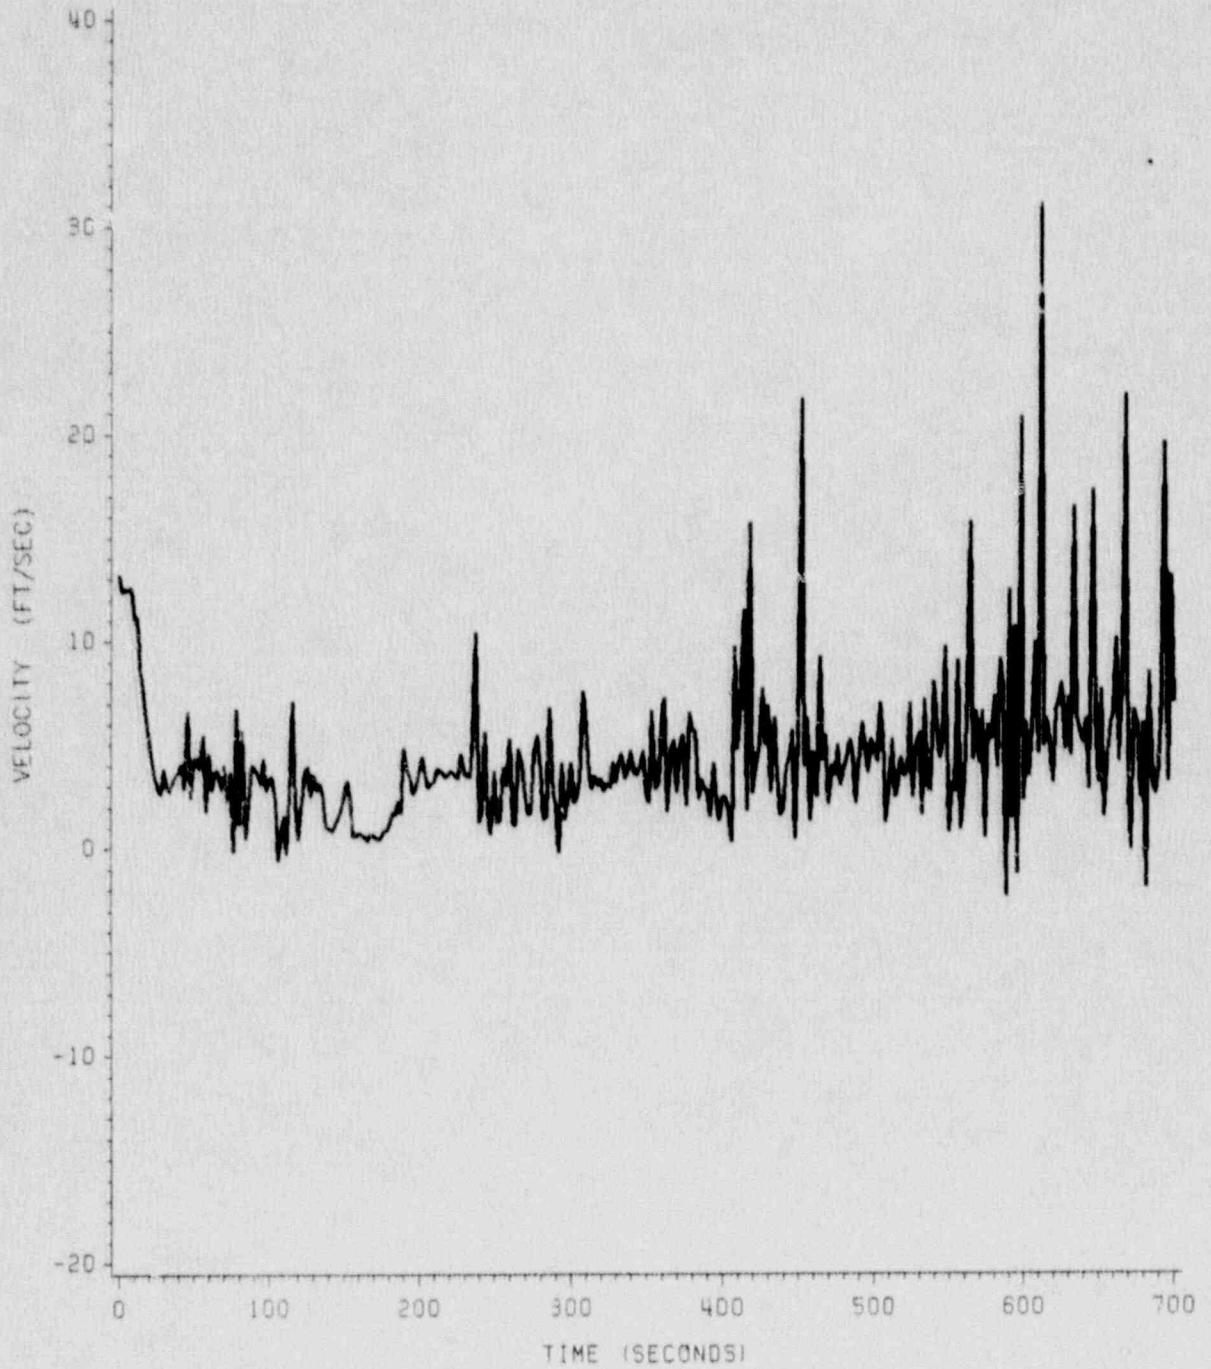
FIGURE 7-7

HADDAM NECK PLANT ZIRCALOY SBLOCA  
0.1 FT<sup>2</sup> DISCHARGE LEG BREAK

NOT SPOT VAPOR VELOCITY  
— VELGJ 343210000

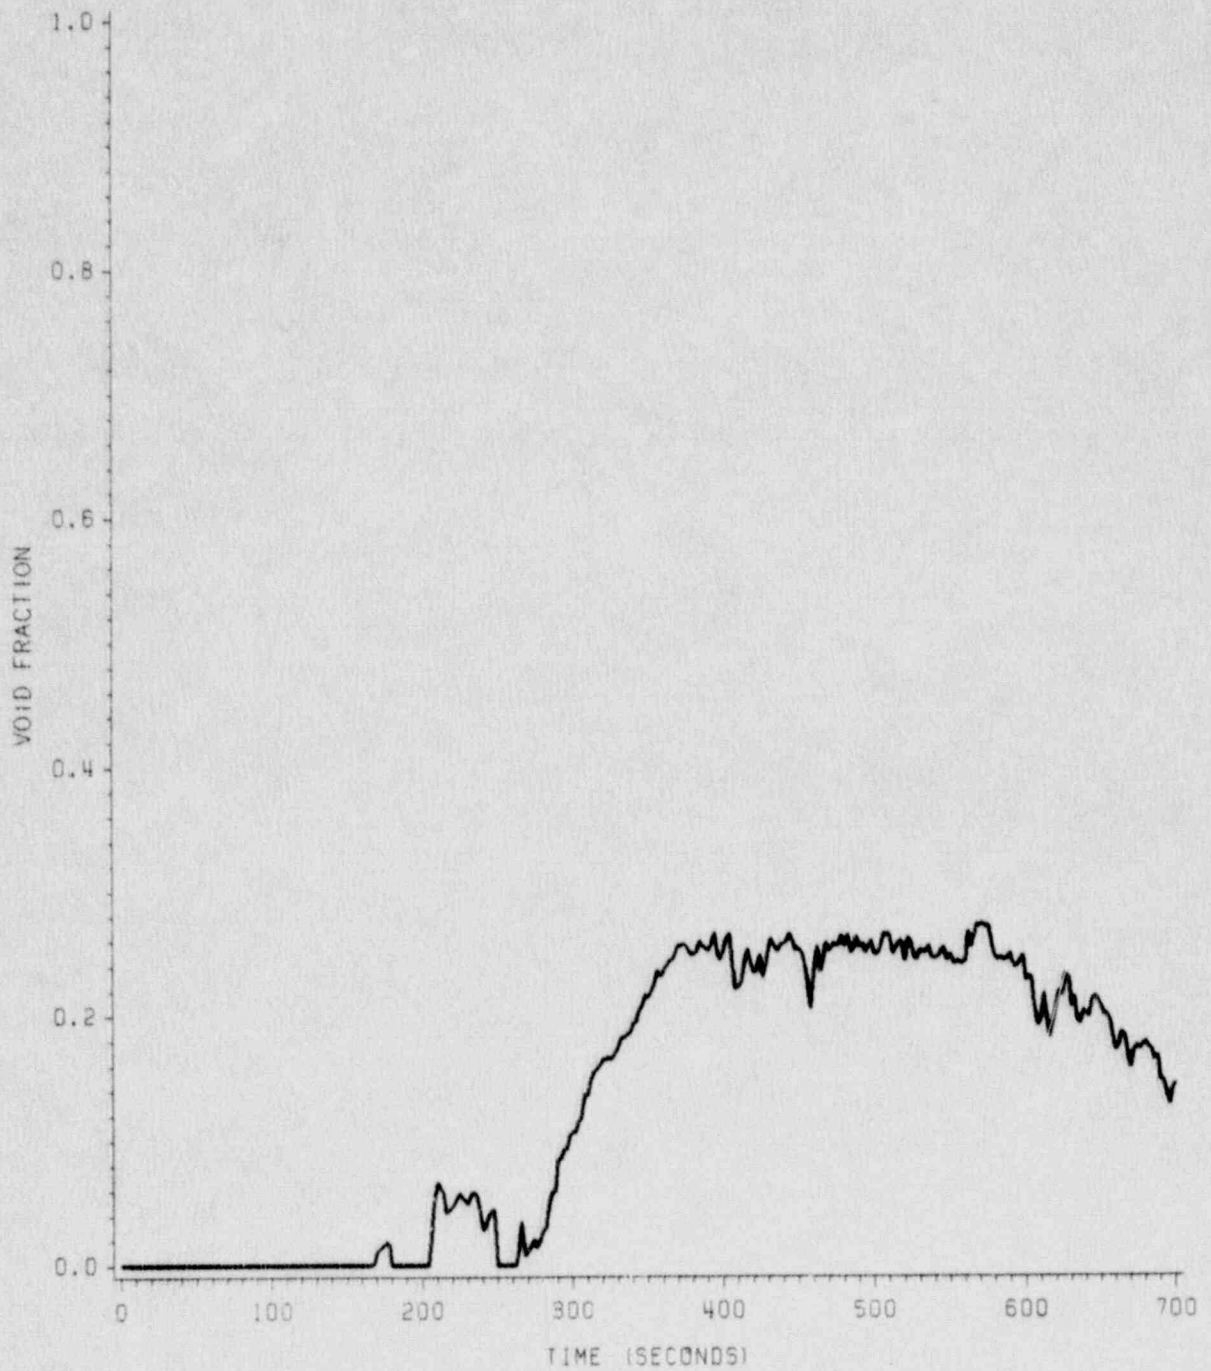
FIGURE 7-8

HADDAM NECK PLANT ZIRCALOY SBLOCA  
0.1 FT<sup>2</sup> DISCHARGE LEG BREAK

VOID FRACTION - VOLUME 33801  
—— VOIDG 338010000

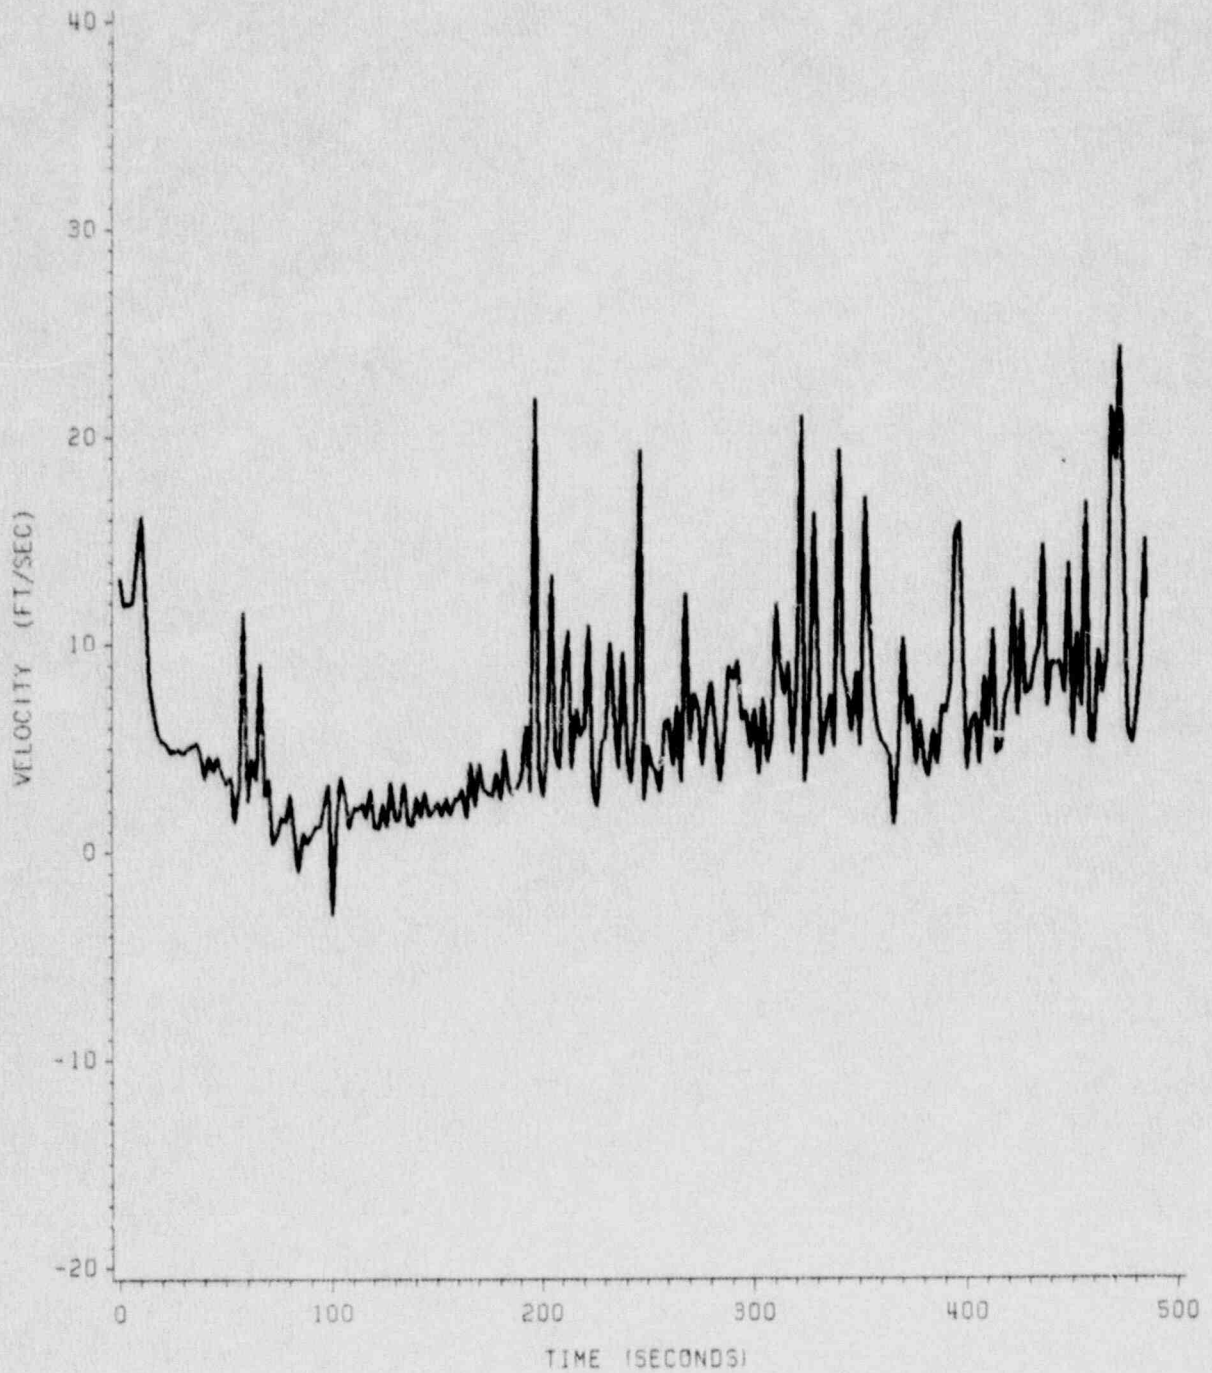
FIGURE 7-9

HADDAM NECK PLANT ZIRCALOY SBLOCA  
0.2 FT<sup>2</sup> DISCHARGE LEG BREAK

HOT SPOT VAPOR VELOCITY  
— VELD J 343210000

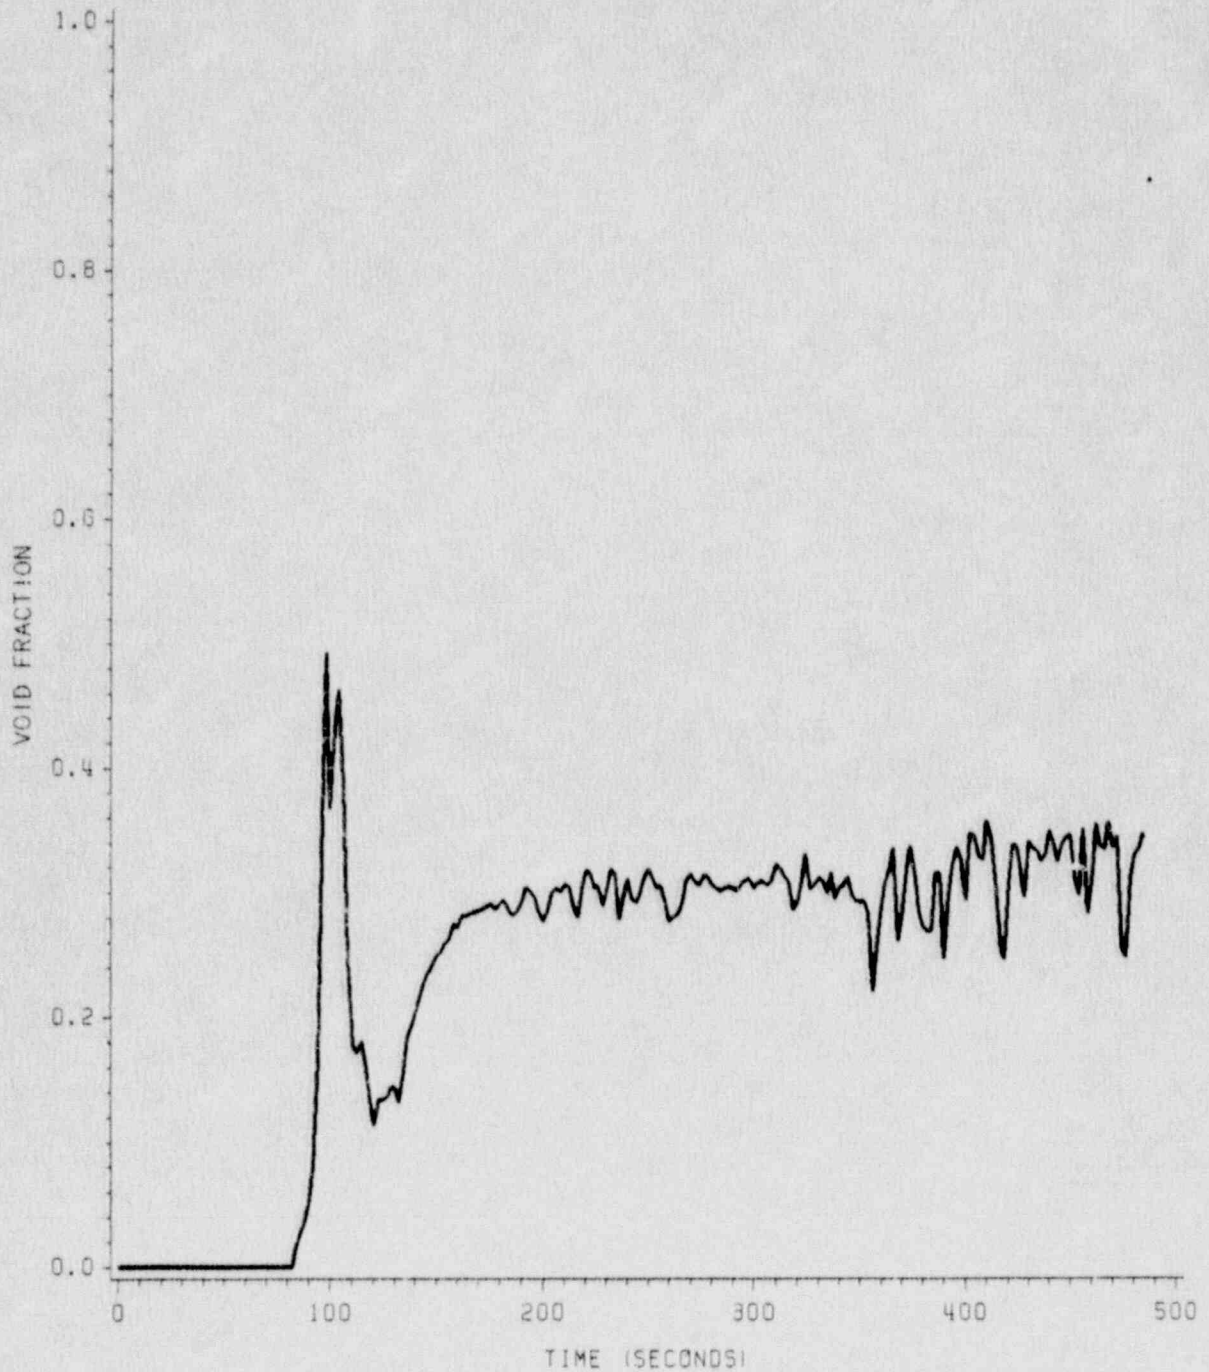
FIGURE 7-10

HADDAM NECK PLANT ZIRCALOY SBLOCA  
0.2 FT2 DISCHARGE LEG BREAK

VOID FRACTION - VOLUME 33801  
—— VOIDG 338010000

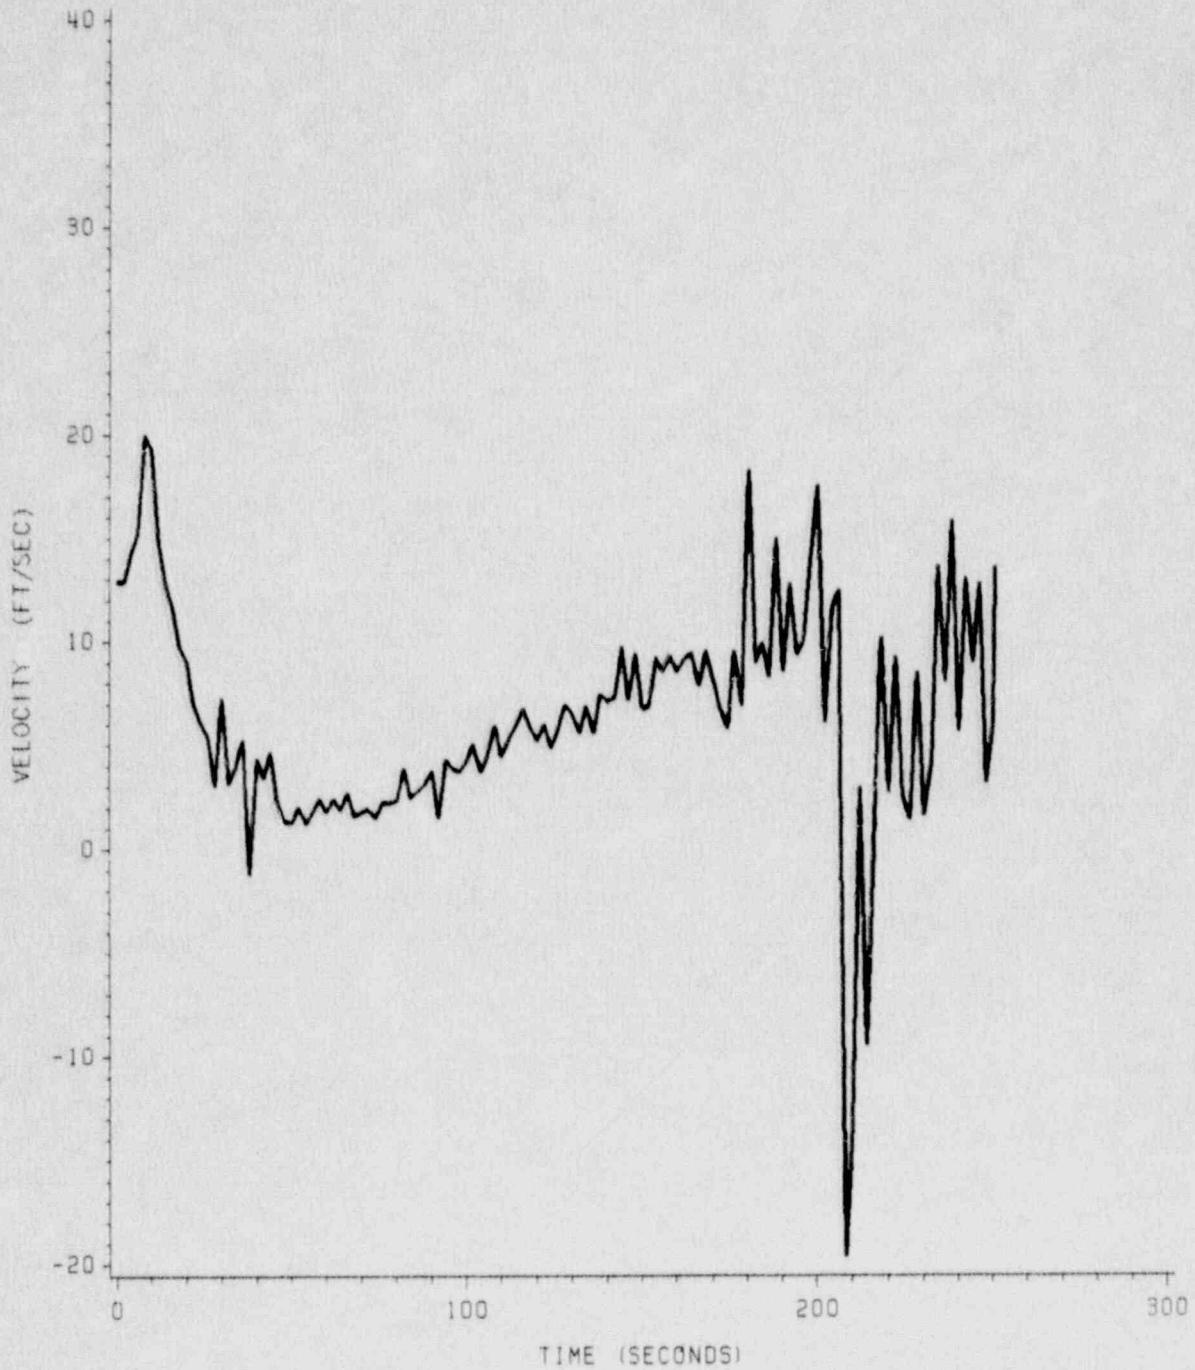
FIGURE 7-11

HADDAM NECK PLANT ZIRCALOY SBLOCA  
0.4 FT<sup>2</sup> DISCHARGE LEG BREAK

HOT SPOT VAPOR VELOCITY  
— VEL6J 345200000

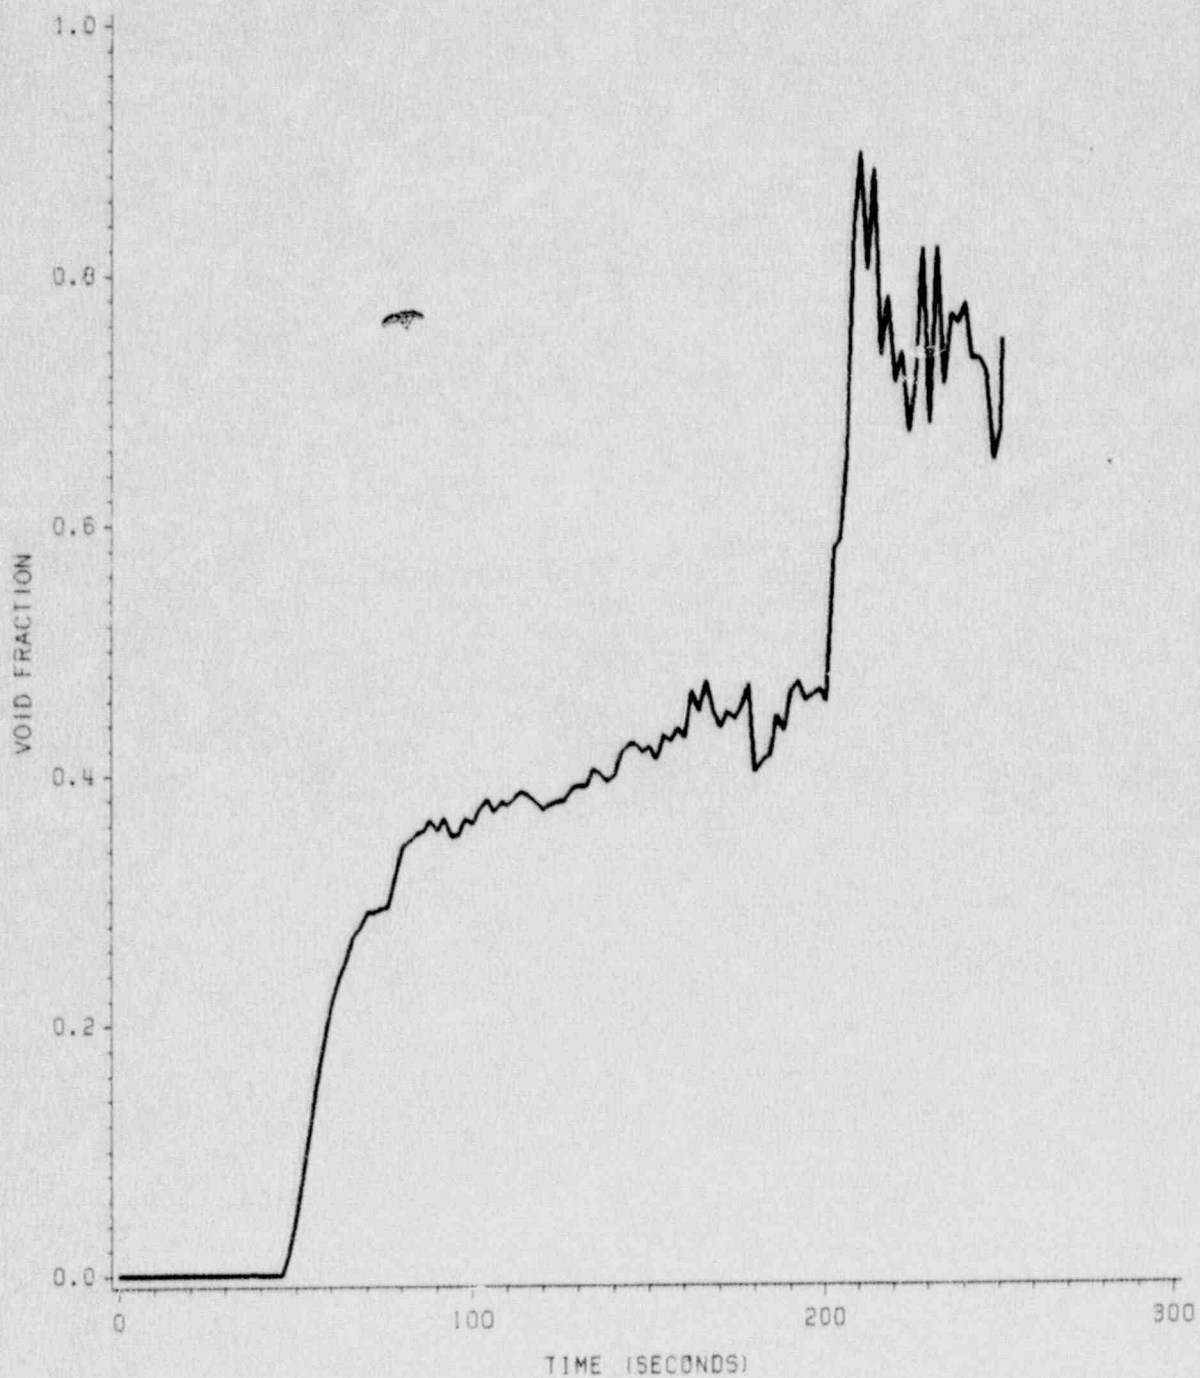
FIGURE 7-12

HADDAM NECK PLANT ZIRCALOY SBLOCA  
0.4 FT<sup>2</sup> DISCHARGE LEG BREAK

VOID FRACTION - VOLUME 33801  
—— VOIDG 338010000

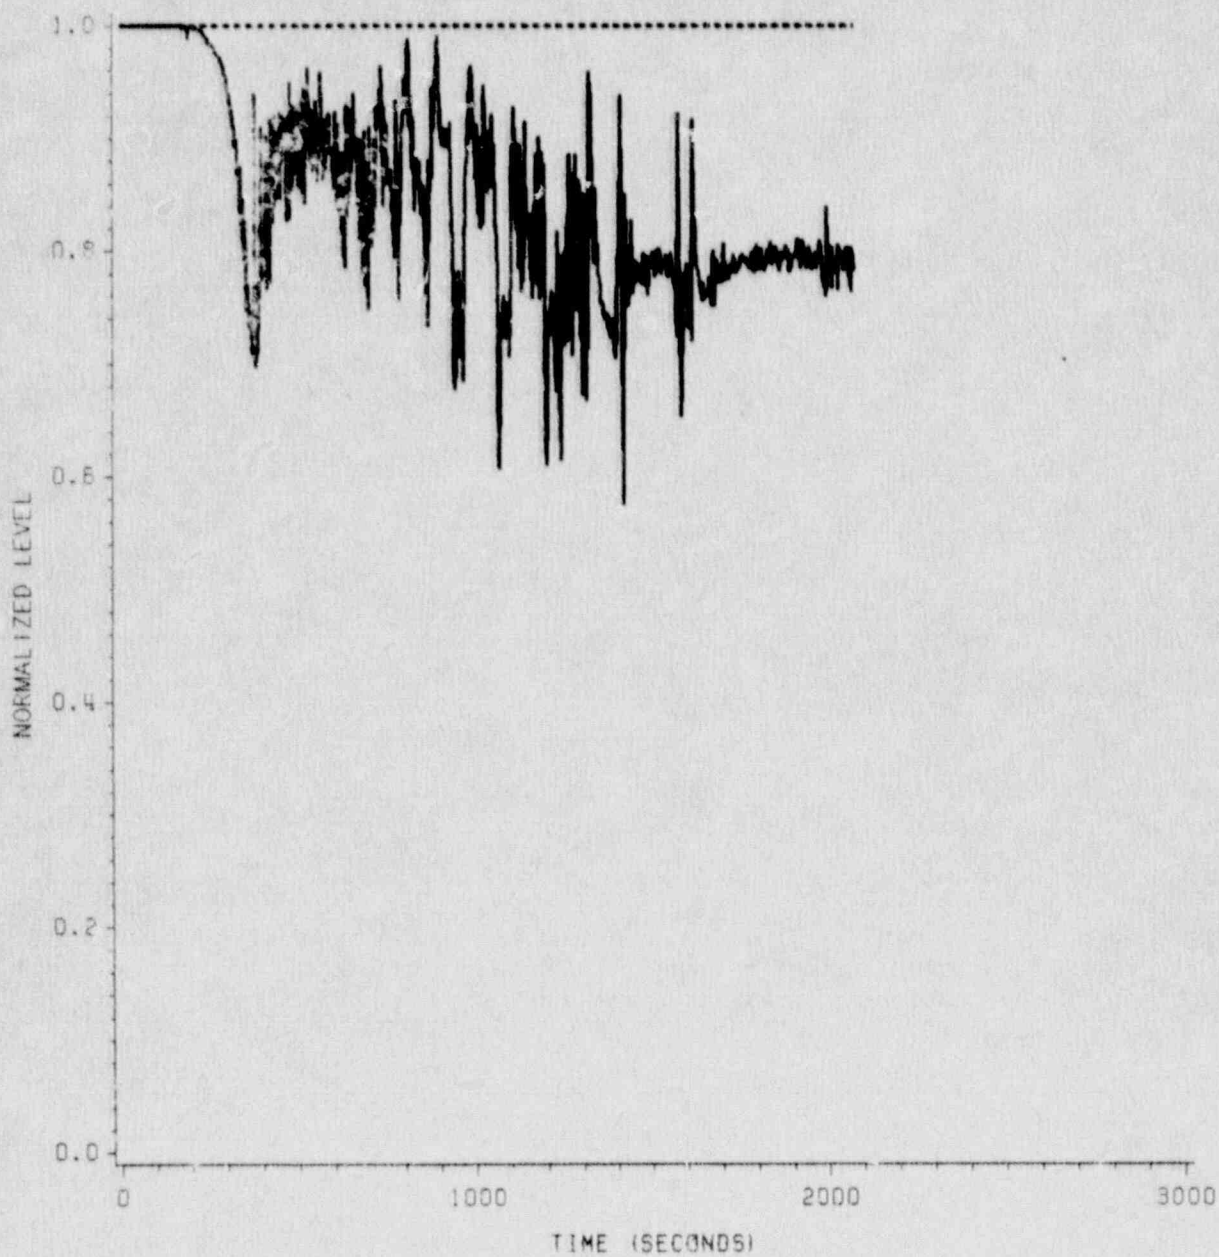
FIGURE 8-1

HADDAM NECK PLANT ZIRCALOY SBLOCA  
0.01 FT<sup>2</sup> DISCHARGE LEG BREAK  
COLLAPSED AND TWO-PHASE WATER LEVEL  
IN 36 CENTER ASSEMBLIES  
NORMALIZED TO ACTIVE CORE LENGTH  
——— CTRLVAR 041  
----- TWO PHASE LEVEL

The inconsistency in the relation between the two-phase level and collapsed level is due to an error in plotting the two-phase level. The two-phase level plots shown on Figures A.15 through F.15 are actually the two-phase levels for the 121 outer assemblies core channel. The collapsed levels are correctly plotted. Figures 8-1 through 8-6 provide the correct curves for collapsed and two-phase level for the 36 center assemblies. It is easily seen that the correlation between two levels is improved.
