Re: Zircaloy Clad  
Conversion  
ISAP Topic 2.17

Haddam Neck Plant  
Additional Information  
Small-Break Loss of Coolant Accident Analysis--  
Zircaloy Clad Fuel

Attachment  
Haddam Neck Plant  
Additional Information

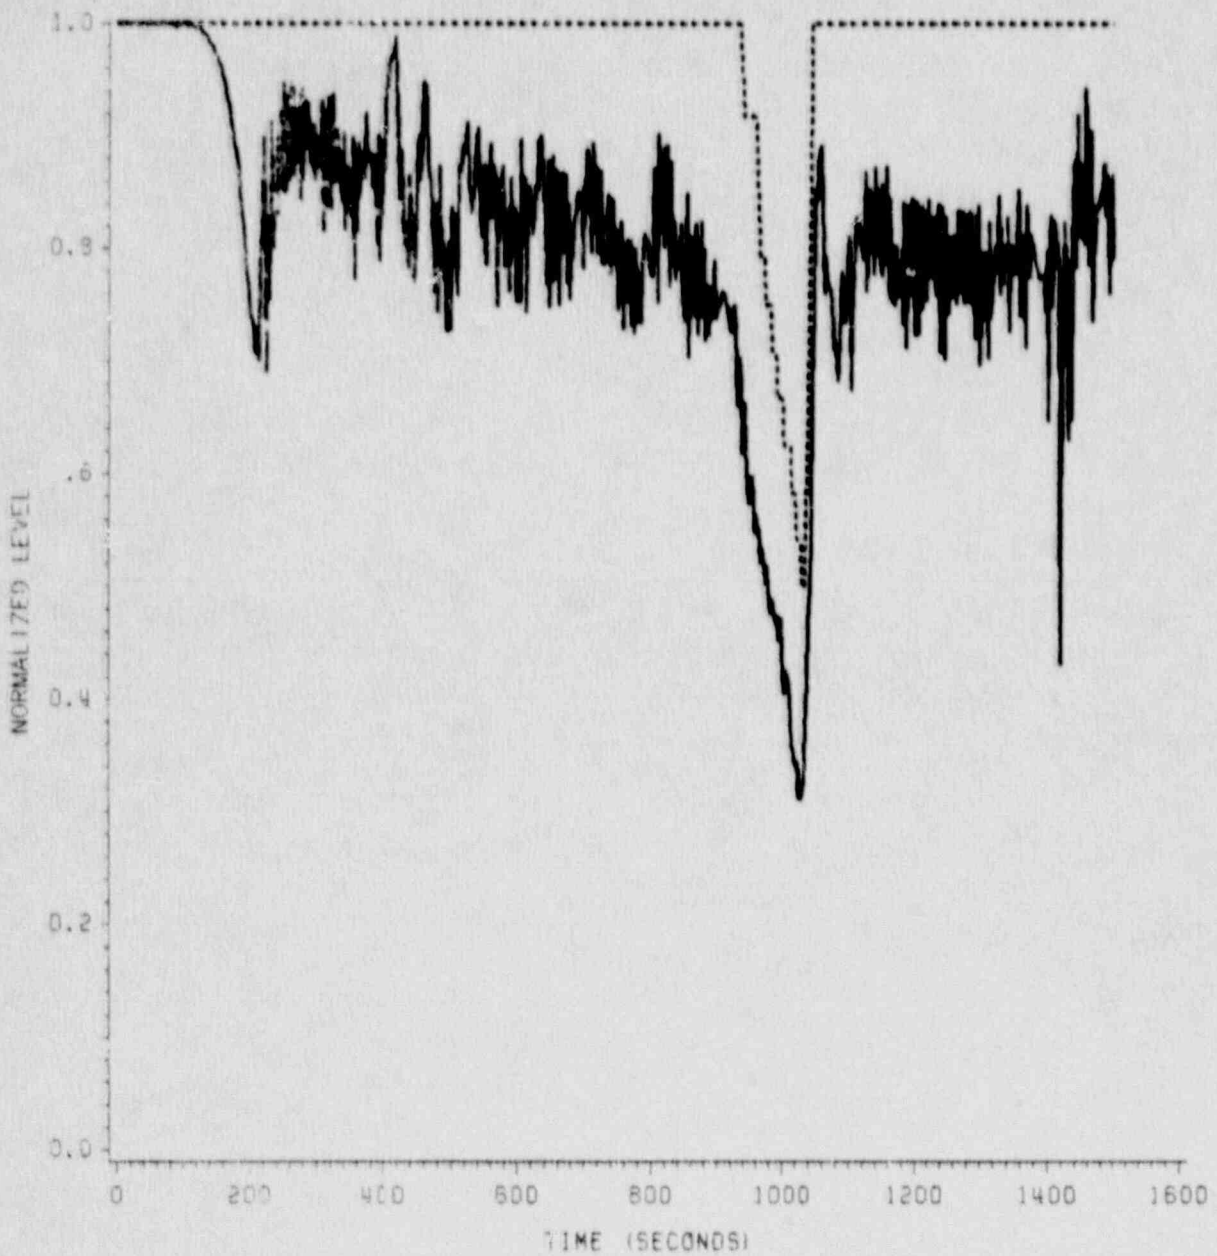
FIGURE 8-2

HADDAM NECK PLANT ZIRCALOY SBLOCA  
0.02 T2 DISCHARGE LEG BREAK  
COLLAPSED AND TWO-PHASE WATER LEVEL  
IN 36 CENTER ASSEMBLIES  
NORMALIZED TO ACTIVE CORE LENGTH  
——— CNTRLVAR 041  
- - - - TWO PHASE LEVEL

The inconsistency in the relation between the two-phase level and collapsed level is due to an error in plotting the two-phase level. The two-phase level plots shown on Figures A.15 through F.15 are actually the two-phase levels for the 121 outer assemblies core channel. The collapsed levels are correctly plotted. Figures 8-1 through 8-6 provide the correct curves for collapsed and two-phase level for the 36 center assemblies. It is easily seen that the correlation between two levels is improved.

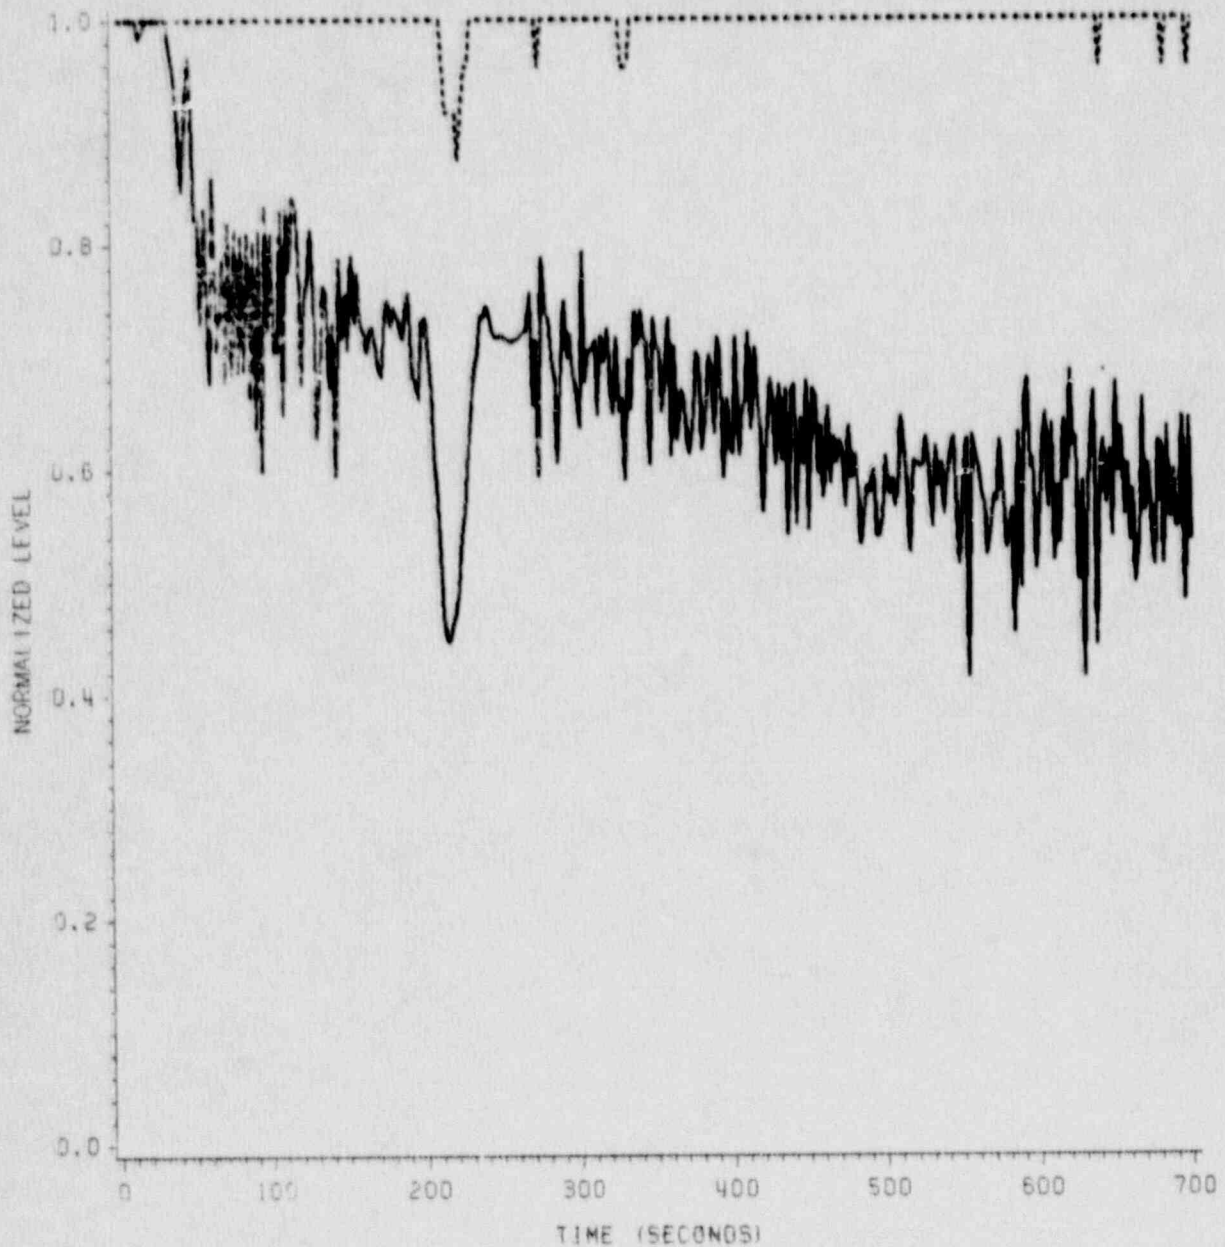
FIGURE 8-3

HADDAM NECK PLANT ZIRCALOY SBLOCA  
0.075 FT<sup>2</sup> DISCHARGE LEG BREAK  
COLLAPSED AND TWO-PHASE WATER LEVEL  
IN 36 CENTER ASSEMBLIES  
NORMALIZED TO ACTIVE CORE LENGTH  
——— CNTRLVAR 041  
- - - TWO PHASE LEVEL

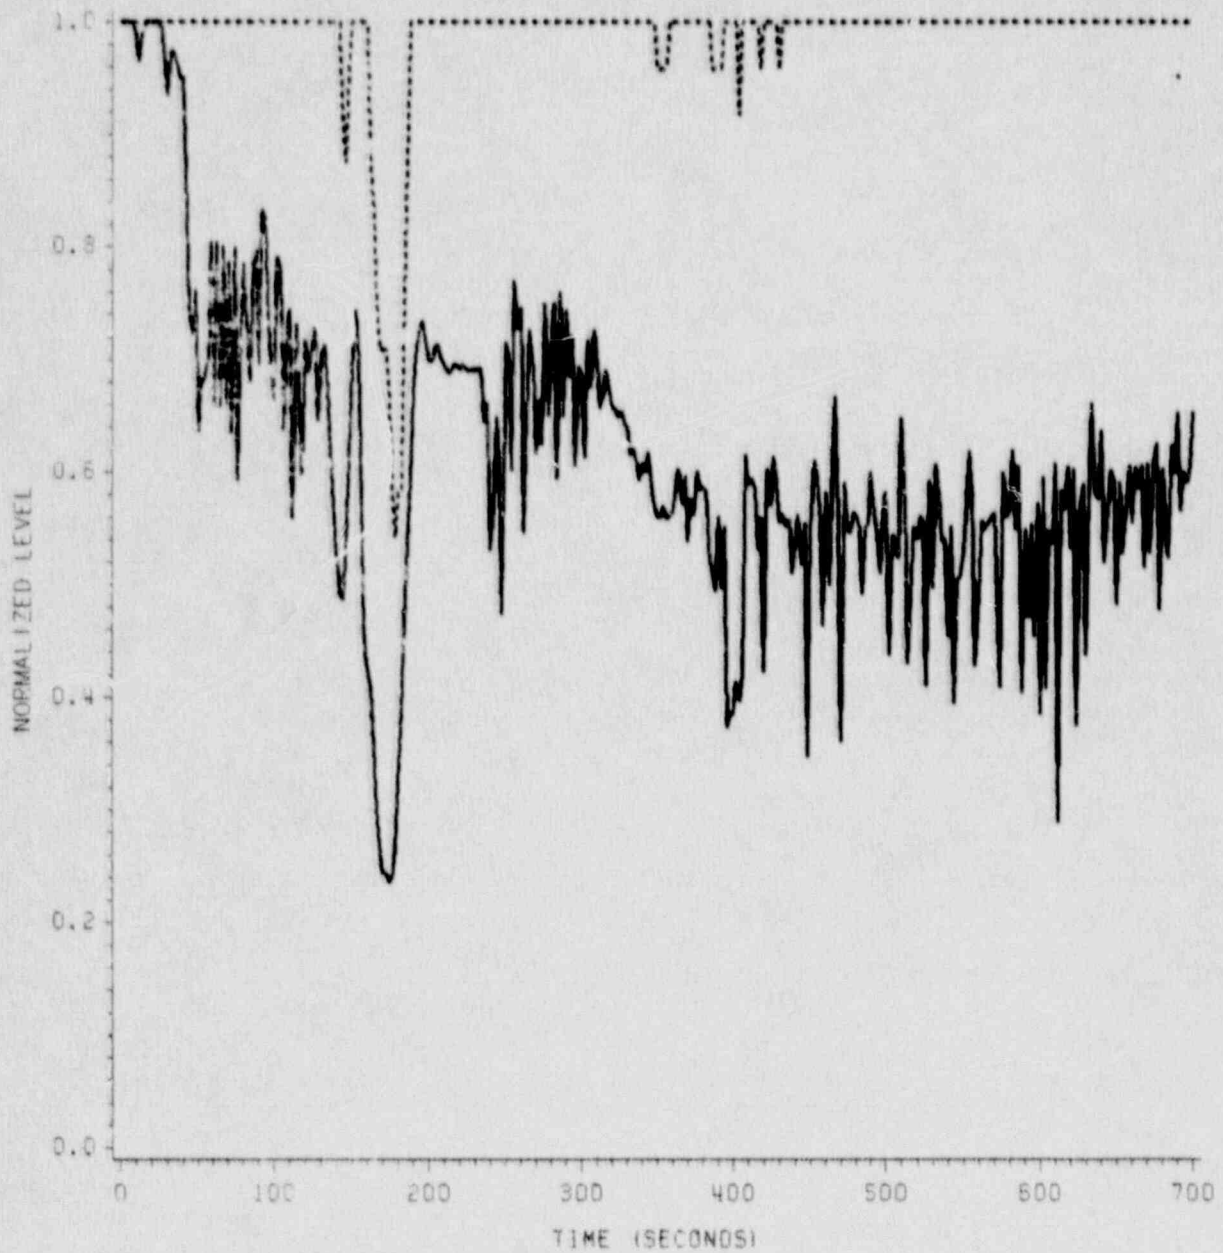
FIGURE 8-4

HADDAM NECK PLANT ZIRCALOY SBLOCA  
0.1 FT<sup>2</sup> DISCHARGE LEG BREAK  
COLLAPSED AND TWO-PHASE WATER LEVEL  
IN 36 CENTER ASSEMBLIES  
NORMALIZED TO ACTIVE CORE LENGTH  
——— CNTRLVAR 041  
----- TWO PHASE LEVEL

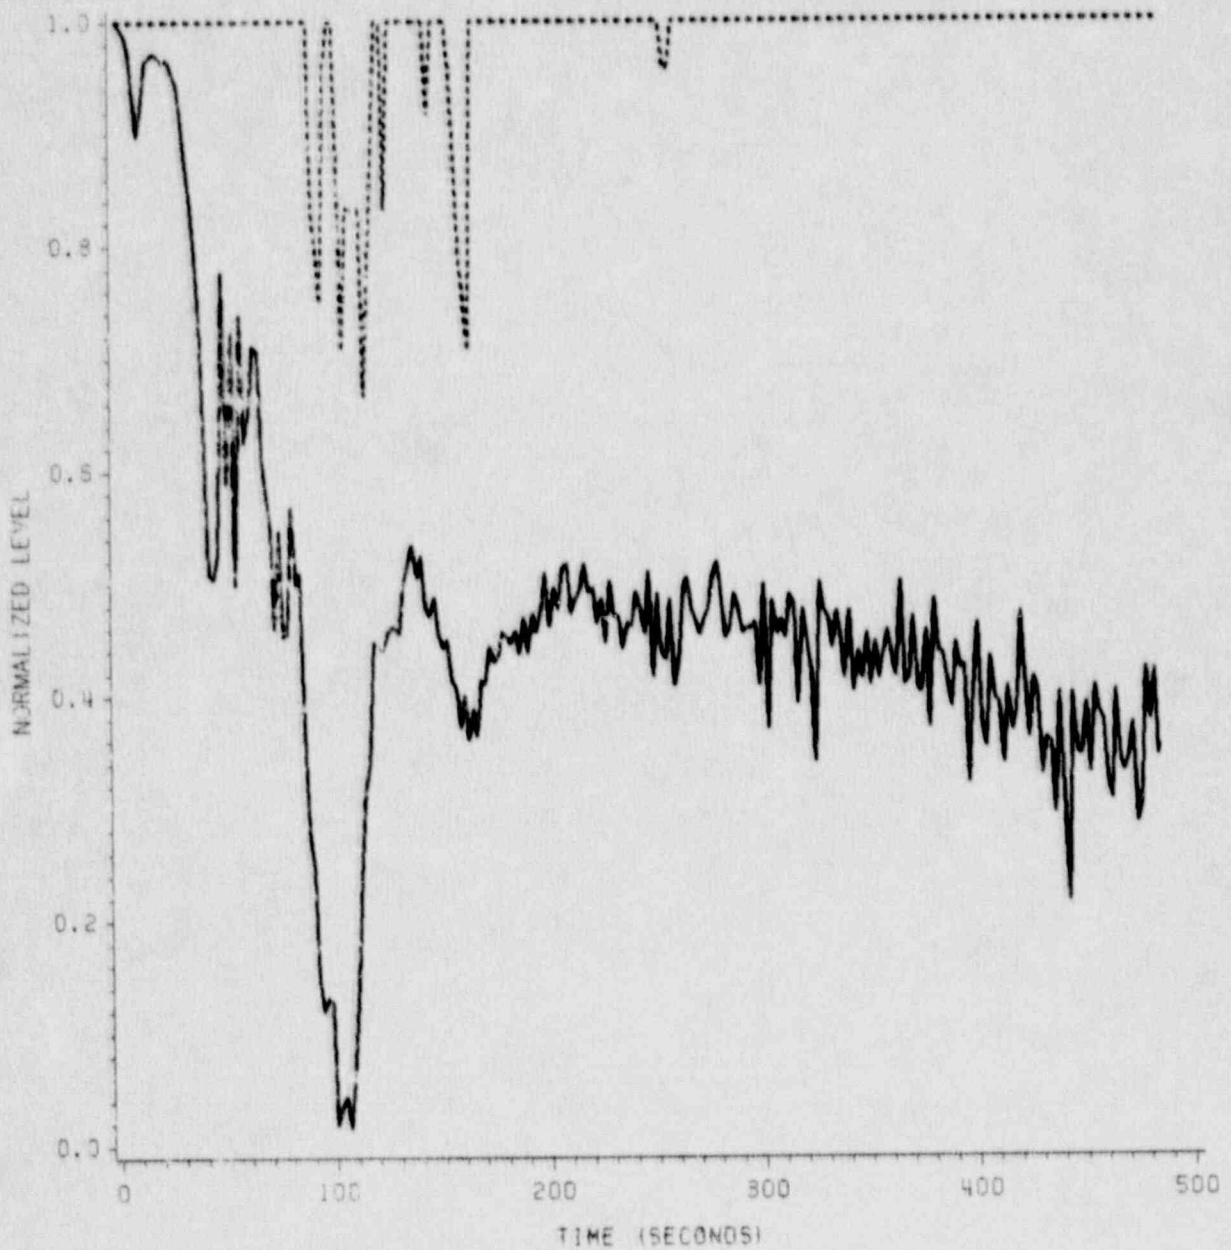
FIGURE 8-5

HADDAM NECK PLANT ZIRCALOY SBLOCA  
0.2 FT<sup>2</sup> DISCHARGE LEG BREAK  
COLLAPSED AND TWO-PHASE WATER LEVEL  
IN 36 CENTER ASSEMBLIES  
NORMALIZED TO ACTIVE CORE LENGTH  
——— CNTRLVAR 041  
- - - - TWO PHASE LEVEL

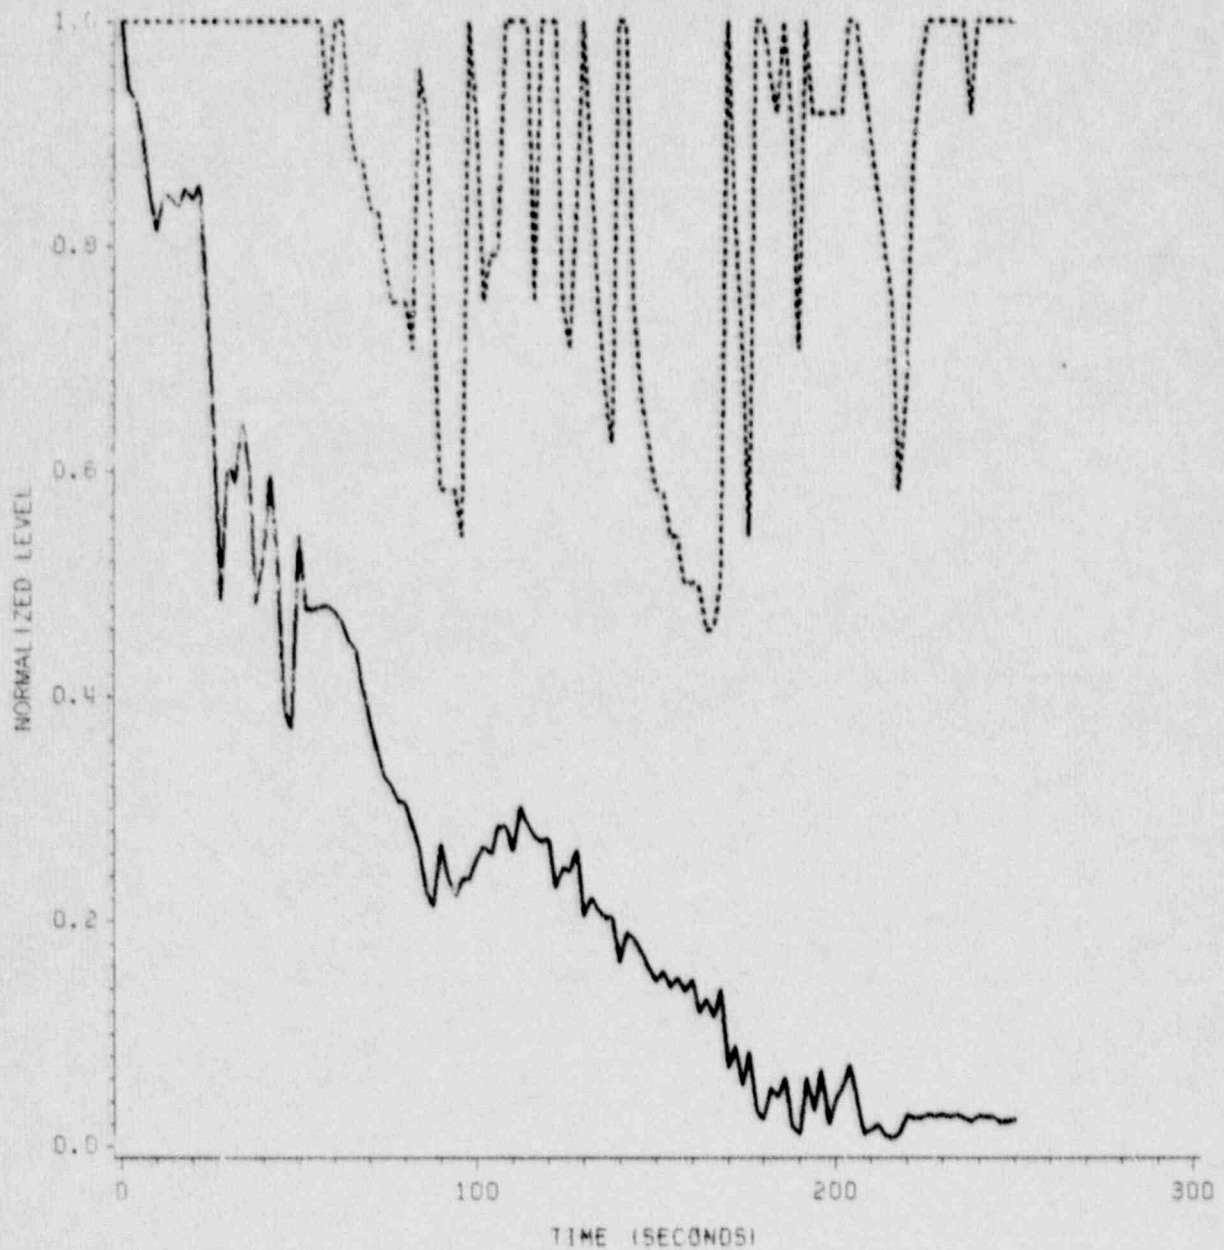
FIGURE 8-6

HADDAM NECK PLANT ZIRCALOY SBLOCA  
0.4 FT<sup>2</sup> DISCHARGE LEG BREAK  
COLLAPSED AND TWO-PHASE WATER LEVEL  
IN 36 CENTER ASSEMBLIES  
NORMALIZED TO ACTIVE CORE LENGTH  
——— CNTRLVAR 041  
- - - TWO PHASE LEVEL

We agree that there appears to be an inconsistency between collapsed and two-phase water level toward the end of the transient for the 0.4 ft<sup>2</sup> break (Figures F.15 and 8-6). This particular break is relatively large and exhibits some of the phenomena associated with medium to large break LOCA's. During the rapid blowdown, there was insufficient time for a well defined two-phase level to develop. Within the NULAP5 Code there is no direct relation between the collapsed and two-phase levels. Both are calculated based on the void fraction distribution in the core channels. As discussed above, the determination of two-phase level is somewhat subjective and can lead to confusing results when applied to highly transient conditions as is the case for the 0.4 ft<sup>2</sup> break. We suspect that for a more stable, quasi-steady conditions that would occur during a long term uncover/recovery period, the consistency between collapsed and two-phase level would be significantly better. Since no long term uncover was predicted due to the large capacity of the ECCS, this effect could not be shown.

It should be noted that for the 0.4 ft<sup>2</sup> break, the data beyond approximately 140 seconds is not representative of the actual plant response since RCS pressure is below 300 ps and LPSI would have injected. LPSI was not modeled for this small break spectrum.

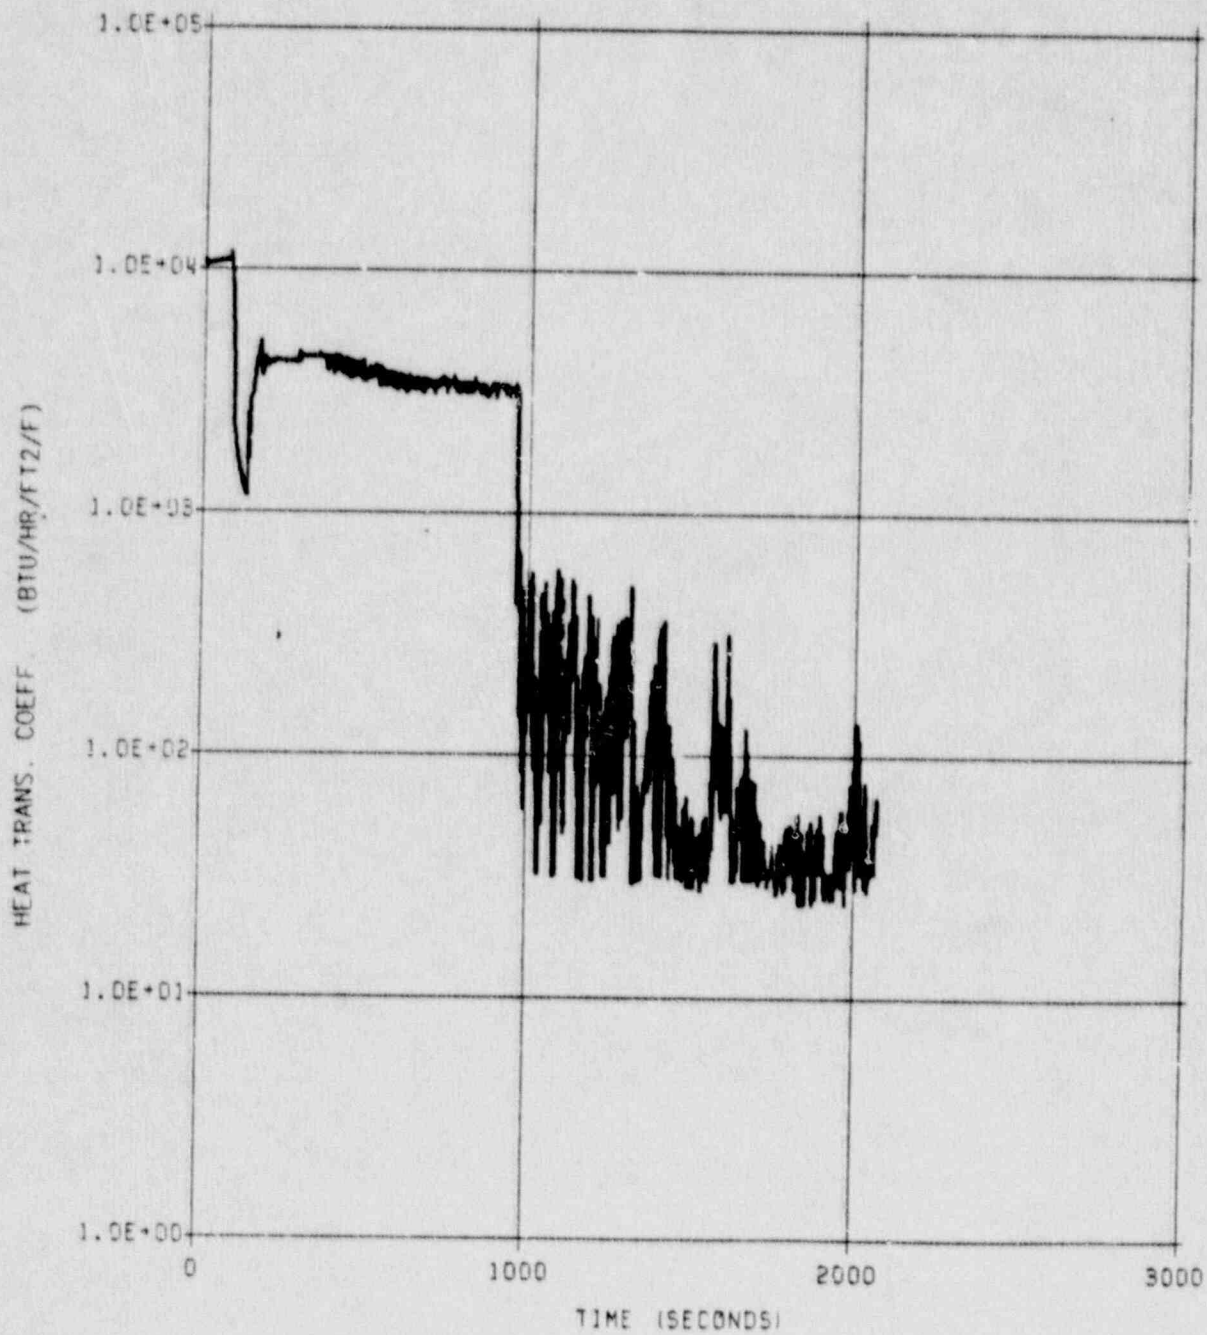
**FIGURE 12-1**  
**HADDAM NECK PLANT ZIRCALOY SBLOCA**  
**0.01 FT2 DISCHARGE LEG BREAK**  
HEAT TRANS. COEFF. - HOT SPOT

Figures 12-1 through 12-6 provide the surface heat transfer coefficient at the hot spot plotted on a log scale for each of the breaks provided in NUSCO 163.

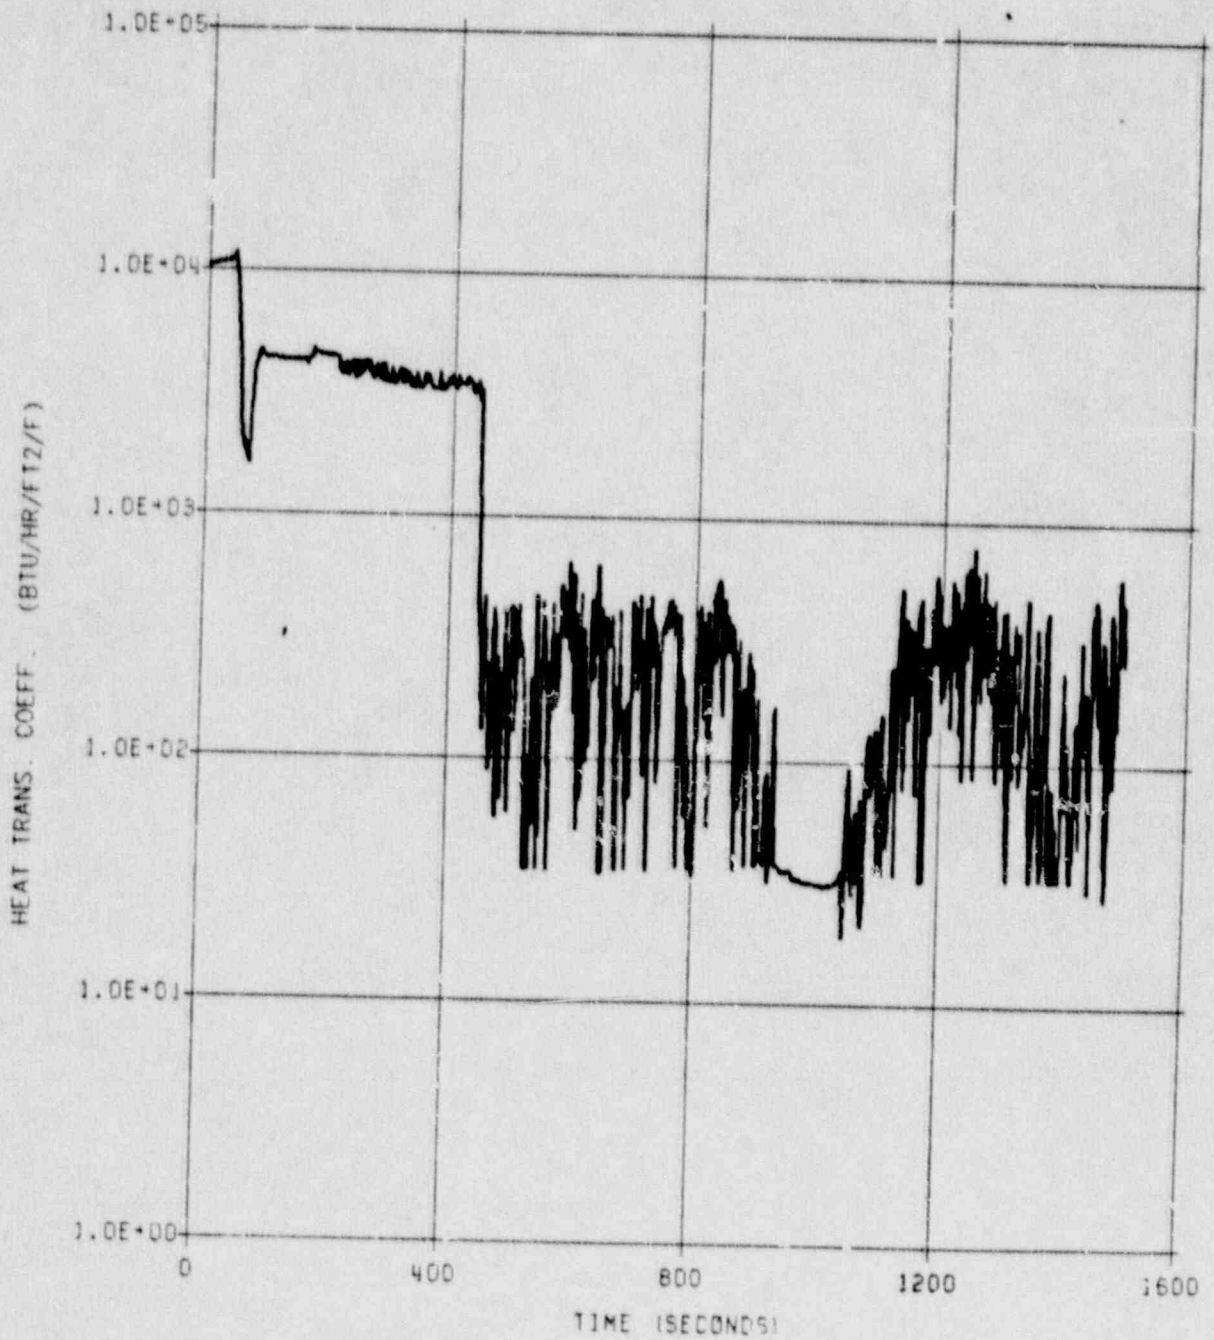
FIGURE 12-2  
HADDAM NECK PLANT ZIRCALOY SBLOCA  
0.02 FT<sup>2</sup> DISCHARGE LEG BREAK  
HEAT TRANS. COEFF. - HOT SPOT

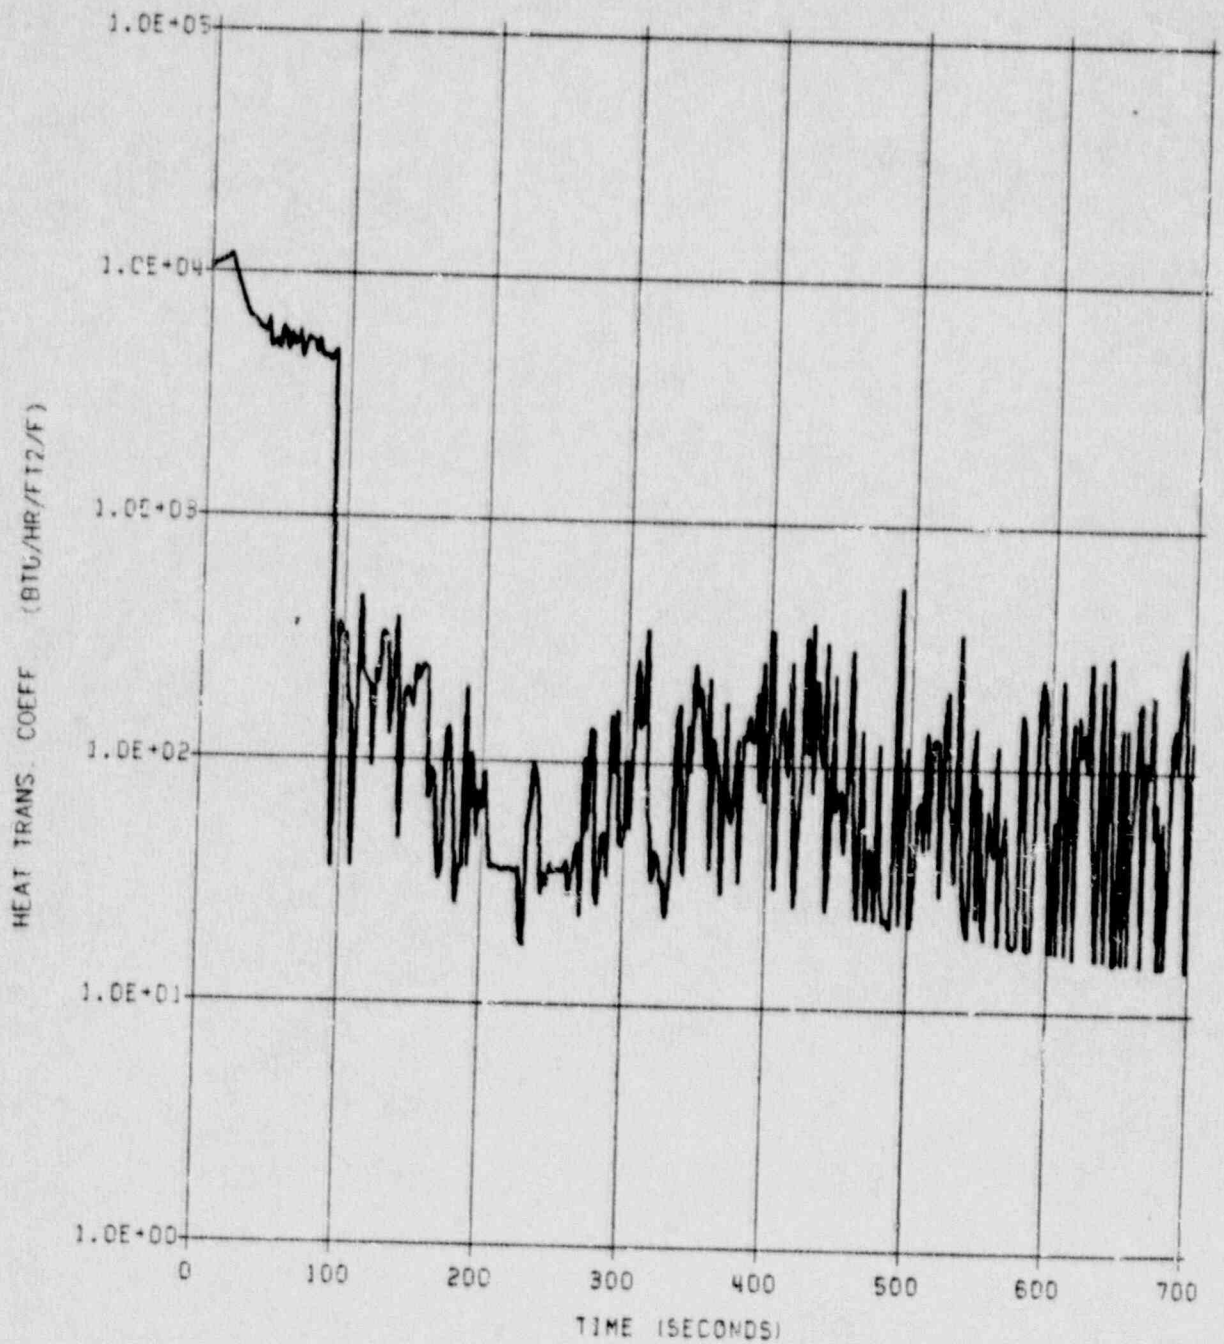
**FIGURE 12-3**  
**HADDAM NECK PLANT ZIRCALOY SBLOCA**  
**0.075 FT<sup>2</sup> DISCHARGE LEG BREAK**  
HEAT TRANS. COEFF. - HOT SPOT

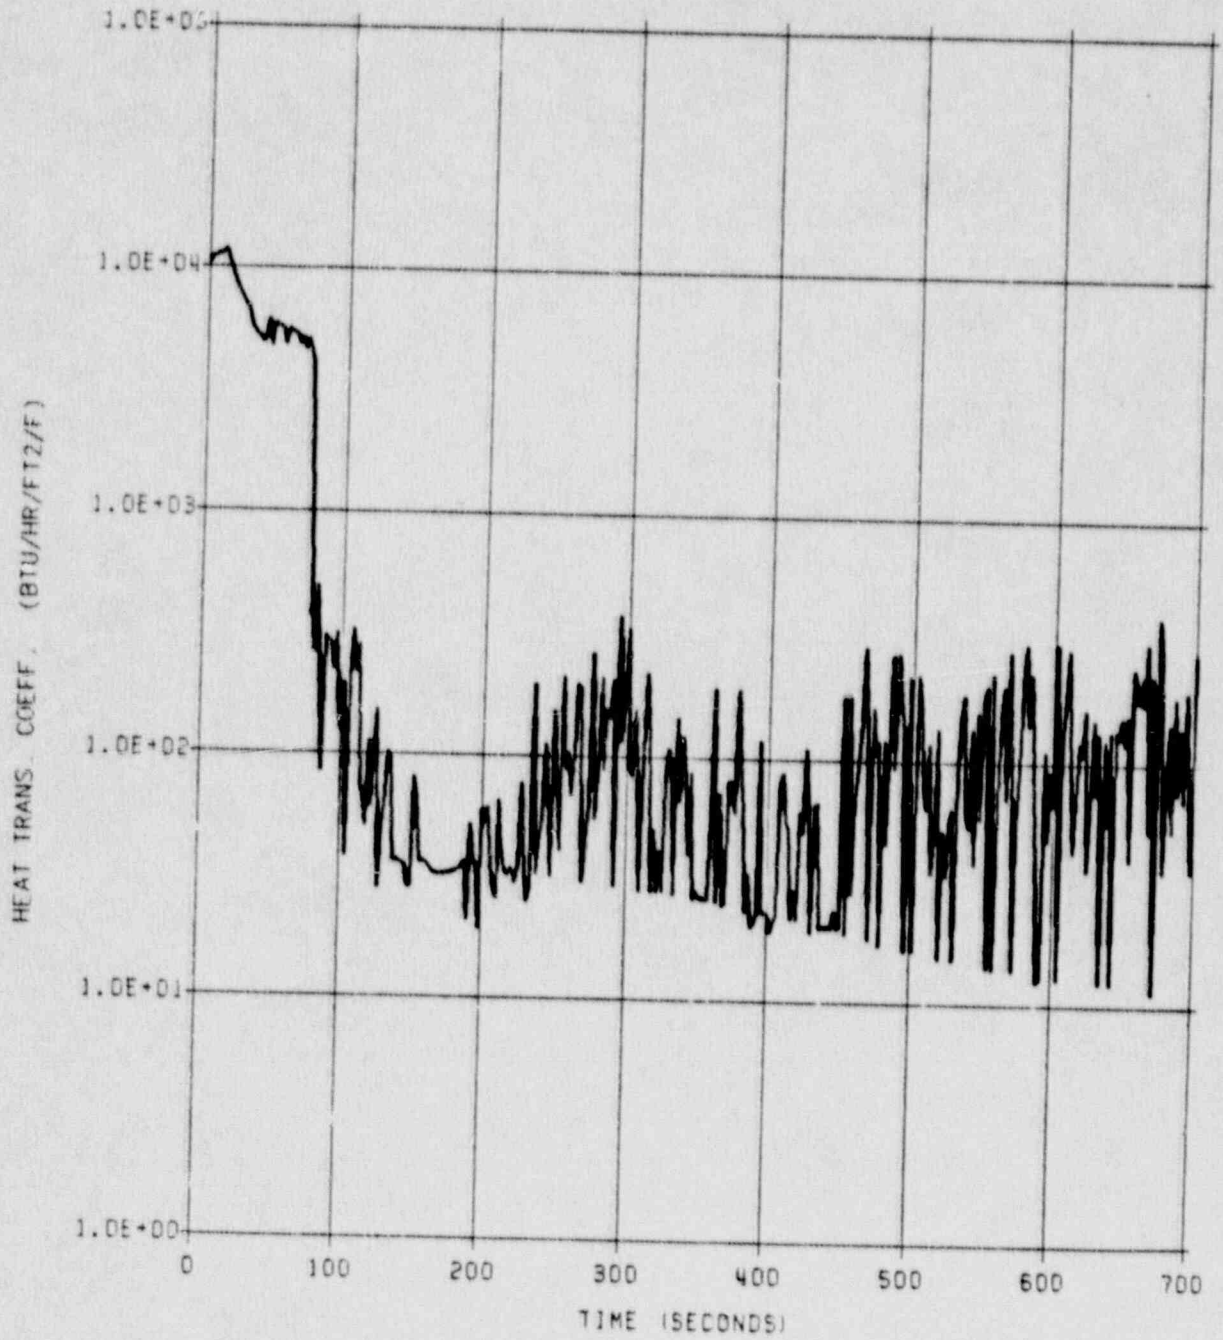
**FIGURE 12-4**  
**HADDAM NECK PLANT ZIRCALOY SBLOCA**  
**0.1 FT2 DISCHARGE LEG BREAK**  
HEAT TRANS. COEFF. - NOT SPOT

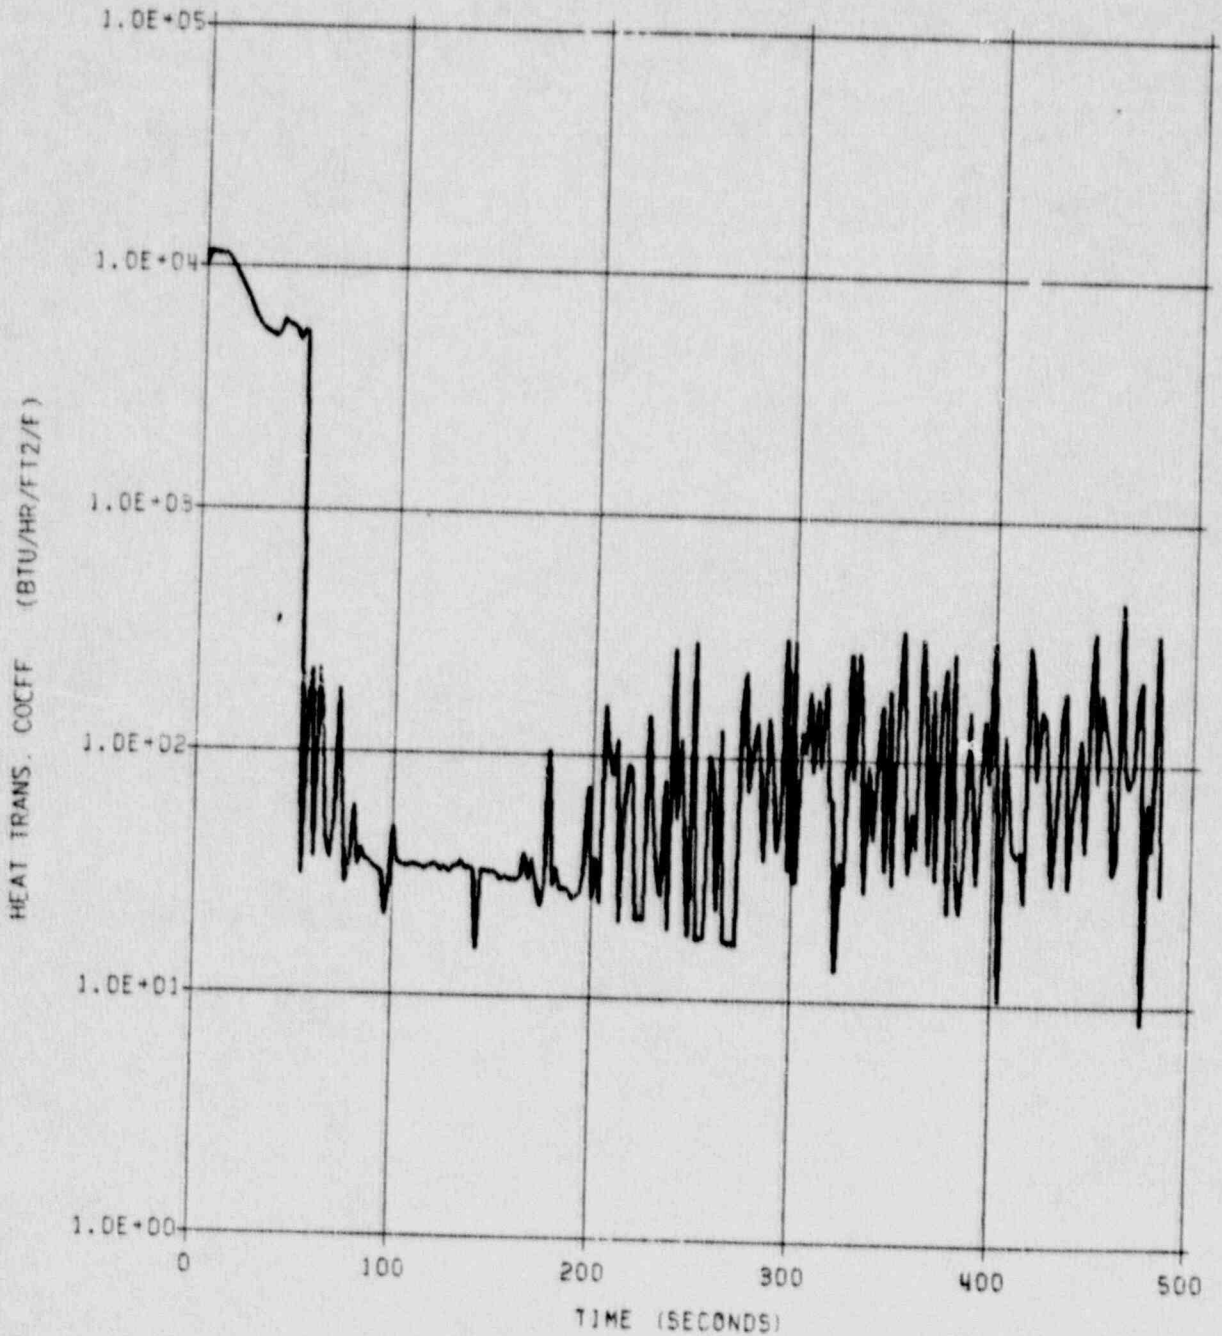
**FIGURE 12-5**  
**HADDAM NECK PLANT ZIRCALOY SBLOCA**  
**0.2 FT2 DISCHARGE LEG BREAK**  
HEAT TRANS. COEFF. - NOT SPOT

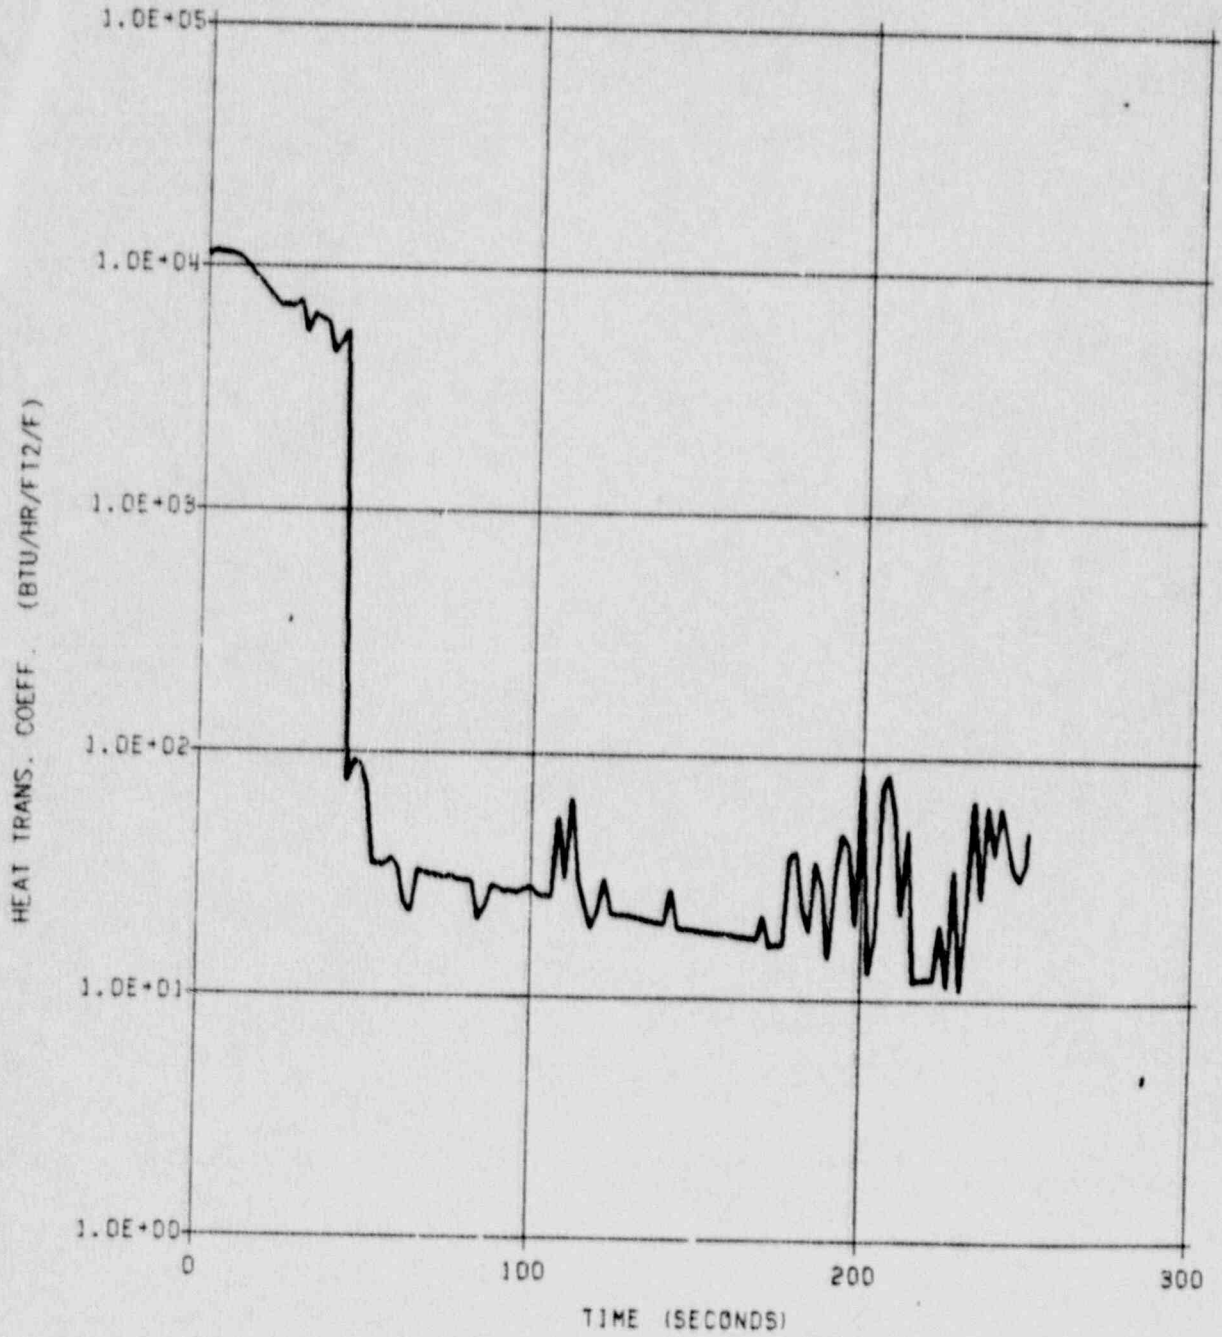
FIGURE 12-6

HADDAM NECK PLANT ZIRCALOY SBLOCA  
0.4 FT<sup>2</sup> DISCHARGE LEG BREAK  
HEAT TRANS. COEFF. - HOT SPOT
