Department of Energy

Subject: U.S. Department of Energy, Office of Legacy Management update to U.S. Nuclear Regulatory Commission Staff on Mexican Hat, Utah, Disposal Site, Radiological Monitoring Summary, Second Quarter 2019 (Docket No. WM-63)

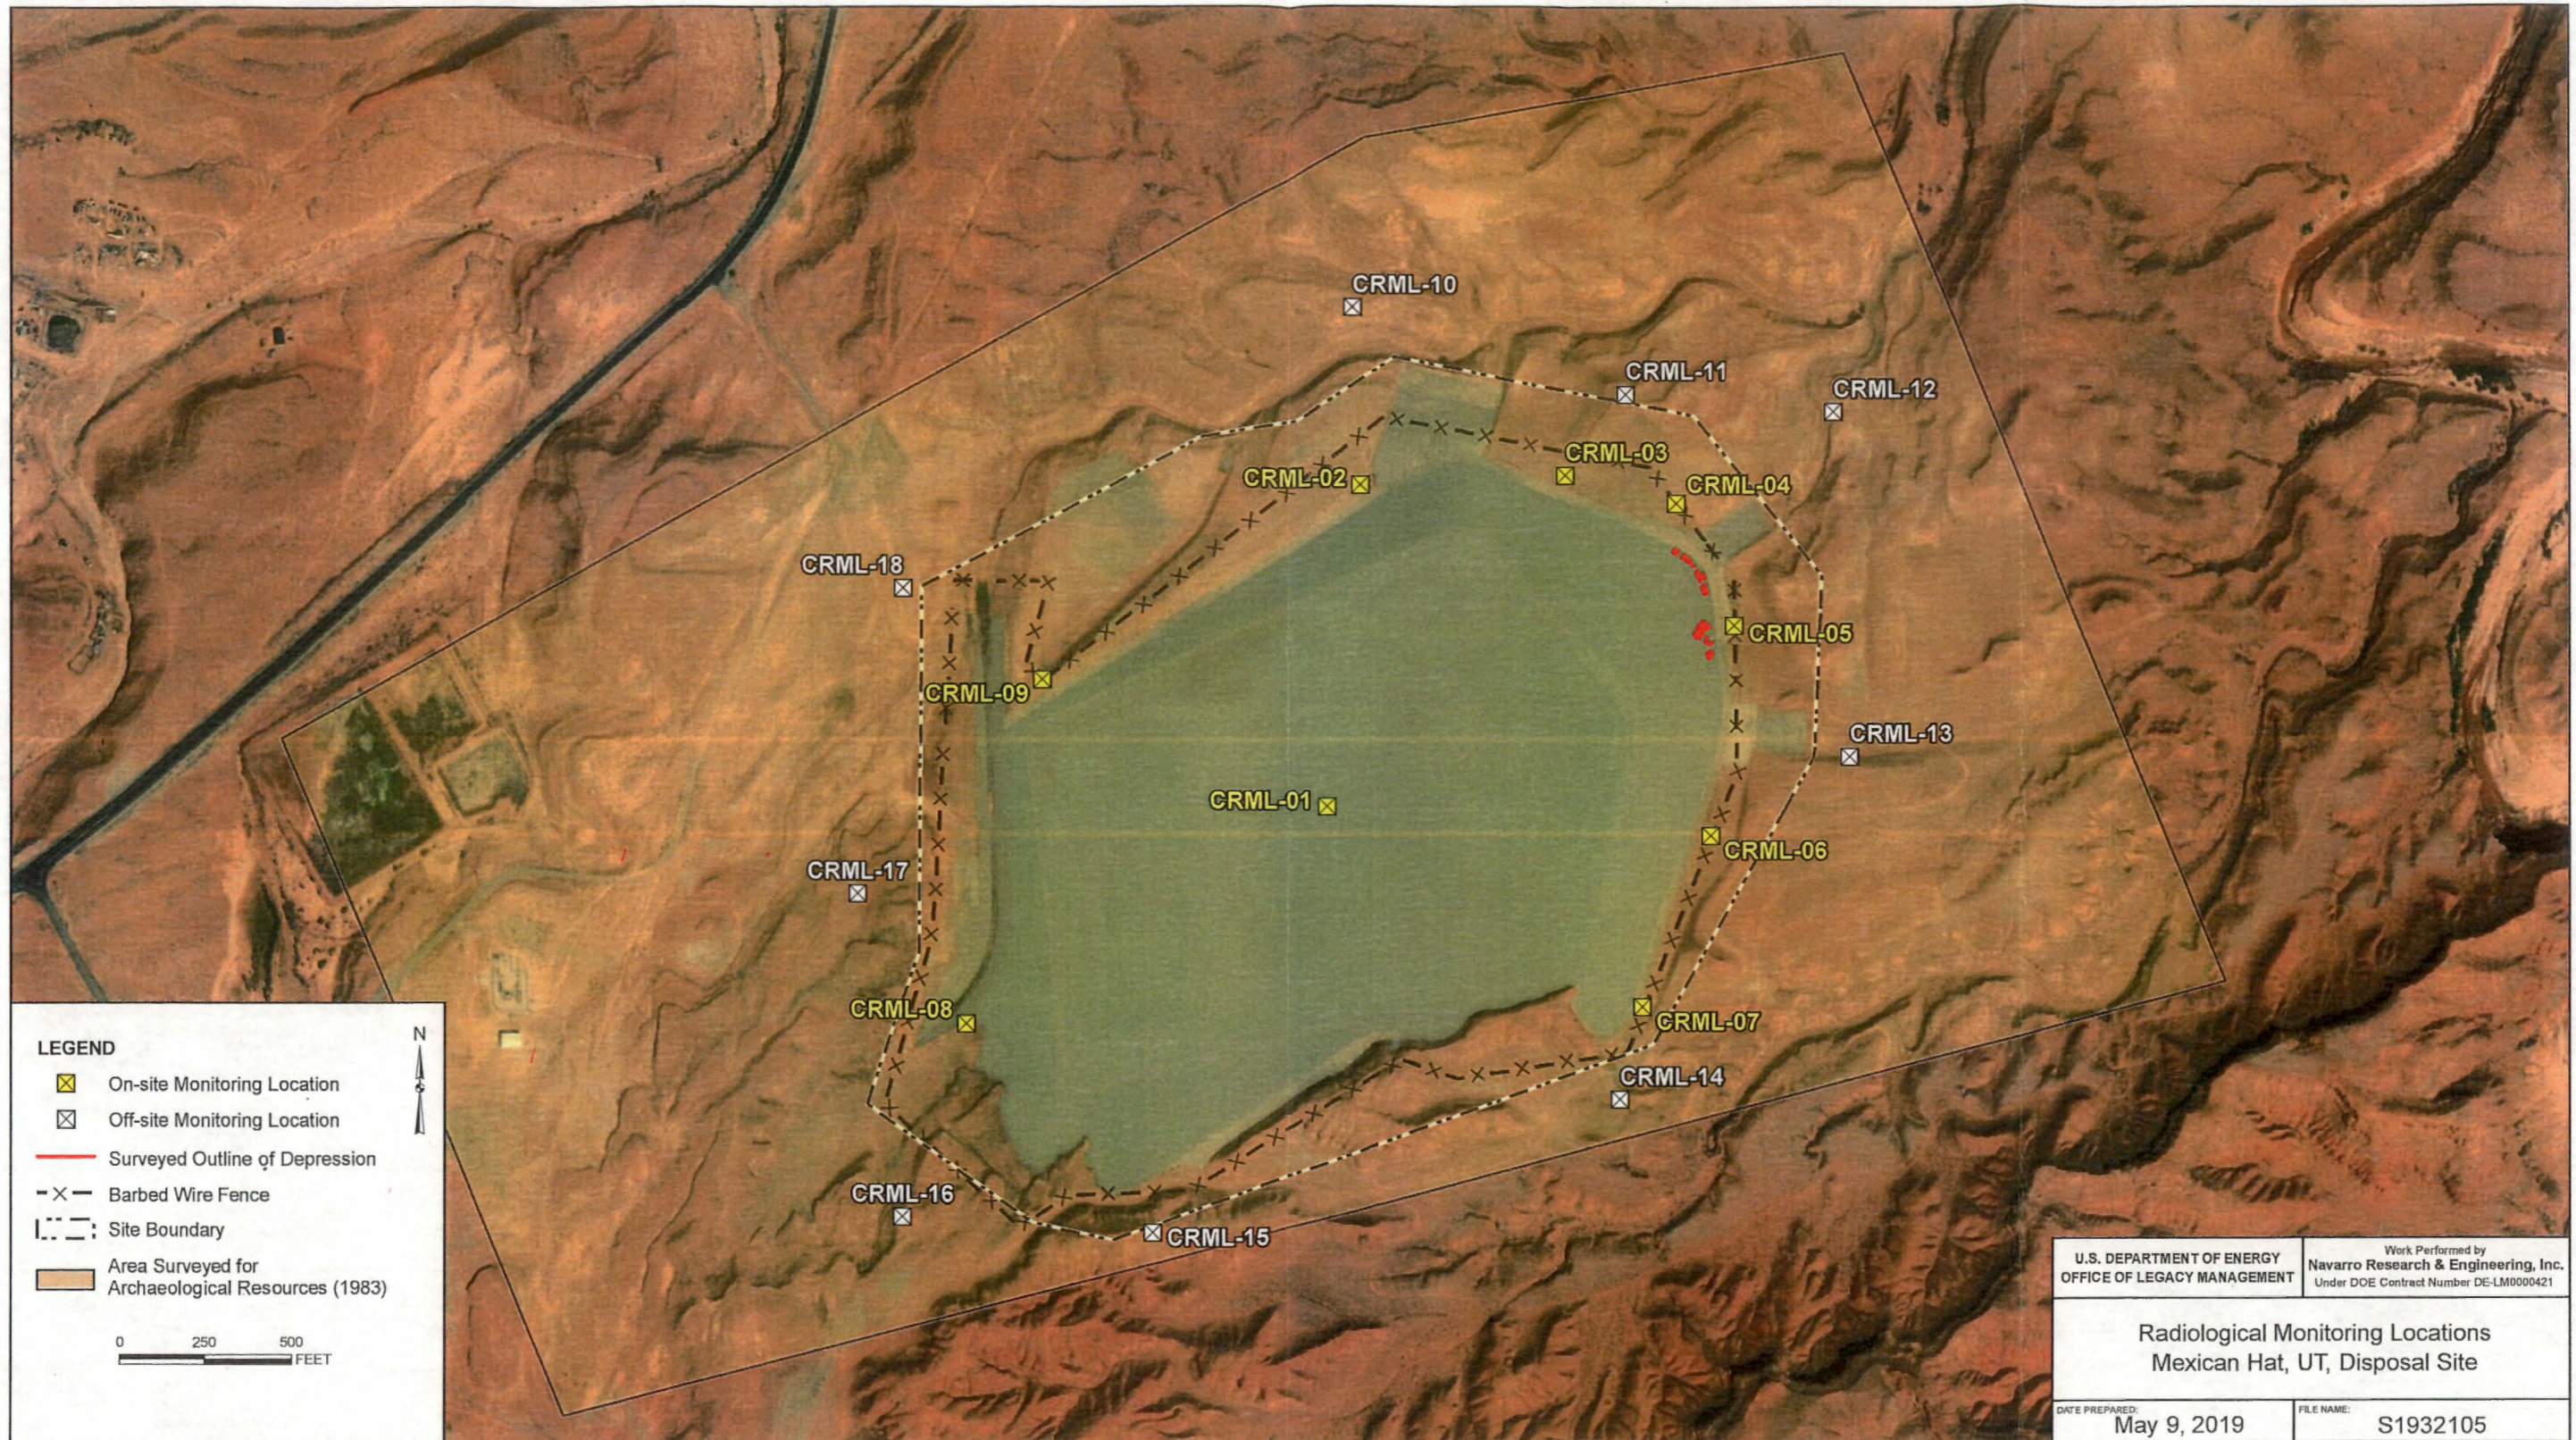
Figure 2. Radon Detector and TLD Placement Locations at the Mexican Hat, Utah, Disposal Site

On April 8, radon detectors and environmental thermoluminescent dosimeters (TLDs) were placed at the Mexican Hat, Utah, Disposal Site in accordance with the *Radiological Monitoring Plan for the Mexican Hat, Utah, Disposal Site* (LMS/HAT/S18816).

On July 10, the deployed radon detectors and TLDs were collected from the site and sent to an accredited vendor for processing and analysis. Replacement radon cups and TLDs were deployed for the current quarter of monitoring at the time of collection.
