PBF/LOFT LEAD ROD TEST SERIES TEST RESULTS REPORT

Published July 1980

**EG&G Idaho, Inc.
Idaho Falls, ID 83415**

Prepared for the
U.S. Nuclear Regulatory Commission
Washington, D.C. 20555
Under DOE Contract No. DE-AC07-76ID01570
FIN No. A6041

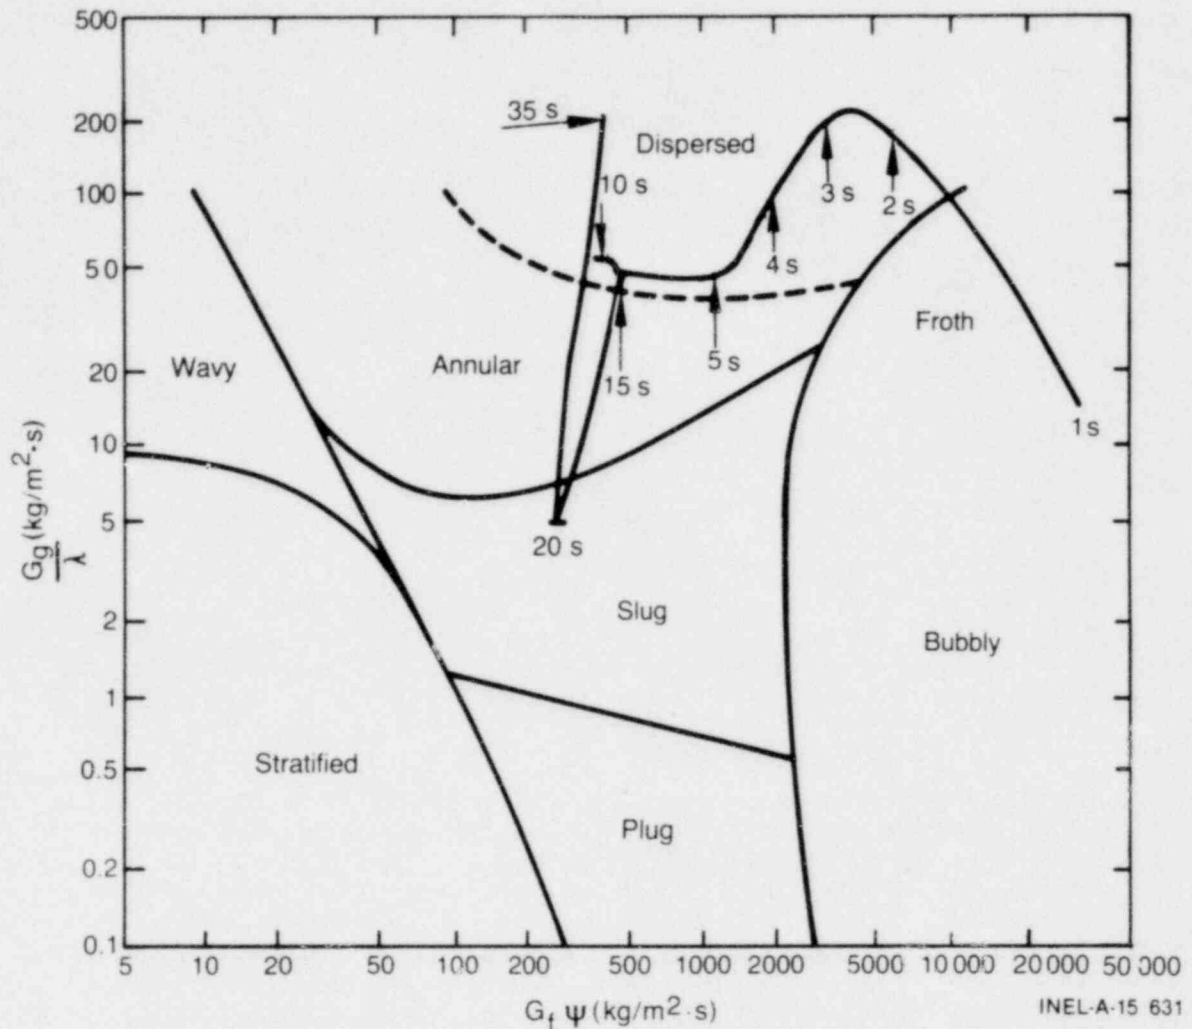
Figure 14. Baker flow pattern map for horizontal flow in the cold leg spool piece during Test LLR-5.

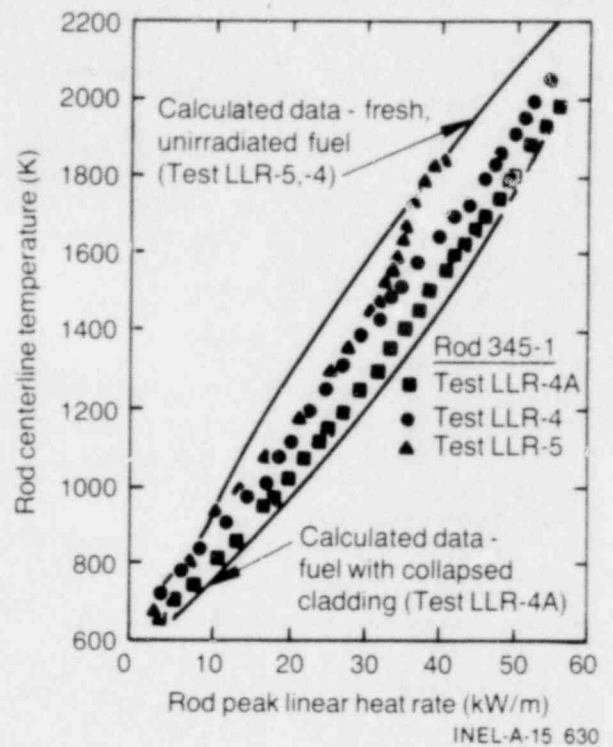
Figure 27. Comparison of steady state response of Rod 345-1 with FRAP-T5 calculations during Tests LLR-5, -4, and -4A.

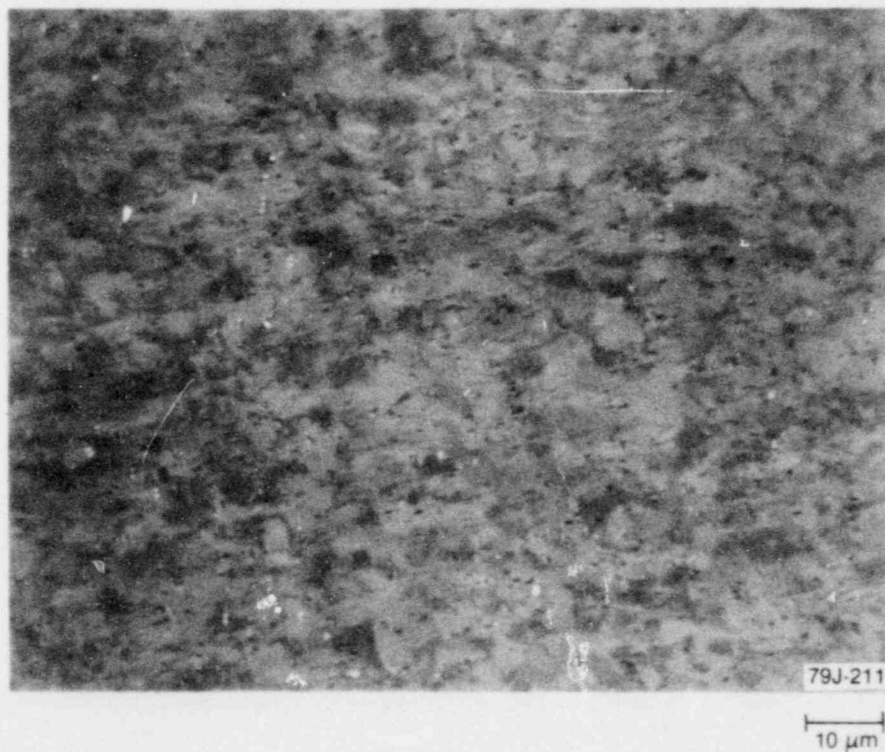
Figure 61. Rod 312-4 transverse cladding microstructure (Sample M4-3) from 0.53 to 0.55 m.

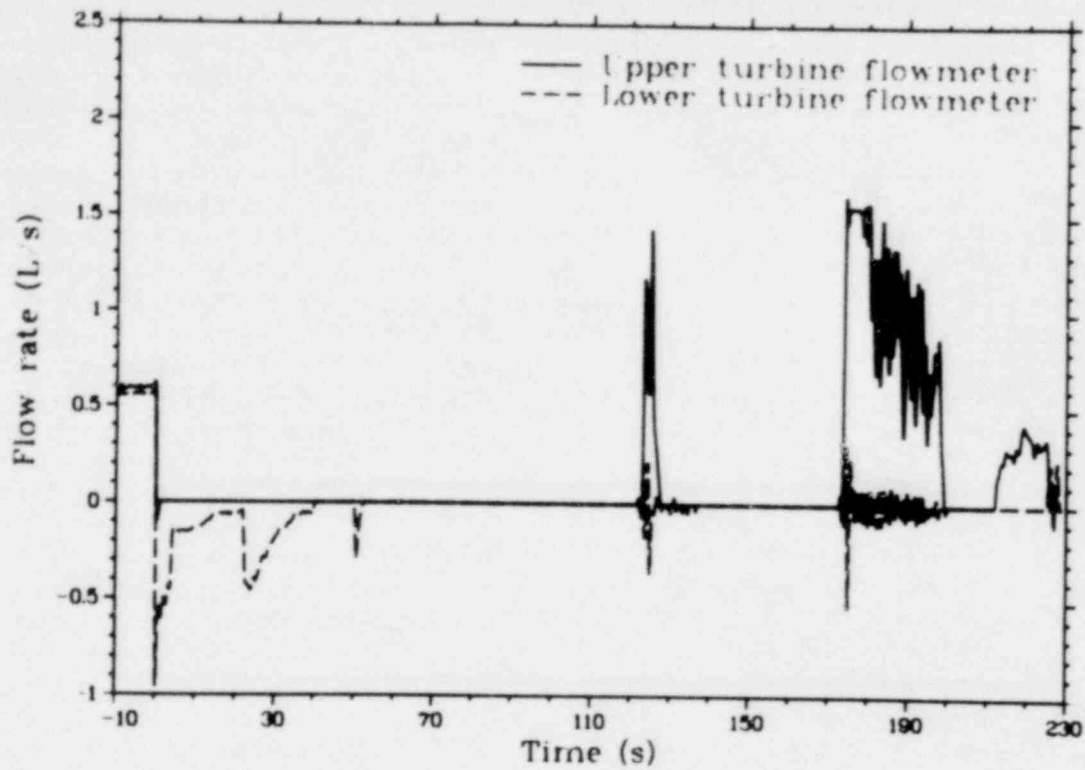
Figure 91. Volumetric flow measurements in the upper and lower portion of the Rod 312-1 flow shroud during Test LLR-3 (240-s duration).
