GETR LANDSLIDE STABILITY ANALYSIS

General Electric Company
Vallecitos Nuclear Center
Pleasanton, California 94566

Earth Sciences Associates
701 Welch Road
Palo Alto, California 94304

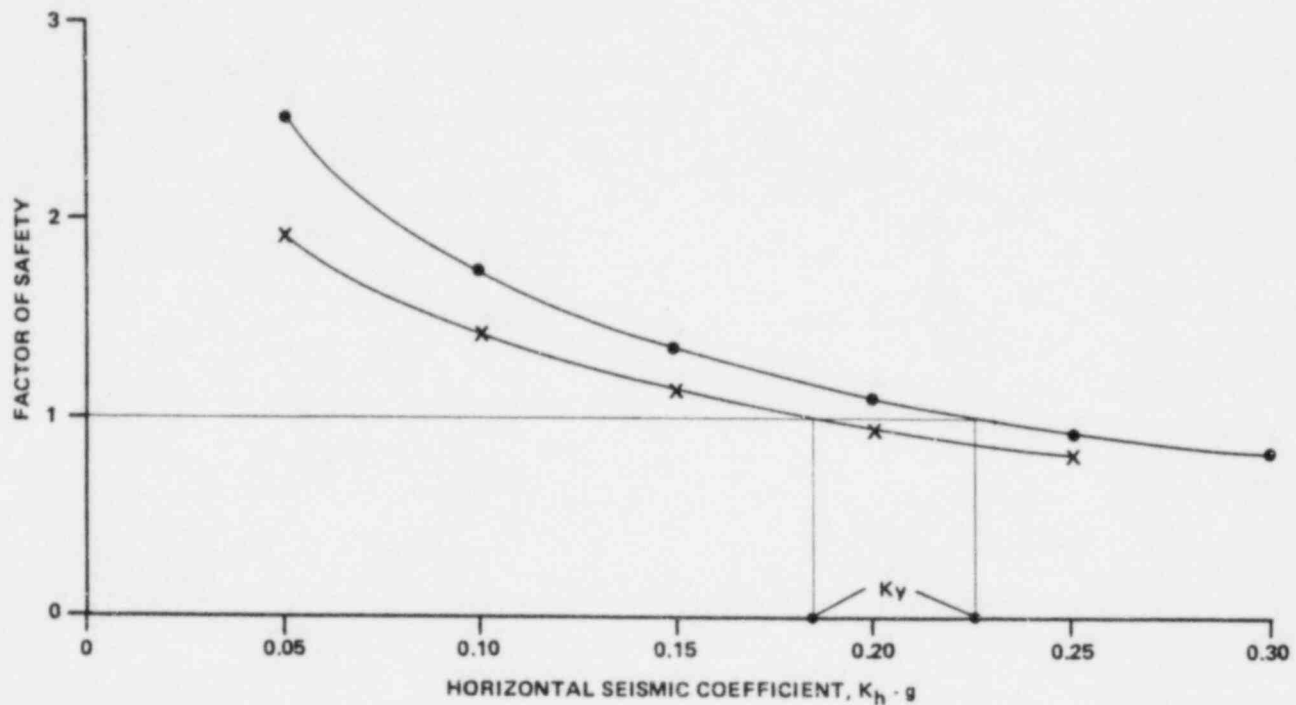
- Existing mid-slope failure surface
- X Existing full-slope failure surface
- K_y Yield seismic coefficient

Earth Sciences Associates Palo Alto, California			
GETR LANDSLIDE STABILITY ANALYSIS VARIATION OF FACTOR OF SAFETY WITH HORIZONTAL SEISMIC COEFFICIENT			
Checked by	<i>JM Yaden</i>	Date	<i>8/28/80</i>
Approved by	<i>RL Newman</i>	Date	<i>8/28/80</i>
Project No.	1886	Figure No.	C-3

<u>Failure Surface</u>	<u>Static Factor of Safety</u>	<u>Yield Seismic Coefficient, k_y (g)</u>	<u>Range of Yield to Maximum Seismic Coefficient Ratio k_y/k_{max}</u>	<u>Range of Estimated Permanent Displacement, u (cm)</u>
Full-slope	2.9	0.18	0.53	3 - 18
Mid-slope	4.4	0.22	0.65	1 - 9
