SUPPLEMENTAL INVESTIGATION
SERVICE WATER POND WEST EMBANKMENT
REPORT NO. 2
VIRGIL C. SUMMER NUCLEAR STATION

Prepared for:
SOUTH CAROLINA ELECTRIC & GAS CO.
COLUMBIA, SOUTH CAROLINA

Prepared by:
WOODWARD-CLYDE CONSULTANTS
PLYMOUTH MEETING, PENNSYLVANIA
and
GILBERT ASSOCIATES, INC.
READING, PENNSYLVANIA

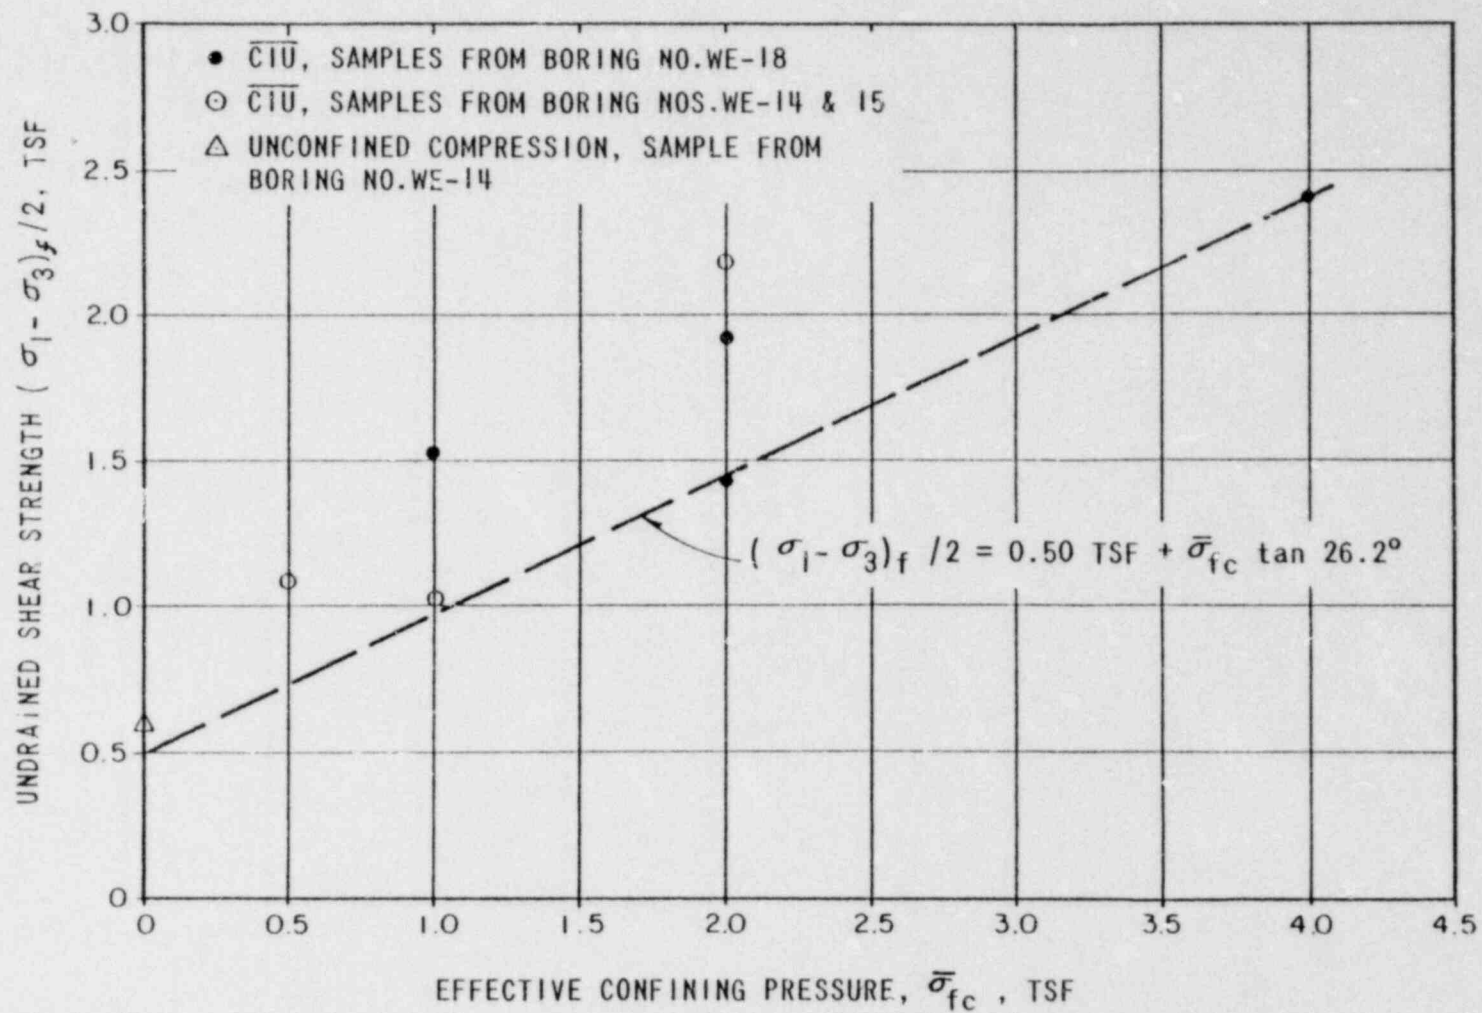
FIGURE 19

UNDRAINED SHEAR STRENGTH
 OF
 ELIBANKMENT MATERIALS

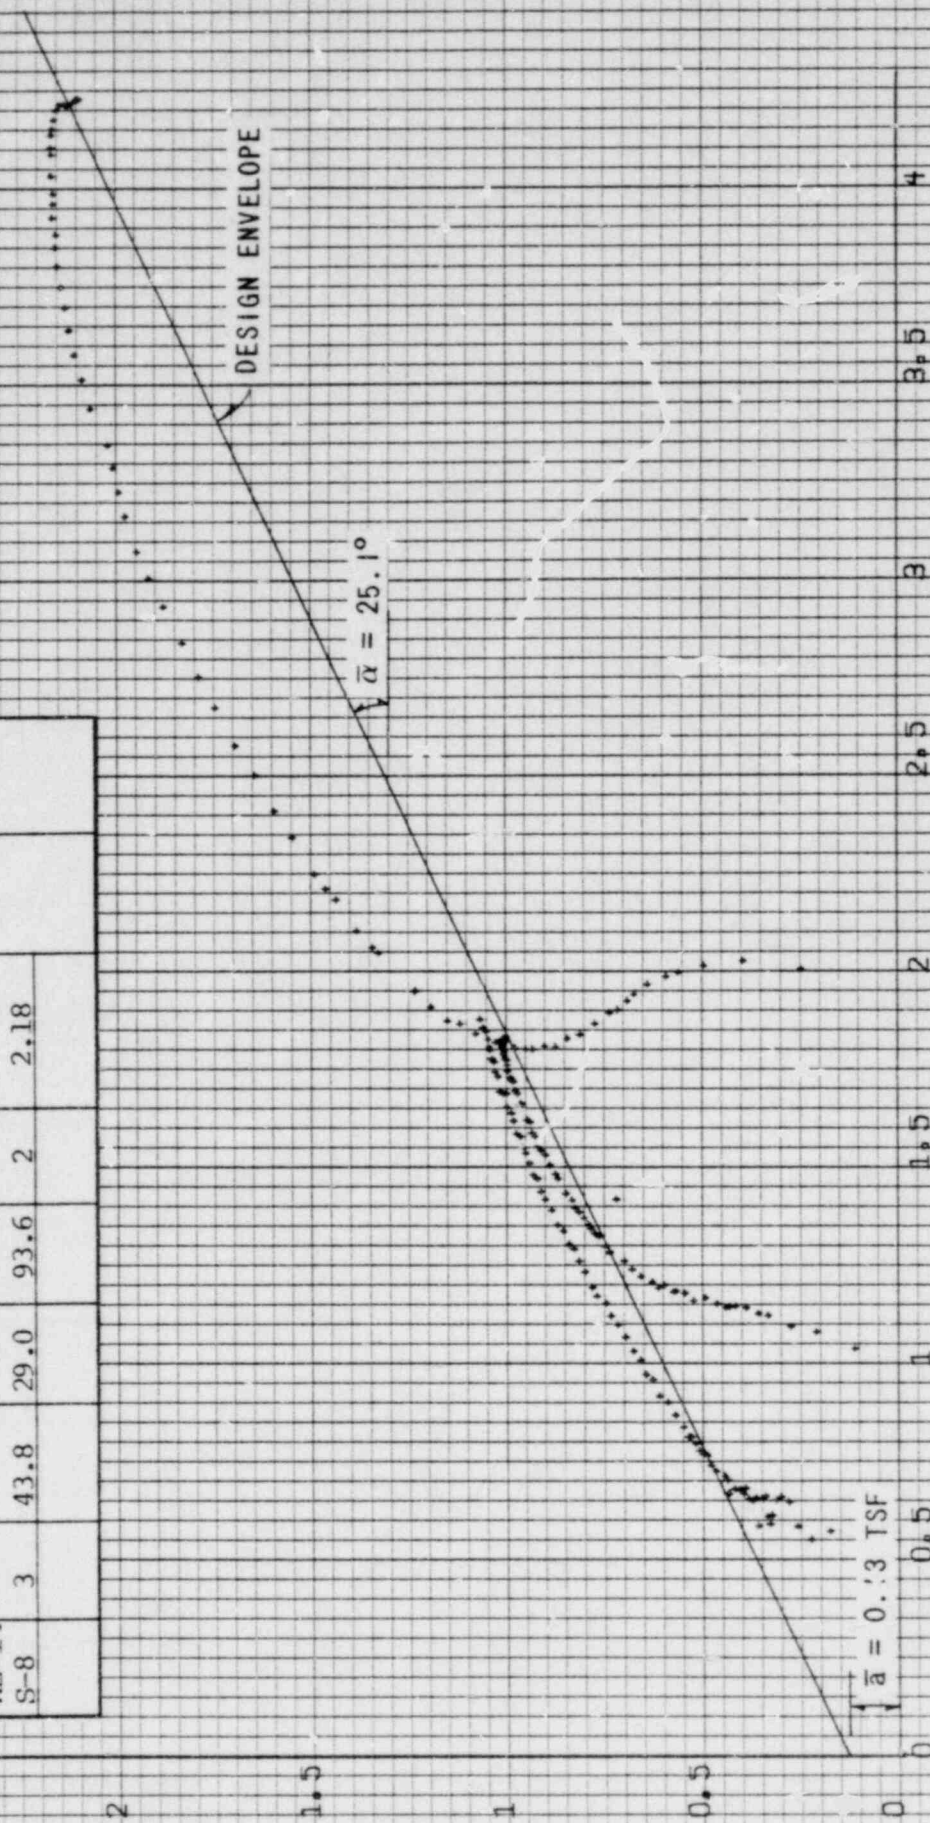
Sample No.	Test No.	Sample Depth Ft.	W_n (%)	γ_d pcf	$\bar{\sigma}_c$ tsf	$\frac{(\bar{\sigma}_1 - \bar{\sigma}_3)}{2}$ tsf	\bar{c} tsf	$\bar{\phi}$
WE-15	1	37.3	34.6	87.5	0.5	1.08		
ST-1	2	49.2	30.8	89.8	1	1.03		
WE-15	3	43.8	29.0	93.6	2	2.18

STRESS DIFFERENTIAL/2 IN TSF

AVERAGE EFFECTIVE STRESS IN TSF
