TITLE: SEISMIC EVALUATION OF BUILDING 102 OF THE GENERAL ELECTRIC
VALLECITOS NUCLEAR CENTER

AUTHOR(S): Elton G. Endebrock

SUBMITTED TO: Winston Burkhardt, US Nuclear Regulatory Commission

LOS ALAMOS SCIENTIFIC LABORATORY

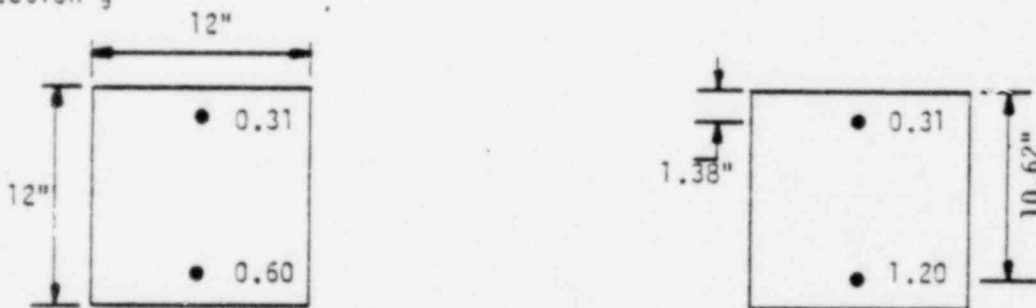
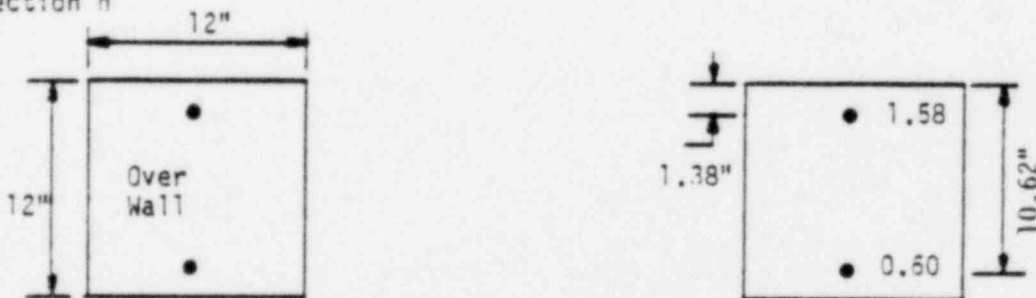
Fig. B-6.
Basement roof slab sections.

Section c

Section d

Section f

Section g

Section h
