# Evaluation of Trench Subsidence and Stabilization at Sheffield Low-Level Radioactive Waste Disposal Facility

Sheffield, Illinois  
Final Report  
October 15, 1980 - March 30, 1981

Ralph Stone and Company, Inc.

Prepared for  
U.S. Nuclear Regulatory  
Commission

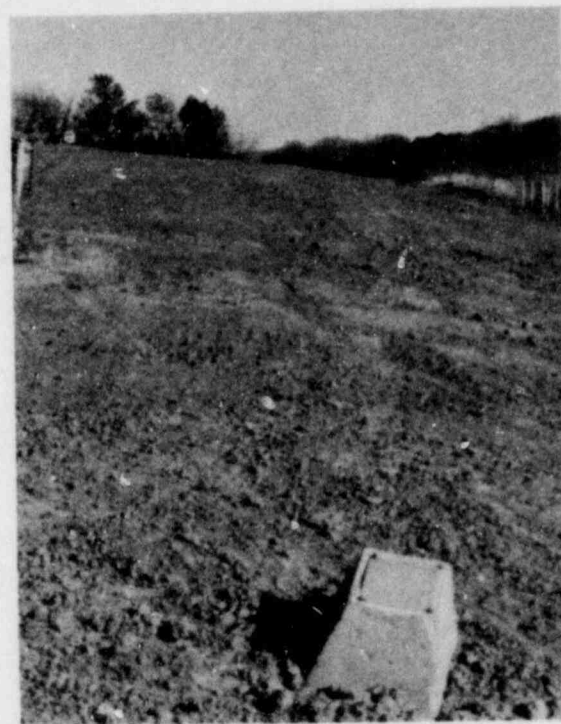
FIGURE 5 - SURFACE REPAIRS - NOVEMBER 5, 1980

The Sheffield site is covered with a bromegrass and tall fescue except for the recent grading, slope and erosion repair areas which make up approximately 20 percent of the total acreage. Photographs of these repair areas are shown in Figure 5. The repairs that have been initiated on the drainage problem areas should be monitored until such time as the bromegrasses or other approved ground cover has been established.

T-11 LOOKING EAST

BETWEEN T-25C AND T-24  
LOOKING WEST

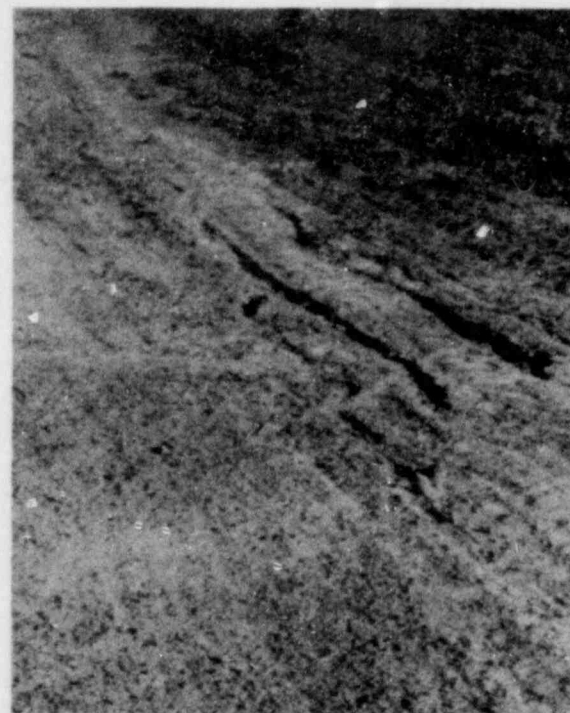
FIGURE 6 - MINOR EROSION - NOVEMBER 5, 1980

Figure 6 depicts minor erosion which can develop into major gully erosion with surface runoff carrying away the topsoil of the caps and soil in the

EAST END OF T-25 LOOKING  
EAST

areas between the trenches. Runoff occurs first as sheet flow which gradually develops into poorly defined rills upon the trench caps. The rills tend to form on the side slopes and run into developing swales along the side of the trenches. The swale water then follows the site topography and ultimately ends up in the well defined drainage channels at the northern end, Figure 7, or the southeastern end of the site, Figures 8 and 9. This erosion process can lead to damage to the caps, loss of cap integrity and will require regular future inspection of the existing caps to determine if rilling develops.

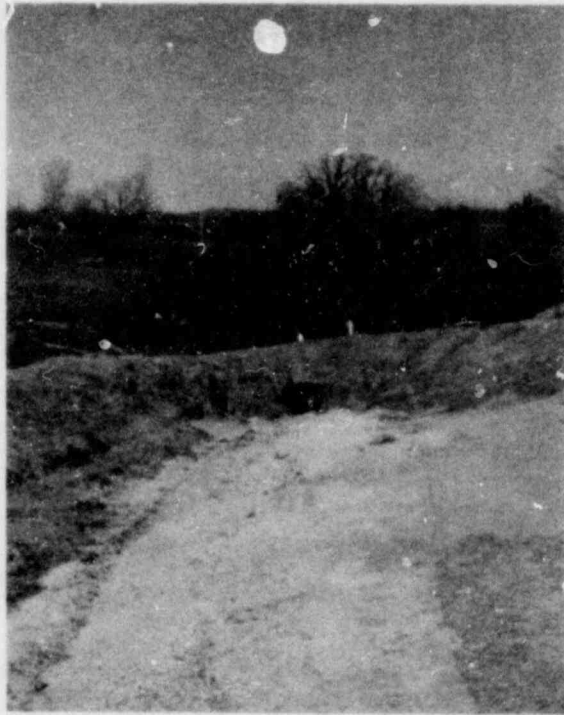
FIGURE 8 - SOUTHERN GULLY - NOVEMBER 5, 1980

DRAINAGE CULVERT LOOKING  
NORTH

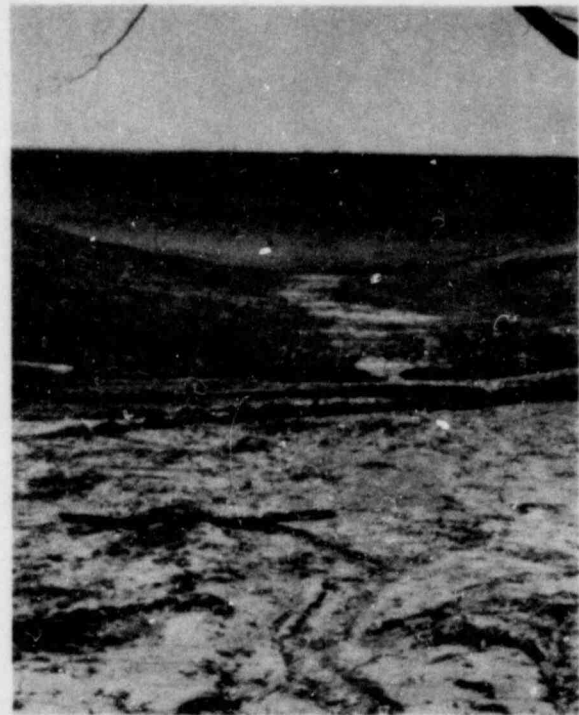
FIGURE 7 - NORTHERN DRAINAGE CHANNELS - NOVEMBER 5, 1980

EAST END OF T-18 LOOKING  
SOUTH

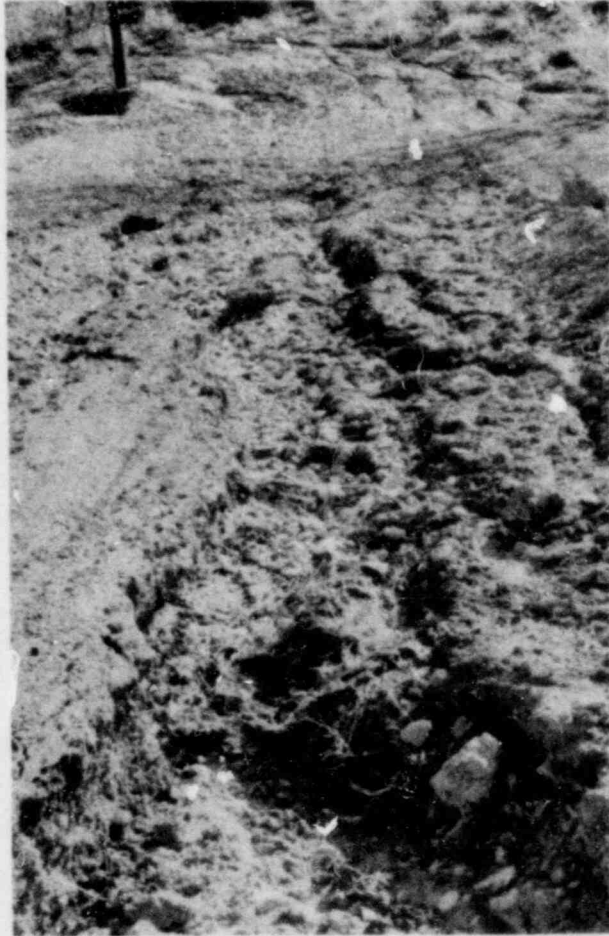
DRAINAGE AT SOUTH END  
OF SITE LOOKING SOUTH  
FROM T-11

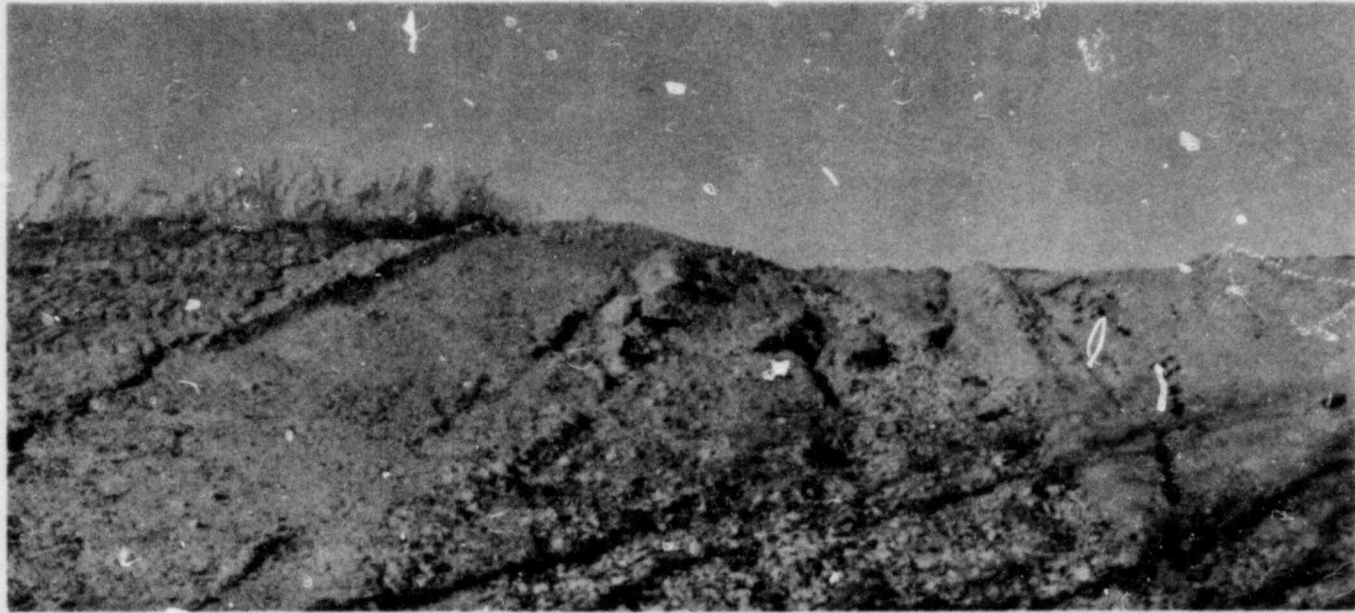
SLOPE AT SOUTH END OF SITE LOOKING NORTH  
FIGURE 9 - SURFACE WATER SWALE - NOVEMBER 5, 1980

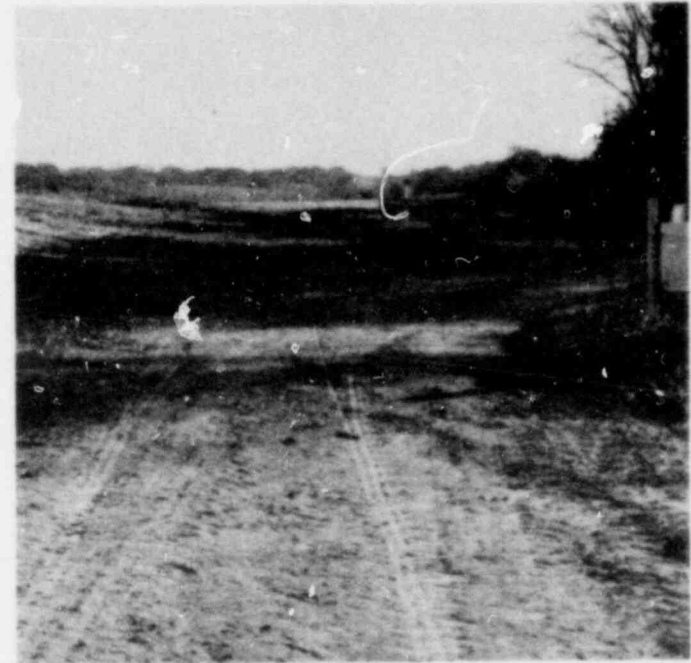
FIGURE 10 - POTENTIAL AREAS OF CONCENTRATED INFILTRATION -- NOVEMBER 5, 1980

Other factors affecting cap integrity are areas of potential concentrated infiltration. Field observations indicate that present potential concentrated infiltration areas are maintenance vehicle tire tracks and low spots developed between the trenches as shown in Figure 10. These areas are located on Plate 2. There are numerous wells and sumps with PVC casings protruding above the ground surface throughout the site, Figure 11. If any of the casings were damaged, a point of concentrated infiltration could result.

TIRE TRACKS AND LOWSPOTS  
BETWEEN T-6 AND T-9

TIRE TRACKS ON WEST END OF SITE  
LOOKING SOUTH

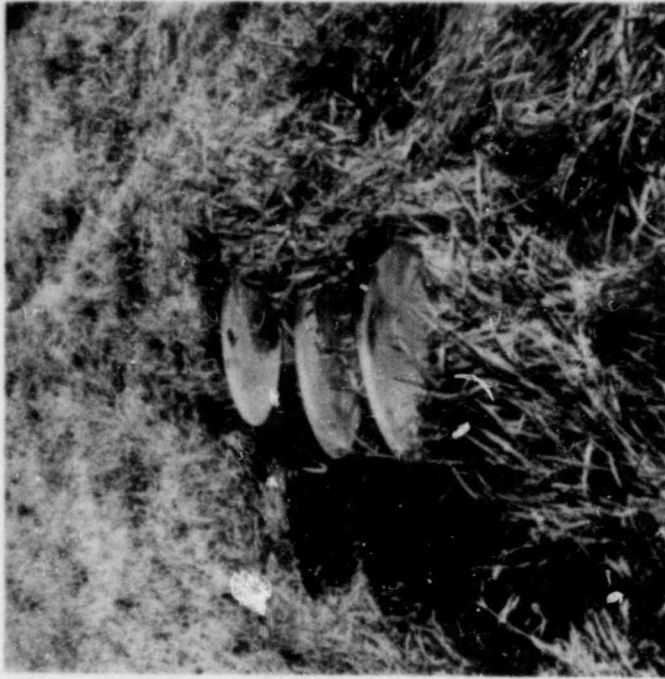
FIGURE 11 - WELL AND SPECIAL BURIAL CASINGS - NOVEMBER 5, 1980

SPECIAL CASINGS NORTH SIDE  
OF T-11 LOOKING EAST

Trench 1 also had three special culverts on its north side installed as the trench was excavated in order to facilitate the burial of tritium, cesium, cobalt, and other special waste. These special casings were filled with concrete and capped with metal lids, Figure 11, in 1977 according to NECO.
