REPORT NO.
UCB/EERC-79/23
SEPTEMBER 1979

EARTHQUAKE ENGINEERING RESEARCH CENTER

SHAKING TABLE STUDY OF SINGLE-STORY MASONRY HOUSES VOLUME 1: TEST STRUCTURES 1 and 2

Report to Department of Housing and Urban Development

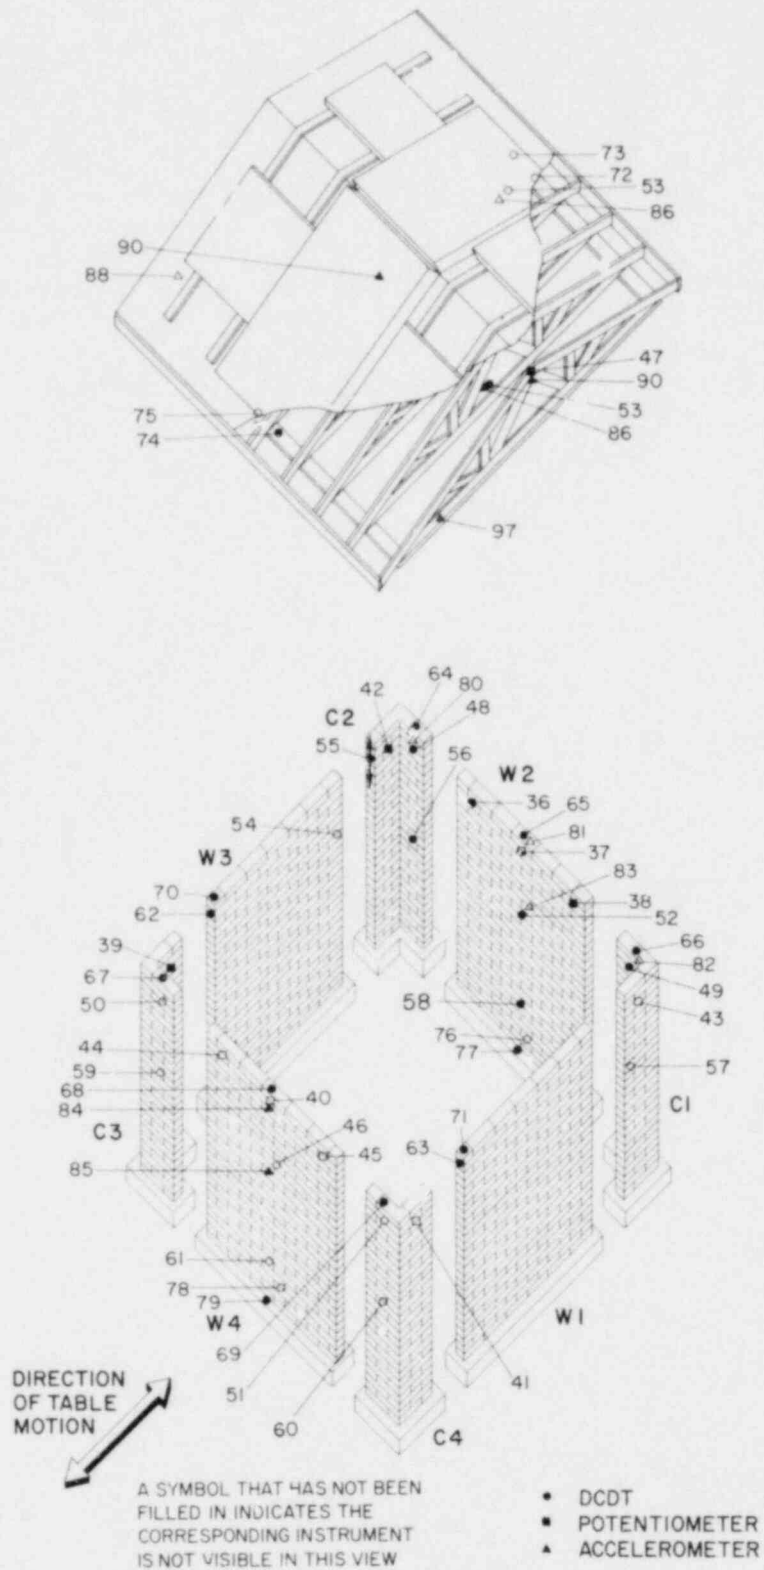
FIGURE 3.5 INSTRUMENTATION FOR HOUSE 1

Displacements of the structures relative to the shaking table were measured from the rigid octagonal reference frame, located inside the walls, which measured approximately 12 ft across. The frame was well braced, and when fully assembled it was extremely stiff. Its natural frequencies (around 30 Hz for the "first" mode), observed by free vibration tests and also predicted by dynamic analysis, were considerably higher than any significant response frequencies of the test structures. The presence of the braced frame inside the test models also provided a possible support for the concrete weights in case of structural failure, although this was a function which the frame was never called upon to perform.

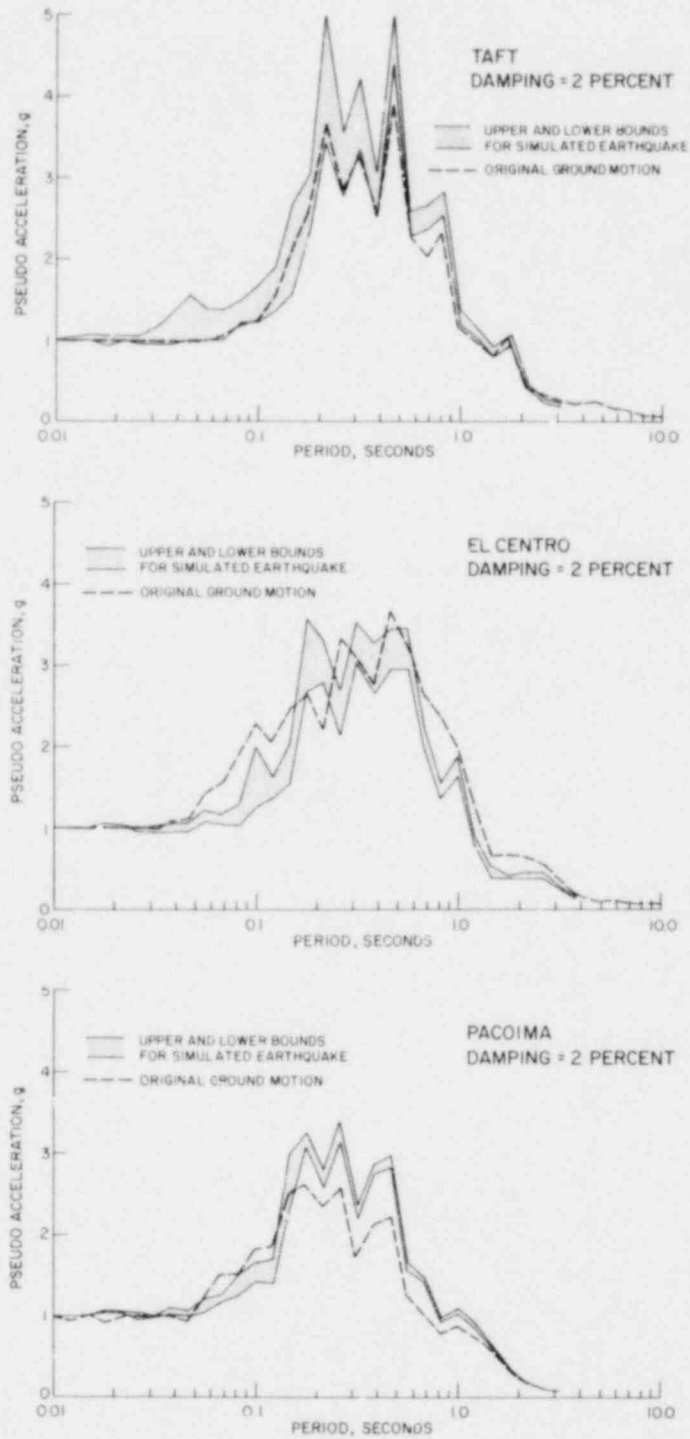
FIGURE 4.3 NORMALIZED RESPONSE SPECTRA

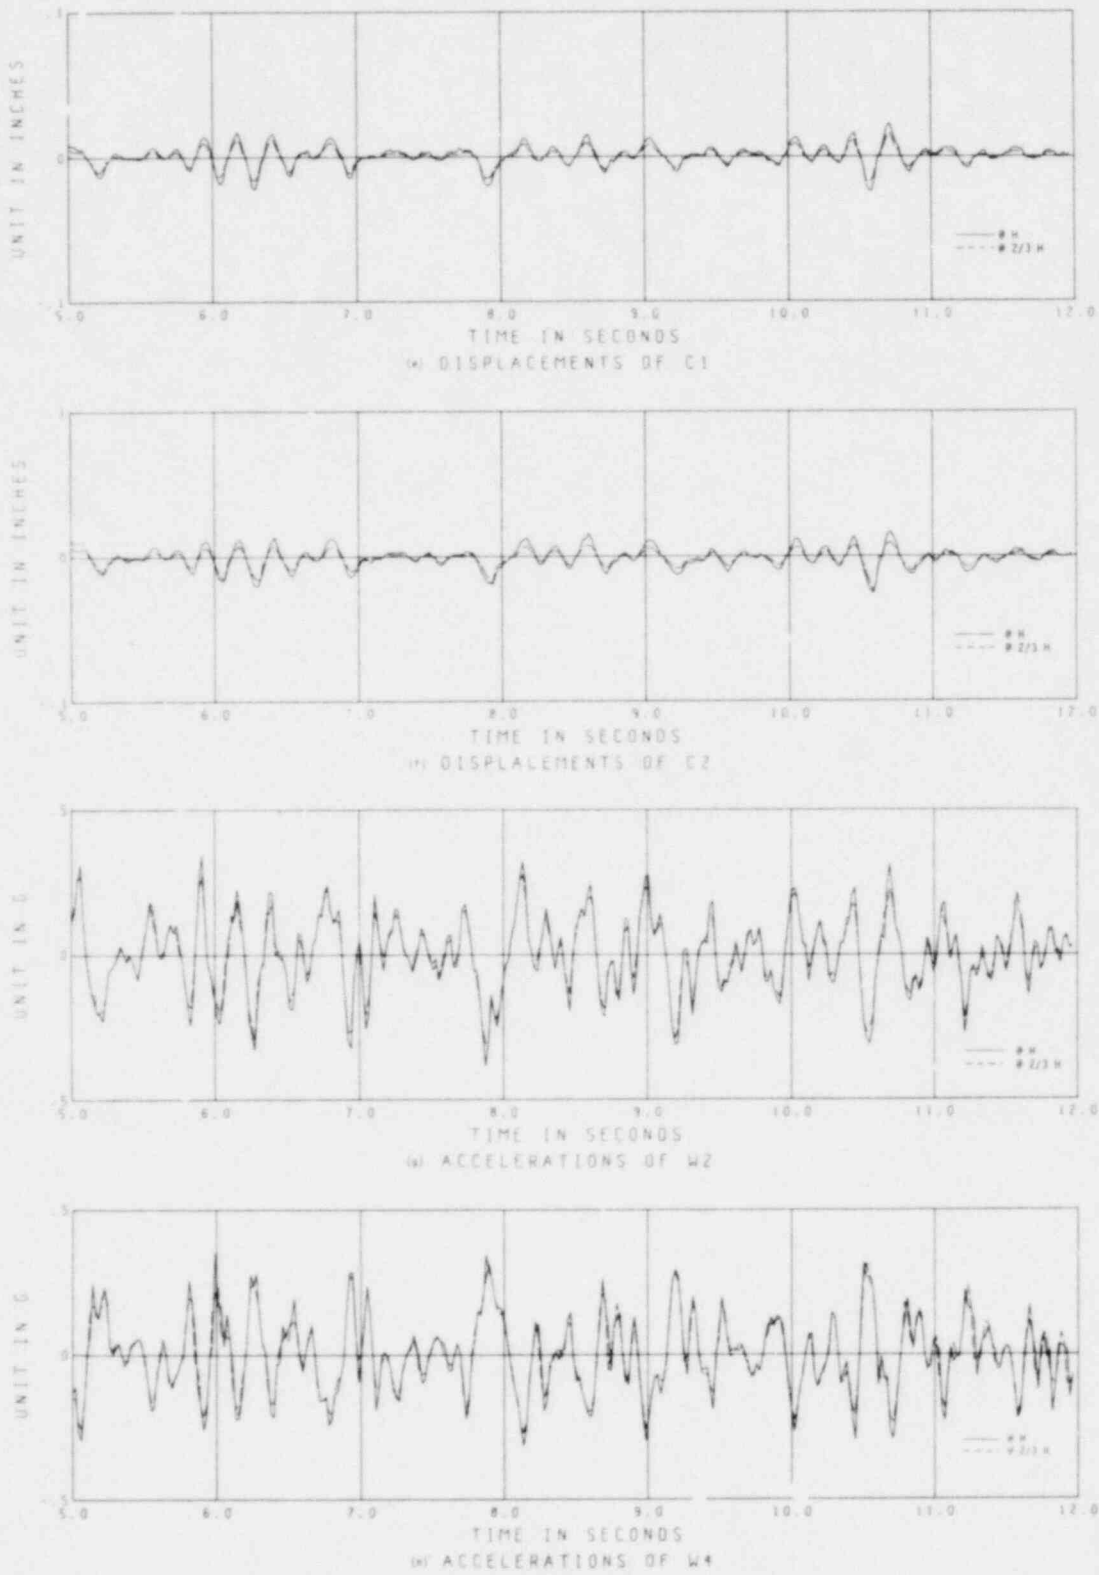
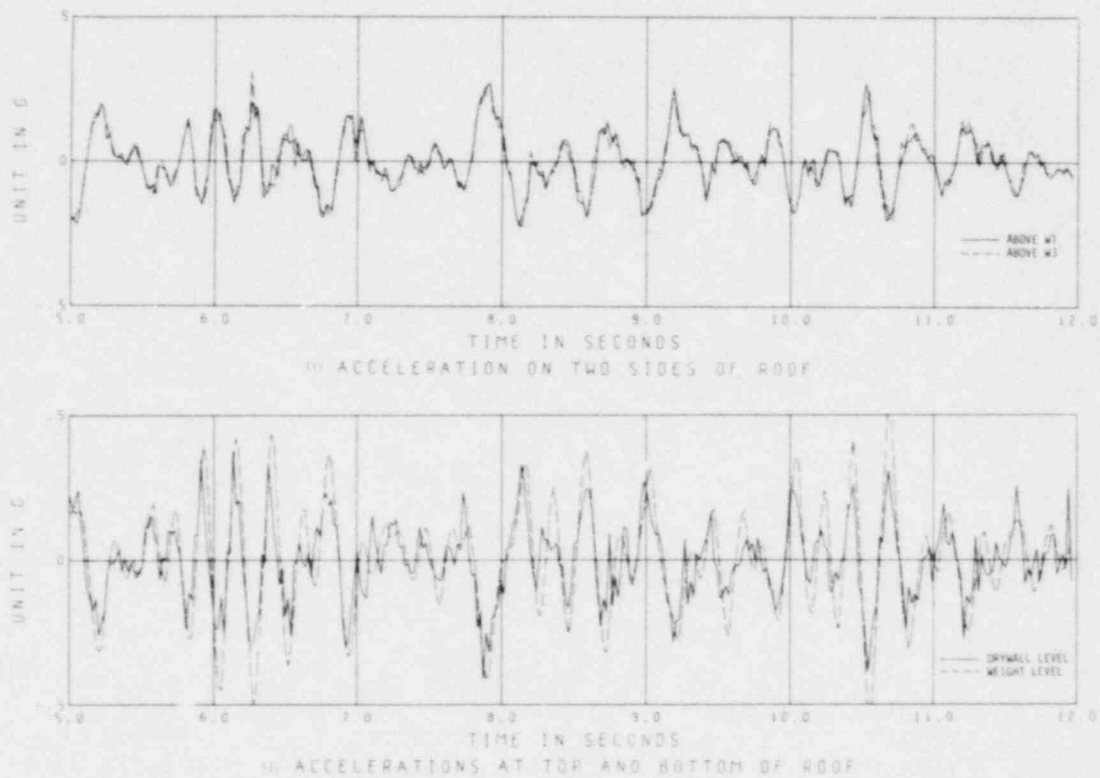
FIGURE 5.3 MEASURED RESPONSE: HOUSE 1, TEST 19 (TAFT - 0.25 g)

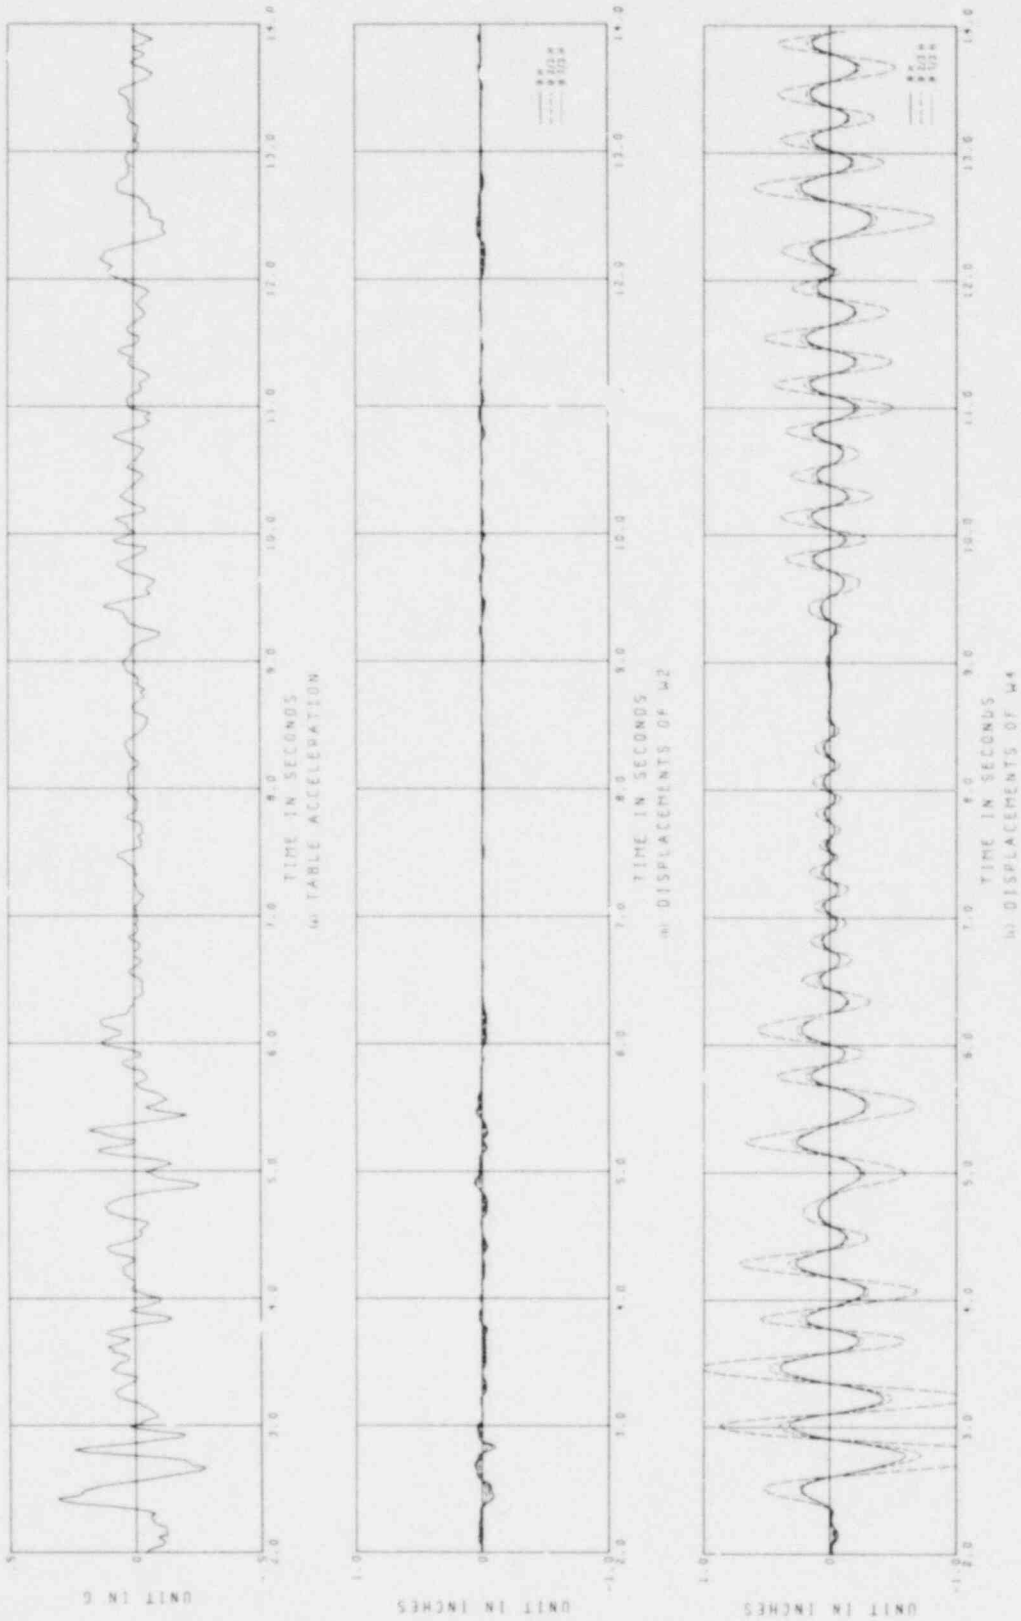
FIGURE 5.4 MEASURED RESPONSE: HOUSE 1, TEST 21 (EL CENTRO - 0.31 g)

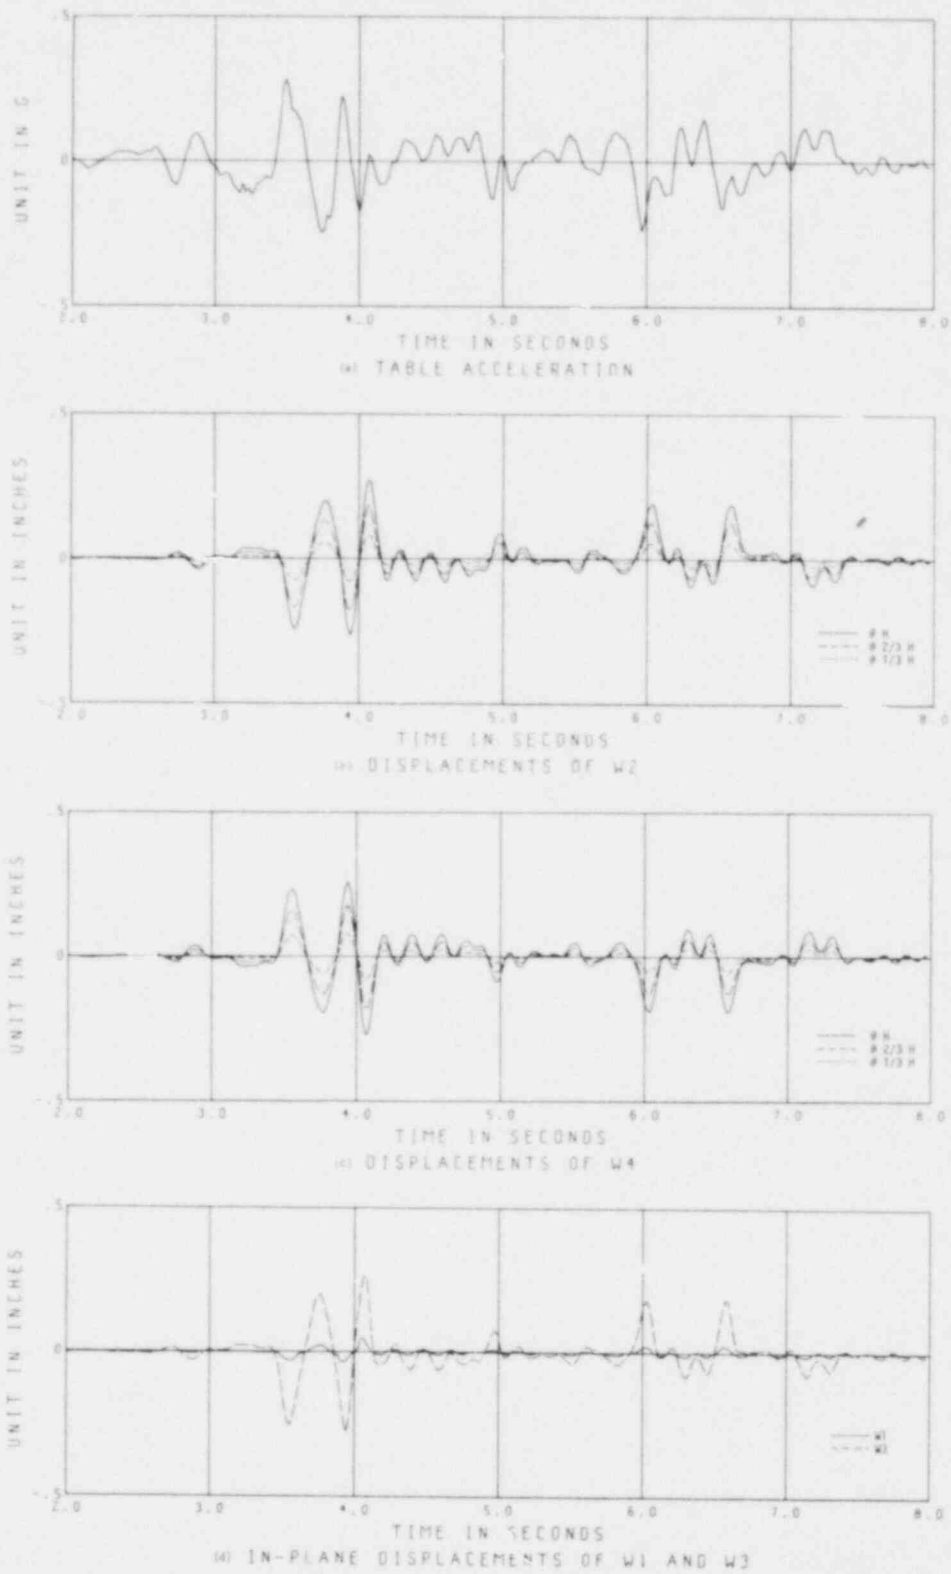
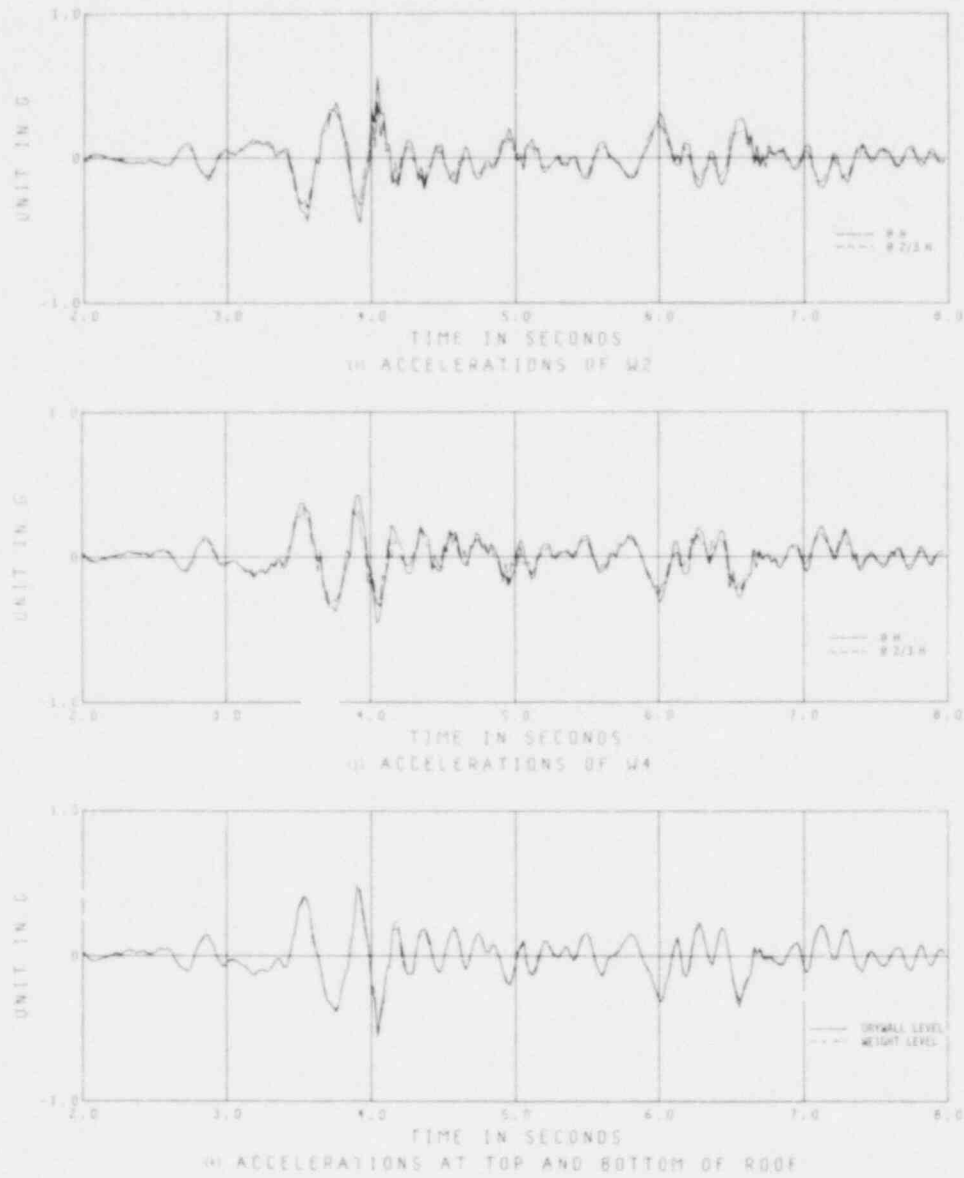
FIGURE 5.9 MEASURED RESPONSE: HOUSE 1, TEST 13 (EL CENTRO - 0.28 g)

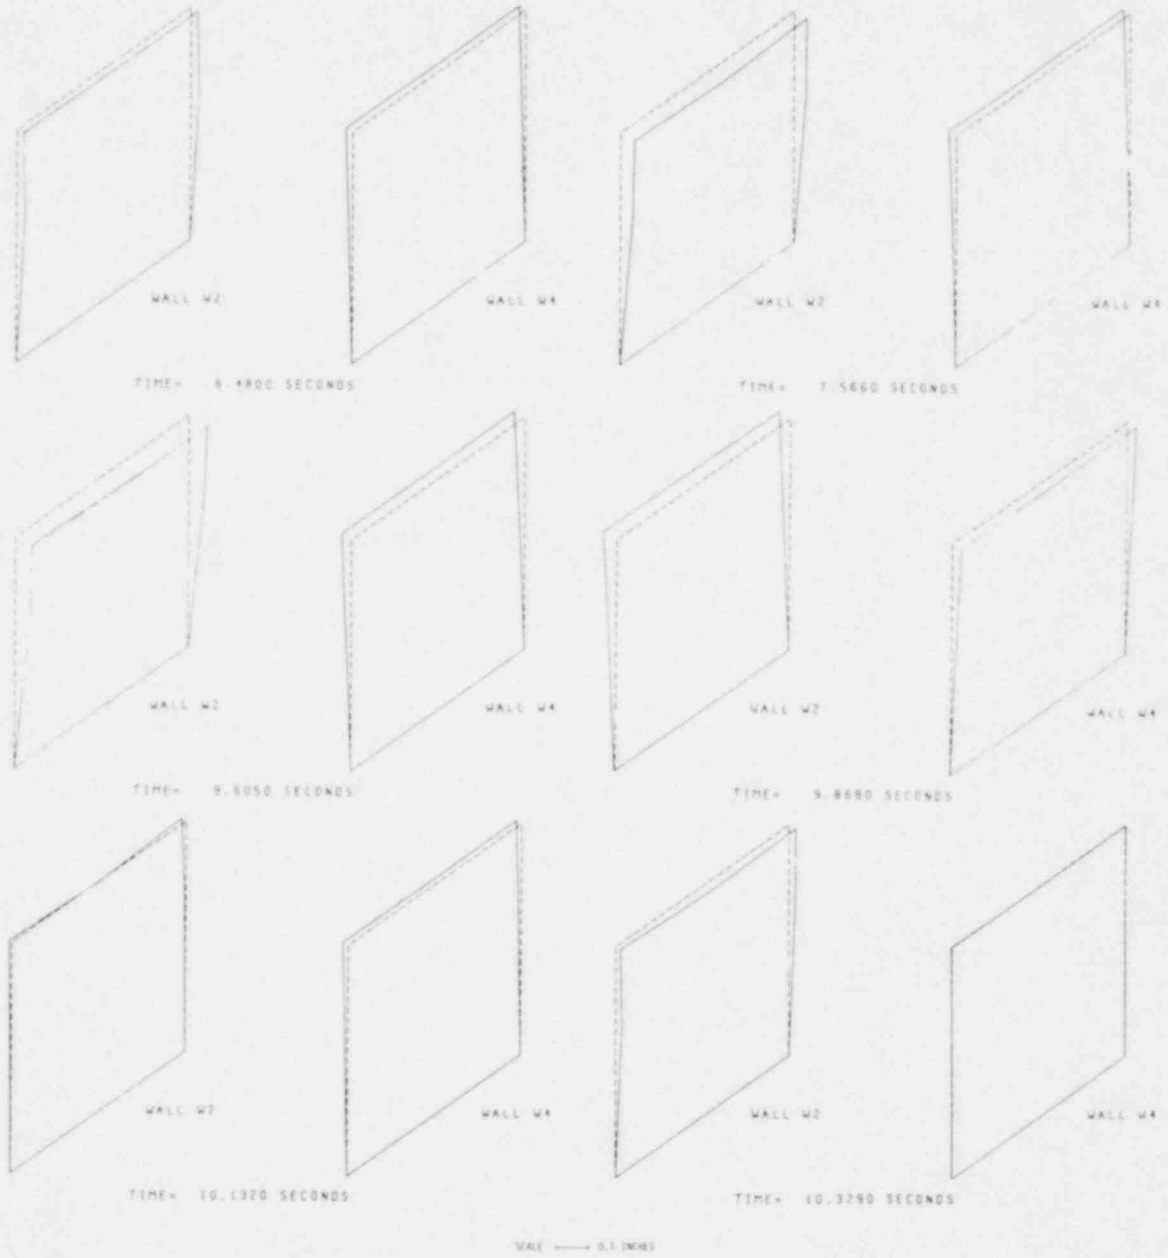
FIGURE 5.11 DEFLECTED SHAPES OF OUT-OF-PLANE WALLS: HOUSE 1
TEST 25 (PACOIMA - 0.25 g)

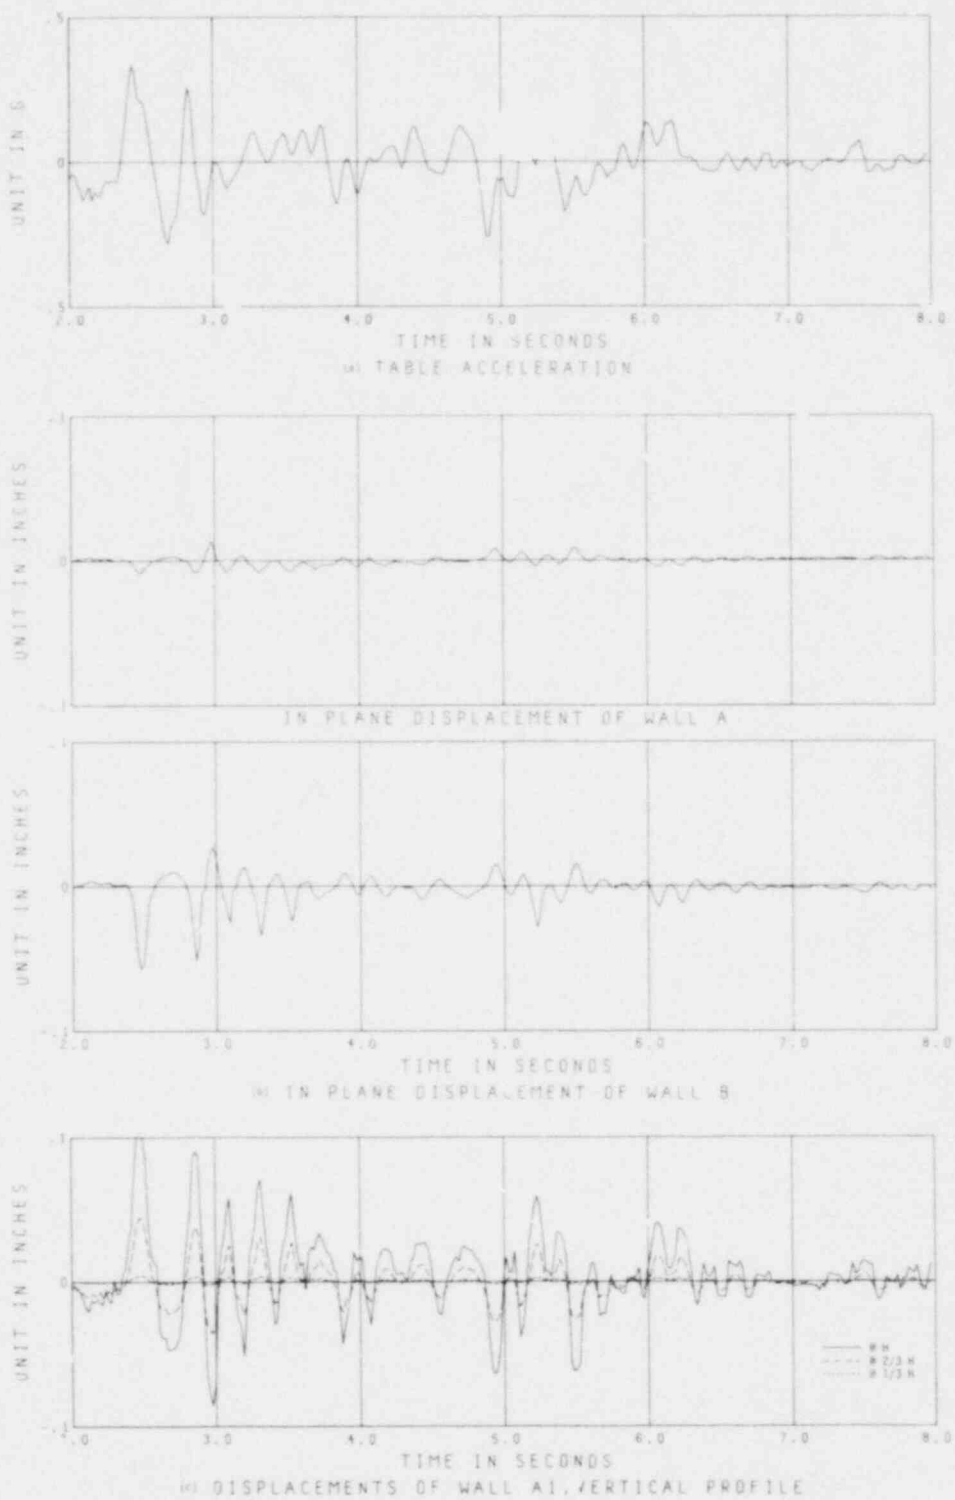
FIGURE 5.13 MEASURED RESPONSE: HOUSE 2, TEST 14 (EL CENTRO - 0.33 g)

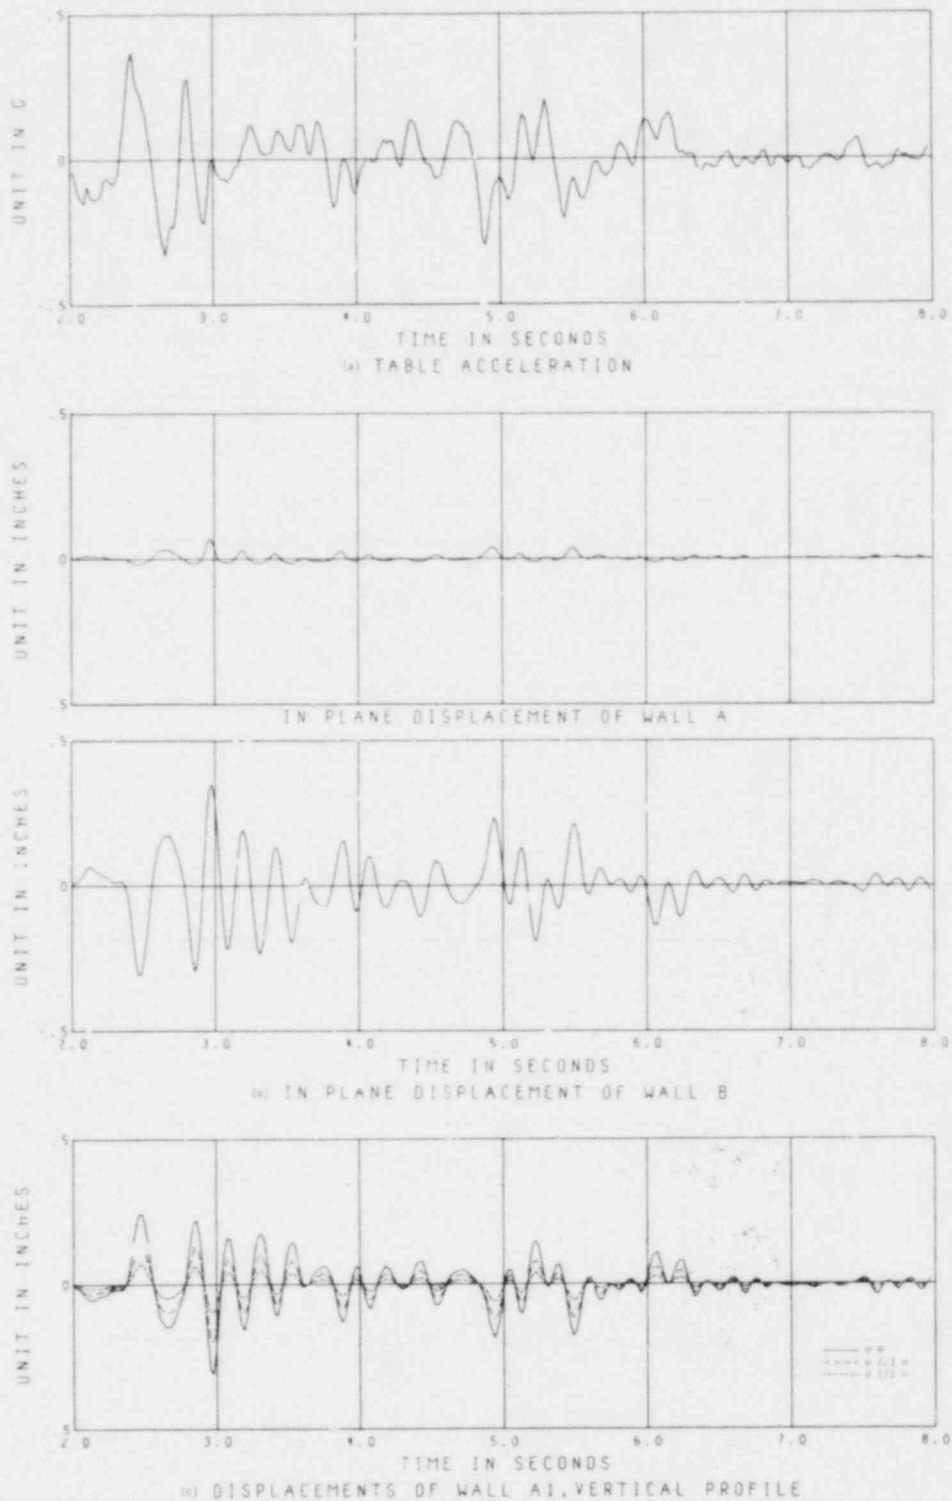
FIGURE 5.15 MEASURED RESPONSE: HOUSE 2, TEST 30 (EL CENTRO - 0.37 g)

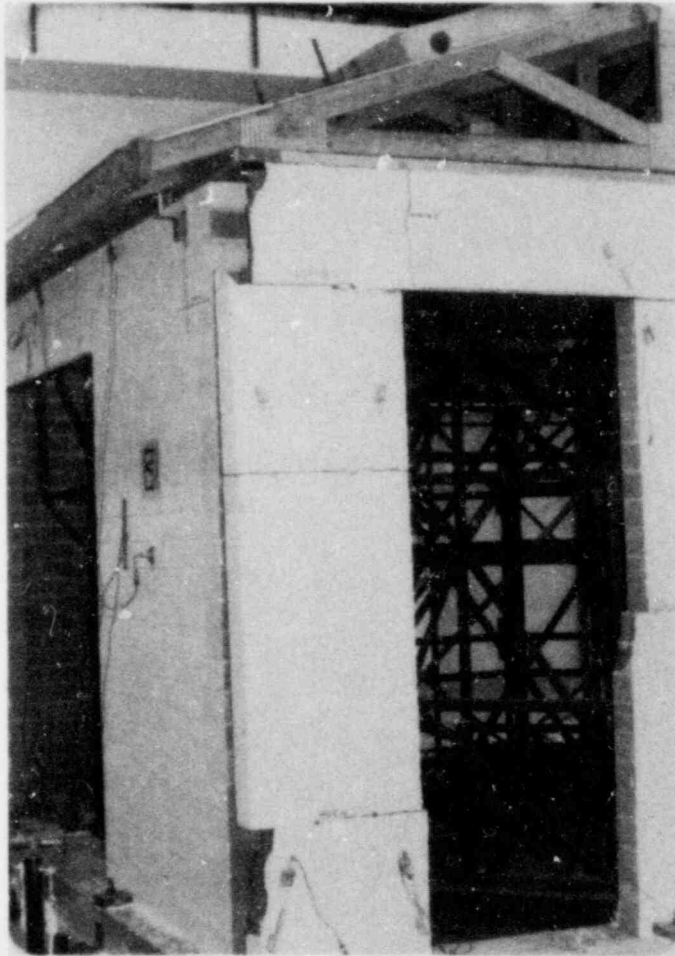
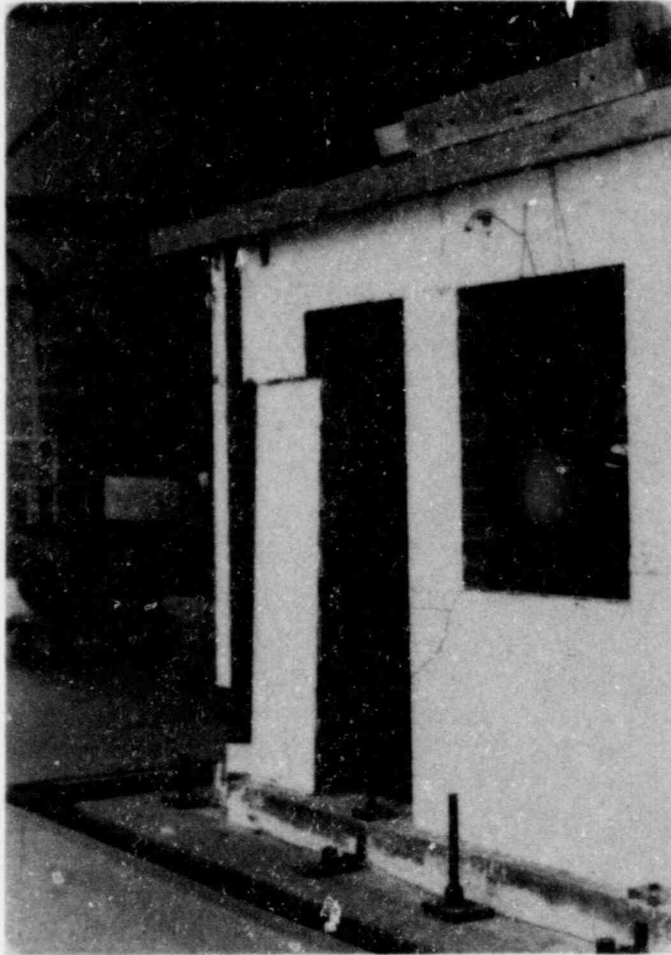
FIGURE 5.17 FAILURE OF HOUSE 2

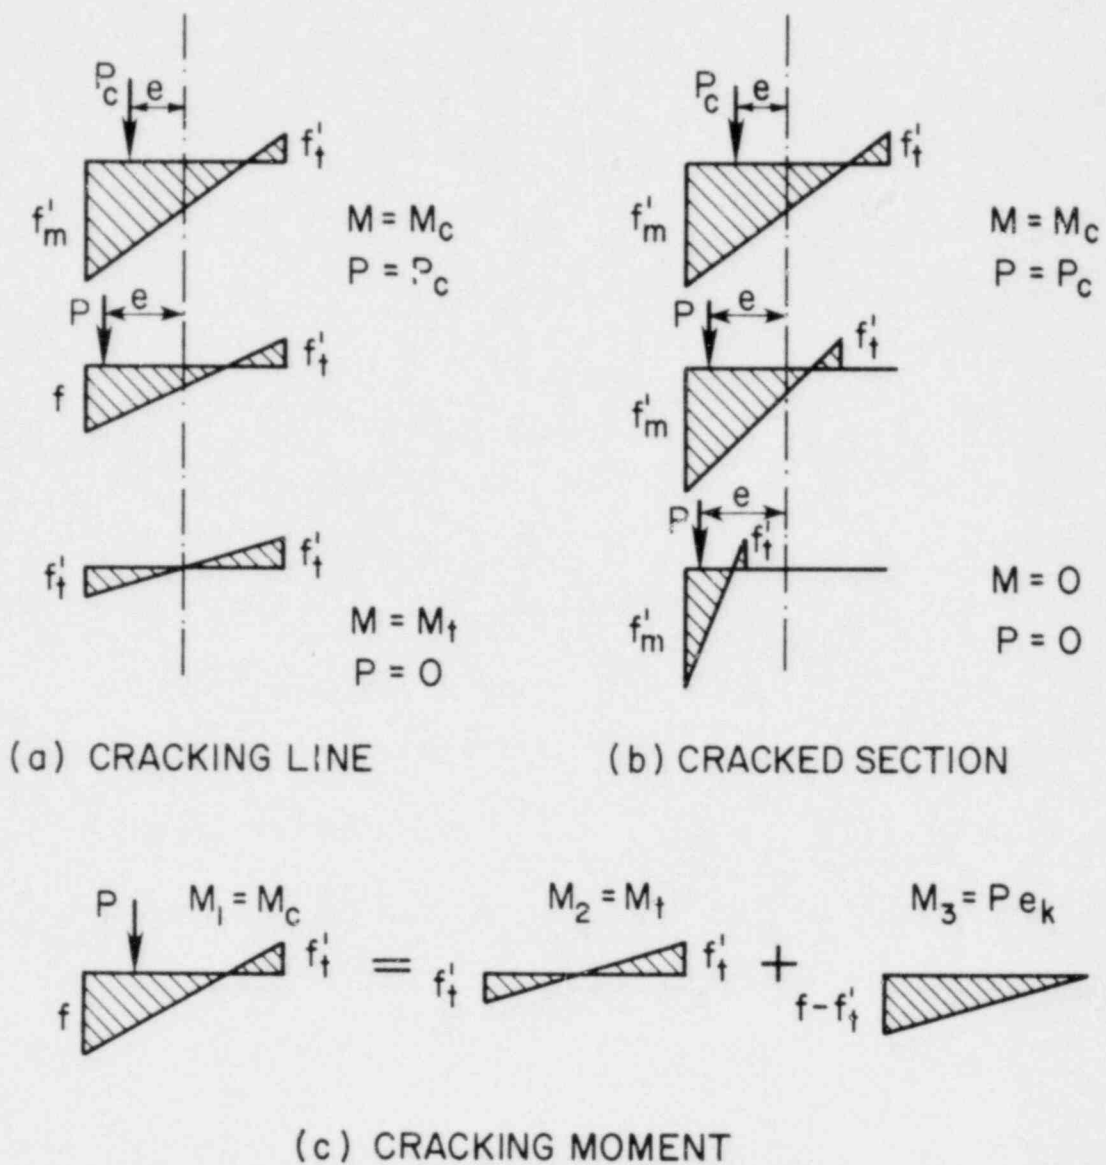
FIGURE B.2 CRITICAL STRESS STATES FOR AN UNREINFORCED INTERACTION DIAGRAM
