SUBJECT: CONTURA COAL WEST, LLC, FORMERLY KNOWN AS BLACKJEWEL, LLC,
NRC INSPECTION REPORT 030-32949/2019-001

CONTURA COAL WEST, LLC FORMERLY KNOWN AS BLACKJEWEL, LLC NRC
INSPECTION REPORT 030-32949/2019-001 – DATED FEBRUARY ____, 2020

Contura Coal West, LLC formerly known as Blackjewel, LLC
NRC Inspection Report 030-32949/2019-001

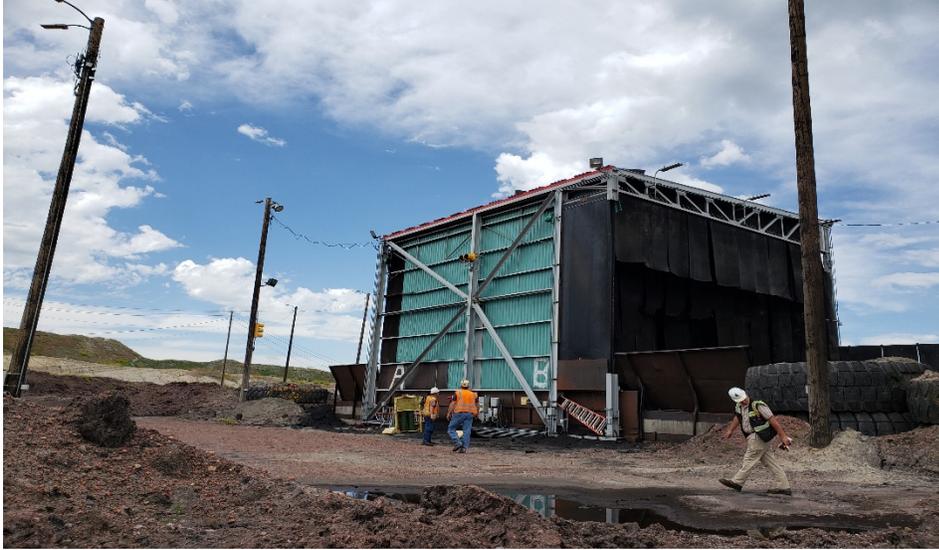
Picture 1: Outside Hopper Building at Belle Ayr Mine (approaching gauges)

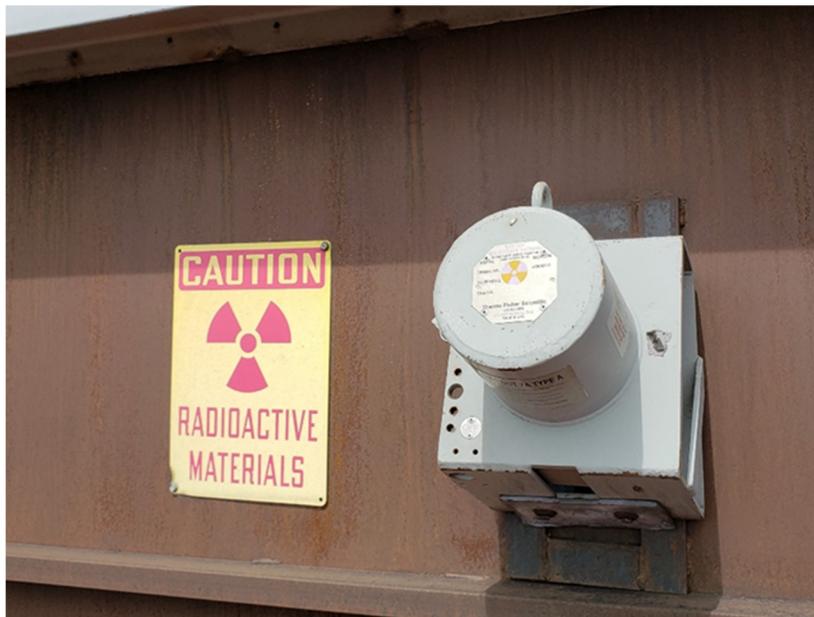
The Belle Ayr site had two Thermo Fisher Model 5207 gauges (Serial Nos. B455 and B456). Each gauge contains a Cesium-137 sealed source with a maximum activity of 2000 millicuries (mCi). These two gauges are in place to monitor hopper levels in Hoppers A and B, and are accessible from outside the hopper building. Dose rates measured adjacent to the gauges at Belle Ayr were a maximum 1.63 microrem/hr. [Pictures 1) approaching Hopper Building, and 2) showing how the gauges were accessible from outside the building].

The licensee conducted a safety briefing and distributed appropriate personnel protective equipment for the mine environment. The inspector accompanied the RSO to the Belle Ayr mine to see the two fixed gauges at that site. These two gauges were on the exterior of the hopper towards the back of the facility. The area was well travelled, and while the inspector was inspecting the gauges, several trucks came into or exited the area. The gauges are mounted to the wall of the hopper and are appropriately labelled. These are the only gauges at Belle Ayr.

Picture 2: Thermo Fisher Model 5207 gauge at Belle Ayr (outside Hopper Bldg.)

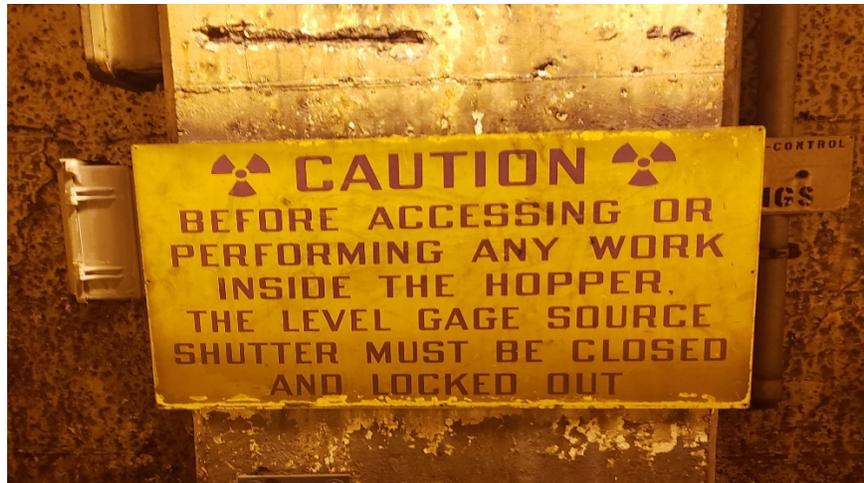
The Eagle Butte mine had four Thermo Fisher Model 5202 gauges (Serial Nos. B3453, B3454, B3455 and B3456). Each gauge contained a Cesium-137 sealed source with a maximum activity of 500 mCi. These gauges were in place to monitor hopper levels in Hoppers 1 thru 4 and were accessible via a ladder from inside the hopper building. [Pictures 3) Posting in Hopper Building, and 4) Gauge and ladder for Hopper 3]

Picture 3: Posting in Hopper Building at Eagle Butte Mine

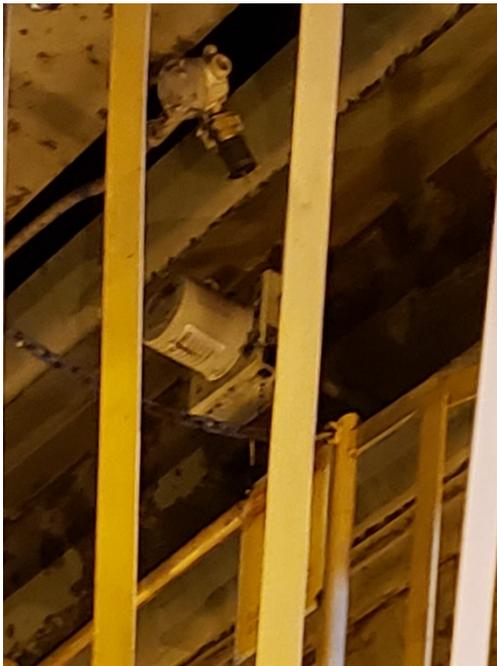
The inspector and RSO then returned to the Eagle Butte mine and entered the hopper building to see the gauges on the hoppers. These gauges were posted on the sides of tanks and accessible by ladder. There were four gauges in the hopper building at the Eagle Butte mine. Each of these gauges were appropriately labelled and fixed in place with a locking mechanism. The inspector and RSO then exited the hopper building and walked across the site to the processing building.

Picture 4: Gauge in Hopper Building at Eagle Butte Mine

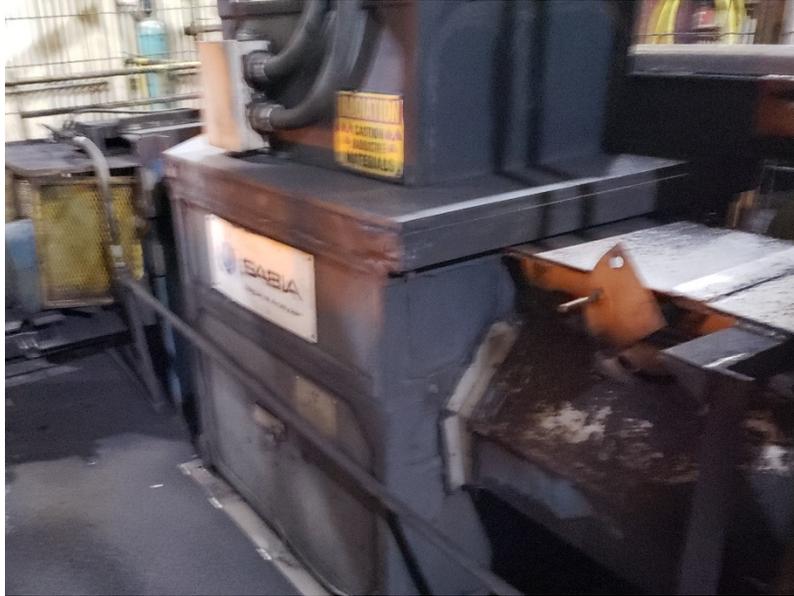
The Eagle Butte mine also possessed a Sabia Model X1 Materials Analyzer in the processing building. This device contained four Californium-252 sealed sources with a maximum activity of 27 mCi per source. [Picture 6) Sabia unit in Processing Building]

The Sabia unit (Model X1) was located on the eighth floor. The gauges were internal to the Sabia unit, the inspector observed that the Sabia unit was appropriately labelled and access to the internal of the unit were secured with a locking mechanism. Radiation dose rate measurements were taken with a Thermo Radeye G-Gamma Survey Meter (Serial No. 086960 Calibration due date April 20, 2020). The postings found on, near, or

Picture 5: Sabia unit in Processing Building
