NUREG/CR-2716  
PNL-4275-1  
Vol. 1

# Reactor Safety Research Programs

Quarterly Report  
January - March 1982

Pacific Northwest Laboratory  
Operated by  
Battelle Memorial Institute

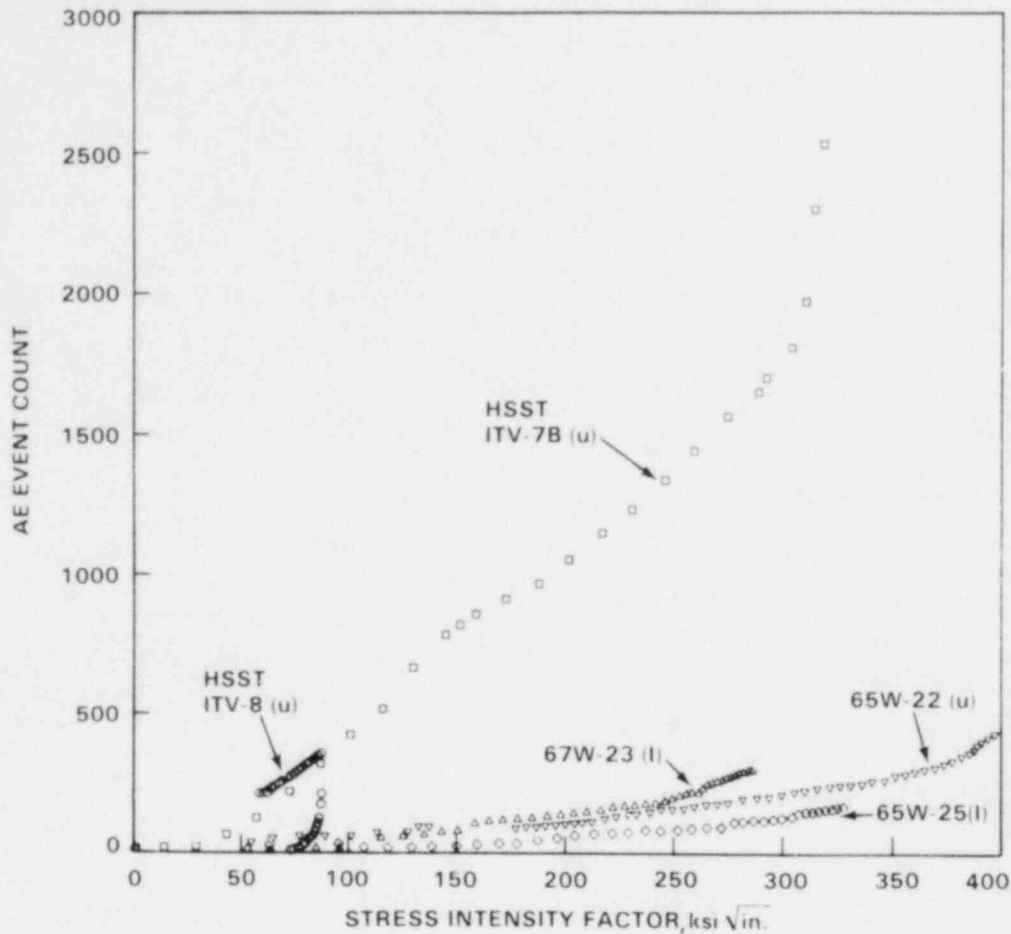
**Figure 1.** AE Event Count Versus Stress Intensity Factor for NRL Irradiated and Unirradiated Fracture and HSST Vessel Tests

Data obtained from monitoring J-integral fracture tests performed at the Naval Research Laboratory (NRL) on irradiated 4T-CT specimens (originally reported in Reference 2) were further analyzed. Data obtained from unirradiated specimens that were contaminated with noise were also re-examined. It was concluded that data for the loading portion of the test sequence were adequate for a preliminary comparison of AE from irradiated and unirradiated material (see Figure 1). There does not seem to be a great difference in AE between the two material conditions; however, one of the remaining unirradiated test specimens will be monitored to verify this indication.

AE data measured from fracture testing the HSST V-7B and V-8 vessels are also shown in Figure 1. The much increased level of AE from a structure with a surface flaw compared to a laboratory specimen with a through-wall flaw is consistent with our experience, but a total explanation for the difference is still not obvious.

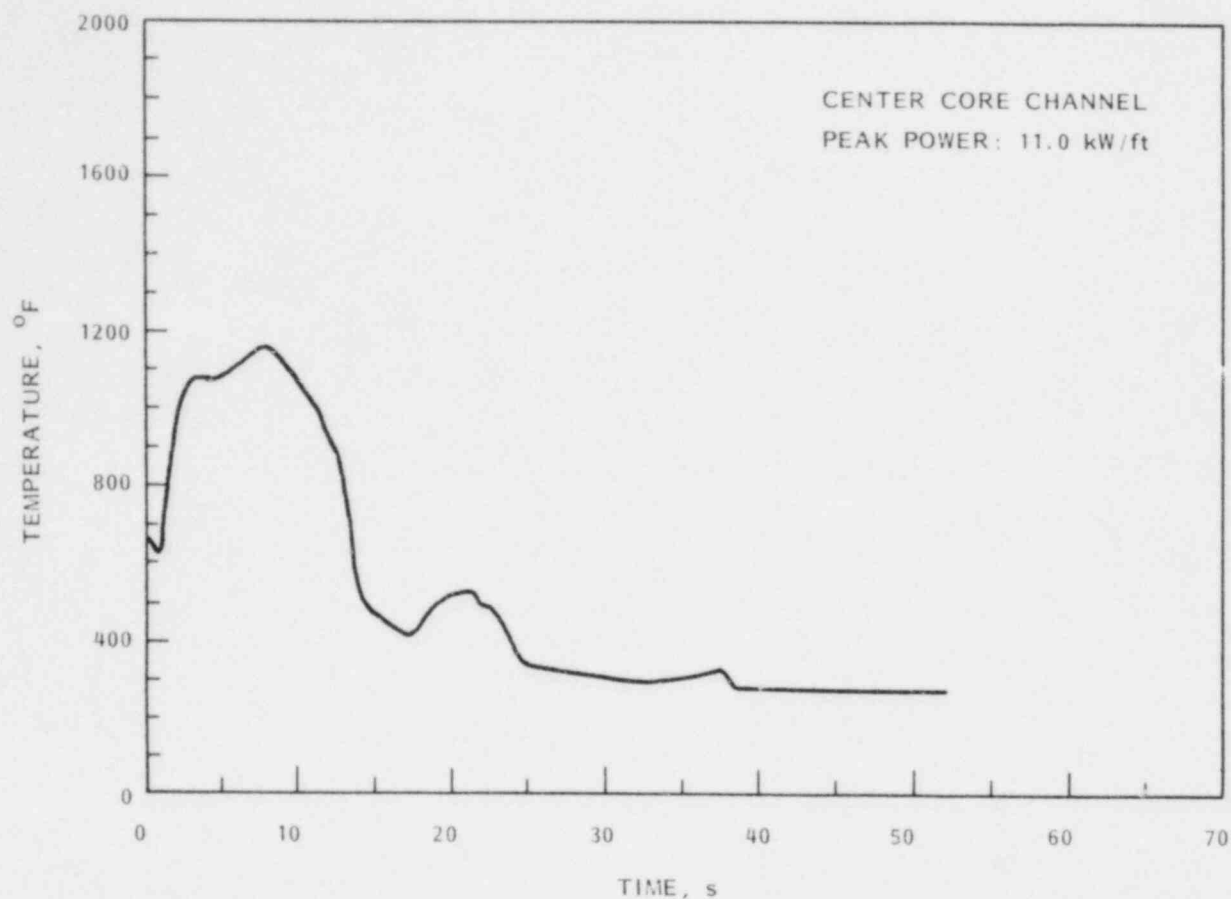
**Figure 1.** Hot Rod Peak Cladding Temperature

This calculation demonstrated COBRA/TRAC's ability to simulate full-scale 3-D systems. Many phenomena were predicted, including upper head flashing, downcomer bypass, and lower plenum level swell. Condensation and CCFL played key roles in the UHI water delivery behavior. Condensation in the upper head limited the UHI delivery and separated each of the three delivery periods while CCFL at the upper tie plate nozzle delayed the initial UHI delivery and prevented UHI penetration during bottom reflood. The peak cladding temperature for this calculation was 1180°F.

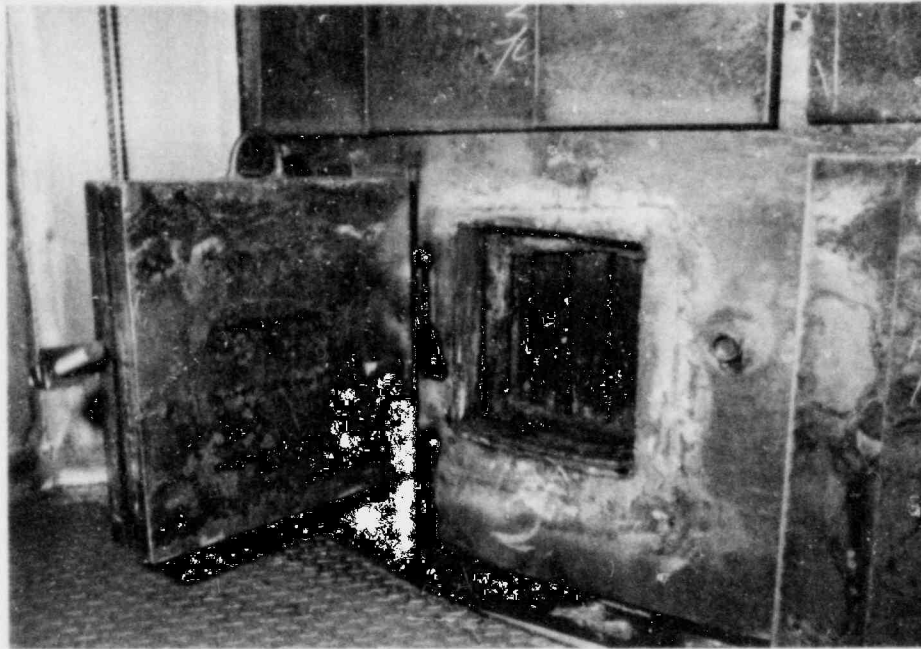
Neg 8201521-7cn

**Figure 7.** Reopened Preshipment Penetration Showing Reusable Shielding Door and Added Side Shielding

After the generator was placed in the SGEF, the first task was to reopen the preshipment penetrations and assess any change of condition or damage that had occurred during barge transport to Hanford, interim storage at Hanford, or placement in the SGEF. Dimensional data taken showed no change in measurements from those acquired at Surry; visually, corrosion product coloring looked unchanged, and there was no evidence that water damage had occurred during transport. There was, as expected, some indication that loose debris had relocated within the secondary side, including loose scale/sludge and metallic parts that had previously broken away from the secondary structure. The only noted mechanical change was that several tight inner row U-bends that were cracked during the preshipment examination had now opened. No dislocation in the upper support plate was measured. Figures 7 through 10 depict results of this task.

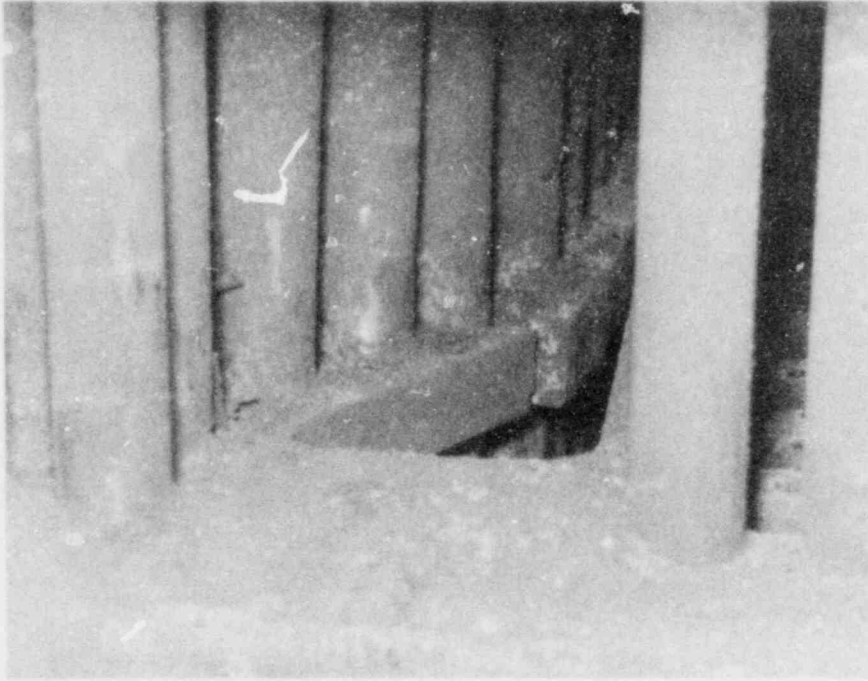
Neg. 8200722-8cn

**Figure 9.** First Support Plate at Flow Slot
