RETIREMENT OF THE ENRICO FERMI
ATOMIC POWER PLANT

Supplement 1

Power Reactor Development Company
Newport, Michigan (USA)

Supplement 1 to Report NP-20047 describes the decommissioning activities performed by Power Reactor Development Company (PRDC) from March 1974 through October 1975 relating to the retirement of the Enrico Fermi Atomic Power Plant (EFAPP or Fermi-1). The major decommissioning tasks undertaken and reported are the following:

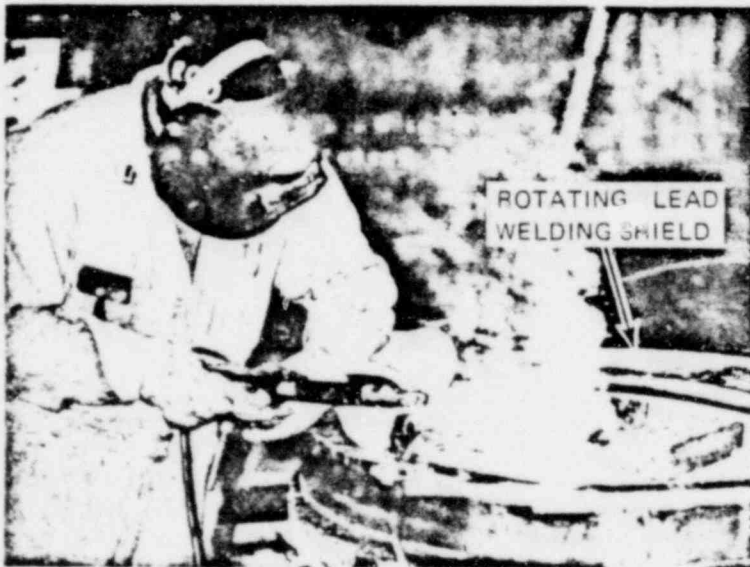
FIG. 7 SEAL-WELDING THE BASKET CONTAINER IN CASK

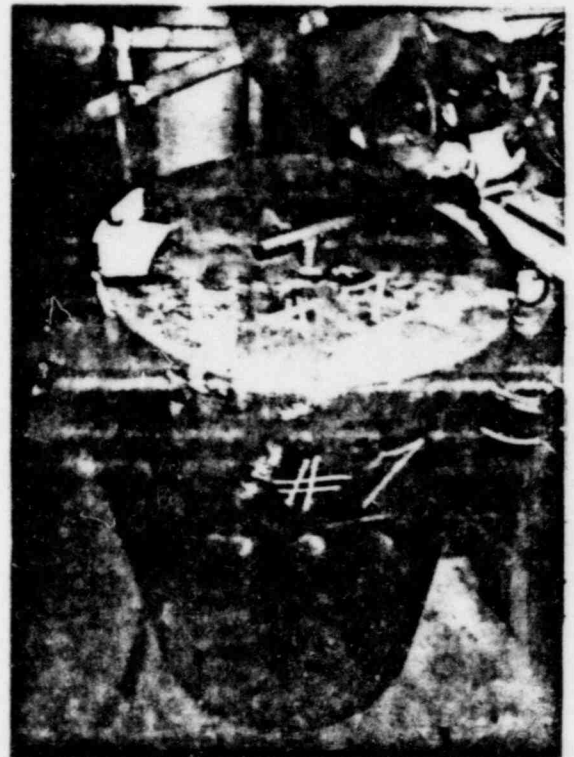
FIG. 12 NOZZLE CONTAINER FOR B-3
SHIPPING CASK

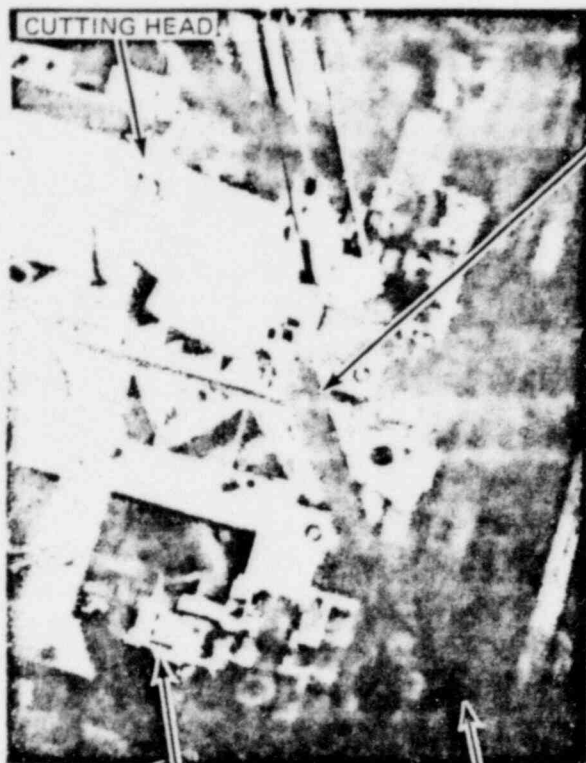
UPRIGHT SUB-
ASSEMBLY READY
FOR TRANSFER

FIG. 17 CUTUP MACHINE IN CUTUP POOL
(UNDERWATER)

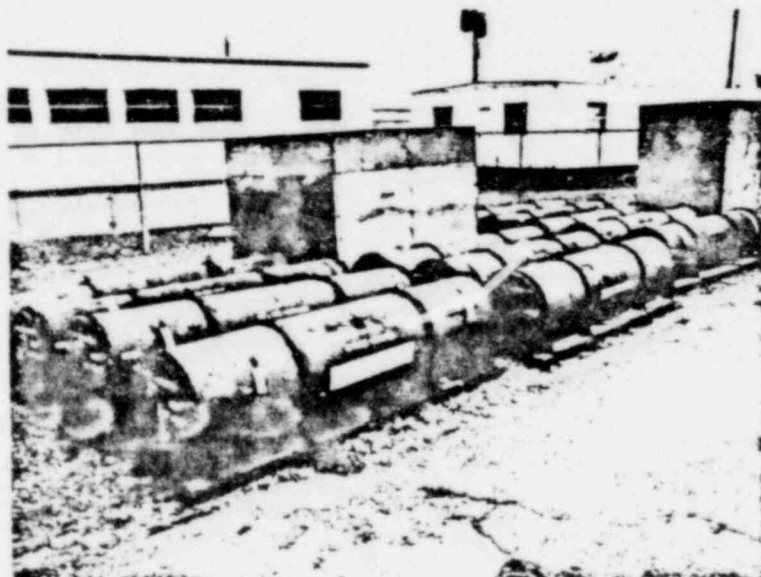
FIG. 19 CONTAINERS AWAITING USE FOR
PACKAGING CONTAMINATED SCRAP

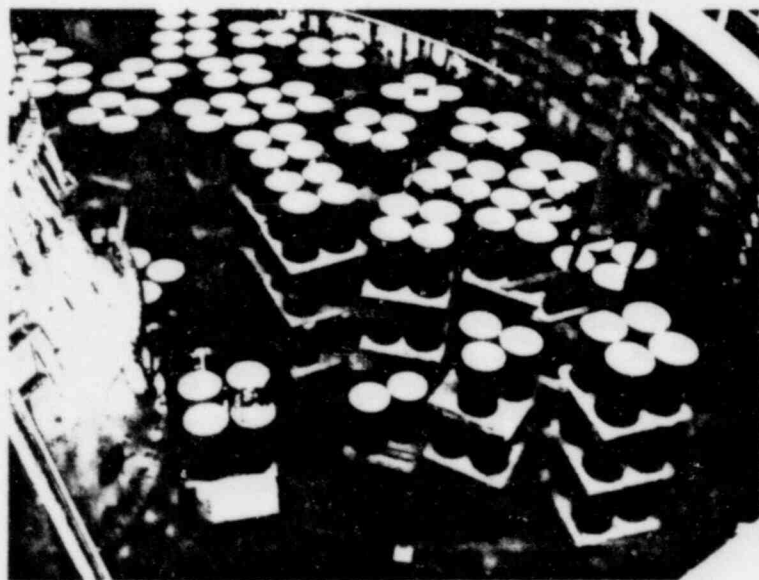
FIG. 25 THREE-TIER STORAGE OF REFINISHED DRUMS IN REACTOR BUILDING

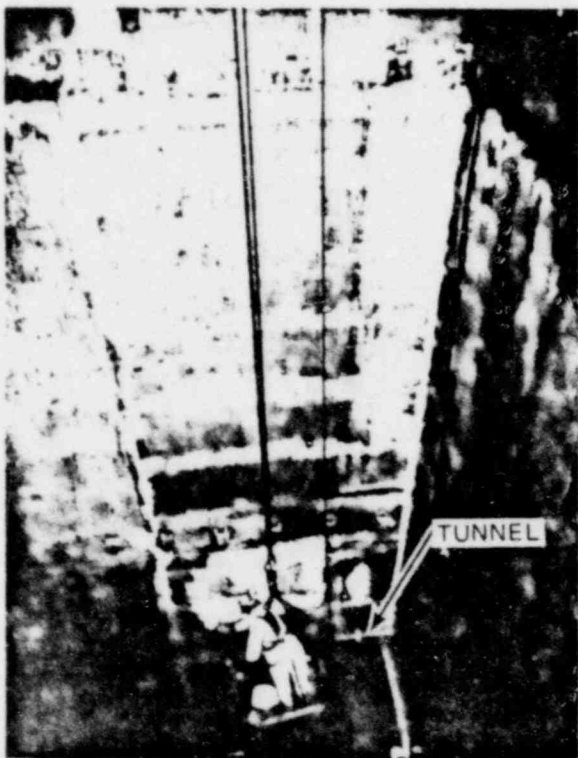
FIG. 28 ROLLER PAINTING THE DECAY POOL
AND TUNNEL BETWEEN POOLS

Subsequent to the final cleaning and drying of the decay pool, a 20-mil-thick layer of Cooks Spray Booth Shield White strippable paint was applied in several coats to all surfaces of the decay pool walls, floor, and tunnel, as indicated in Figure 28. Approximately 50 gallons of paint were applied using hand rollers. Personnel wore coveralls and oxygen breathing masks and worked from a hanging cage. Additional air horns were provided for ventilation during the painting process. The decay pool room cleanup started in May and was completed July 23, 1975.

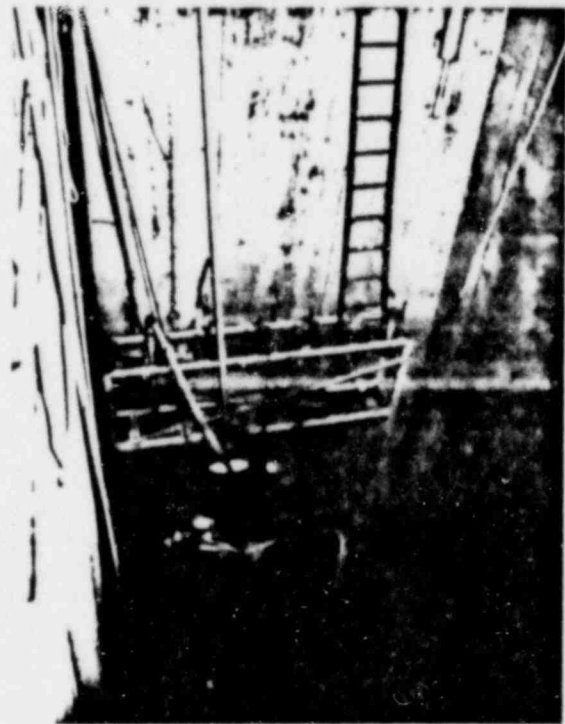
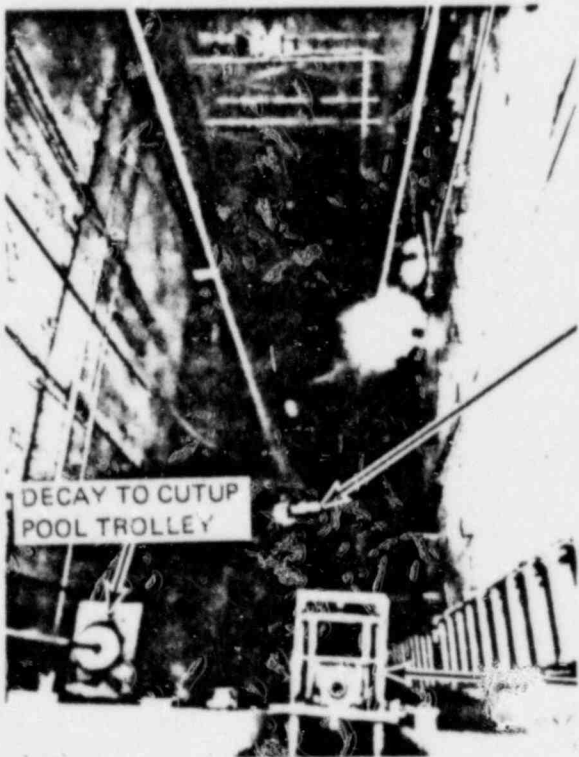
BELLOWS PUMP
HANGING ABOVE
WATER SURFACE

FIG. 31 PUMPING WATER AND CHIPS FROM
FLOOR OF CUTUP POOL USING
BELLOWS PUMPS
