NEDC-21463-1

**EVALUATION OF NEAR-TERM
BWR PIPING REMEDIES
FIRST SEMIANNUAL
PROGRESS REPORT
APRIL — SEPTEMBER 1976**

**EVALUATION OF NEAR-TERM
BWR PIPING REMEDIES**

**First Semiannual Progress Report
April — September 1976**

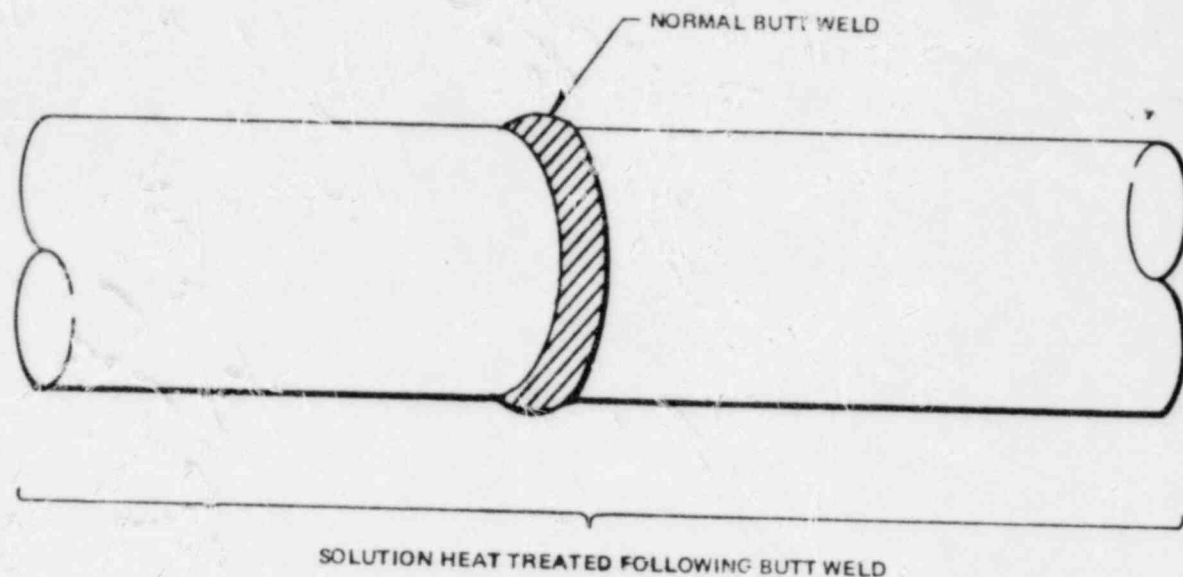
Figure 1. Application of Solution Heat Treatment of Type-304 Stainless Steel Pipe Welds

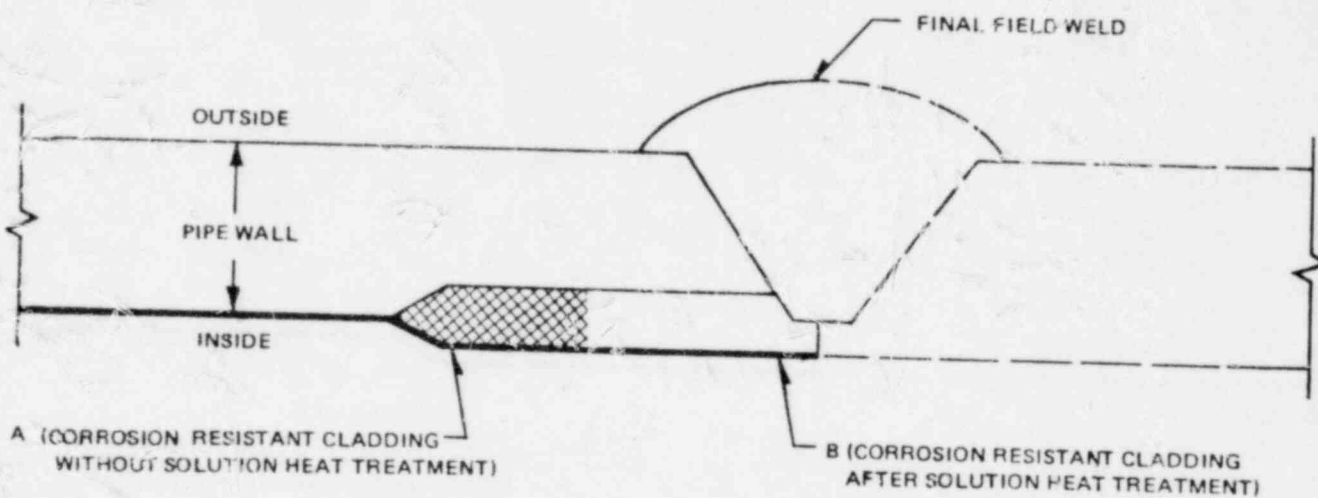
Figure 2. Corrosion Resistant Cladding Process for Type-304 Stainless Steel Welded Piping

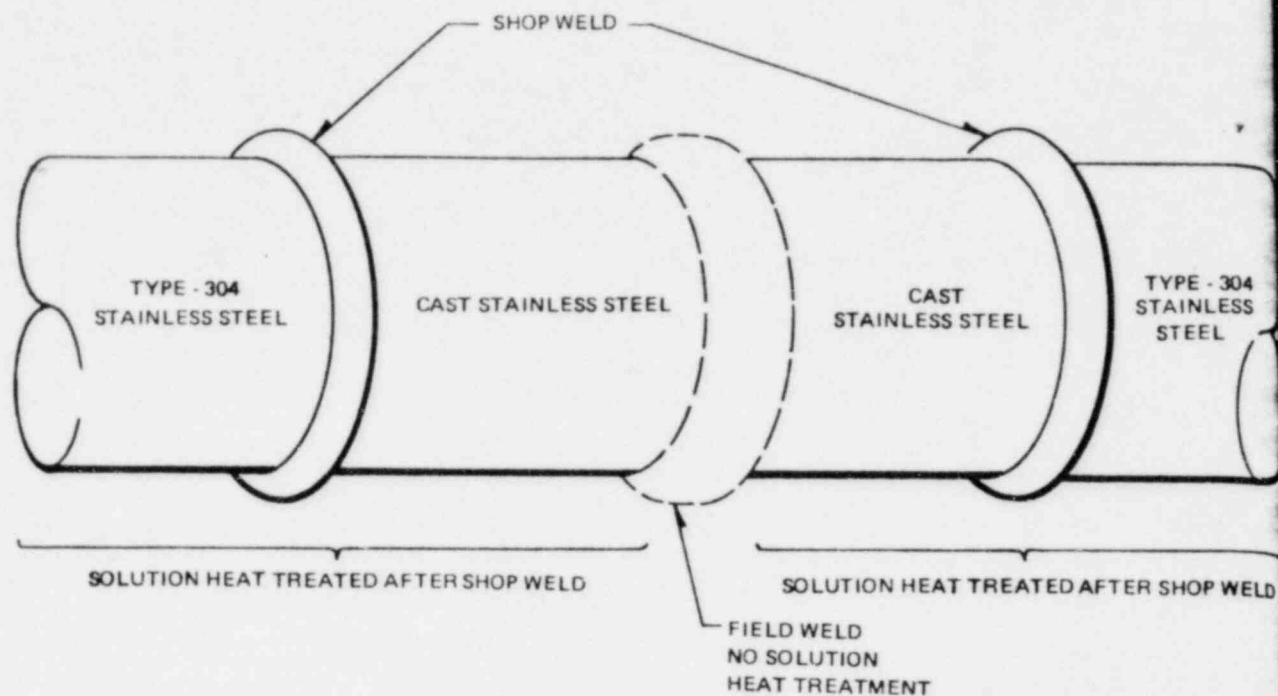
Figure 3. Application of Cast Transition Piece Candidate Remedy to Type-304 Stainless Steel Pipe Welds

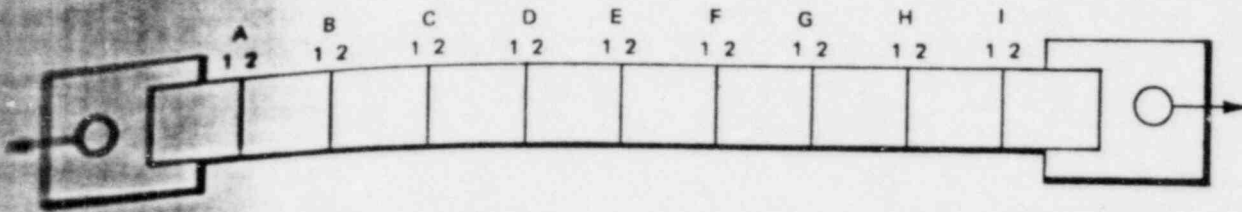
Figure 4. Weld Identification for Large Environmental Fatigue Pipe Tests

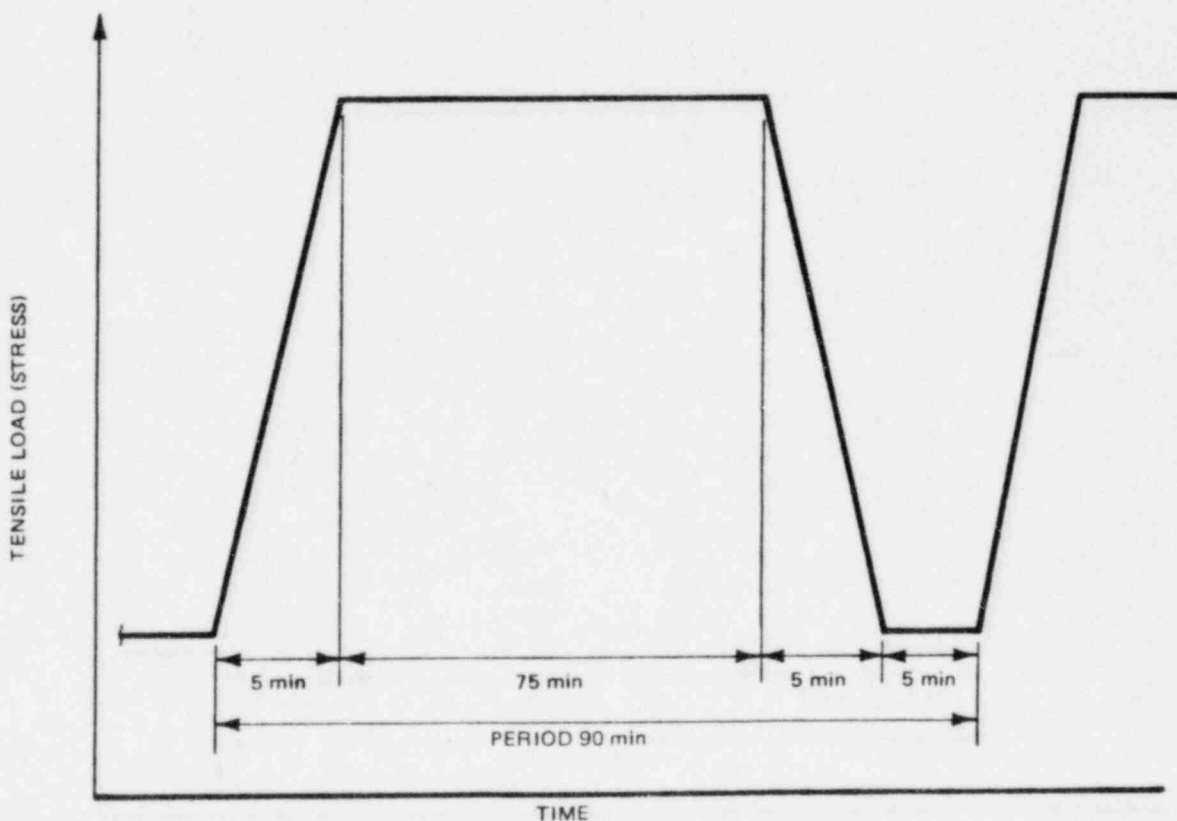
Figure 6. Cyclic Test Waveform

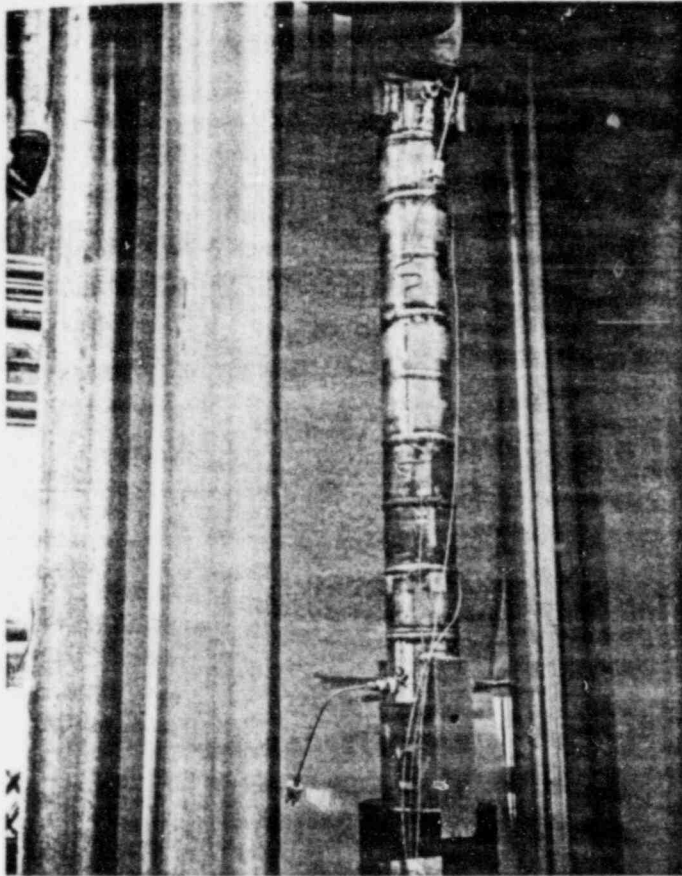
Figure 10. Another View of Pipe Weldment Shown in Figure 9

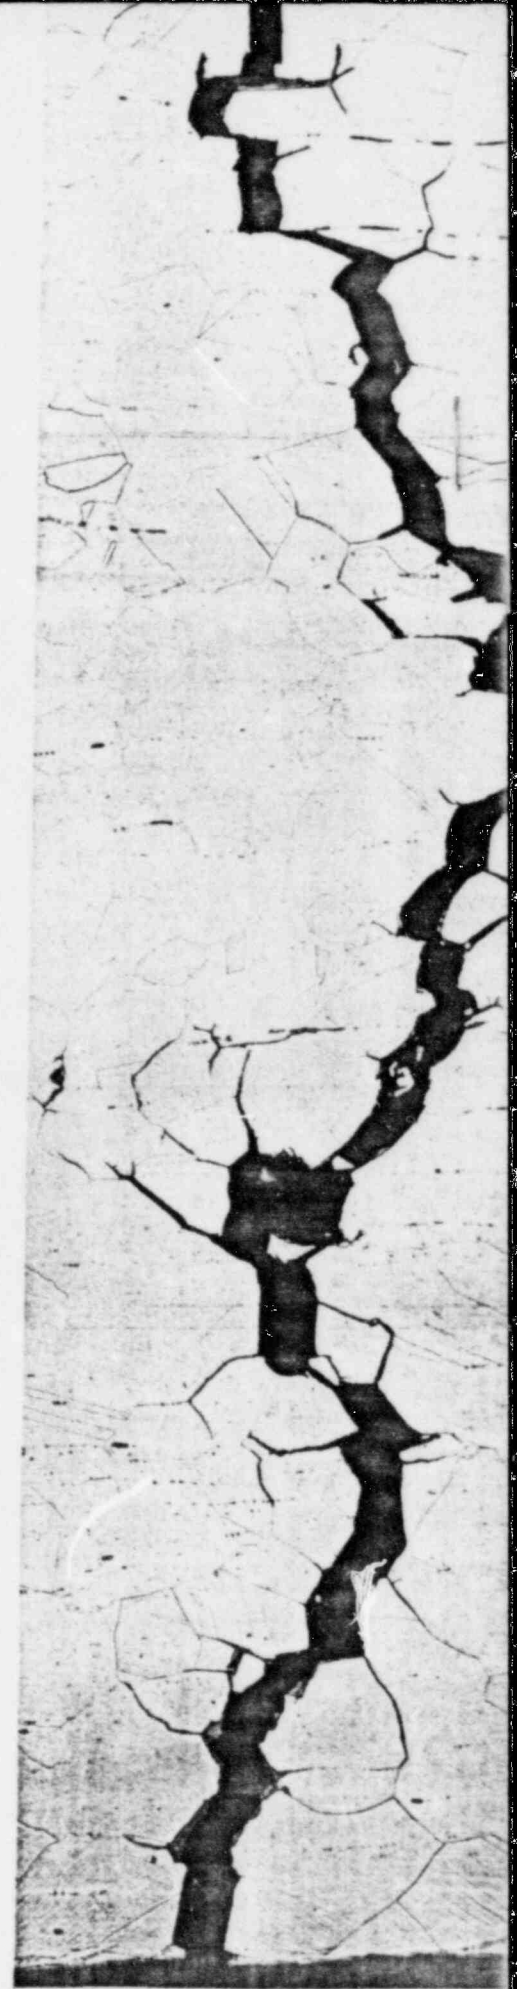
Figure 12. Macro Phot.
Crack in T₁
Weld Heat A
120 to 180 C.

A typical crack in the reference unprotected Type-304 stainless steel weld heat affected zone (Weld E2') is presented in Figures 12 and 13. As seen in Figure 12, multiple cracking at a distance of 0.2 to 0.3 inch from the weld fusion line occurred. A micro section shown in Figure 13 shows a typical intergranular crack to a depth of 51 mils (0.13 cm). The cracking in this pipe occurred at 175% of the 288°C (550°F) yield strength. No grinding was performed on this weld.

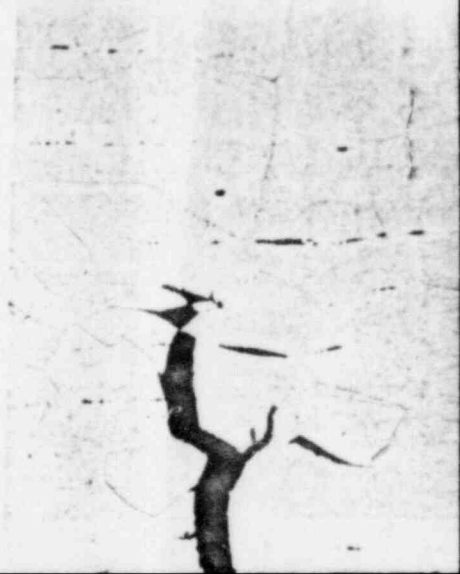
Figure 12. Macro Photograph of Intergranular Crack in Type-304 Stainless Steel Weld Heat Affected Zone, Side E2', 120 to 180 Degrees

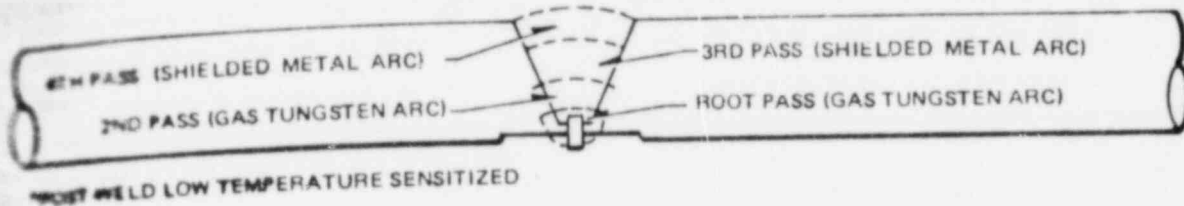
Figure 20 Test Weldment for Fourth Cyclic Tension Test in Large Environmental Fatigue Test Facility

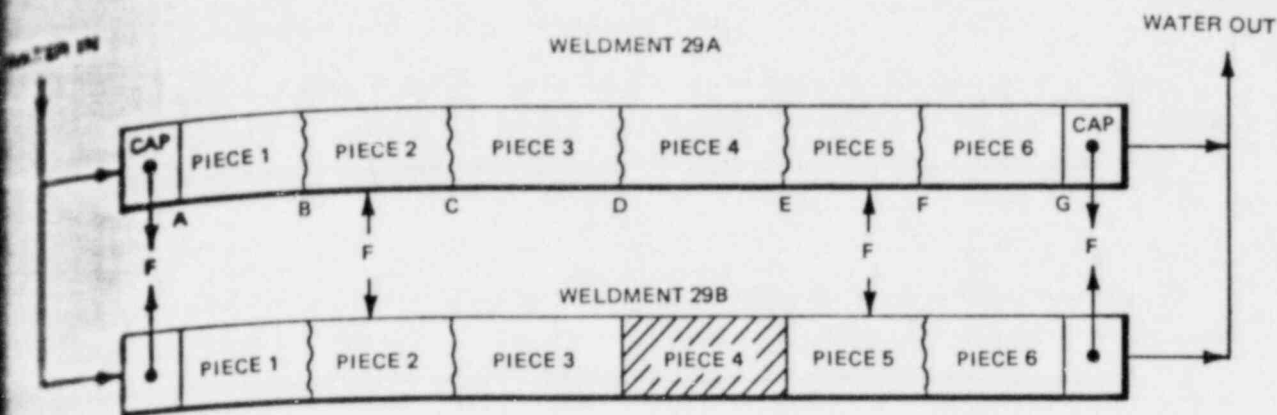
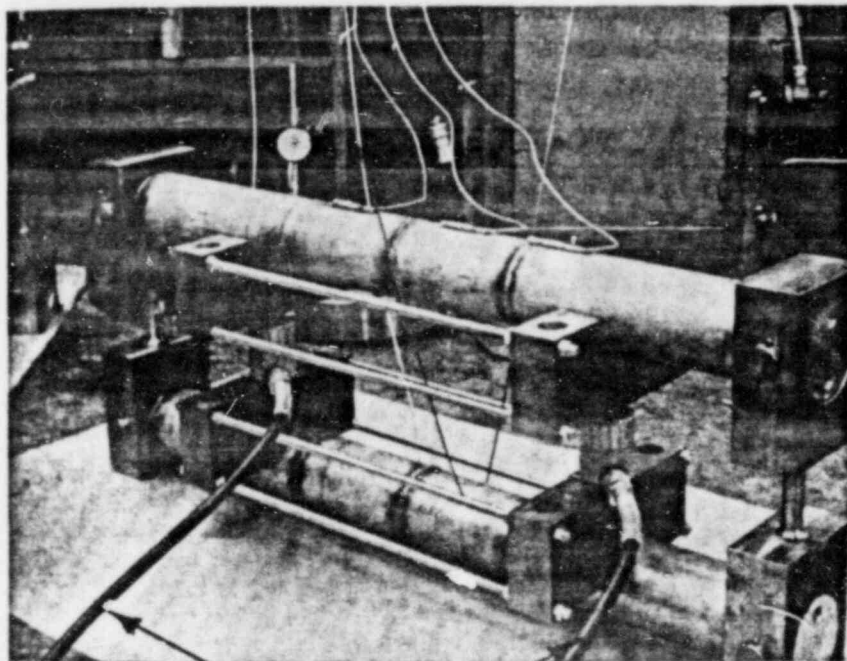
Figure 22. Four-Point Static Bend Test Pipe Weldments Set in Position

The four-point bend test fixture used for the third four-point bend pipe test was a fixture similar to that shown in Figure 22 for the second four-point pipe bend test. In this bend test pipe set, the corrosion resistant cladding pipe remedy was the principal remedy evaluated, as an overlay using both Type-308L stainless steel and Type-312 stainless steel for cladding material. A drawing of the procedure used for applying the overlay is shown in Figure 25. In Figure 25, clad region A was solution heat treated following the cladding operation (as shown in the marked region of the figure) and region B was then

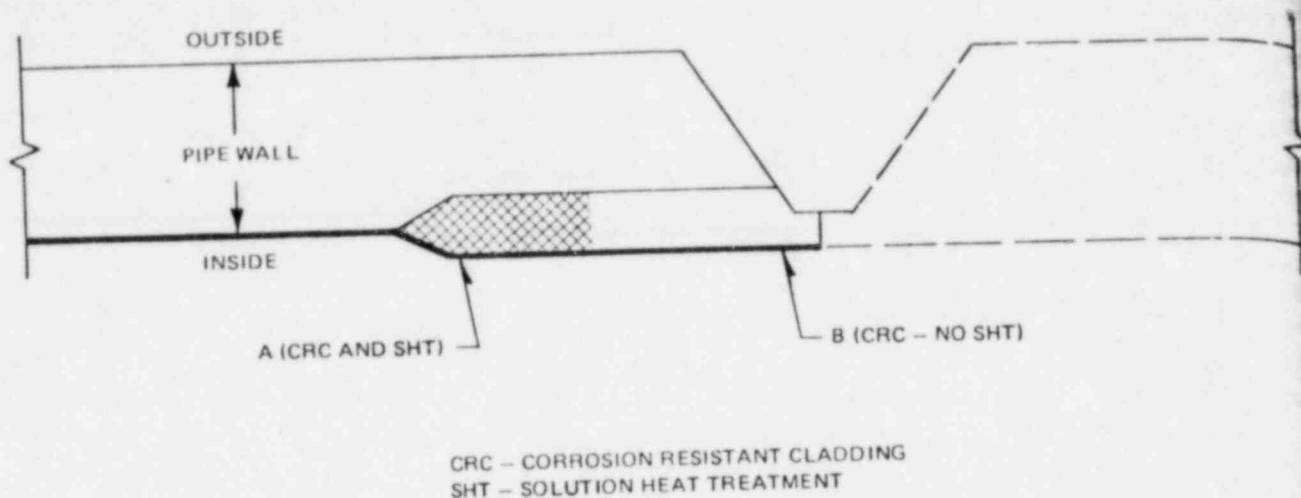
Figure 25. Cladding Process for Third CL-4 Pipe Bend Test

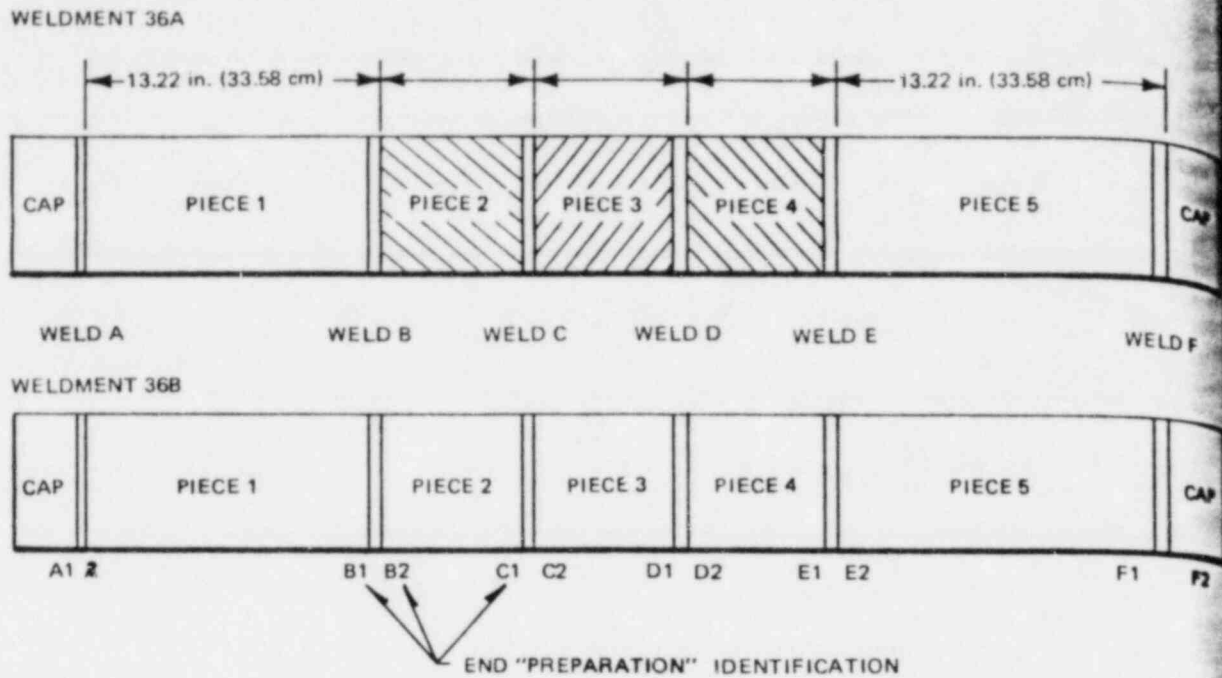
Figure 26. Test Weldments for Third Full-Size Pipe Bend Test in CL-4 Test Facility

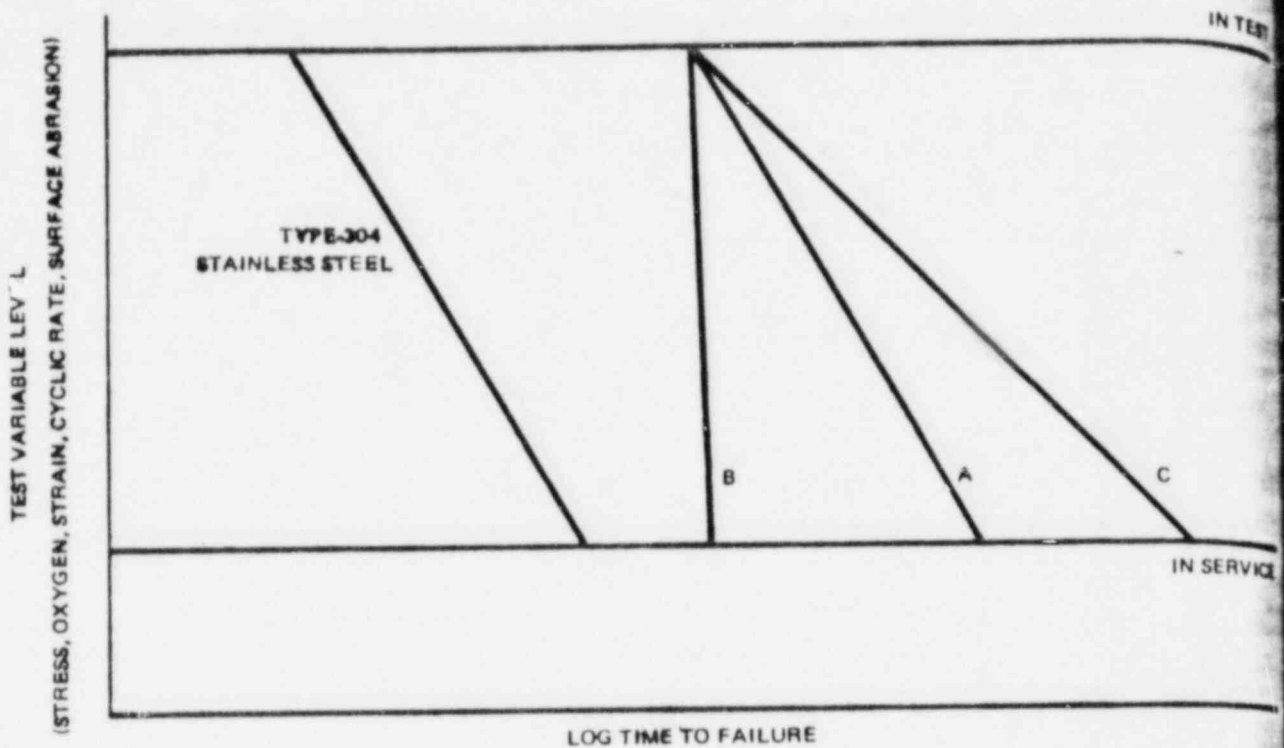
Figure 27. Possible Effect of Accelerants on Type-304 Stainless Steel and on an Alternate in Test and in Service

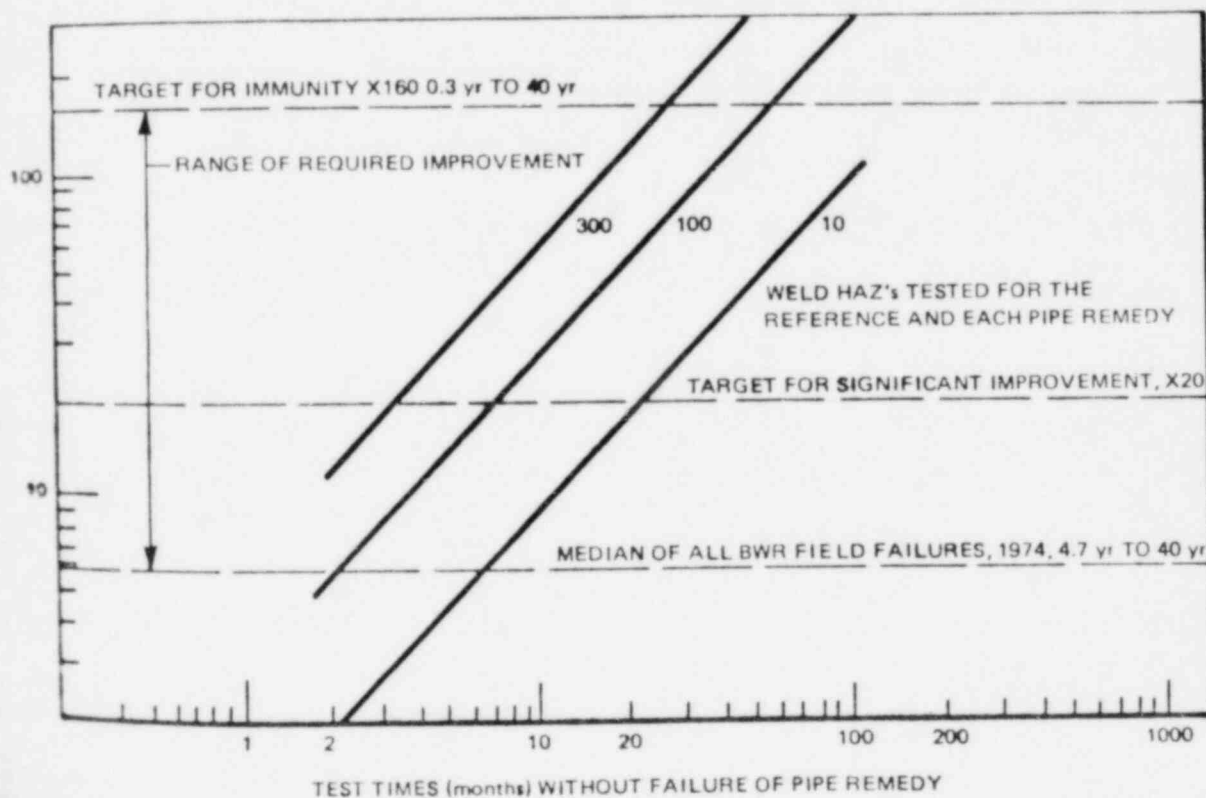
Figure 28 Test Parameters for Statistical Qualification of Factor Improvement in Pipe Crack Remedies

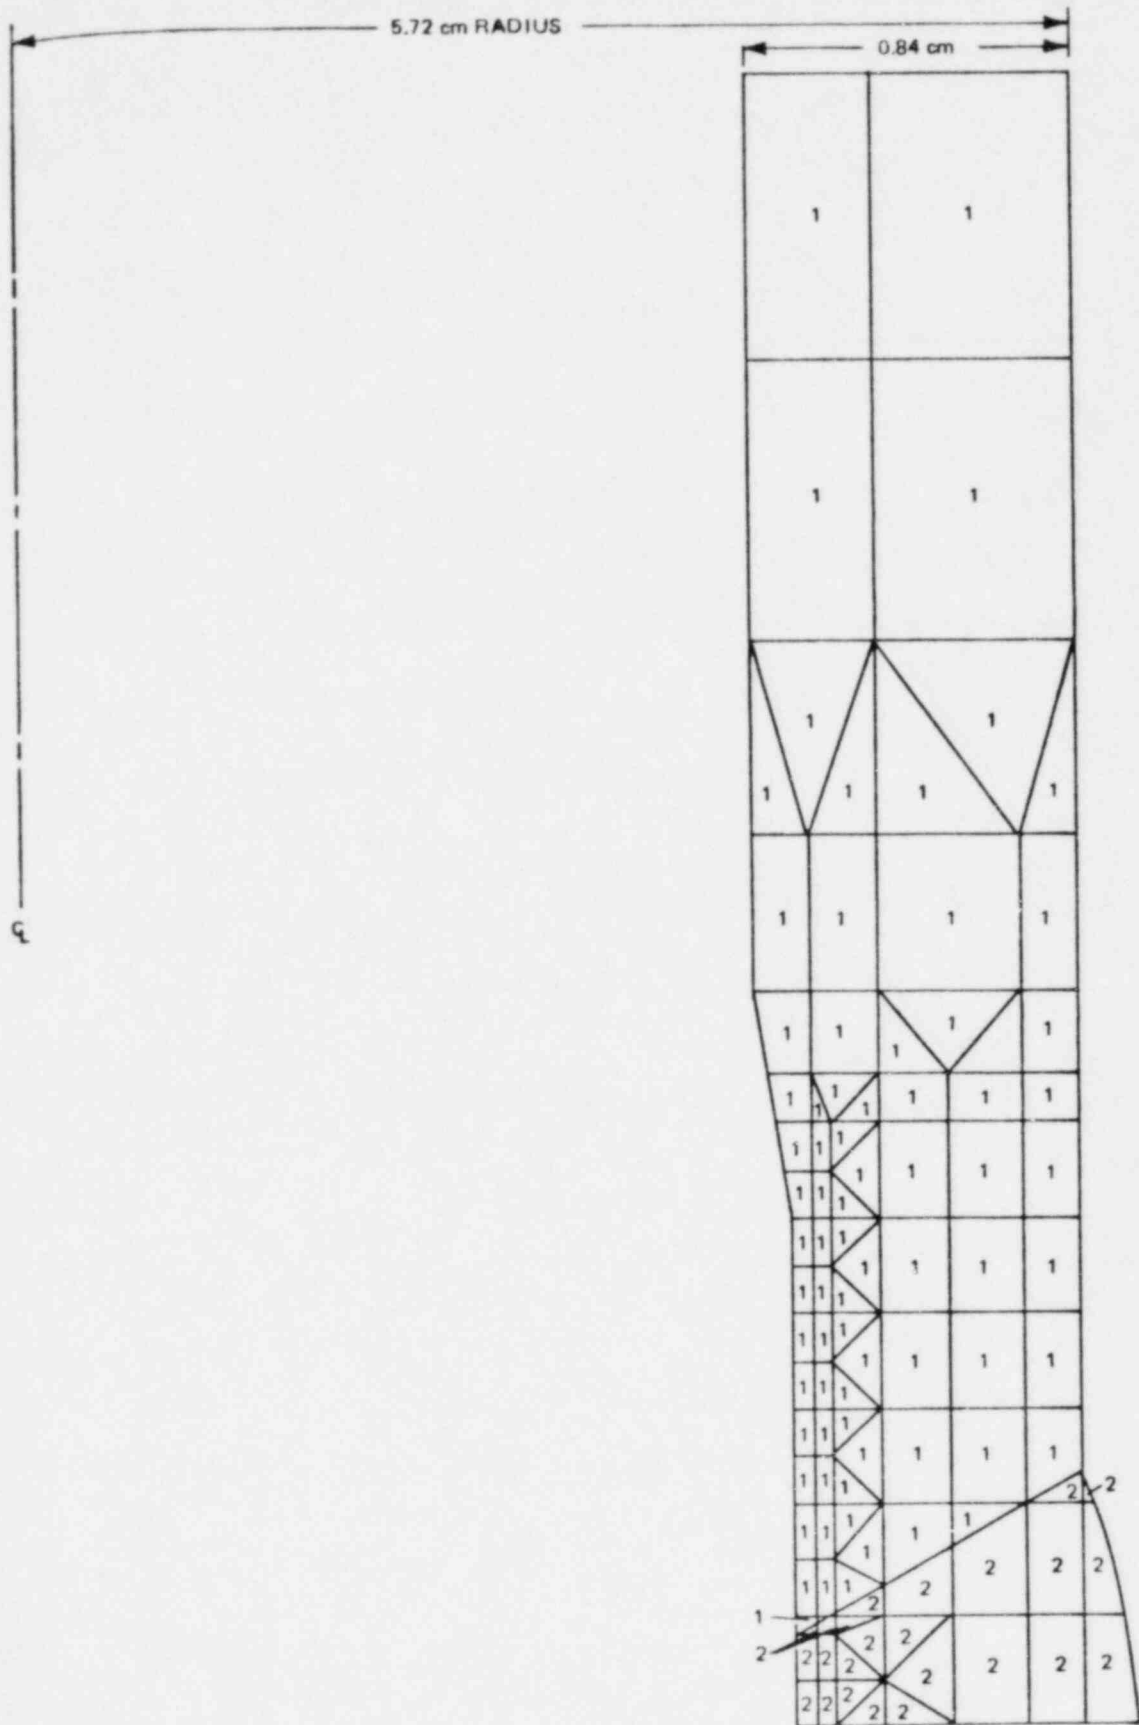
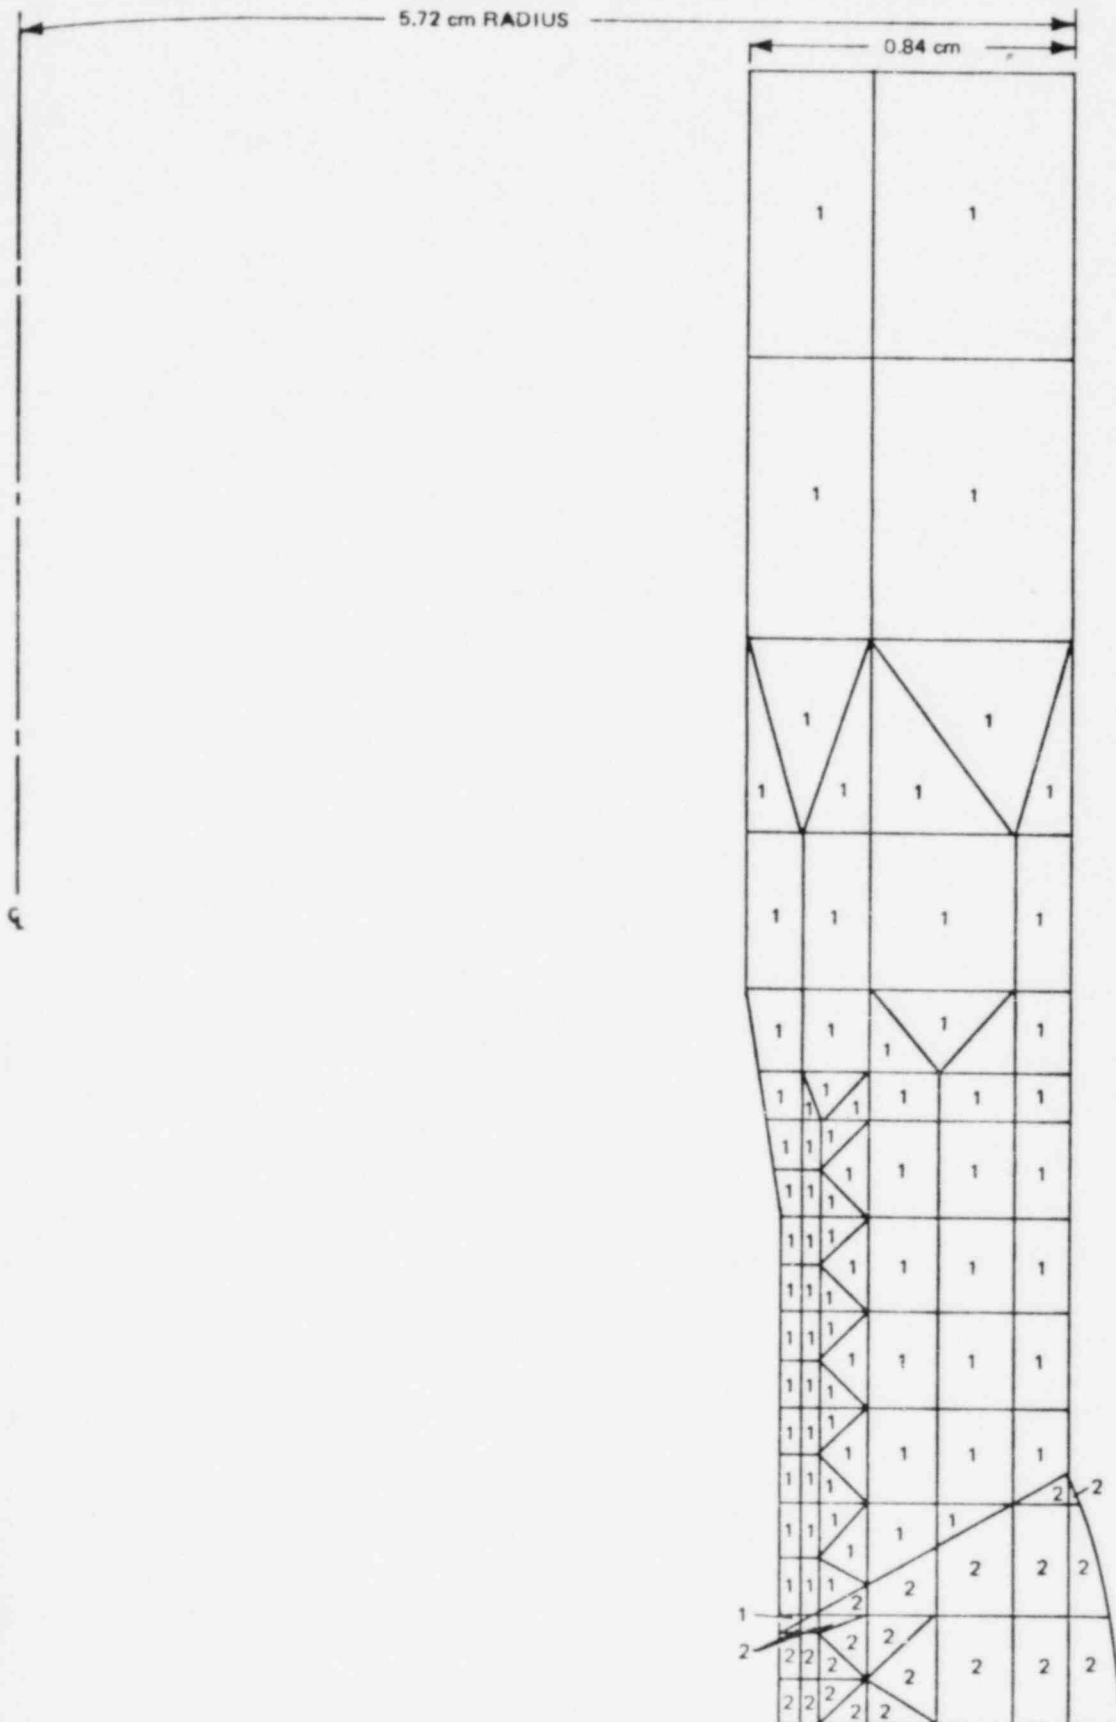
Figure 29. 10.16-cm-Diameter Schedule 80 Pipe Finite Element Weld Constraint Model

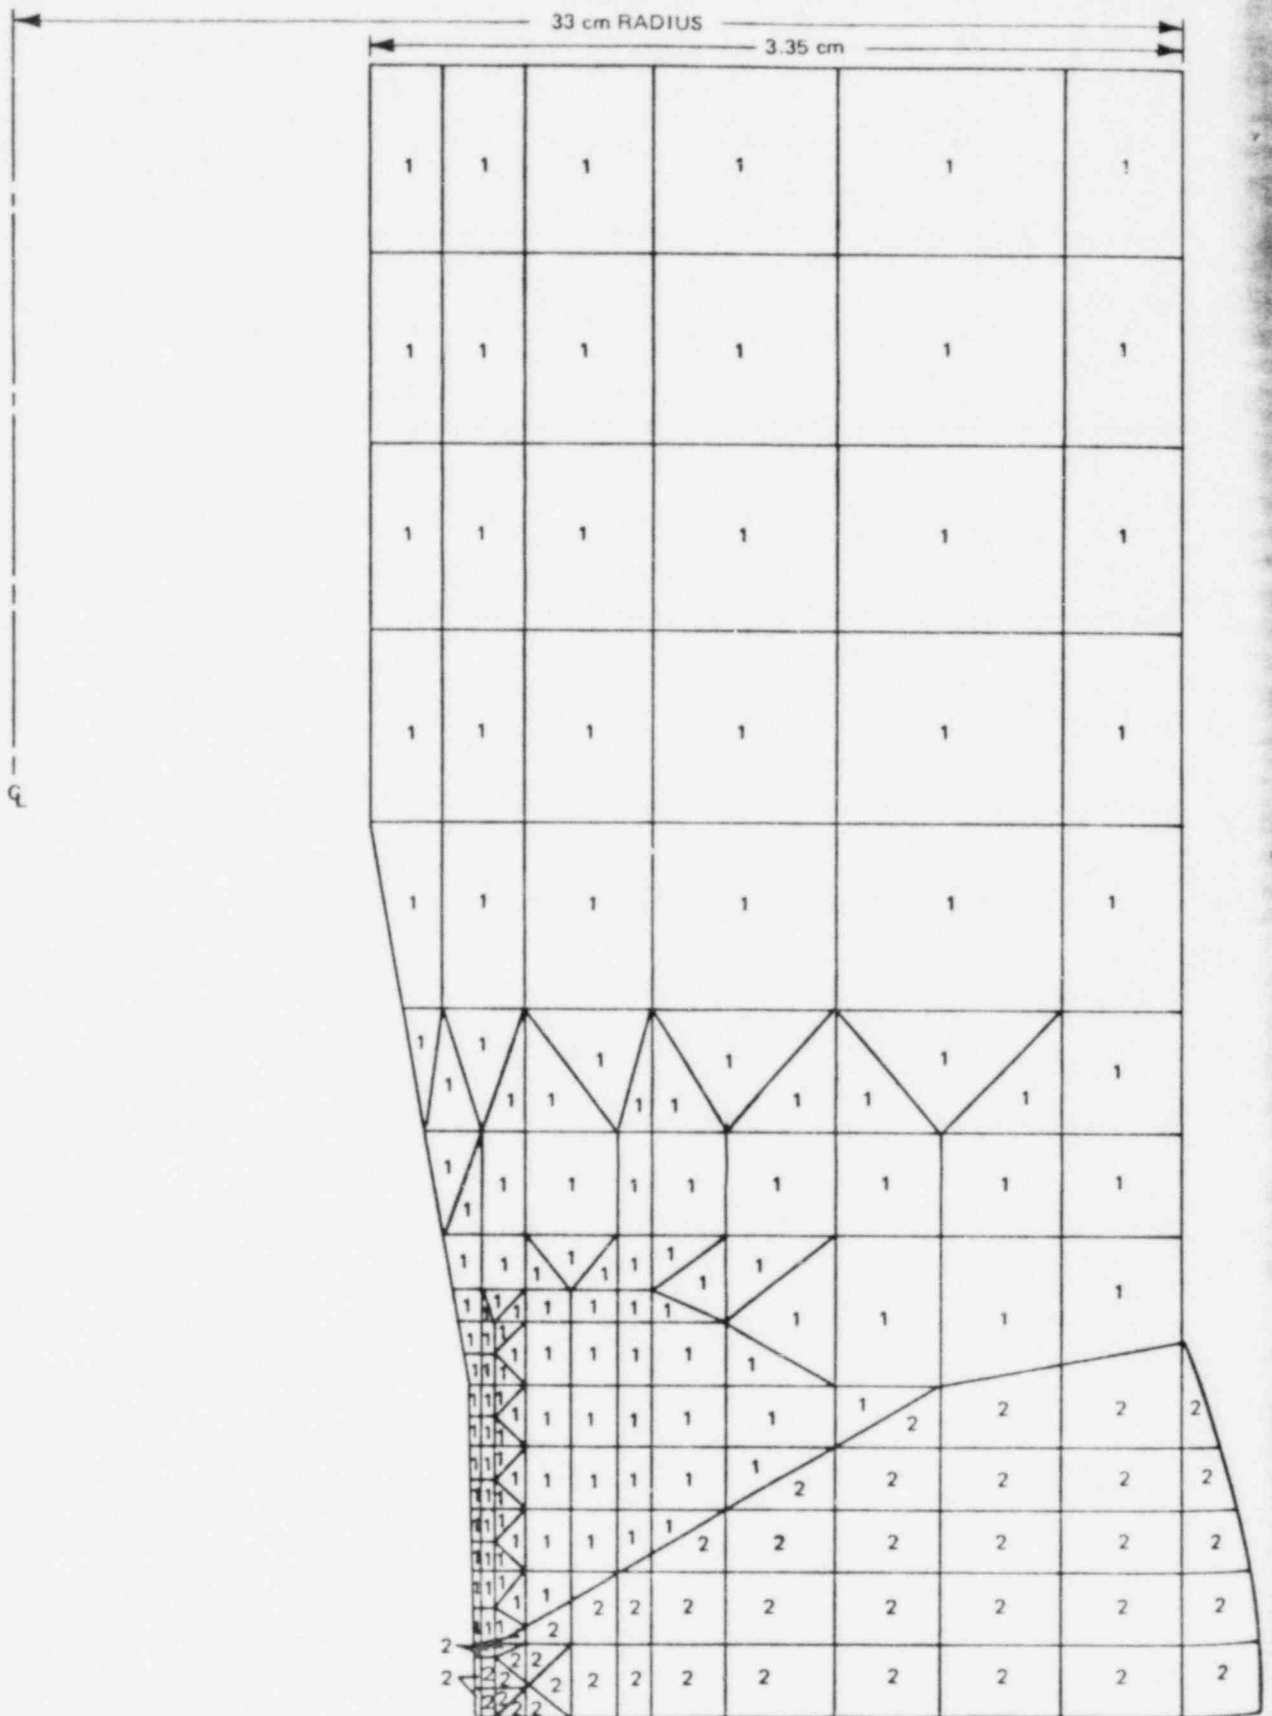
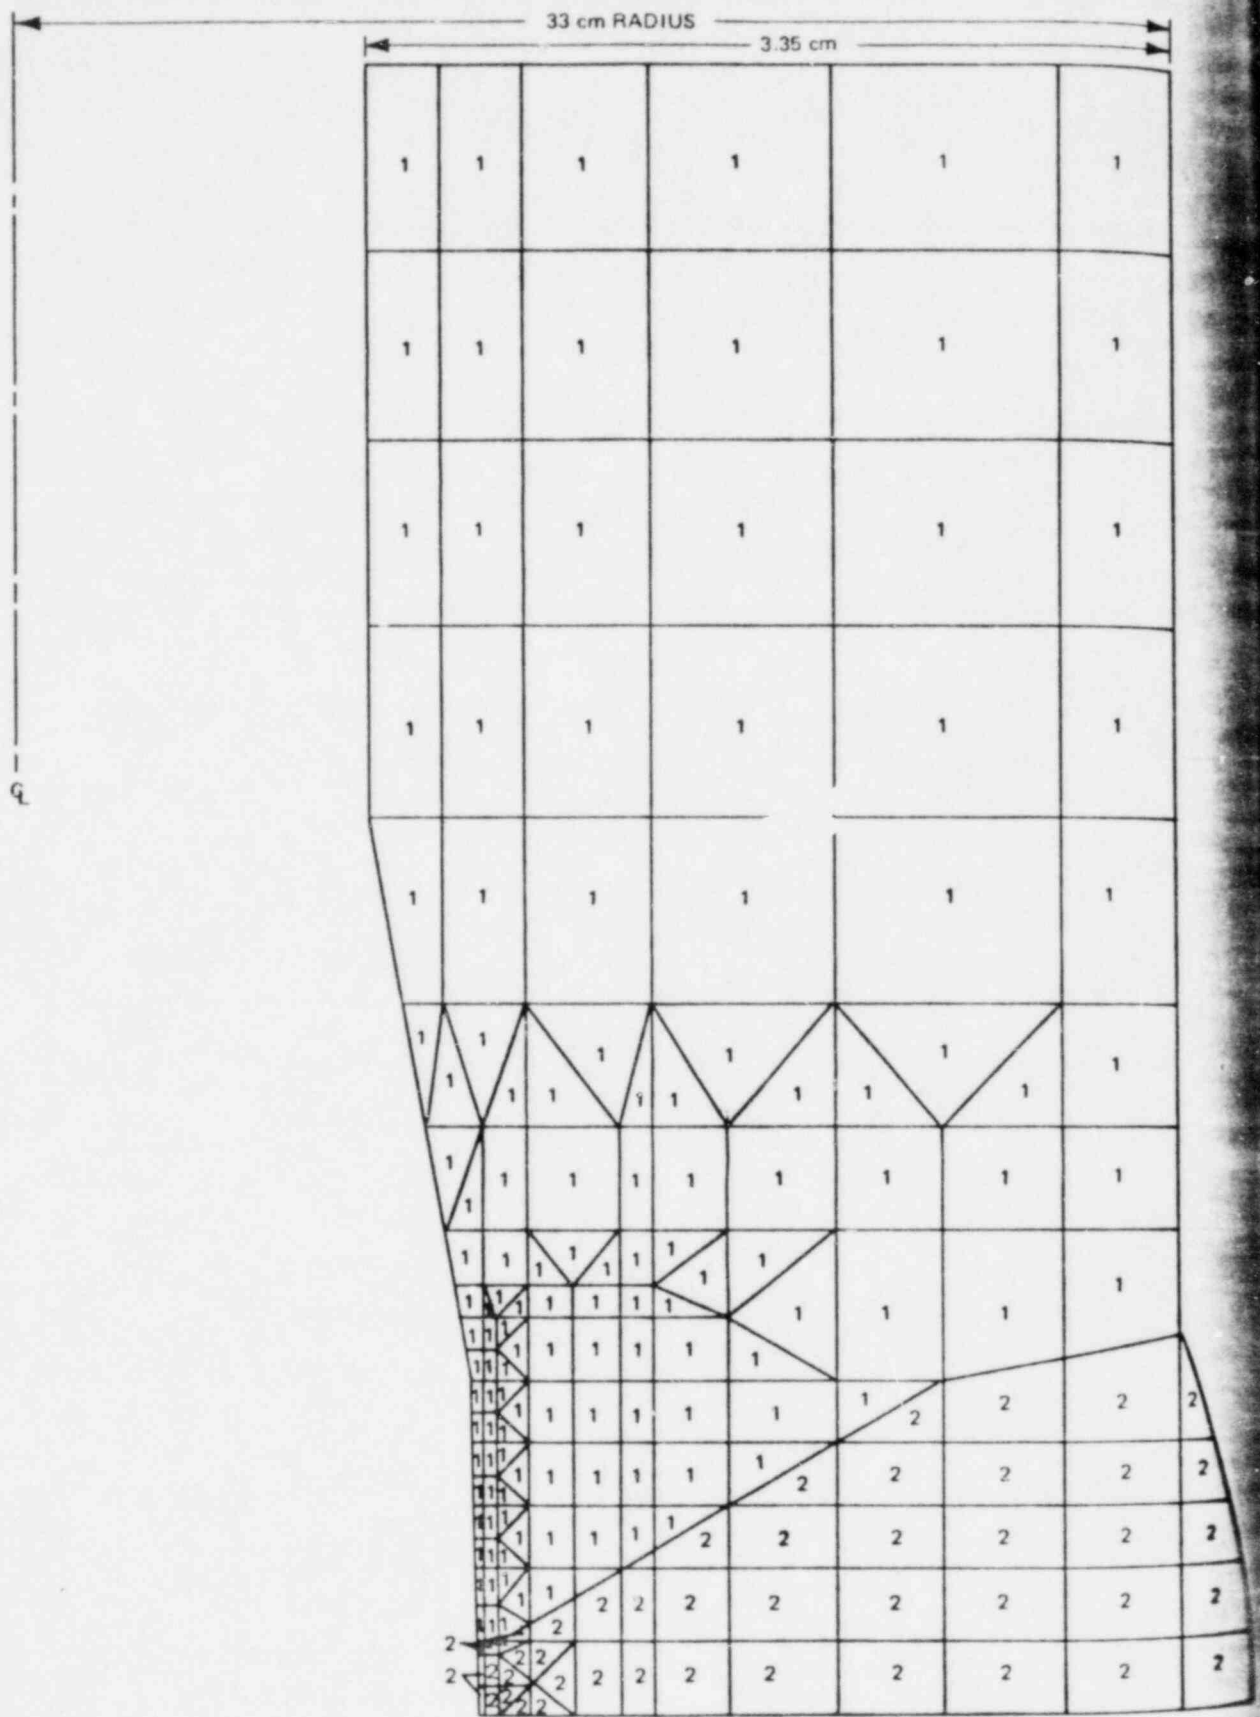
Figure 30. 66-cm-Diameter Schedule 80 Pipe Finite Element Weld Constraint Model

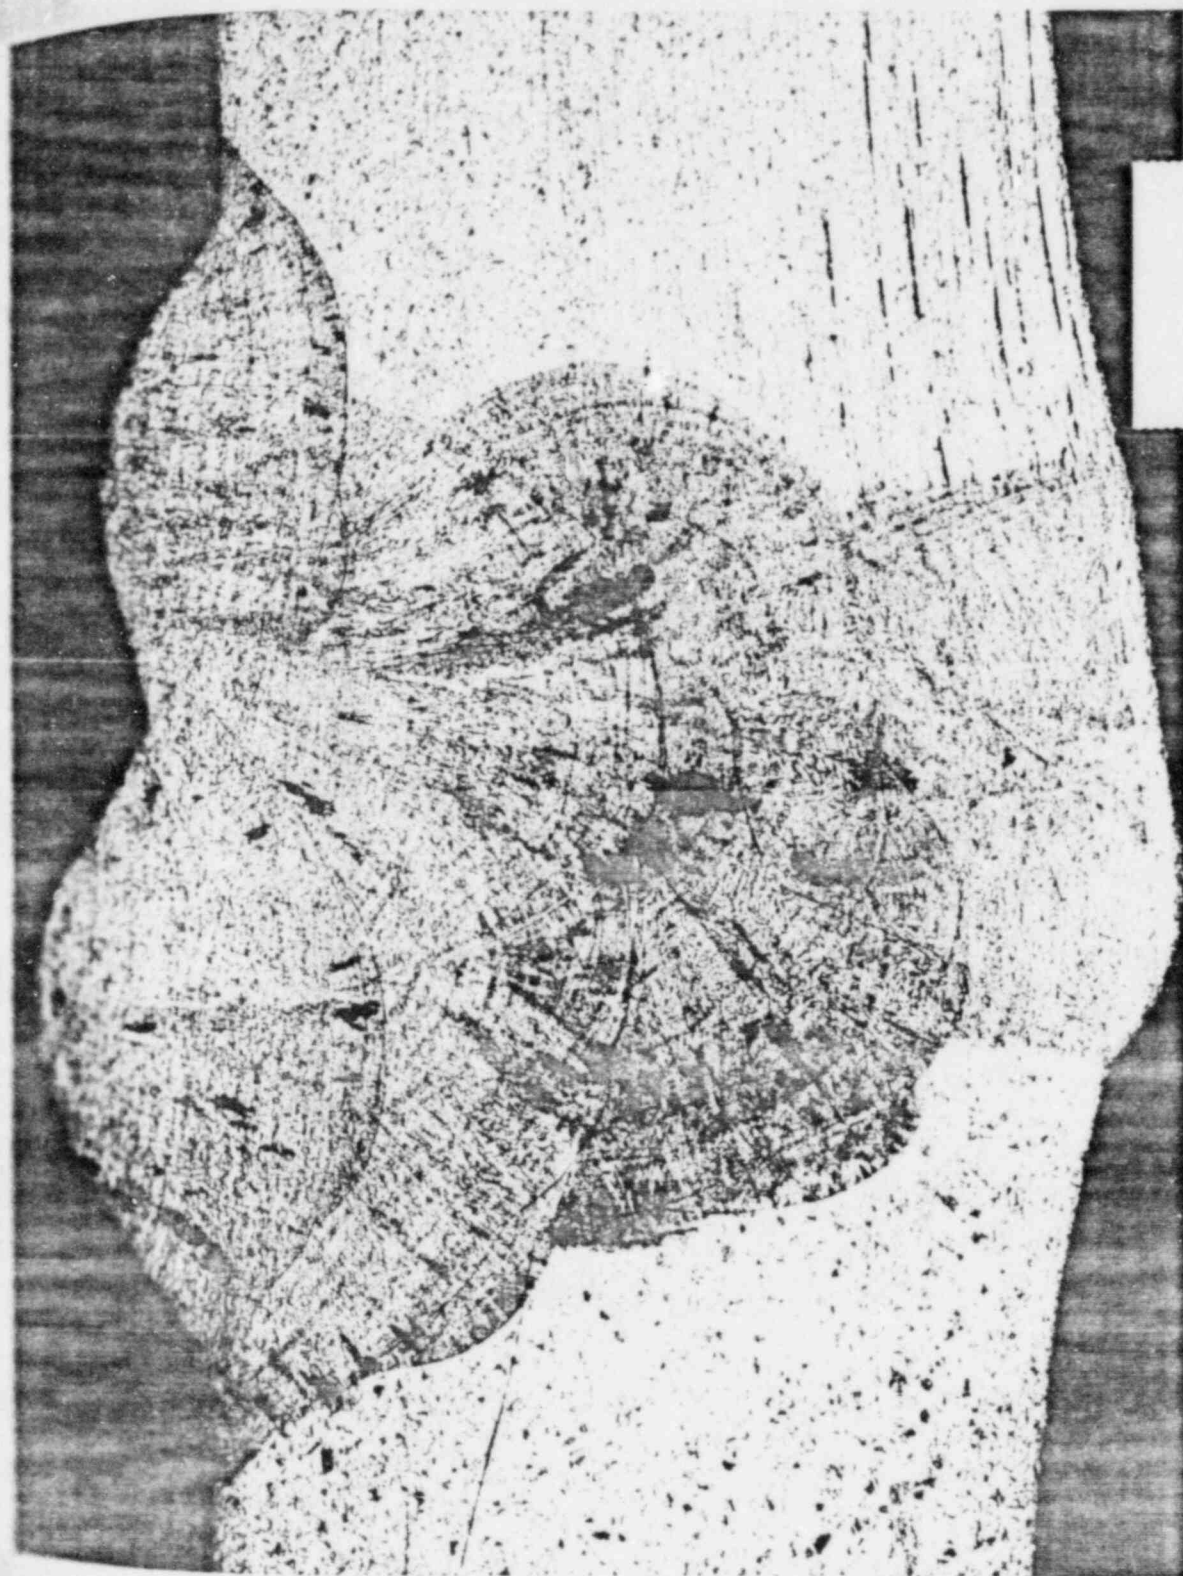
Figure 31. 10.16-cm-Diameter Schedule 80 Stainless Steel Pipe Butt Weld

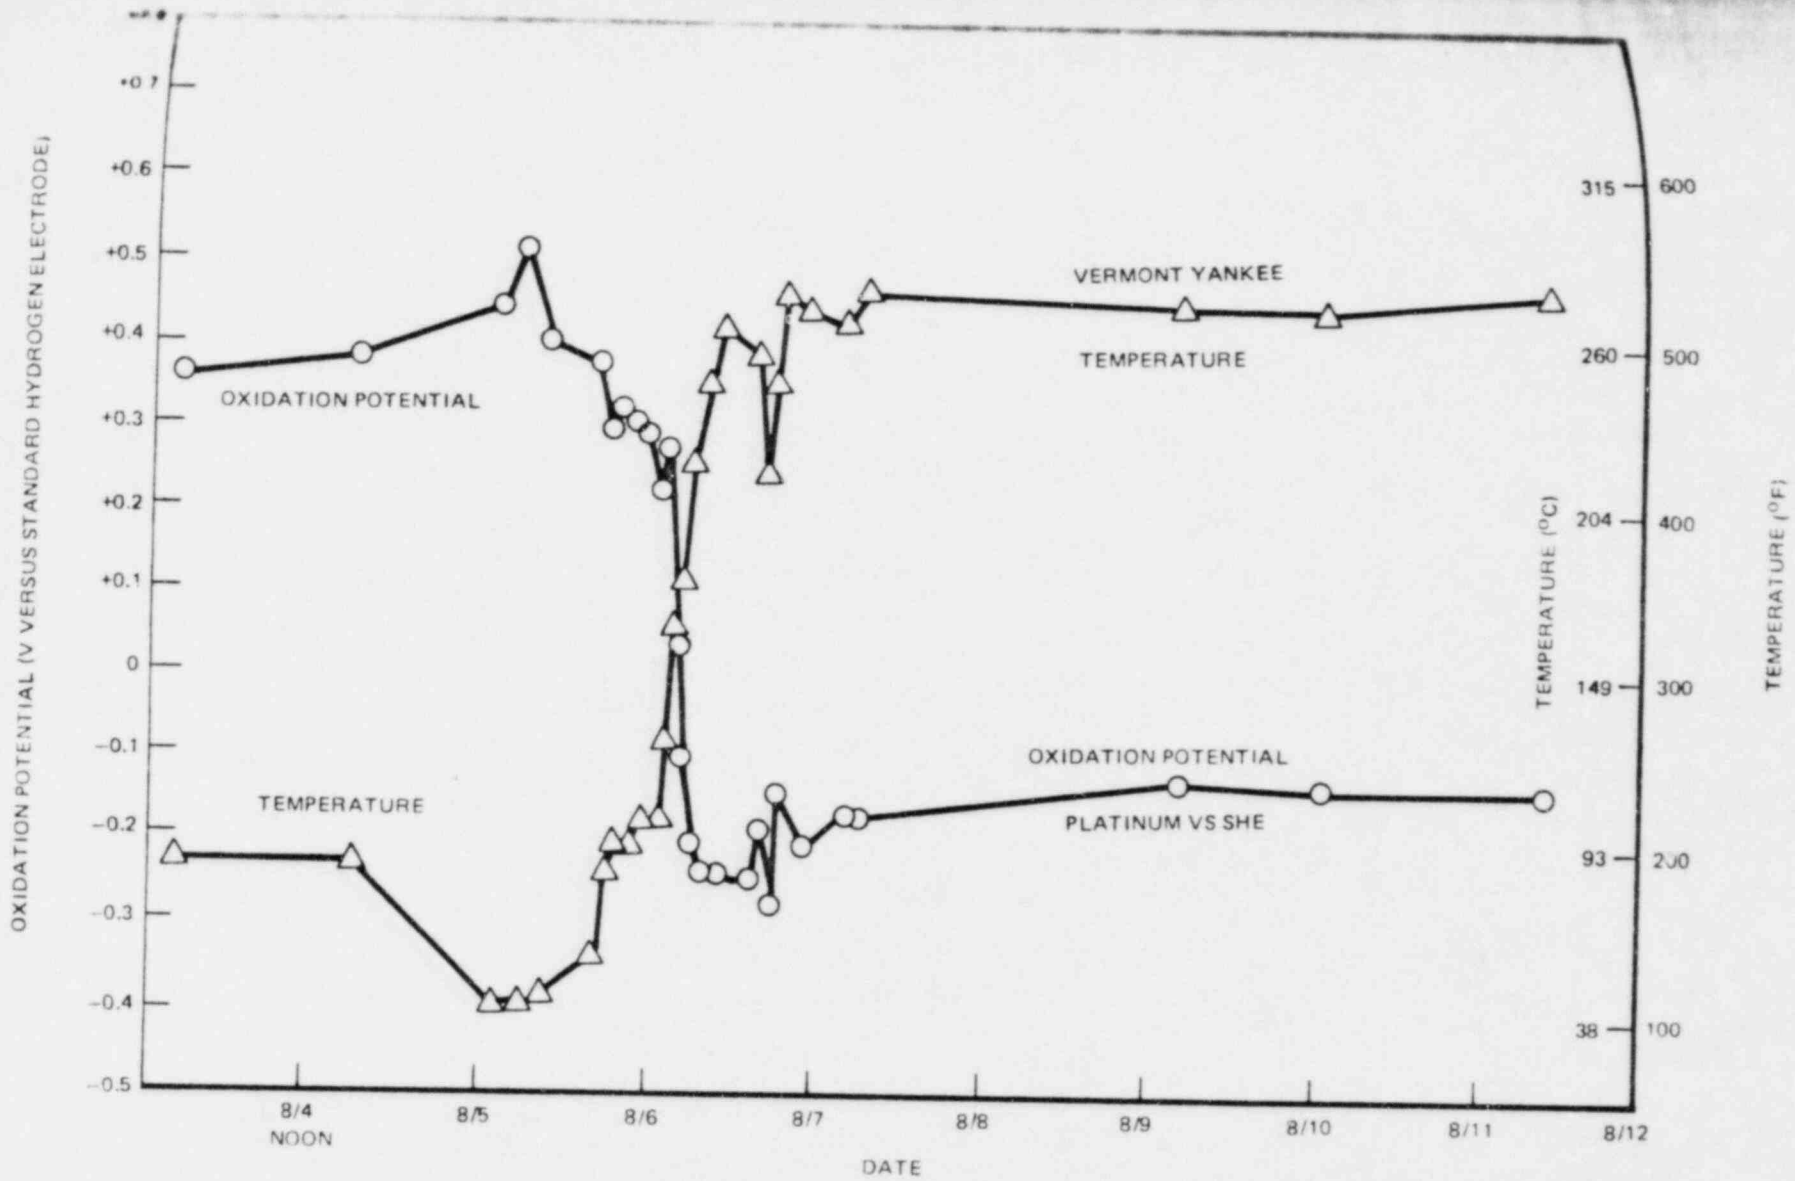
Figure 35 Oxidation Potential of Platinum During Reactor Startup
