NEDC-21463-1

**EVALUATION OF NEAR-TERM
BWR PIPING REMEDIES
FIRST SEMIANNUAL
PROGRESS REPORT
APRIL — SEPTEMBER 1976**

**EVALUATION OF NEAR-TERM
BWR PIPING REMEDIES**

**First Semiannual Progress Report
April — September 1976**

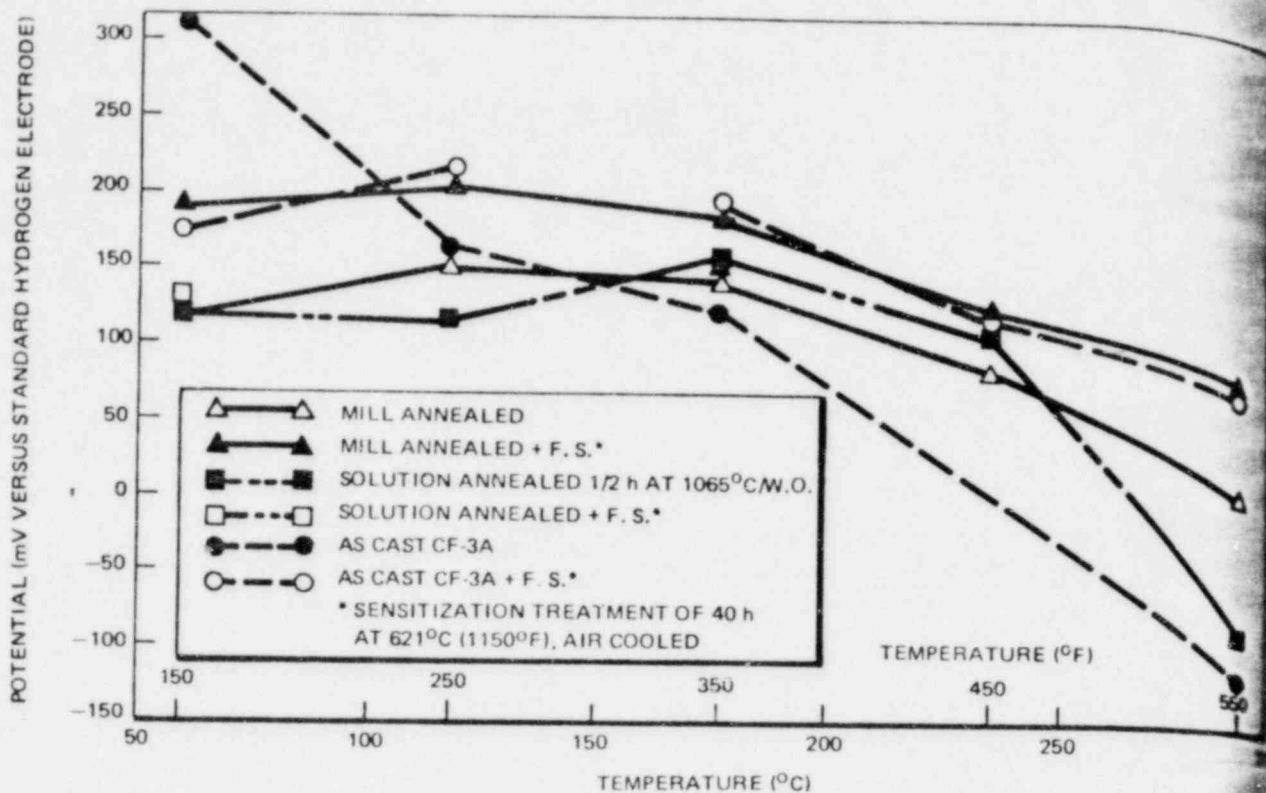
Figure 36. The Effect of Heat Treatment on the Corrosion Potential of Type-304 Stainless Steel in Air Saturated High Purity Water

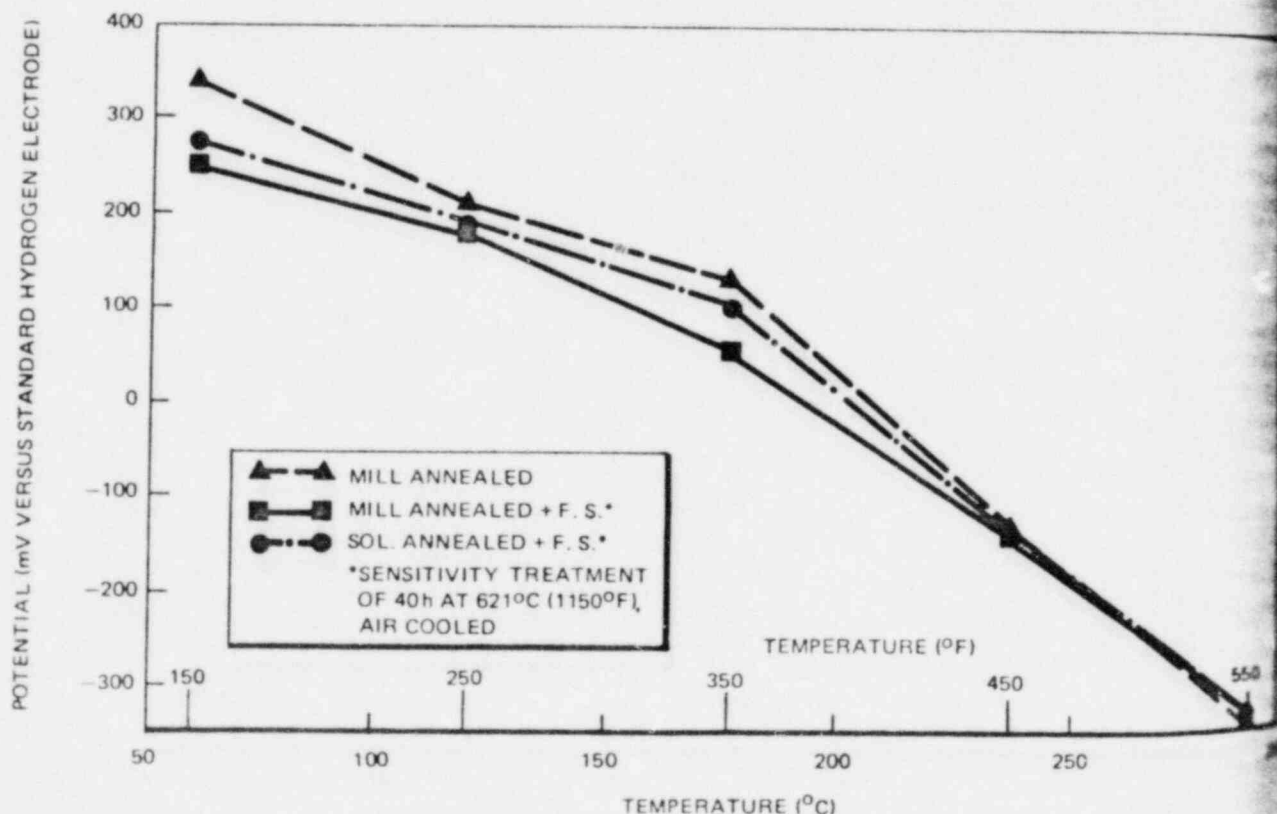
Figure 37. The Effect of Heat Treatment on the Corrosion Potentials of Type-304 Stainless Steel in High Purity Water with 0.1-0.2 ppm Dissolved Oxygen

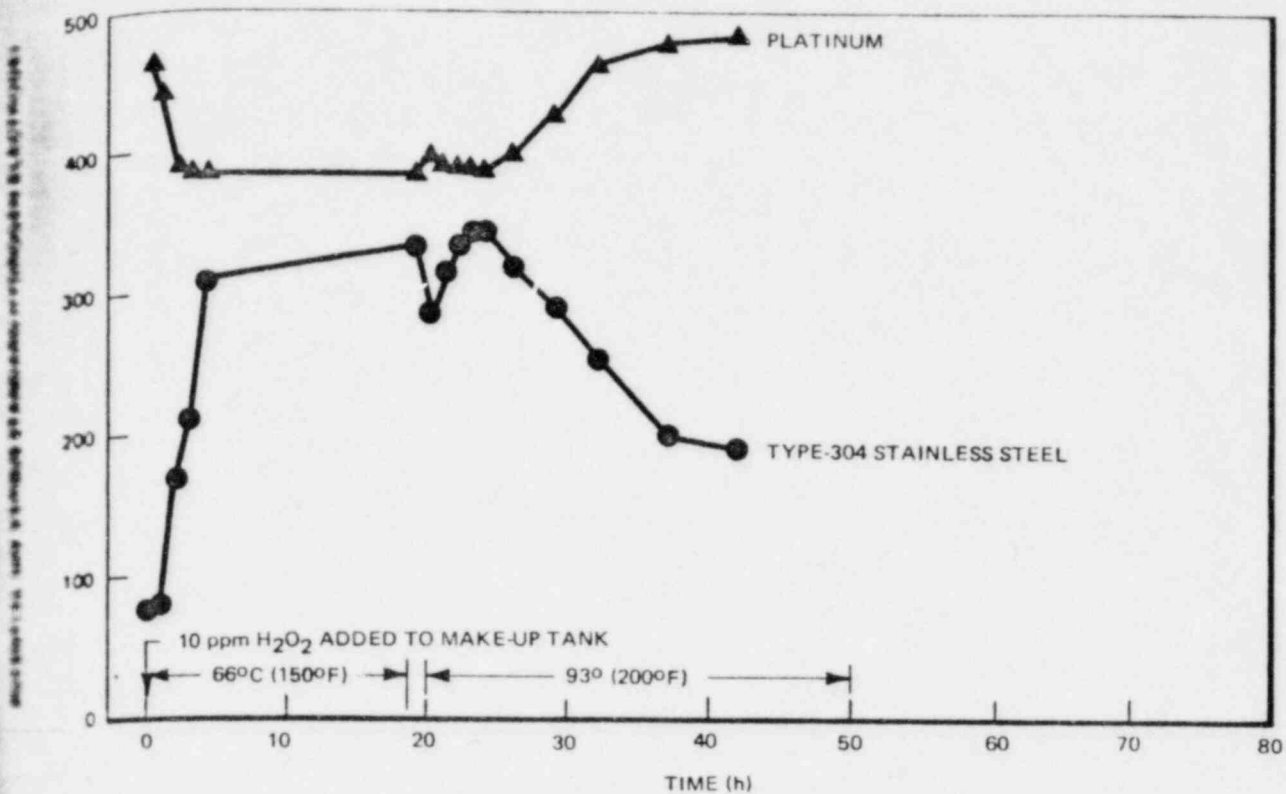
Figure 38 Effect of Hydrogen Peroxide on Oxidation and Corrosion Potential of Platinum and Type-304 Stainless Steel in Aerated Water

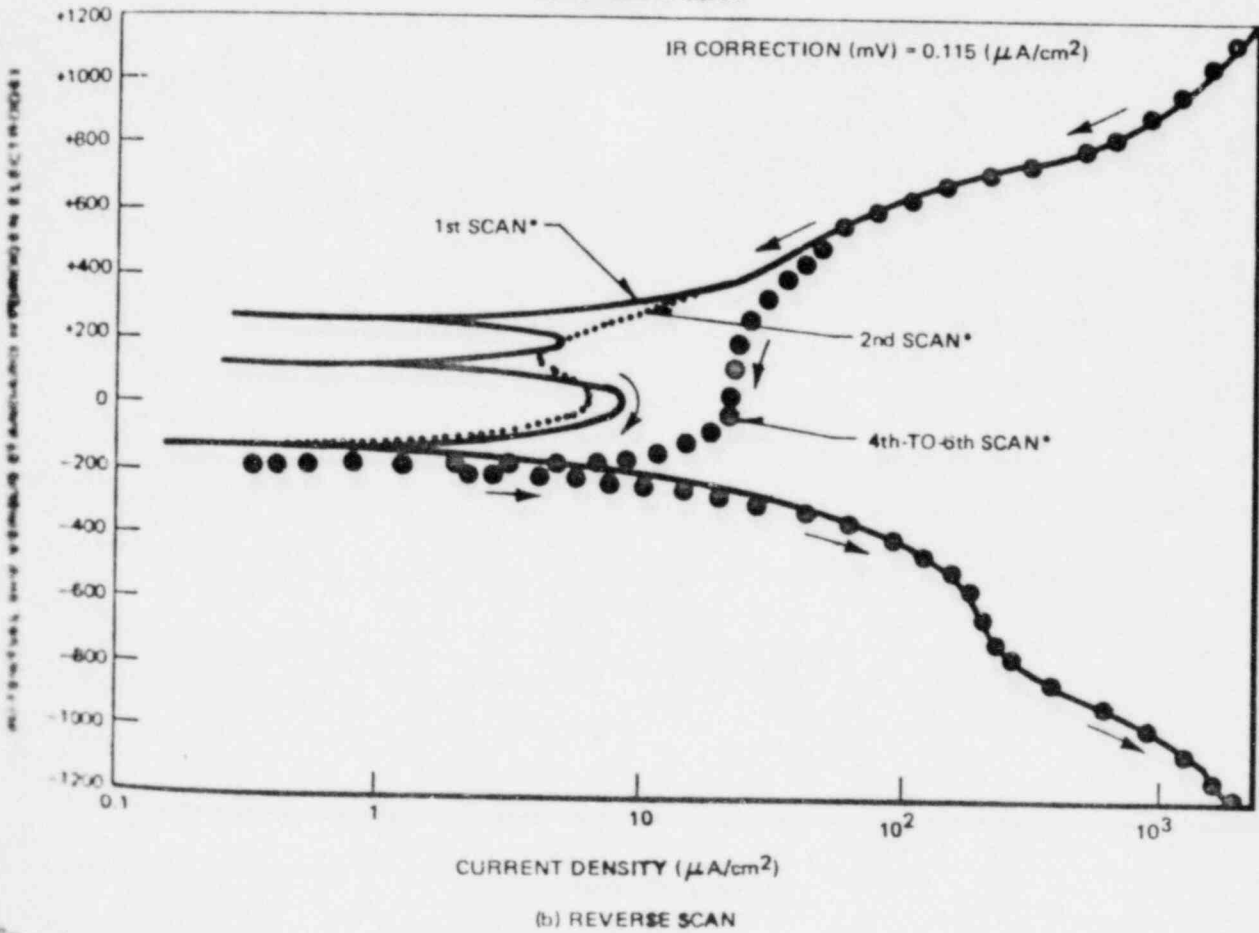
Figure 2a Forward (A) and Reverse (B) Scan Polarization Curves of Mill Annealed Type-304 Stainless Steel at 274°C (525 F) in Deaerated Water Containing 0.01 N Na₂SO₄ (Scan Rate 5 mV/sec)

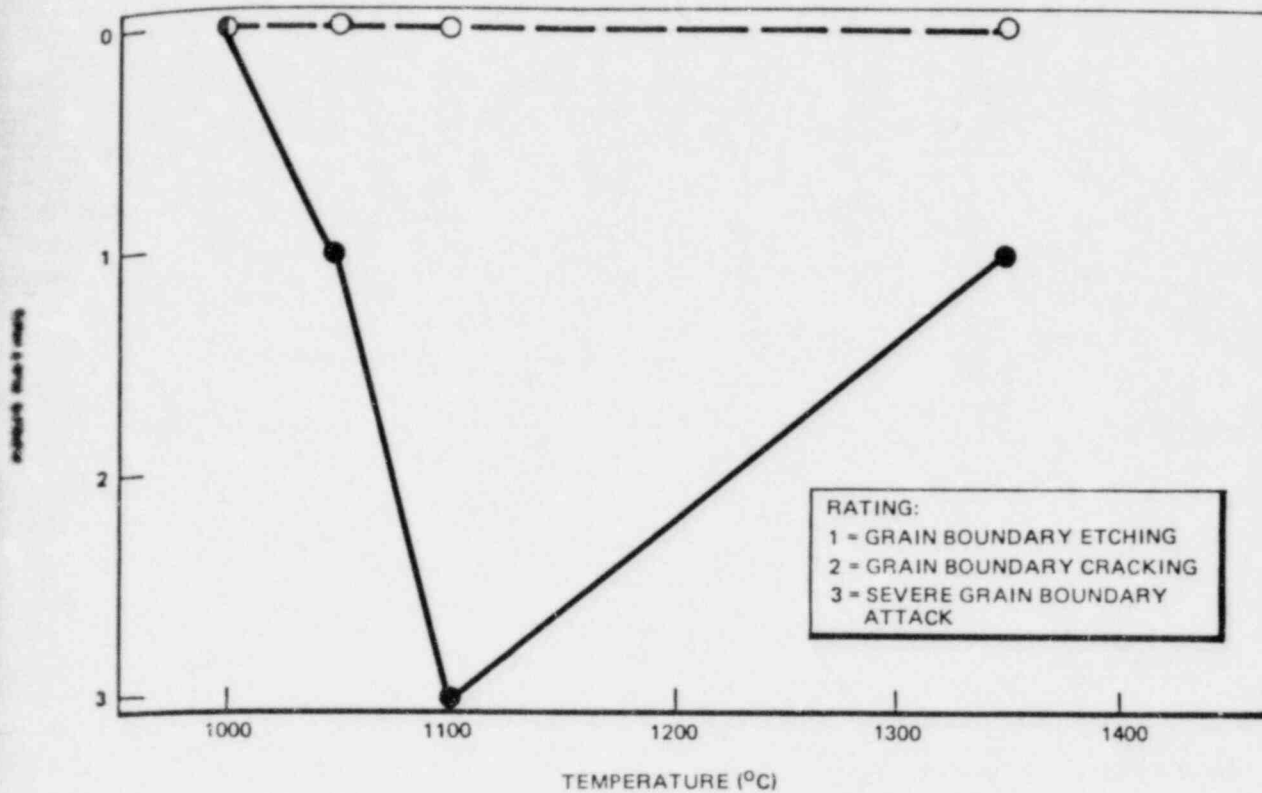
Figure 40. Effect of Heat Treatment on the Corrosion of Type-308 Stainless Steel in A262 Practice E Test

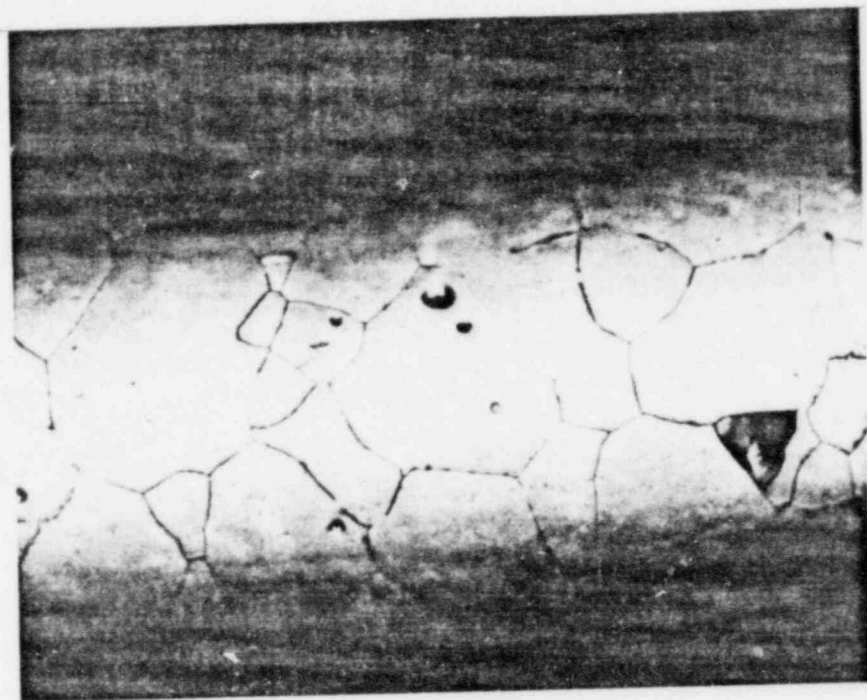
Figure 41. Photomicrograph of Type-308 Stainless Steel Heat Treated at 1100°C for 1 Hour, Water Quenched Followed by 600°C for 24 Hours, Water Quenched, then Followed by 3 Days in A262 Practice E Solution. 250X

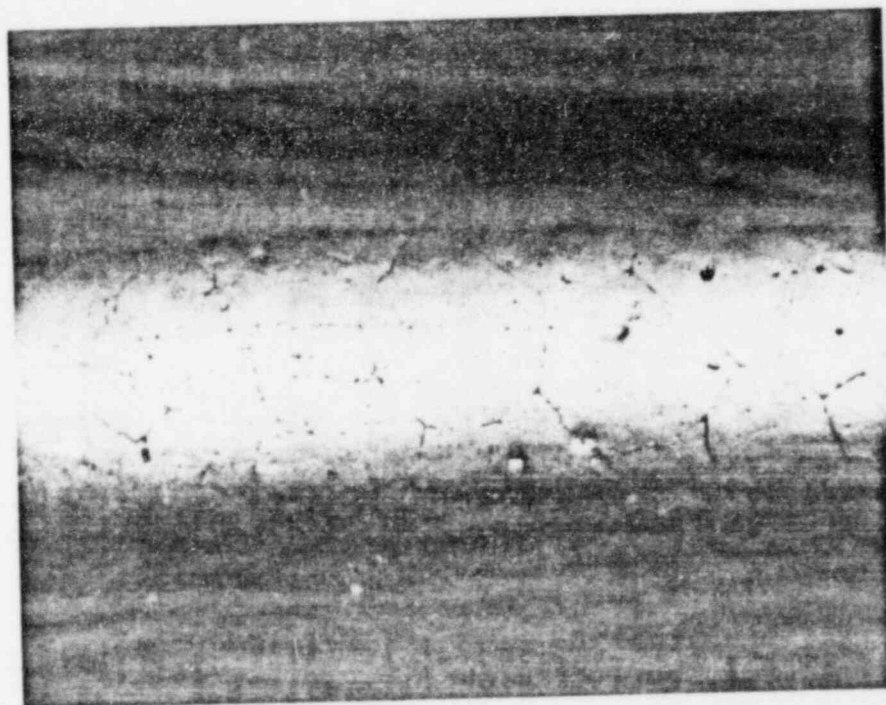
Figure 42. Photomicrograph of Type-308 Stainless Steel Heat Treated at 1050°C for 1 Hour, Water Quenched Followed by 600°C for 24 Hours, Water Quenched, then Followed by 3 Days in A262 Practice E Solution. 250X

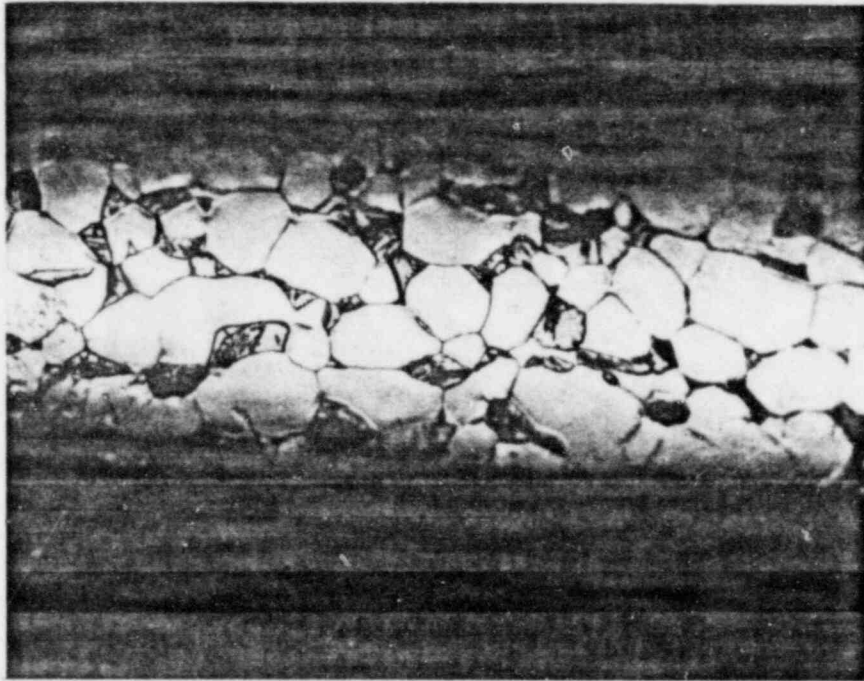
Figure 43. Photomicrograph of Type-308 Stainless Steel Heat Treated at 1350°C for 1 Hour, Water Quenched Followed by 600°C for 24 Hours, Water Quenched, then Followed by 3 Days in A262 Practice E Solution. 250X

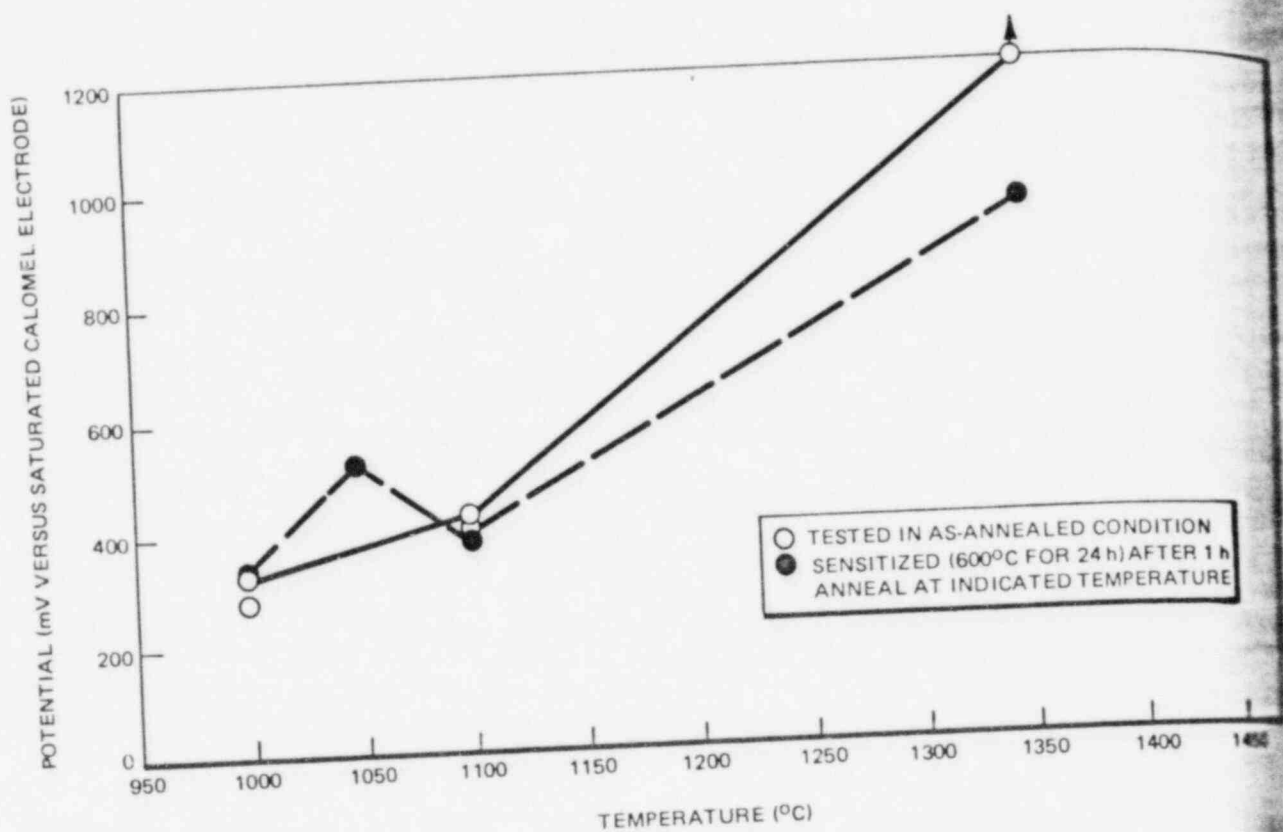
Figure 44. Pitting Potential of Type-308 Stainless Steel in 0.16 M NaCl

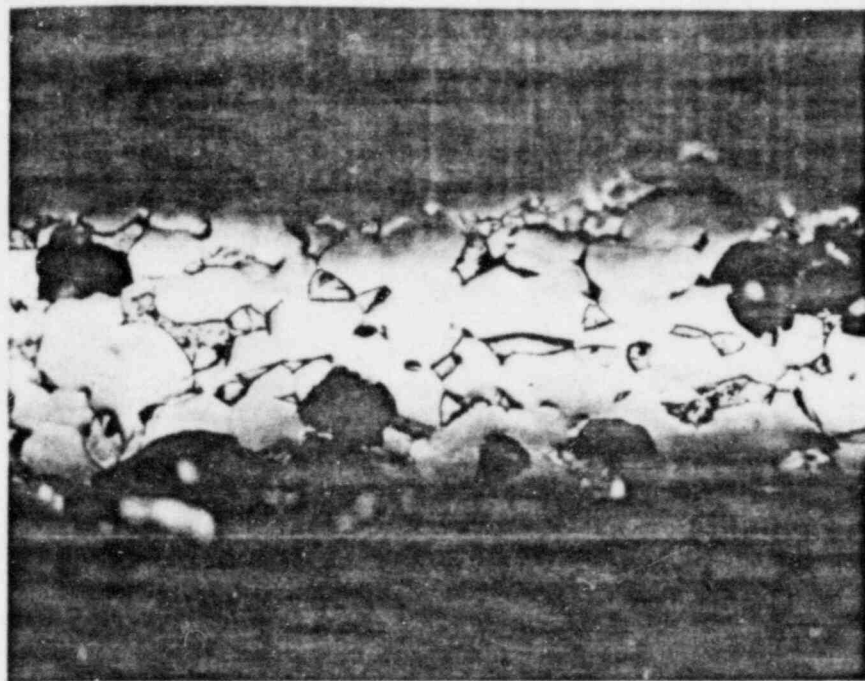
Figure 45. Photomicrograph of Type-308 Stainless Steel Heat Treated at 1350°C for 1 Hour, Water Quenched Followed by 600°C for 24 Hours, Water Quenched and Anodically Polarized in 0.16 M NaCl. 250X

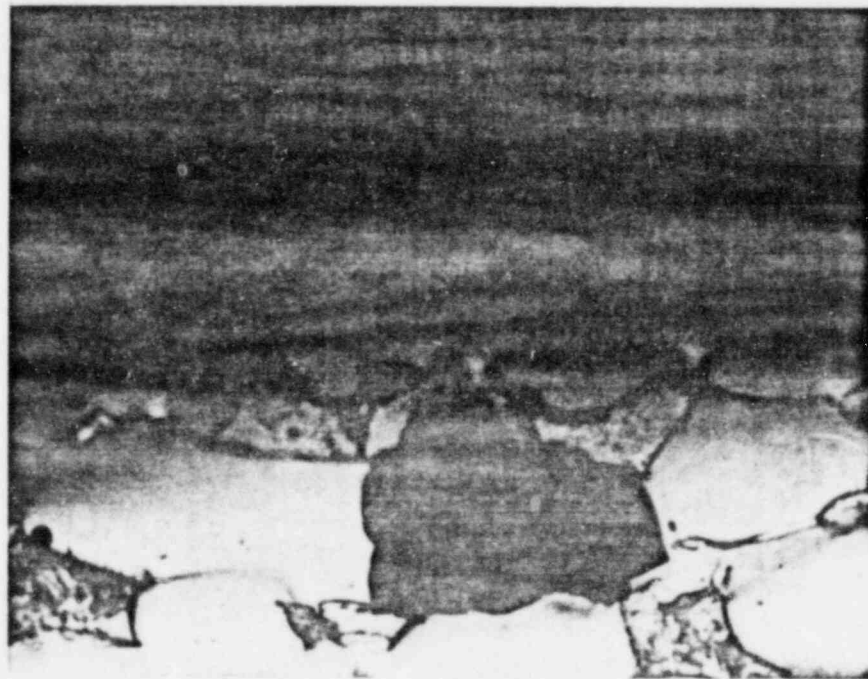
Figure 46. Photomicrograph of Type-308 Stainless Steel Heat Treated at 1350°C for 1 Hour, Water Quenched Followed by 600°C for 24 Hours, Water Quenched and Anodically Polarized in 0.16 M NaCl. 750X

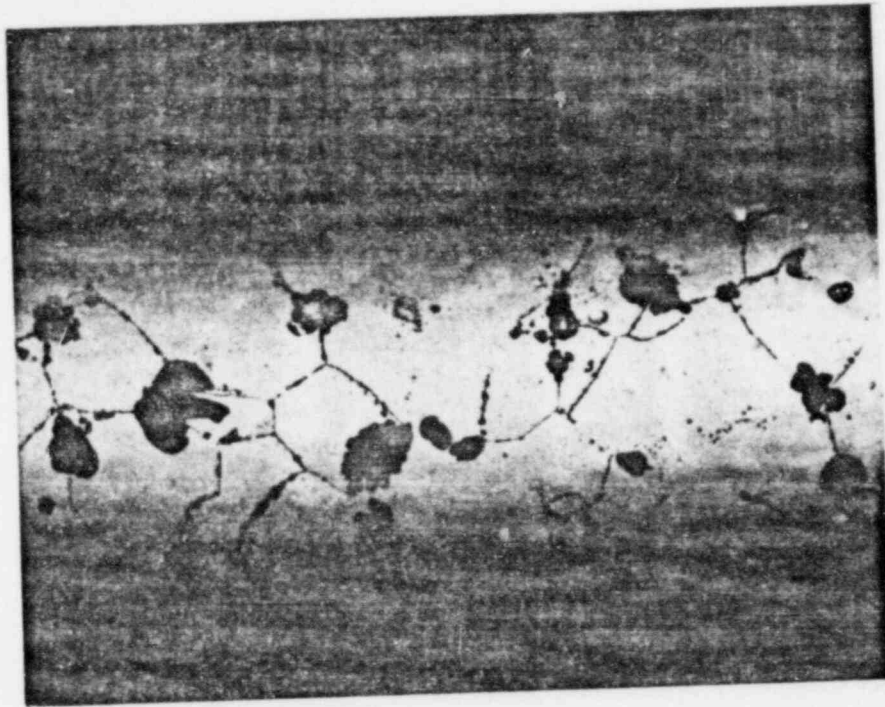
Figure 47. Photomicrograph of Type-308 Stainless Steel Heat Treated at 1100°C for 1 Hour, Water Quenched Followed by 600°C for 24 Hours, Water Quenched and Anodically Polarized in 0.16 M NaCl. 250X

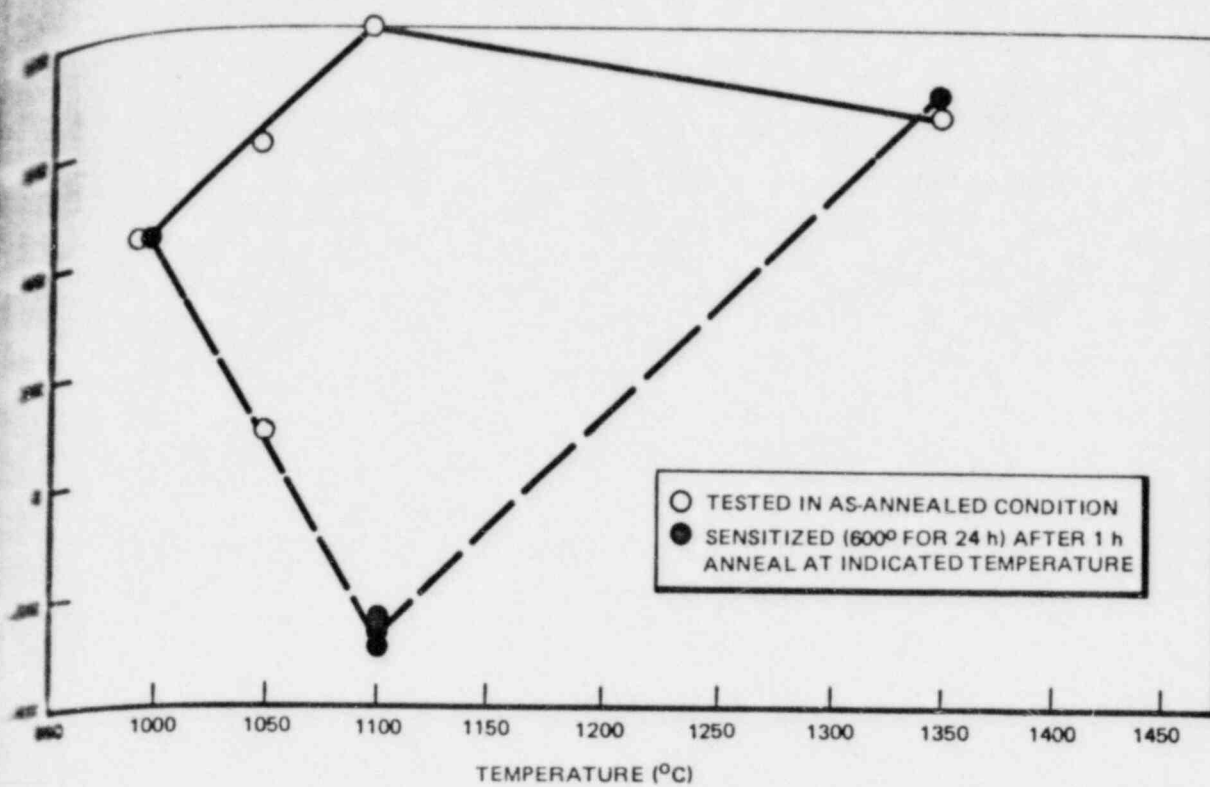
Figure 48. Pitting Potential of Type-308 Stainless Steel in 0.16 M HCl.

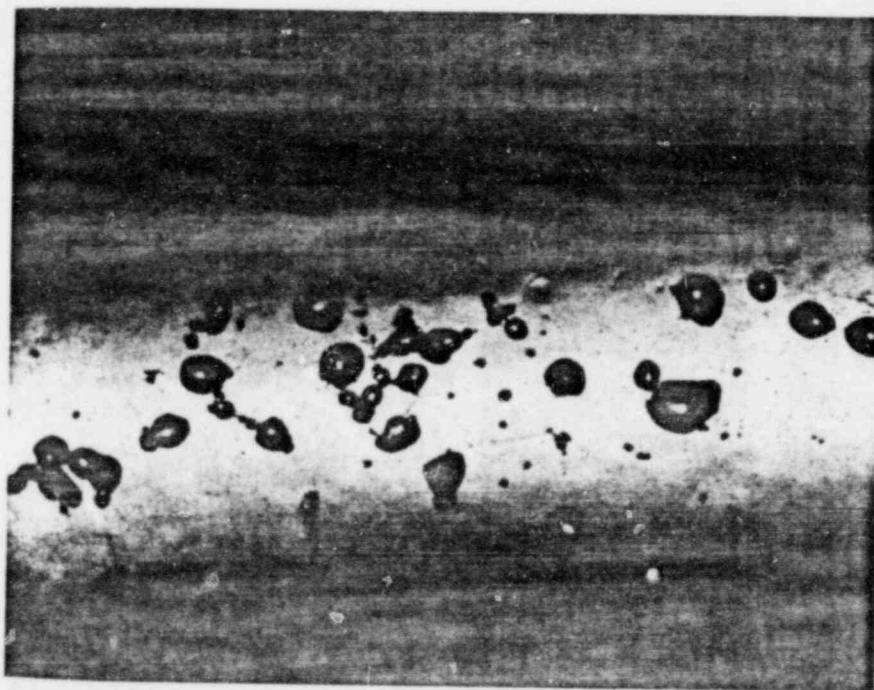
Figure 49. Photomicrograph of Type-308 Stainless Steel Heat Treated at 1050°C for 1 Hour, Water Quenched, Followed by 600°C for 24 Hours, Water Quenched and Anodically Polarized in 0.16 M HCl. 250X

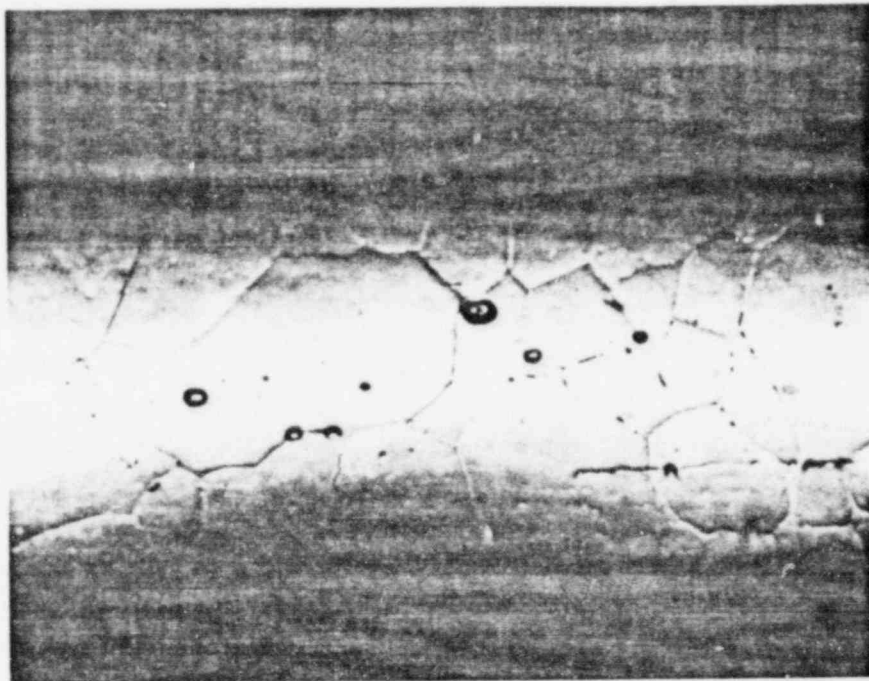
Figure 50. Photomicrograph of Type-308 Stainless Steel Heat Treated at 1100°C for 1 Hour, Water Quenched, Followed by 600°C for 24 Hours, Water Quenched and Anodically Polarized in 0.16 M HCl. 250X

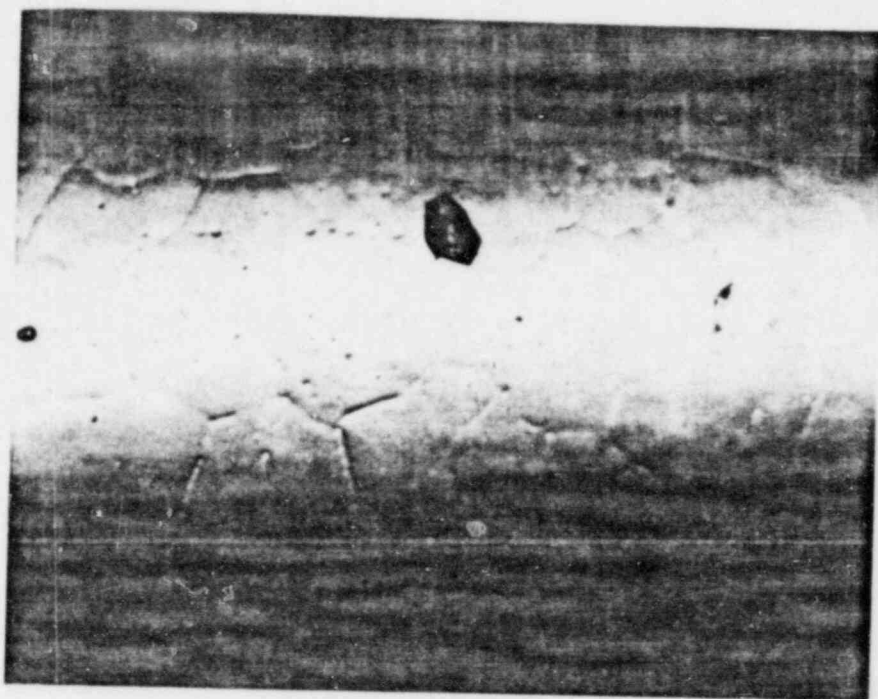
Figure 52. Photomicrograph of Type-308 Stainless Steel Heat Treated at 1100°C for 1 Hour, Water Quenched Followed by 600°C for 24 Hours, Water Quenched and Anodically Polarized in 0.16 M HCl. 250X

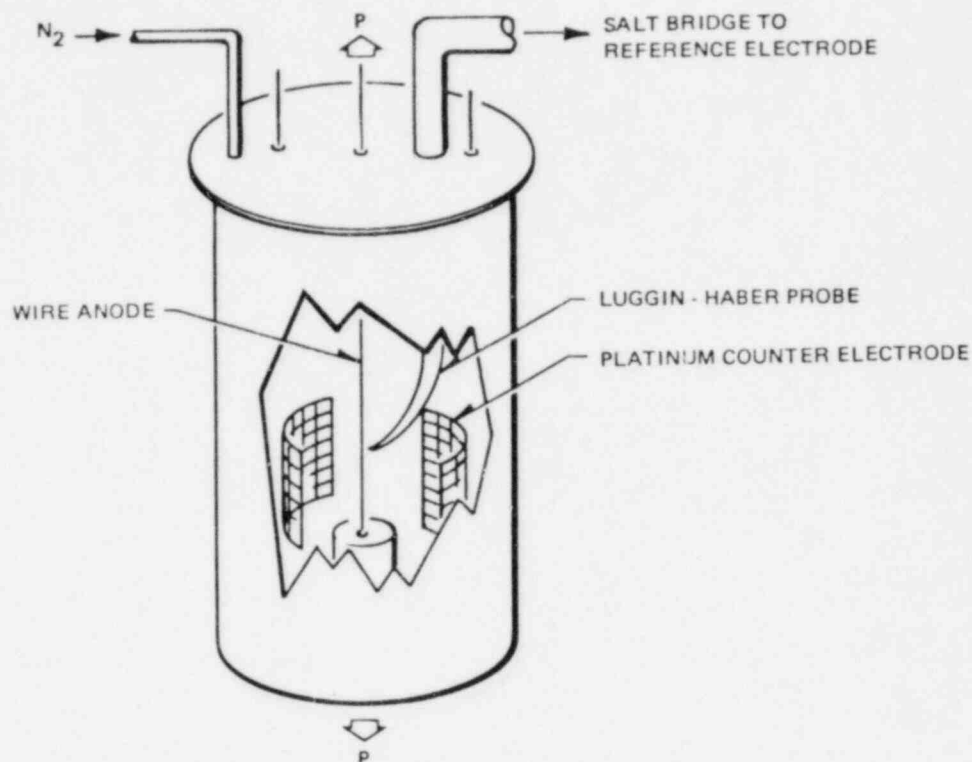
Figure 53. Schematic Drawing of Stress Corrosion Cracking Polarization Cell

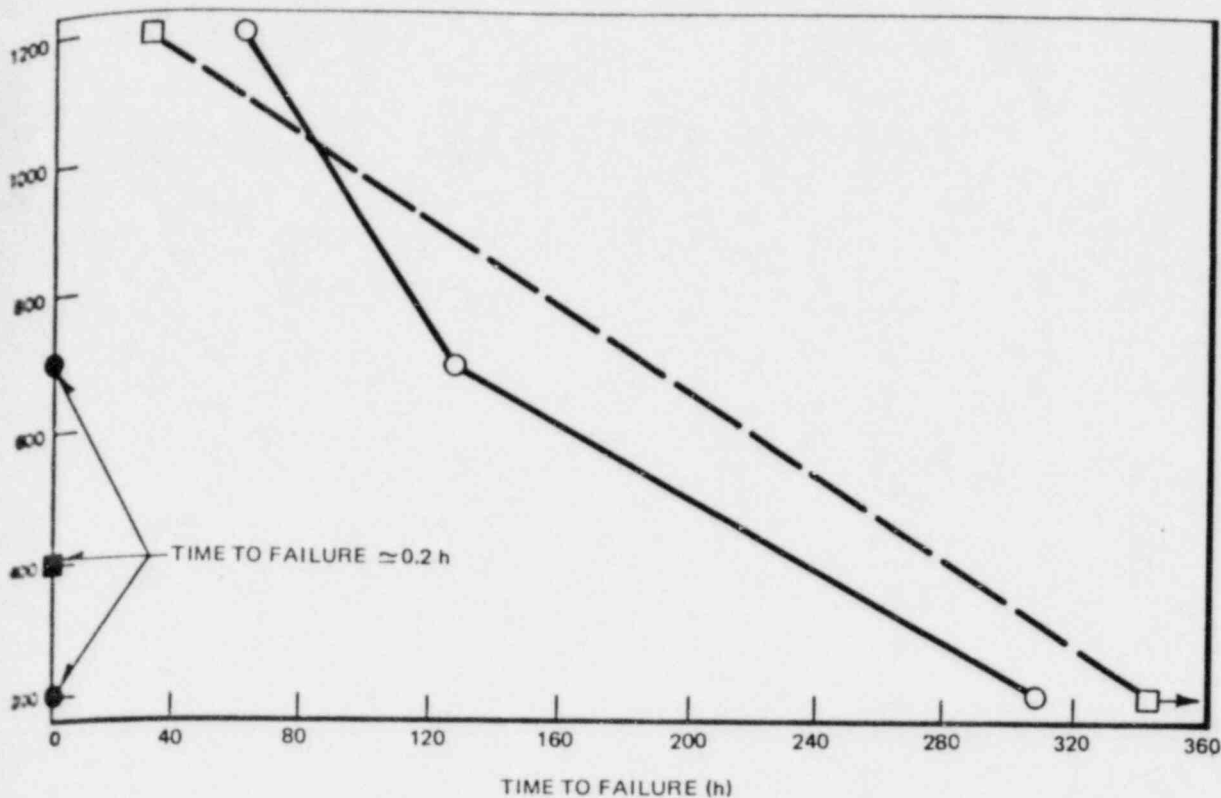
Time to Failure as a Function of Applied Potential in 0.01 $N H_2SO_4$ of Type-308 Stainless Steel Dead-Weight Loaded to an Initial Tensile Strain of 10%

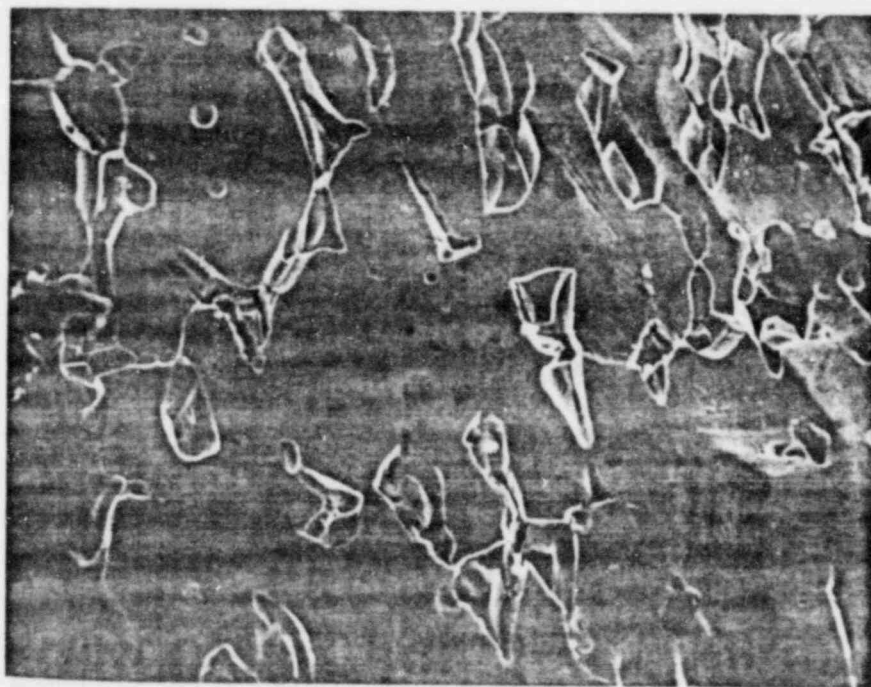
Figure 55. Scanning Electron Micrograph of Type-308 Stainless Steel Heat Treated at 1350°C for 1 Hour, Water Quenched, and Tested to Failure in 0.01 $N H_2SO_4$ at an Applied Potential of +700 mV. 400X

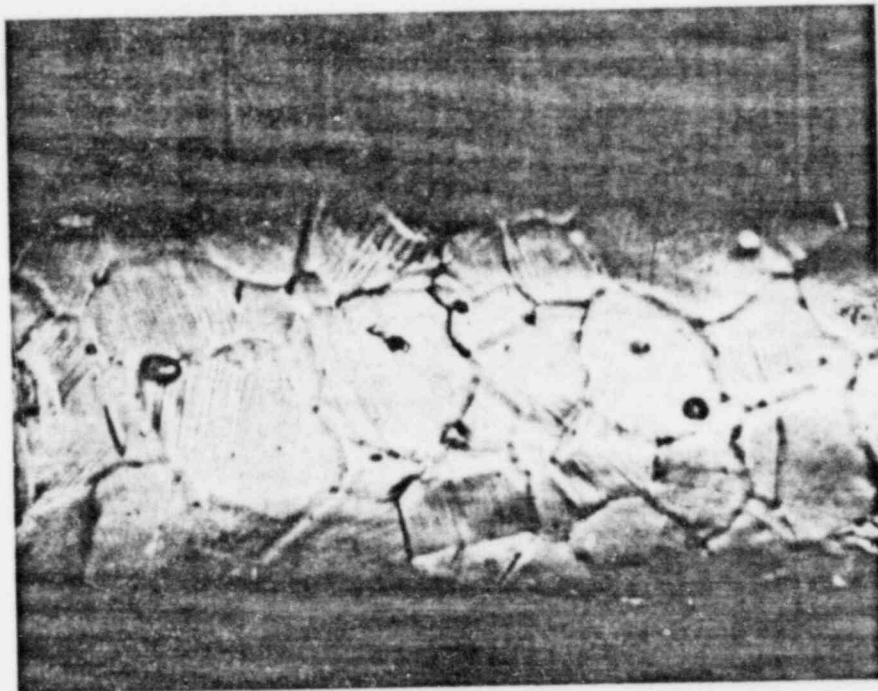
Figure 56. Photomicrograph of Type-308 Stainless Steel Heat Treated at 1100°C for 1 Hour, Water Quenched, Followed by 600°C for 24 Hours, Water Quenched and Stress Corrosion Cracked in 0.01 *N* H₂SO₄ at an Applied Potential of +400 mV. 250X

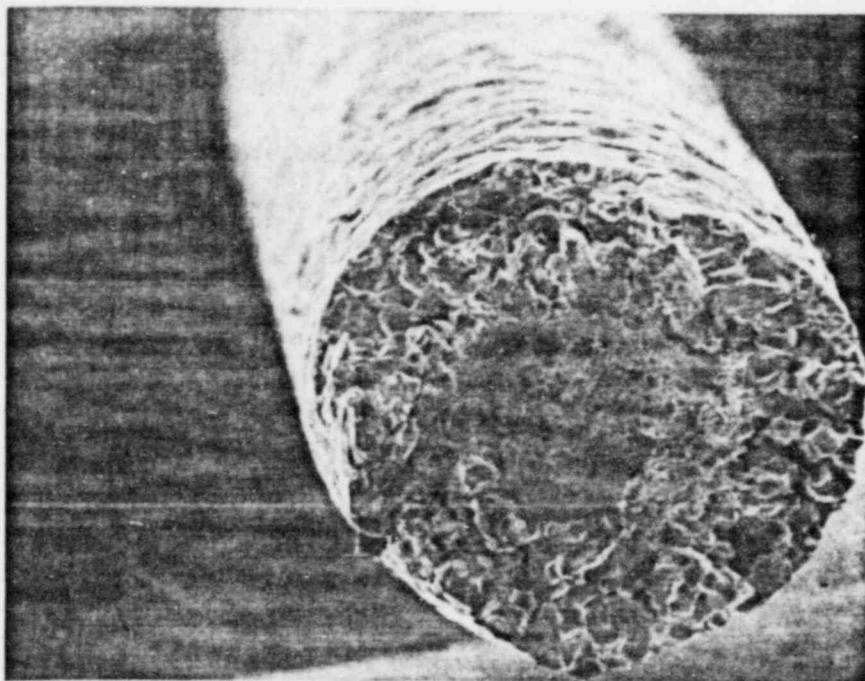
Figure 57. Scanning Electron Micrograph of Fracture Surface of Type-308 Stainless Steel Heat Treated at 1350°C for 1 Hour, Water Quenched, Followed by 600°C for 24 Hours, Water Quenched and Tested to Failure in 0.01 N H_2SO_4 at an Applied Potential of +700 mV. 100X

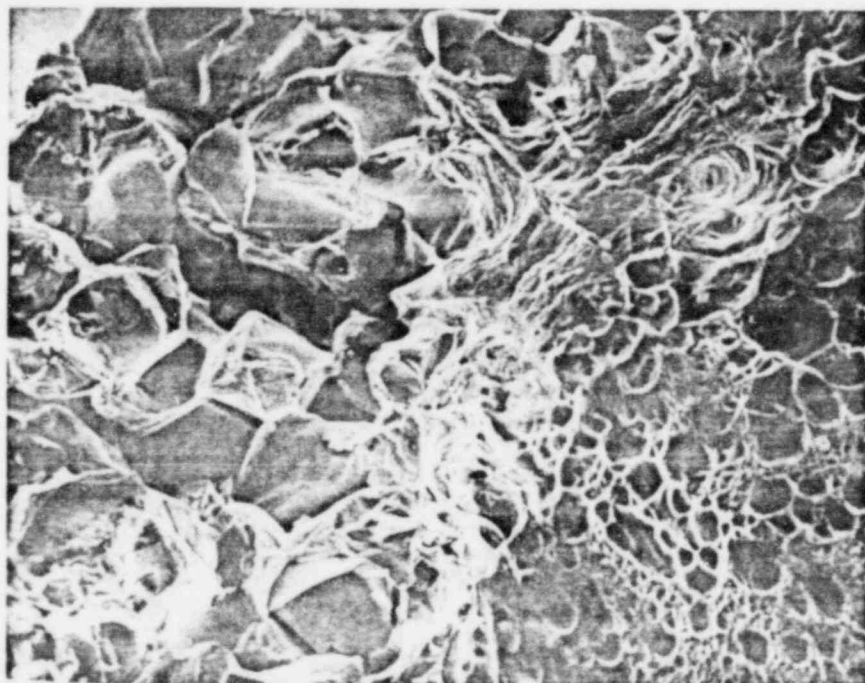
Figure 58. Scanning Electron Micrograph of Fracture Surface of Type-308 Stainless Steel Heat Treated at 1350°C for 1 Hour, Water Quenched, Followed by 600°C for 24 Hours, Water Quenched and Tested to Failure in 0.01 N H_2SO_4 at an Applied Potential of +700 mV. 250X

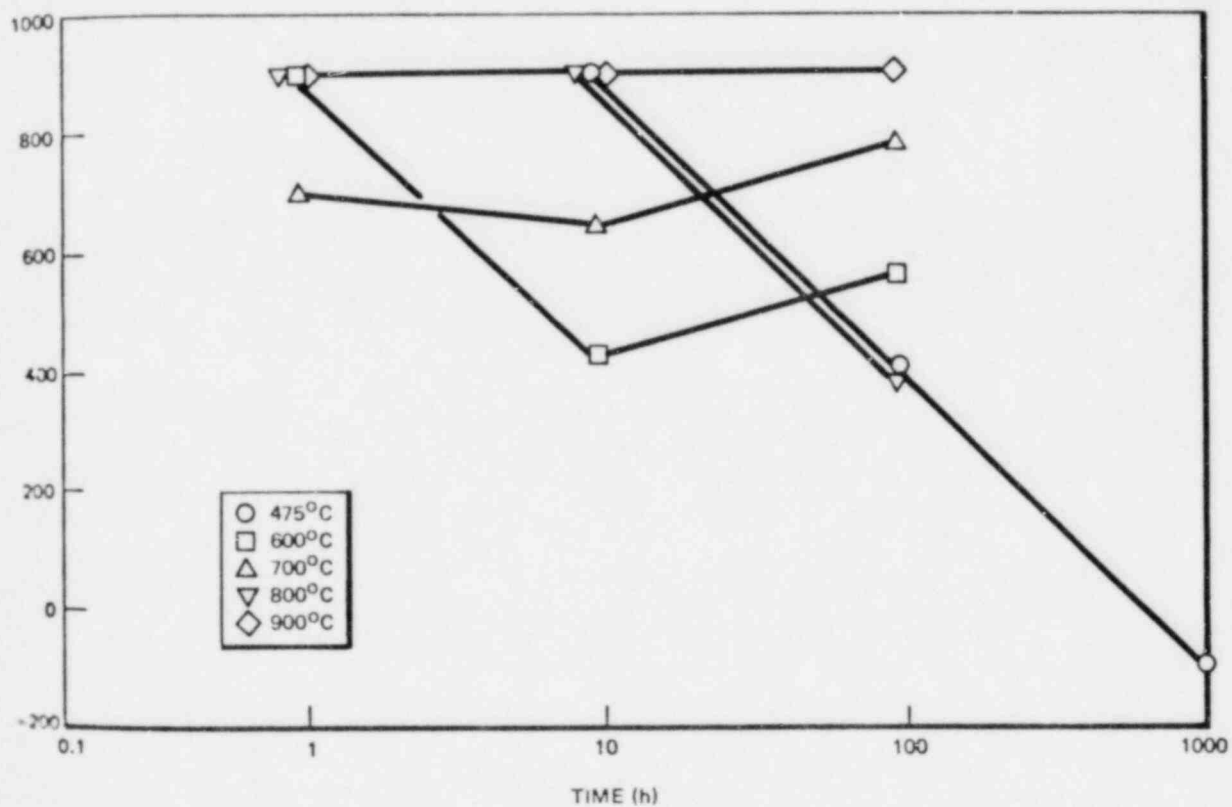
Figure 59. Effect of Heat Treatment on the Pitting Potential in 0.01 M HCl of Type-308 Stainless Steel

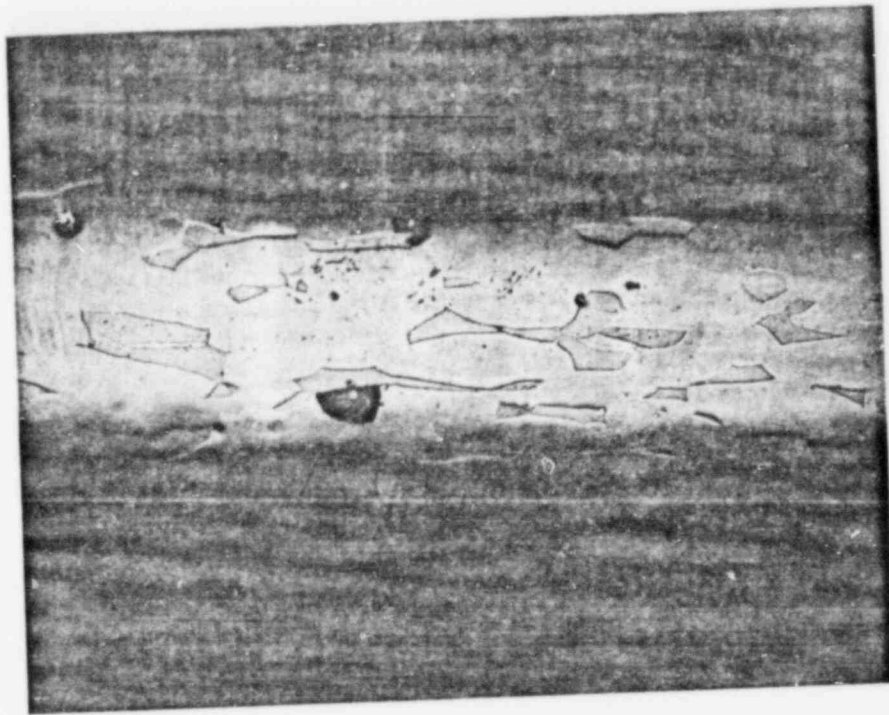
Figure 60. Photomicrograph of Type-308 Stainless Steel Heat Treated at 1350°C for 1 Hour, Water Quenched, Cold Drawn to 38.9% Reduction of Area, Heat Treated at 700°C for 1 Hour, Water Quenched and Anodically Polarized in 0.1 M HCl. 250X

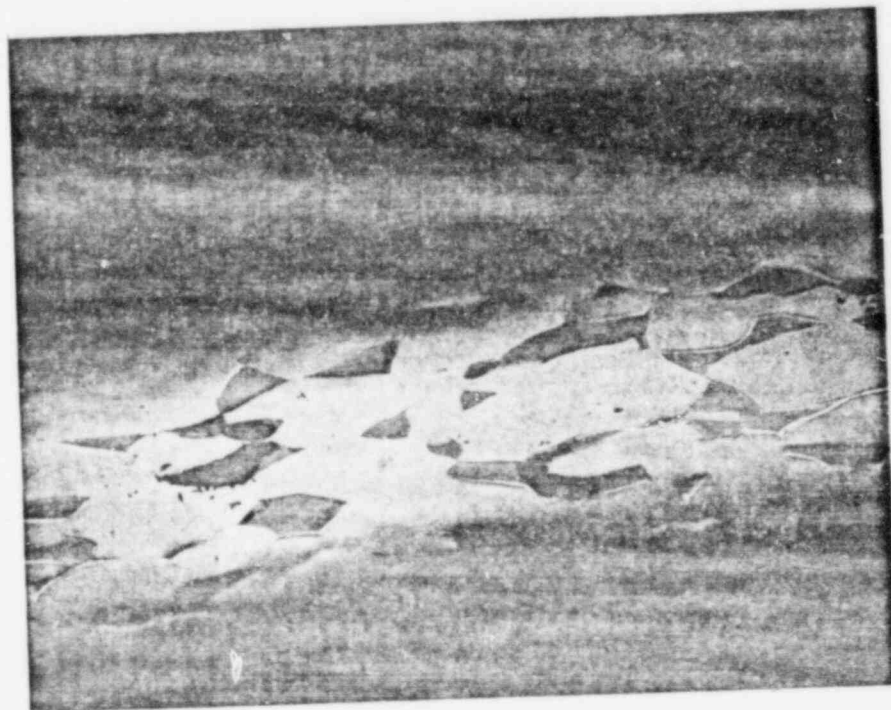
Figure 61. Photomicrograph of Type-308 Stainless Steel Heat Treated at 1350°C for 1 Hour, Water Quenched, Cold Drawn to 38.9% Reduction of Area, Heat Treated at 475°C for 100 Hours, Water Quenched and Anodically Polarized in 0.1 M HCl. 250X

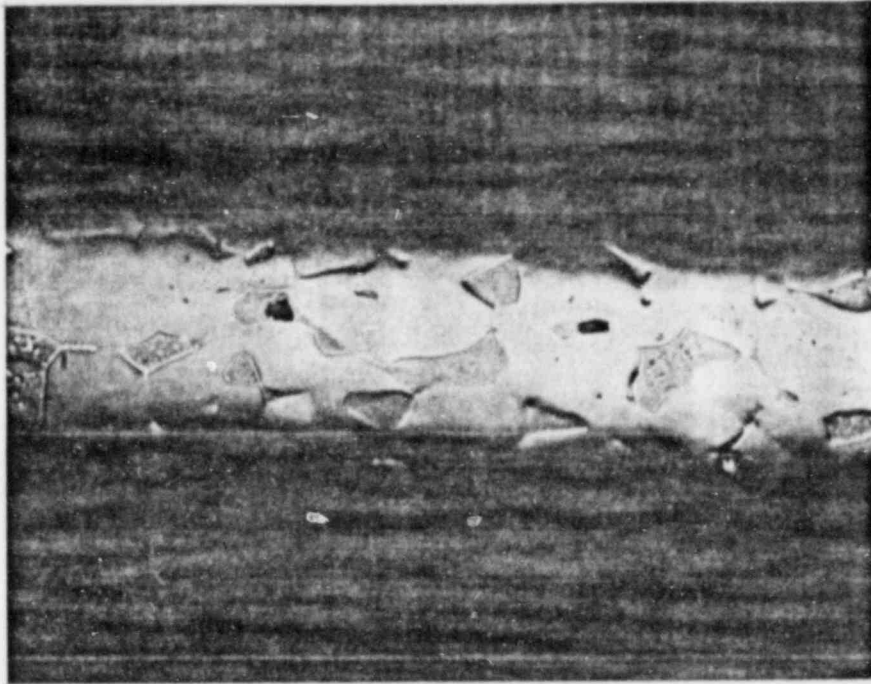
Figure 62. Photomicrograph of Type-308 Stainless Steel Heat Treated at 1350°C for 1 Hour, Water Quenched, Cold Drawn to 38.9% Reduction of Area, Heat Treated at 475°C for 1000 Hours, Water Quenched and Anodically Polarized in 0.1 M HCl. 250X
