**TESTING OF PROTOTYPICAL  
BOILING WATER REACTOR  
WATER LEVEL INSTRUMENTATION  
REFERENCE LEG DE-GASSING**

Revision 1

CONTINUUM DYNAMICS, INC.  
P.O. BOX 3073  
PRINCETON, NEW JERSEY 08543

BOILING WATER REACTOR OWNERS GROUP

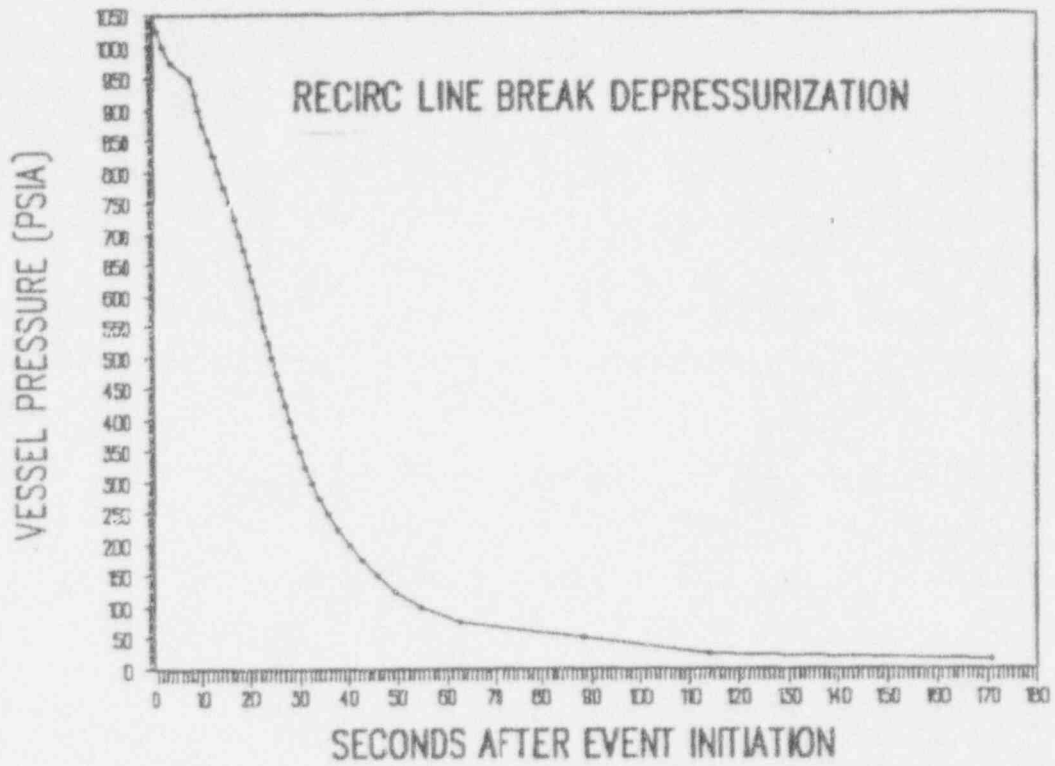
Fig. 1.2a: Generic LOCA-Event BWR Depressurization Curve

The depressurization rates selected included both generic worst-case design basis severe accident scenarios, and normal shutdown depressurization time histories, including shutdown cooling operations. The slow depressurization tests were added to the original test scope because of newly identified concerns to attempt to duplicate degassing phenomena observed during shutdown operations on some BWRs. Time histories of the rapid depressurization rates and the shutdown depressurization pressure time histories are shown in Figures 1.2 and 1.3.

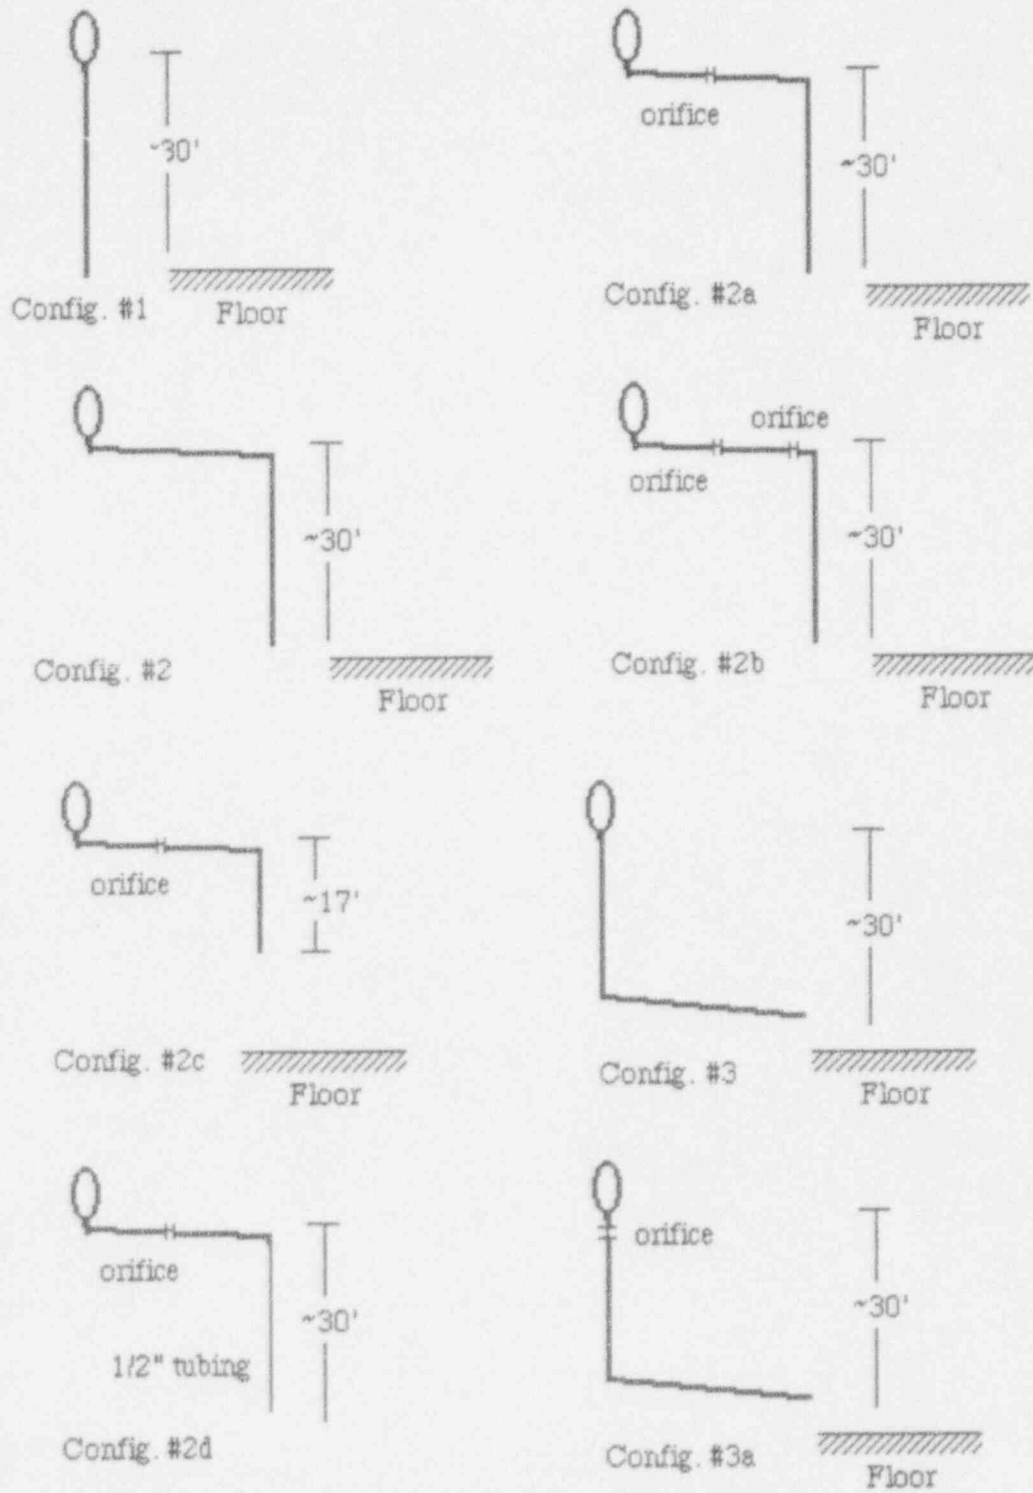
Fig. 1.6: Sketches of Tested Configurations (#1-#3a)

The first configuration tested, configuration #1, consisted of a straight vertical 30' (nominal) 1" SCH 80 stainless steel pipe. This configuration, due to its almost 1:1 sensitivity of percent volume loss to percent indicated height loss, provided a good baseline test case for analytical model correlation efforts. The second configuration tested, #2, had a short vertical stub connected to the coupling chamber, followed by a 30' nearly horizontal segment having a 1/2" per foot slope, which was then connected to a 28' vertical segment, all of 1" SCH 80 stainless steel pipe. Data from this configuration provided an indication of the effect of horizontal segments on potential water level loss, and was also used to investigate the effects of gas type on indicated water level transient and end point readings. This configuration was modified into configuration #2a to include an offset 1/4" orifice located approximately half way along the horizontal segment, to investigate the influence of an orifice on the measured level error. Configuration #2a was further modified by adding a second orifice in an attempt to simulate flow constrictions that may be present due to an excess flow check valve; this modified configuration was denoted #2b. Configuration #2c was then tested to examine the effect of a reduced vertical segment as compared to #2a, by shortening the 29' vertical pipe to a 17' length. Finally, the vertical pipe was completely replaced with 1/2" stainless steel tubing to assess the influence of smaller diameter tubing located in vertical runs in reference legs; this last modification became configuration #2d.

Configuration #3 was a "mirror image" of configuration #2, in that the 29' vertical segment was directly connected to the coupling chamber, followed by a 30' horizontal segment of 1/2" per foot slope. This variation, when compared to configuration #2, provides data that shows the influence of the sequence of piping segments on the indicated level error. Other parametric variations performed on this configuration were

selected so as to provide similar comparisons as was done for configuration #2: configuration #3a included a 1/4" orifice located 4' below the free surface of the coupling chamber; #3d replaced the nearly horizontal segment of configuration #3a with 1/2" tubing; #3c used a shortened vertical segment of approximately 17' length; and configuration #3e varied the horizontal slope of configuration #3c to 1/4" per foot to investigate effects of slope on level error.
