September 30, 1982
MN-83-190

Subject: I.E. Bulletin 80-11 - "Masonry Wall Design"

This letter transmits Maine Yankee Atomic Power Company's response to your request for additional information, Reference (b), regarding masonry walls at Maine Yankee. We have addressed each request and have provided additional information for your review.

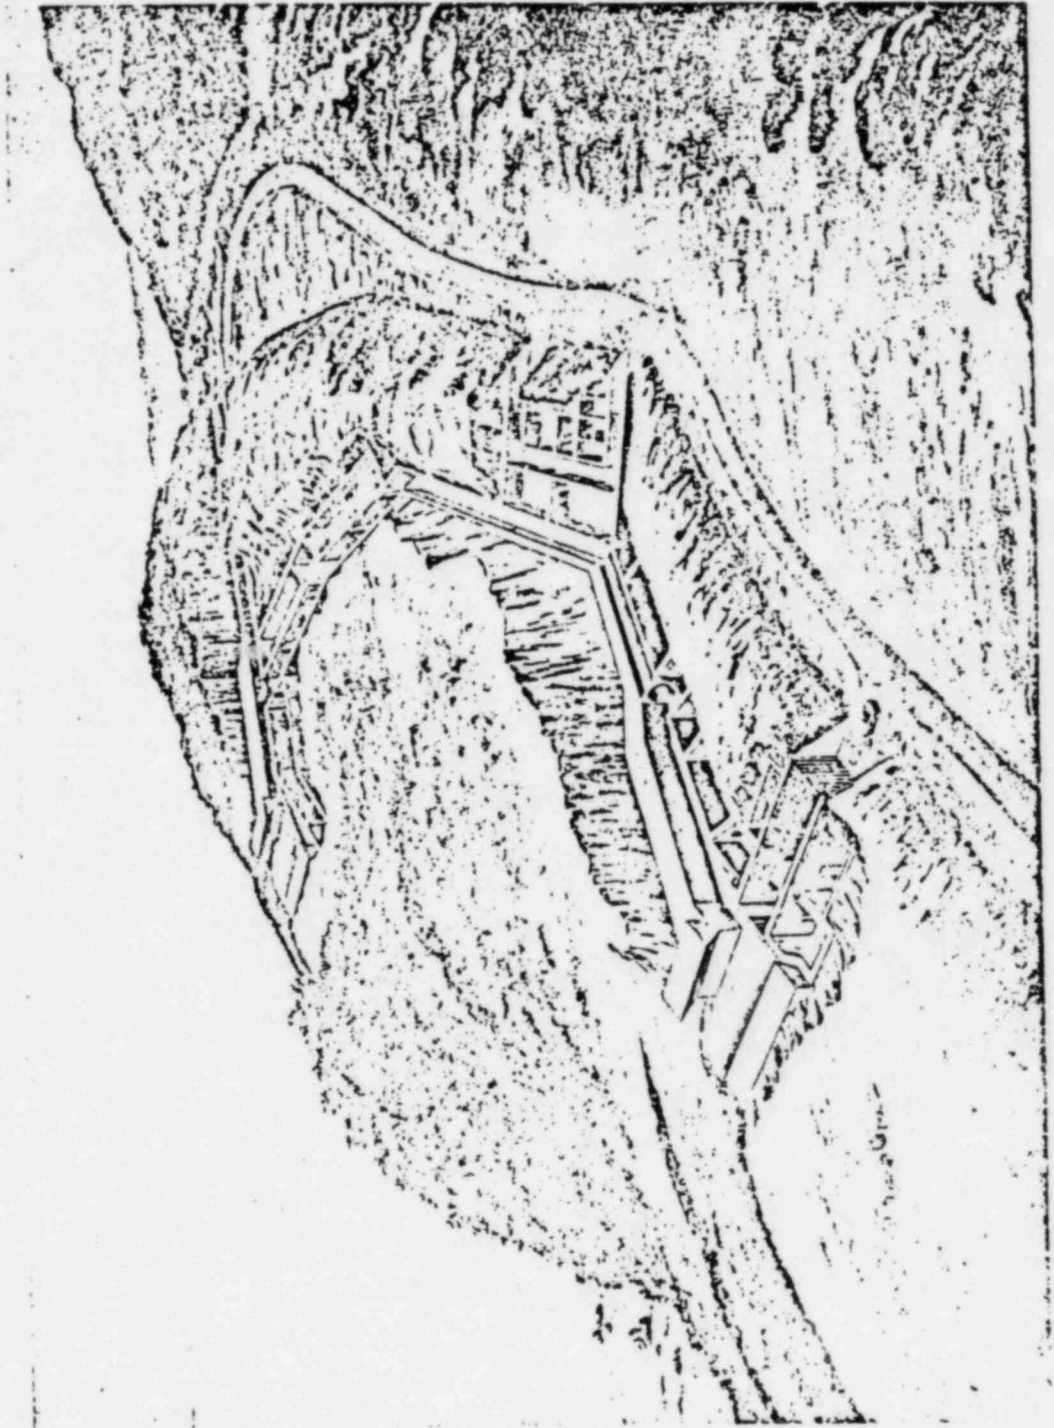
Fig. 1 Cutaway view of the shock tunnel test facility.

For the Civil Defense studies, a unique facility called a shock tunnel was used which enabled full-scale walls to be subjected to air blast loadings over one entire face. Fig. 1 is a cutaway view of the facility, a former coastal defense installation. The area occupied by the shock tunnel is in the foreground. It consisted of a 63-ft (19.2 m) long steel cylinder which served as a "compression" chamber, and a 100-ft (30.5 m) long passageway 8½ ft (2.6 m) high by 12 ft (3.7 m) wide which served as an "expansion" chamber, in which full scale walls were mounted. The expansion chamber opened on a large casemate area which once housed a 16-in. (40.6 cm) gun.

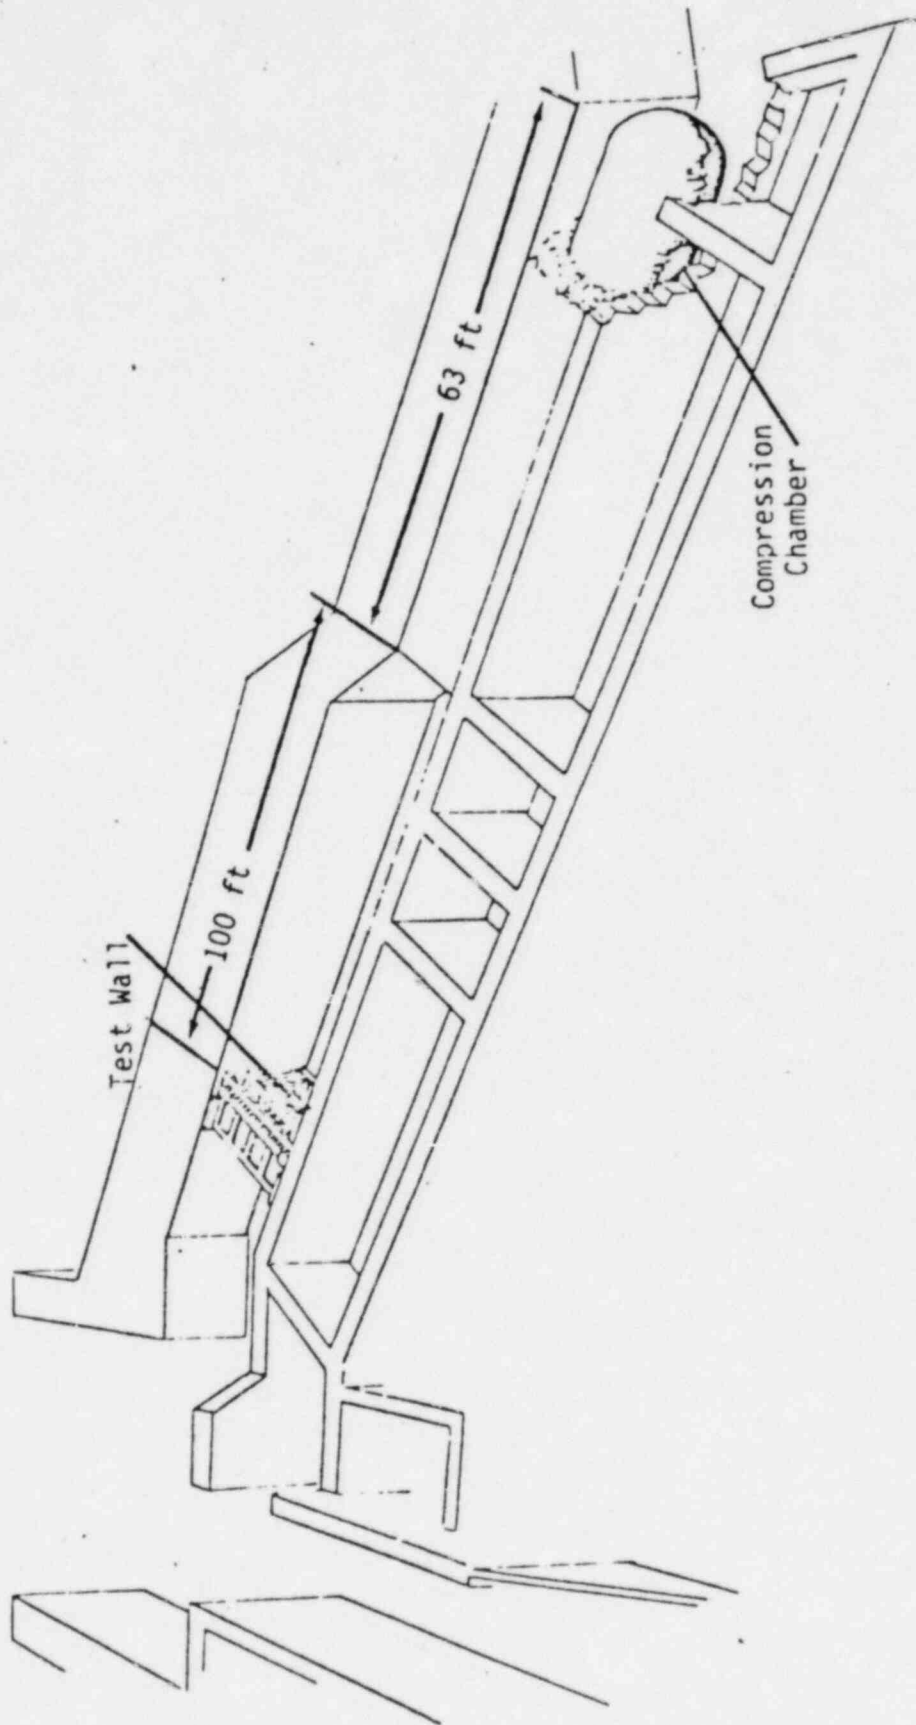
Fig. 2 Cutaway view of shock tunnel showing wall in place.

Fig. 2 is a closer cutaway view of the shock tunnel. In the domed steel cylinder, 60-ft (18.3 m) long strands of Primacord (detonating fuse) were strung. Upon detonation, the hot, high-pressure detonation products expanded rapidly in the compression chamber and acted like a piston to drive a shock (blast) wave out the open mouth of the cylinder. The cylinder, which experienced thrusts of up to 1,000,000 lbs (4.5×10^3 kN), is held in the tunnel solely by polyurethane foam. The shock wave, moving at a velocity somewhat greater than the speed of sound, proceeded down the expansion chamber, at the end of which it encountered a test wall, which thereupon experienced a generally uniform loading over one entire face.

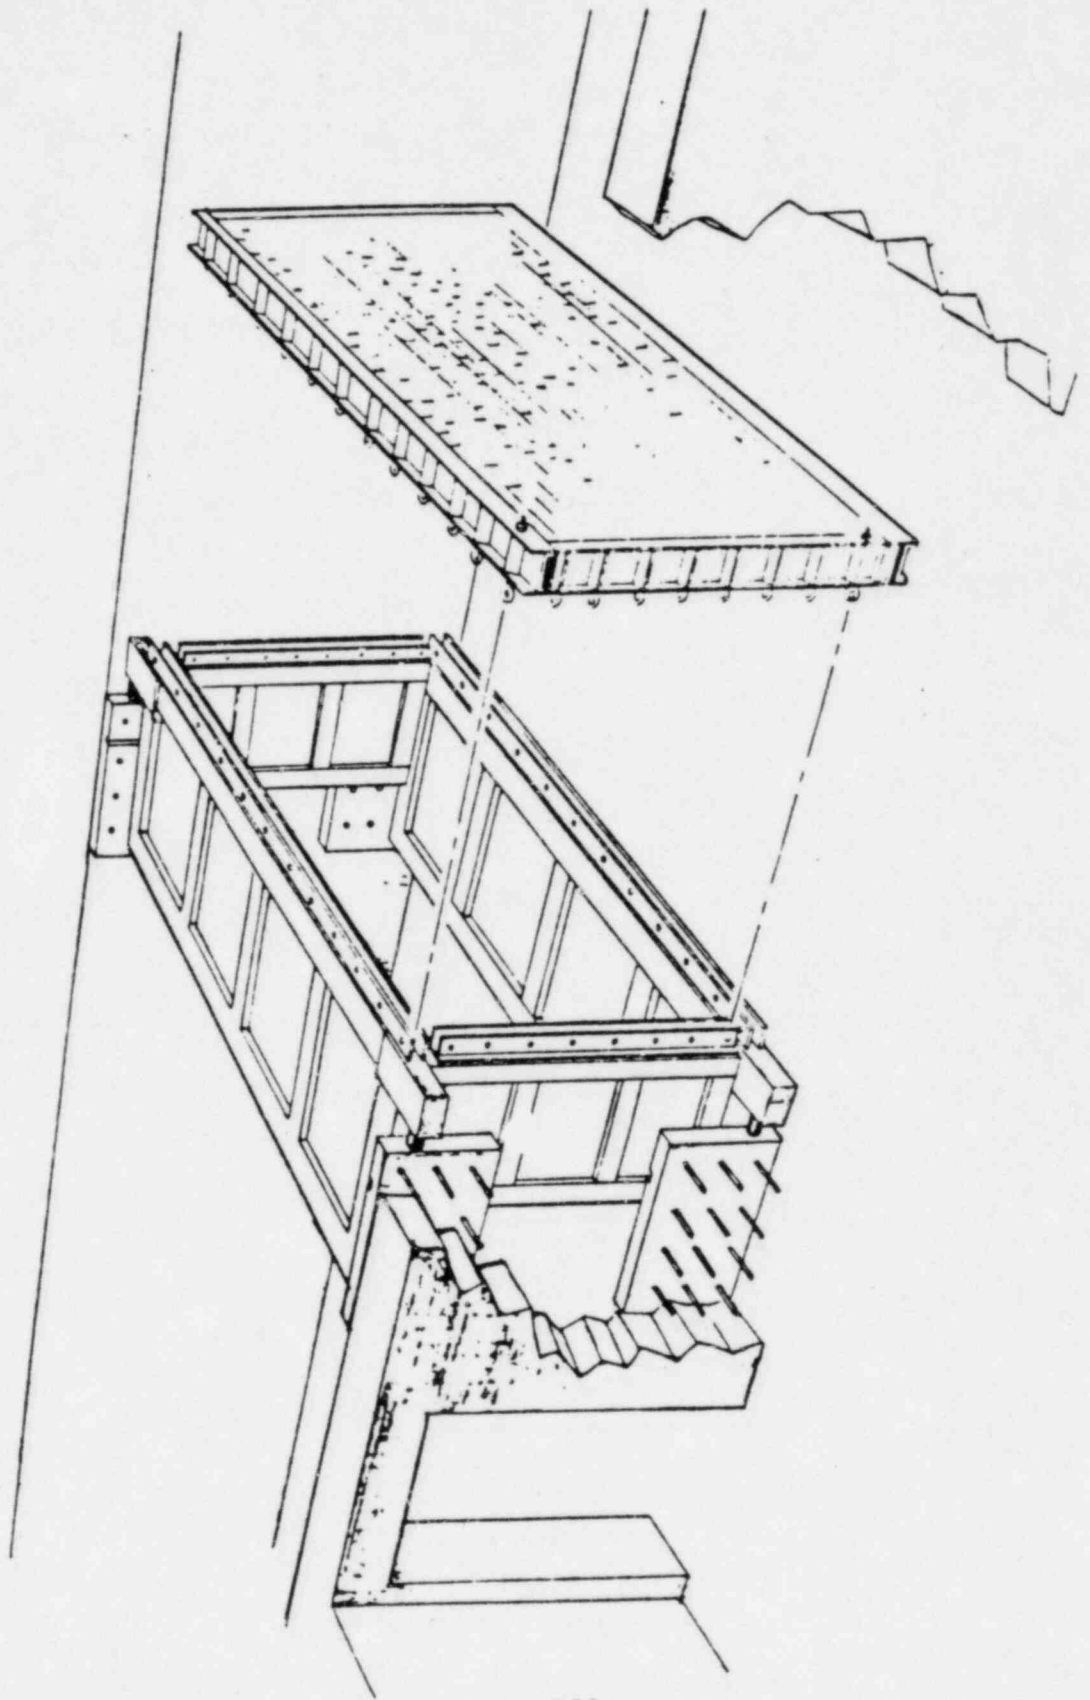
Fig. 3 Cutaway view of shock tunnel showing test panel and simple plate support condition hardware.

A still closer cutaway view of the tunnel showing wall mounting details is sketched in Fig. 3. Heavy steel blocks were bolted to the tunnel wall to serve as anchors for steel girders which spanned the tunnel, simulating floor systems in actual buildings. Two additional vertical girders were used in connection with walls that were mounted as plates. Most of the walls were constructed outside the shock tunnel itself in light steel frames. After curing, the wall in its frame was moved into the tunnel and affixed to the girders.

Walls which were mounted as simple plates (with all edges pinned) in the manner shown in Fig. 3, actually exhibited modified arching behavior once flexural failure began. Because of wall bonding to the frame members, the "picture frame" support structure became a perimeter restraining ring (to a rose petal type shell). As a result, arching thrusts developed as shown in Fig. 4, and the walls appeared to be approximately twice as strong as true simple plates would have been. In one impressive case [1], the result of this behavior was to neatly remove a section of wall, approximately 2.5 ft (0.75 m) on a side, from the center of a panel, leaving the remainder of the panel standing. This

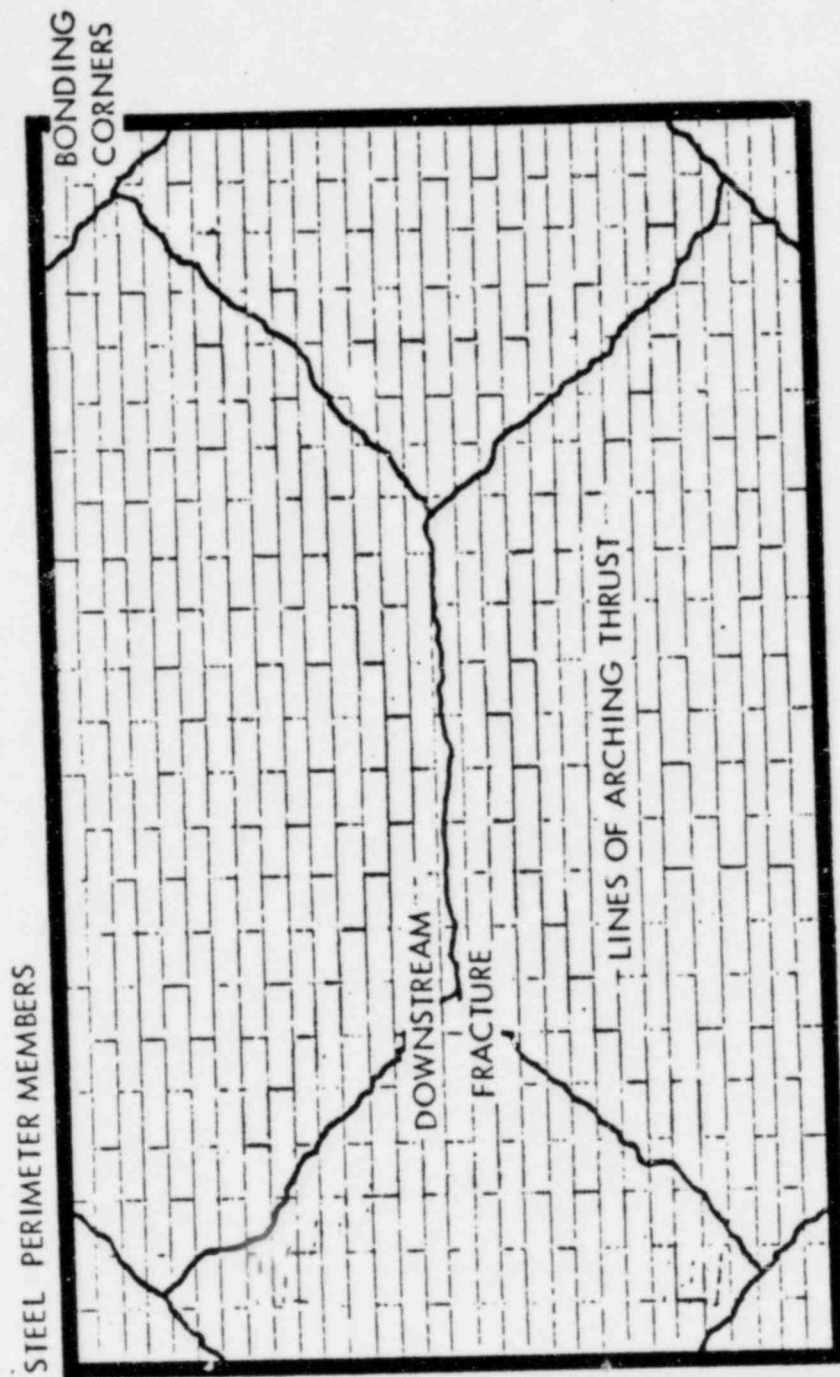
Fig. 4 Thrust lines for modified arching; in plate mounted walls.

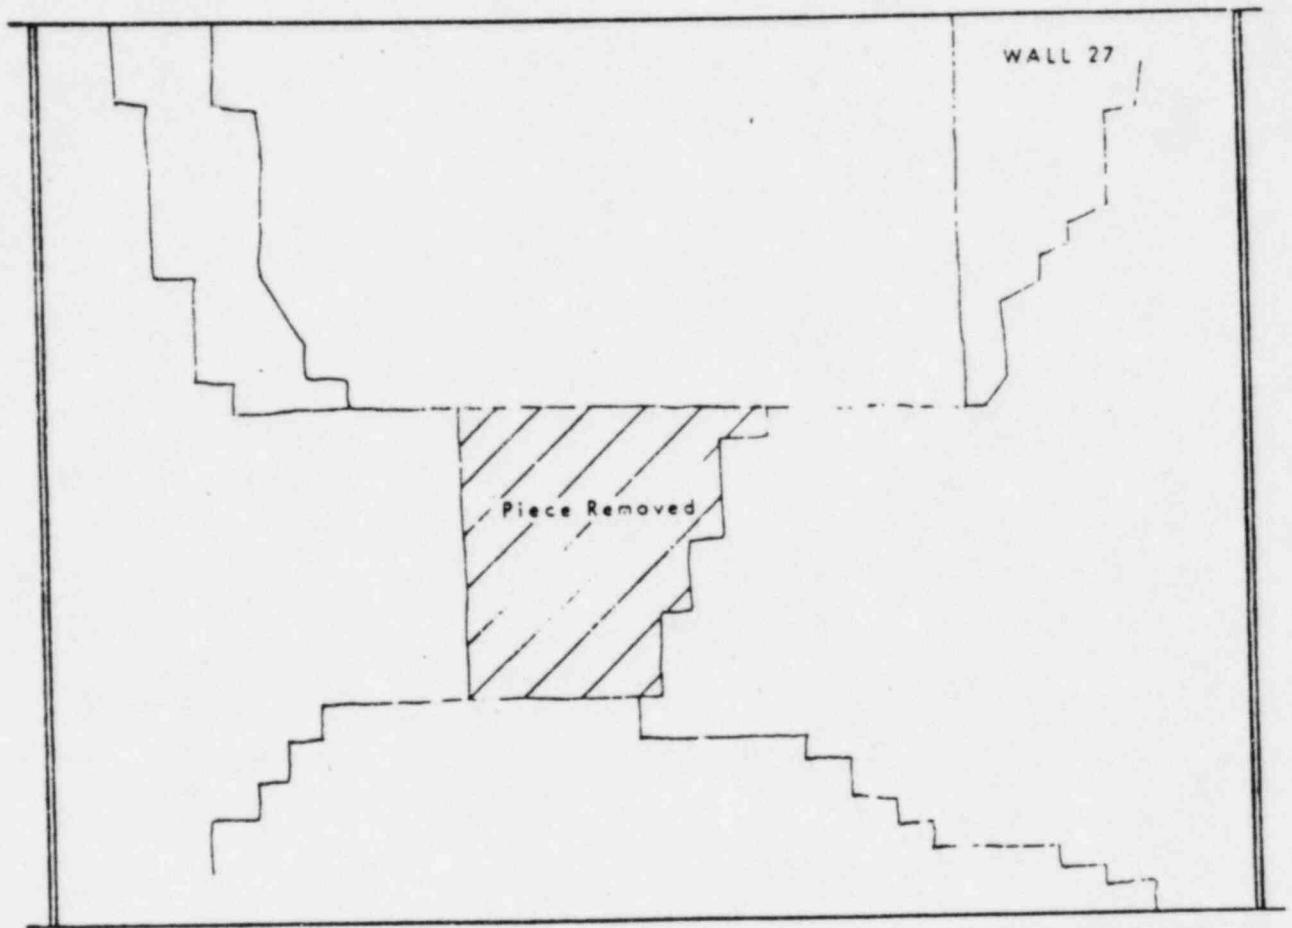
Fig. 5 Sketch of downstream face of plate-mounted wall after loading with overpressure of 3.5 psi.

is shown in Fig. 5. Note the crack pattern on the downstream face of the wall extending from the corners of the hole.

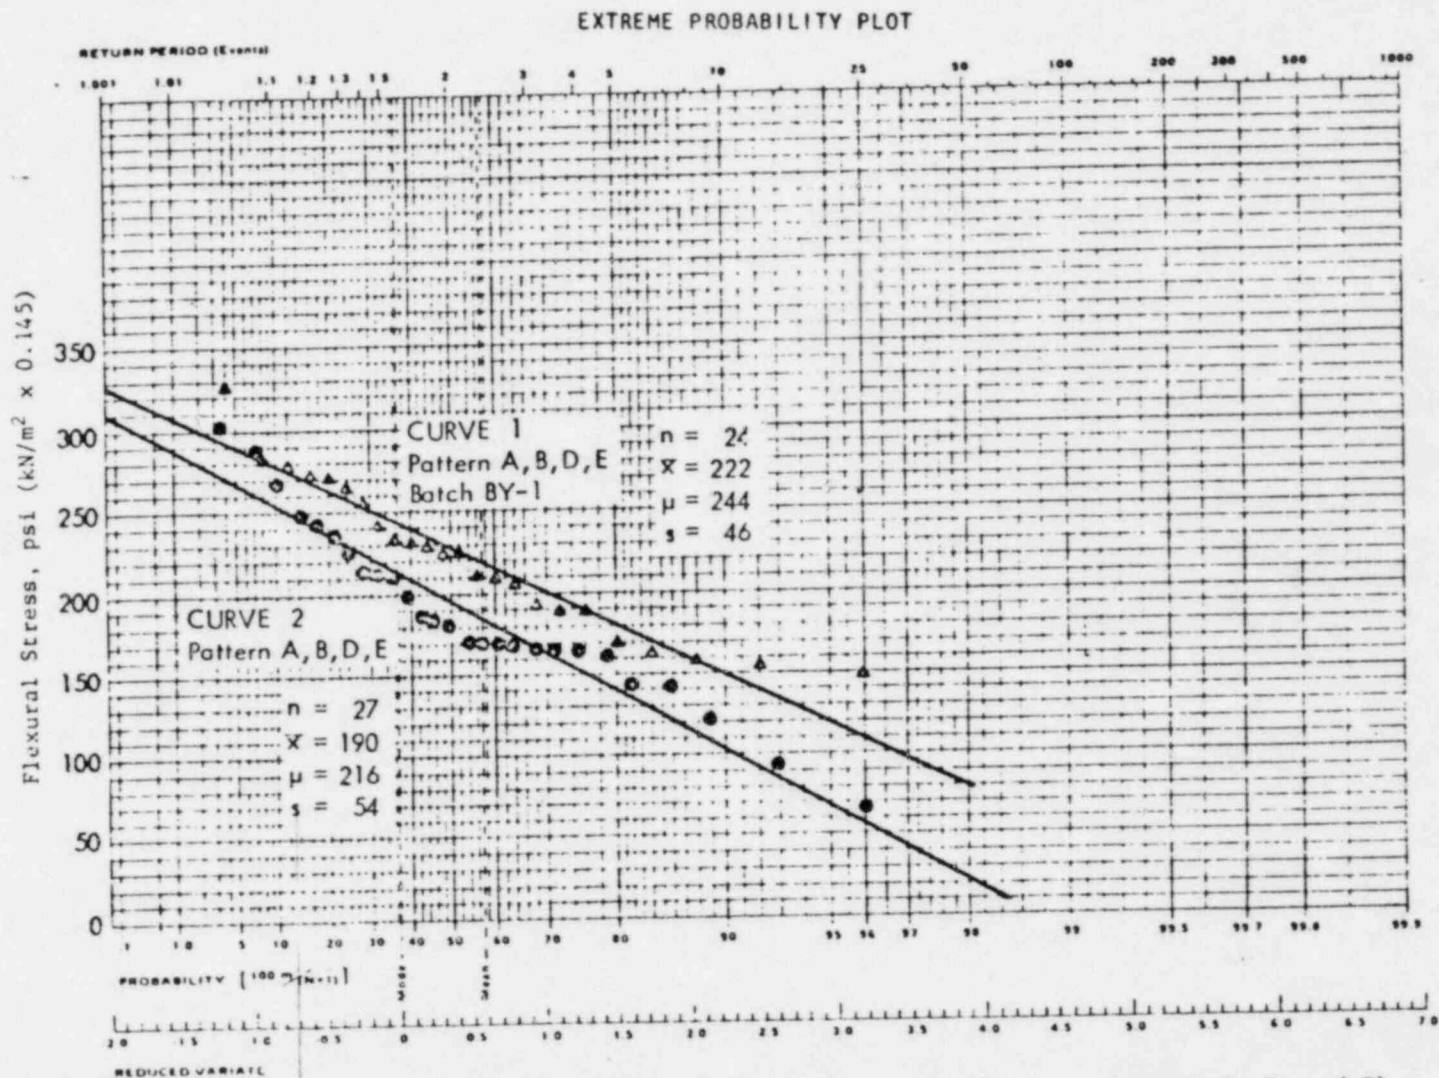
Fig. 6 Comparison of wall specimens and laboratory control specimens (patterns A, B, D, and E).

Failure statistics reflected a fairly large property variability, as can be seen in Fig. 6, an extreme probability plot of tensile stress at flexural failure [2]. Curve 1 is for specimens carefully constructed in the laboratory, and Curve 2 is for specimens constructed by the bricklayer. The data for both lines show stresses that differ by about a factor of three. There is good correlation between failure stresses in the field and laboratory samples.

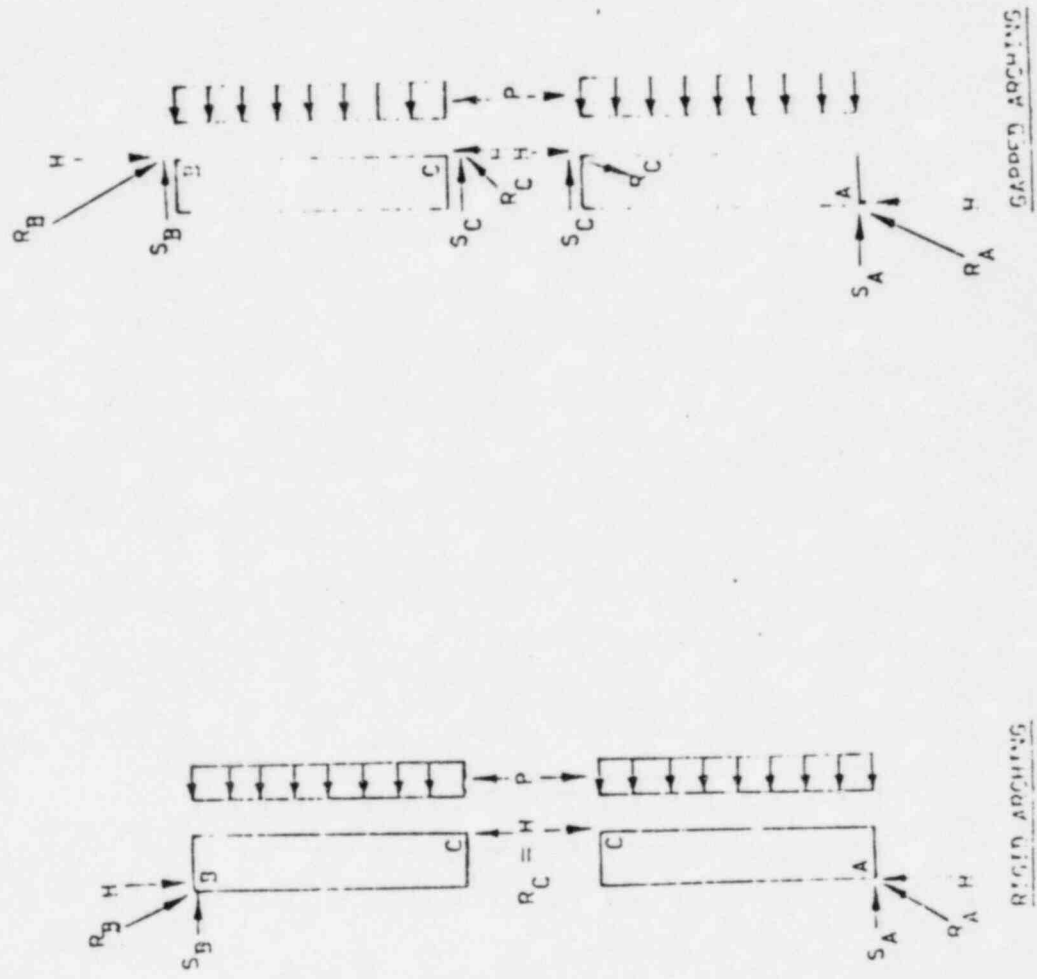
Fig. 8 Free body diagram showing forces in rigid and gapped arching.

The essential differences between the two forms of arching are shown in Figs. 7 and 8. Fig. 7 shows, in exaggerated fashion, the motions that take place. In rigid arching, a symmetrical three-hinged arch is formed; in gapped arching, an unsymmetrical arch is formed. Fig. 8 contains free-body diagrams of the wall elements in the two cases. In rigid arching, forces at the arch hinge points are all directed into the wall (or parallel to its face). In gapped arching forces at two hinge points are directed away from the wall. Thus, in rigid arching, failure at the hinge points should be largely through crushing (compressive) forces. In gapped arching, failure would also take place through spalling (tensile) forces.

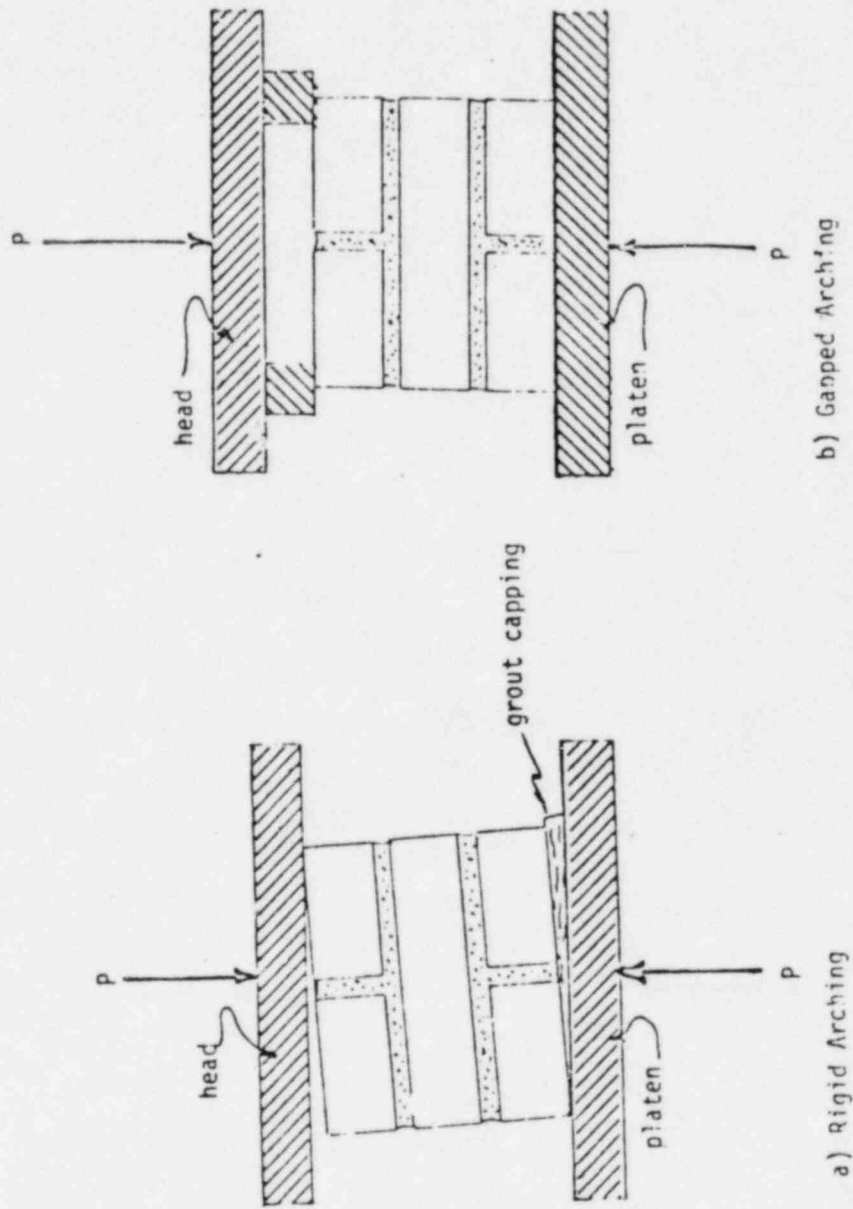
Fig. 9 Configurations for rigid and gapped arching, line load tests.

In both types of arching, the loads at the hinge points are applied along the hinges, that is along lines in the wall faces. To determine failure strengths under these line-loads, static tests were conducted using the specially designed test configurations shown in Fig. 9, modifications of standard compression test configurations. In 11 tests with rigid arching samples, an average line-load of 4500 lb/in. (7900 N/cm) was required to cause failure; in four tests with gapped arching samples, line loads of about 1000 lb/in. (1800 N/cm) caused failure [7]. Photographs of a rigid arching type of static line-load test are shown in Fig. 10. The sample is one from a wall of a V.A. hospital [8].

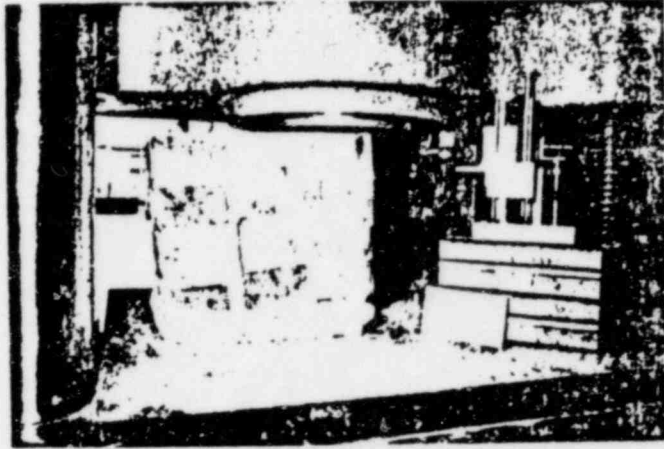
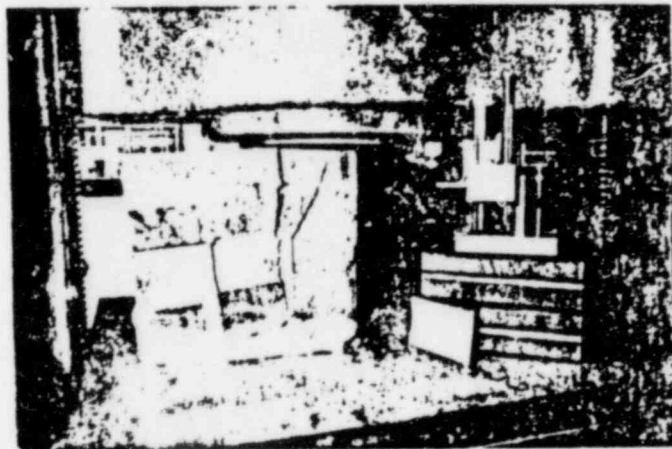
FIG. 10 Pre-, and post-test photographs of a rigid arching type of line-load strength test.

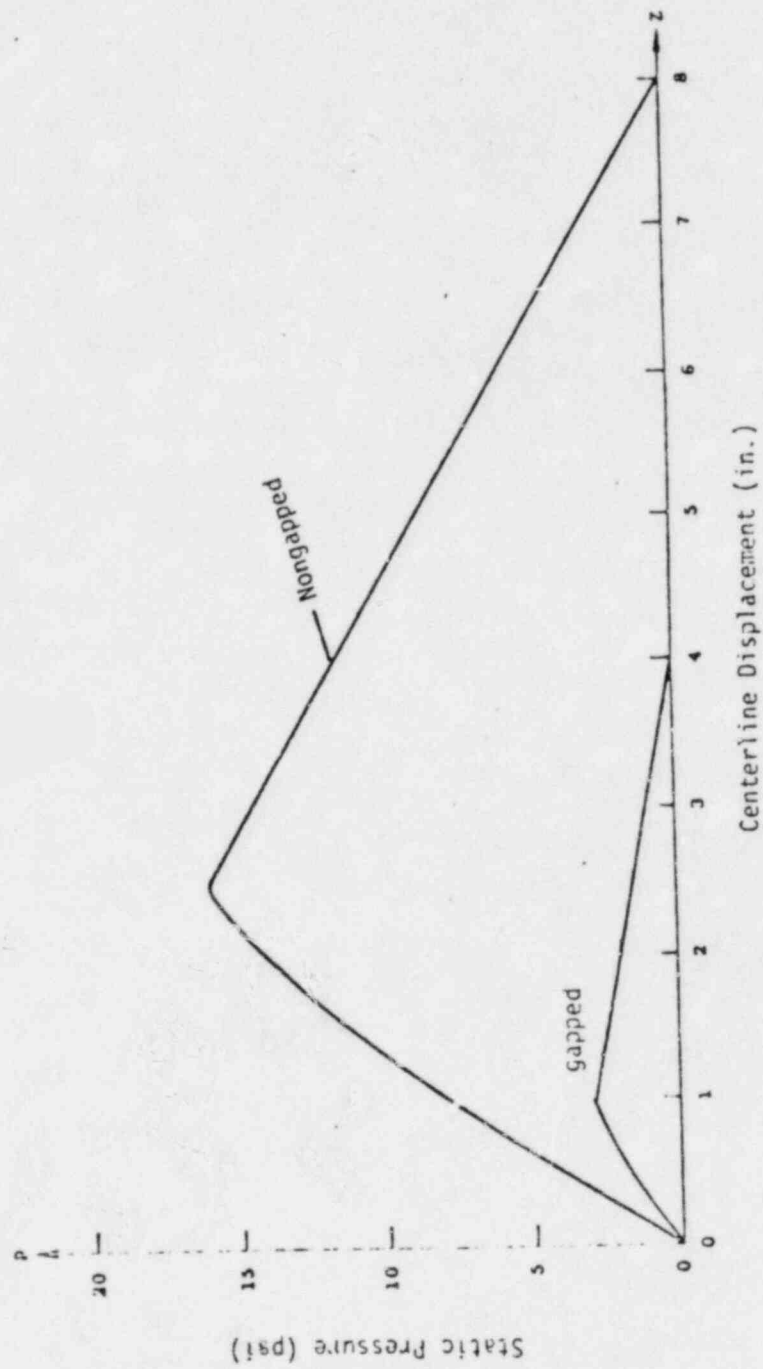
Fig. 11 Arched brick wall, static resistance.

functions for walls (resistance of a wall to uniform loadings normal to one face) such as those shown in Fig. 11. Clearly, the resistance of gapped arching walls is much less than that of rigid arching walls. It should be appreciated, however, that both are still considerably larger than the resistance of non-arching walls. Consider, for example, the four types of walls shown in Fig. 12, on which tests and analysis were conducted, and which resemble each other superficially. Pressures to cause wall failure, and the relative energy absorbed by the walls to the point of their failure (i.e., when they become unstable and would collapse under gravity alone) are shown in Table 1.

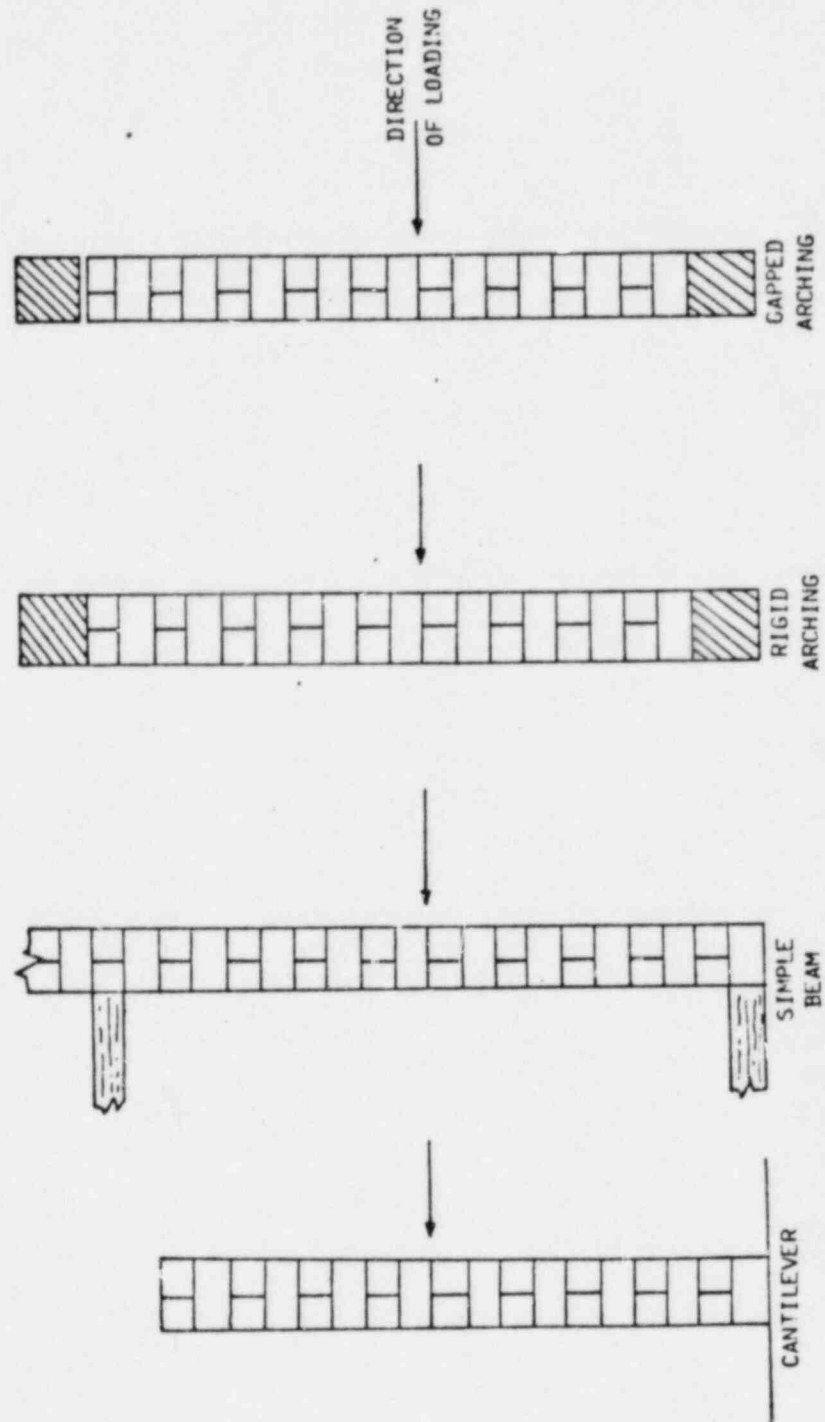
Fig. 12 Types of walls.

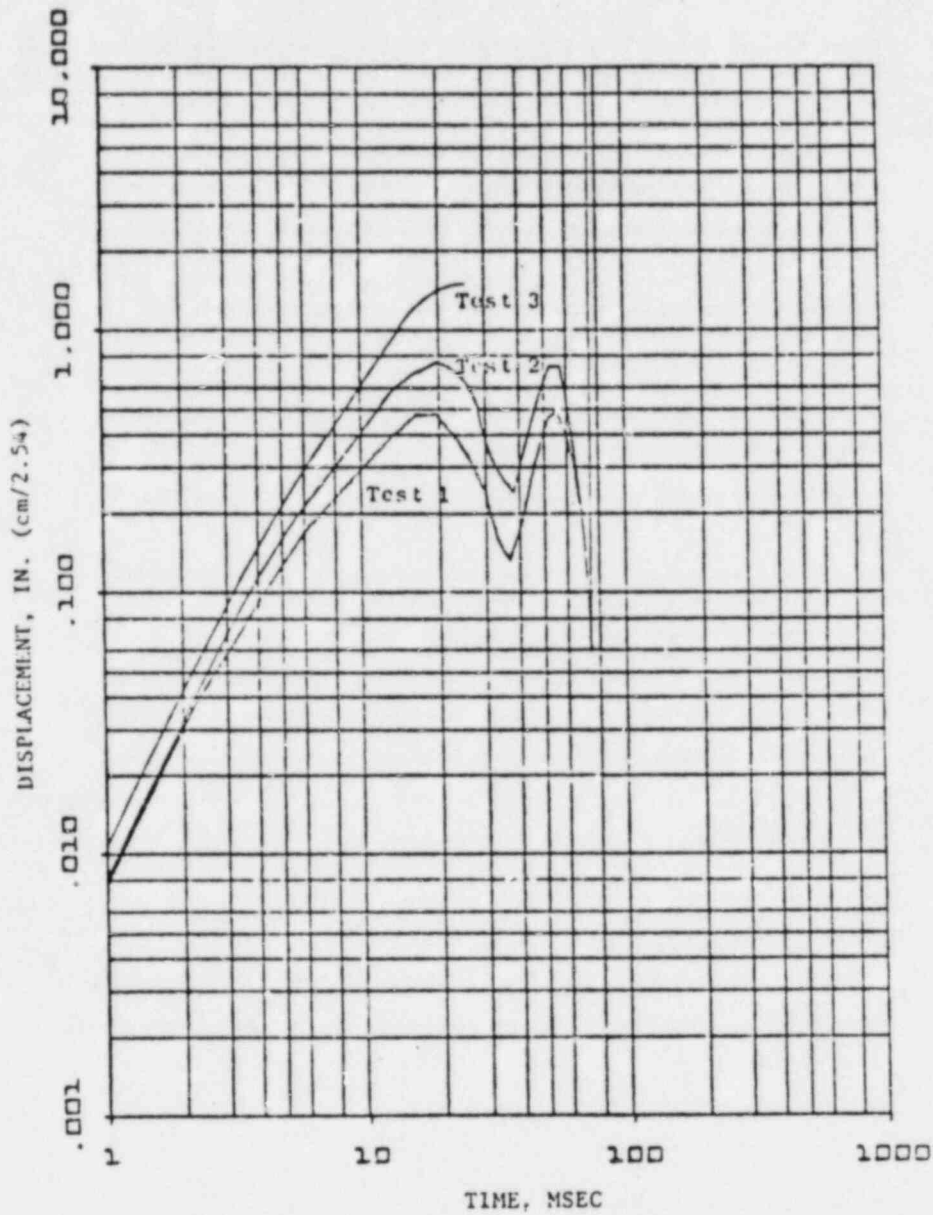
Fig. 13 Displacement as a function of time, wall no. 87. Test 1, 13 psi (90 kN/m²); Test 2, 15 psi (100 kN/m²); Test 3, 20 psi (140 kN/m²).

Theory and experiment for rigid arching walls compare quite well. In Fig. 13 are shown records of motion at the centerline of an 8-in. thick brick wall, tightly fitted between floor and ceiling of the tunnel so as to undergo rigid arching. The wall was tested three times. It was first exposed to a blast loading of 13 psi (90 kN/m^2). It cracked in the center, oscillated, but recovered. It was then exposed to a loading of 15 psi (100 kN/m^2). Again, it oscillated, but recovered. Finally, it was loaded at 20 psi (140 kN/m^2) well above its predicted failure point, and it did fail. Fig. 14 shows a comparison between centerline motion measured during the second test, and predictions of this

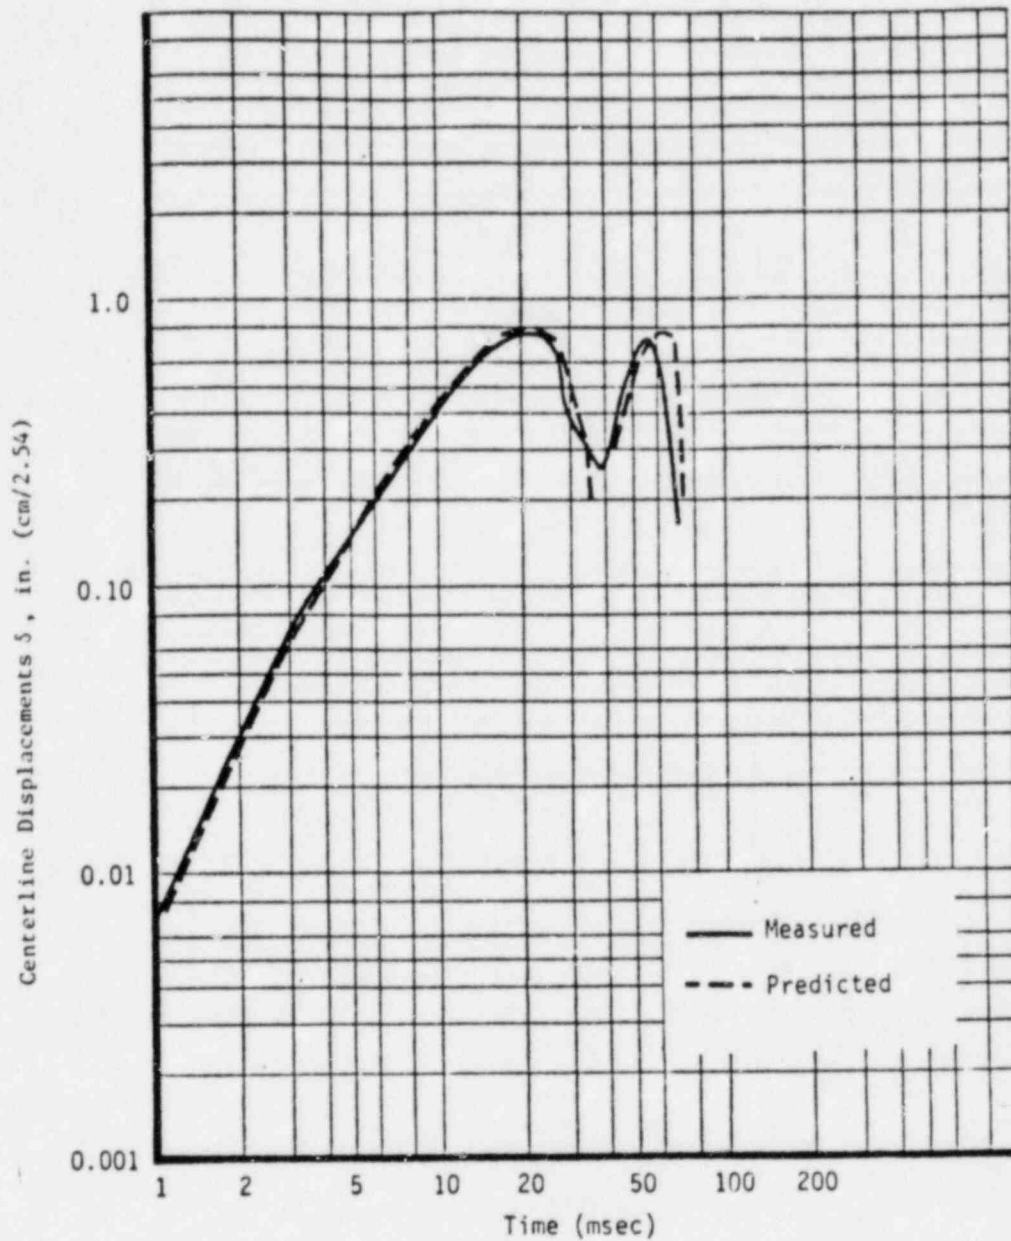
Fig. 14 Predicted and measured wall centerline displacements for a rigidly arching wall vs time from initial blast loading, wall no. 87, second test. Loading pressure = 15 psi (103.5 kN/m²)

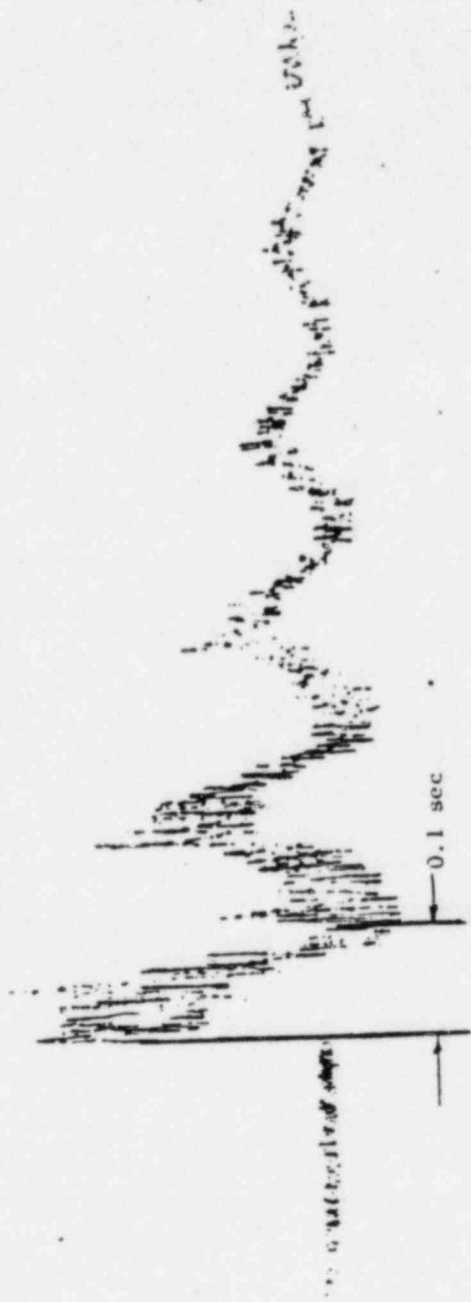
Fig. 15 Shock tunnel pressure gauge traces. Gauges mounted in nonfailing wall (peak reflected overpressure, first peak 5 psi.)

The type of pressure loadings experienced by a solid wall that did not fail is illustrated in Fig. 15, which clearly shows the loading reversals (the troughs of the trace where pressure is negative).

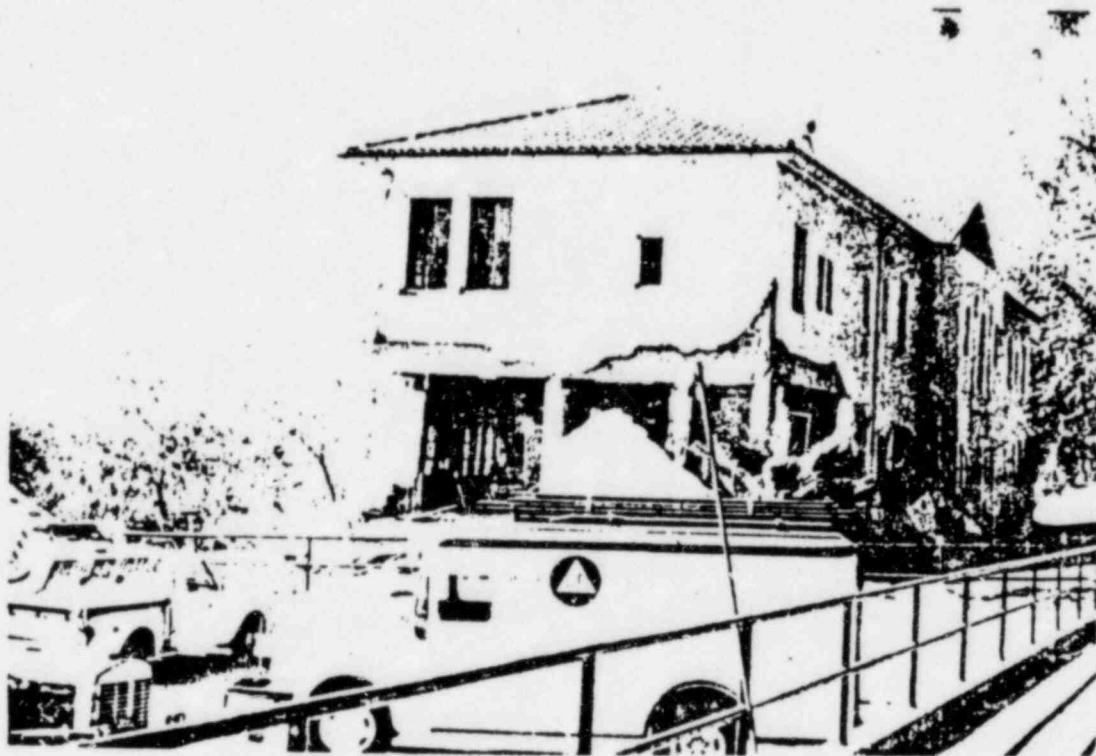
Fig. 16 Masonry infill wall and frame building at Sylmar, California.

Field evidence confirms that non-reinforced, masonry, in-fill walls can provide increased resistance to out-of-plane loads over non-arching walls. Fig. 16 is a photograph of a building on the grounds of the V.A. hospital at Syimar, which was exposed to an earthquake in February, 1971. Note that the upper walls facing the observer (which run north-south) are intact while the lower walls have fallen. The east-west walls of this building showed diagonal cracking from shear forces, strongly suggesting that the major direction of the earthquake was in the plane of these walls, that is, normal to the walls shown in Fig. 16.

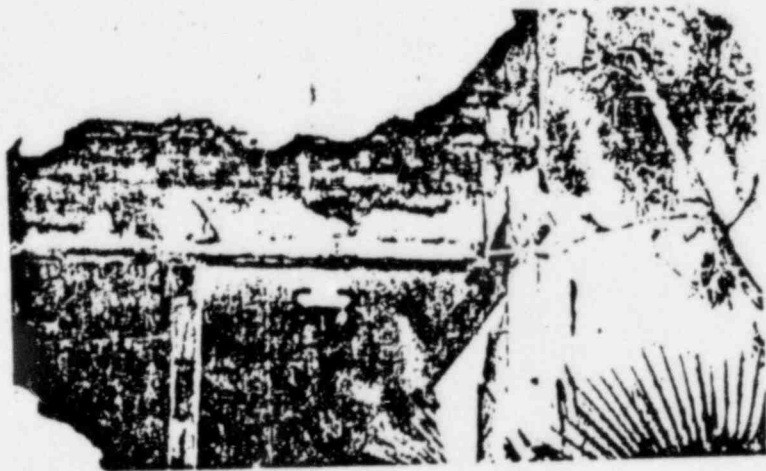
Fig. 18 Detail of Sylmar building showing failure at corner column.

of frame failure in the same building that prevented arching from occurring and caused failure of the first-floor walls.

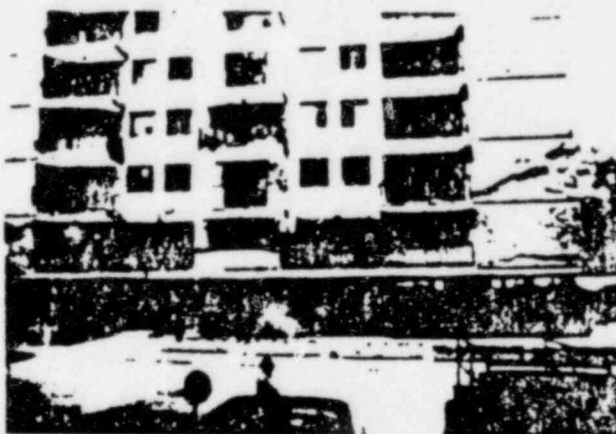
Fig. 20 Building at Caracas, Venezuela showing cracked infill walls.

A building in Caracas whose walls show evidence of severe loading is shown in Fig. 20. Walls in both the face of the building in the photograph, and in the hidden side of the building were identified as being infill walls in rigid frames [9]. None failed.

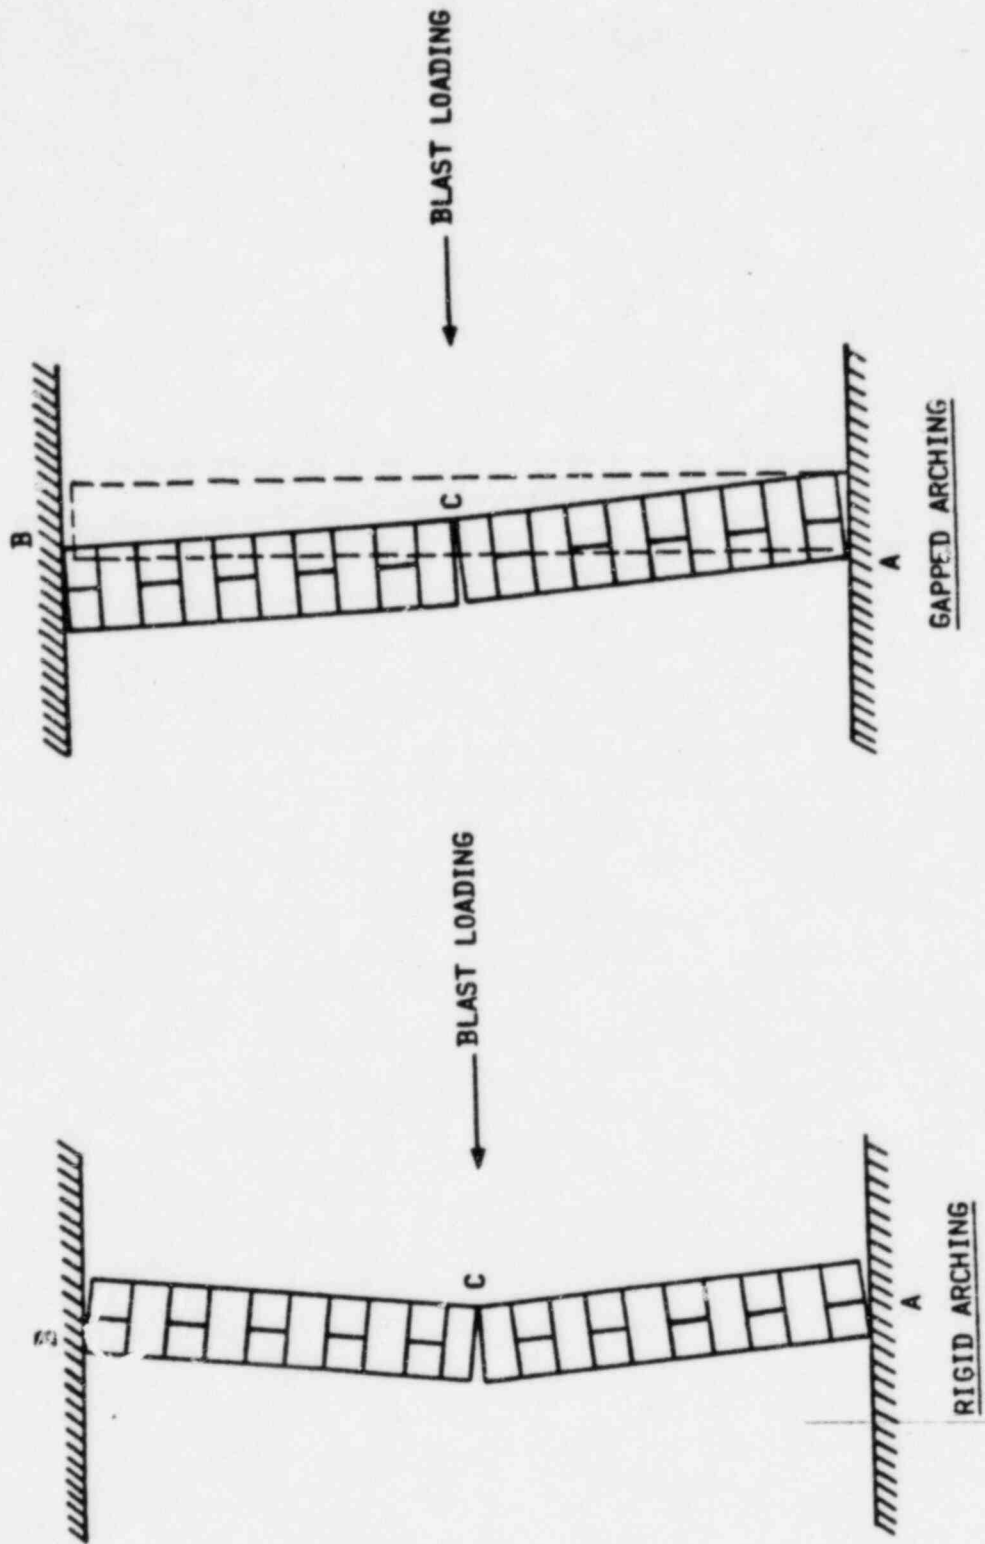
Fig. 2-1. Sketch Illustrating the Differences in Motion Between Rigid and Gapped Arching.

In gapped arching on the right, in Fig. 2-1, the gap permits the wall to move, either by bending or because of a crack at its base until the upstream edge at the top of the wall contacts the upper restraint. The original position of the wall is shown by the dashed line. A tensile crack forms at the wall center where maximum tensile stresses still occur. Again a three-hinged arch forms, but one which is not as symmetrical as in the rigid case. Loadings are at the downstream edge of the wall bottom, at the upstream edges of the tensile crack and the top of the wall. Note that the gap can be very small; (as shown in Ref. 1, it can be as little as about 0.01 in. - one hundredth of an inch - for an 8-in. thick, 96-in. high wall) the only requirement is that the upstream edge at the top of the wall contact the restraint.

Fig. 2-1 and 2-2 illustrate the important difference between rigid and gapped arching. (Only "one-way" arching in which the wall is restrained on only two edges, is discussed**). Fig. 2-1 contains sketches showing how walls behave in the two cases (exaggerated for clarity). In rigid arching on the left, blast induced forces (or actually any force normal to the face of the wall) push the wall to the left. However, the wall is prevented from rotating about its top and bottom supports. Tensile (flexural) cracks form at the top, bottom, and center (where tensile stress is highest), but the wall elements cannot move downstream. A three-hinged arch forms with loadings along lines at the downstream edges of the top and bottom of the wall, and at the upstream edge of the crack.
