September 30, 1982
MN-83-190

Subject: I.E. Bulletin 80-11 - "Masonry Wall Design"

This letter transmits Maine Yankee Atomic Power Company's response to your request for additional information, Reference (b), regarding masonry walls at Maine Yankee. We have addressed each request and have provided additional information for your review.

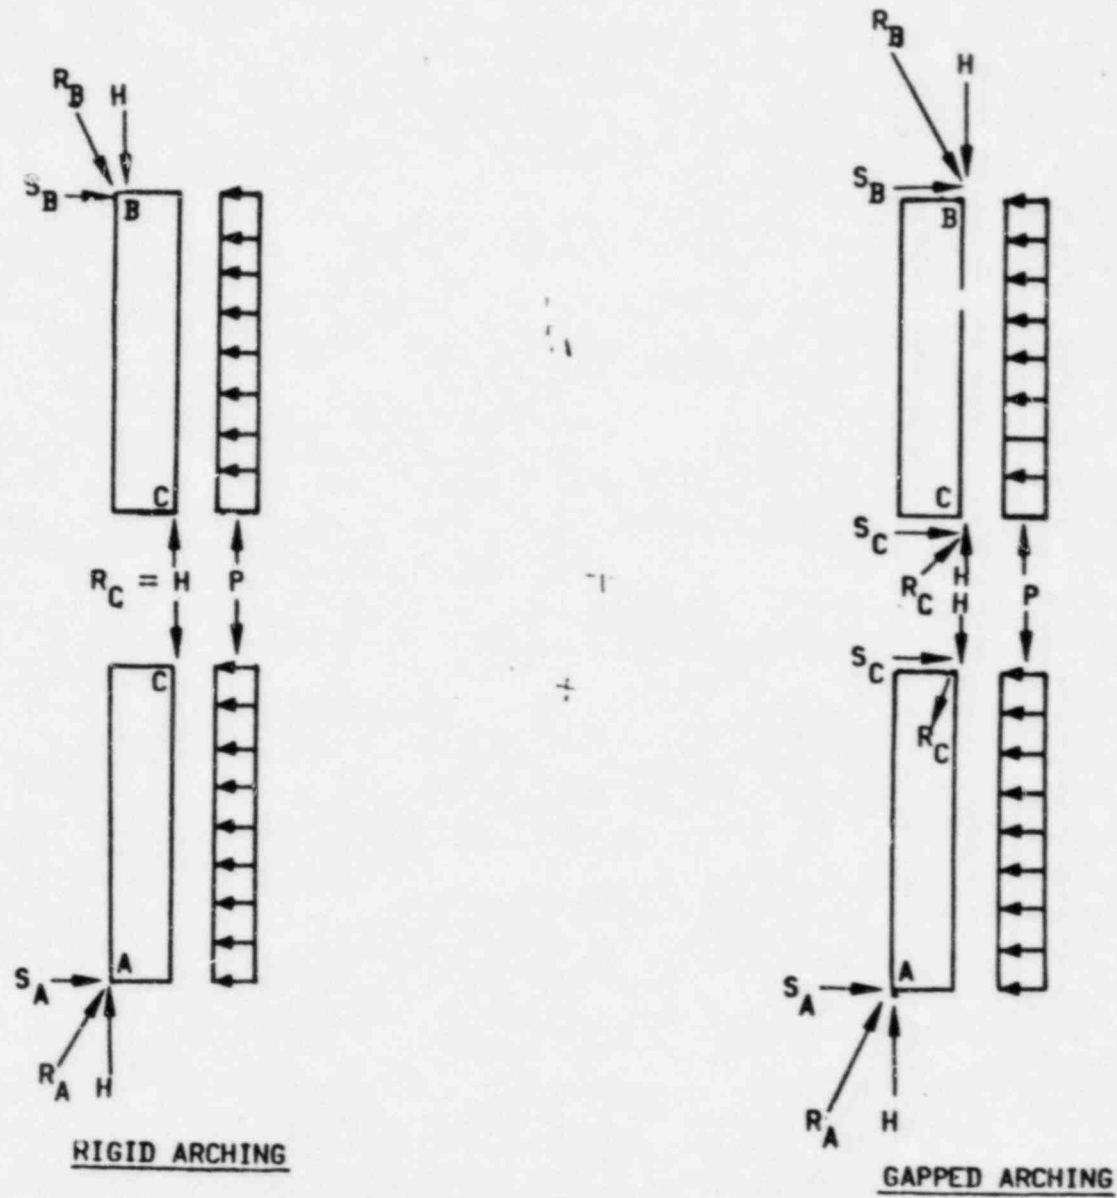
Fig. 2-2 shows the directions of forces on the two parts of each wall. The general formulas for these forces per unit length of wall and the initial magnitudes of these forces for a wall with a height (l) of 96 in. and a thickness, (t) of 8 in. are given in Table 2-1 for a uniform pressure (p). Fig. 2-2 shows that in rigid arching, the resultant forces are either directed into the wall (R_A and R_B) or are parallel to the wall face (at C). In the gapped arching case, however, there are forces (R_B and R_C) directed away from the upper part of the wall, and both the force directed into the wall (R_A) and the in-plane force (H) are about twice as large as they are in the rigid arching case. Forces directed into the wall would tend to cause compressive (crushing) failures; those directed away from the wall would tend to cause tensile (spalling) failures which occur at much lower stress values. Thus, the upper part of the wall in gapped arching should fail essentially in ten-

Fig. 2-2. Free Body Diagrams Showing Forces in Rigid and Gapped Arching.
(See Table 2-1 for force values.)

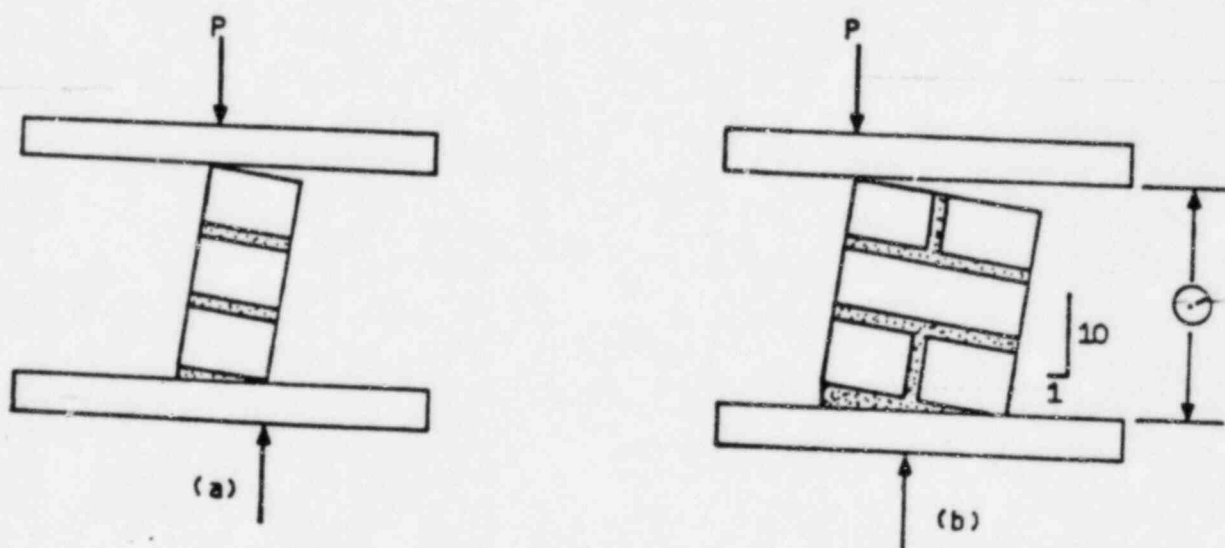
One series of tests were made using tilted brick-mortar composite specimens to determine the strength of wall composites under compressive (crushing) line loads. The basic test geometry for these static tests is sketched below.

Results from 11 tests with test setup (a) showed that failure occurred at an average total load (p) of 28,100 lbs. (Values ranged from 18,000 to 35,000 lbs. as shown in Table B-5 in Appendix B). The average line load at failure f_l for the approximately 8 in. long specimens used was 3300 lb/in. (range 2100 to 4000 lb/in.). In the test setup (b) results from 11 tests gave an average p value of 43,100 lbs. (range: 35,000 to 52,000 lb) and an average f_l value of 5100 lb/in. (range 4100 to 6000 lb/in.) again using approximately 8-in. long specimens.

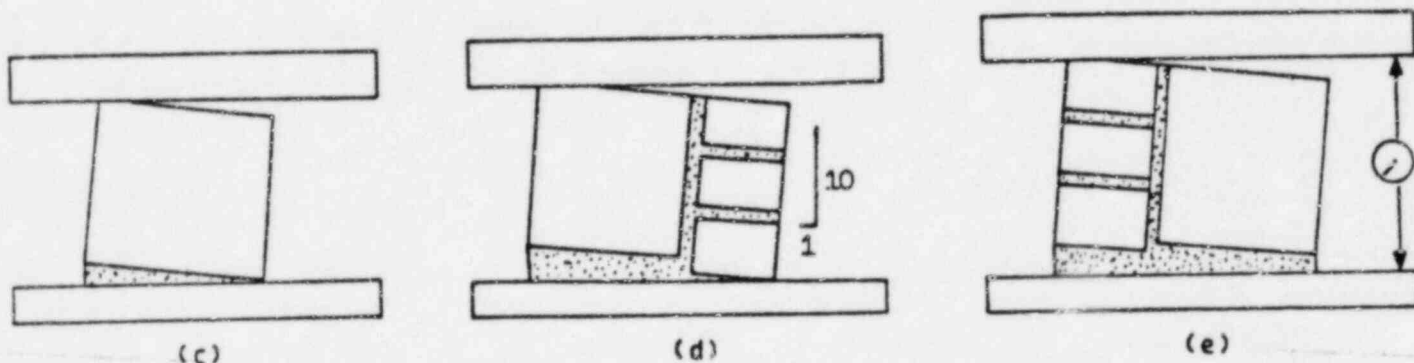
Fewer line loading tests were made with concrete block, and brick-concrete block mortar composites. Test set ups are sketched below:

Specimen	Number of tests	average p (lb)	average f_l lb/in.
(c)	4	30,200	4,000
(d)	3	39,000	4,600
(e)	4	23,200	3,000

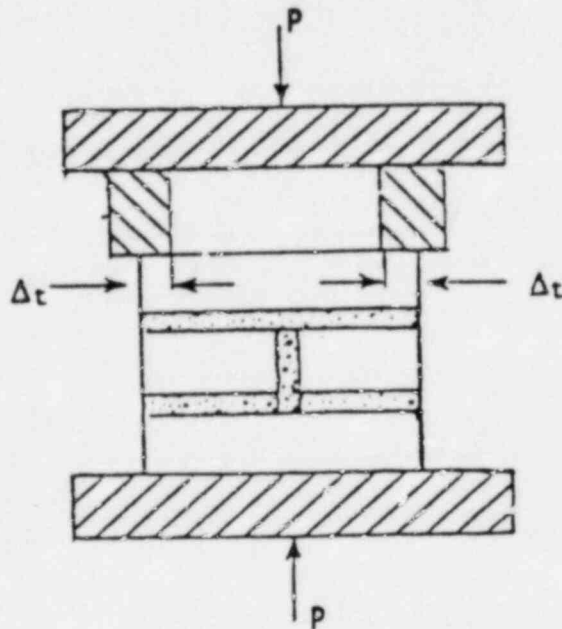
Additional tests were conducted to develop an approximation of strength under the tensile (spalling type) of line loading that could occur in the gapped arching case at points B or C in Fig. 2-1 and 2-2. That test set up is shown in the sketch below.

Two values of Δt were tested, $\frac{1}{2}$ in. and $\frac{1}{4}$ in. For the latter, spalling was clearly occurring, and on four tests, the average P was 13,390 lb. and the average f_2 was 824 lb/in. As expected, these tensile line loading strengths are far below those for compressive line loading.

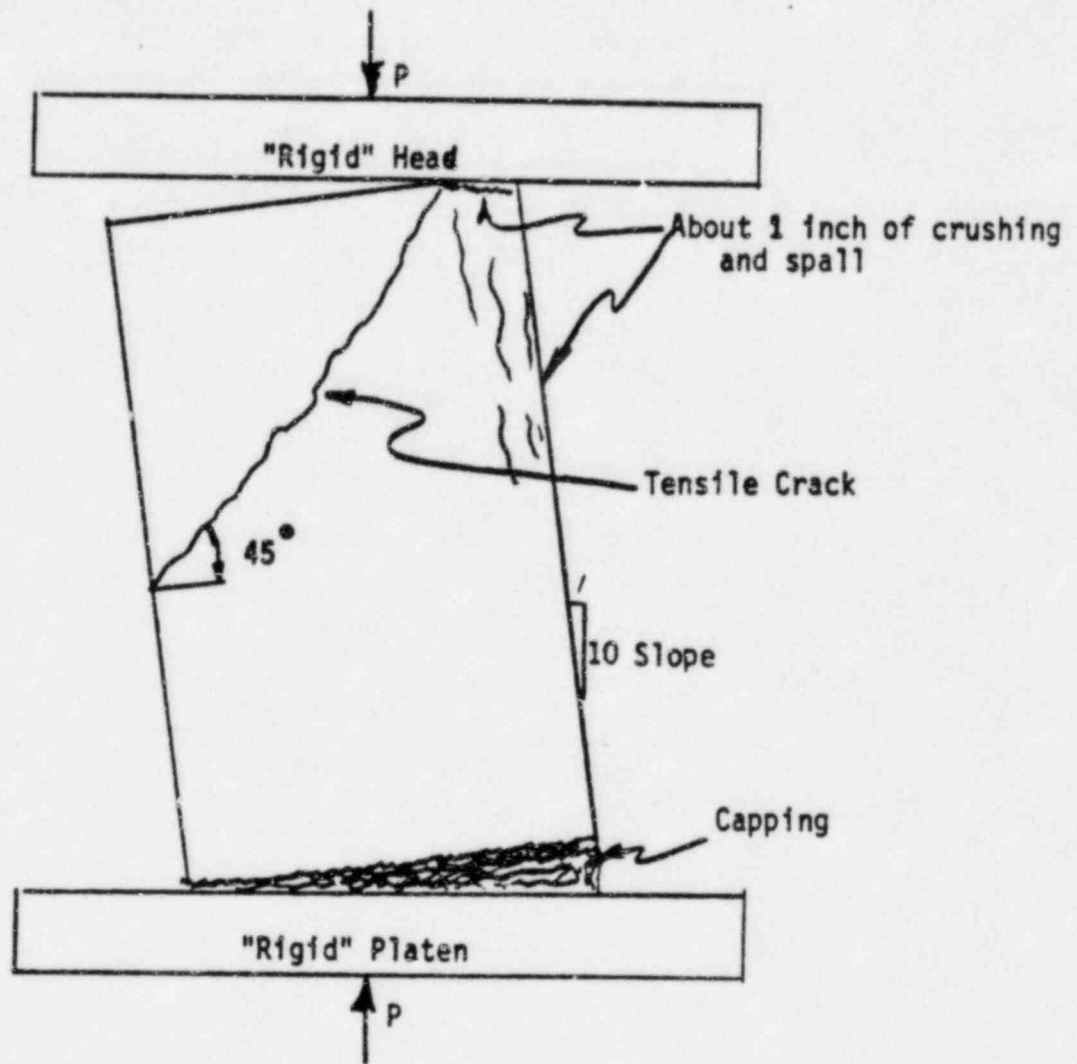
For brick test specimens consider the test set-up shown below.

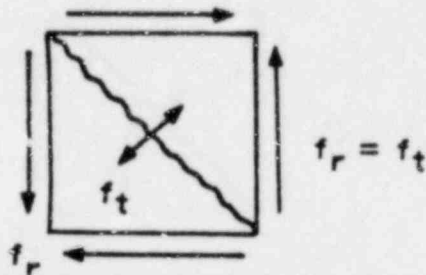
Assume the tensile crack is caused by pure shear as shown below.

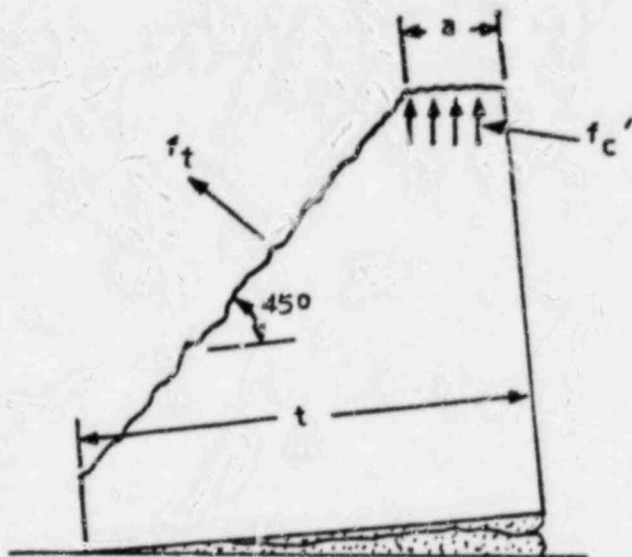
In the force diagram sketched below, if a unit width is assumed:

$$f_L = f_c' a + f_t (t-a) \cos 45^\circ$$

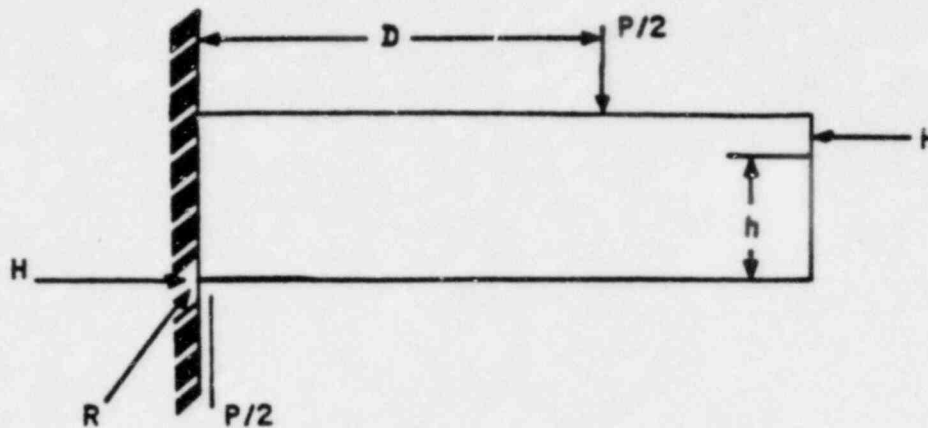
Fig. B-4). A free-body diagram of one-half the beam is sketched below.

$$H_h = (P/2)d, \text{ or } H = Pd/2h$$

in which h , the uncrushed portion of the beam is about 3 in., $d = 16$ in., and $P = 10,479$ lb. Therefore, $H = 27,944$ lb., the resultant force $R = \sqrt{H^2 + (P/2)^2} = 28,431$ lb., and the line load at failure, calculated by dividing R by the brick width of 8.625 in., is 3296 lb/in. This compares quite favorably with either the calculated value of 3439 lb/in. or the static test value of 3300 lb/in.

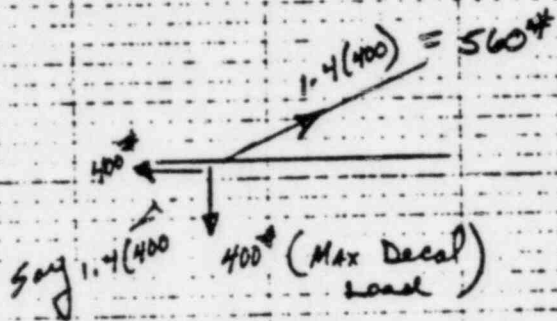
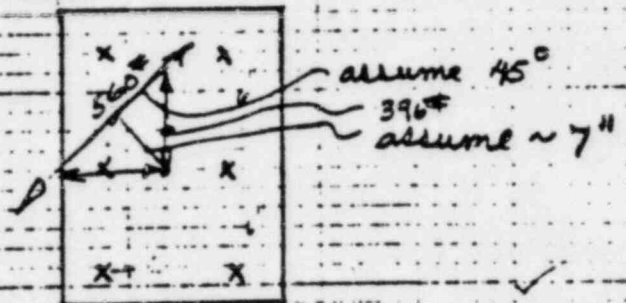
DETERMINE BOLT LOADS DUE TO 1" LINE

$$HORIZ SHEAR = VERT SHEAR = 396 \# / 6 BOLTS = 66 \# / BOLT$$

$$MOMENT = 7" (560 \#) = 3920 \text{ in}\cdot\# \checkmark$$

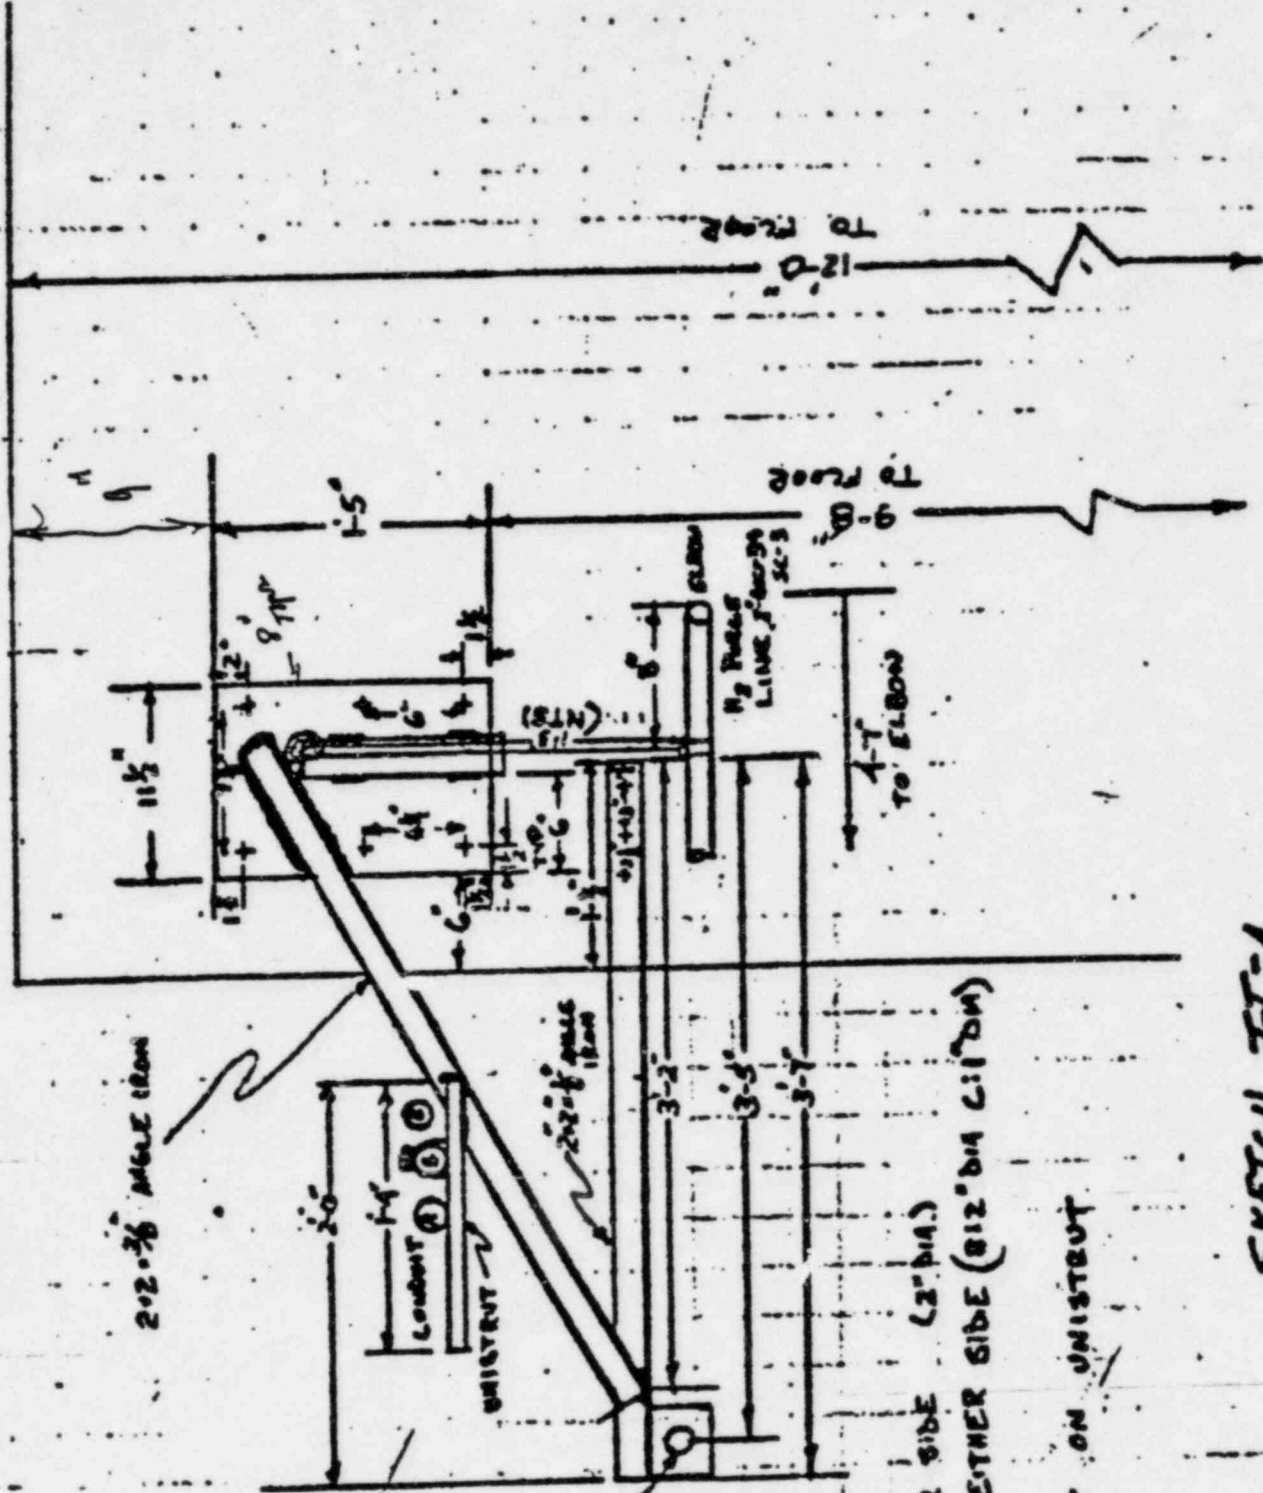
SKETCH TT-A

7AB WALL SECTION

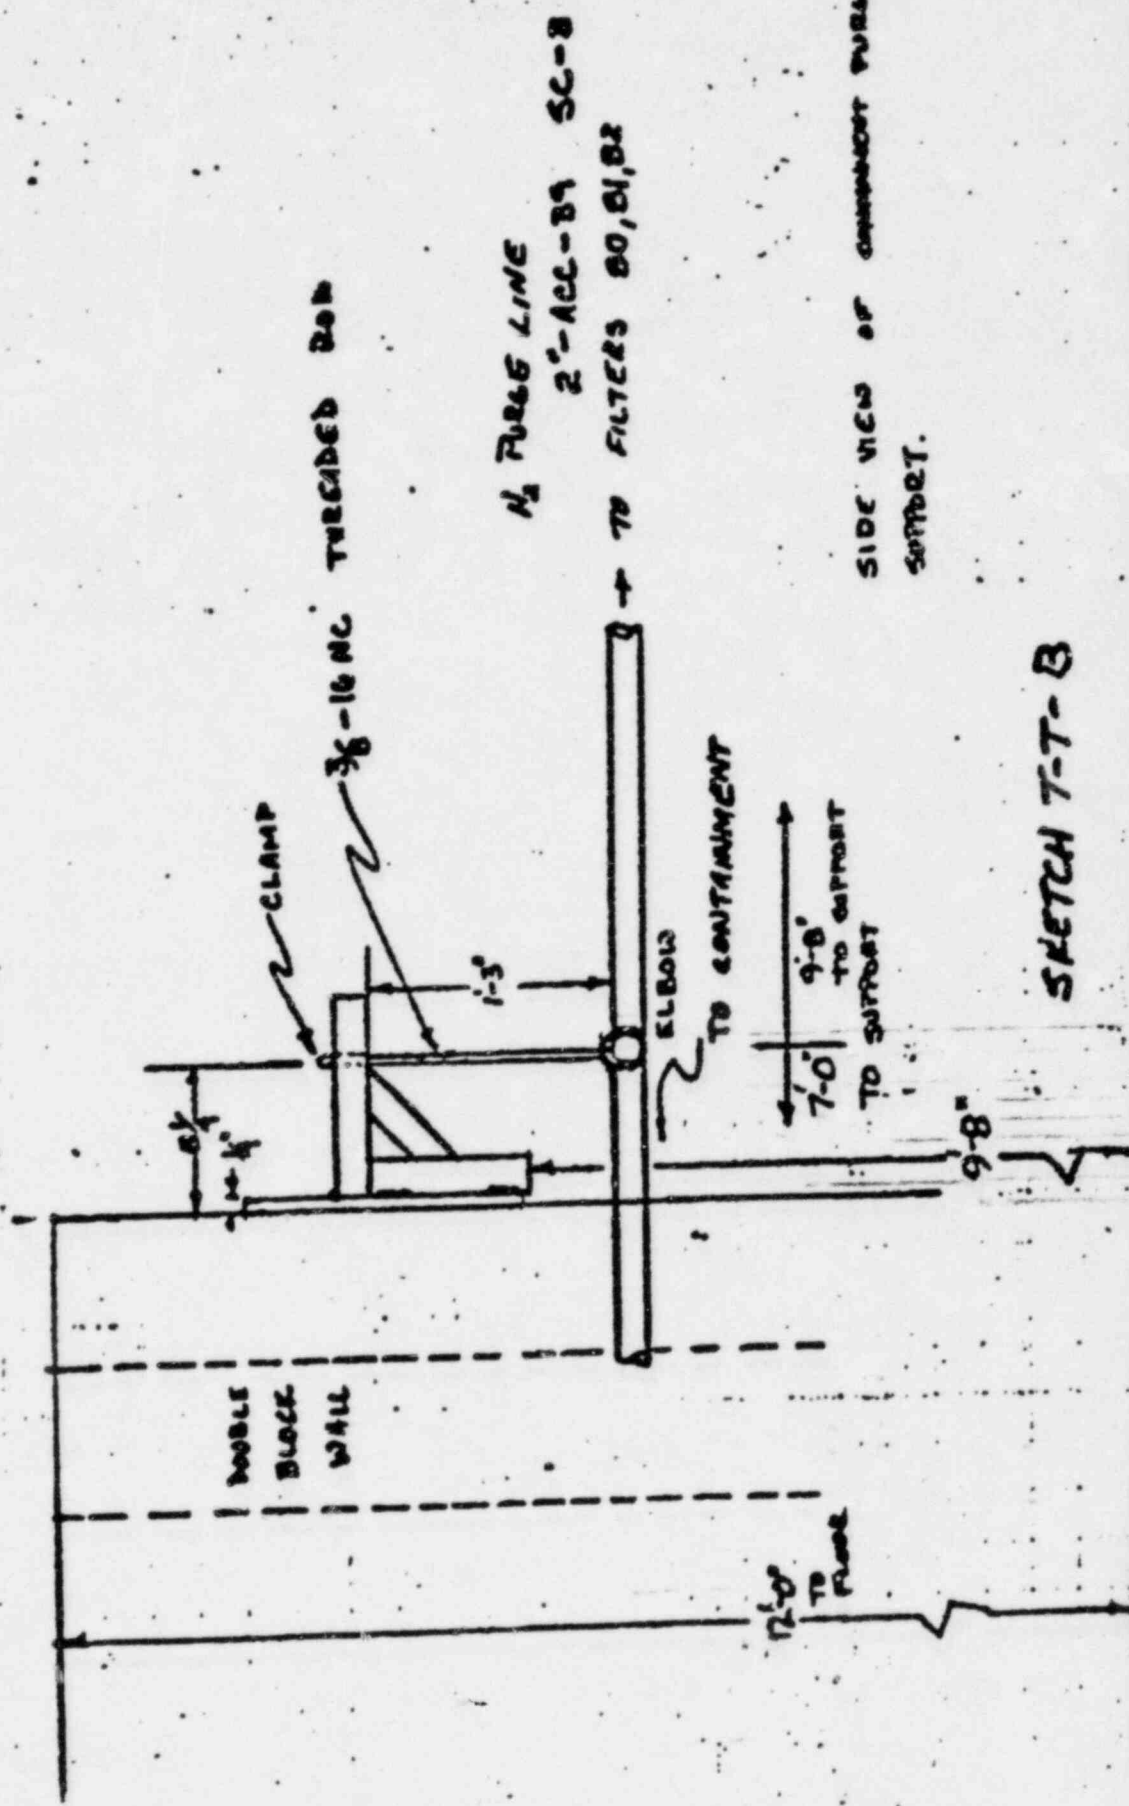
SKETCH T-T-B

SIDE VIEW OF CONNECT FUEL LINE. SUPPORT.

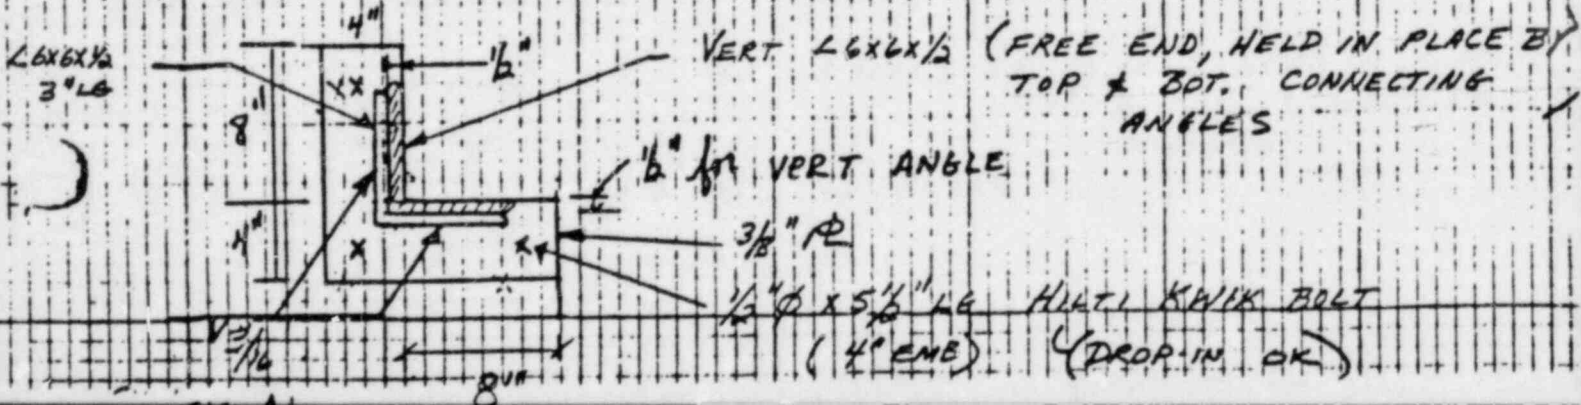
THIS VALUE IS TOO LARGE FOR THE ANCHORS WE HAVE AVAILABLE \therefore A PINNED SUPPORT MUST BE DESIGNED

TRY THE DETAIL SHOWN BELOW

DESIGN REVISED BASE CONNECTION

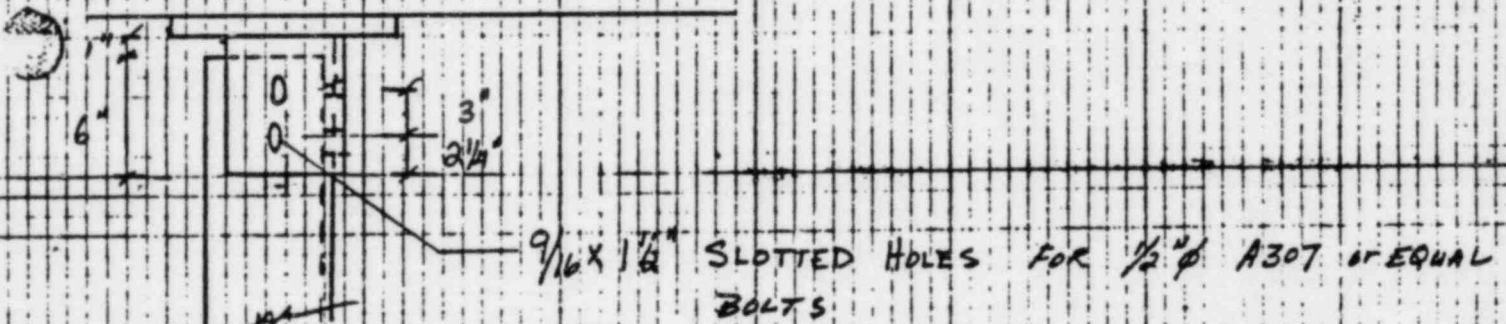
Design Top Connection

REACTION = 512.5# M_{max} = 512.5(2") = 3587.5 #-ft ✓
