LONG-TERM SURVEILLANCE PLAN FOR THE SHIPROCK DISPOSAL SITE, SHIPROCK, NEW MEXICO

December 1993

Uranium Mill Tailings Remedial Action Project

Prepared by
Jacobs Engineering Group Inc.
Albuquerque, New Mexico

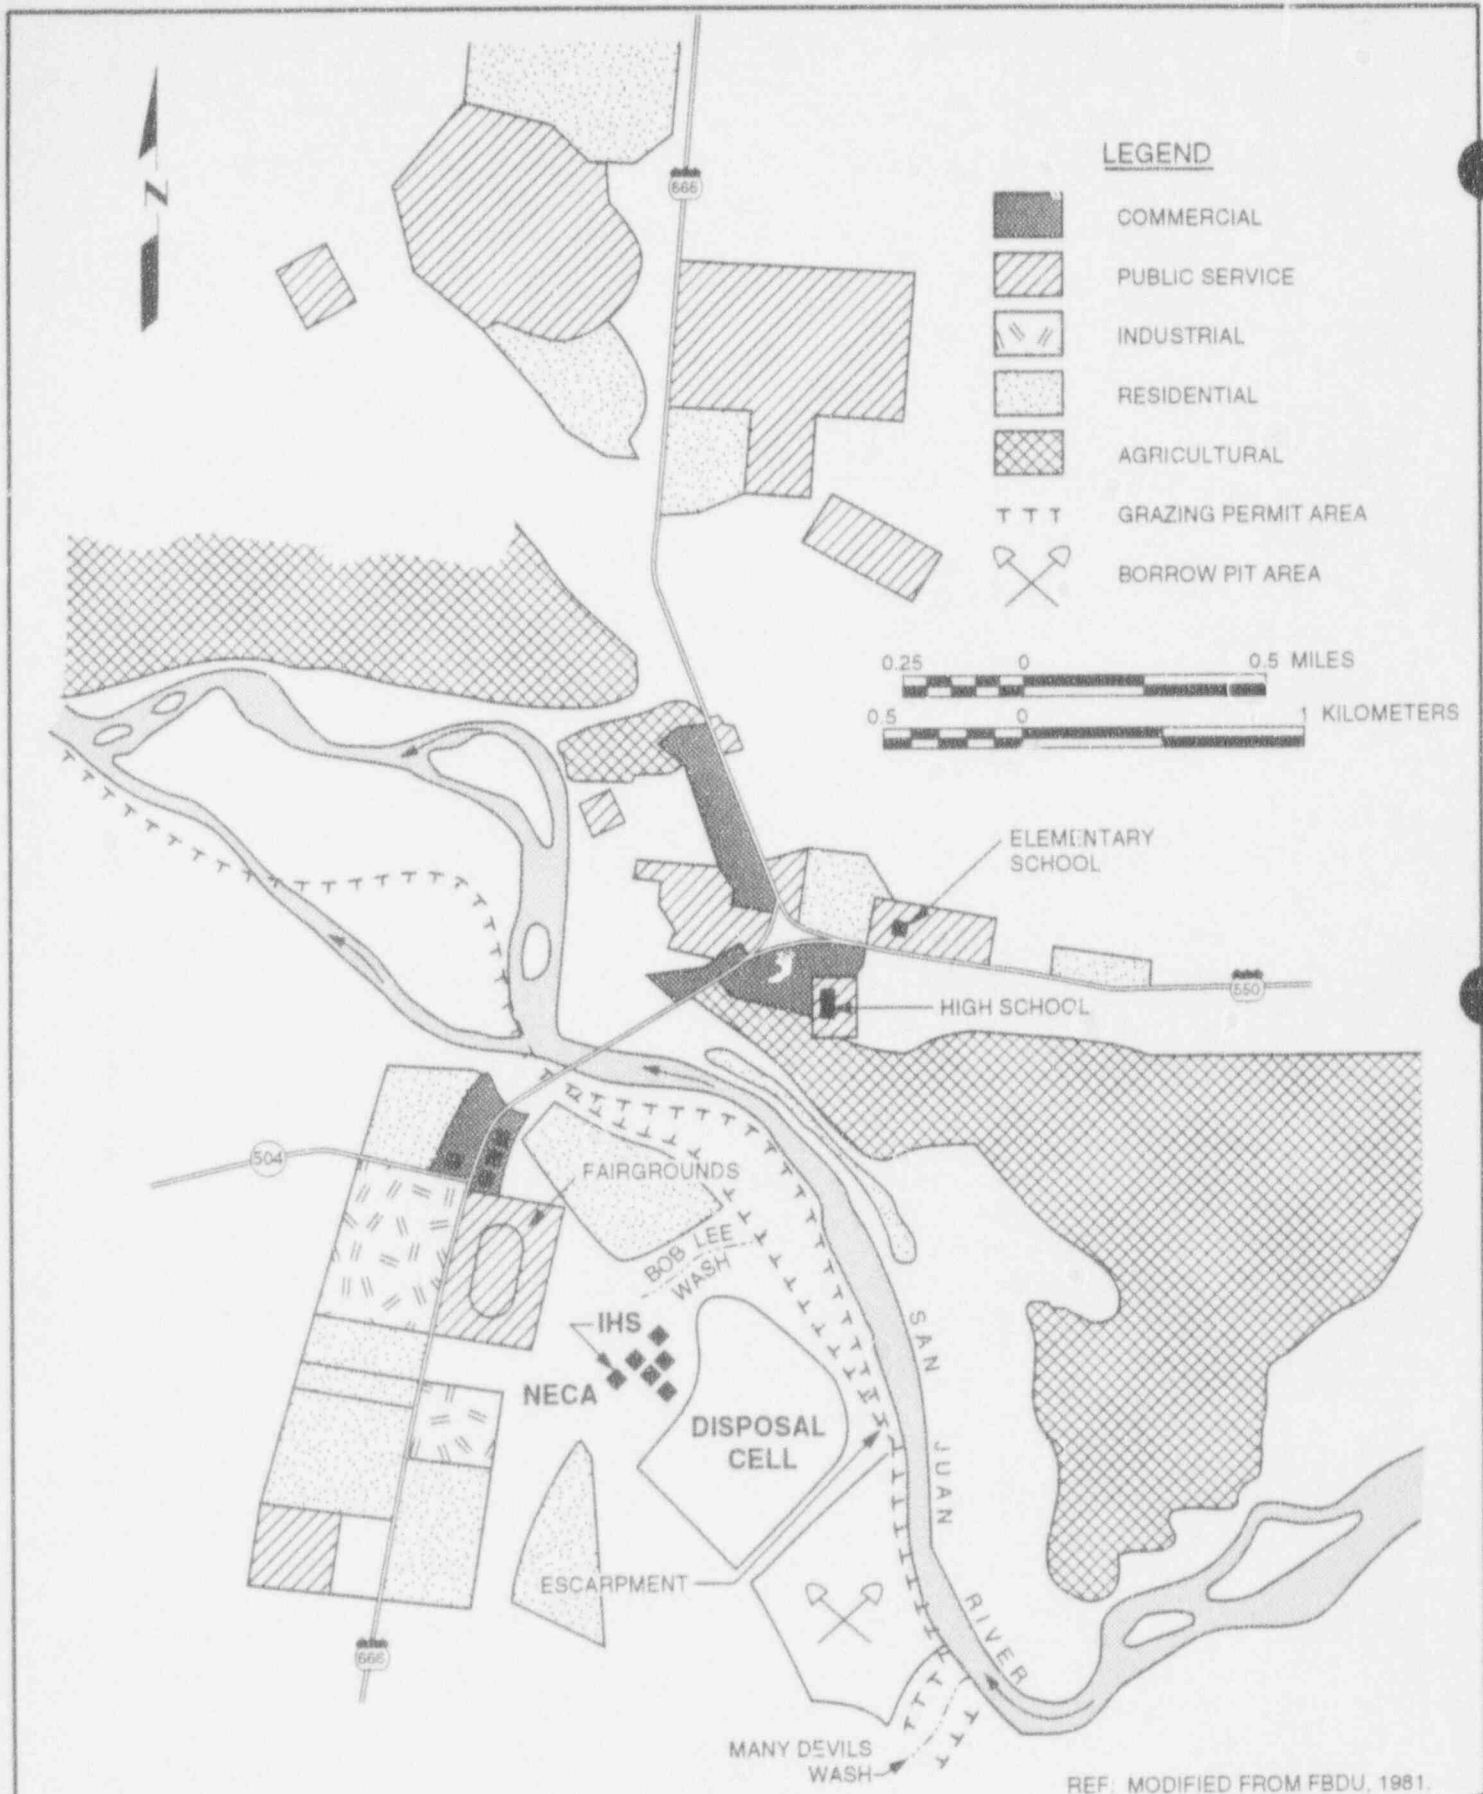
FIGURE 2.5
LAND USE IN THE VICINITY OF
SHIPROCK, NEW MEXICO, SITE, 1993

The Shiprock disposal site is on the Navajo Indian reservation adjacent to the unincorporated town of Shiprock. Figure 2.5 shows the land uses in the vicinity of the site.

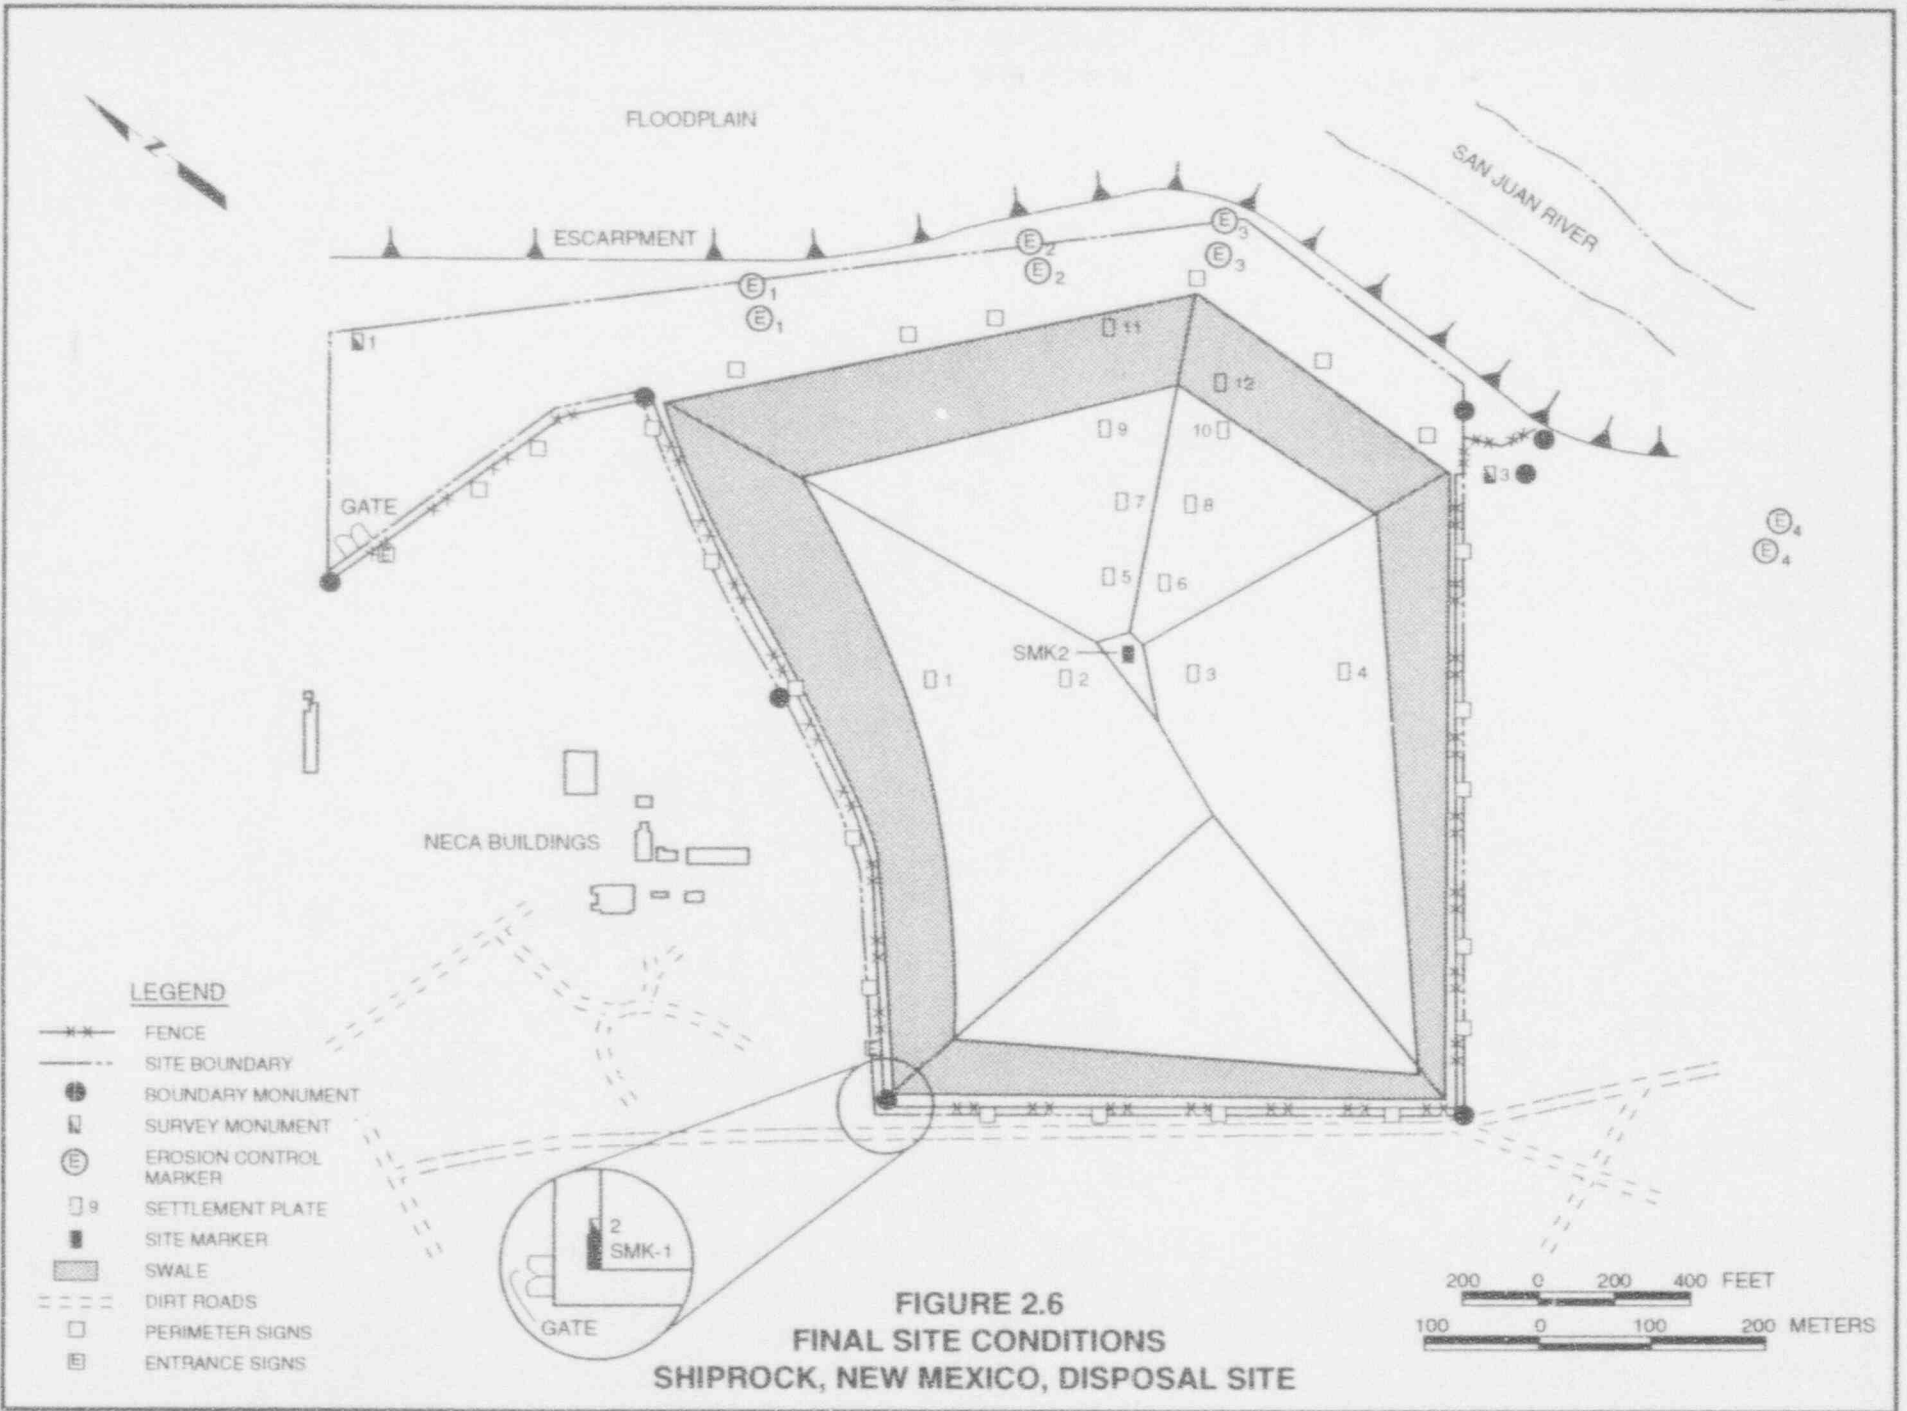
FIGURE 2.6
FINAL SITE CONDITIONS
SHIPROCK, NEW MEXICO, DISPOSAL SITE

The final condition of the Shiprock disposal cell is shown in Figure 2.6. The abovegrade disposal cell is an asymmetrical pentagon with a maximum side length of 1800 ft (550 m) and a minimum side length of 800 ft (244 m). The maximum height of the disposal cell is approximately 48 ft (15 m) above the original ground surface. The sides of the disposal cell have a maximum slope of one vertical to five horizontal. The top varies in slope from 2 to 4 percent. The disposal cell covers approximately 77 ac (31 ha).

^aSee Figure 2.6 for relative locations of these features. The coordinates are based on the project survey control point (N 10,000.00, E 10,000.00) located at the southeast corner of Section 36, Township 30 North, Range 18 West.

Four pairs of erosion control markers (eight total) were installed along the edge of the escarpment at the locations shown in Figure 2.6 and in Plate 1. The erosion control markers are Berntsen Model A-1 boundary monuments

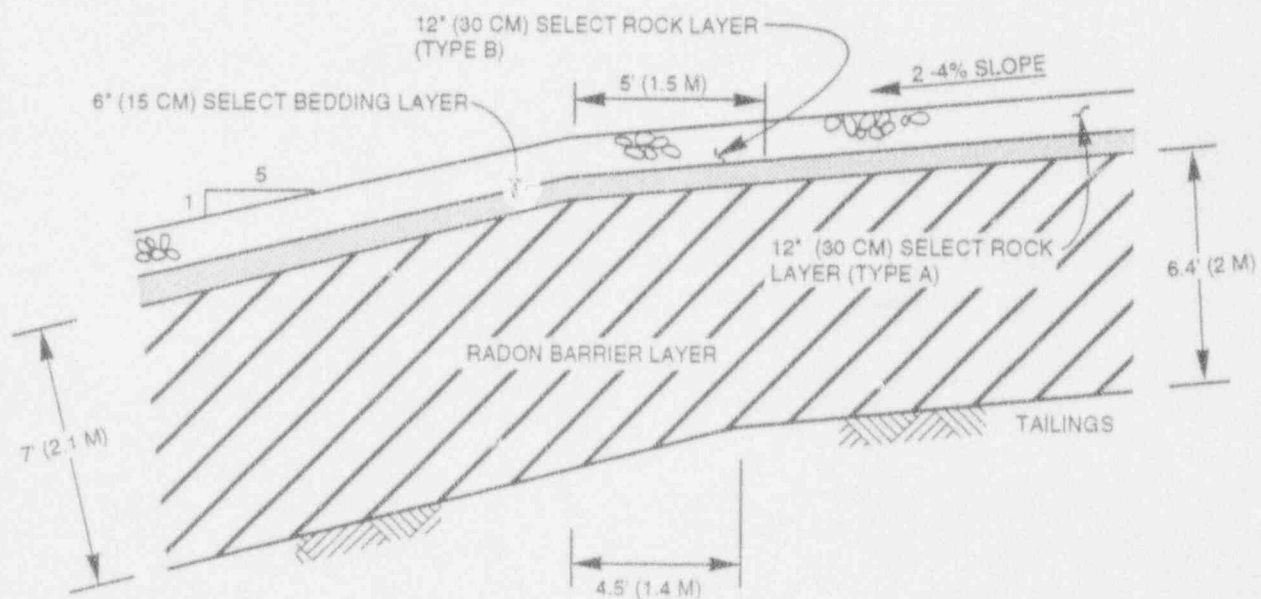
FIGURE 2.7
DISPOSAL CELL COVER CROSS SECTION
SHIPROCK, NEW MEXICO, DISPOSAL CELL

Figure 2.7 shows a typical cross section of the Shiprock disposal cell cover. The cover consists of two components: an infiltration/radon barrier and an erosion protection layer. The infiltration/radon barrier is 6.4 ft (2 m) thick on the top and 7.0 ft (2.1 m) thick on the sides. This layer consists of predominantly sandy silt compacted to a hydraulic conductivity of not more than 2.5×10^{-5} centimeters per second (cm/s). It was designed to protect the groundwater by minimizing infiltration into the disposal cell and reduce radon emanations from the disposal cell to less than 20 picocuries per square meter per second ($\text{pCi}/\text{m}^2\text{s}$).

The erosion protection layer, on the top consists of a 1-ft (0.3-m) thick layer of Type A riprap underlain by a 6-inch (in) [15-centimeter (cm)] thick layer of bedding material. For the sides, this layer consists of a 1-ft (0.3-m) thick layer

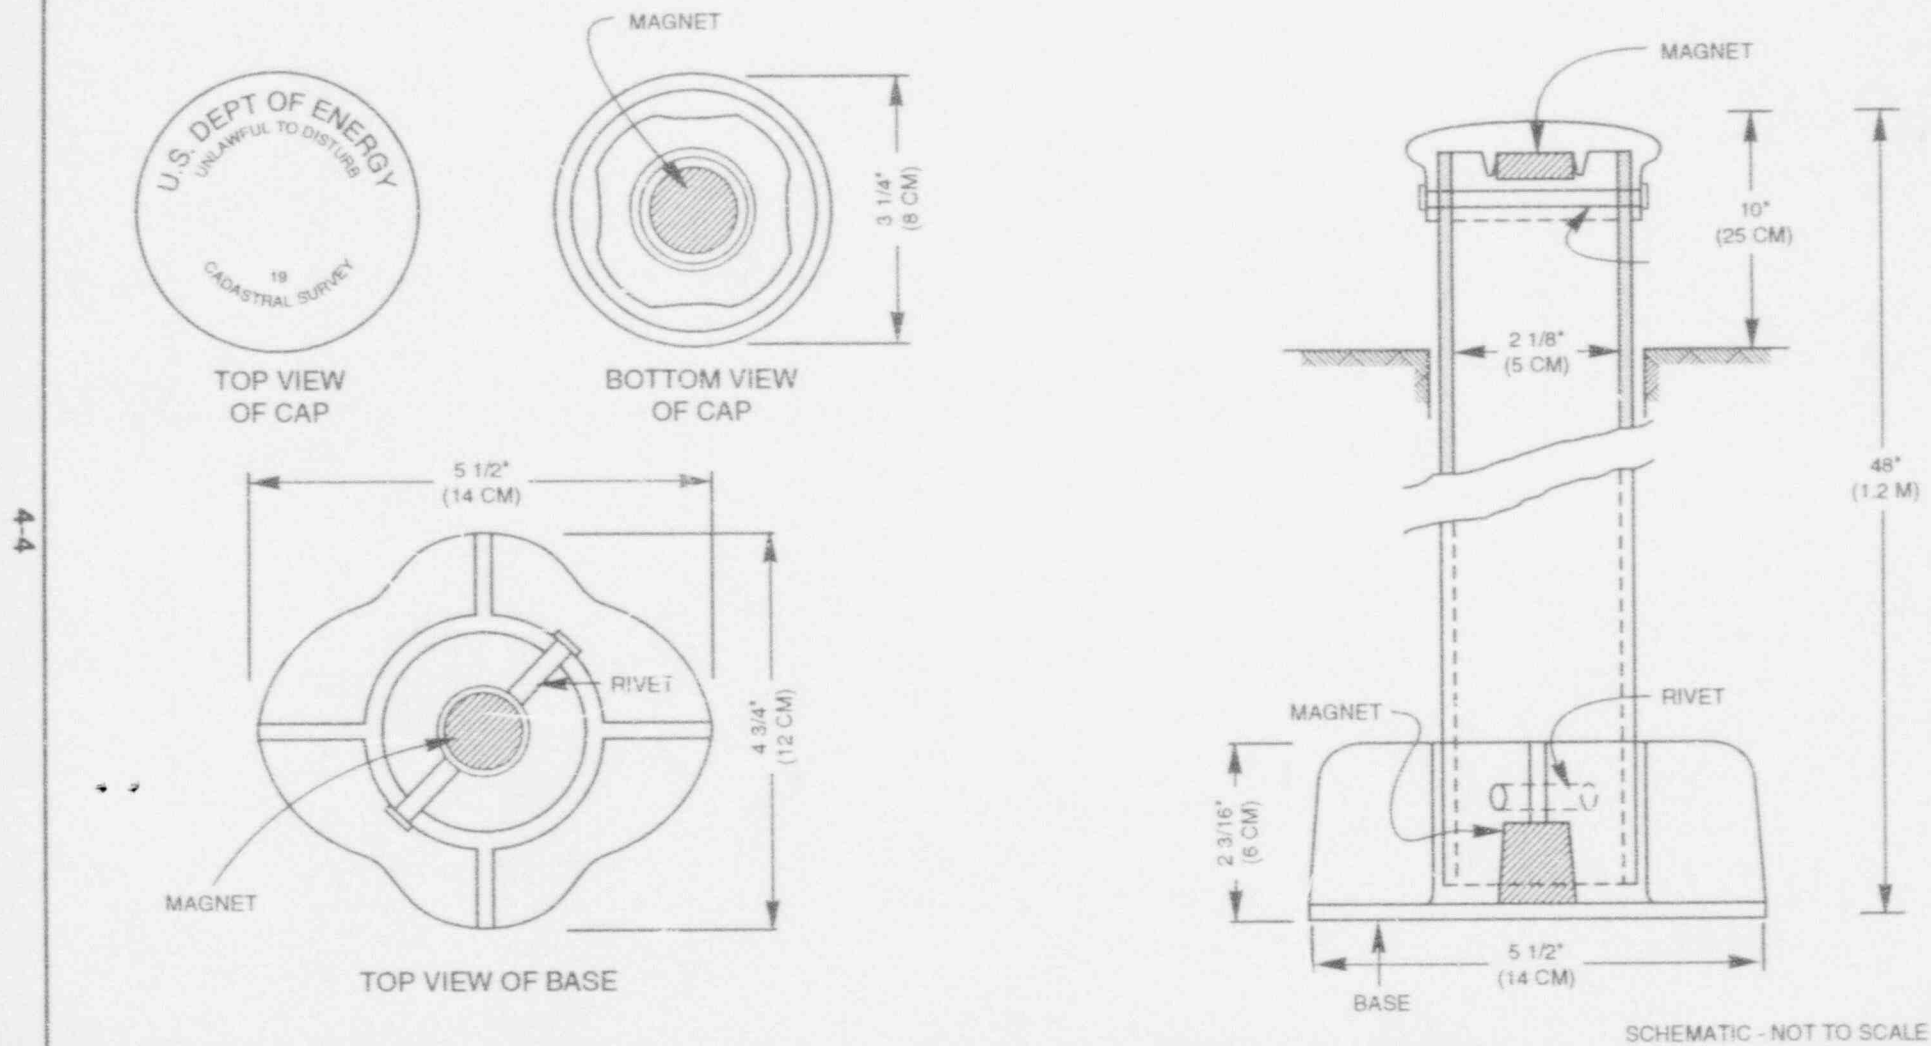
FIGURE 4.2
TYPICAL BOUNDARY MONUMENT/EROSION CONTROL MARKER
SHIPROCK, NEW MEXICO, DISPOSAL SITE

BERNTSEN FEDERAL ALUMINUM BOUNDARY MONUMENT, MODEL A-1, STANDARD LOGO CAP

Berntsen federal aluminum survey monuments, Model A-1, were used for the eight boundary monuments (Figure 4.2). Ceramic magnets are epoxied in the cap and base of each monument and are vertically oriented so that they can be detected easily if they become covered. Each 4-ft (1.2-m) long monument is set with the cap flush with the ground surface.

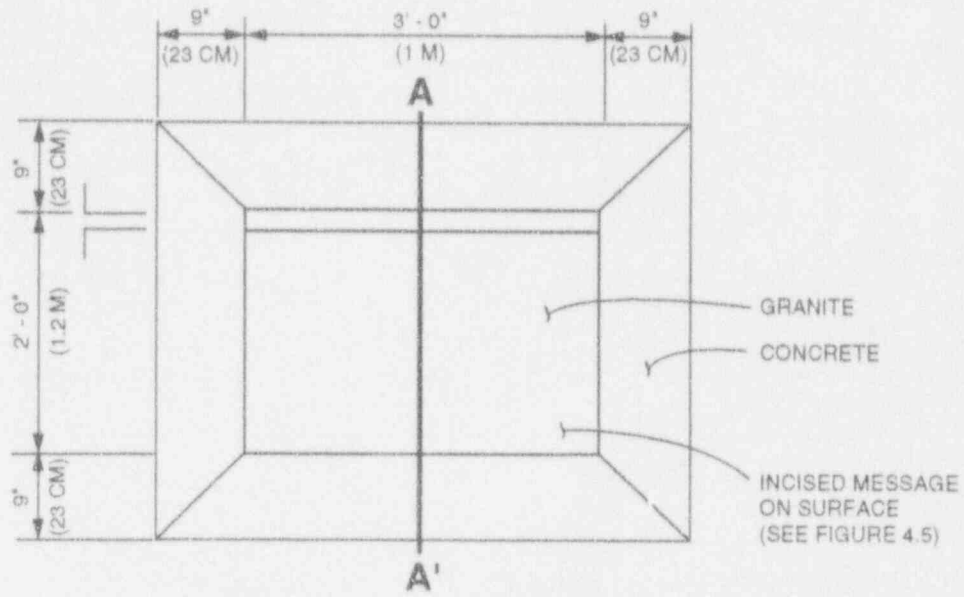
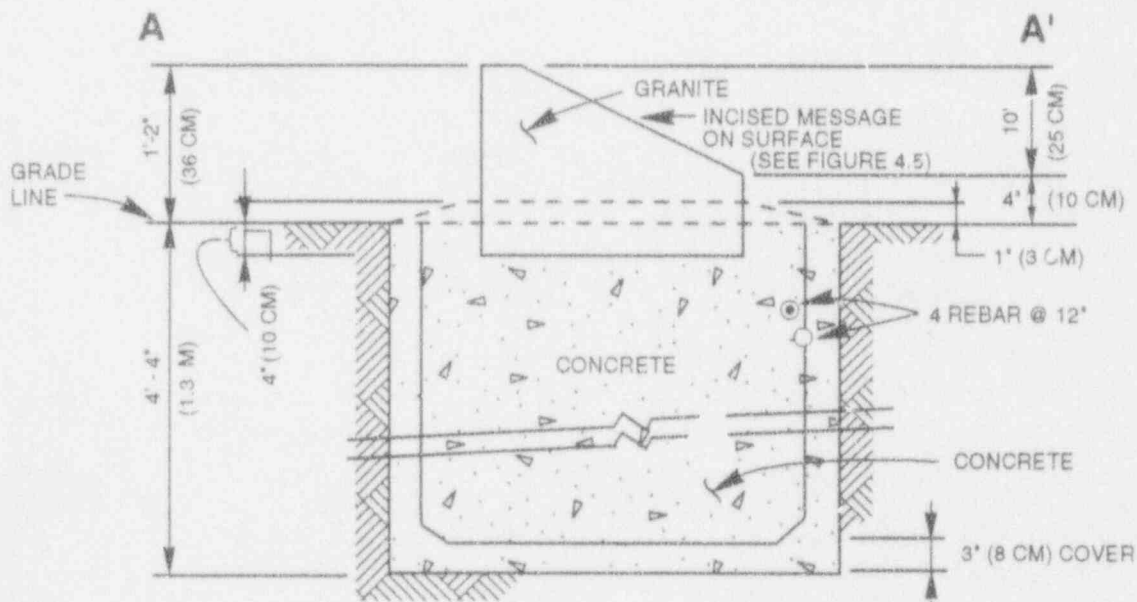
FIGURE 4.3
 SITE MARKER - SMK-1
 LOCATED AT SITE ENTRANCE
 SHIPROCK, NEW MEXICO, DISPOSAL SITE

PLAN VIEW

SECTION A-A'

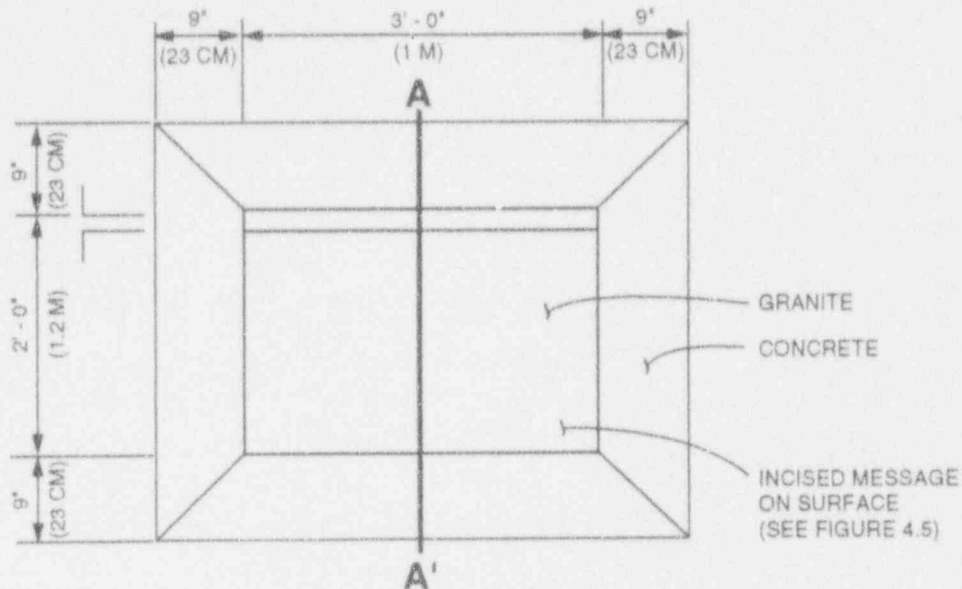
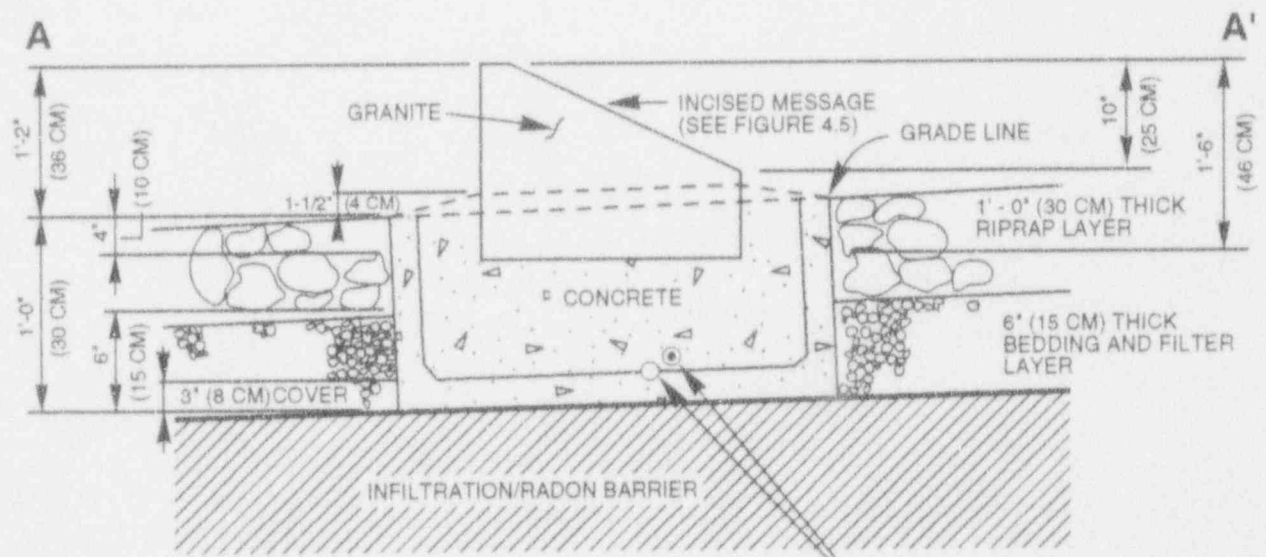
Two unpolished granite site markers were installed on the Shiprock disposal cell. Site marker SMK-1, located near the entrance to the disposal cell, is set in a bed of reinforced concrete that extends 4.3 ft (1.3 m) below ground surface (Figure 4.3). Site marker SMK-2, located at the crest of the disposal cell, is set in a bed of reinforced concrete that extends to the bottom of the riprap layer (Figure 4.4). The inscriptions on the two site markers identify the general location of the Shiprock disposal cell, the boundary of the site, the date of closure (September 1986), the tonnage of tailings (2,520,000 tons), and the curies of radioactivity (1746 curies of Ra-226). The international radiation symbol is also inscribed in each marker (Figure 4.5).

NOTE: MINIMUM DEPTH OF INCISING TO BE 1/4" (0.6 CM).

#4 REBAR @ 12" (30 CM) EACH WAY

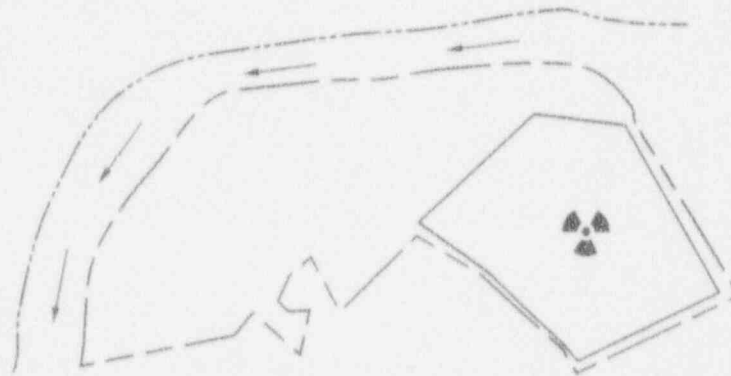
FIGURE 4.5
SITE MARKER INCISED MESSAGE
SHIPROCK, NEW MEXICO, DISPOSAL SITE

NOTE: MINIMUM DEPTH OF INCISING IS 1/4" (6CM).

INCISED MESSAGE

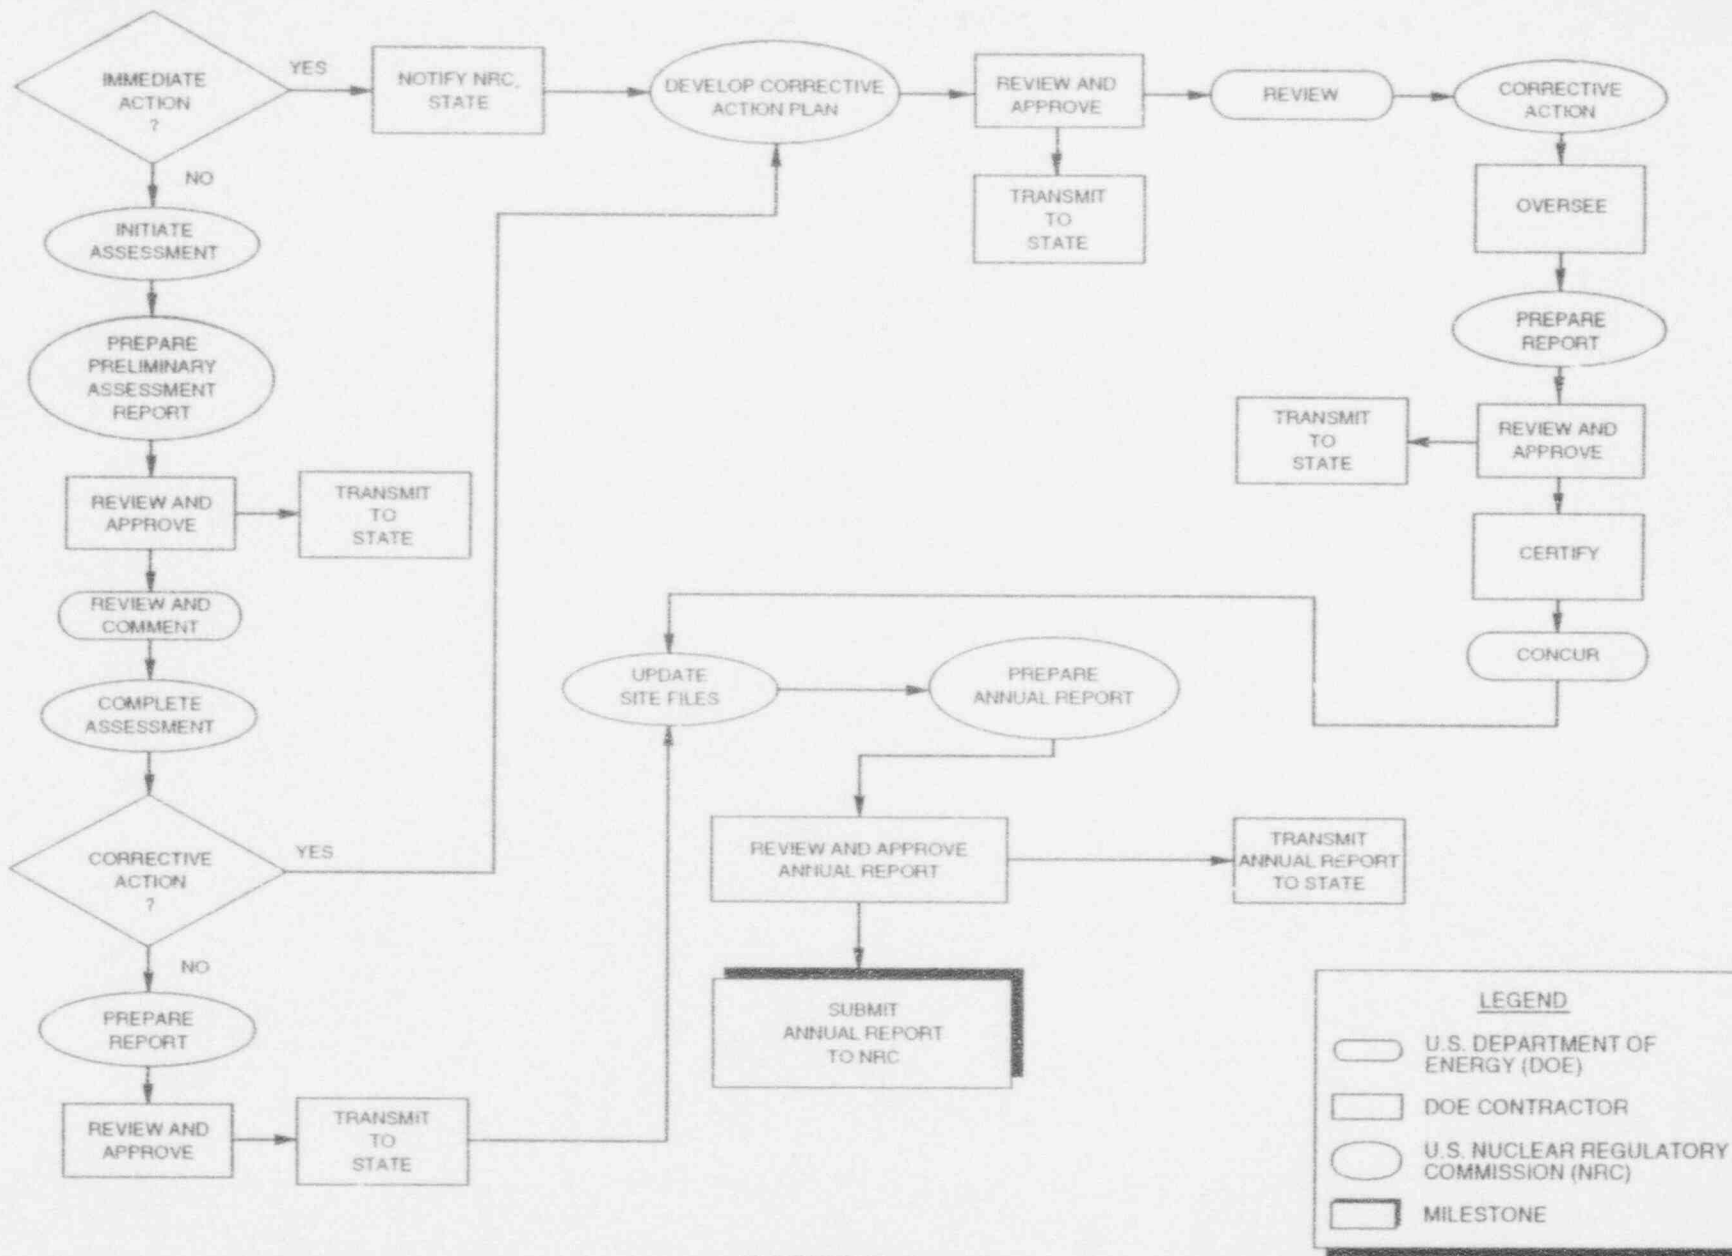
FIGURE 9.1
CORRECTIVE ACTION
UMTRA PROJECT LONG-TERM SURVEILLANCE PROGRAM

PROBLEM INDICATING CORRECTIVE ACTION IDENTIFIED

NEED FOR CORRECTIVE ACTION IDENTIFIED

When a potential problem is identified, the DOE will notify the NRC and the Navajo Nation and submit an inspection/preliminary assessment report of the situation to the NRC and the Navajo Nation for review within 60 days of problem identification. The preliminary assessment report will evaluate the problem and will provide recommendations for the next step (e.g., immediate action or continued evaluation). After the NRC and Navajo Nation have reviewed the report and recommendations, the DOE will develop a corrective action plan and submit it to the NRC for approval. The DOE may also choose to combine the inspection and recommendation in one report, depending on the severity of the problem. With NRC approval, the corrective action plan will be implemented by the DOE. Figure 9.1 illustrates the general sequence of events in the corrective action process, and Figure 9.2 identifies the key elements in the corrective action process.
