**INVESTIGATION OF THE CRASH
ENVIRONMENT AND IMPACT CONDITIONS
OF THE PSA FLIGHT 1771 AIRCRAFT CRASH ON
DECEMBER 7, 1987**

February 28, 1990

Prepared for
U.S. Nuclear Regulatory Commission

PATC-IR 90-01

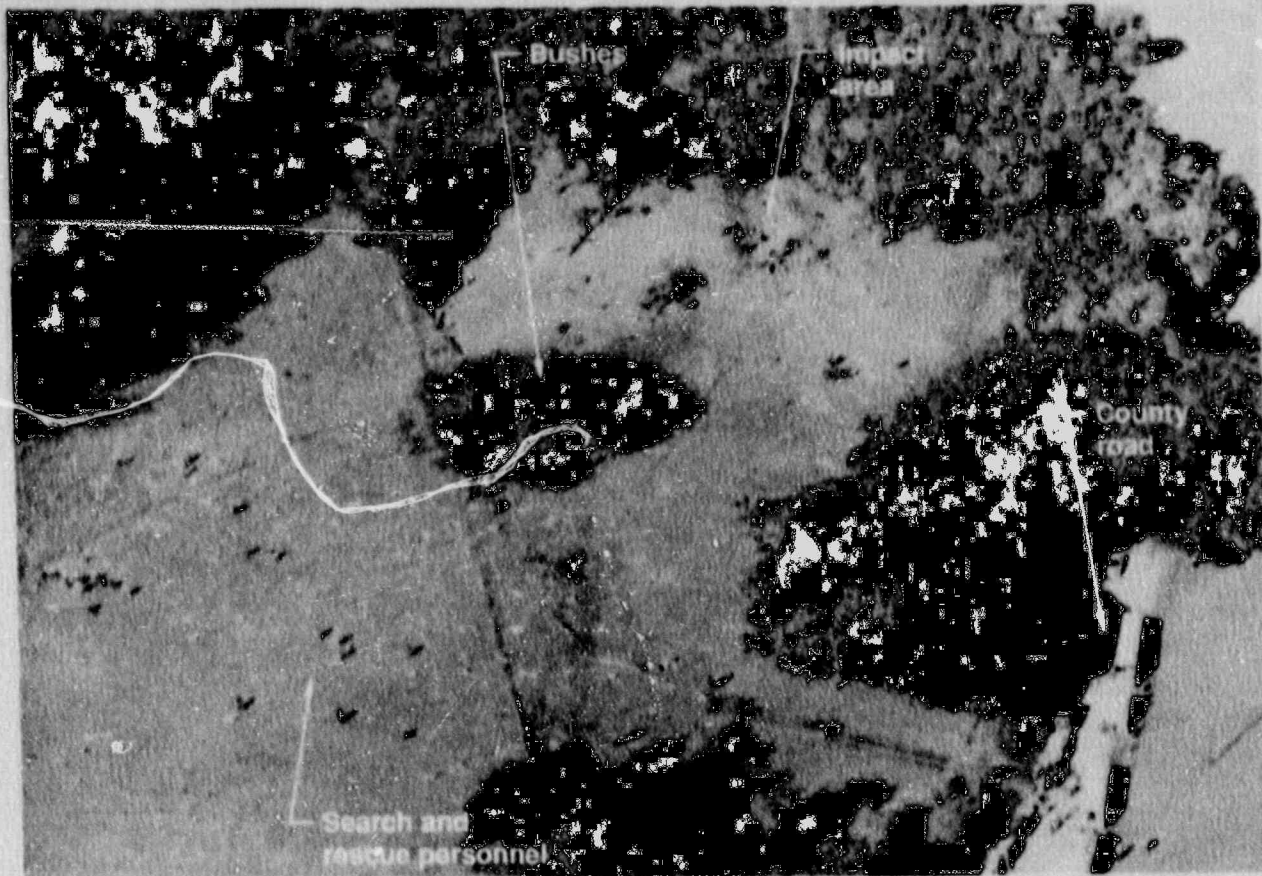
Fig. 2.1-1. Photo of PSA Flight 1771 crash site.

The BAe 146-200 aircraft used on PSA Flight 1771 remained intact until it crashed, nose first, on a hillside of the Santa Rita Range in San Luis Obispo County. None of the 43 persons on board survived. Only minor ground fires resulted from the approximately 3200 kg** (1000 gallons) of fuel estimated to be on board (Ref. 3) at the time of the crash. A dense black smoke cloud was observed at the time of the crash, indicating that some of the fuel apparently burned in the air above the impact point. The aircraft and its contents fragmented into many small pieces, mostly dispersed south of the impact point within a radius of about 100 m (see Fig. 2.1-1). The most distant aircraft piece was found 265 m from the impact point, and some paper debris was found as far away as 2 km.

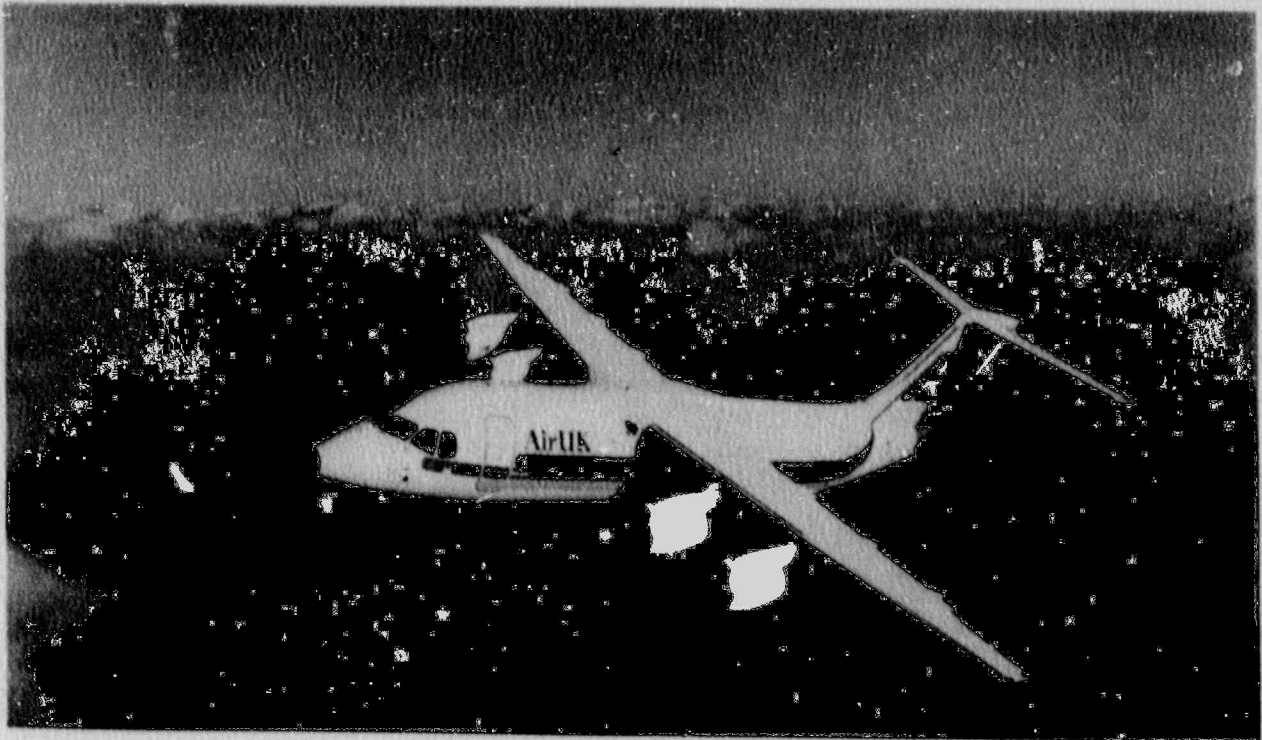
Fig. 2.2-1. BAe 146-200 aircraft.

The BAe 146-200 is a high-wing, four-engine, jet-powered aircraft designed for short-range (2000-km) intercity flights. As configured, it could carry 83 passengers and a crew of four. The series 200, shown in Fig. 2.2-1, has an overall length of 28.6 m and a wing span of 26.3 m. Fuselage diameter is 3.6 m. Maximum takeoff weight is 42,200 kg. The design cruise Mach number is 0.7. At the time of the PSA Flight 1771 crash, the estimated total weight was 29,300 kg. The aircraft was flying at 6.7 km (22,000 ft) altitude where the design true airspeed is 218 m/s (425 kt). The true airspeed and Mach number of PSA Flight 1771 just prior to the shooting as determined from analysis of radar data were 178 m/s (349 kt) and 0.56, respectively.

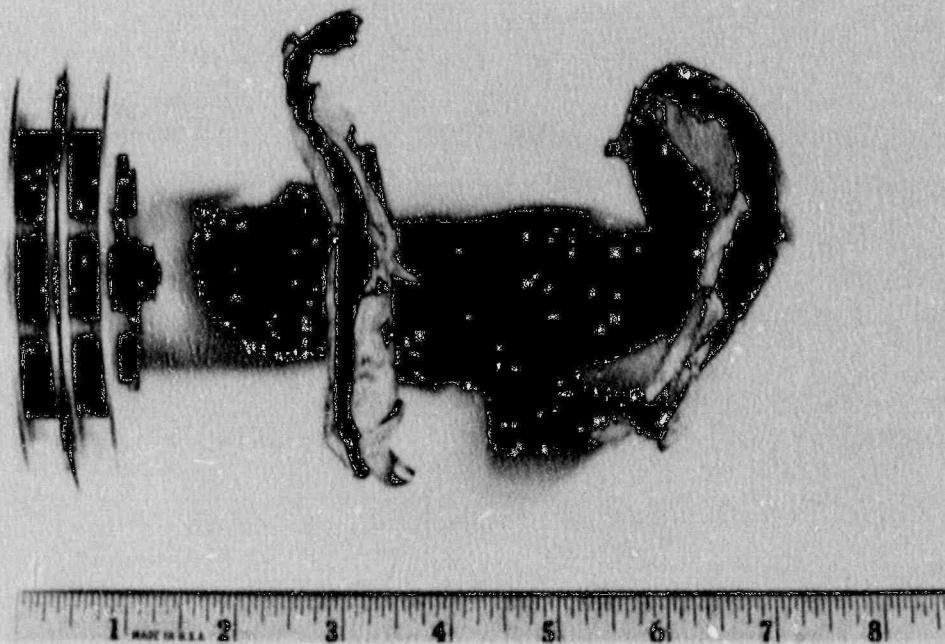
Fig. 7.1-2. Photograph of the tape reel assembly recovered from the PSA Flight 1771 FDR with a similar undamaged unit.

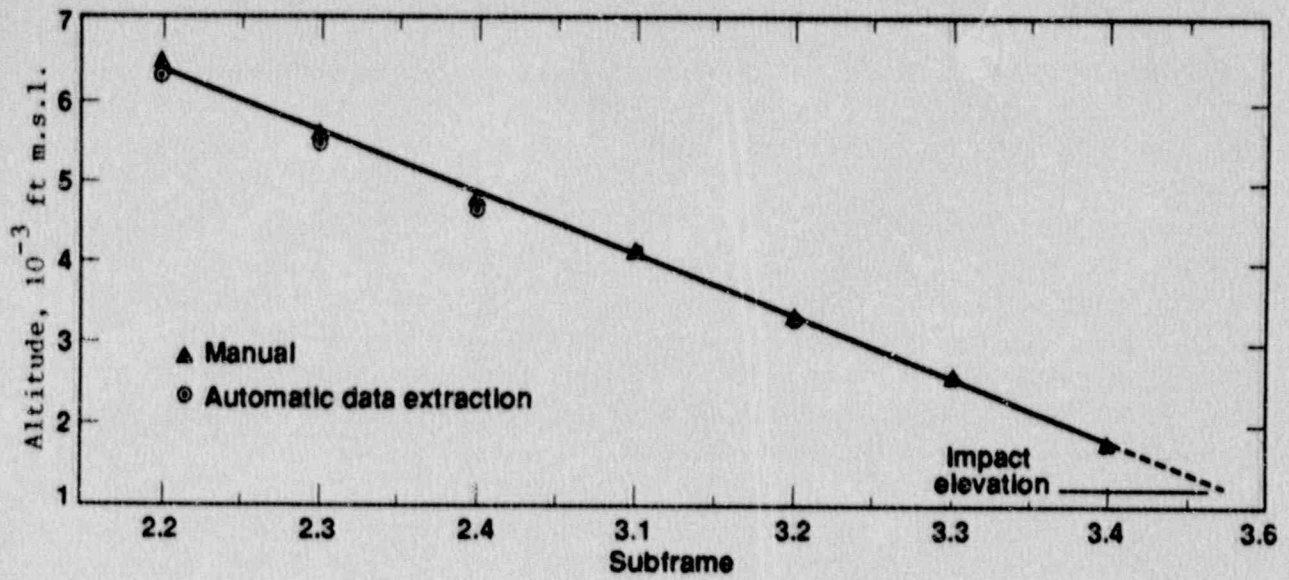
Fig. 7.3-1. Plot of fine altitude data as reduced from the FDR and extrapolated to impact.
