UCRL-ID-104557
PATC-IR 89-03

FUSELAGE MODEL CRASH TESTS

August 14, 1989

Prepared for
U.S. Nuclear Regulatory Commission

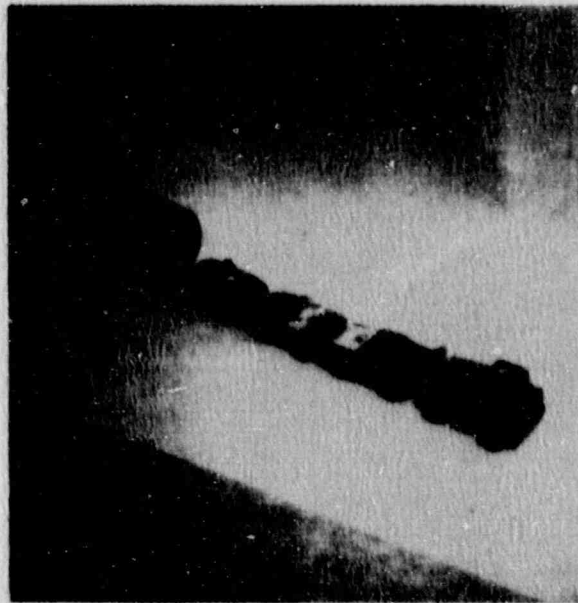
Figure A.3.1. Metal and plastic toy cars represent rigid and semi-rigid mass internal to the fuselage.

Four small toy cars, made of metal and plastic, were glued together (end-to-end), as detailed in Figure A.3.1, and were placed inside the model fuselage. The string of cars were glued to the front end of the tube. A high-speed camera (22,000 frames/sec, max.) was stationed such that the impact event could be recorded. The test environment was partial vacuum. The nose of the model was blunt. Other specific test conditions were:

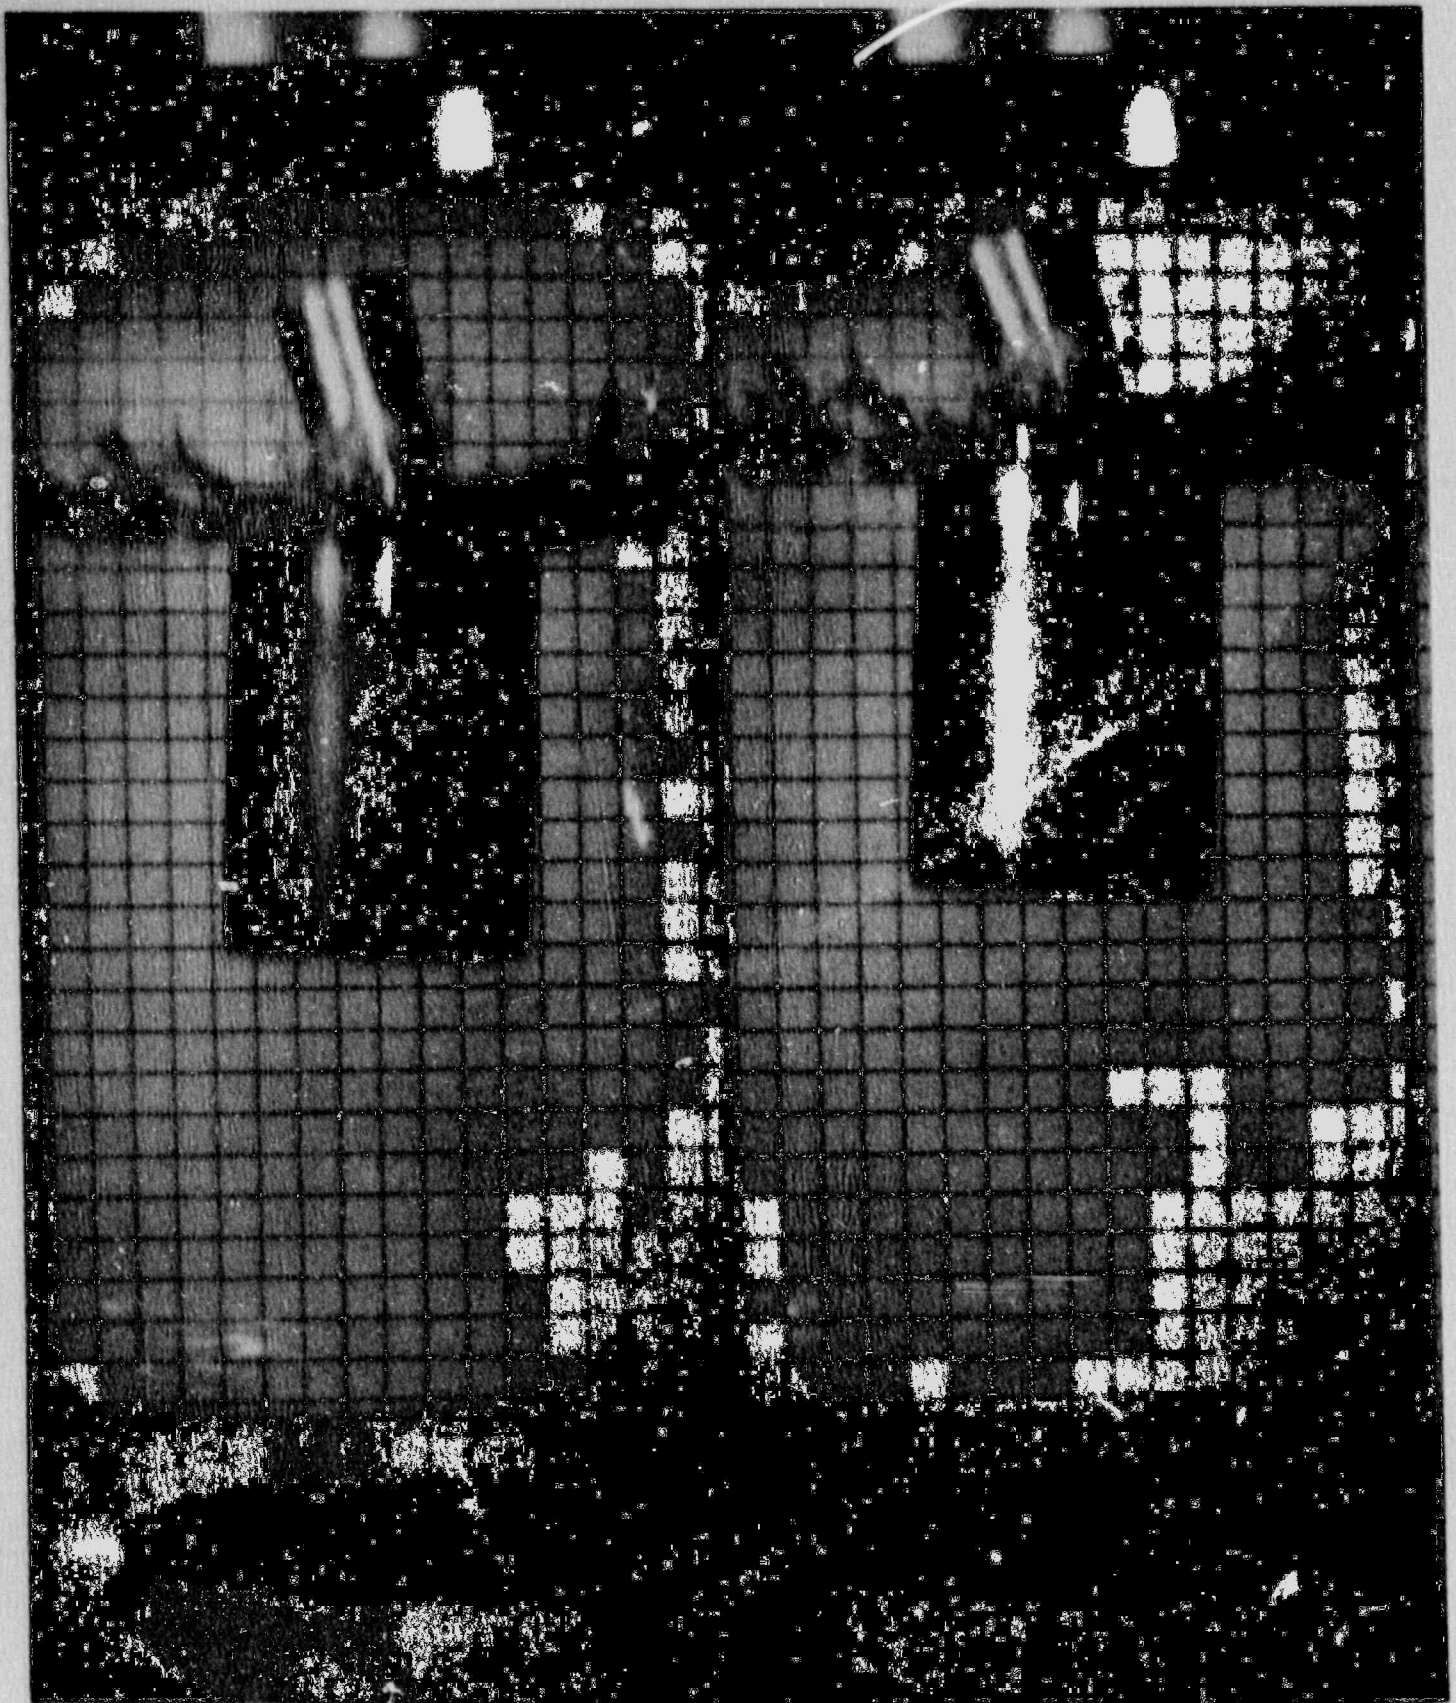
Figure A.9.1. Impact sequence, rigid and semi-rigid mass.

Concentrated rigid and semi-rigid mass inside the model "fuselage" represent a major contributor to fuselage shattering on initial impact. It is likely this conclusion can be extrapolated with confidence to PSA Flight 1771, where the concentrated masses would be in the form of seats, instruments, panels, and miscellaneous fixtures.

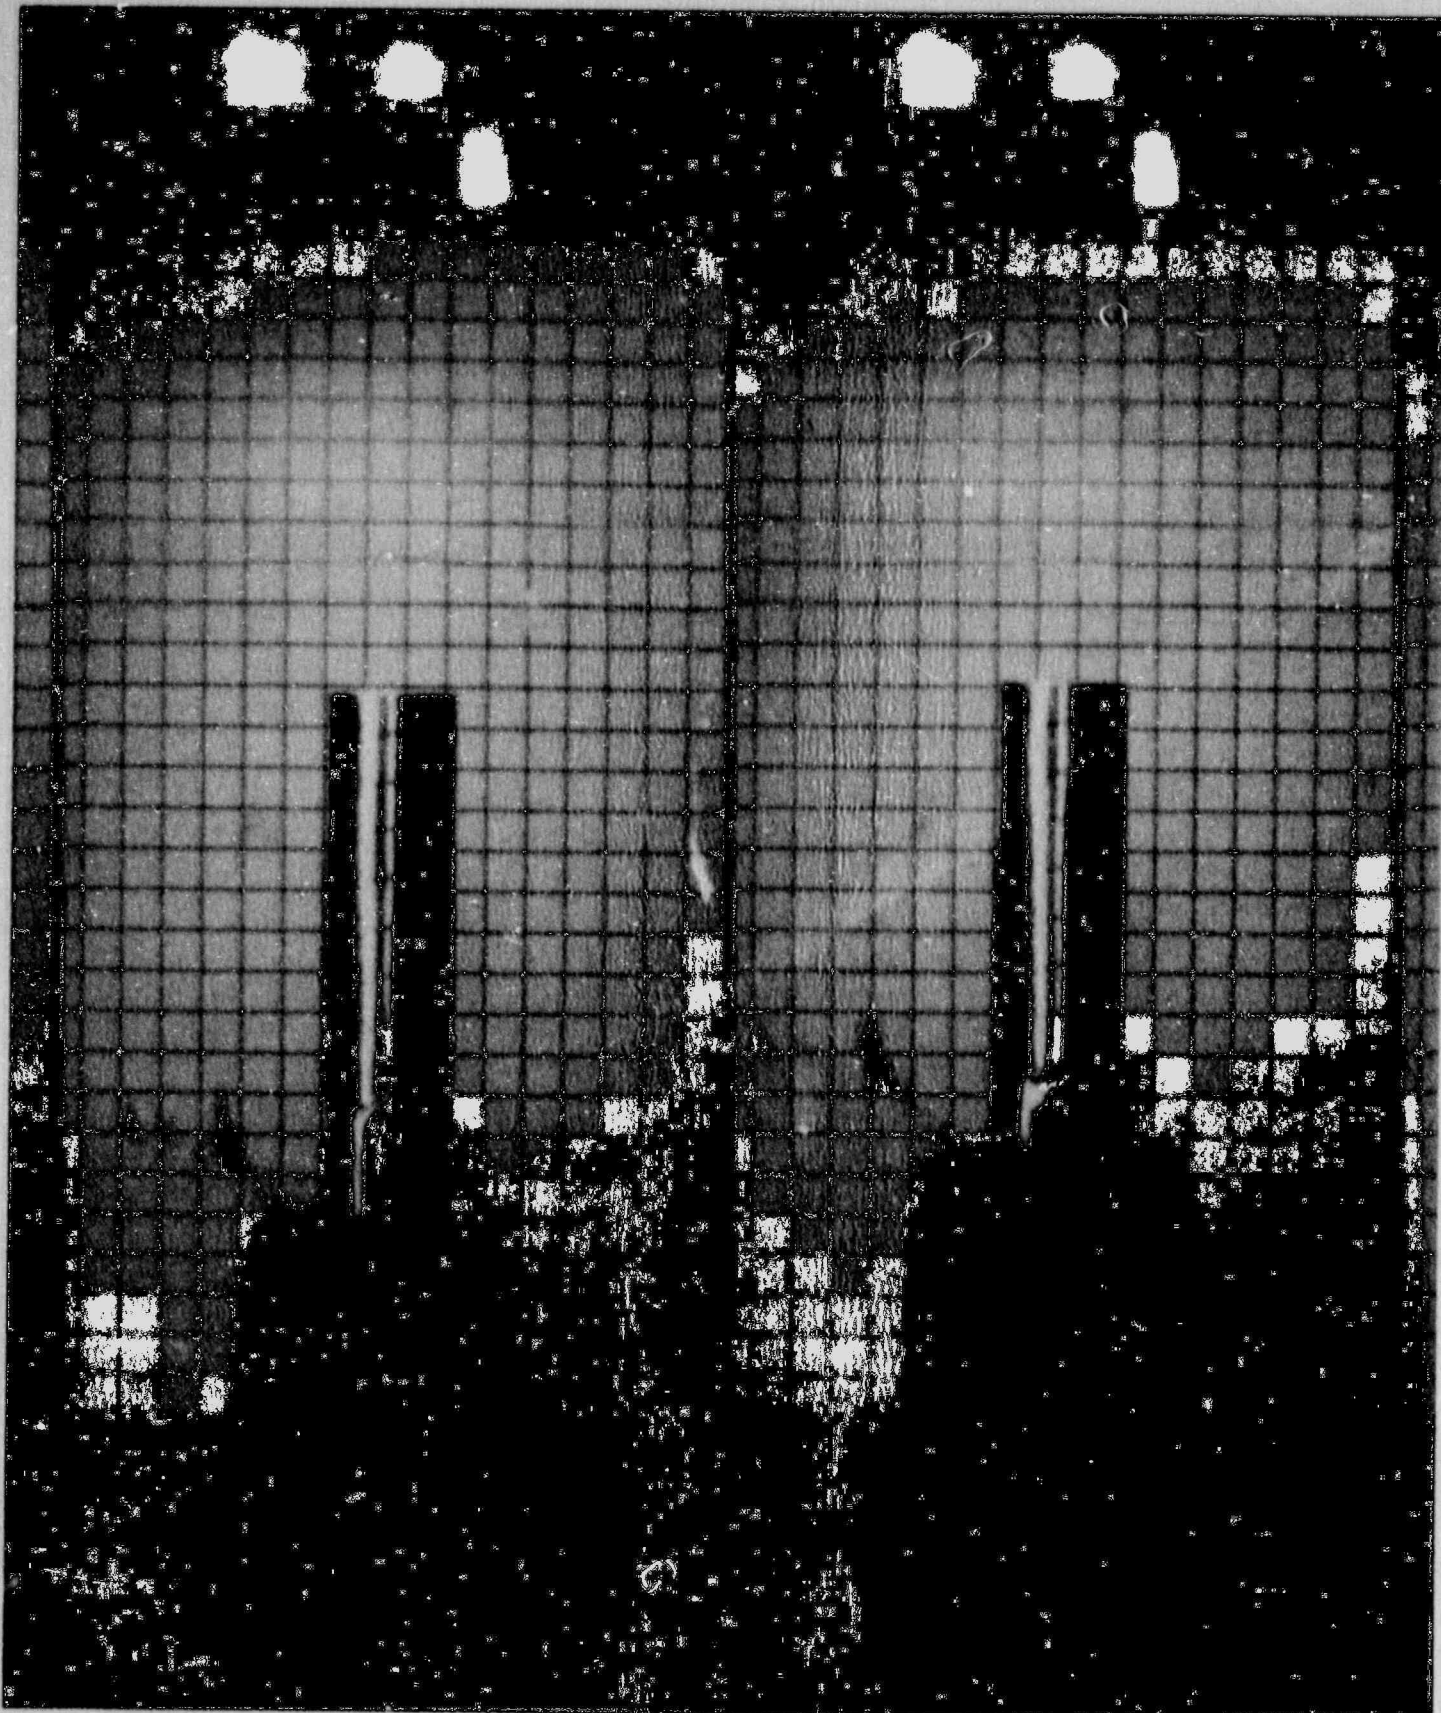
Figure A.10.1. Impact sequence, Base Case w/o 0.005-in. wall.

The superposition of high-deformation rate and high-strain rate are sufficient to produce a small amount of shattering of a model fuselage when impacted at a velocity of 290 m/s.
