NUREG/CR-6194  
TMI V(92)EG01  
EGG-2731

# Metallographic and Hardness Examinations of TMI-2 Lower Pressure Vessel Head Samples

Prepared by G. E. Korth

Idaho National Engineering Laboratory  
EG&G Idaho, Inc.

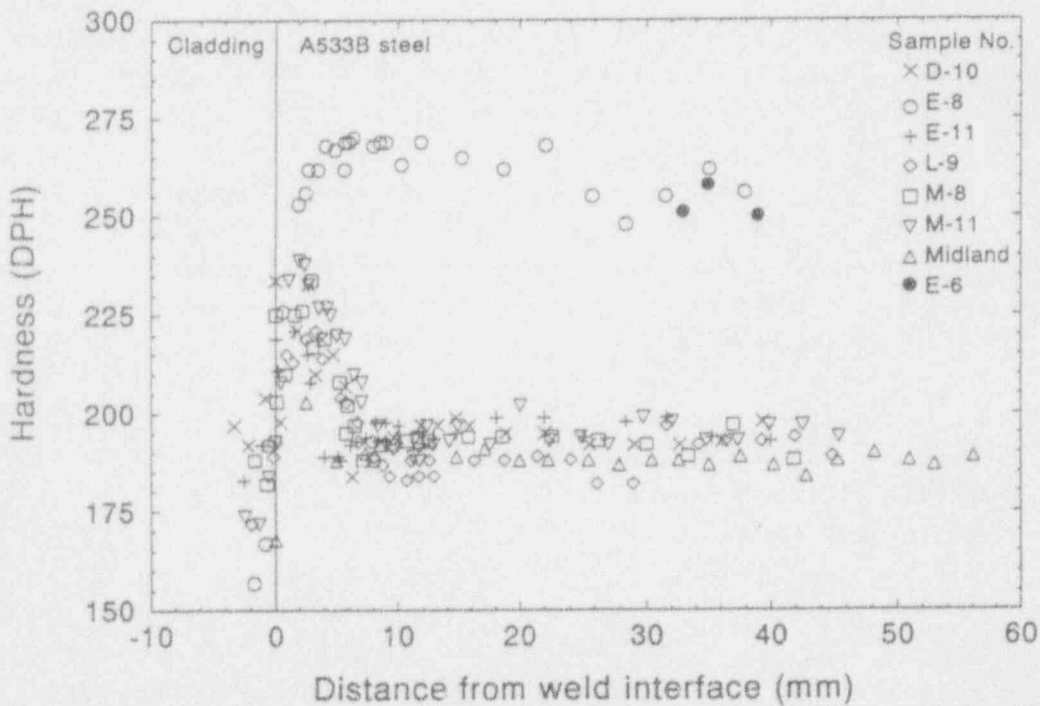
**Figure 3.** Composite hardness profiles of lower pressure vessel head metallographic samples. Data for eight samples are shown in upper figure; data for remaining seven samples plus Midland archive material are shown in lower figure.

The final hardness of the TMI-2 samples is a strong indicator that the A533B steel transformation temperature of 727°C (1,000 K) was exceeded during the accident, and the discussion to follow shows that the cooling rate back through the phase change was  $\geq 10^\circ\text{C}/\text{minute}$ . Figure 5 compares the final hardnesses of Samples E-8(m-3), F-10(m-3), G-8(m-1), and E-6(m-1) with the results of the cooling rate studies of the Midland archive material. Assuming the Midland material is representative of the TMI-2 lower head material, this figure shows that if the cooling rate had been in the vicinity of  $1^\circ\text{C}/\text{minute}$  or less, then the final hardness would have been approximately the same as that of the as-fabricated parent metal. Therefore, hardness measurements would not have been very helpful in determining the thermal history due to the accident - they would only reveal that the hardness peak from the heat-affected band from the weld cladding was eliminated. However, the final hardness values for E-8(m-3), F-10(m-3), G-8(m-1), and E-6(m-1) are consistent with cooling rates of  $\geq 10^\circ\text{C}/\text{minute}$  and any peak temperature

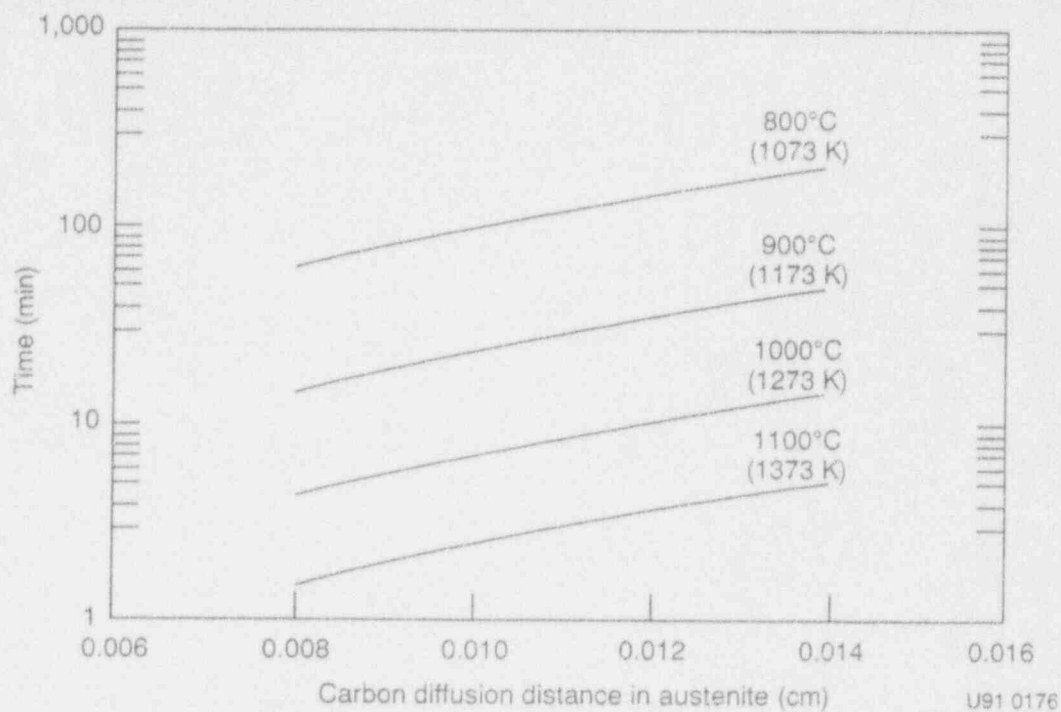
Figure 8. Calculated time/temperature/distance relationship of carbon diffusion into austenite.

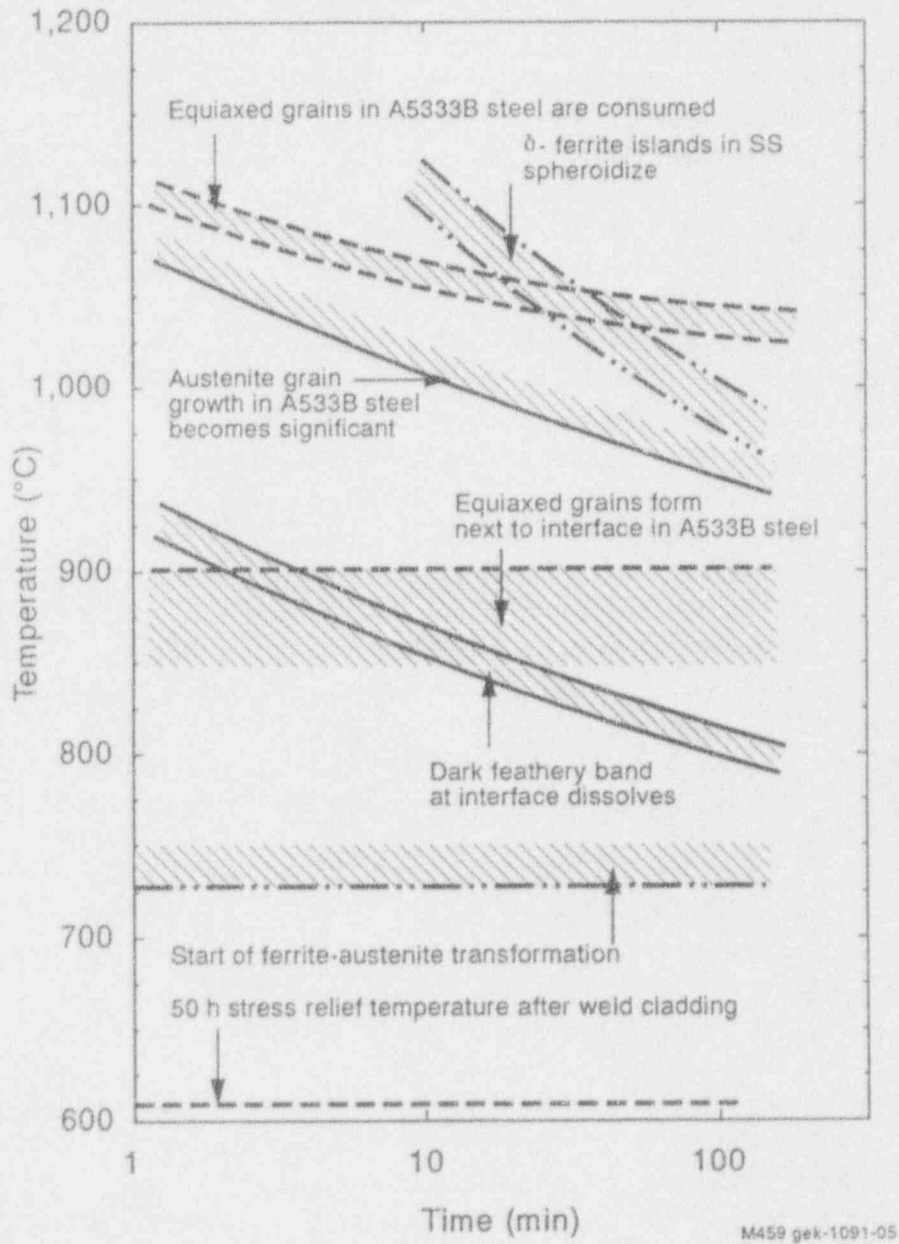
Figure 11. Diagram of time/temperature observations of A533B pressure vessel steel clad with Type 308L stainless steel.

In an attempt to illustrate the various metallurgical observations from the prepared standards of Midland archive material and the heat treated TMI-2 material, the diagram shown in Figure 11 was constructed. Since the vessel was stress relieved at 610°C after the weld cladding, no thermal effects from the accident could be detected at or below this temperature and, therefore, the diagram only shows metallurgical observations for temperatures above this point. The lowest temperature indicator, above the stress relief temperature, was the ferrite-austenite transformation, which starts at 727°C and is complete by 810°C. Variations in hardness will be evident when this threshold is exceeded. The next indicator is the dissolution of the dark feathery band at the interface; this occurs between 800 and 925°C, depending on the time. The next indicator of increasing temperature is the appearance of small equiaxed grains in the A533B steel adjacent to the interface that form between 850 and 900°C and disappear between 1,025 and 1,100°C as they are consumed by grain growth in the low alloy steel. The dissolution of the dark feathery band and the formation of the equiaxed grains are believed to be associated with carbon diffusion into the stainless steel cladding. The dark feathery band appears to be some sort of carbide that disperses as the carbon diffuses into the stainless steel. The equiaxed grains, which are not typical for a low alloy steel, appear to be devoid of cementite, undoubtedly due to a loss of carbon into the stainless steel. Grain growth in the A533B steel becomes significant above approximately 950 to 1,075°C, depending on the time involved. The highest temperature indicator shown on the diagram is the spheroidizing of the  $\delta$ -ferrite islands in the stainless steel cladding, which occurs in the approximate range of 975 to 1,000°C at 100 minutes or 1,100 to 1,125°C at 10 minutes.

The thermal histories were determined by applying the above observations to microstructural examinations of areas near the stainless steel/low alloy steel interface (within 2.5 mm). The temperature gradient through the thickness of the lower vessel head wall was estimated by two methods. First, since the high level of hardness of the four affected samples persisted to the full depth of the boat samples (50 mm from the inside surface, 45 mm from the weld clad interface, see Figure 3), it could be concluded that the temperature at that depth was greater than the 727°C transformation temperature. Secondly, since it had been established that the thermal excursion on the lower head due to the accident was of the order of 30 minutes, prior austenite grain size at the bottom-most tip of the heat-affected samples was compared with the prepared standards given the 30-minute heat treatments. The results of this rough analysis indicated that the temperature 50 mm from the inside surface (45 mm from the stainless steel/low alloy steel interface) was approximately 50 to 150°C lower than the peak temperatures determined previously for the region near the interface. There is a fair amount of uncertainty in the gradient estimate since only average prior austenite grain size was used for the determination and that measurement cannot be made with precision. Also, the assumption that 30 minutes was the actual time at peak temperatures 50 mm into the thickness may be in error.
