HEALTH PHYSICS REPORT #1  
of  
RADIOLOGICAL SURVEYS  
of the  
AMERICIUM-241 CONTAMINATION  
at  
DRILLING SITES NEAR JOLLYTOWN, PA

Consolidation Coal Company  
Consol Plaza  
Pittsburgh, PA 15241

September 30, 1982

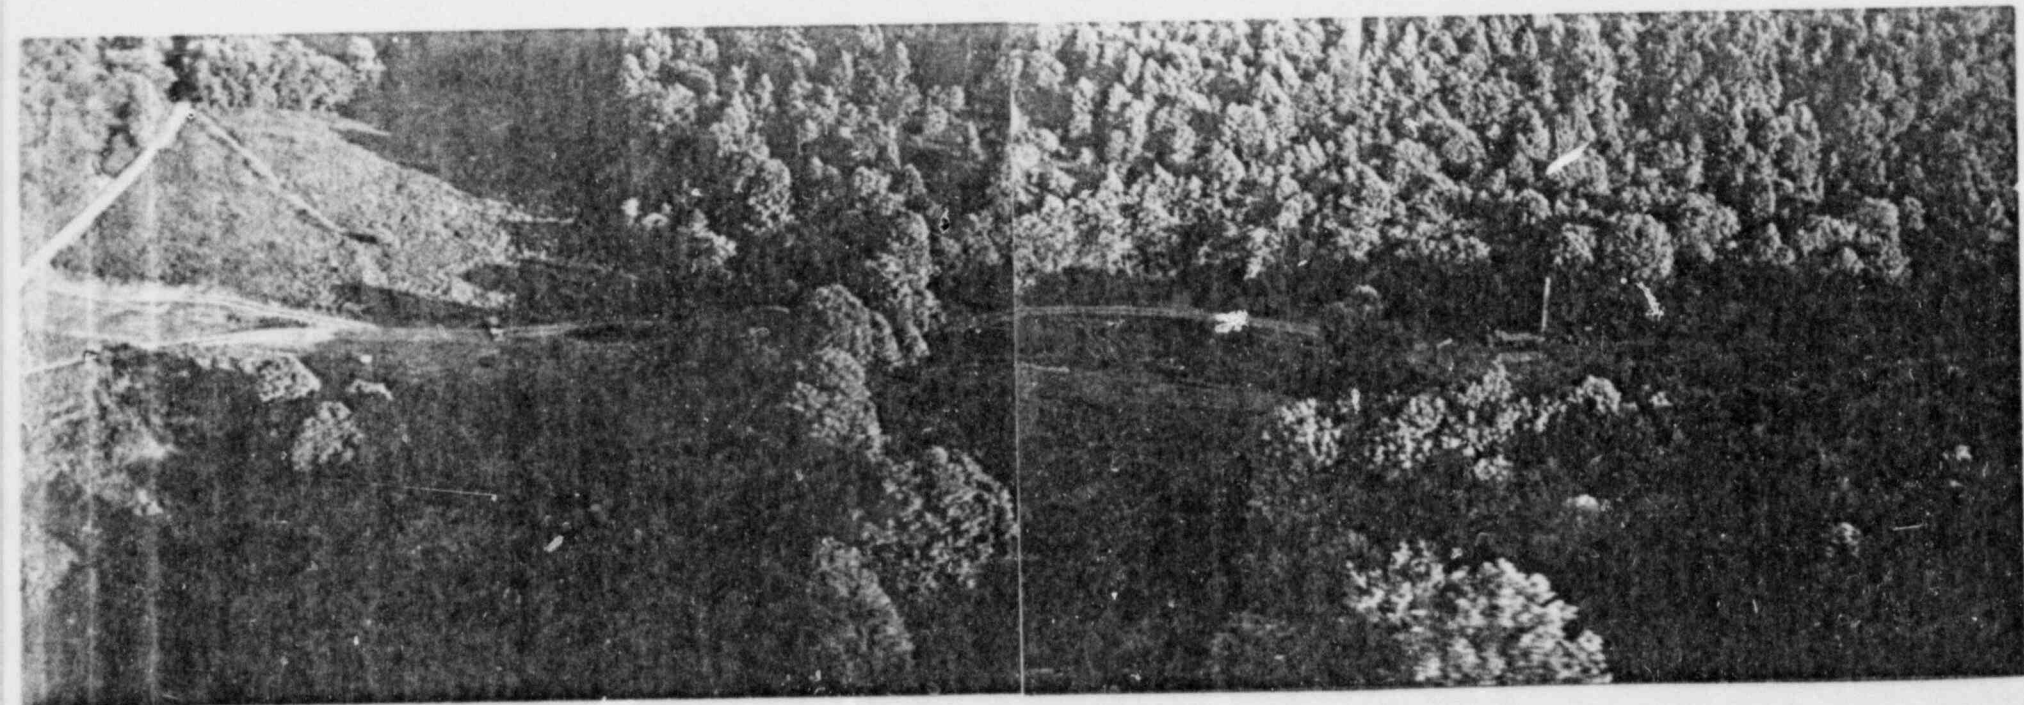
AERIAL VIEW OF ZONE A

FIGURE 2A Composite aerial color photographs of Site #1 showing the location of the air rotary drill rig and pipe truck within Zone B. (Right half of picture) Zone A is shown in the left half of the aerial view where the red pick up truck blocks the entrance road into the drilling area.

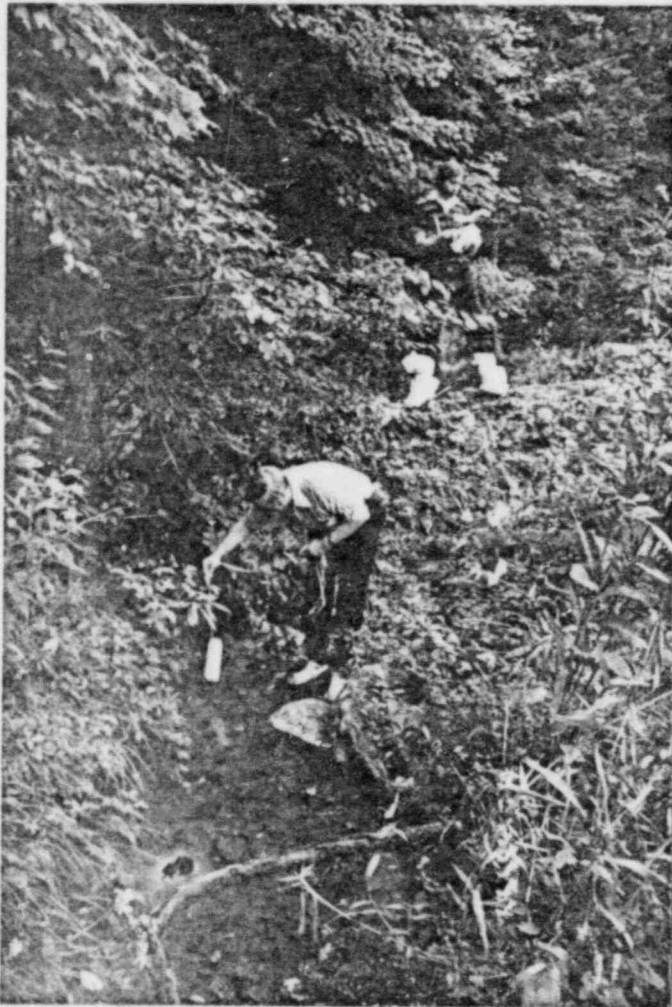
FIGURE 3

Photograph of state and US-NRC inspectors collecting water and silt samples of the contaminated pond above Dam #2 at Consol drill Site #1 on September 8, 1982. Mr. James Yusko, CHP, from PA, Bureau of Radiological Health is in the foreground. Mr. James Nicolosi, Region 1, US-NRC is taking field notes.

was joined by Mr. James Nicolosi, a health physicist and compliance inspector from Region I of the US-NRC. Both Mr. Nicolosi and Mr. Yusko have reviewed and witnessed the practices and procedures used to perform the radiological surveys described in this report. Figures 3 and 4 are photographs showing these officials collecting water and silt samples at Site 1 on September 7, 1982.

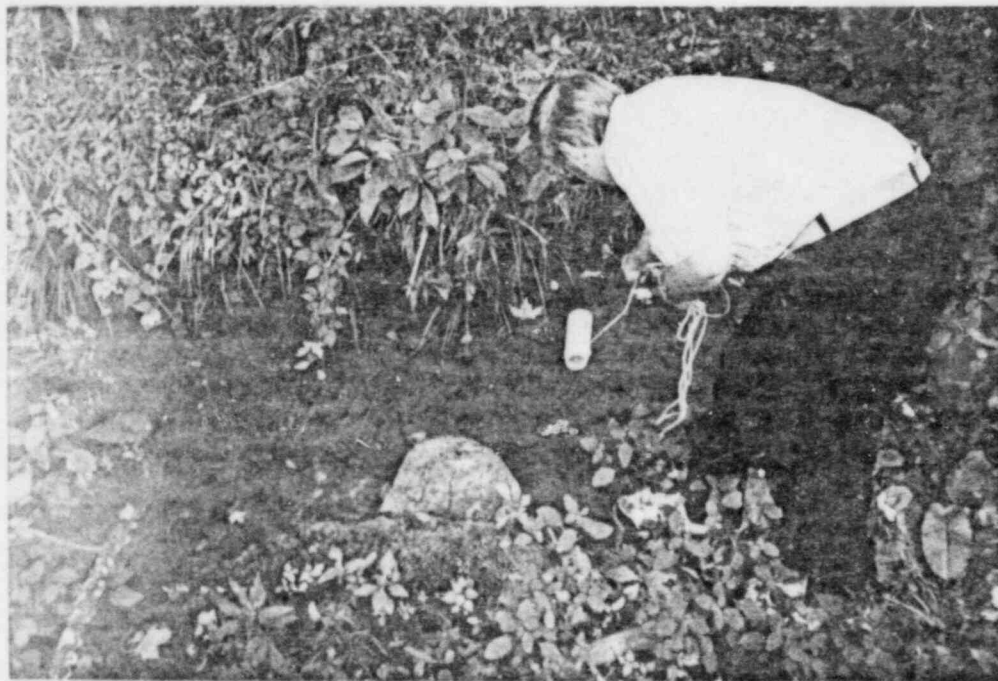
FIGURE 4

Photograph of Mr. Yusko obtaining water and silt samples at the same time and location as shown in Figure 5

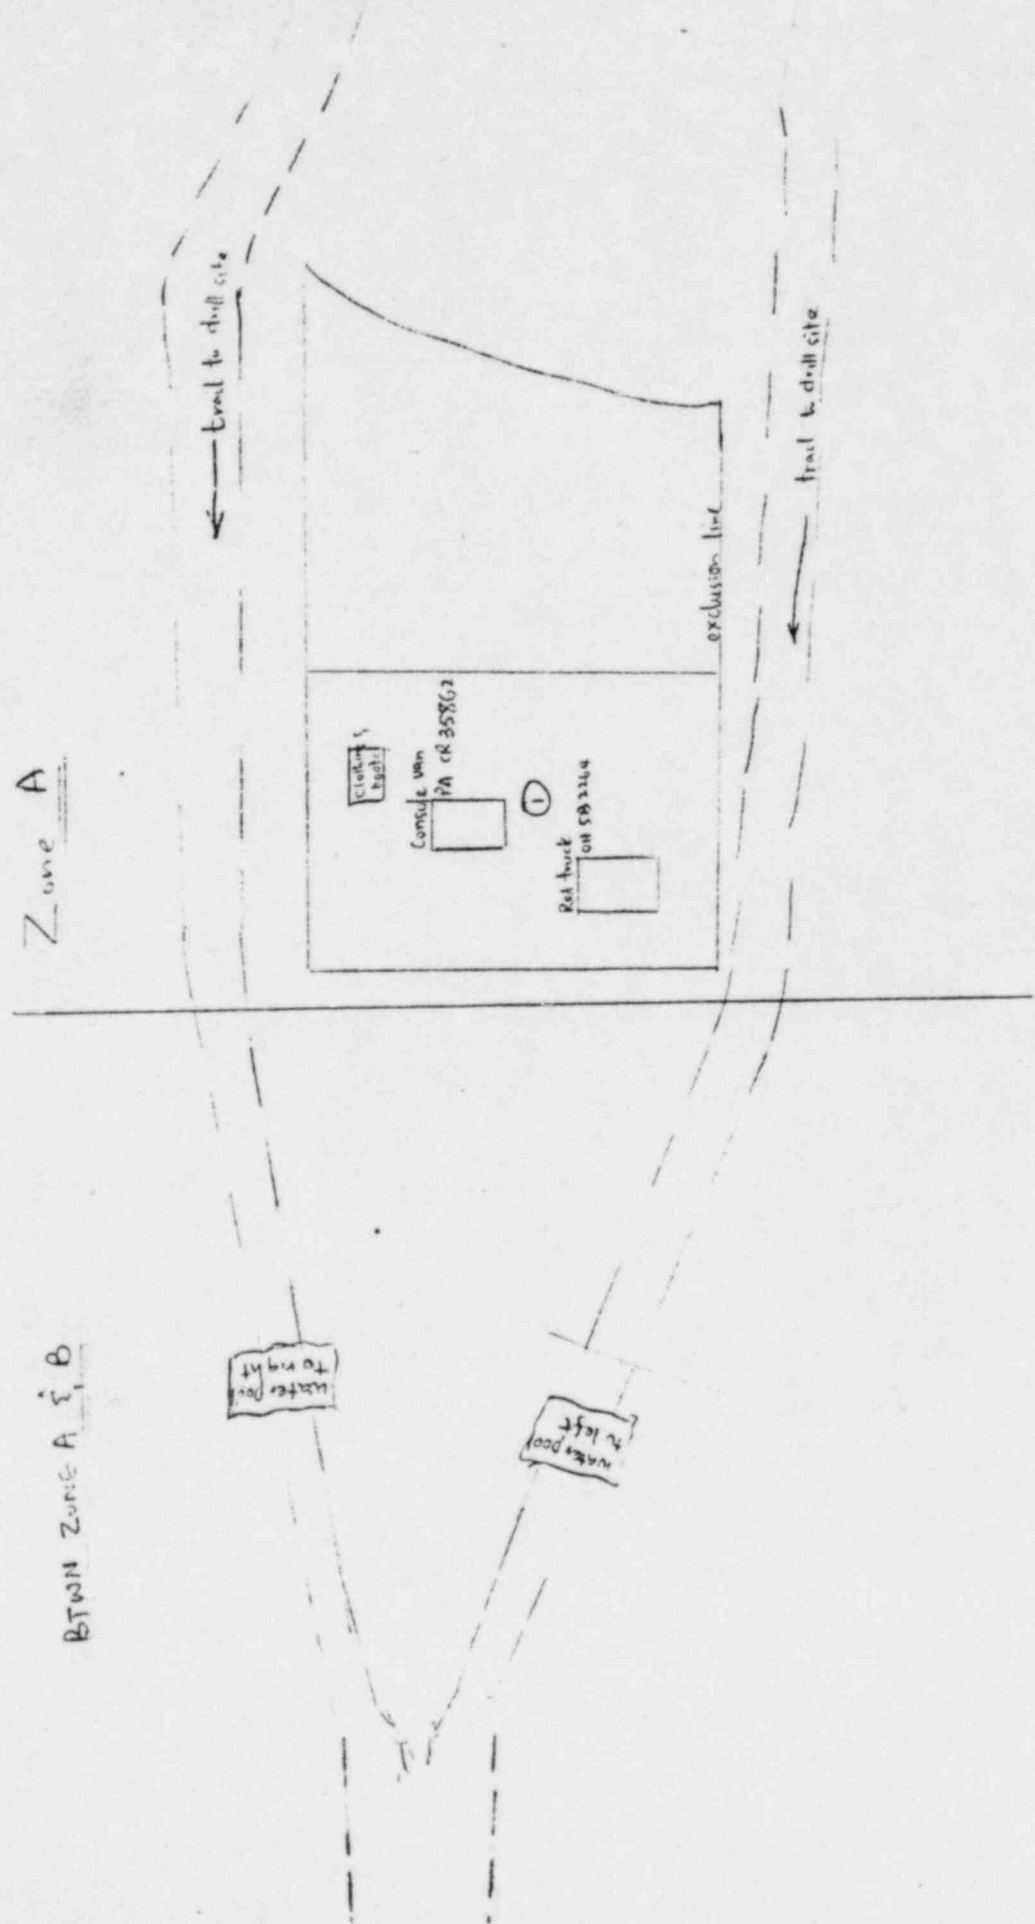
SITE I, FIGURE 5

This zone covers an area of about 40 square yards. See Figure 5.

This area is shown in Figure 5 and consists of isolated patches of contaminated soil.

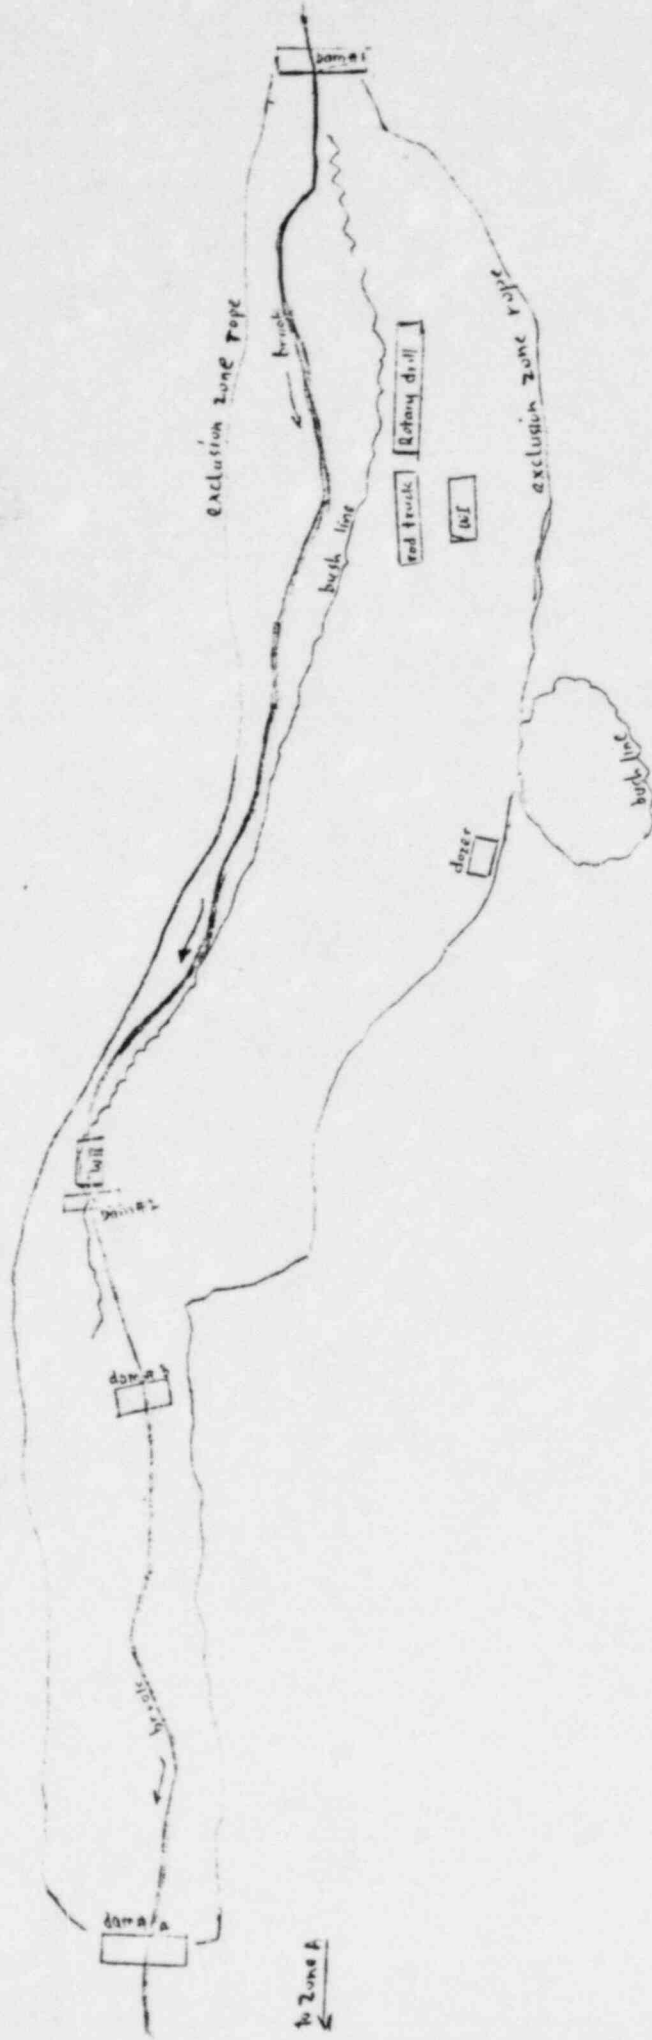
SITE I [ZONE B] Figure 6

This is the primary site of the Americium-241 contamination. Figure 6 provides a sketch of the area, and its contents. The contaminated equipment at this site include:

In addition, more than 600 feet of brook bed is contaminated to varying degrees, dependent on proximity to the rotary drill position.

The entire 600 ft length of the brook bank (facing the air rotary drill) is also contaminated. The small ponds (identified as W1 and W2) are also contaminated, with W1 having the higher degree of radioactive content. Several large expanses and discrete patches of soil are contaminated as well.

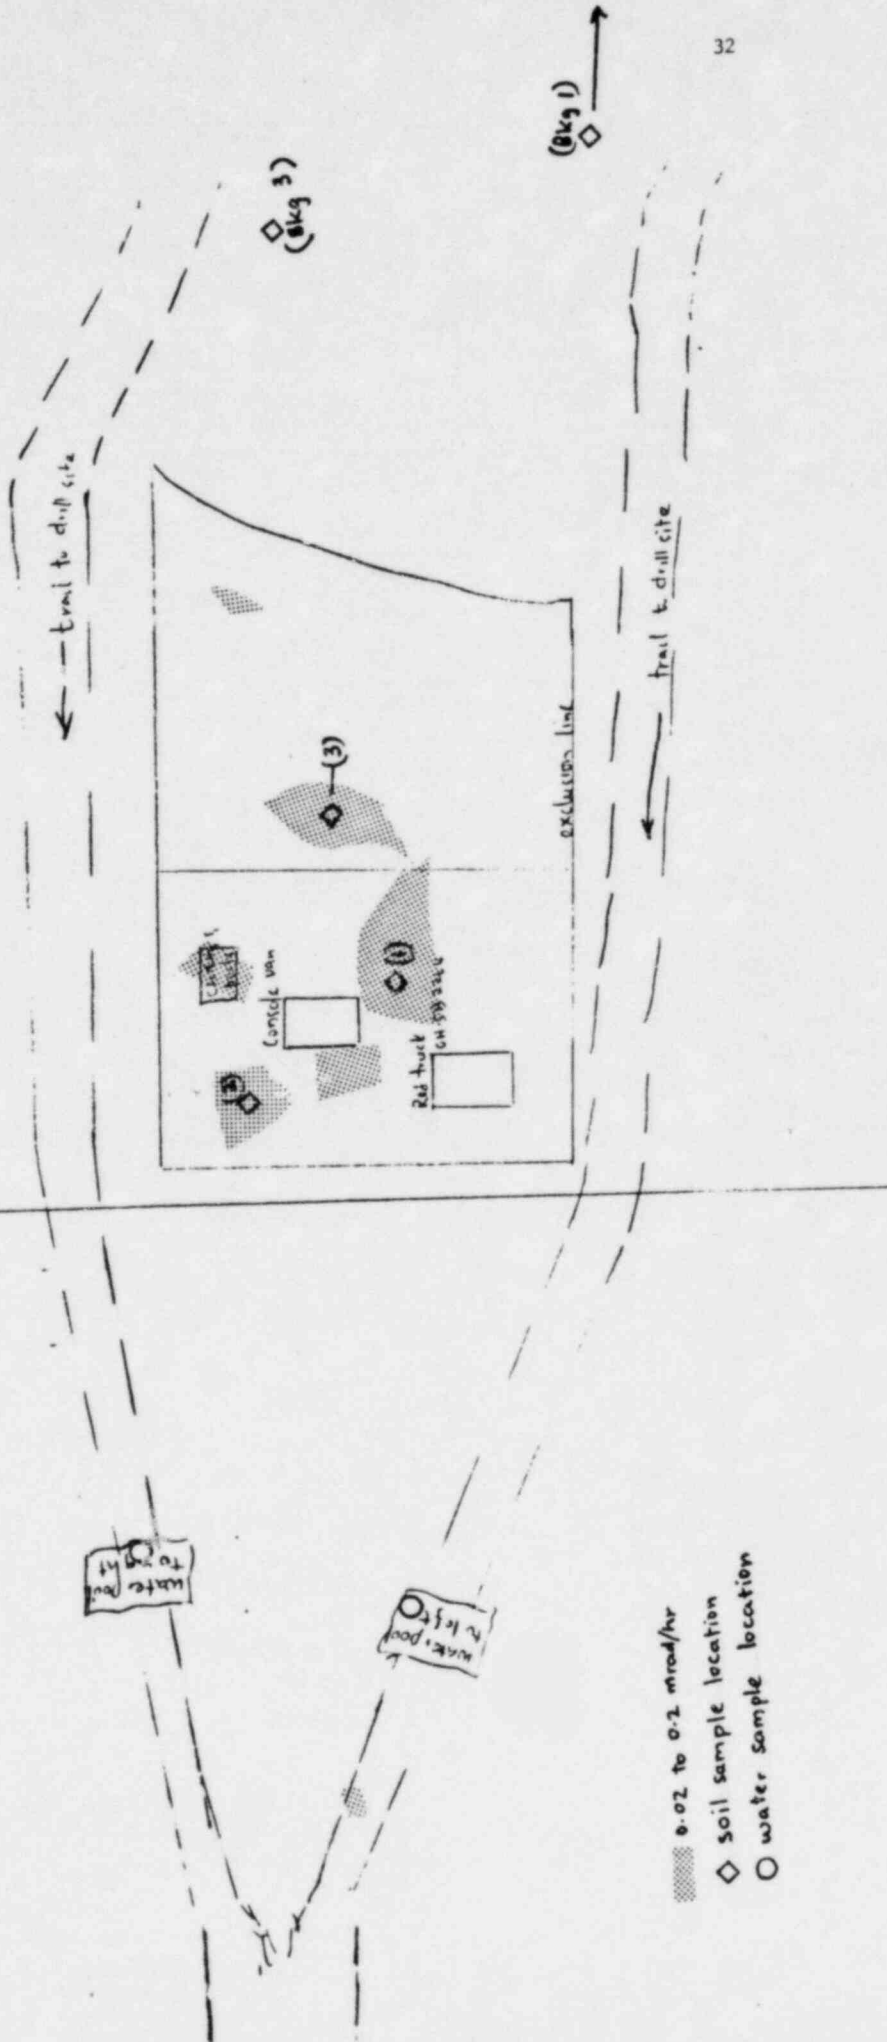
SITE I Figure B

The results of the water and soil samples are provided in Tables 1 and 2. Figures 8 and 9 show the locations where the samples were obtained. The smear survey results are provided in Appendix 1 and 2.

Contamination survey was conducted on this trail. Water samples were taken and so were direct exposure measurements. The results are included in Table 10 and Figure 8.

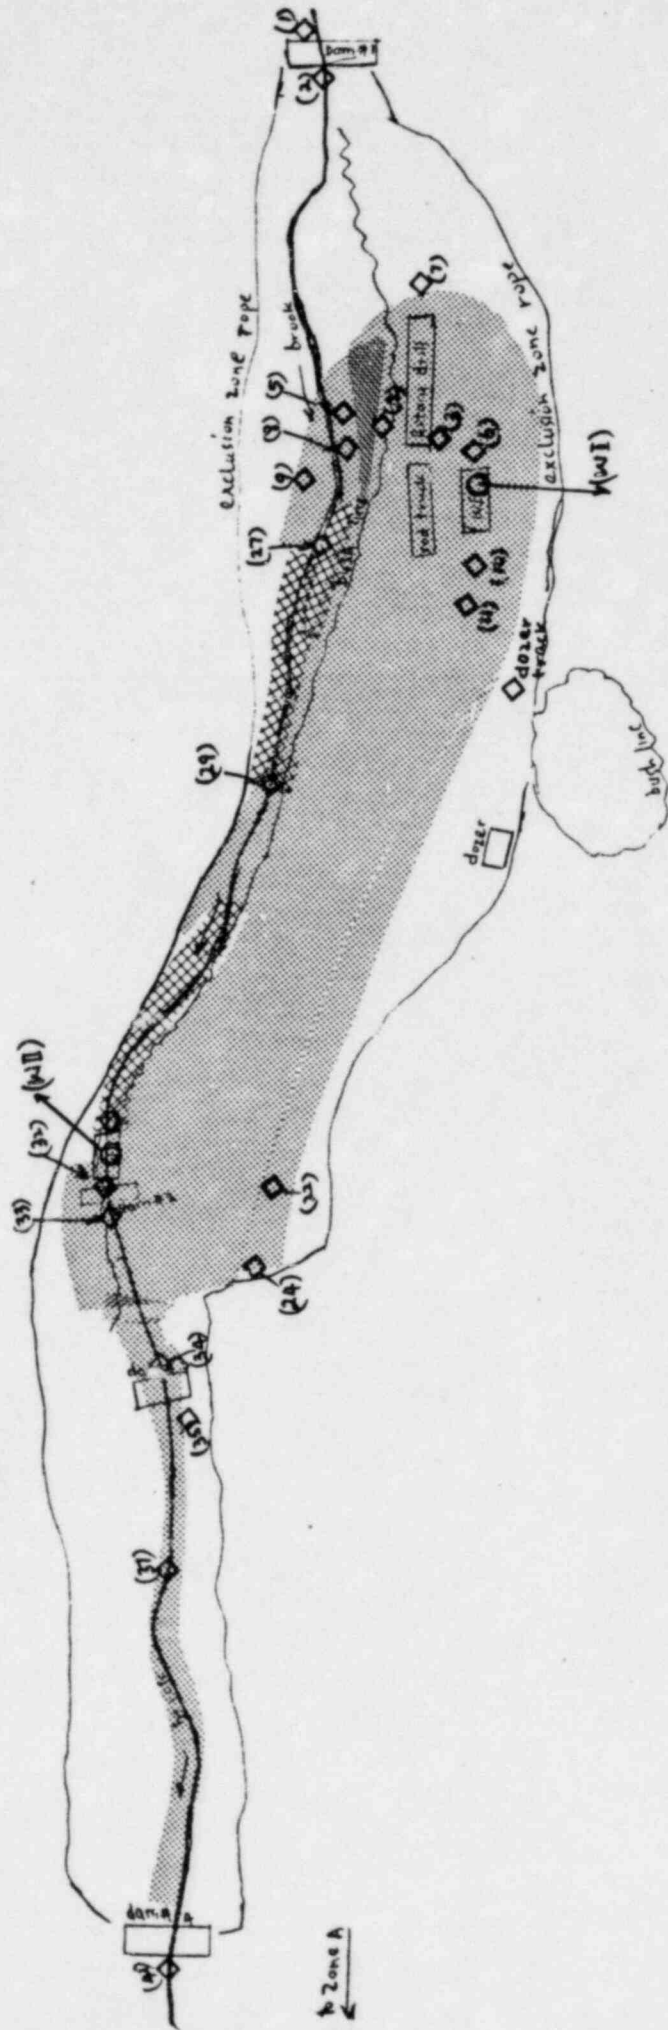
SITE I [ZONE B] FIGURE 9

The results of smear surveys are given in Appendix 2. Figure 9 shows the direct exposure profile of the area.

Exposure measurements considered here were obtained on September 28 with the HP Model 1010 at areas where the FIDLER and/or scintillometers gave the highest readings. As Figure indicates, the highest exposure (0.5 mRad/hr.) was obtained close to the W2 ditch. This ditch, as explained earlier, is close to being filled to the brink as a result of the runoff. The runoff between Dams #1 and #2, along with the eroded soil, is ending up in this ditch along with their additional radioactive contents. The exposure, at about 25 feet from W2, is 0.2 mRad/hr. at one meter and 0.5 mRad/hr. at about 3 cm above the ground. The rest of the exposure profile is shown in Figure 9.

- XXX 0.2 to 0.5 mrad/hr
- XXXX 0.02 to 0.2 "
- ◇ soil sample location
- water sample location

It should be pointed out that these exposure levels may change as the water carries the Am-241 into the ground or sieves, causes it to leach through Dam #2. Therefore, these measurements will necessarily be repeated periodically.

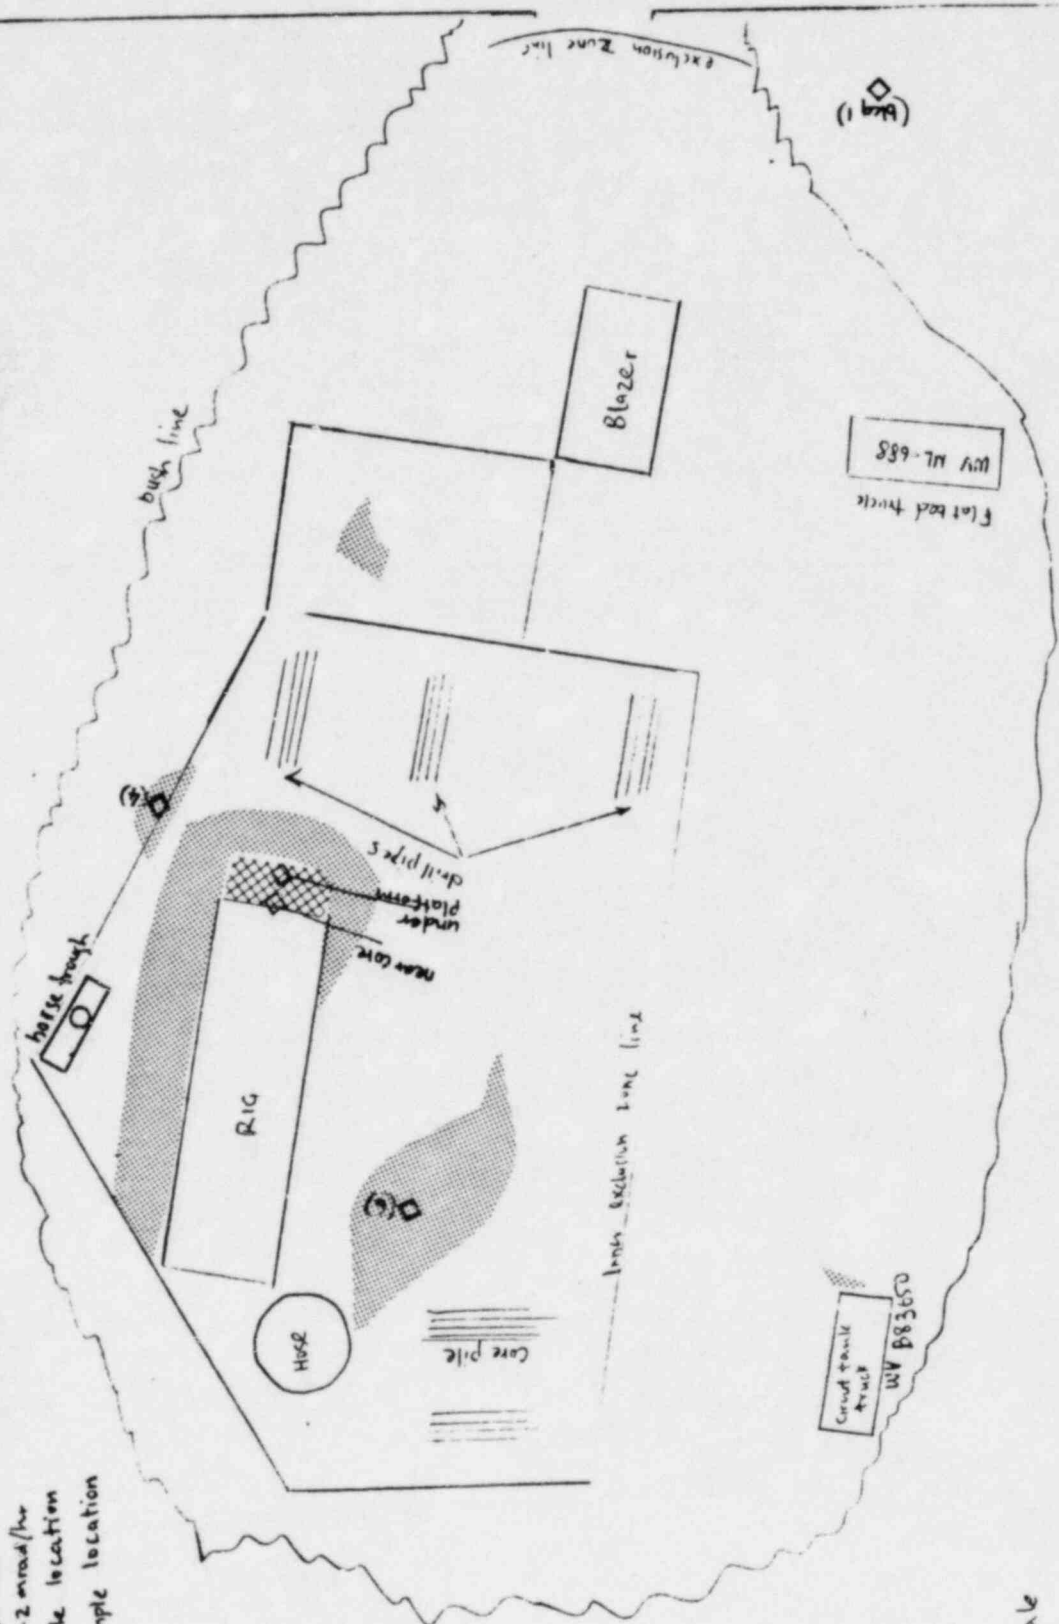
SITE II FIGURE 10

Appendix 3 provides the results of the smear surveys on equipment. The exposure profile is shown in Figure 10. Soil and water sample locations are included in the figure. Tables 1C and 2C provide the results of their analysis.

The highest exposure occurs at the position of the drill platform. This exposure, 0.2 mrad/hr, is from both the raised platform and the contaminated soil below it. Other measurements made are as shown in Figure 10.

- XX 0.1 to 0.5 area/hr
- ▨ 0.01 to 0.2 area/hr
- ◇ soil sample location
- water sample location

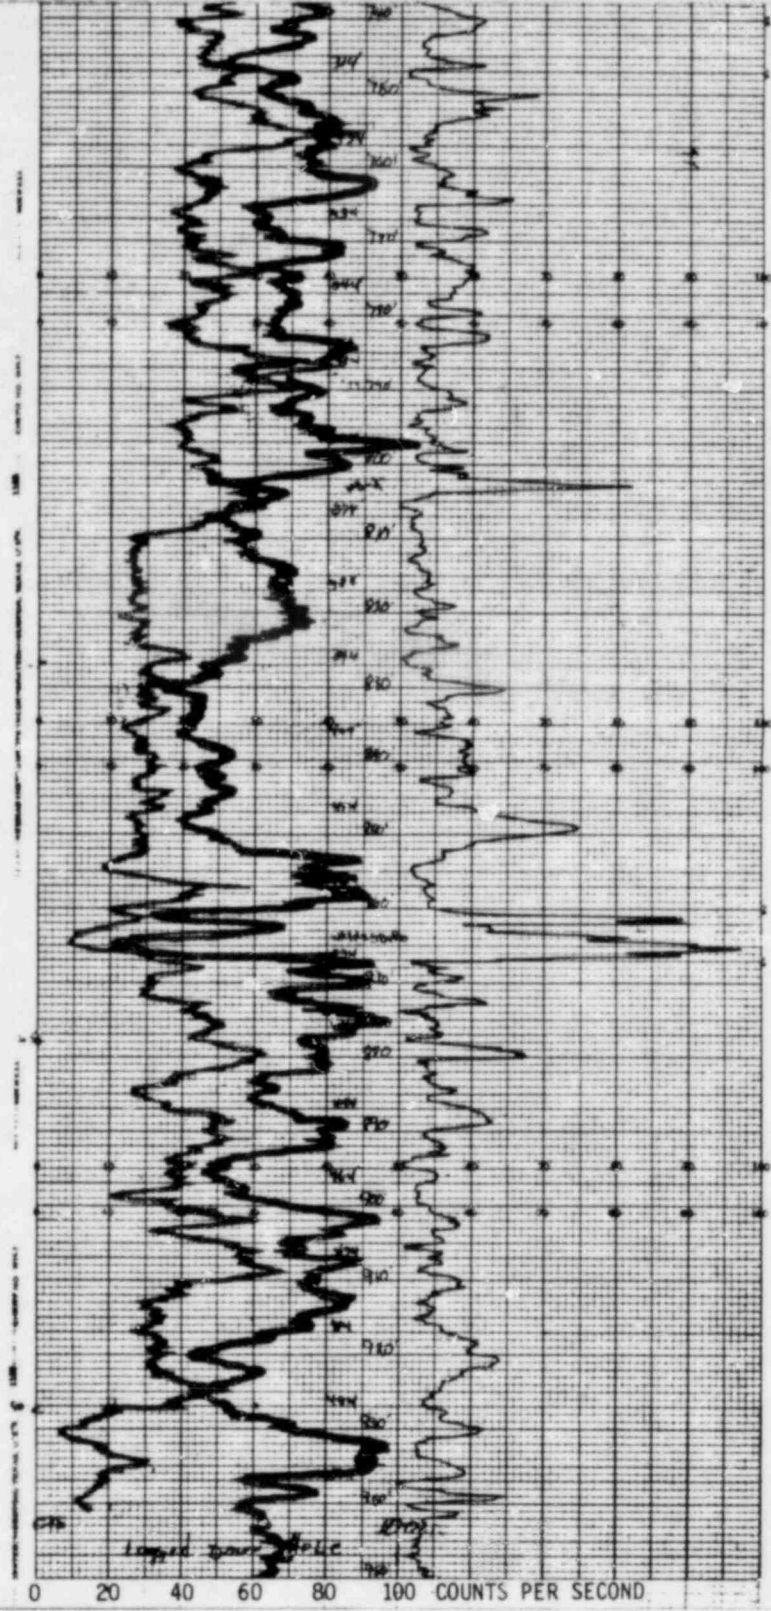
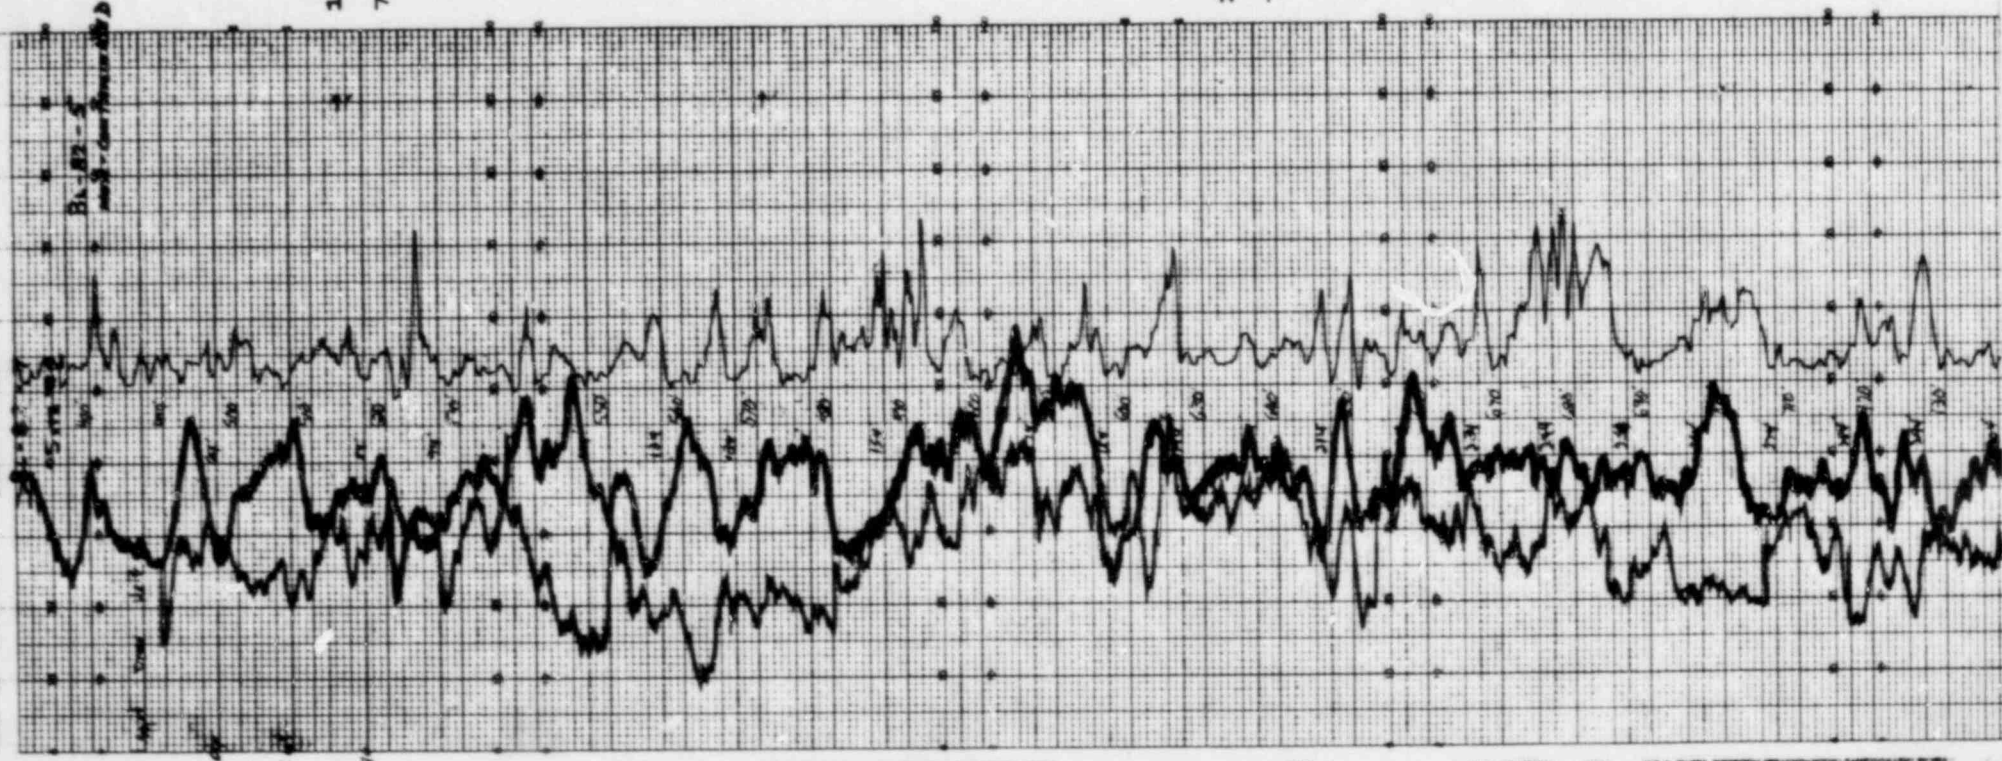
The exposure profile as plotted, Figure 11, indicates no contamination along the walls of the hole. This is substantiated by the following;

- a) The second plot in Figure 11 is that of another drill hole about 5000 ft. away which was never involved in the Am-241 incident. A comparison of this plot with that of drill hole

#BL-82-7 indicates that the other drill hole (BL-82-5) has even higher radiation exposure emanating from the rock beds than the drill hole involved in the Am-241 incident.

The segment of plastic tape that was used to cover the bottom of the probe is the only portion with soil and contamination on it. This means that the debris at the bottom of the hole could not be more than 4 inches thick. It is impossible to estimate the amount of radioactivity at the bottom, but if that which came out with the tape is any indication, the radioactive content could not be sizable. This 4 inches of debris is located in an impermeable shaly claystone and therefore, cannot migrate from its position. Its position is 75 feet below the potentially mineable Waynesburg coal bed and over 100 feet above the Sewickley coal. It is 85 feet below the last potential source of potable ground water, the Waynesburg Sandstone.
