Contract Program or Project Title: Container Assessment

Subject of this Document: Corrosion of T: Code 12

CORROSION OF TiCode-12 IN A SIMULATED WASTE ISOLATION PILOT PROJECT (WIPP) BRINE*

T. M. AHN, B. S. LEE, J. WOODWARD, R. L. SABATINI, AND P. SOO
Brookhaven National Laboratory, Upton, NY 11973

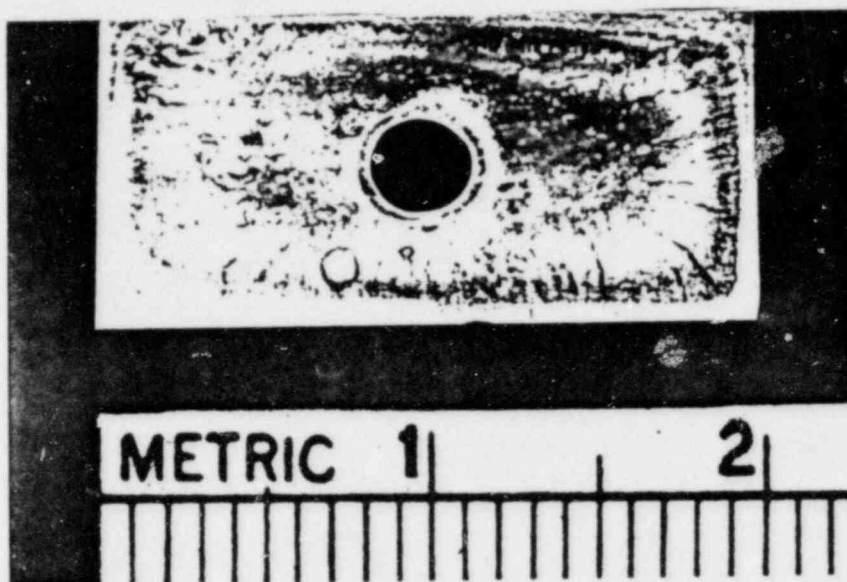
Fig. 1. The initial stage of the crevice corrosion of TiCode-12.

During the initial stage of the crevice corrosion in Brine A (first few days immersion) a very thin multicolored corrosion product was observed (Fig. 1). This film was found to be the anatase form of TiO_2 . For exposures of over two weeks the largest samples (2 x 4 cm) with the smallest crevice gap showed a thicker black corrosion product (Fig. 2). This was composed of the rutile form of TiO_2 with traces of lower oxides such as Ti_3O_5 . Higher O_2 concentrations promote rutile formation. In general, lower pH, larger sample sizes, and smaller crevice gaps gave higher crevice corrosion rates. In order to understand the crevice corrosion mechanism, measurements of the open-circuit corrosion potentials were made at 80°C. These showed a breakdown of the passive film occurs as the pH of the brine falls below 1.0. Since a pH drop is expected to occur in the crevice, loss of passivation and crevice attack are also anticipated. These results are similar to the crevice corrosion of pure titanium in NaCl solution [10,11]. However, the crevice corrosion rates are much slower in TiCode-12. Mass transport calculations for oxygen inside the crevice showed a significant oxygen depletion in this region. The results imply that the compact and passive anatase form of TiO_2 [12] is no longer stable as the macroscopic concentration cell is developed. Consequently, the more porous rutile form of TiO_2 and lower oxides are probably formed in the crevice.

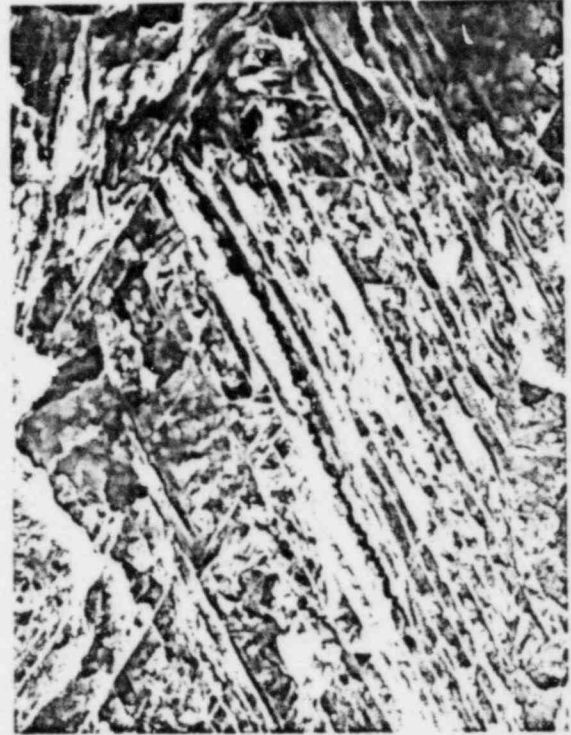
Fig. 4. Brittle fracture of TiCode-12 at hydrogen concentration in excess of 6560 ppm. Note the interface cracking in the center.

In the hydrogen embrittlement tests for SEN samples, the apparent stress intensity (K_Q) [13] values and hydrogen concentrations were determined and are given in Table III. At the 100 ppm hydrogen concentration level, the sample was very ductile (Fig. 3) with a slanted fracture surface and it had a high K_Q value. The K_Q values for 6560 and 10900 ppm of hydrogen were decreased by a factor of about 10 compared to the 100 ppm hydrogen sample. Fractographs show both alpha phase brittle fracture and alpha-beta interface cracking (Fig. 4). These features are similar to those observed in other near-alpha titanium alloys [14,15], and implies that the formation of hydride is responsible for crack initiation [16,17].
