CONTAINER ASSESSMENT - CORROSION STUDY  
OF HLW CONTAINER MATERIALS

QUARTERLY PROGRESS REPORT  
JULY-SEPTEMBER 1982

T. M. AHN, B. S. LEE, AND P. SOO

NUCLEAR WASTE MANAGEMENT DIVISION

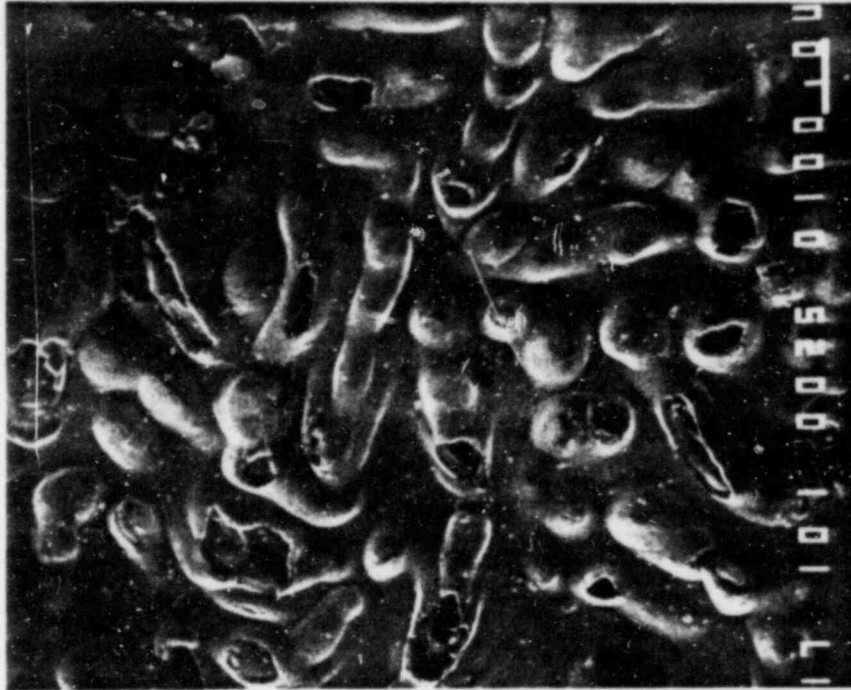
Figure 4. Blister formation and cracking in anatase films formed in Ti-Ti crevices exposed to WIPP Brine A for two weeks at 150°C. Magnification 100 X.

The morphology of Ti-Ti crevice corrosion products formed after severe attack is quite different from that observed for Ti-Teflon specimens. No oxide or metal dissolution was observed. Instead, the anatase scale contains blisters which eventually crack (Figure 4). Figure 5 shows a magnified

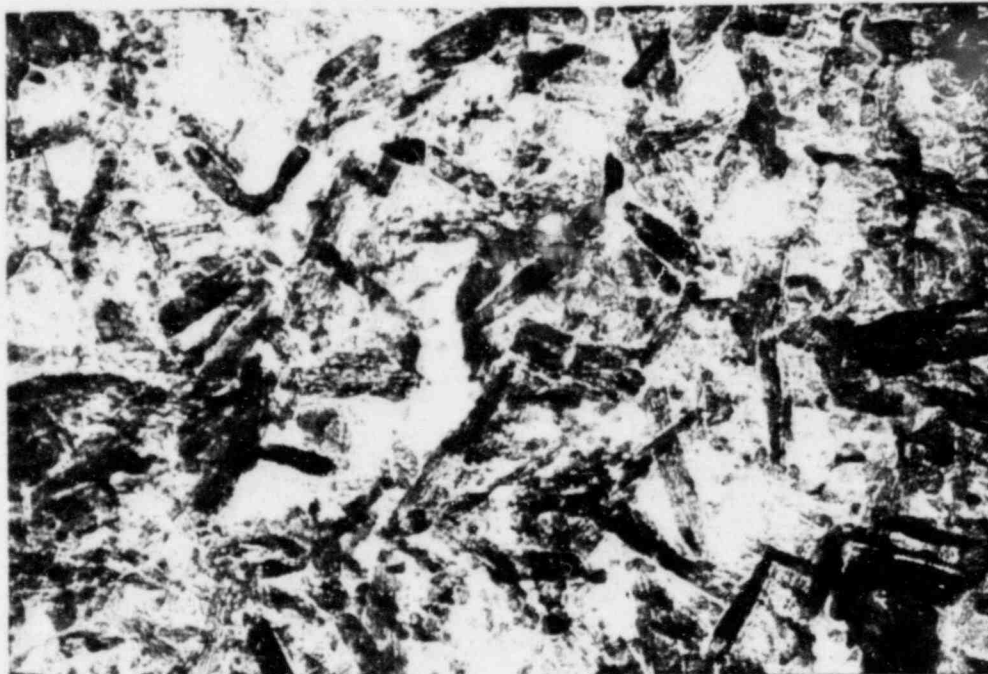
FIGURE 4--TEM micrograph of the rutile form of  $\text{TiO}_2$ .  
200000 X.

as block-shaped crystals as shown in Figures 1 and 2. For exposures of over two weeks, the largest samples (2 x 4 cm) with the smaller crevice gaps showed severe black corrosion products. This was composed of the rutile form of  $TiO_2$  with traces of lower oxide also present. The rutile was in the form of needle-shaped crystals as shown in Figures 3 and 4.

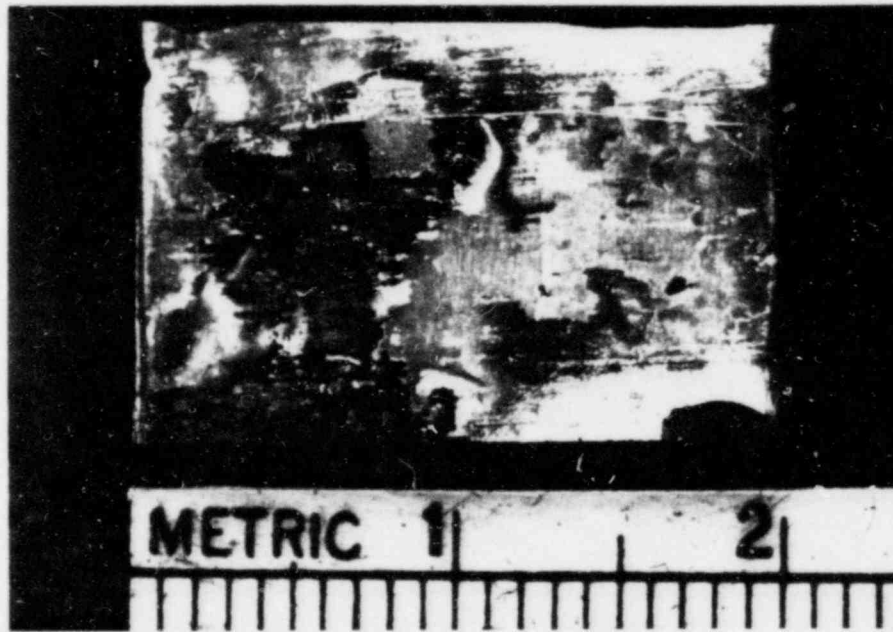
Fig. 2. Well developed crevice corrosion product on TiCode-12.

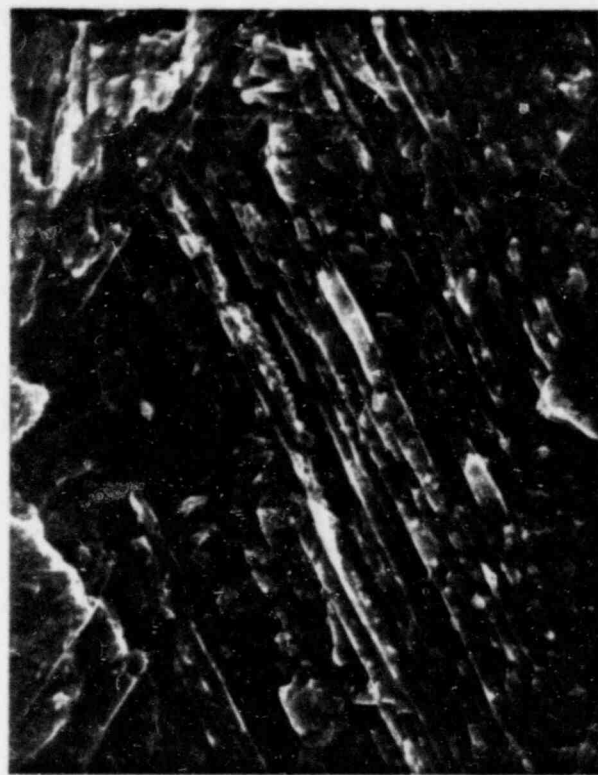
Fig. 4. Brittle fracture of TiCode-12 at hydrogen concentration in excess of 6560 ppm. Note the interface cracking in the center.
