EVALUATION OF
MAIN FEEDWATER PIPING MISALIGNMENT
AND STEAM GENERATOR NOZZLE CRACKING
BEAVER VALLEY POWER STATION UNIT 1

DUQUESNE LIGHT COMPANY
NUCLEAR GROUP
CORPORATE NUCLEAR SERVICES UNIT
NUCLEAR ENGINEERING DEPARTMENT

Final Report
January 17, 1991

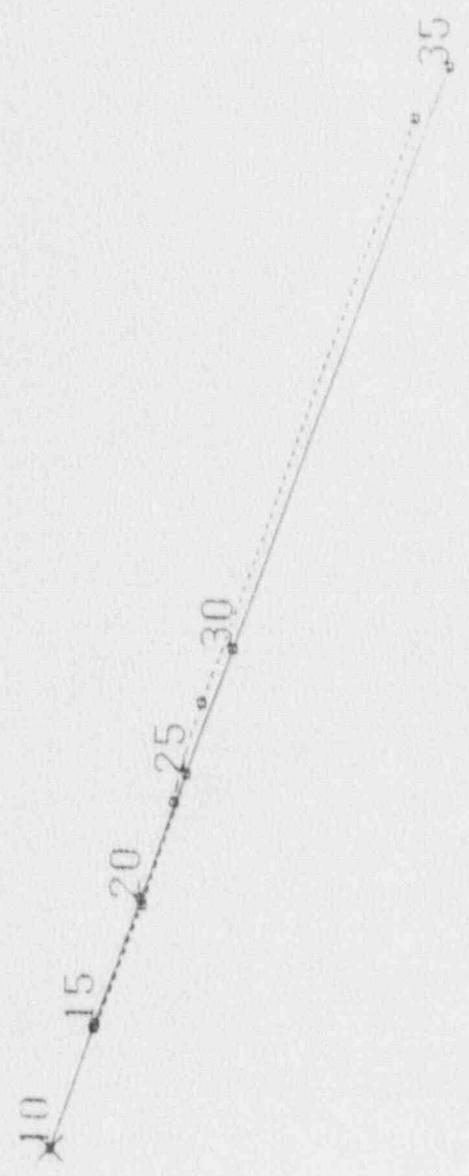
FIGURE 6.4.1.2-3

HORIZONTAL DISPLACEMENT RESULTS UNRESTRAINED MONOBALLS - LOOP A
