Geomorphic Processes and Evolution of Buttermilk Valley and Selected Tributaries West Valley, New York

Fluvial Systems and Erosion Study
Phase II

NUREG/CR-2862

Fluvial Systems and Erosion Study,
Phase II

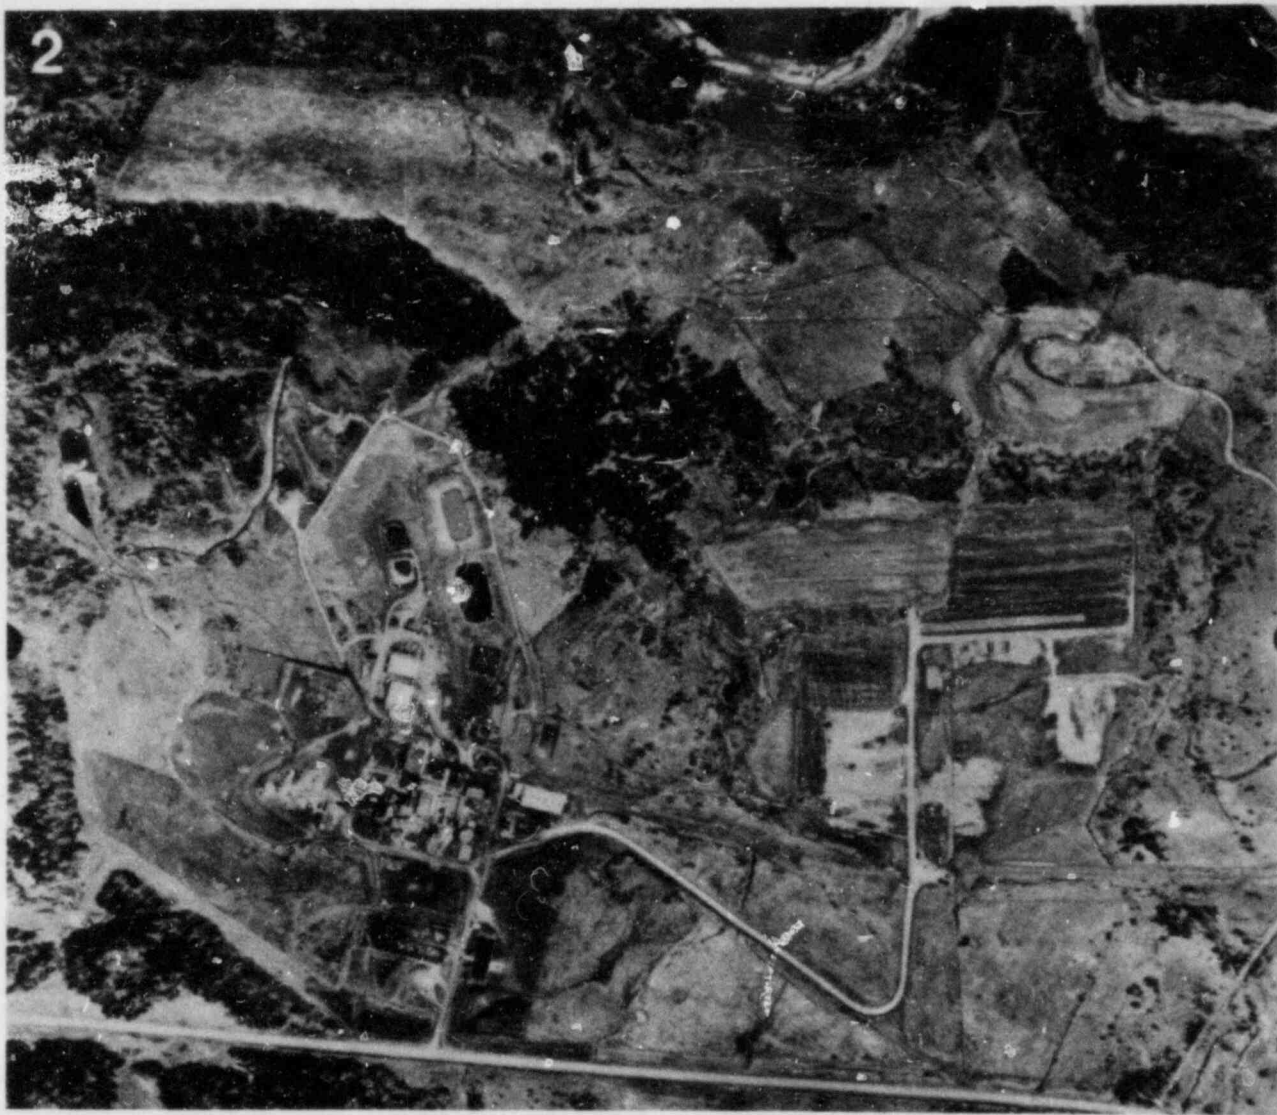
Figure 2. Vertical aerial view of the Nuclear Fuel Services facilities, the waste-burial sites, and the general plateau area. A section of Buttermilk Creek is shown at the top of the photograph (taken April 22, 1980 by Erdman, Anthony Associates).

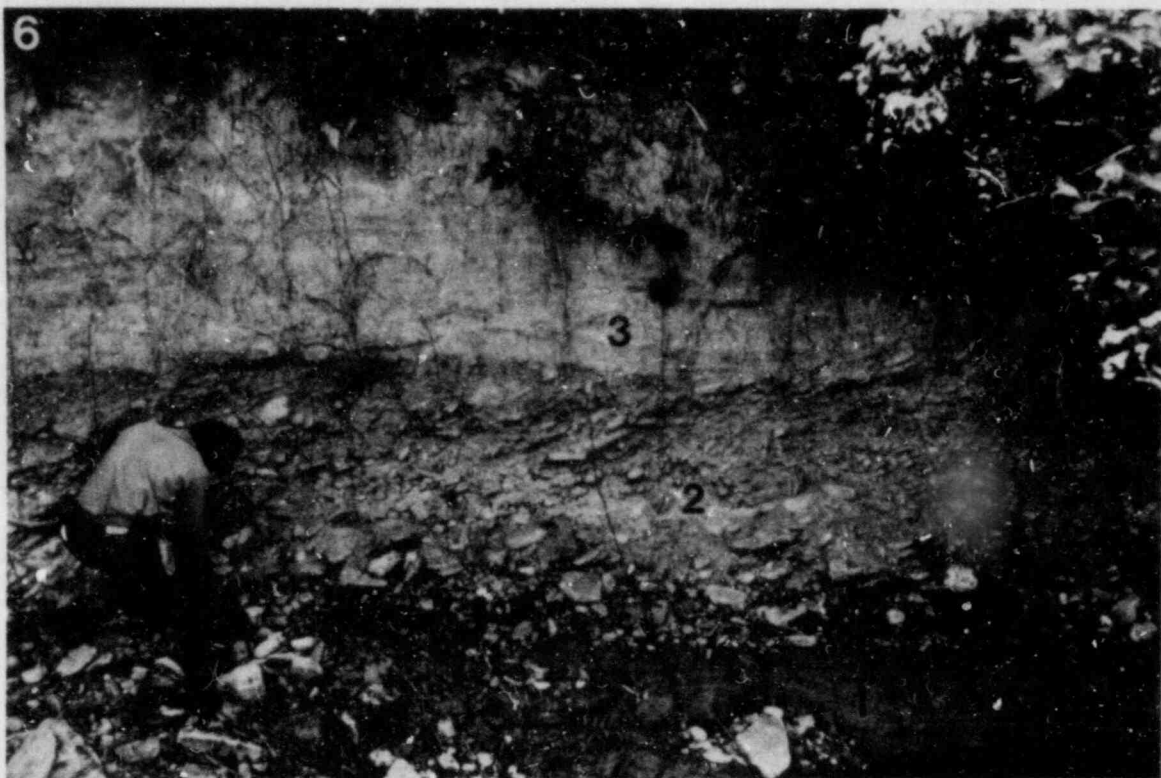
Figure 6. Stratigraphy exposed in the western terrace scarp opposite bar complex 3. The units are: 1) Kent till; 2) bar and channel gravel; 3) silt and clay deposited in a ponded depression at the base of alluvial fan BC-3. Bulk sediment samples GS-1,2,3, correspond to the numbered units.

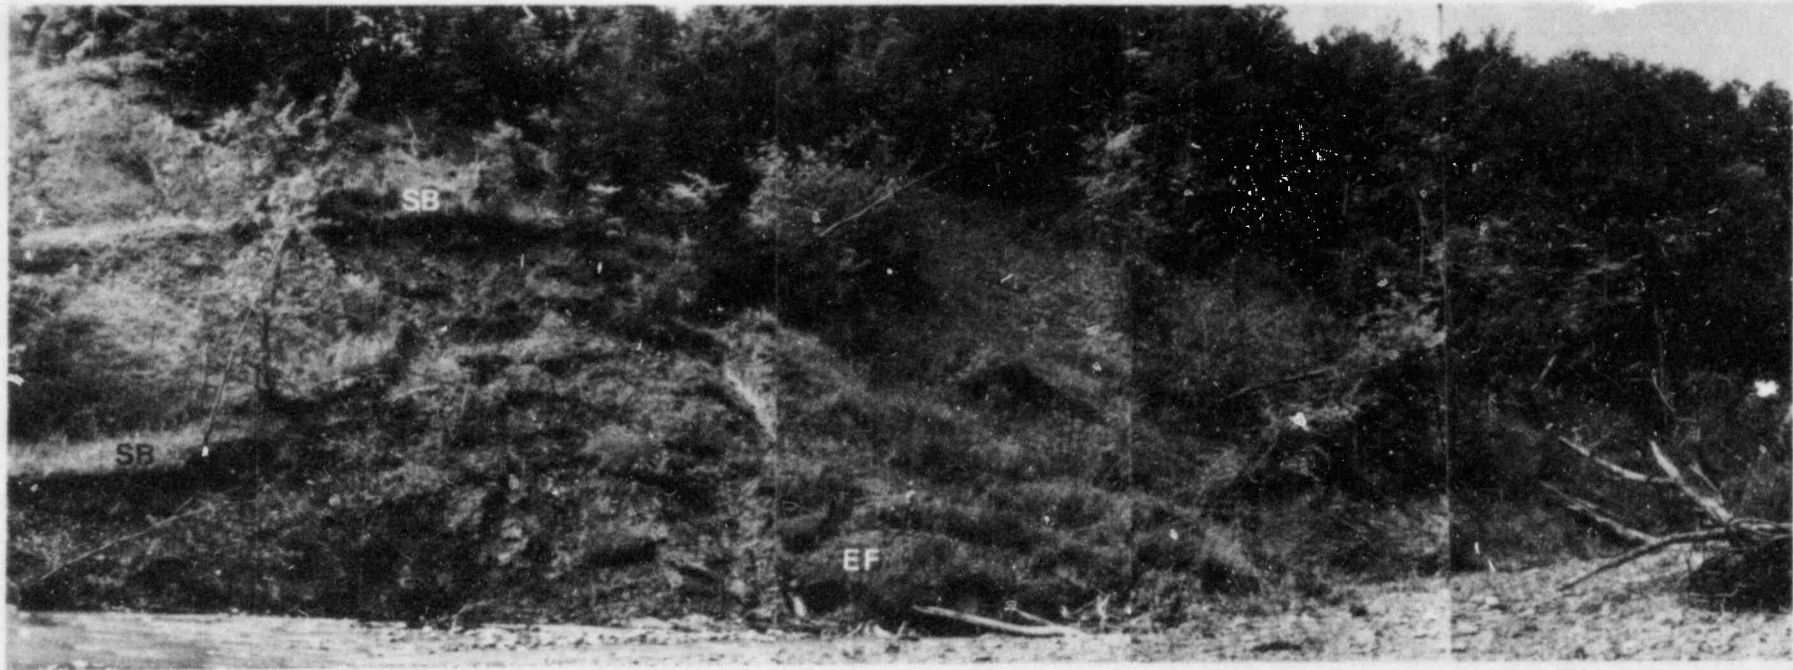
Figure 7. Large landslide on the west wall of Buttermilk Creek at BC-6. The slide is a complex of coherent slump blocks (SB) and hummocky, earthflow deposits (EF). Horizontal movement up to 32 m, and vertical movement up to 10 m occurred between 1978 and 1980. Photograph taken July 28, 1980.

Monitoring Stations - The landslide complex was marked with a series of 1.5 m steel fence posts and shorter wooden stakes in October 1978. A resurvey in July 1980 recovered 20 of 35 original stations. All the recovered stations were steel posts. These stations, as well as the new monitor posts, are shown on Plate 7 with movement tabulated in Table 4 and Appendix C.

Downslope horizontal, 8-32 m, and vertical, .3-10 m, movement was measured. The movement occurs as a series of coherent slumps, 20-50 m wide at the top of the slide, which change to a hummocky, tension-cracked, earthflow mass at the toe of the slide. Downslope trajectories of the upper slide slumps are steeper than the lower earthflow (Table 4). This contributes to a pile-up of material at the base of the slide. This material can rapidly flow out onto Buttermilk bar-and-channel areas as shown in Figure B1 (Appendix B). The earthflow accumulation of material had been removed by April, 1980 (Fig. B3) and was probably eroded by Hurricane Frederic flooding.

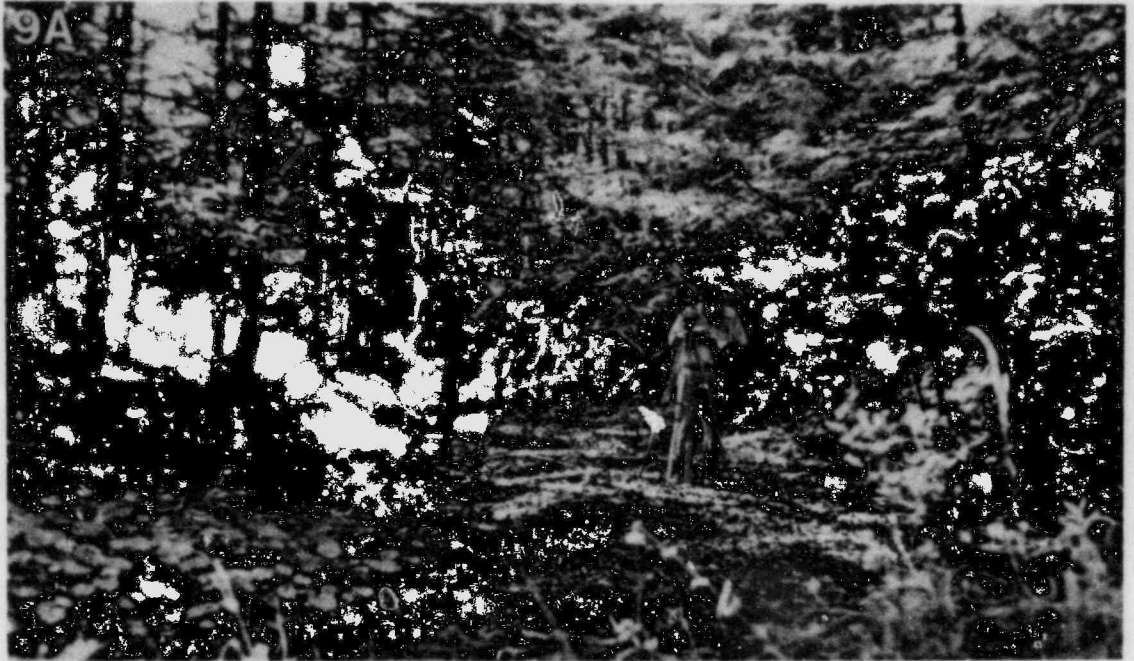
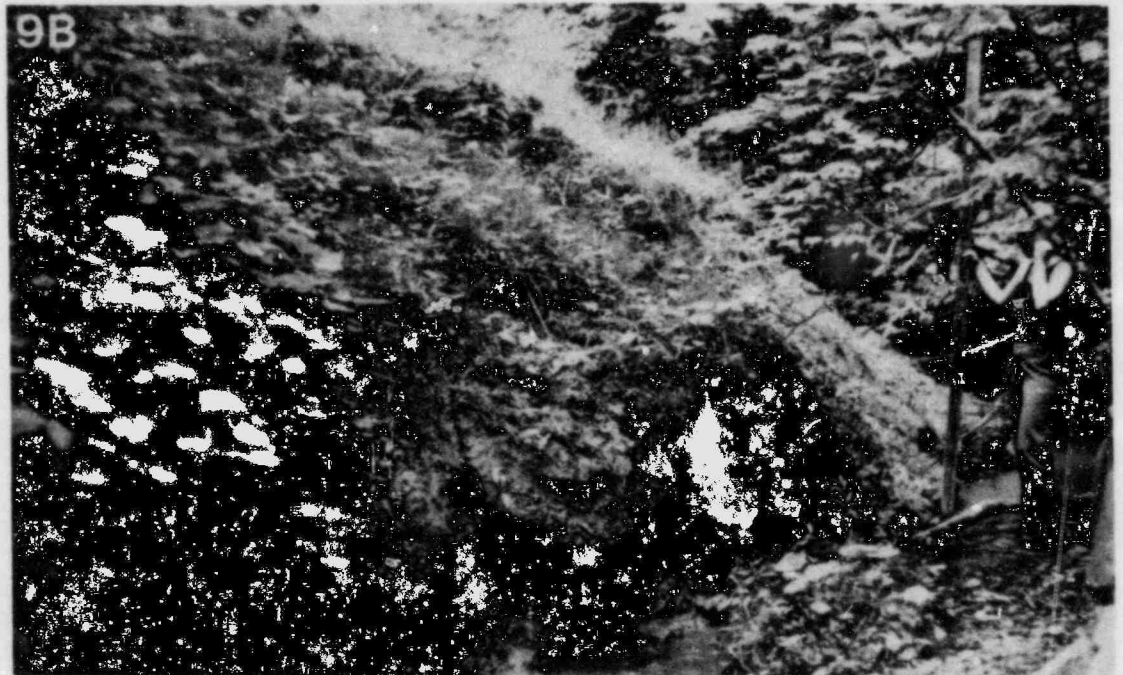
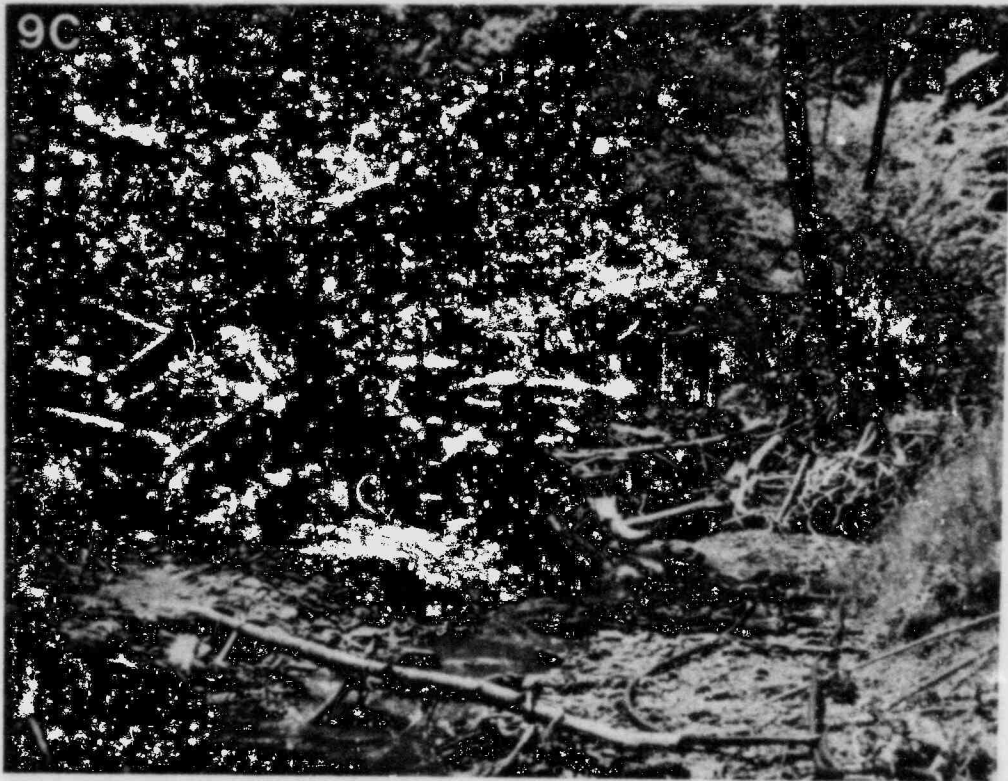
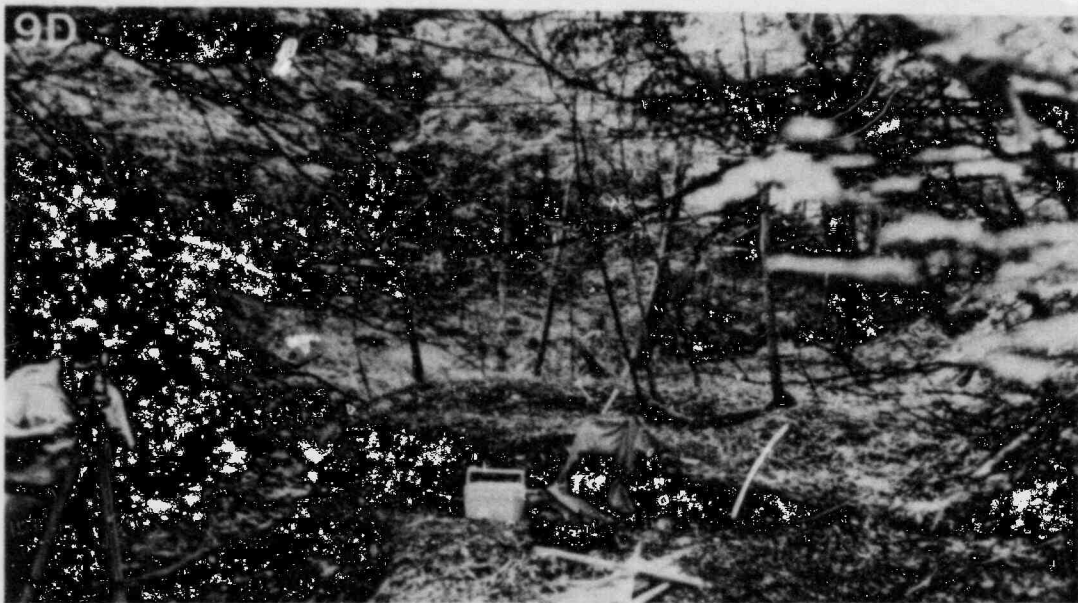
Figure 9. Franks Creek/Erdman Brook geomorphic subenvironments.
A. Small longitudinal bars fill the channel and function as riffles in the pool-and-riffle sequence. Transit operator is on the high point of a bar. View is upstream.
B. Undercut slump block extending over and into the base-flow channel. View is downstream.

- C. Log jam created by flood pileup of trees transported to the valley bottom by slumps. Rod person (arrow) is standing on gravel accumulated behind the jam. View is upstream.
- D. Fluvial terraces preserved near the valley bottom of Erdman Brook. View is upstream.

Undercutting of the steep valley walls is a constant occurrence at high-stage flow. This causes failure by slumping on the walls and mass wasting of the till (unit Tb_{1S} , Plate 1) down the slope and onto the channel bottom (Fig. 9b). The till is then transported as suspended sediment down and out of the reach by succeeding flood events. Heavy forest growth on the valley walls is also transported to the channel on slump blocks, where the large trees create log jams. This results in trapped bedload gravel in temporary storage behind the jams (Fig. 9c).

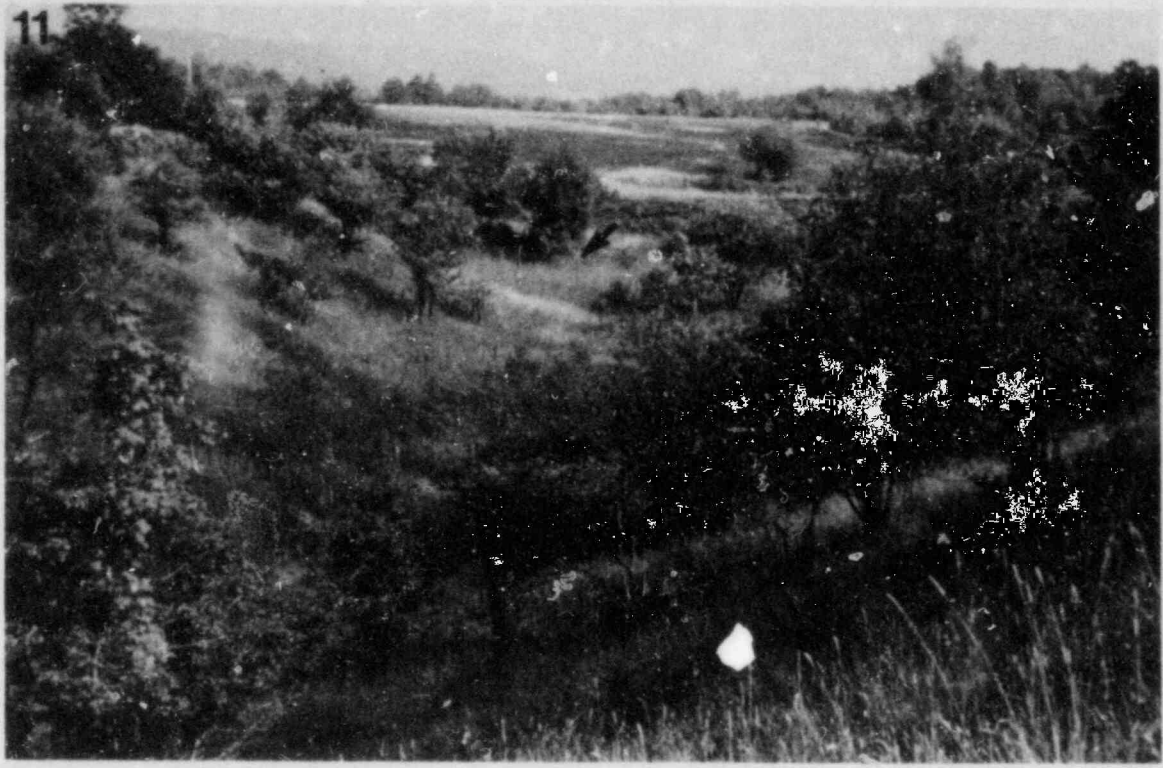
Figure 11. Erdman Brook valley morphology. Area shown is at cross-section (1) (Fig. 10). Arrow points to the NFS security fence.

zone from the flat (1) to the V-shape (2). In the V-shaped zone, it appears that valley widening is proceeding by parallel retreat of slopes.

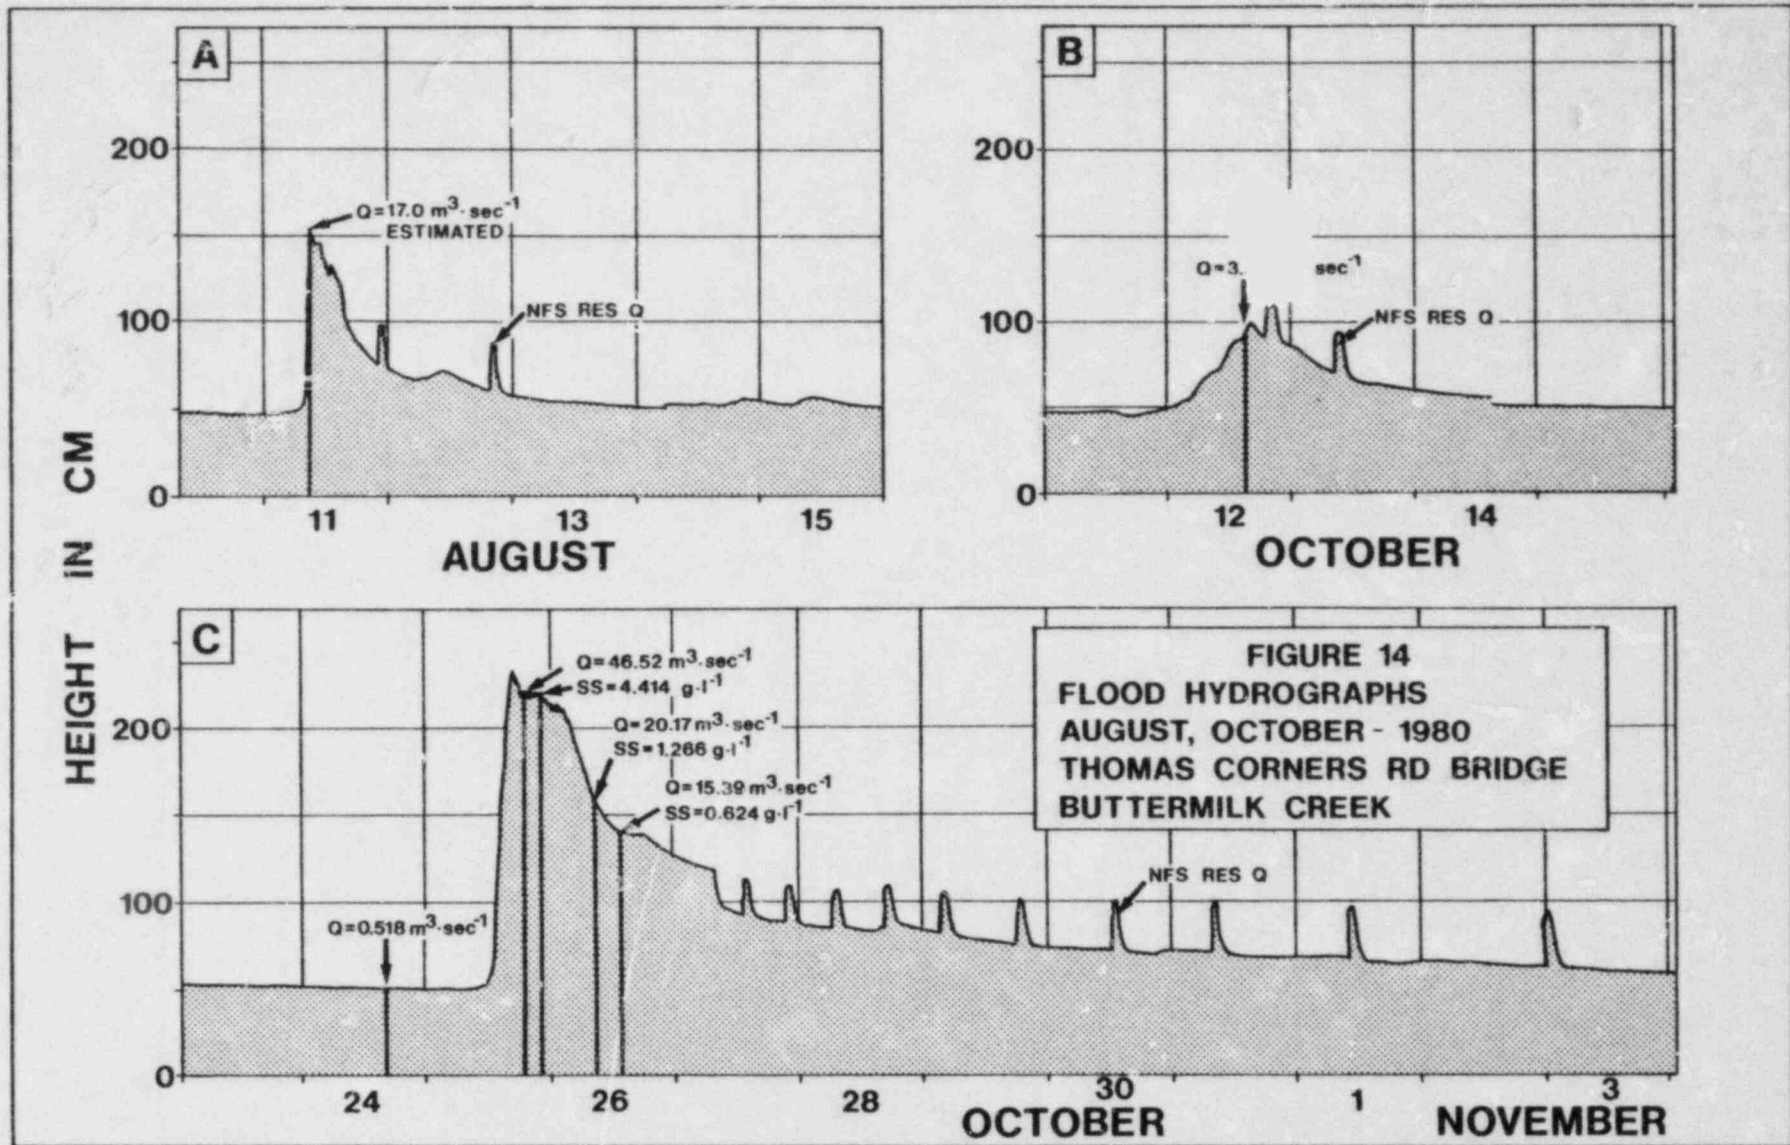
Figure 14. Stage-height records, Thomas Corners Road bridge (NYSGS), 1980.

- A. August 11, 1980 flood hydrograph. A moderate event with peak flow estimated at $17.0 \text{ m}^3\text{sec}^{-1}$. Movement of small clasts occurred on bar complex 4-6.
- B. October 12, 1980 flood hydrograph. A small event with a measured peak flow of $3.57 \text{ m}^3\text{sec}^{-1}$.
- C. October 25-26, 1980. A large flood event with peak flow estimated at $60 \text{ m}^3\text{sec}^{-1}$ (the first high spike). Times of discharge measurements and suspended sediment sampling are shown.

Selected stage-height records for the summer and fall of 1980 are shown in Figure 14. Velocity-area information and suspended sediment samples collected during the summer and fall period, and shown on the stage-discharge, suspended sediment concentration-discharge plot (Fig. 15 and Table 7). Regression lines were not computed for these data because there are too few readings to give a meaningful result. However, the stage-discharge plot can be used in a non-statistical, but geologically meaningful way to evaluate stage-heights for which there are no accompanying discharge data sets.

Flood Events - The hydrographs of three flood events are illustrated in Figure 14 and include a relatively low-discharge event (Oct. 12), a moderate event (Aug. 11), and a high-discharge event (Oct. 25-26). The moderate and high events show the "spikey" nature of the flooding as described by Boothroyd and others (1979), particularly the rapid rise in stage to peak flow in a matter of hours.

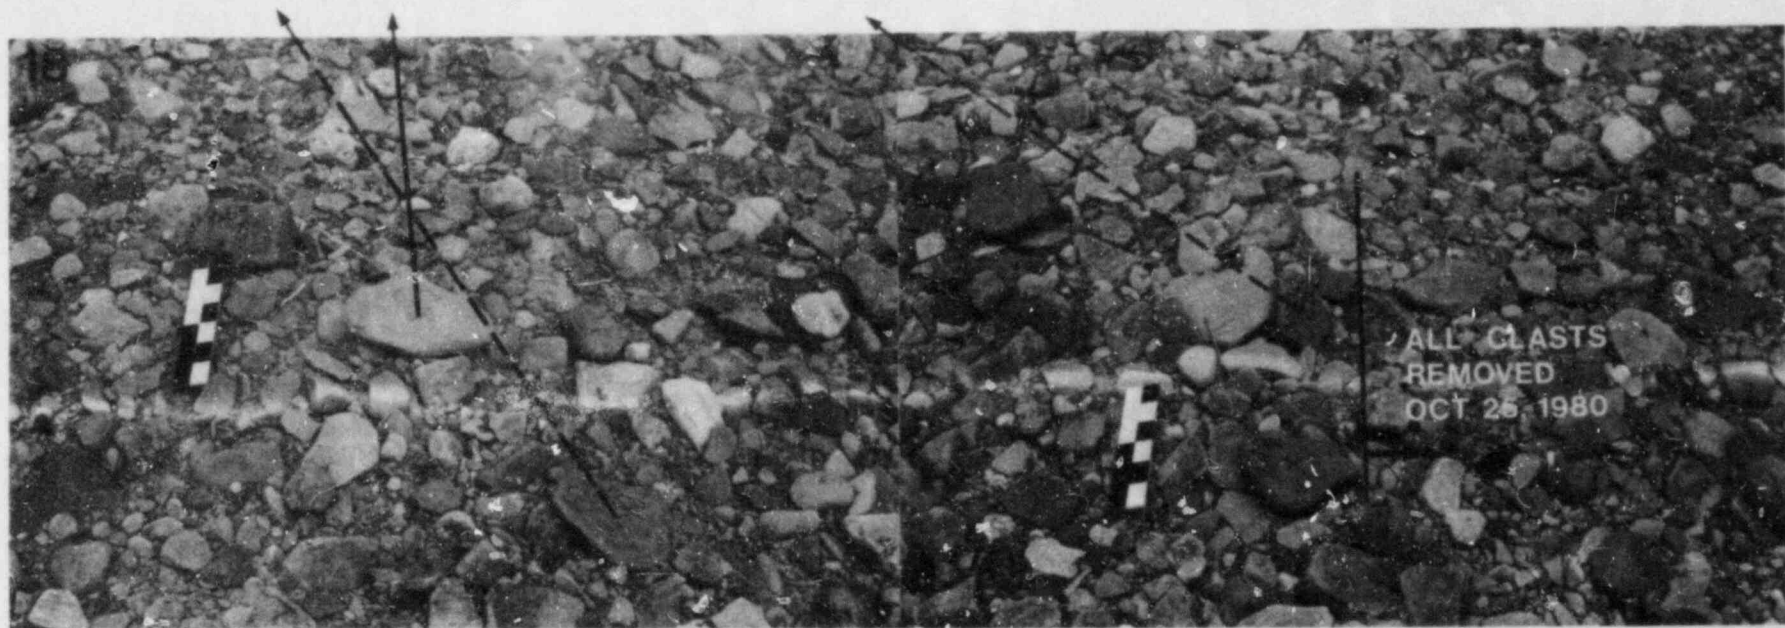
Figure 18. Clast movement station, transect 16, bar complex 4-6. The part of the line shown is on the shoulder of the bar where maximum measured movement occurred on October 25-26, 1980. Markings as in Figure 17; view is downstream, before movement occurred. Selected trajectories are shown. Scale is 30 cm.

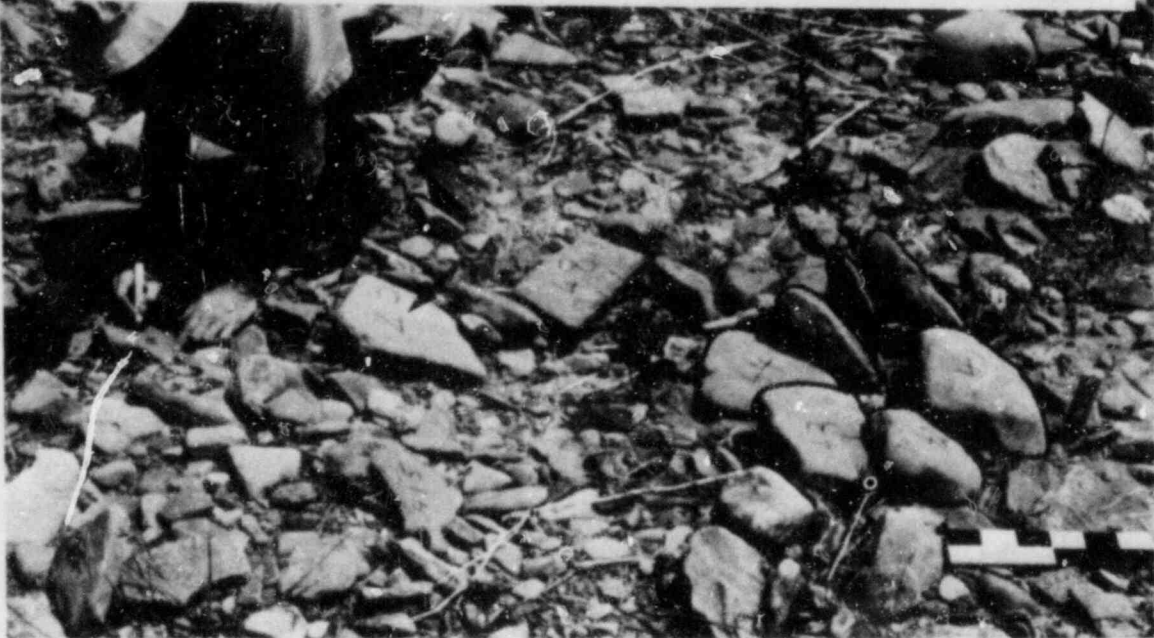
19A 1978 clast movement station (transect 8-9) recovered in 1980. View in 1978. Note the tightly-grouped, imbricated clasts (outlined), and the location of clast 49 (arrow) (from Boothroyd and others, 1979), Fig. 14). Downstream is to the left.

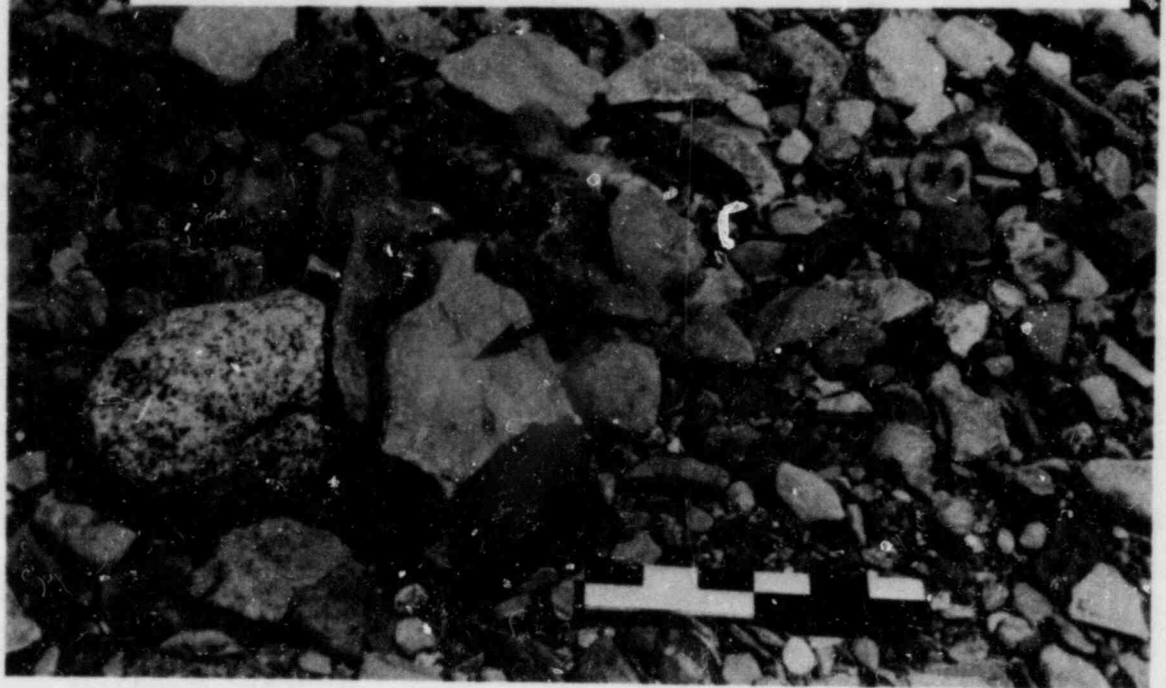
19C

Clast 49 (arrow) relocated downstream of transect 11, on the high point of a new transverse bar (see Fig. 3 and Plate 4 for location). Downstream is to the left. Scale is 30 cm.

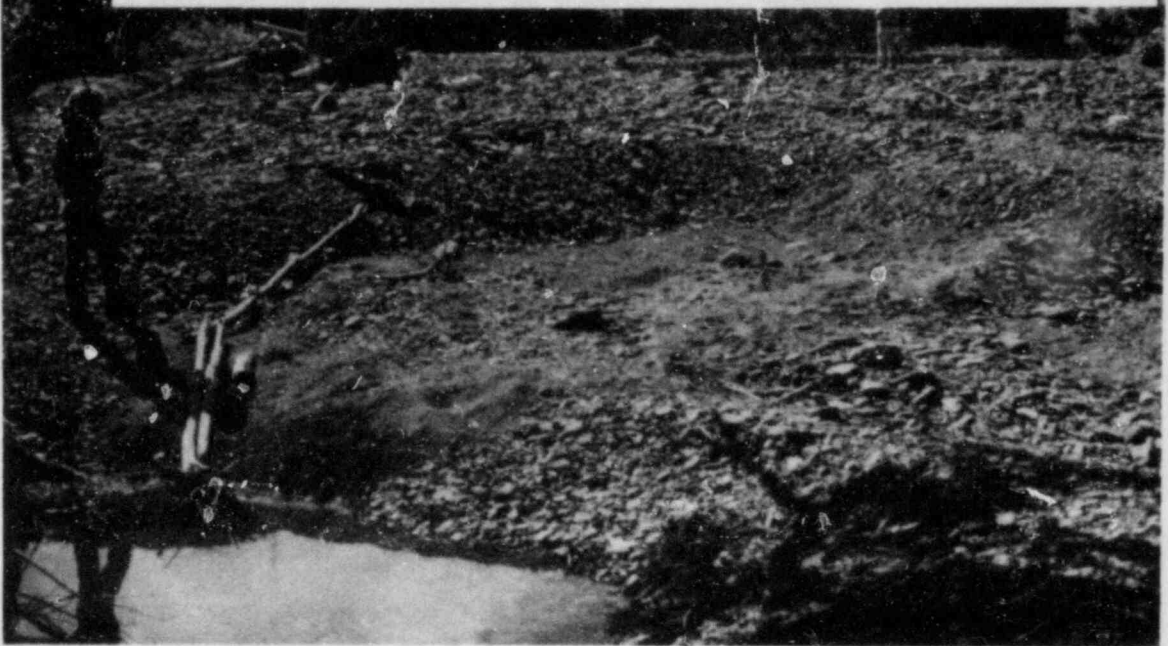
20A

Slipface of large transverse bar (arrow) located downstream of transect 11, bar complex 4-6. Maximum flow depth over the bar top was at least 85 cm as measured by debris in trees. See Figure 3 for more detail. View is upstream.

Figure 20. Hurricane Fredric bedload gravel transport.

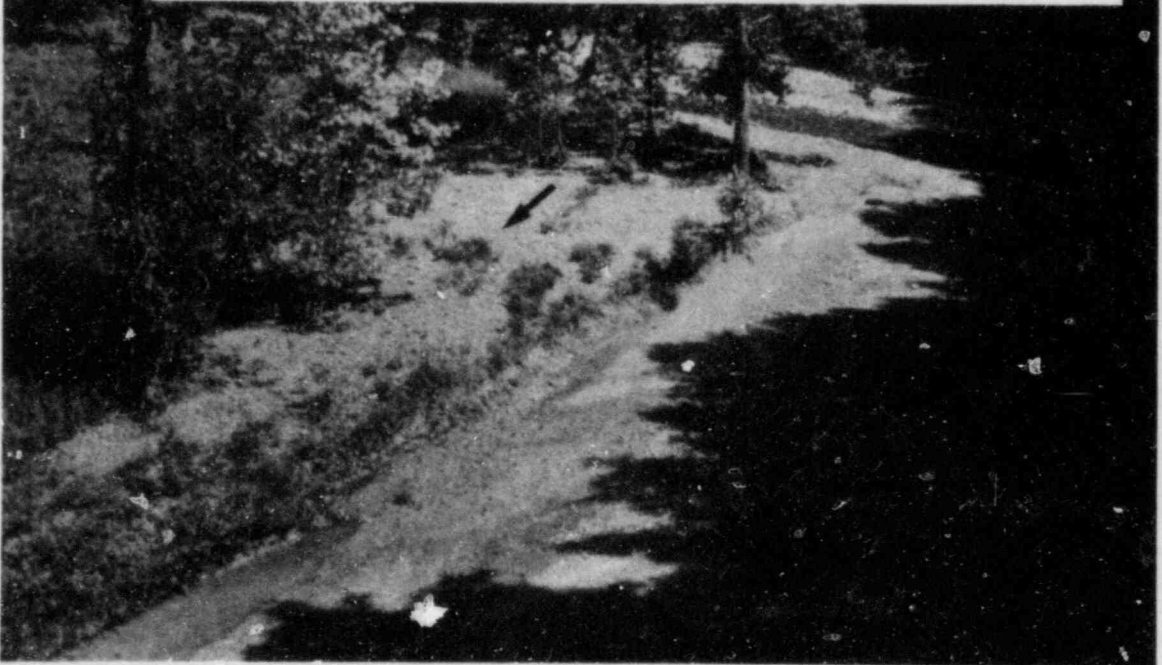
20B

Longitudinal bar complex (arrow) deposited on a low-active terrace at bar complex 25, just upstream of the Bond Road bridge. View is upstream.

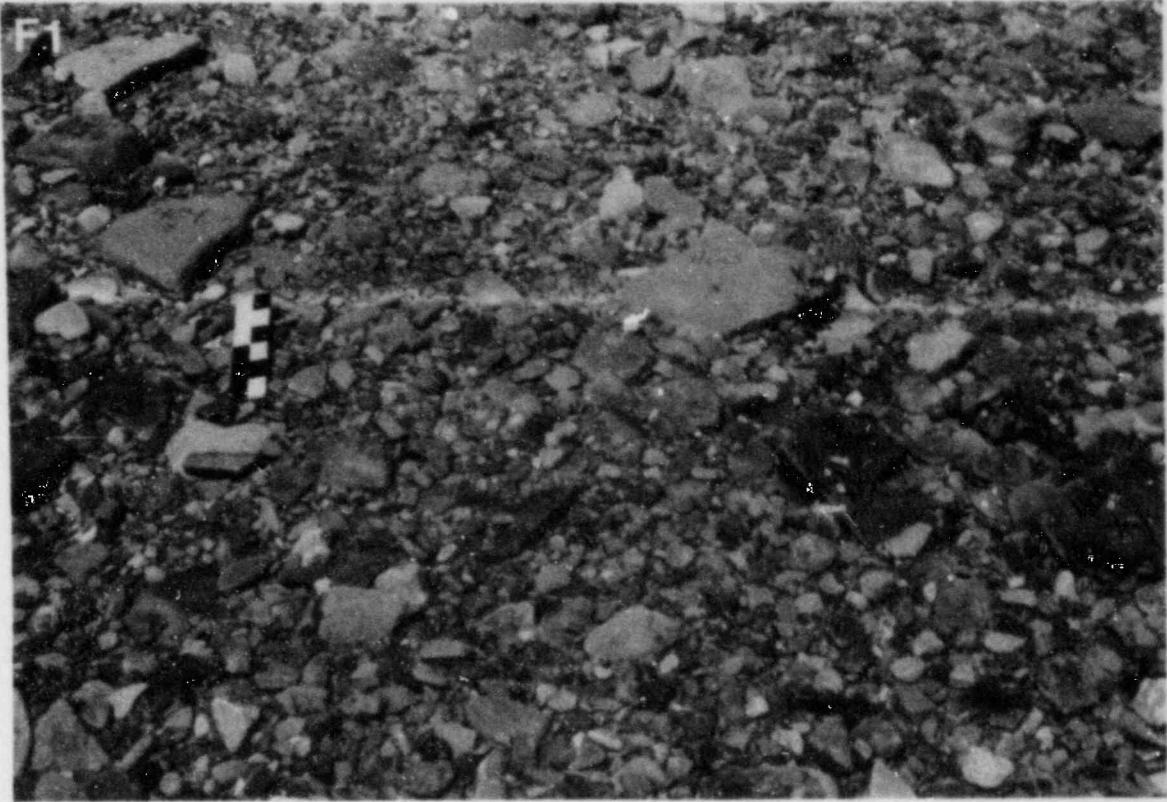
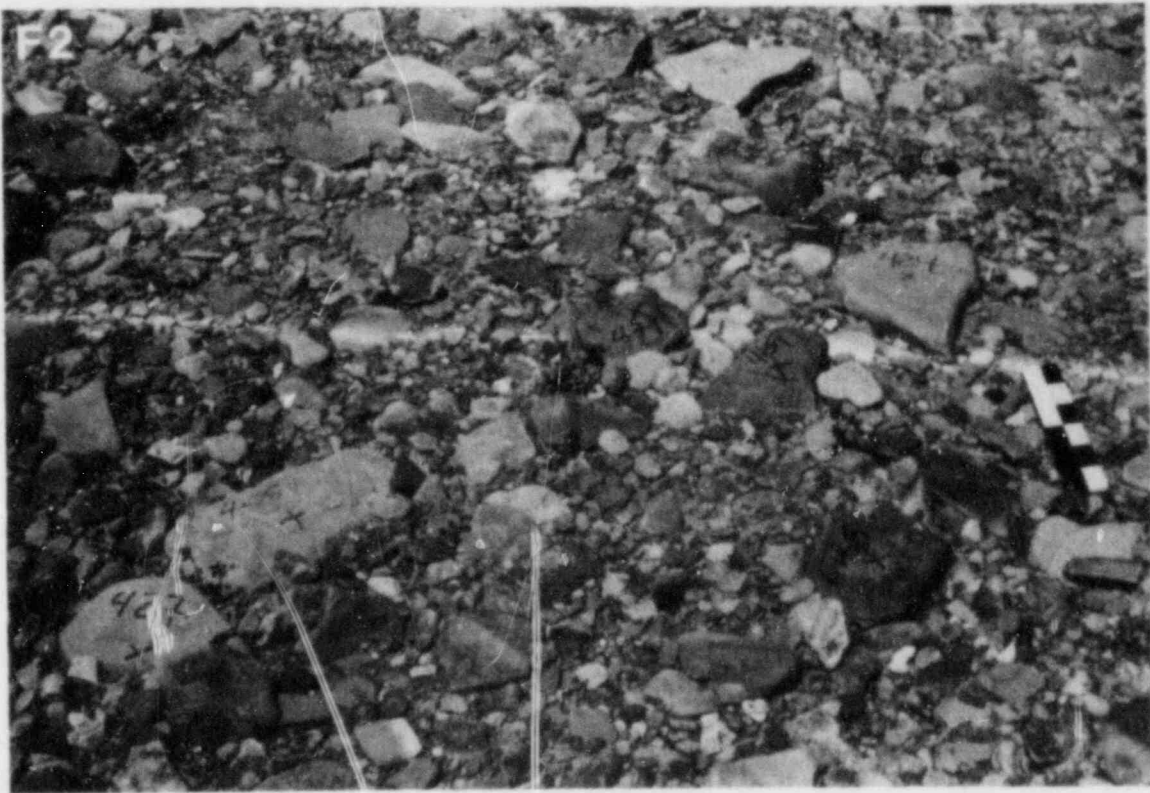
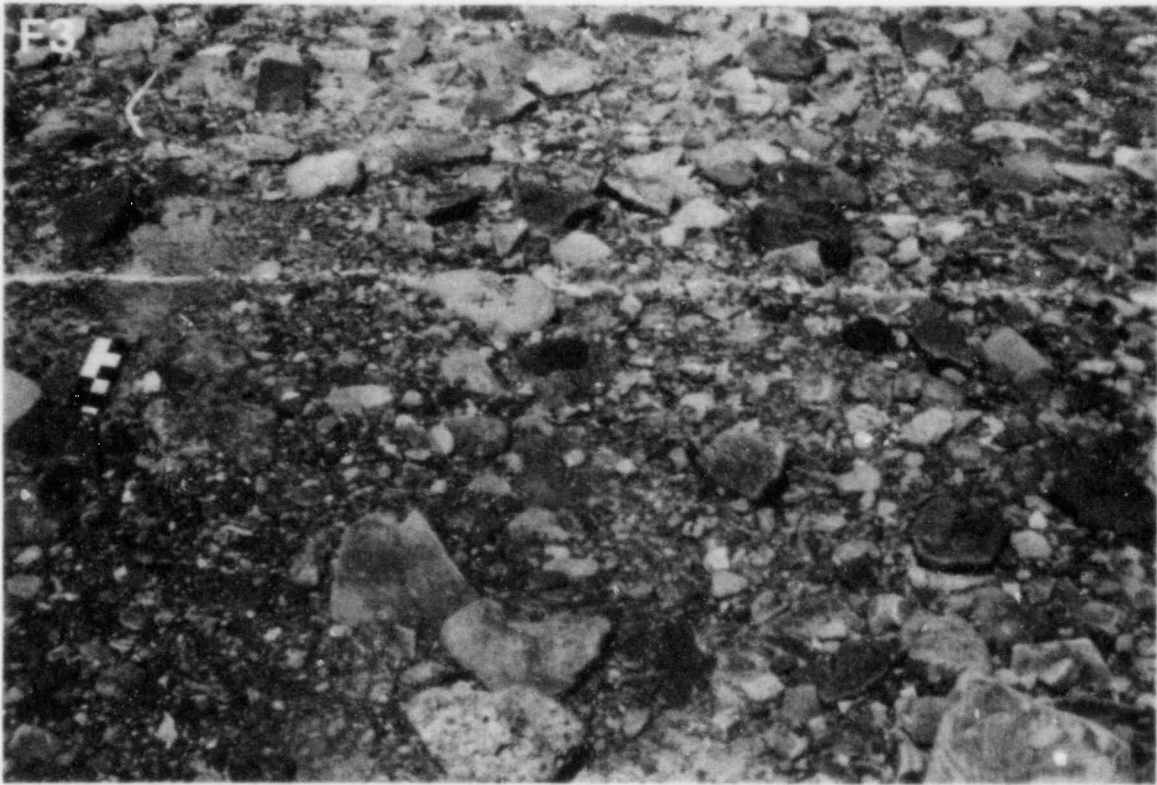
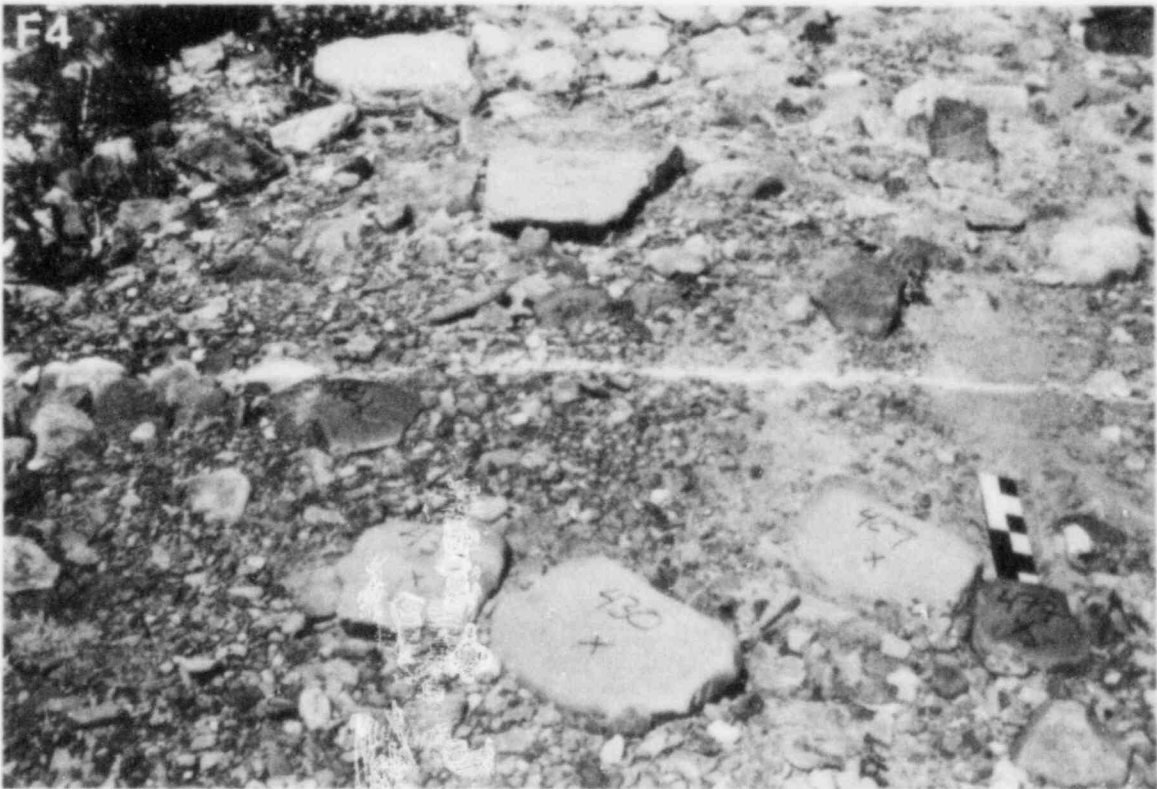
Figure F1-4. Bar top, east side.

Sequence is from east (F1) to west (F4). Large marked clasts are light gray (green), medium are dark gray (blue), and transect line is white (yellow). Photos taken July 15, 1980.
