AECL-8767

EXAMINATION OF GARTER SPRINGS  
FROM CANDU REACTORS

E.F. IBRAHIM

Chalk River Nuclear Laboratories

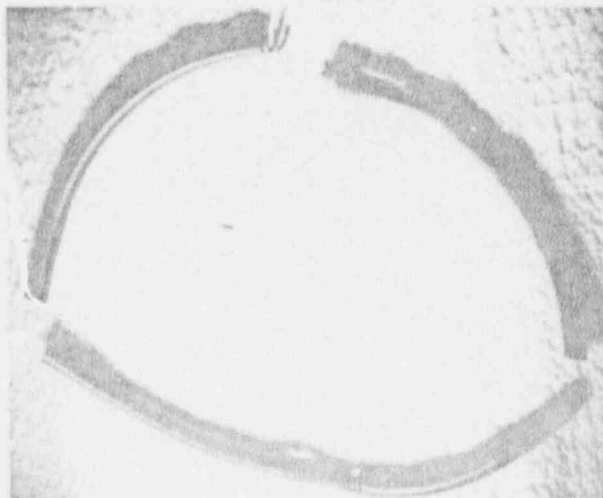
P1K18(2)

P1G16(2)

P2K13(1)

Figure 4.3 Examples of the different conditions that Pickering-A garter springs were received in at CRNL (12 years' operation).

Most of the garter springs received (~70%) were completely intact, i.e. unbroken and undeformed. Some garter springs were deformed and a few were broken and deformed. We believe that all the deformation and breakages were due to handling and shipping damage after service in the reactors (except for P2-G16). Most of the garter springs were shipped in the same cavity in the shipping flask as the pressure tube pieces, and one spring, P1-G16 [2], was jammed on the end of a pressure tube section; it was deformed but not broken. Figure 4.3 shows photographs of an undamaged spring, a deformed spring and a broken and deformed spring. A summary of the condition of the springs is given in Table 4.3. No hydride blisters were visible on any of the springs, and oxide appeared to be thin with different interference colours. The spring from B2-A14 showed the least signs of deformation at its fractures and photographs are shown in Figure 4.4. All other fractured springs showed much more deformation close to the fractures.
