CENTER FOR NUCLEAR WASTE REGULATORY ANALYSES

TRIP REPORT

SUBJECT: DOE-NRC Site Visit - Faults/Fractures near Yucca Mountain and Stratigraphy/Structure/Rock Properties along the ESF North Ramp (20-5702-425, 441, and 723 for Stirewalt; 20-5702-441 for Ferrill; 20-5702-641 and 642 for Ofoegbu)

DATE/PLACE: May 2-5, 1994 - Yucca Mountain and Vicinity

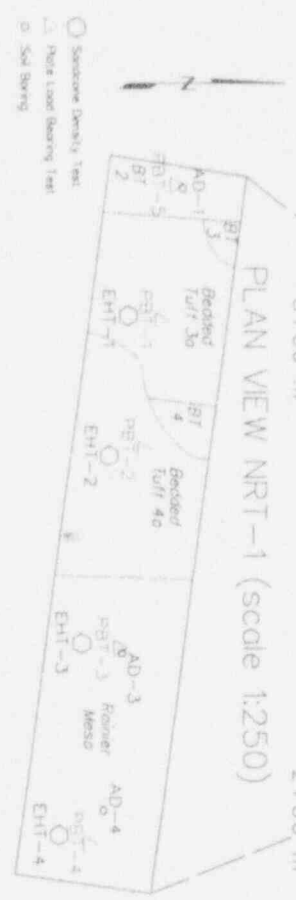
SECTION VIEW (scale 1:500)

PLAN VIEW NRT-1 (scale 1:250)

Four main paleosoil horizons were noted separating bedded tuff units in boreholes at the location of Trench NRT-1. Attachment 12 illustrates stratigraphy and locations of soil tests in the vicinity of this trench. Maintenance of cohesion is related to dryness of the materials, so D. Kessell cautioned that use of water during construction would need to be closely monitored. However, he did not anticipate that grout would be necessary to stabilize the walls of the ESF for use of the TBM.

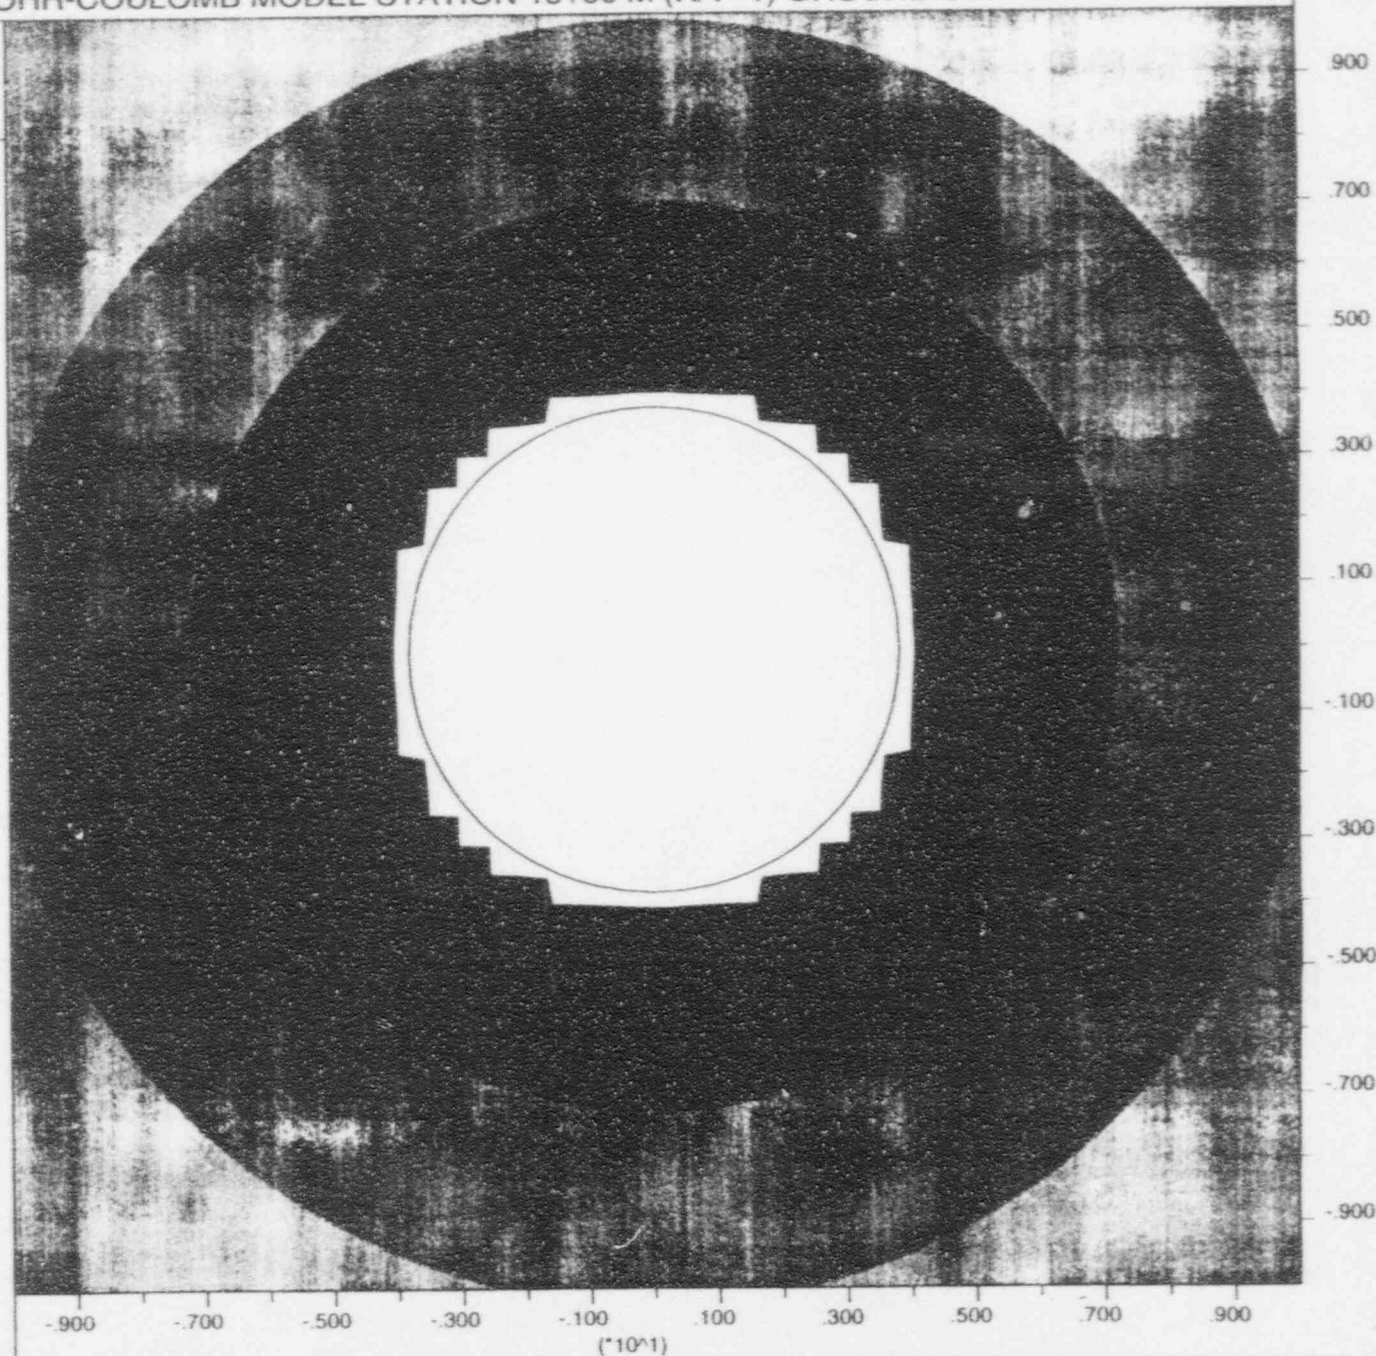
JOB TITLE : TS NORTH RAMP MOHR-COULOMB MODEL STATION 18+00 M (H/V=1) GROUND SUPPORT

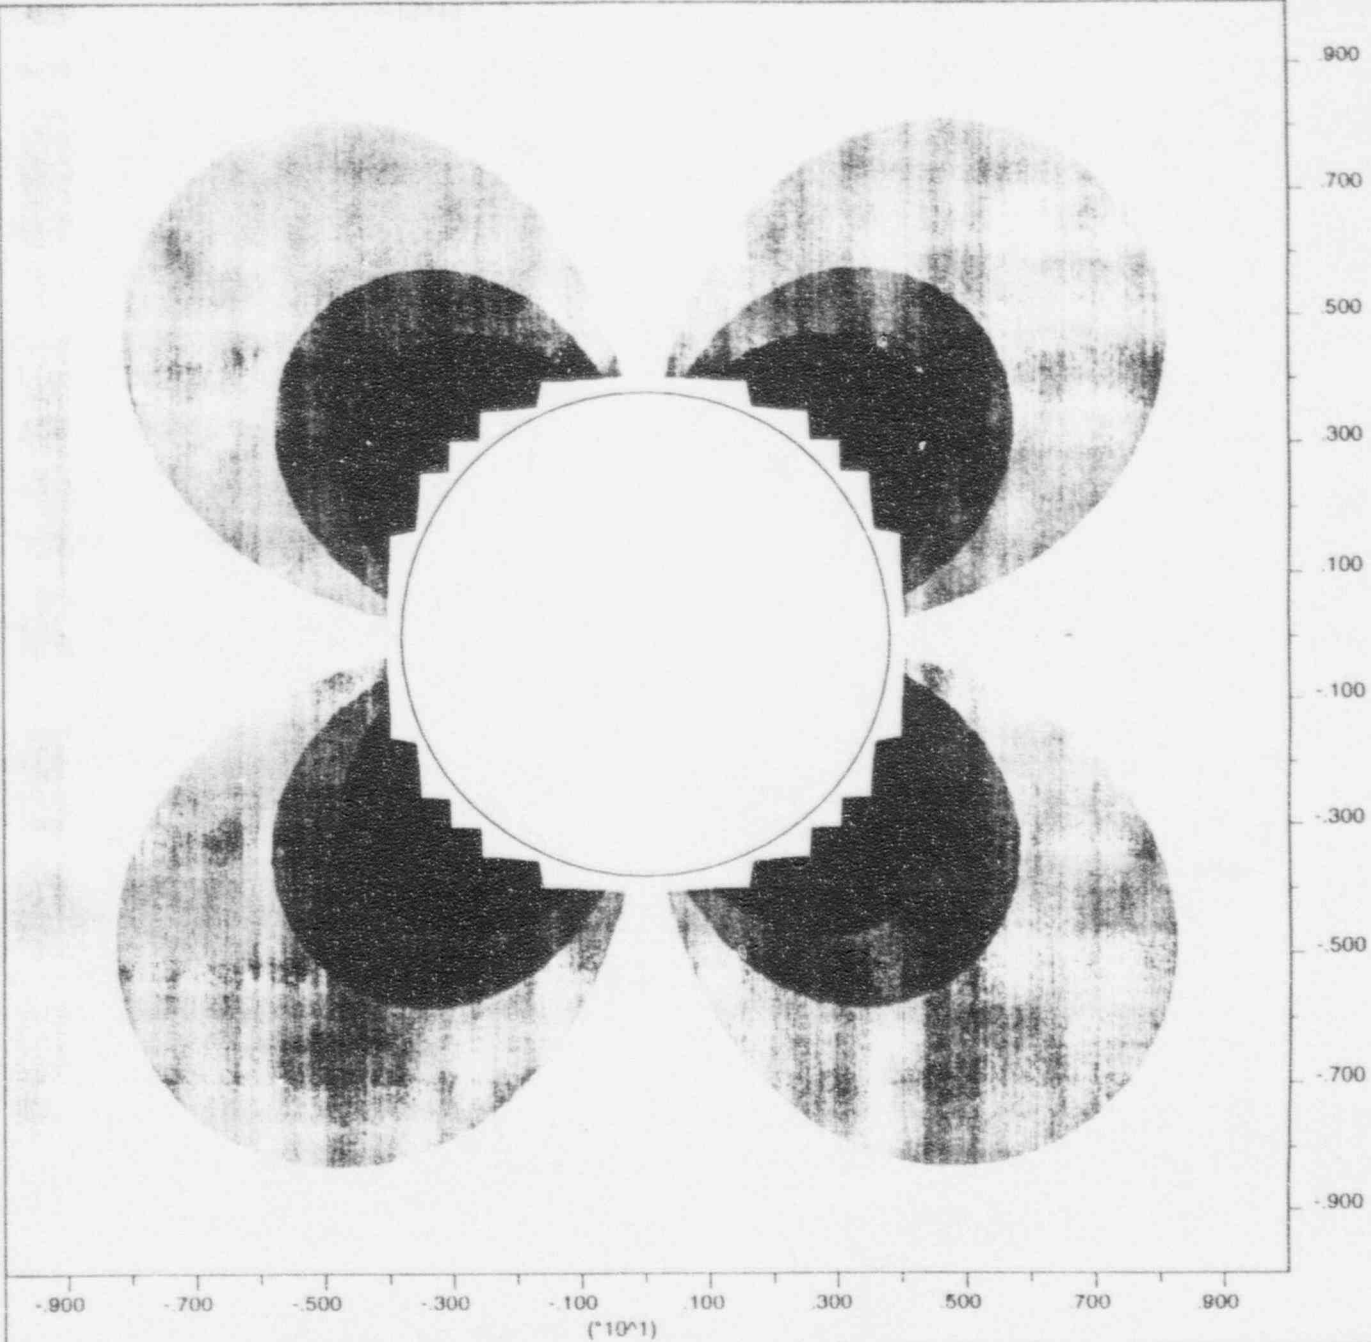
JOB TITLE : TS NORTH RAMP MOHR-COULOMB MODEL STATION 18+00 M (H/V=1) GROUND SUPPORT

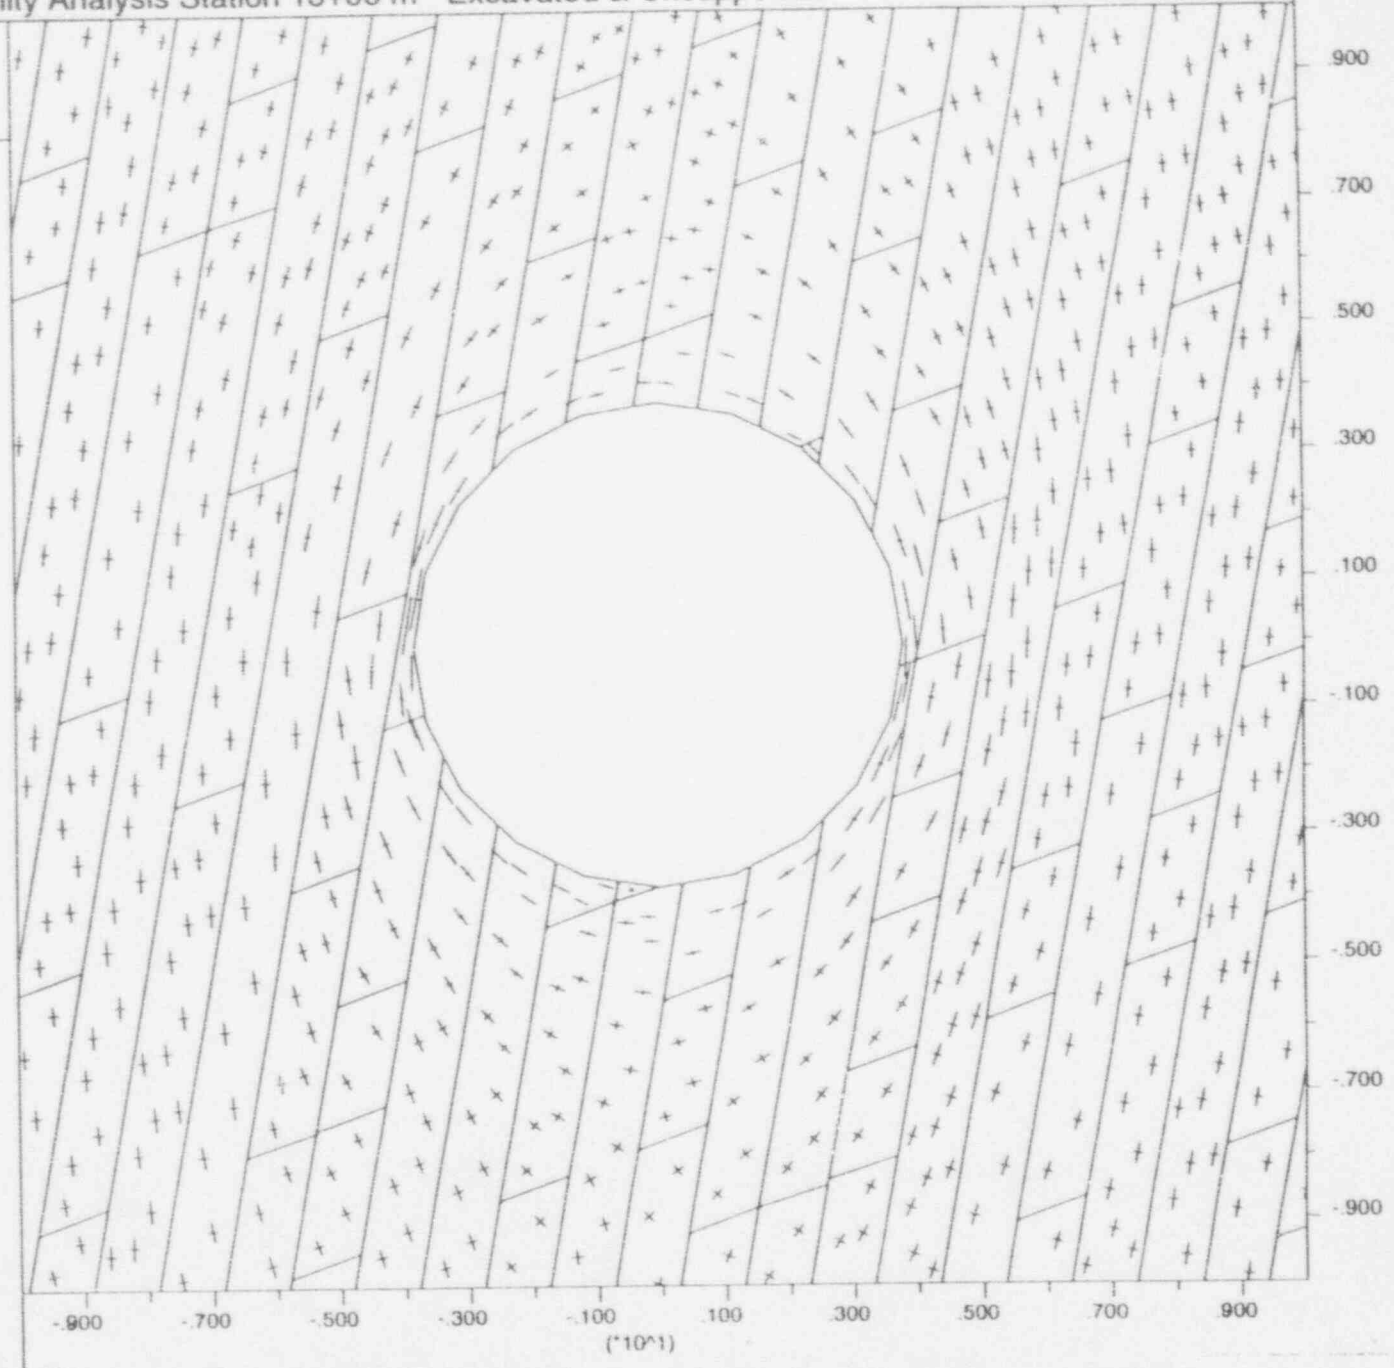
JOB TITLE : TS North Ramp Stability Analysis Station 18+00 m - Excavated & Unsupported

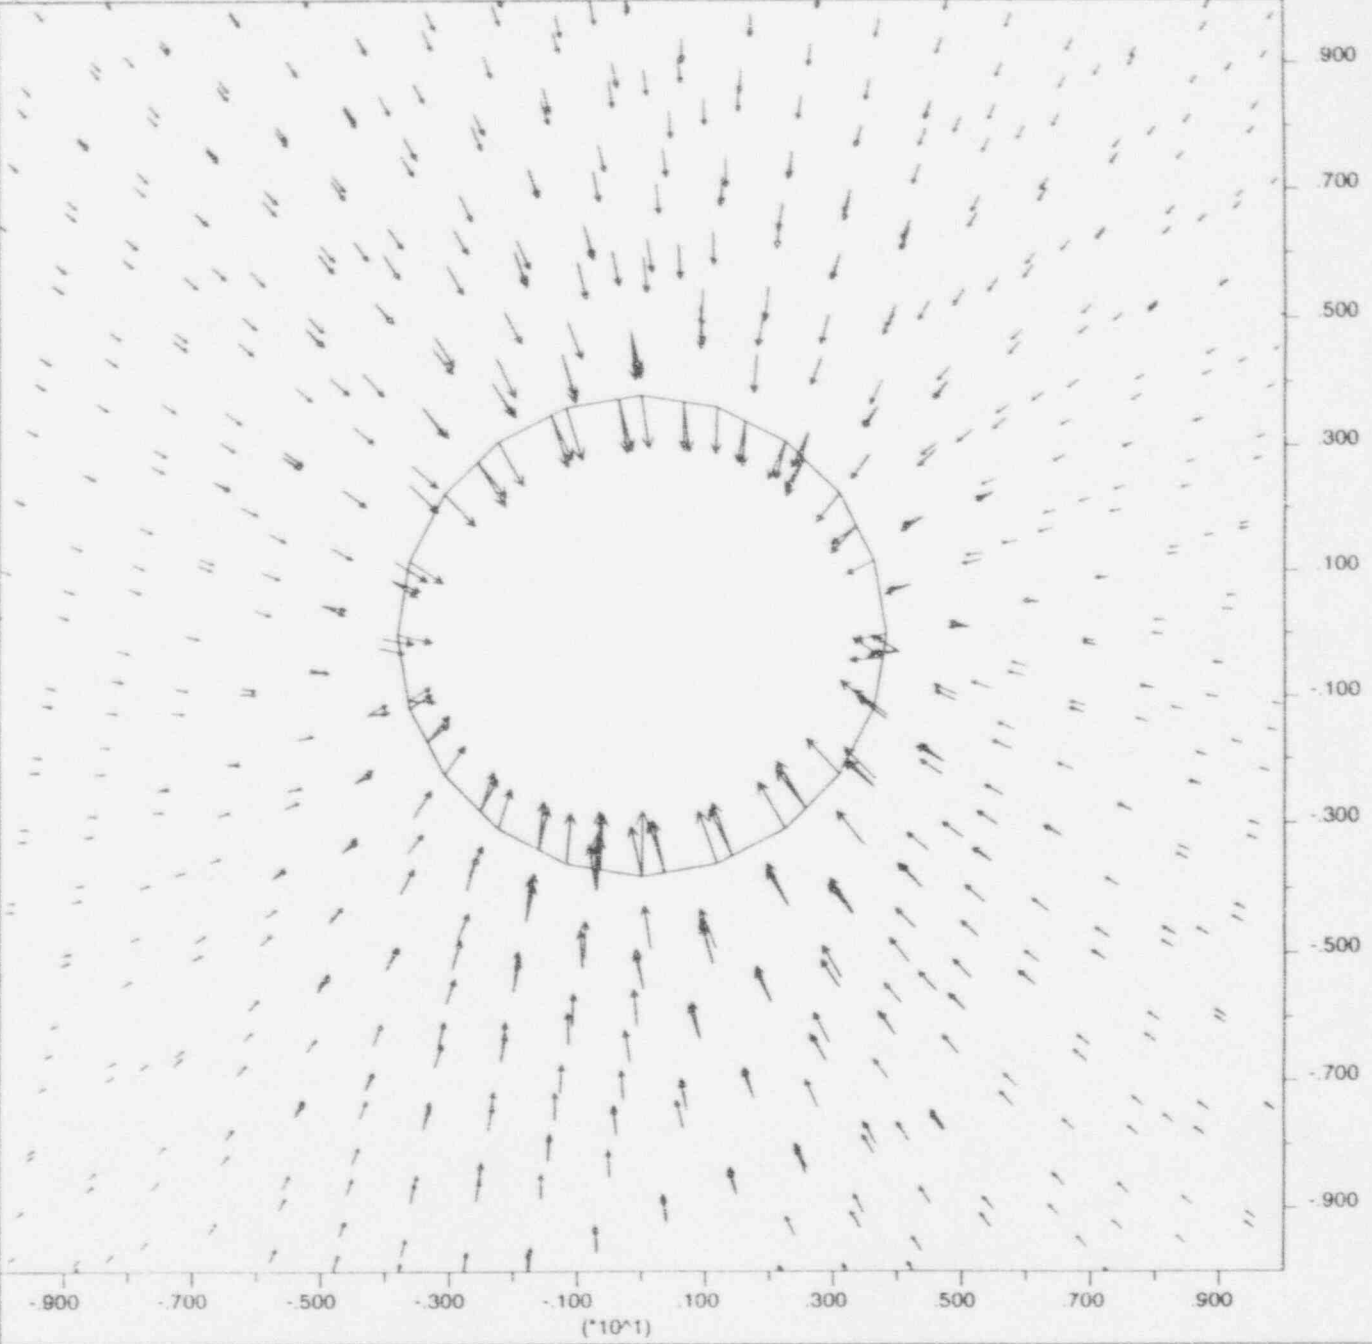
boundary plot
shear displacements on joints
max shear disp = 3.611E-04
each line thick = 7.222E-05

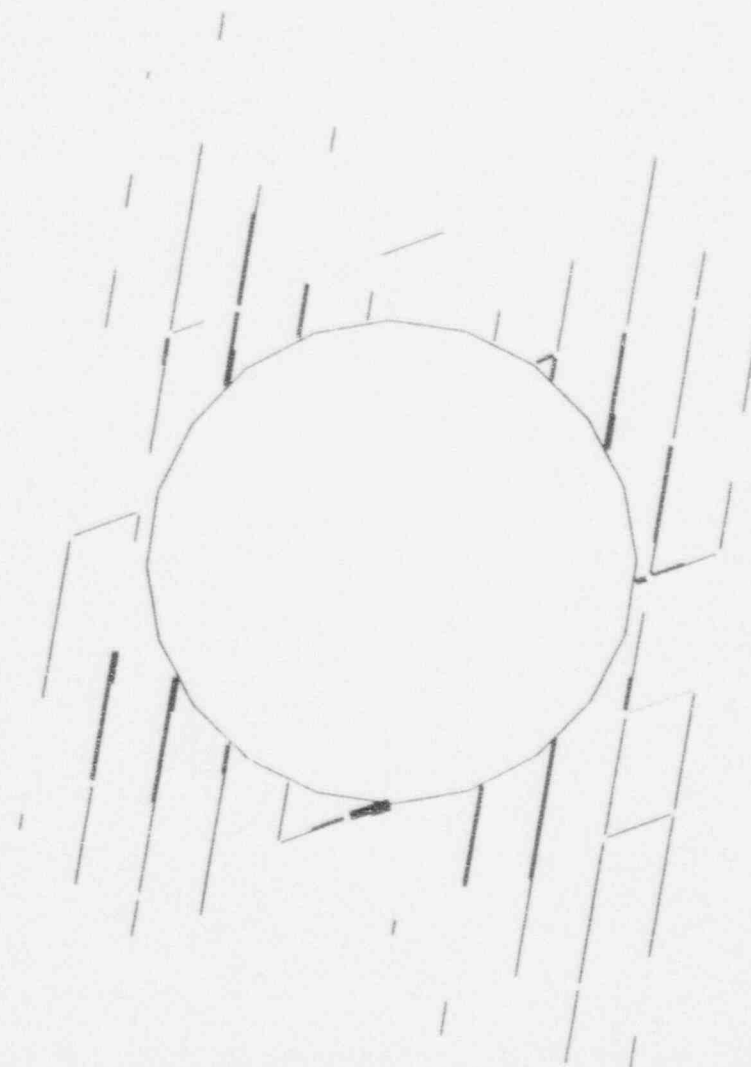
5/02/1994 14:58
cycle 6000
time 1.280E+00 sec
