CONSTRUCTION REPORT
SECOND PHASE
TAILINGS MANAGEMENT SYSTEM

White Mesa Uranium Project
Energy Fuels Nuclear, Inc.
March, 1983

SUA-1358, Docket 40-8681

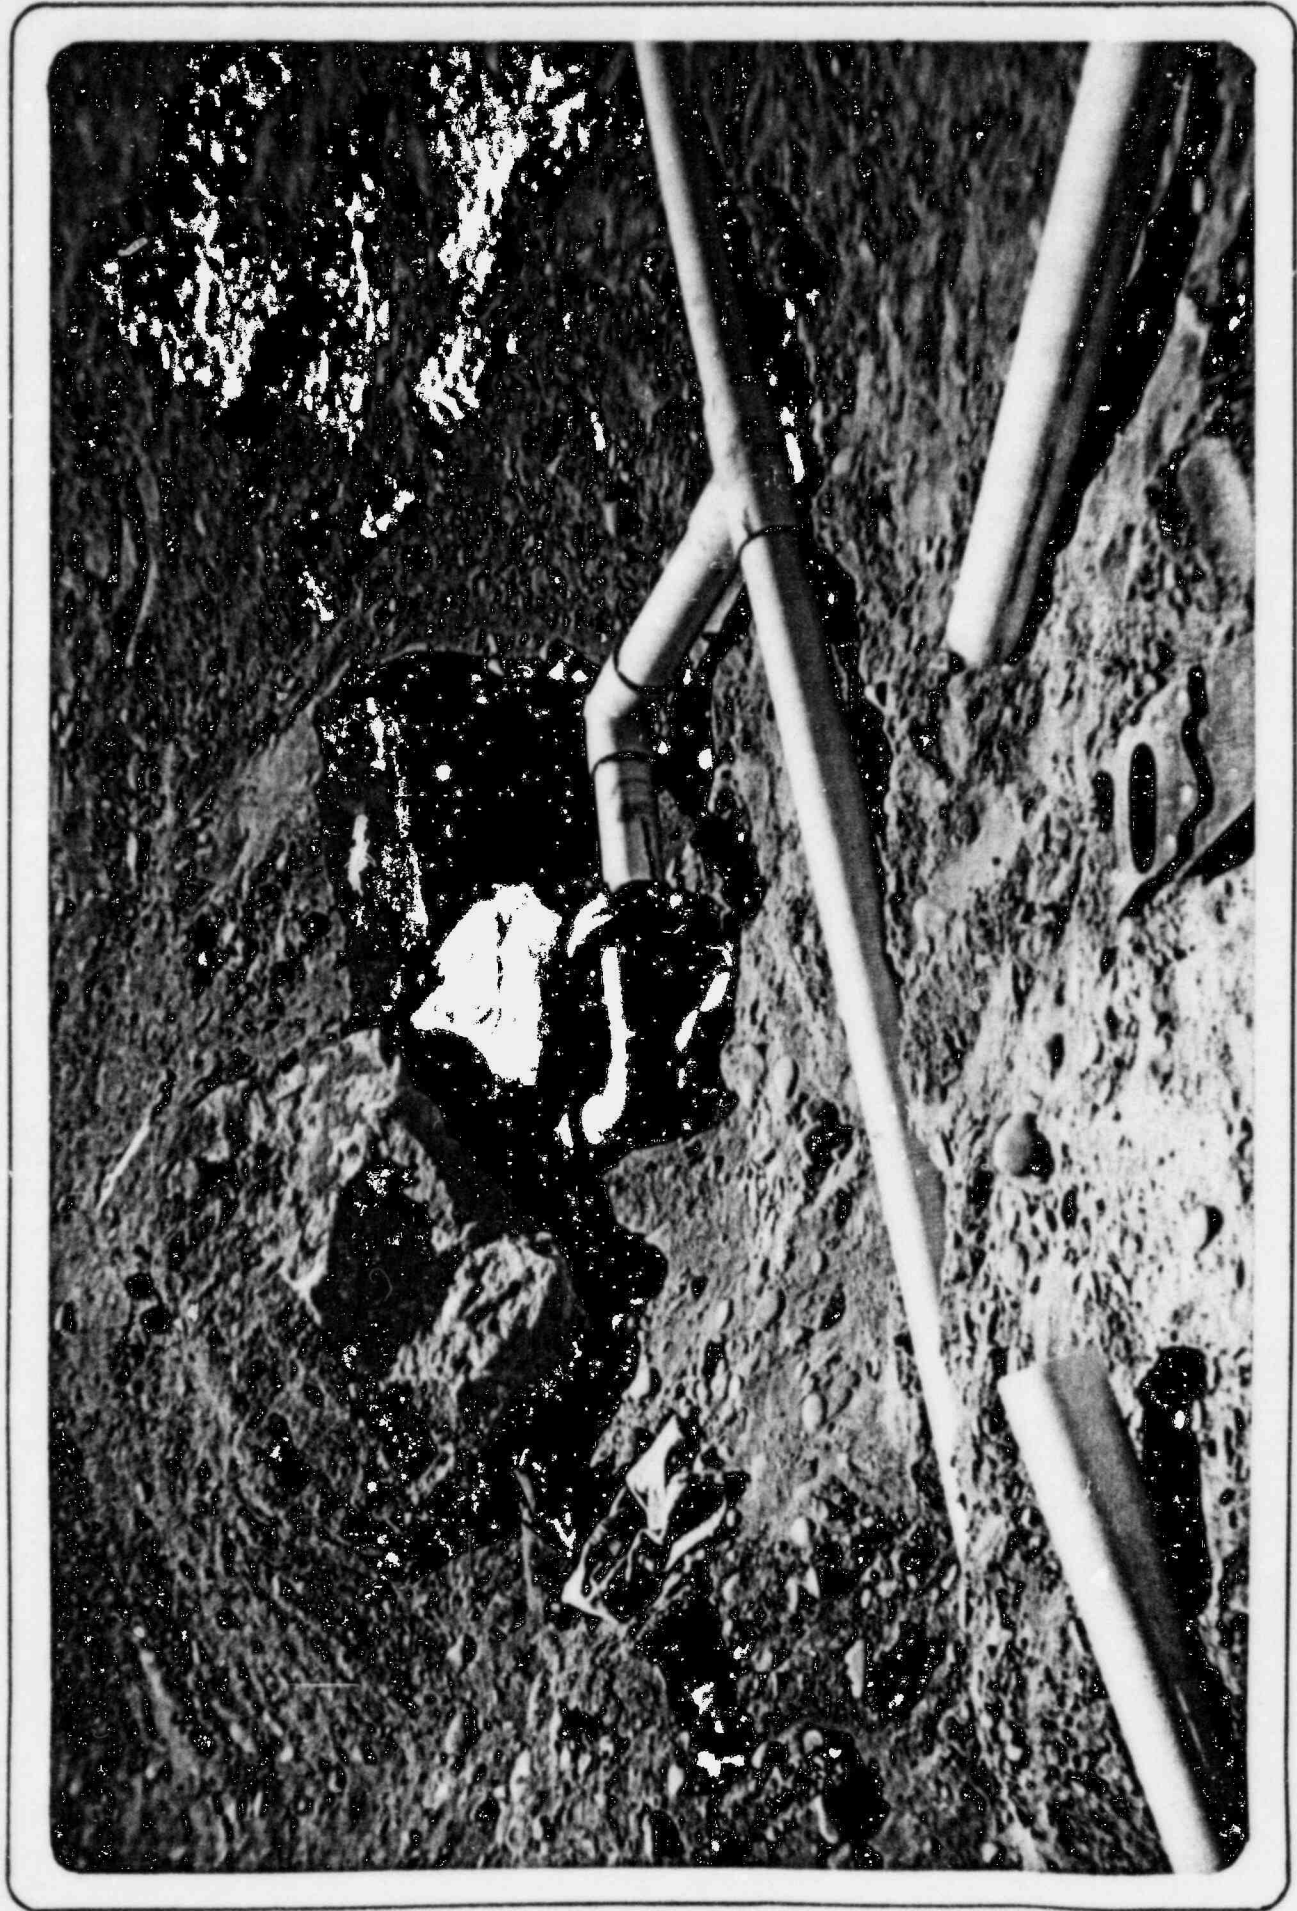
Cell 3 - Underdrain System, Final Piping Tie-in and Rock Stabilization

The three inch diameter PVC slotted pipe was installed at the toe of the upstream face of the Cell 3 Dike. At the lowest invert elevation of the drain pipe, a T-connection was installed and an extension to the access riser was made via an additional 90° bend and flanged connection. After the piping connections were complete, large rocks were hand-placed at the bottom of the access riser in order to stabilize the installation and avoid having the riser creep down the slope of the dam face. Project photos attached as Appendix E to this report show the installation and rock-fill operations for the underdrain system. Details are also provided on Figure 4, which shows changes made where piping connections were different than the original approved plans and specifications. All piping installation and connections were made prior to any liner installation.

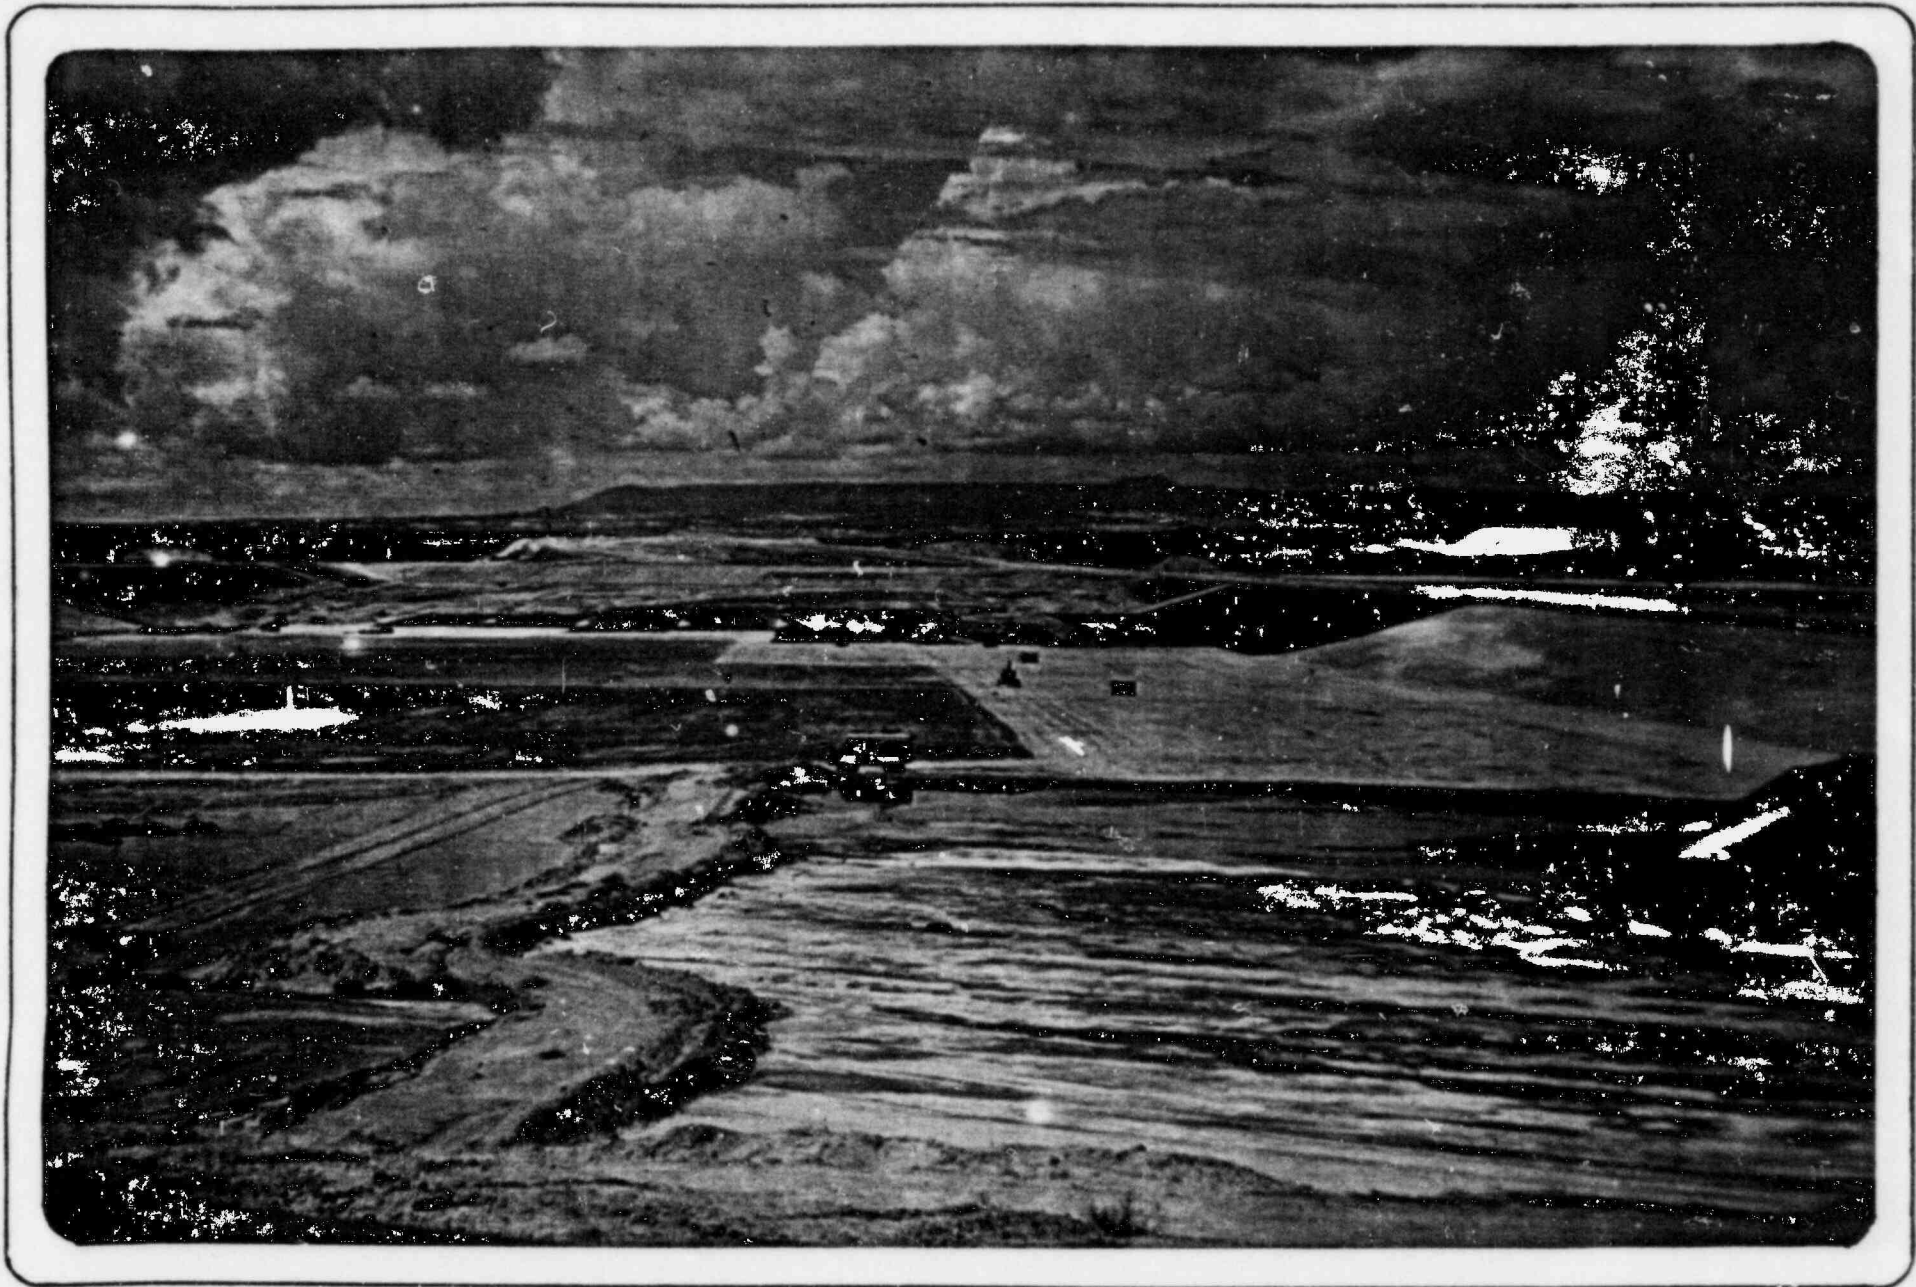
Cell 3 - Liner Installation, approximately 50% complete.
(Note storage area for dewatered tailings sands - lower
right)

As outlined in the Engineer's Report (D'Appolonia May, 1981), the liner cover was to be made up of dewatered tailings sands from the White Mesa Uranium Mill process. The dewatered tailings sands were obtained by the installation of a 24-inch Linatex Separator cyclone and the use of a stacking conveyor. The stacking conveyor was used in order to deposit the dewatered sands into the Cell 3 pond area and still allow for the overflow from the cyclone to drop directly into Cell 2. Due to the high slime content and low sand percentage contained in the ores being run through the White Mesa Mill during the summer of 1982, the quantity of dewatered sand material was not as great as originally hoped for. The dewatering operations were started during July, 1982 and progressed through September. During this period, sufficient quantities of sand were recovered to enable Energy Fuels to cover approximately 30% of the Cell bottom with the tailings sands and also allowed additional material for installation around the slimes drain piping network. In order to facilitate the storage of the dewatered sands prior to the actual Cell completion and lining operations, the northeast corner of Cell 3, covering an area of approximately 5 acres, was lined with PVC liner and the sands directly deposited in
