U.S. NUCLEAR REGULATORY COMMISSION  
REGION I

Report No. 040-09027/95-001  
Docket No. 040-09027  
License No. SMC-1562  
Licensee: Cabot Corporation  
Facility Name: Reading Pennsylvania Site

Inspection Summary: Confirmatory survey inspection on January 18 and 19, 1995  
(Inspection No. 040-09027/95-001).

Areas Inspected: Announced inspection limited to a confirmatory survey of the overhead and walls of the Main Processing Building at the licensee's Reading, Pennsylvania facility for residual uranium and thorium contamination prior to release of facility for unrestricted use. Eighty wipes were taken and assayed for removable uranium and thorium activity. The facility was surveyed and 160 direct readings were made to identify fixed surface contamination.

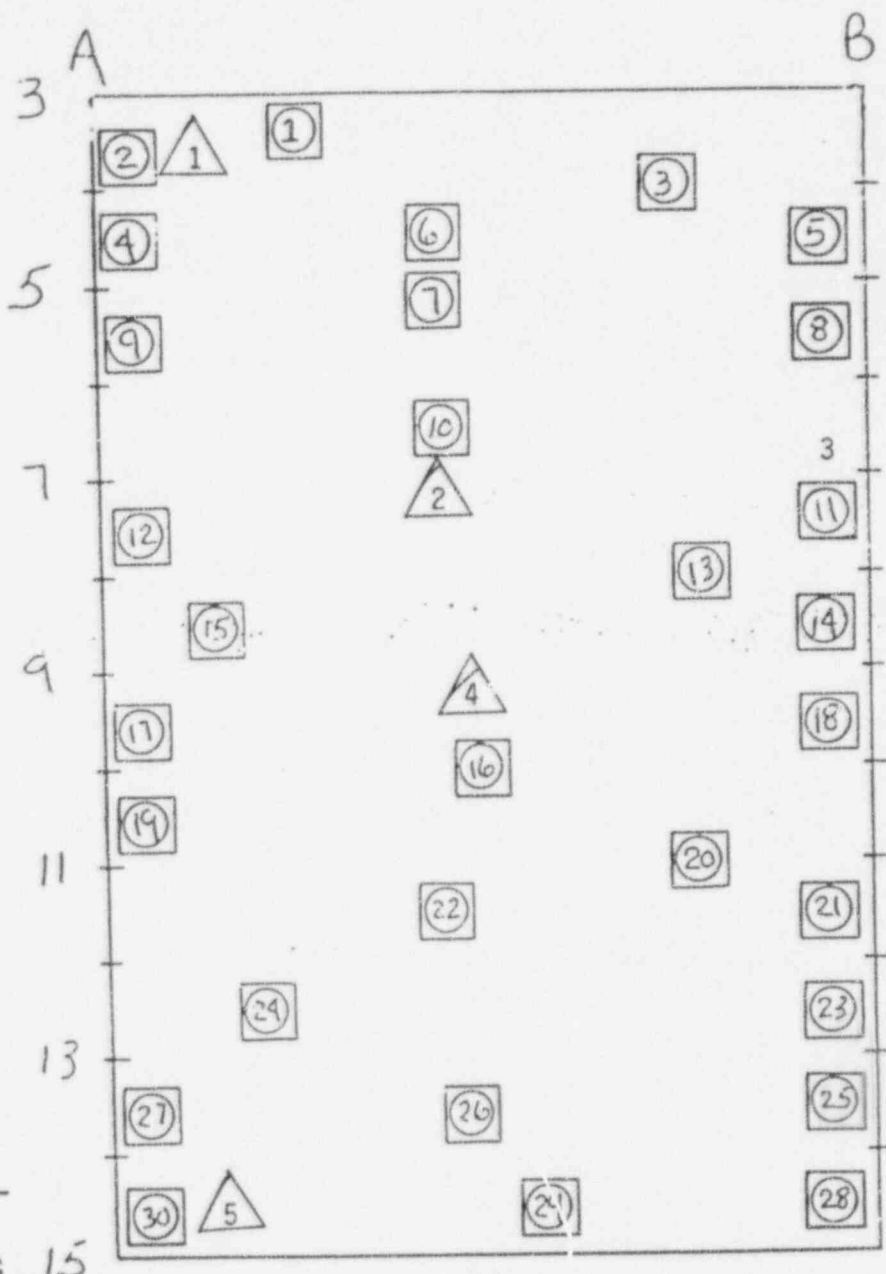
CEILING GRID # 20

<u>Wipe Number</u>	<u>Location</u>	<u>Alpha<sup>(1)</sup></u>	<u>Beta<sup>(1)</sup></u>	<u>Survey<sup>(2)</sup></u>
1	I-Beam	< LLD	< LLD	<586
2	I-Beam	< LLD	< LLD	<586
3	I-Beam	< LLD	< LLD	<586
4	I-Beam	< LLD	< LLD	<586
5	I-Beam	< LLD	< LLD	<586

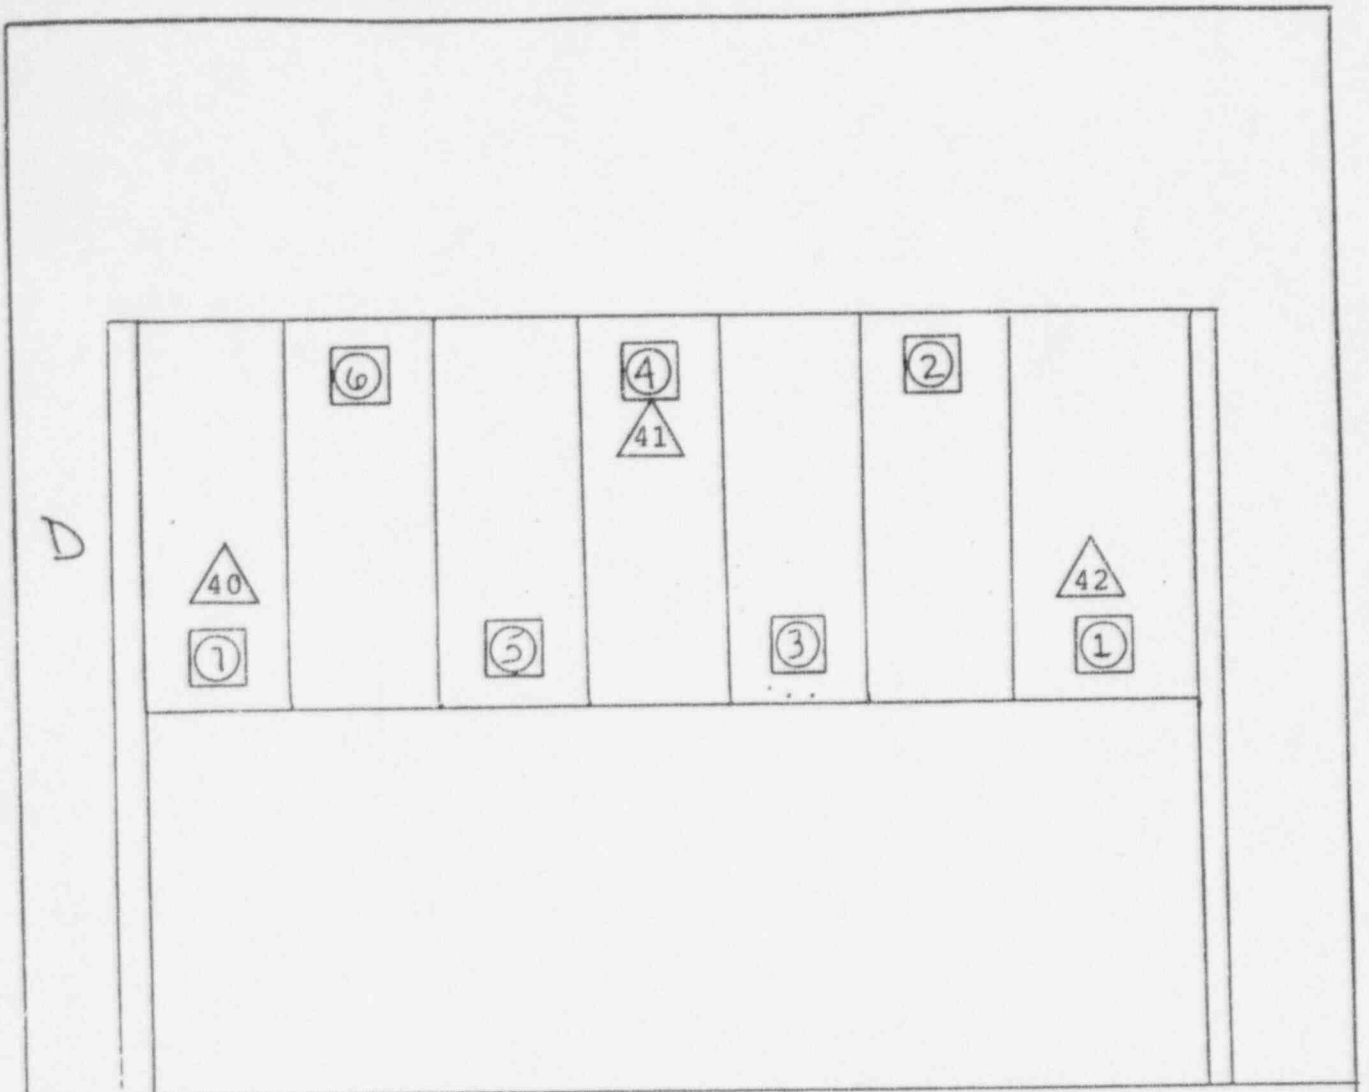
AFFECTED BEAM D 28-27

During the inspection, two locations with elevated surface contamination levels were identified by the inspectors. The two elevated contamination levels were located in affected areas previously surveyed by the licensee. Location # 41 was found to read 1,986 dpm/100cm<sup>2</sup> and location # 47 was found to read 1,458 dpm/100cm. The licensee promptly performed decontamination of these areas. The contaminated surface area identified in each case was less than one hundred square centimeters. The inspector re-surveyed the remediated areas and concluded that the licensee's decontamination efforts were successful in reducing the contamination to less than the average value in the Guidelines.

<u>Wipe Number</u>	<u>Location</u>	<u>Alpha<sup>(1)</sup></u>	<u>Beta<sup>(1)</sup></u>	<u>Survey<sup>(2)</sup></u>
40	I-Beam at NES survey point	< LLD	< LLD	<699
41	I-Beam at NES survey point	< LLD	8 ± 3	<699
42	I-Beam	< LLD	< LLD	<699
