MEMORANDUM FOR: William J. Dircks, Executive Director for Operations  
FROM: Raymond F. Fraley, Executive Director  
SUBJECT: BOLT FAILURES IN NUCLEAR POWER PLANTS

SUBJECT: BOLT FAILURES IN NUCLEAR POWER PLANTS

SUBJECT: CORROSION OF RCP STUDS

### PRIORITY SCORE FOR RCP STUD CORROSION

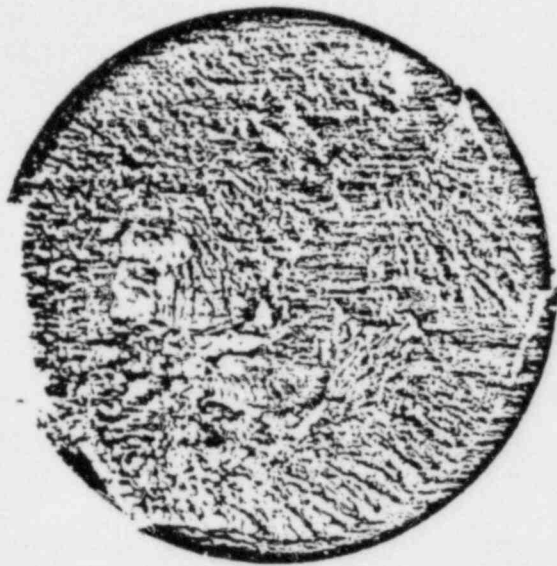
Figure 3-3. Views of Stud "A" After Tensile Testing.  
(Negatives 53497, 53499)

The conditions of three additional studs subsequent to tensile testing to determine remaining load bearing capability are shown in Figures 3-3, 3-4 and 3-5. These three studs had been cleaned at the site as part of the NDT program and were further cleaned on arrival at C-E to remove the residues from liquid penetrant testing. The

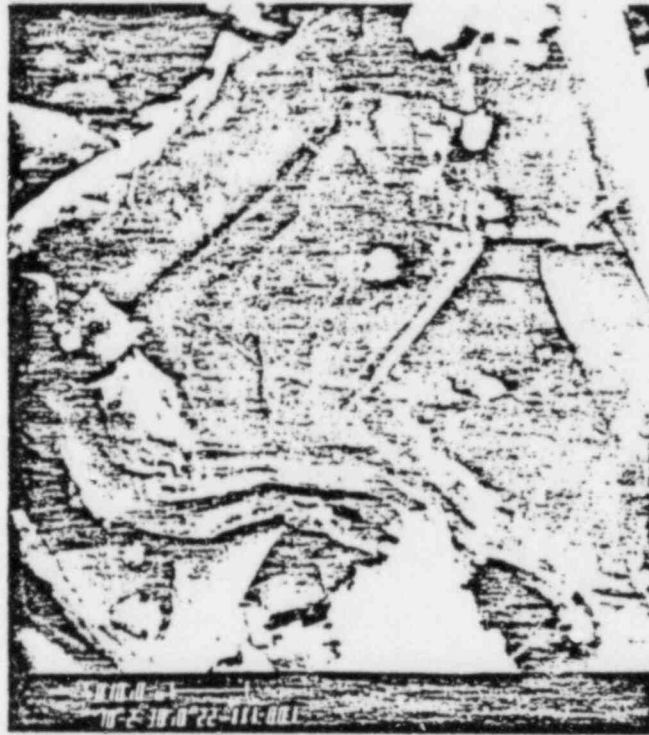
Figure 4-1. Scanning Electron Micrograph and EDS Results from Area 1 of the Failed Stud 4 Lubricant Scrapings.. (1000X)

The samples of lubricant scraped from the threaded regions of studs 4 and 11 were qualitatively analyzed to determine the elemental species present. The objective of these analyses was to determine if elements were present in the lubricant that are aggressive toward corrosion of alloy steel fastener materials. The instruments used in the analyses were a KEVEX 7000 energy dispersive spectrometer (EDS) and an ETEC wavelength dispersive spectrometer (WDS), both of which were coupled to an ETEC Autoscan scanning electron microscope. The EDS qualitatively indicates the presence of elements with atomic number 11 or greater (Na and above). However, because of the close proximity of two of the characteristic energy peaks for Mo and S, EDS cannot determine if S is present in a sample also containing Mo. The WDS can distinguish between Mo and S and was used for that purpose in this investigation.

<u>Scud</u>	<u>Area</u>	<u>Mo</u>	<u>S</u>
4	1	--	X
	2	--	X
11	1	X	X
	2	X	X

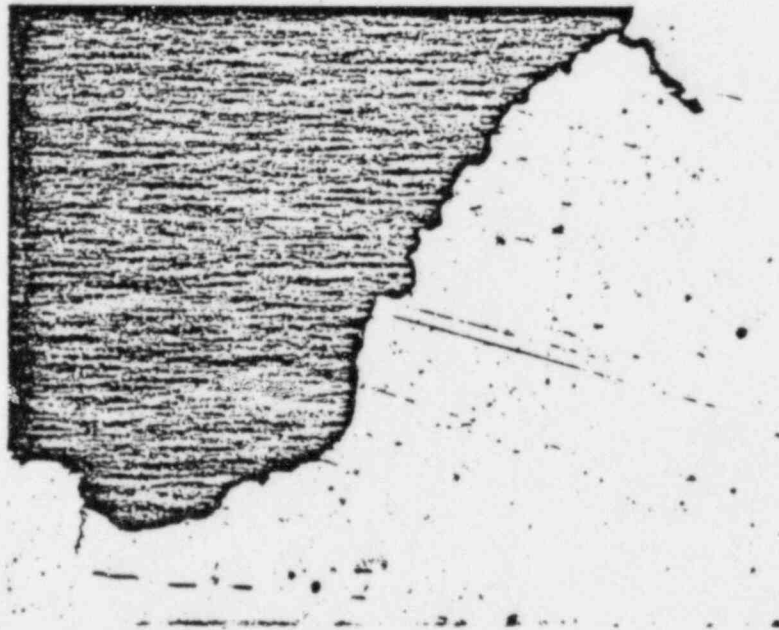
Figure 6-1. Cracks in the Root of a Thread in Failed Stud 4. (As-Polished, 100X)

Figure 6-1 to 6-3 are photomicrographs of part of one thread, including the thread root, of stud 4. This thread root was adjacent to the thread root from which the major failure crack originated. Two short cracks are evident in the figures; one of which originated near the thread root and one of which originated further up the flank. The higher magnification photomicrographs suggest the cracks followed prior austenite grain boundaries, at least over parts of their lengths. Even these short cracks show some crack branching, a phenomena usually associated with environmentally induced cracking. Corrosion product was present in the cracks.

Figure 6-1 also shows corrosion had occurred to the thread and thread root. The surface was irregular and numerous small oxide filled pits were present. Both cracks appeared to originate from the bottom of surface irregularities which may have been the result of the corrosion process.

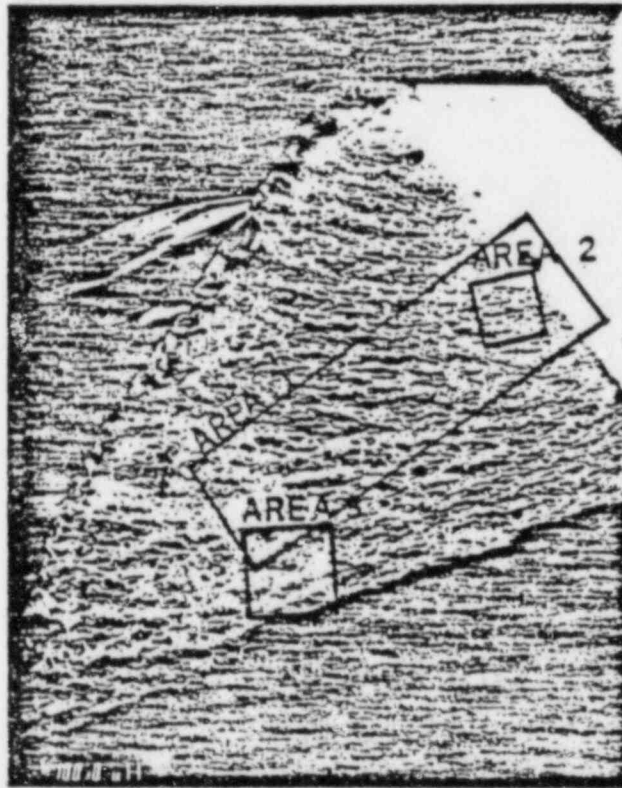
Figure 6-5 Low Magnification Scanning Electron Micrograph of a Section of the Crack Surface of Failed Stud 11 Showing Areas Examined at High Magnification. (10X, Negative 52792)

Figures 6-5 to 6-9 show surface features of the pie shaped segment. Figure 6-5 is a 10X scanning electron micrograph showing the sample and areas examined at high magnification. Figure 6-6 is a montage of three higher magnification (30X) SEMs. At this magnification, the most significant feature was the large number of secondary cracks in the crack surface. These are present from the outer periphery to the tip of the specimen as shown by closer examination of Figure 6-5 and Figure 6-8. Figure 6-7 shows ductile dimples present at the outer periphery of the specimen, which was the root of a thread. The secondary cracks are characteristic of environmentally induced cracking and the ductile dimples characteristic of a ductile overload failure.

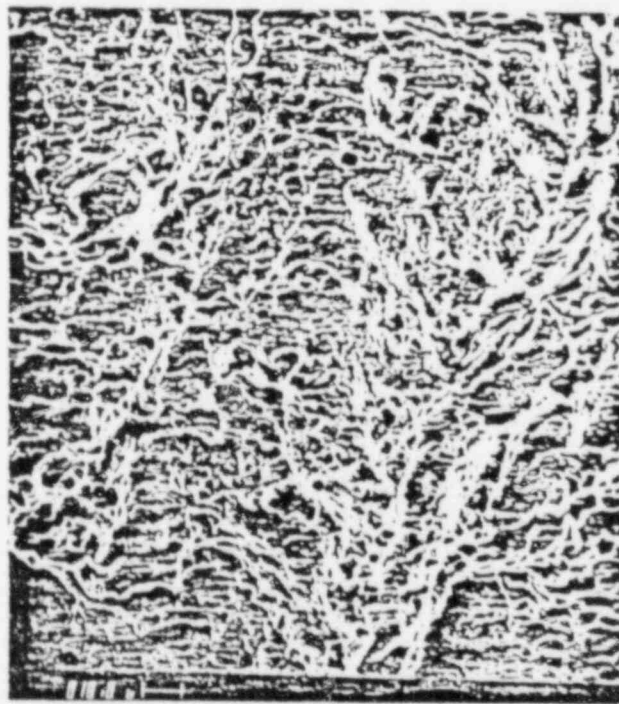
Figure 6-11. Scanning Electron Micrographs of the Central Ridge Region of Figure 6-10. (Negatives 53304, 53305, 53306)

Figures 6-10 to 6-14 are SEMs of the central area of stud 11. Figure 6-10 is a low magnification (10X) view of the central ridge running across the specimen and surrounding areas. The SEMs in Figure 6-11 are higher magnification SEMs of the central ridge and show ductile dimples. Figures 6-12 to 6-14 show no indications of ductile dimples but show indications similar to Figure 6-8. Also visible in these areas are numerous secondary cracks.

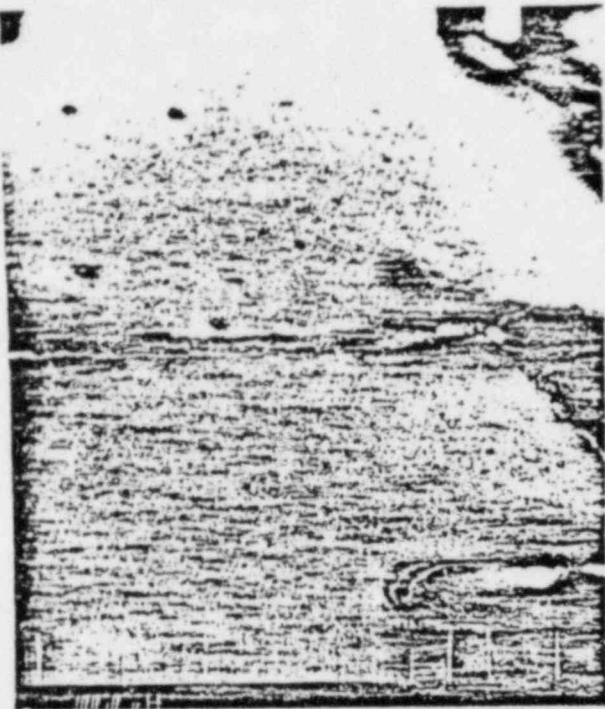
Figure 6-14. Scanning Electron Micrographs of Area 3 of Figure 6-10.  
(Negatives 53311, 53312)

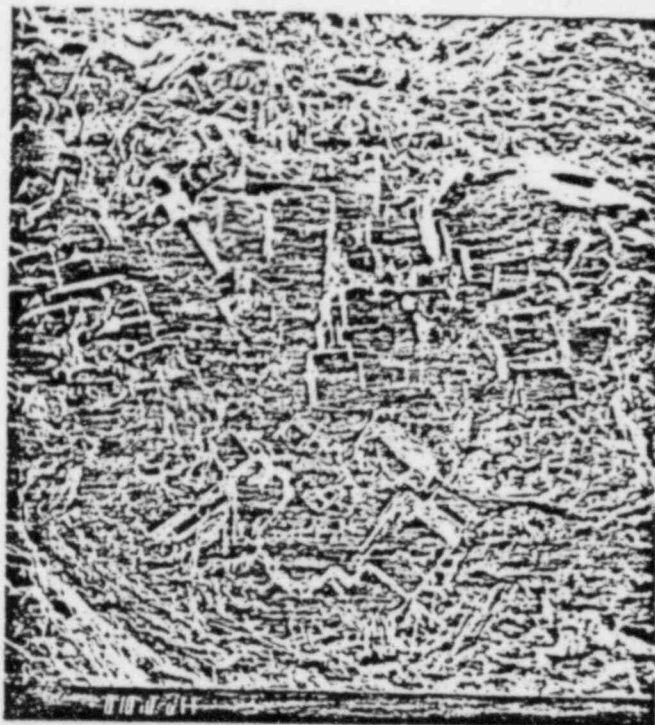
Figure 6-23. Higher Magnification SEM and EDS Analysis Results from Area 2 of Figure 6-22. (100X, Negative #53335)

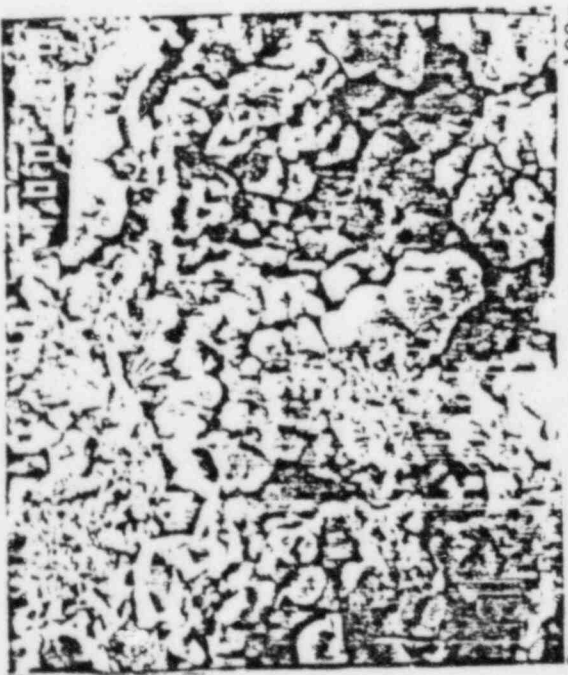
100x  
Figure 9. SEM photograph of "nodular" oxide.

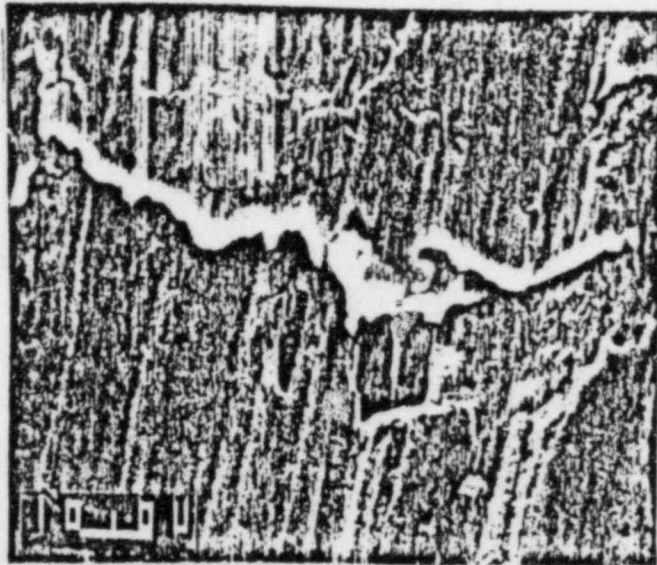
Figure 14. SEM photo of base material area scanned.

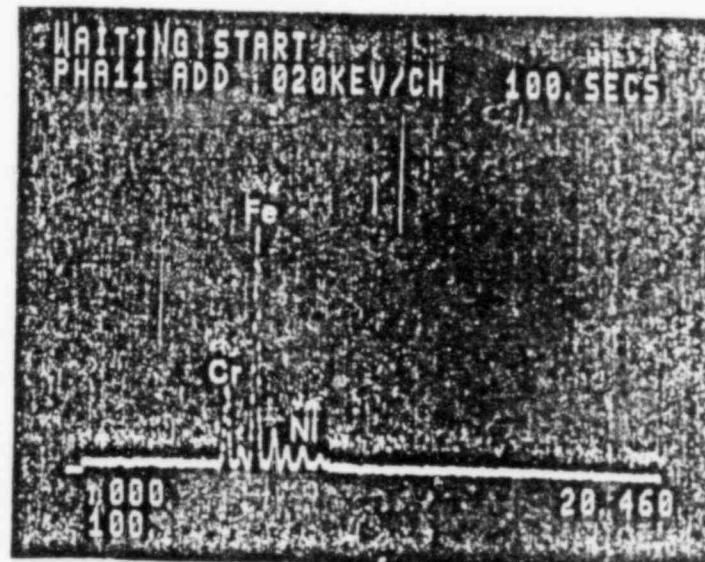
Figure 19. Constituents of second fibrous particle scanned by EDS.

Various particles and areas of apparent material smearing were scanned for constituents using EDS. The first particle scanned from stud No. 2C6 was fibrous in appearance (Figures 16 & 17) and had quite high peaks of silicon and nickel in relation to the Fe alloy background. The scan also showed trace amounts of S, Ca and Cr. The high silicon content is probably related to the use of the silicon base Furmanite sealer used by the utility to seal the leaking stud holes. The high nickel content is attributed to the utility's use of Fel-Pro-5000, a nickel-base lubricant. (For typical certifications of materials used at Maine Yankee (see Tables 2-5.)) A second fibrous particle scanned (Figures 18 & 19), however, showed only peaks of Fe, Cr and Ni.

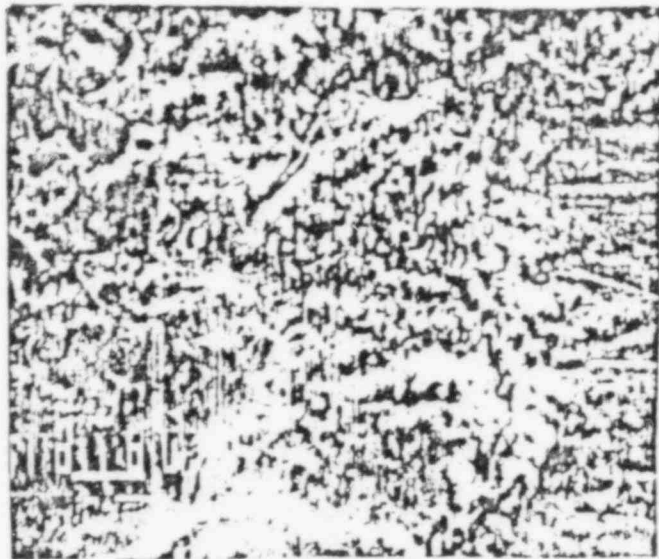
Figure 24. SEM photograph of second "smeared" area on bolt.

A second smeared area (Figure 24) had such a high peak in sulfur (Figure 26) that a wavelength dispersive spectrographic scan was accomplished to determine if molybdenum was present with the sulfur. It can be clearly seen (Figures 27 & 28) that this particular area is quite concentrated in Mo which is indicative that a molybdenum disulfide type lubricant may have been used sometime in the service history of the stud.
