In the Matter of	)	
	)	
METROPOLITAN EDISON COMPANY, ET AL.	)	Docket 50-289
	)	(Steam Generator Tube Repairs)
(Three Mile Island Nuclear	)	
Generating Station, Unit 1)	)

JOINT INTERVENORS RESPONSE TO LICENSEE'S SECOND SET OF INTERROGATORIES

HISTORICAL REVIEW OF THE PRINCIPAL RESEARCH  
CONCERNING THE PHENOMENA OF CRACKING OF  
NICKEL BASE AUSTENITIC ALLOYS<sup>(1)</sup>

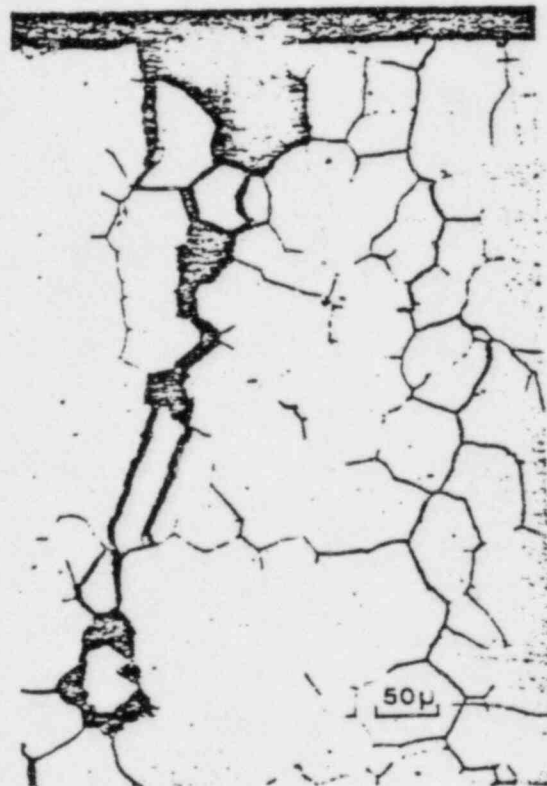
FIGURE 1 — Alloy Cr 17%, Ni 77% cracked after six months of testing in 350 C water.

Cracking of the alloy Cr 17%, Ni 77% is noted after 6 months of testing, and that of Inconel 600 after 9 months. Figures 1 and 2 show the micrographic aspect of the cracking for these two materials. The cracking occurs

almost always intergranularly with, however, a few rare transgranular paths for the alloy Cr 17%, Ni 77%. The other alloy types: Cr 17%, Ni 10%; Cr 17%, Ni 35%; Cr 17%, Ni 45%; and Cr 20%, Ni 45%, Mn 5% do not show any cracking whatsoever after 10 months of testing. Other researchers<sup>5,6</sup> have also produced stress cracking in Inconel 600 in pure water at high temperatures.

It is noted that cracking as shown in Figure 1 occurs in an alloy whose composition is similar to that of Inconel 600 but which has been specially prepared by vacuum melting and has a very low carbon content, C = 0.002% (commercial alloys contain 10 to 20 times as much carbon). This extra low carbon alloy behaves almost the same as the commercial alloys. Also, tests made under dynamic conditions (resistivity of the water maintained constantly at 1 M  $\Omega/cm$ ,  $O_2 \leq 3 \mu g \cdot kg^{-1}$ , temperature 350 C) have led to the same results.<sup>7</sup> Electron micrographs reveal carbide precipitation in commercial Inconel 600, whereas the grain

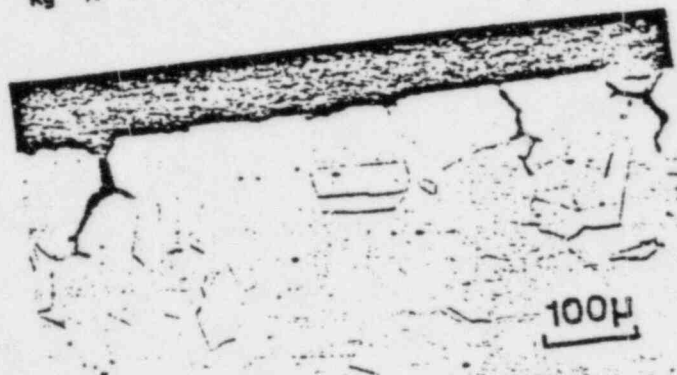
FIGURE 5 — Intergranular cracking of a Cr 17%, Ni 77% alloy in water containing  $1 \text{ g} \cdot \text{l}^{-1} \text{ Cl}^{-1}$  (NaCl), after six months of testing (experimental conditions same as those in Figures 3 and 4).

10% nickel alloy and intergranular (Figure 5) in the 77% Nickel alloy and in commercial Inconel 600 (Cr 15%, Ni 78%). Transgranular striations were revealed in the 15% nickel alloy. The alloys with 25, 35, 45, and 65% nickel do not show any cracking.<sup>7</sup>

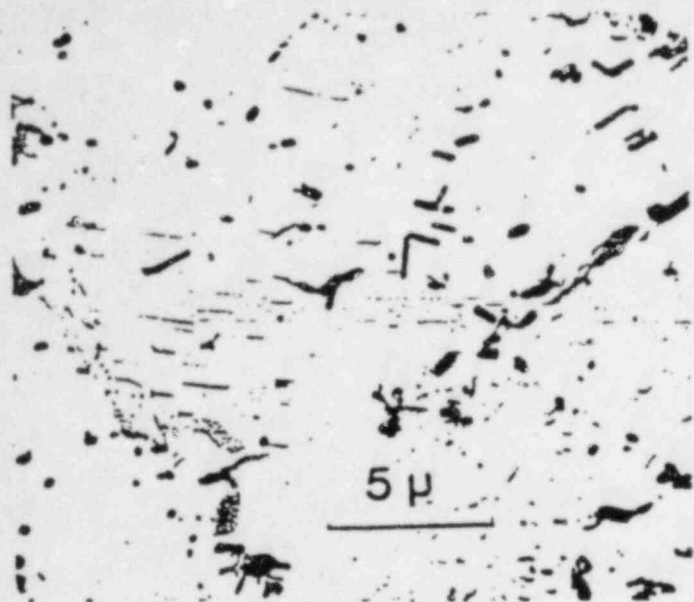
FIGURE 13 — Alloy A (Inconel 600) electron microscopic examinations. A3 = Sensitized condition (one hour at 700 C).

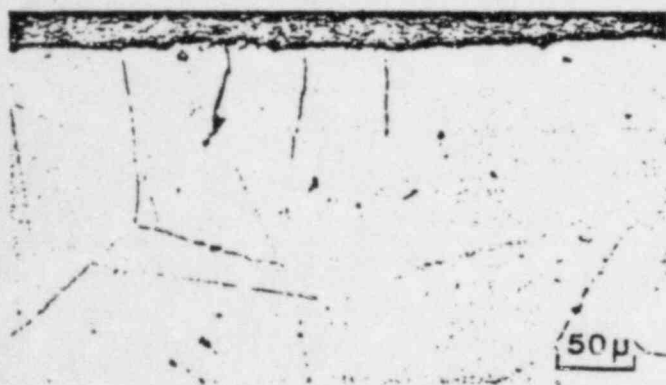
FIGURE 21 — Example of intragranular cracks.

However, under our particular conditions, we note the appearance of a few rare cracks of an intragranular nature but which do not go beyond the perimeter of the grain for the time of our test (Figure 21).

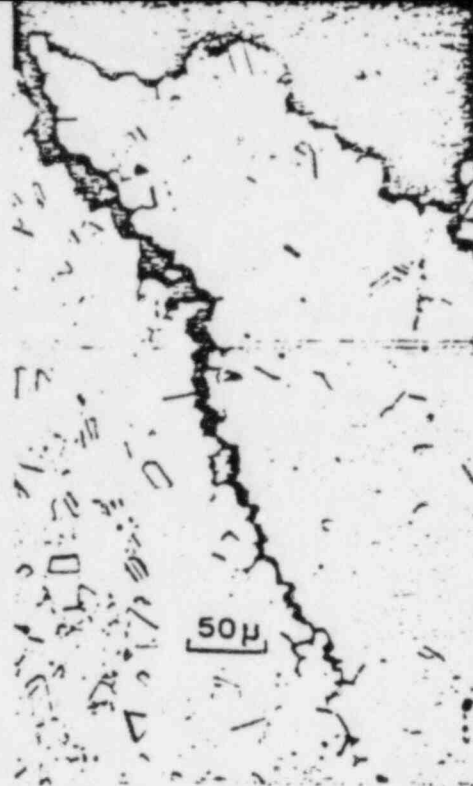
FIGURE 22 — Tensile specimen ( $\alpha = 2/3 E_{0.2}$  300 C) after 2,000 hours in 350 C deoxygenated water. Intergranular nature of the crack.

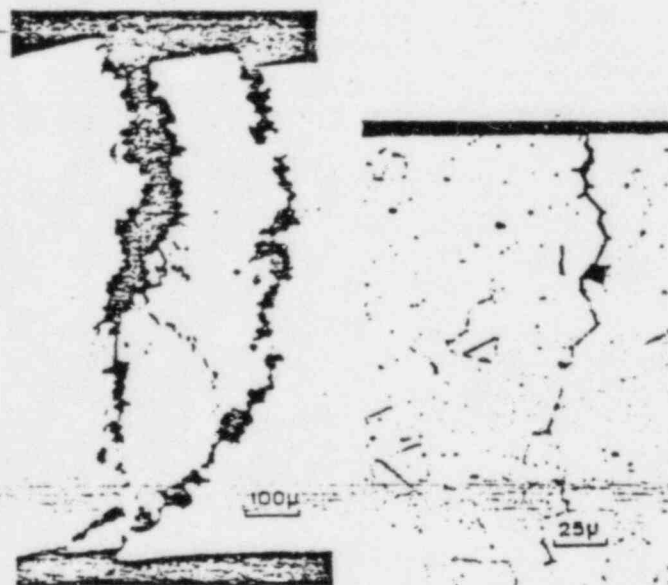
FIGURE 23 — Bend specimen ( $E_{0.2}$  300 C = 86  $\text{kg} \cdot \text{mm}^{-2}$ ) after 2,000 hours in 300 C deoxygenated water. (a) Fracture zone of the sample; (b) example of intergranular cracking in the middle of the bent region of the specimen.

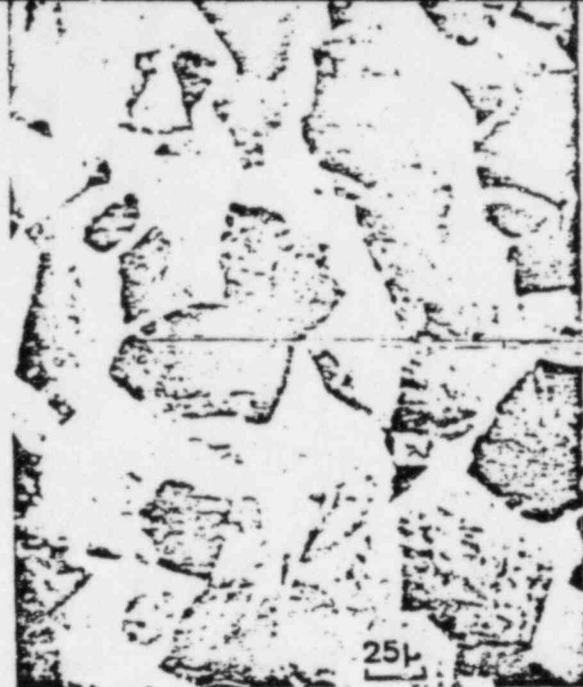
FIGURE 25 — Intergranular aspect of cracking (Inconel 600 type alloy).

The following points are made from the test: (a) Microfractography confirms the microscopic observation that the cracking is intergranular in nature (Figure 25). This cracking is then transformed into an aspect of brutal fracture of a ductile transgranular type (Figure 26); (b) in the propagation zone of the intergranular crack, the

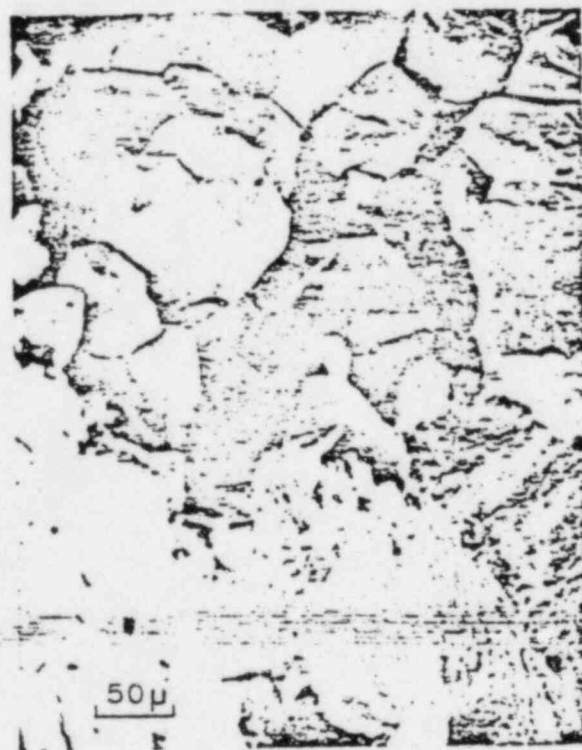
FIGURE 26 — Transition between intergranular cracking and brutal ductile transgranular fracture. (Inconel 600 type alloy).

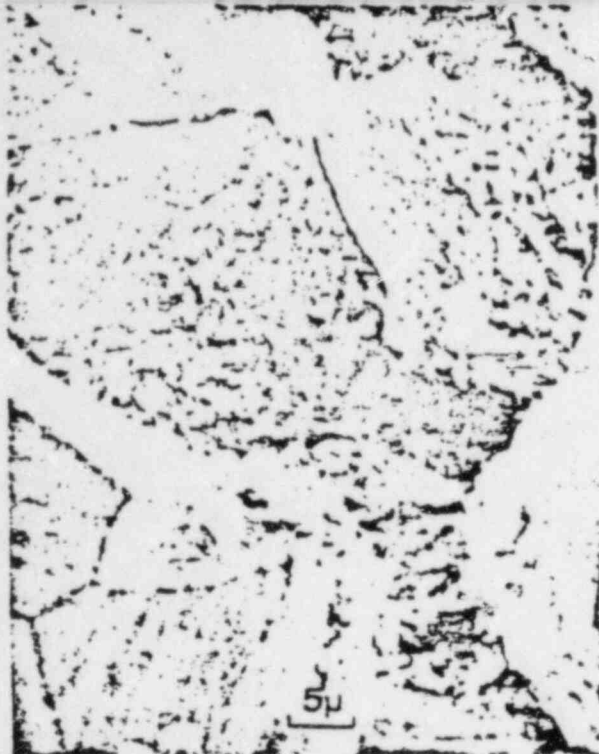
FIGURE 27 — Precipitates at grain surfaces on flanks of the crack (Inconel X 750).

presence of numerous crystalline precipitates at the grain surface is noted. These precipitates are dispersed or in aggregates in platelet or rod-like form (Figures 27 and 28); (c) these precipitates have a tendency to be more abundant

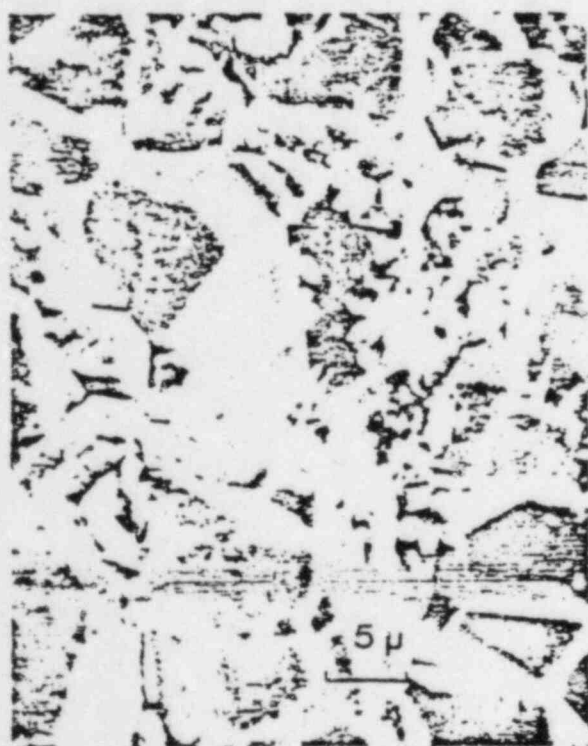
FIGURE 28 — Precipitates at grain surfaces on flanks of the crack (Inconel X 750).

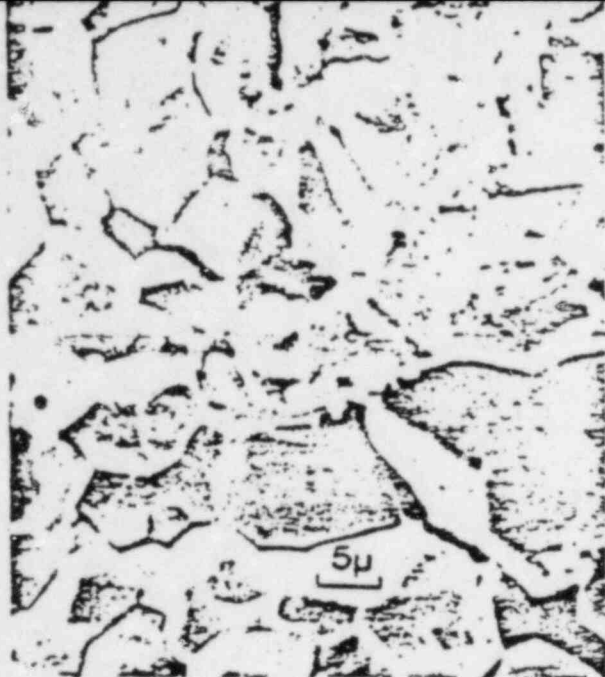
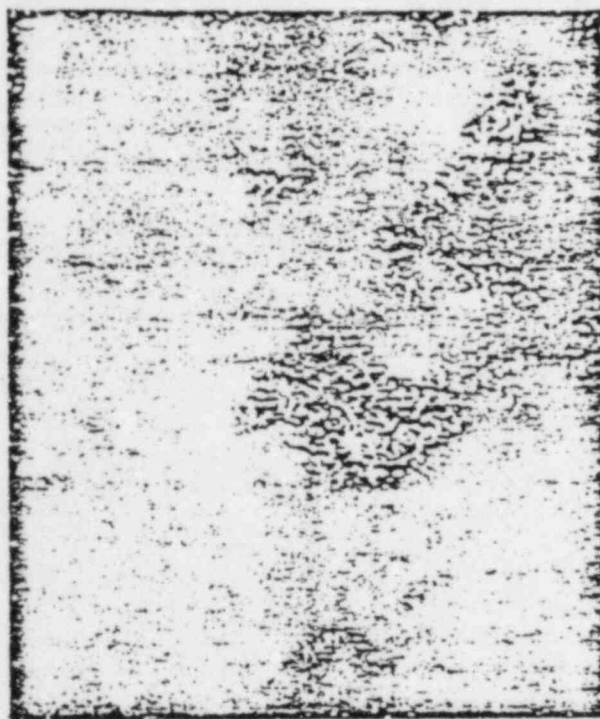
FIGURE 30 — Electronic images (above) and X-rays (below) from the same zone of the crack, showing the association of sulfur with the precipitates (Inconel X 750).

precipitates reveal that they are very rich in sulfur, frequently in nickel (Figure 29), and that they can also contain some iron. The X-ray image, compared to the electronic image, confirms this point very well (Figure 30).
