## Commonwealth Edison Company

Dresden Nuclear Power Station  
 R. R. #1  
 Morris, Illinois 60450  
 September 8, 1971

SUBJECT: LICENSE DPK-19, DRESDEN NUCLEAR POWER STATION UNIT 2: REPORT  
 OF PARTIAL CONTROL ROD INSERTION FOLLOWING SPURIOUS REACTOR  
 SCRAM SIGNAL.

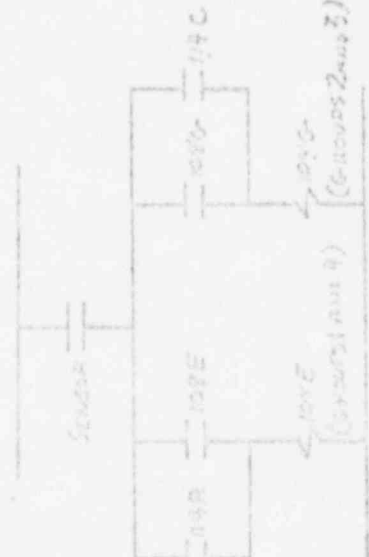
FIGURE 2

# SIMPLIFIED CIRCUIT DIAGRAM DEFCON PROTECTION SYSTEM START AND RESET RELAYS

Resetting the scram relays is accomplished through the reset relay circuit shown in Figure 2. The operator uses a single reset switch as shown in Figure 3 for the reset circuit. When the reset switch is in the center position, all switch contacts are open. When the switch is operated to the right, scram relays for control rod Groups 2 and 3 in Channels "A" and "B" are reset (re-energized.) When the switch is operated to the left, scram relays for control rod groups 1 and 4 in Channel A and B are reset.

Relays 114A, B, C and D are the reset relays. The 114 relays are energized through the reset switch following a scram. When the 114 relays are energized their contacts close and energize the scram relay thereby returning the scram relays to their normal energized position. When the reset switch is released, the 114 relays de-energize (see figure 3) but the scram relays remain energized through their own seal-in contacts (see figure 2).

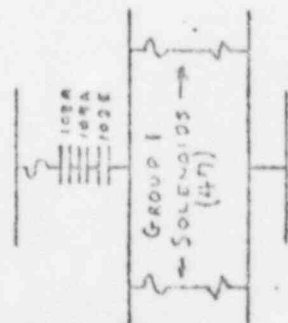
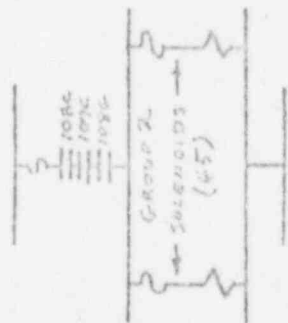
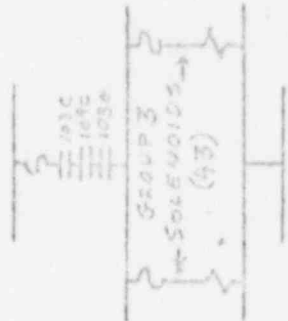
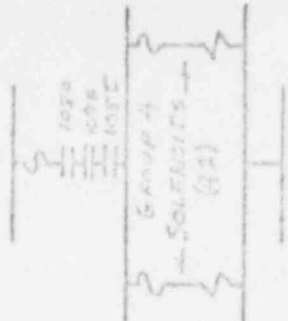
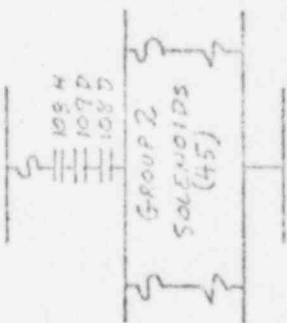
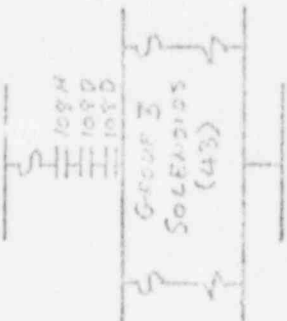
FIGURE 5

# SUPPLIED SCHEMATIC DIAGRAM

## REACTOR PROTECTION SYSTEM PILOT SEVEN VALVE SOLENOIDS

The control rods are divided into four nearly equal groups, identified as Groups 1, 2, 3 and 4. Group 1 and 4 control rods are scrambled by Channel "A" relays 108A, 108E and 109A and Channel "B" relays 108B, 108F and 109B. Group 2 and 3 control rods are scrambled by Channel "A" relays 108C, 108G and 109C and Channel "B" relays 108D, 108H and 109D. (See Figure 1 & 5).

The operator then completed his reset action by turning the switch to the group 1 & 4 position. This successfully energized reset relay 11A, and re-energized scram relay 10SE in Channel "A" and the pilot scram valve solenoids in Channel "A" groups 1 & 4. This left the solenoids of Channel "A" groups 2 & 3 and Channel "B" groups 1 & 4 de-energized; no rod group had both Channel "A" and "B" solenoids de-energized. (See figure 5).
