Report No.: SIR-91-077  
Revision No.: 2  
Project No.: GPCO-20Q-2  
January 1992

IGSCC Flaw Evaluations and Weld Overlay  
Activities During the E. I. Hatch Unit 1  
Fall 1991 Outage

Prepared for:  
Georgia Power Company

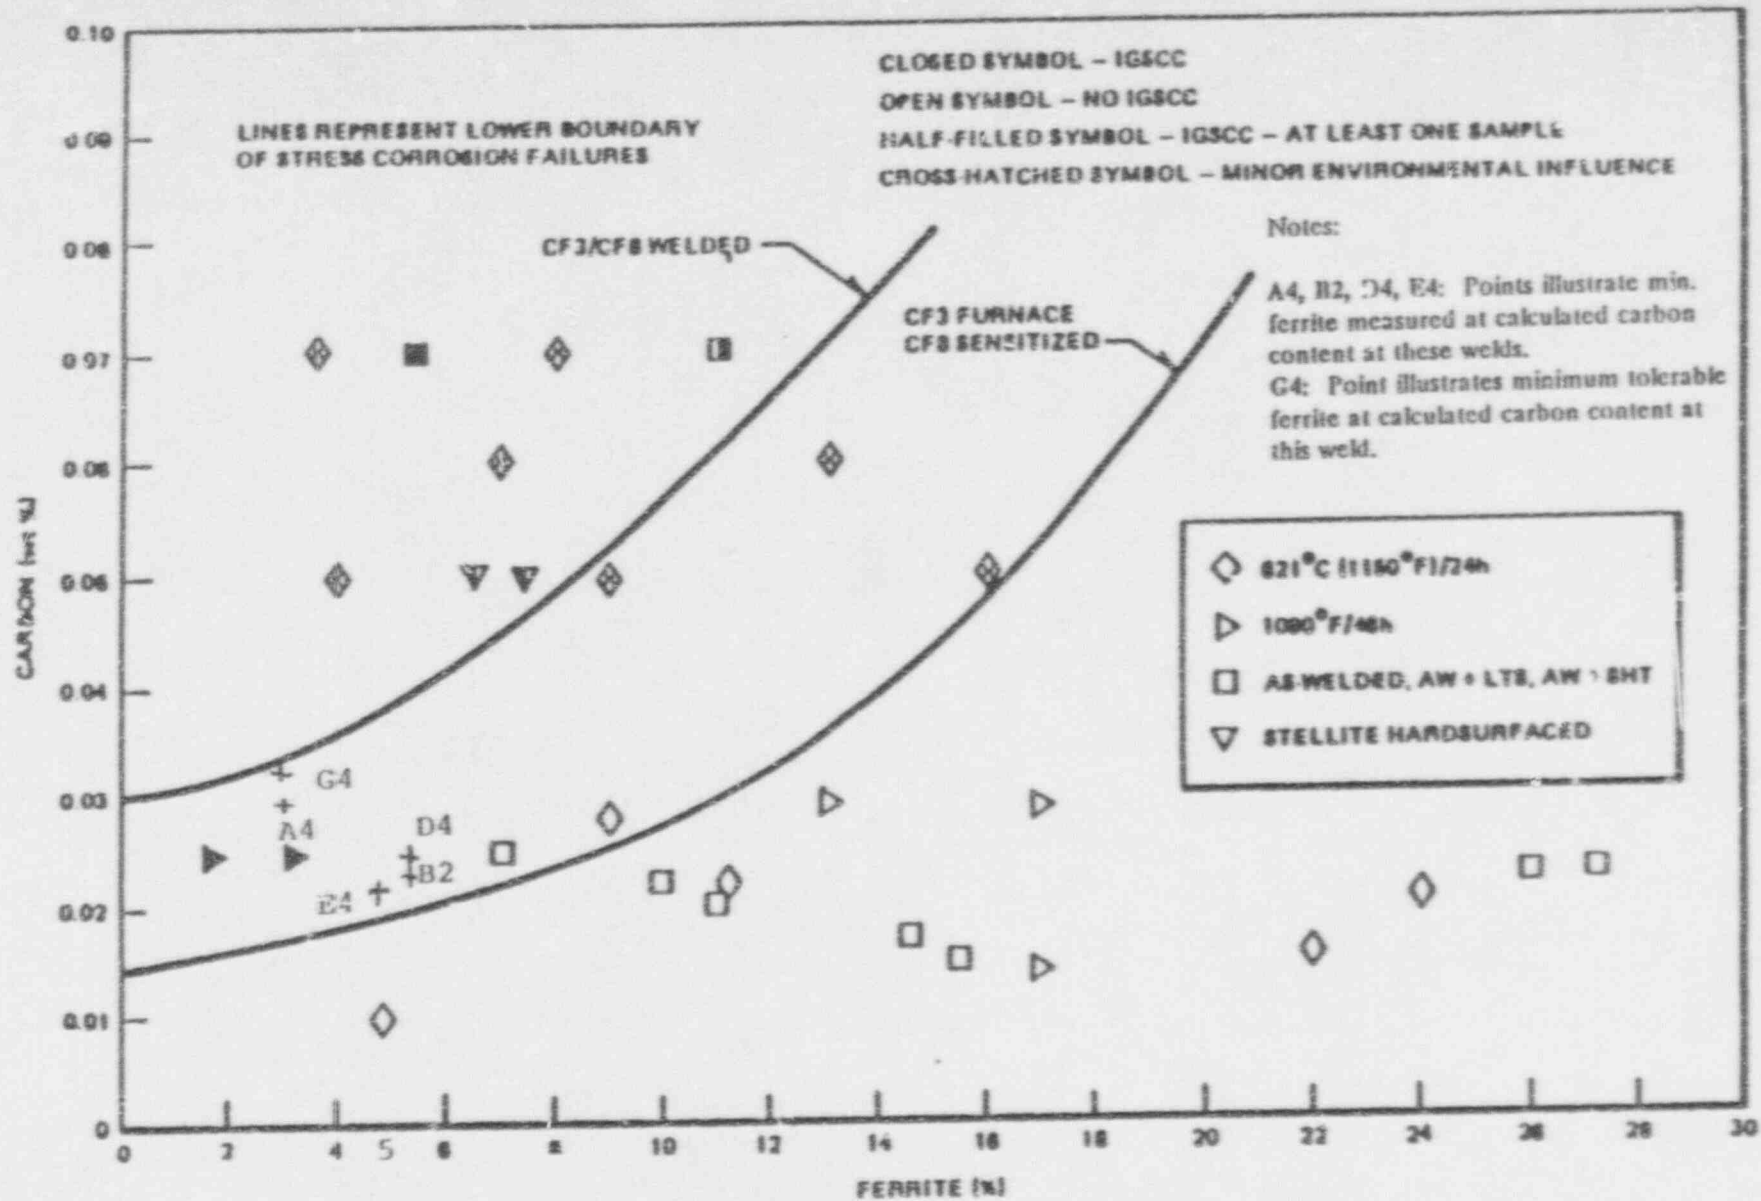
Figure 3-1. IGSCC Resistance Figure from Reference 6, with Worst Case 1991 Hatch Data Points Added

Austenitic stainless steel materials with delta ferrite content equal to or greater than 7.5 FN and with carbon content of 0.035 wt% max have been shown to be resistant to IGSCC. Also, where carbon content is less than or equal to 0.035 wt%, wrought austenitic stainless steels like Types 304L and 316L have been shown to be IGSCC resistant even with no delta ferrite present. If ferrite content is less than 7.5 FN but greater than 5.0 FN, it is possible to justify the IGSCC resistance of the resulting weld metal on a case by case basis, by considering a trade-off between delta ferrite content and carbon content, if the carbon level is less than 0.035 wt%. Note that the  $\delta$ -ferrite issue does not apply to weld 20B-D-5.

Figure 3-1 includes data points representative of each of the five stainless steel weld overlay locations. These data have been superimposed on the Reference 6 curve and data. These weld overlay data points reflect the as-diluted first layer carbon content, and the lowest

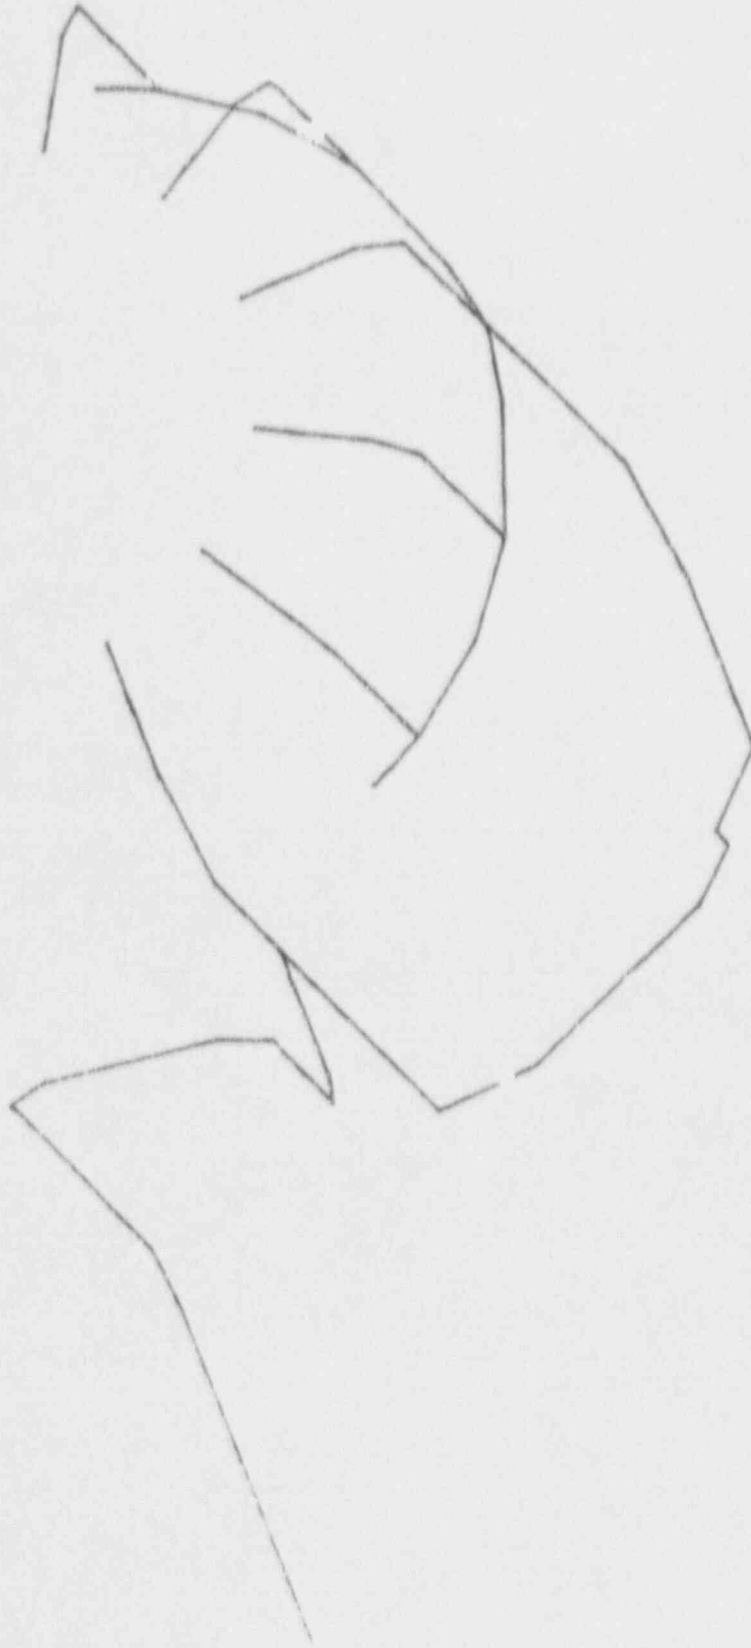
Figure 4-1. Finite Element Models: Loops A and B

Table 4-4 presents the modal response analysis results. The first mode was found to be about 5.52 hz. for the recirculation system without any overlays. With the overlays, the first mode frequency decreases to about 5.49 hz. for a difference of 0.68%. The biggest difference is about 2.1% for mode 20.

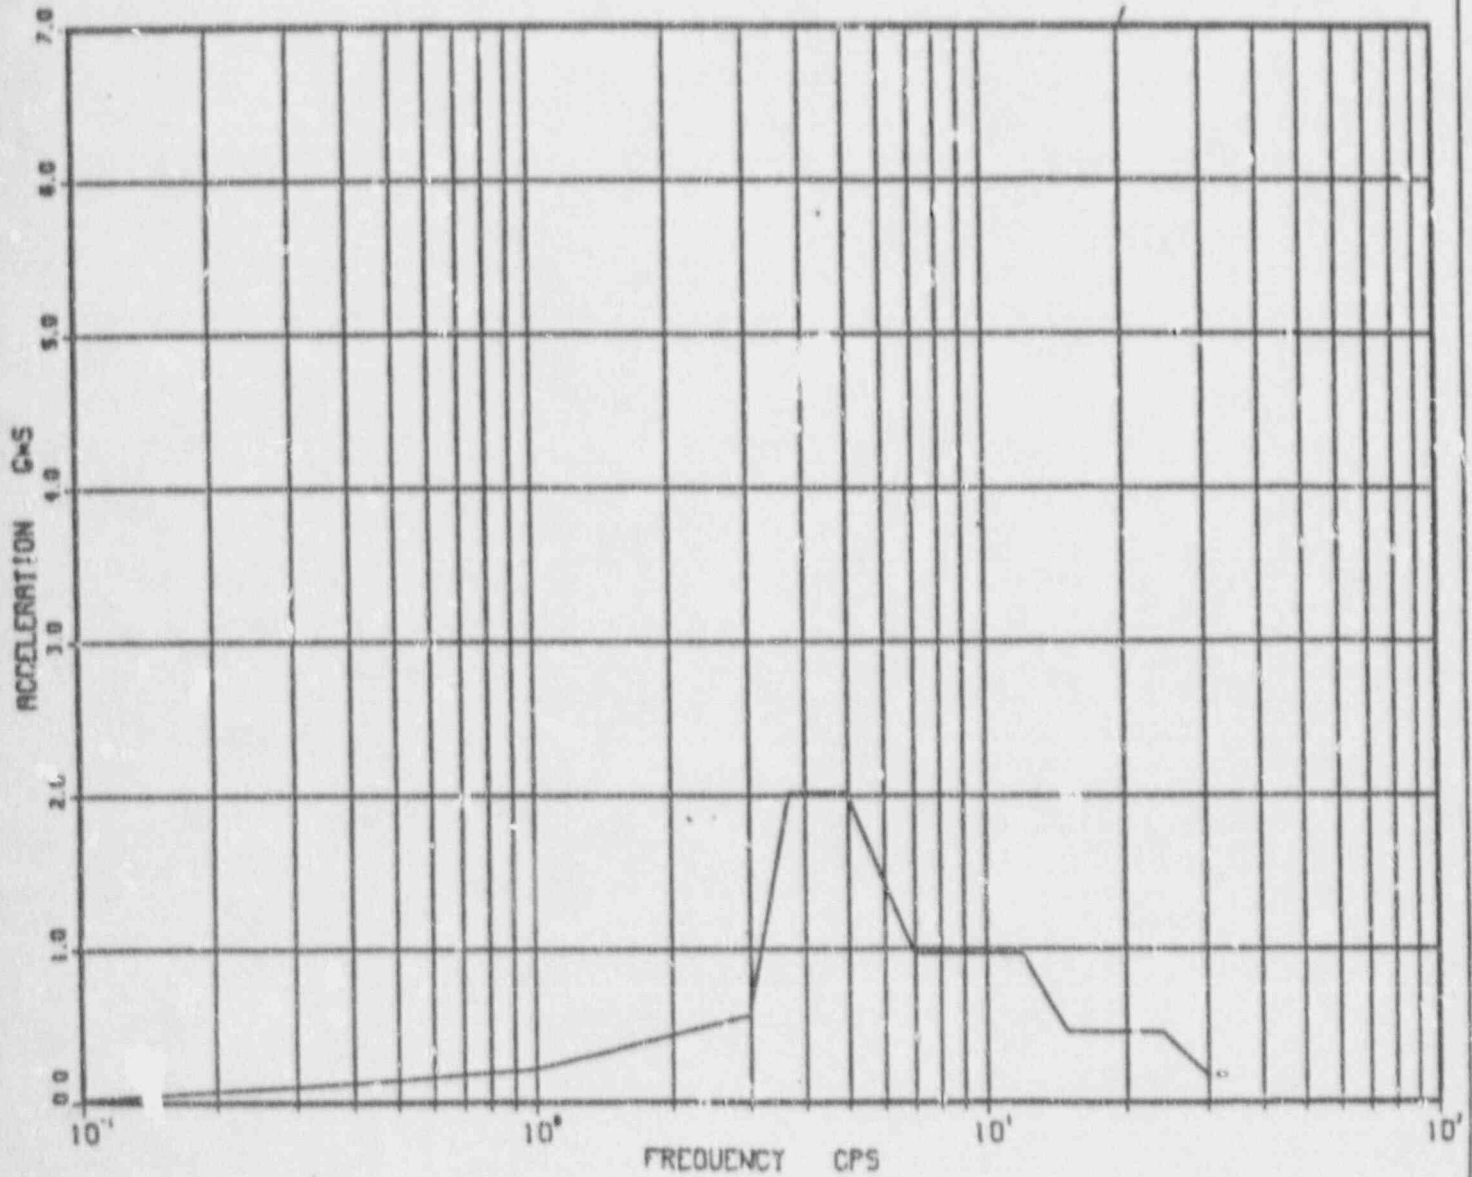
HNP UNIT 1 RPV HORIZONTAL OBC MASS PT 19 CL. 146'-0"

Figure 4-2. Hatch Seismic Response Spectra: Elev. 146 ft.

Figures 4-2 and 4-3 present the Hatch Unit 1 response spectra at reactor vessel elevations 146 ft. and 172 ft. They both show a peak response at a frequency range of about 3.5 hz. to 5 hz. With the first mode of 5.52 hz. when there are no overlays, the response is very close to the peak of the spectrum. Even though a decrease in the mode frequency would correspond to an increased response for the given spectrum, the magnitude of the decrease in the first mode frequency is so small that it would not cause a significant change in the response. With only about 50% of the welds overlaid, the change in the first mode frequency would be even smaller. Therefore, it is concluded that the overlays, either in the current or any imagined future configuration, would have a negligible effect on the dynamic analysis of the system.

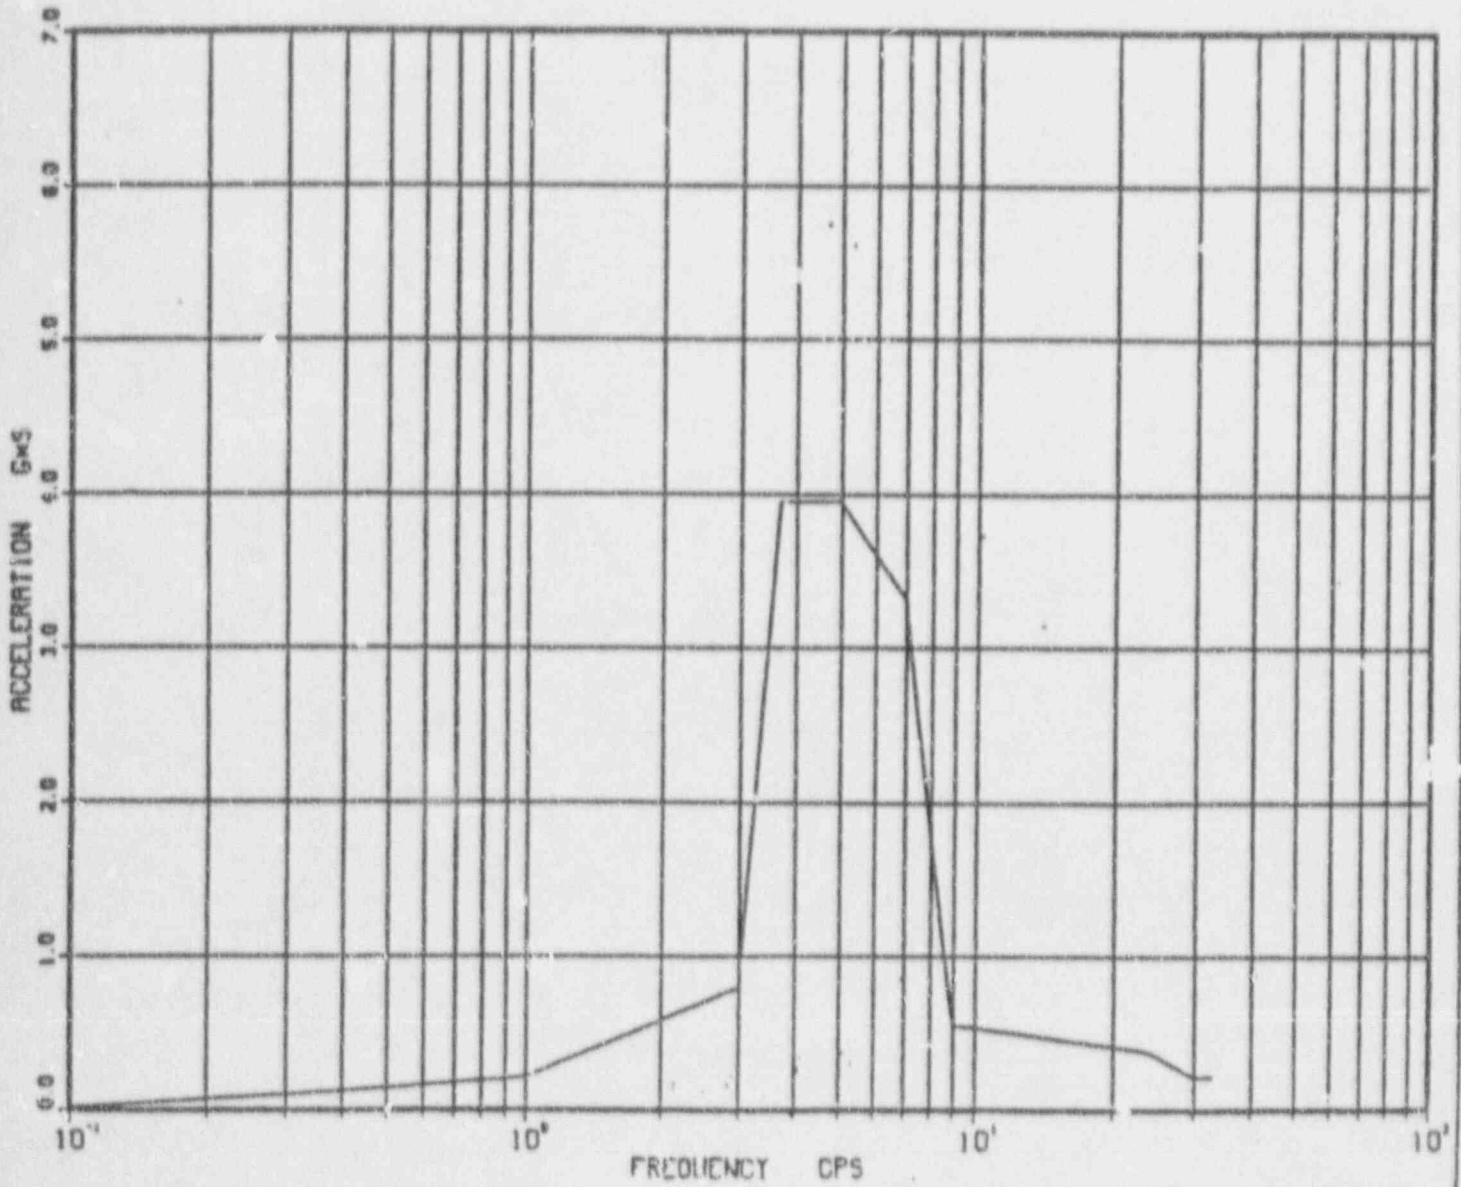
HNP UNIT 1 RPV HORIZONTAL OBC MASS PT 20 EL. 172'-0"

Figure 4-3. Hatch Seismic Response Spectra: Elev. 172 ft.

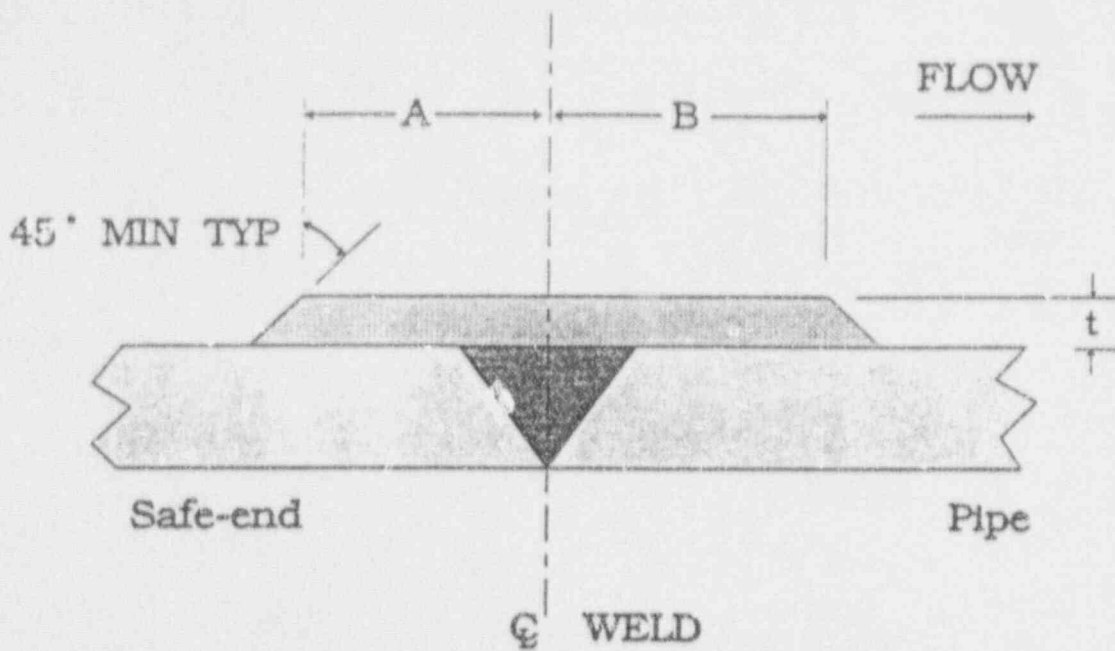
<b>STRUCTURAL INTEGRITY ASSOCIATES, INC.</b>
File No: GPCO-20Q-401			
Drawing No: GPCO-20Q-07	Title: Standard Weld Overlay Design	Sheet <u>2</u> of <u>2</u>

WELD NUMBER	FLAW CHARACTERIZATION	DESIGN DIMENSIONS			COMMENTS
		t	A	B	
1B31-1RC-28B-2	Assumed 360° Circ. 100% throughwall flaw	0.52"	4.0"	4.0"	Overlay Thickness revise.
1	GAM 10/22/91	NGC 10/22/91	NRD 10/22/91		Overlay dimensions based on as-built thickness.
0	NRD 6/18/91	JH 6/18/91	REC 6/15/91		
Revision	Prepared by/ Date	Checked by/ Date	Approved by/ Date		COMMENTS
Job No:	Plant/Unit

4. First weld layer is to have a measured delta ferrite content greater than 7.5 FN. This requirement does not apply to the final weld layer.
5. Design thickness includes no allowance for surface conditioning operations to facilitate UT inspections.

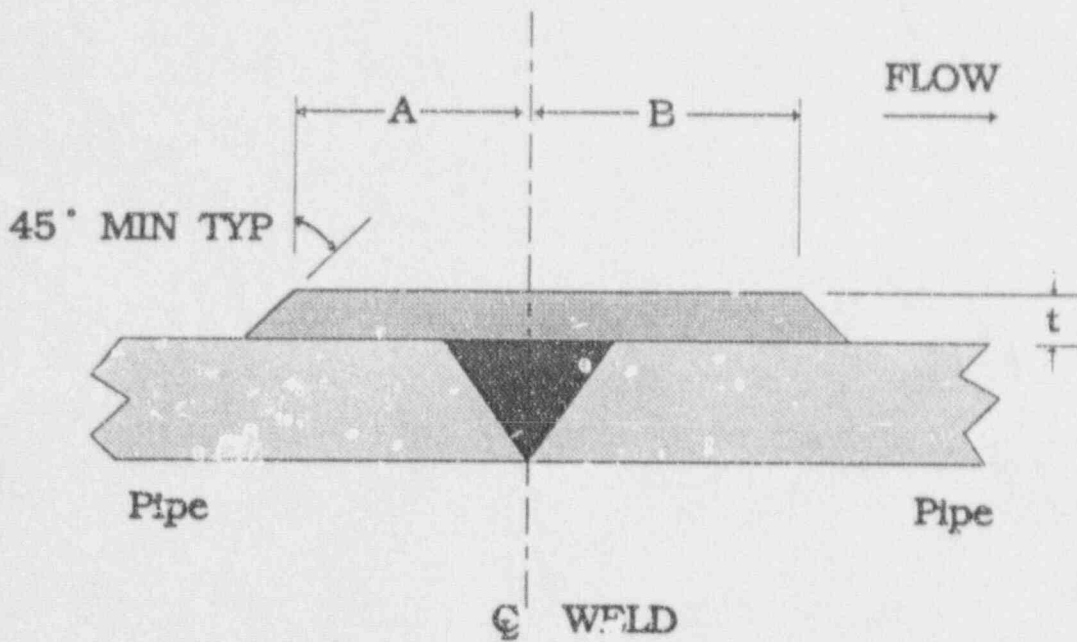
<b>STRUCTURAL INTEGRITY ASSOCIATES, INC.</b>
File No: GPCO-20Q-401			
Drawing No: GPCO-20Q-13	Title: Standard Weld Overlay Design	Sheet <u>2</u> of <u>2</u>

WELD NUMBER	FLAW CHARACTERIZATION	DESIGN DIMENSIONS			COMMENTS
		t	A	B	
1E11-1RHR-20B-D-4	Assumed 360° Circ. 100% throughwall flaw	0.36"	3.0"	3.0"	
0	HD 6/18/91	HJ 6/18/91	QSC 6/18/91		
Revision	Prepared by/ Date	Checked by/ Date	Approved by/ Date	COMMENTS

4. First weld layer is to have a measured delta ferrite content greater than 7.5 FN. This requirement does not apply to the final weld layer.
5. Design thickness includes no allowance for surface conditioning operations to facilitate UT inspections.

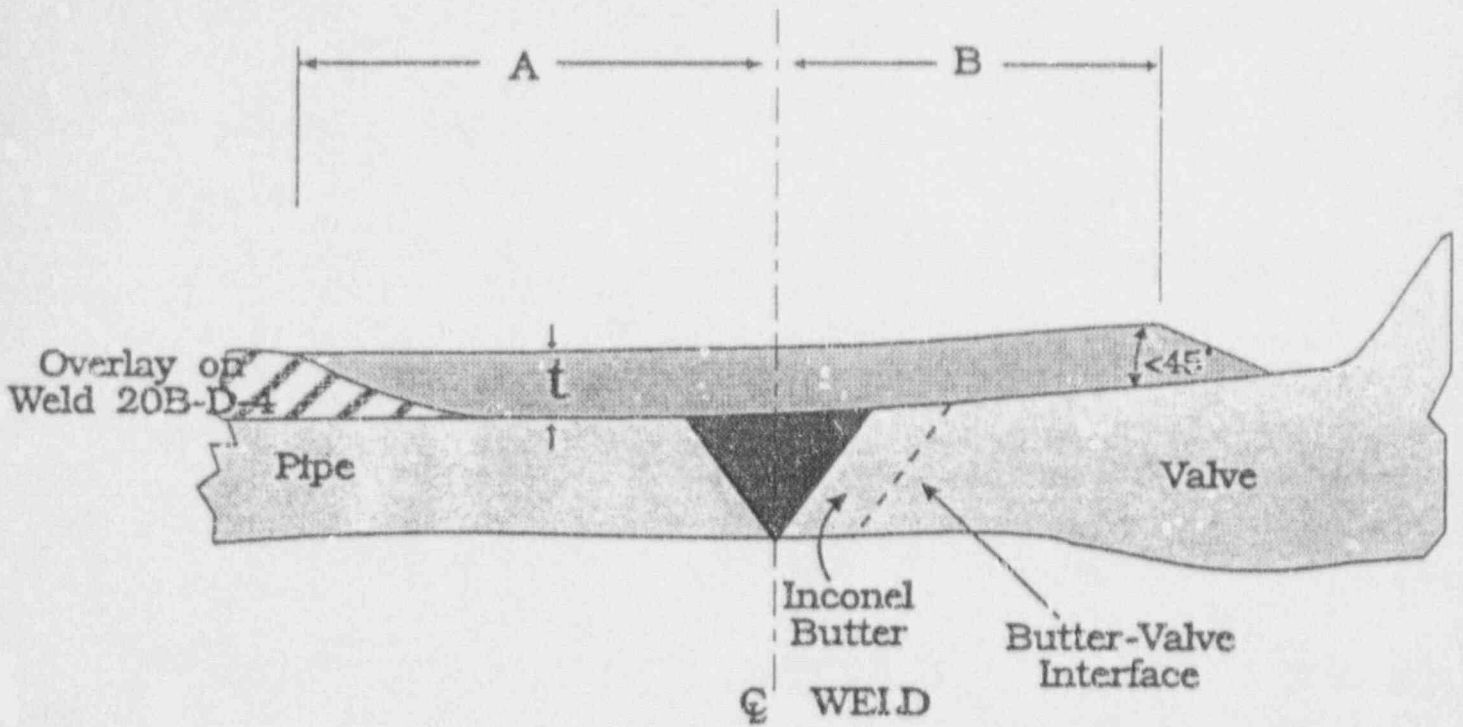
<b>STRUCTURAL INTEGRITY ASSOCIATES, INC.</b>
File No: GPCO-20Q-401		
Drawing No: GPCO-20Q-14	Title: Standard Weld Overlay Design	Sheet <u>2</u> of <u>2</u>

WELD NUMBER	FLAW CHARACTERIZATION	DESIGN DIMENSIONS			COMMENTS
		t	A	B	
WE11-1RHR-20B-D-5	Assumed 360° Circ. 100% throughwall flaw	0.33"	Note 1	3"

1. Blend repair into adjacent repair on weld 20B-D-4. Follow contour of transition with all weld layers. Repair should blend into valve body transition at an angle of 45 degrees or less with the component surface.

5. Design thickness includes no allowance for surface conditioning operations to facilitate UT inspections.
6. Design length is that required for structural reinforcement; greater length may be required for effective UT inspection. This is to be determined in the field.

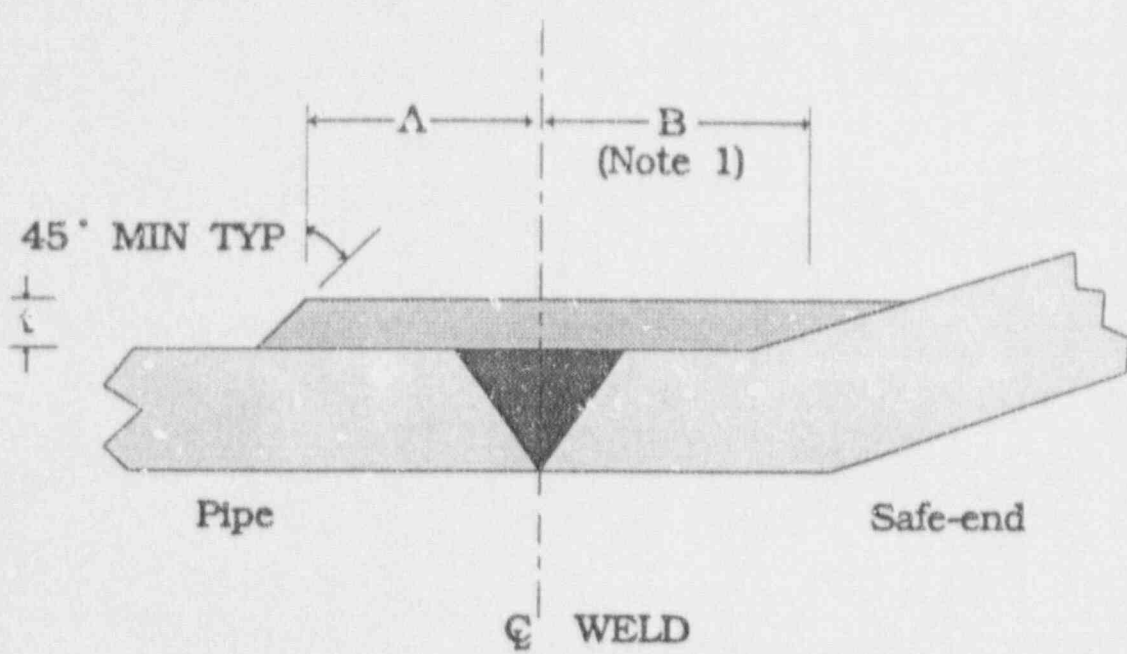
<b>STRUCTURAL INTEGRITY ASSOCIATES, INC.</b>
File No: GPCO-20Q-401			
Drawing No: GPCO-20Q-28	Title: Standard Weld Overlay Design	Sheet <u>2</u> of <u>2</u>

WELD NUMBER	FLAW CHARACTERIZATION	DESIGN DIMENSIONS			COMMENTS
		t	A	B	
1B31-1RC-12AR-G4	Assumed 360° Circ. 100% throughwall flaw	0.26"	2.0"	NA	
1	HLD 10/23/91	QJZ 10/23/91	QJZ 10/23/91		Revised to show safe-end transition
0	HLD 6/18/91	QJZ 6/18/91	QJZ 6/18/91		
Revision	Prepared by/ Date	Checked by/ Date	Approved by/ Date		COMMENTS

1. Blend repair into transition.
2. Weld overlay wire is to be type ER308L, with as-deposited delta ferrite content greater than 7.5 FN.
3. Component surface is to be examined by dye penetrant method and accepted as clean prior to overlay application in order to include the entire deposited overlay thickness in meeting the design thickness requirement, per NUREG-0313, Revision 2.

5. First weld layer is to have a measured delta ferrite content greater than 7.5 FN. This requirement does not apply to the final layer.
6. Design thickness includes no allowance for surface conditioning operations to facilitate UT inspections.

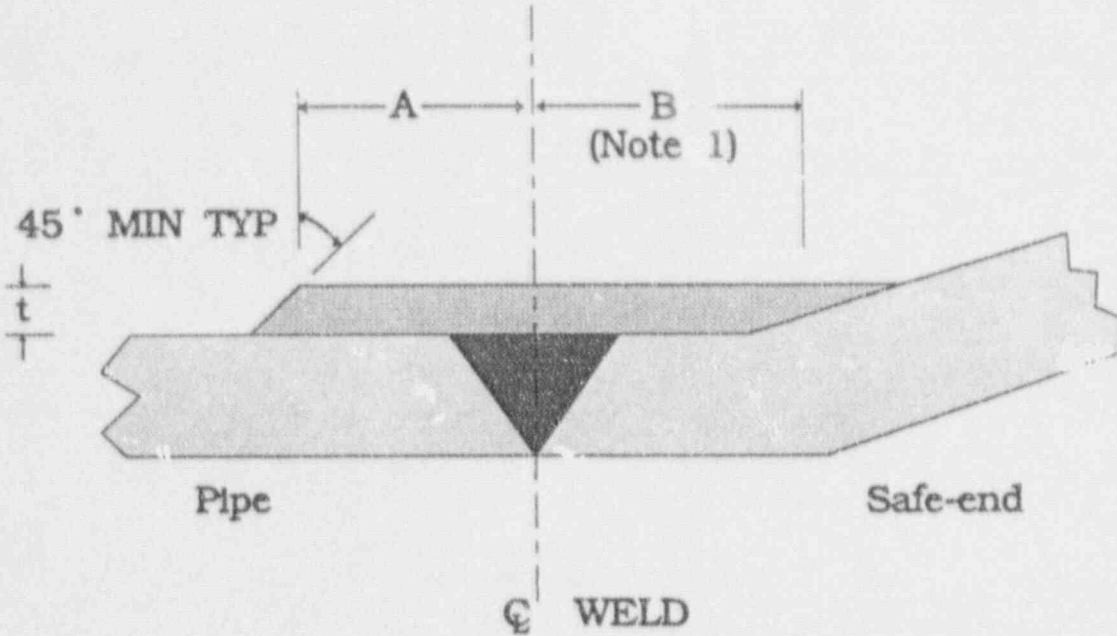
<b>STRUCTURAL INTEGRITY ASSOCIATES, INC.</b>
File No: GPCO-20Q-401			
Drawing No: GPCO-20Q-33	Title: Standard Weld Overlay Design	Sheet <u>2</u> of <u>2</u>

WELD NUMBER	FLAW CHARACTERIZATION	DESIGN DIMENSIONS			COMMENTS
		t	A	B	
RC-12BR-E4	Assumed 360° Circ. 100% throughwall flaw	0.27"	2.0"	NA

1. Blend repair into transition.
2. Weld overlay wire is to be type ER308L, with as-deposited delta ferrite content greater than 7.5 FN.
3. Component surface is to be examined by dye penetrant method and accepted as clean prior to overlay application in order to include the entire deposited overlay thickness in meeting the design thickness requirement, per NUREG-0313, Revision 2.

5. First weld layer is to have a measured delta ferrite content greater than 7.5 FN. This requirement does not apply to the final layer.
6. Design thickness includes no allowance for surface conditioning operations to facilitate UT inspections.

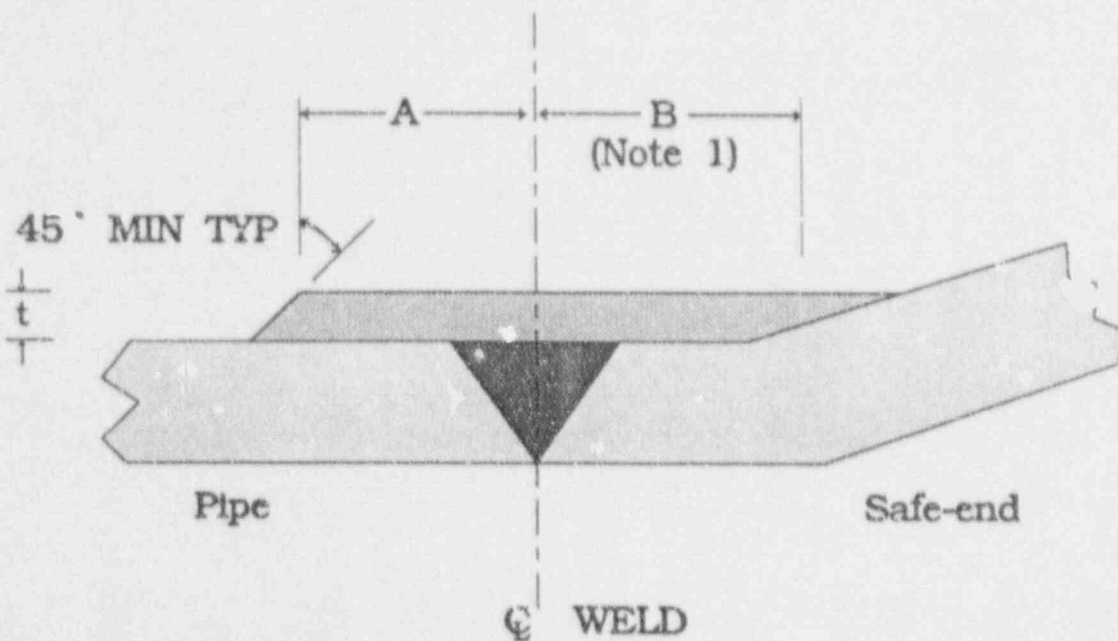
WELD NUMBER	FLAW CHARACTERIZATION	DESIGN DIMENSIONS			COMMENTS
		t	A	B	
1B31-1RC-12BR-A4	Assumed 360° Circ. 100% through-wall flaw	0.27"	2.0"	NA	
1	NLD 10/23/91	AGS 10/23/91	AGS 10/23/91		Revised to show safe-end transition
0	NLD 6/18/91	AGS 6/18/91	AGS 6/18/91		
Revision	Prepared by/ Date	Checked by/ Date	Approved by/ Date		COMMENTS
Job No:	GPCO-20Q	Plant/Unit

1. Blend repair into transition.
2. Weld overlay wire is to be type ER308L, with as-deposited delta ferrite content greater than 7.5 FN.
3. Component surface is to be examined by dye penetrant method and accepted as clean prior to overlay application in order to include the entire deposited overlay thickness in meeting the design thickness requirement, per NUREG-0313, Revision 2.

5. First weld layer is to have a measured delta ferrite content greater than 7.5 FN. This requirement does not apply to the final layer.
6. Design thickness includes no allowance for surface conditioning operations to facilitate UT inspections.

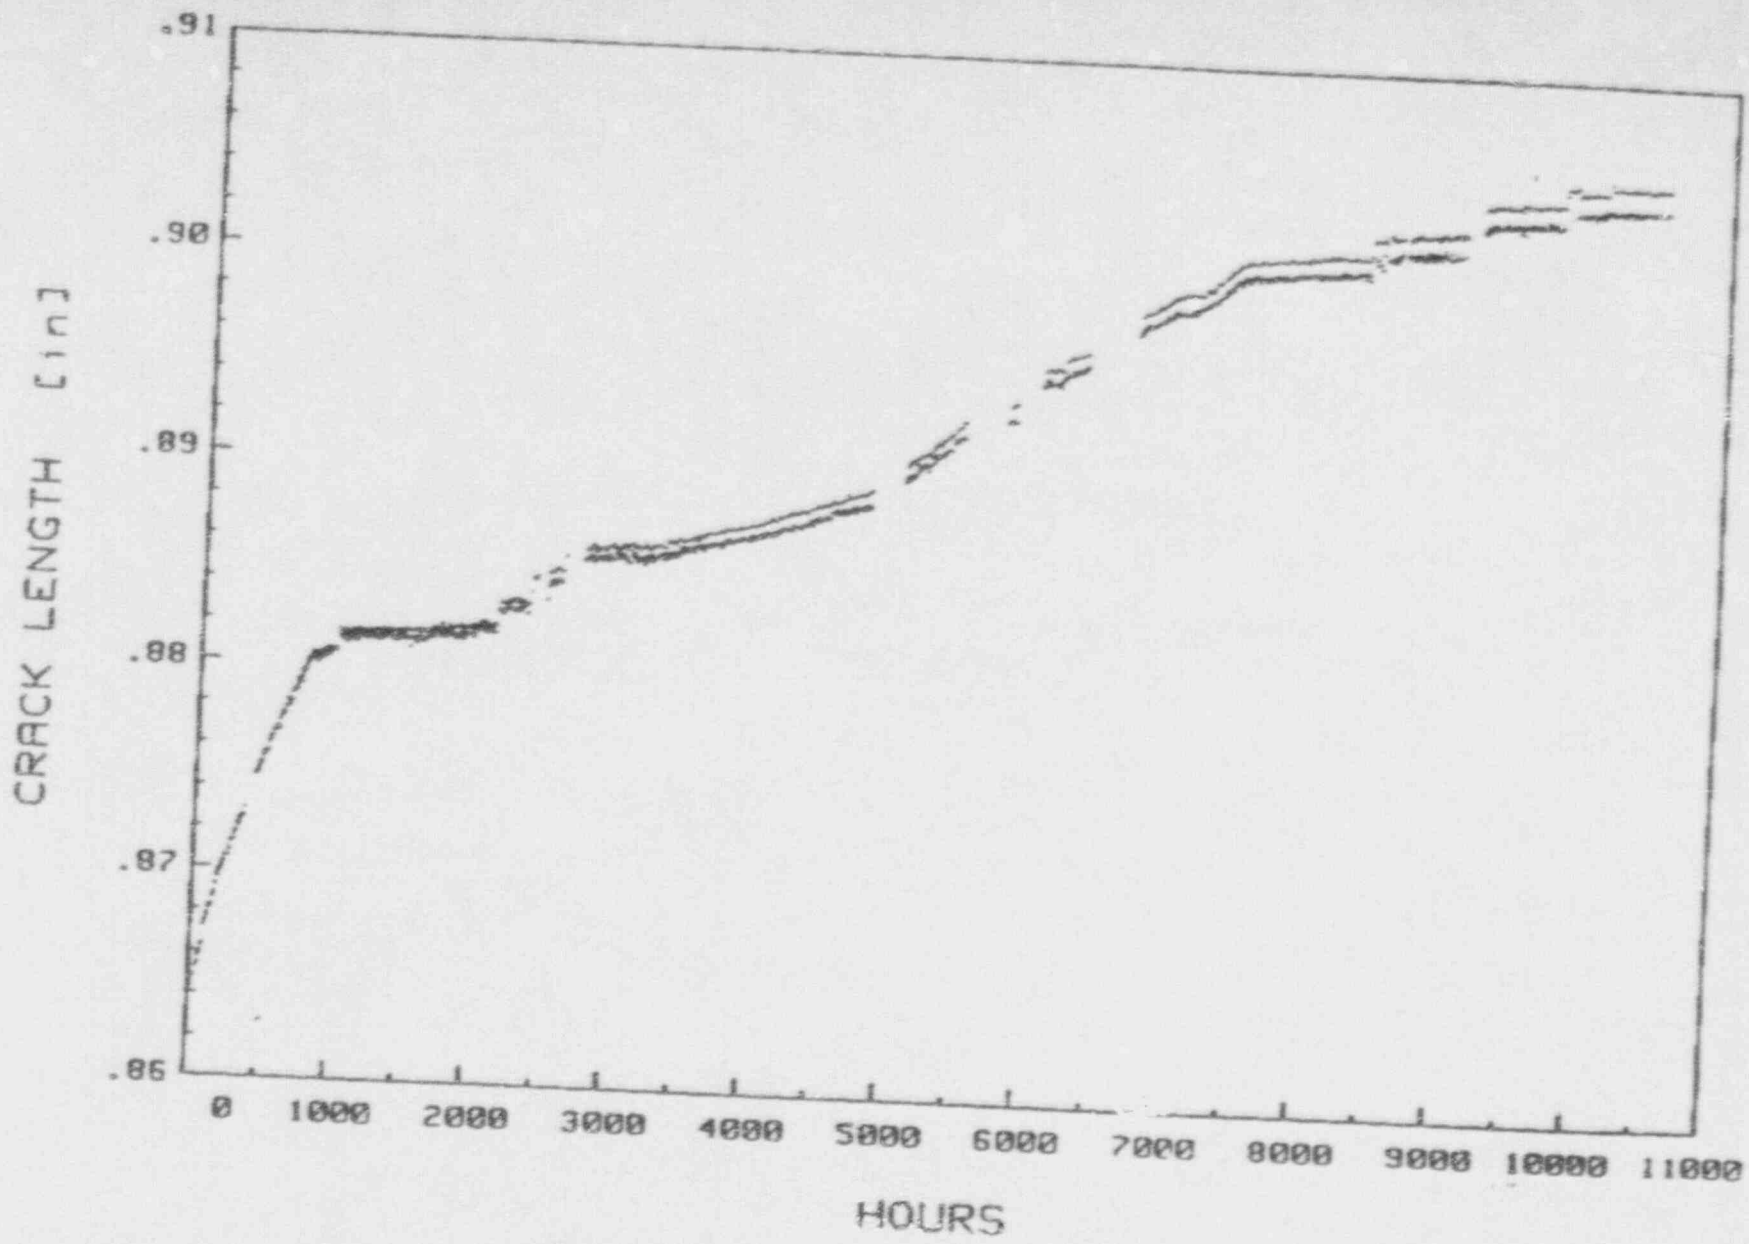
Figure 1. Plant Hatch Unit 1 CAV, Crack Length Versus Time Data, Fuel Cycle 13, Alloy 182, Specimen IMC-76, Stress Intensity 25 ksi/in.

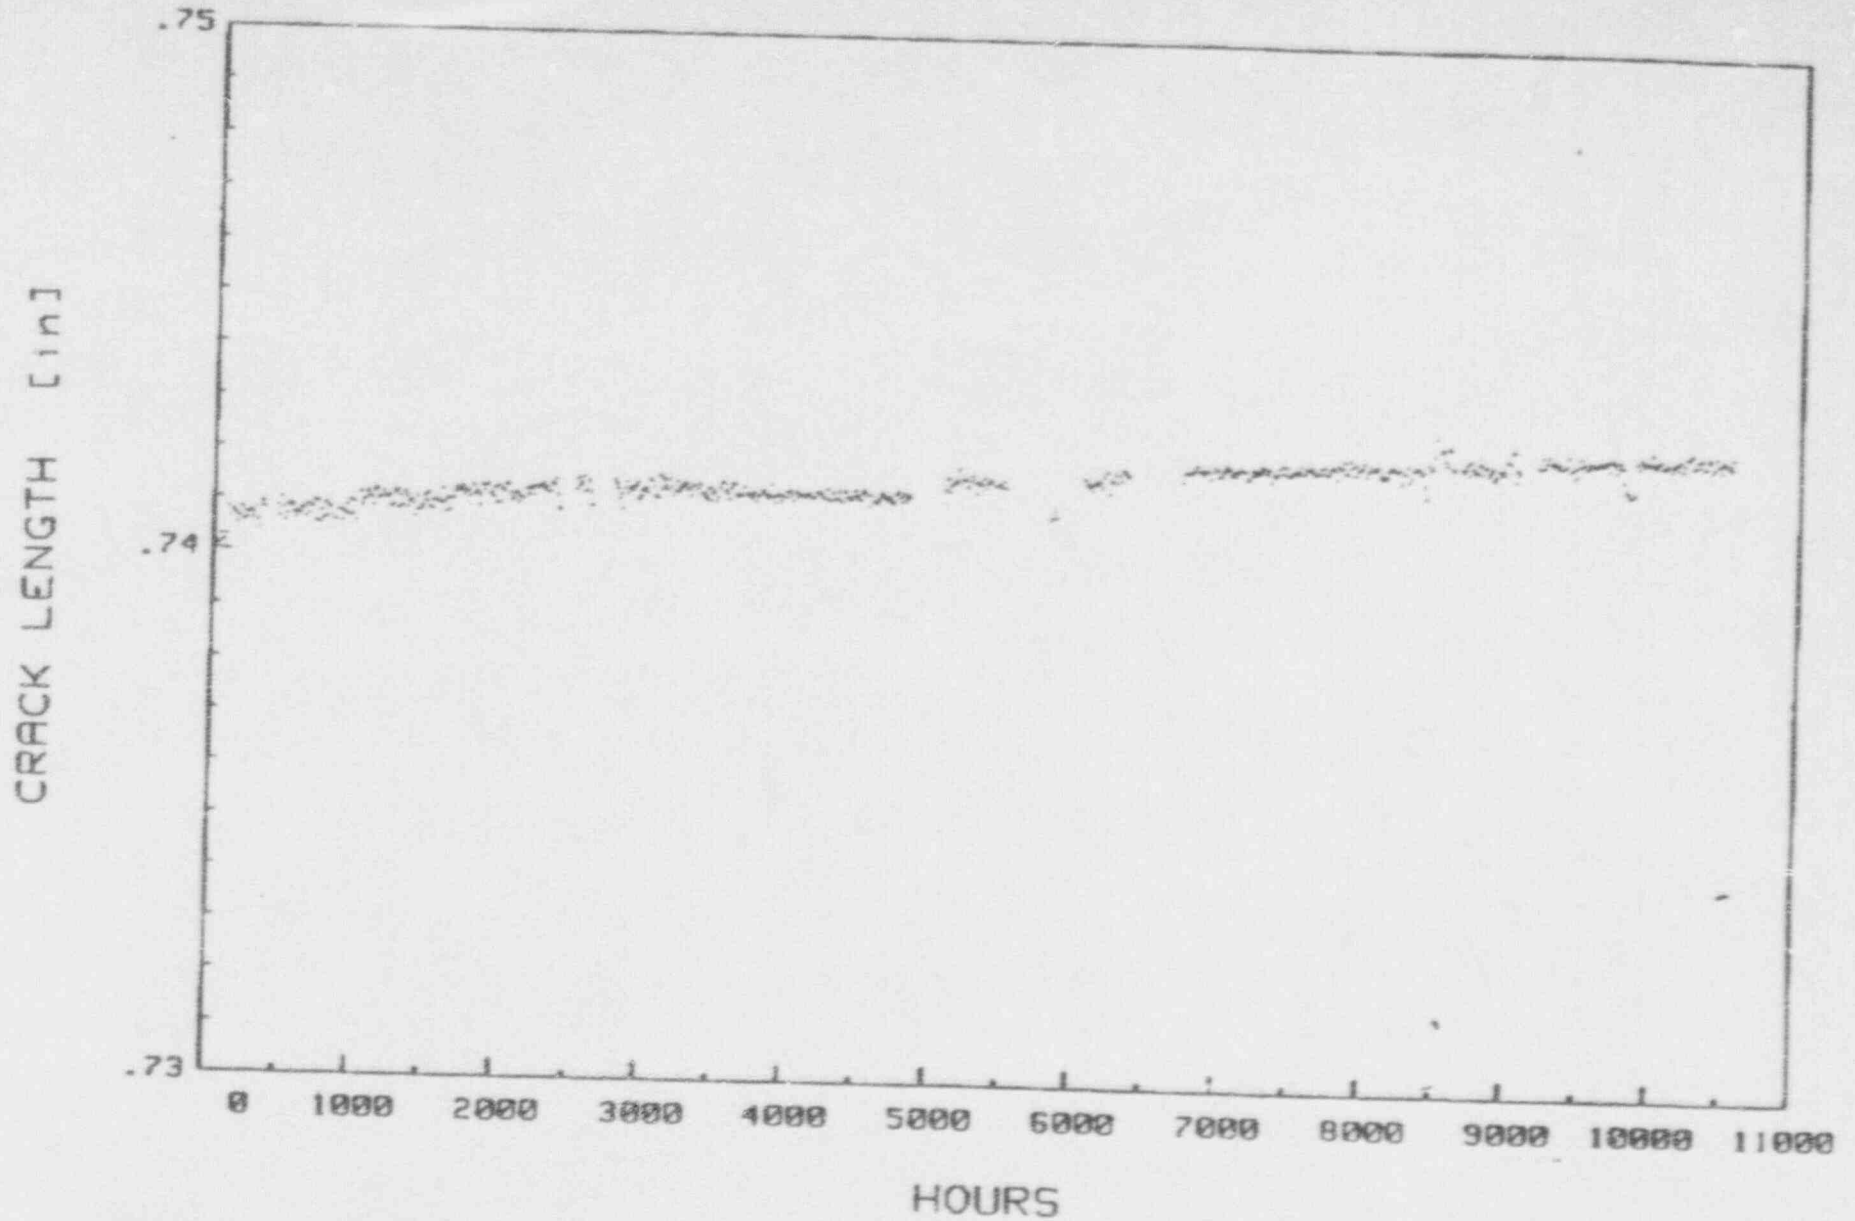
Figure 2. Plant Hatch Unit 1 CAV, Crack Length Versus Time Data, Fuel Cycle 13, Type 304 Stainless Steel (sensitized), Specimen SS-144, Stress Intensity 20 ksi/in.

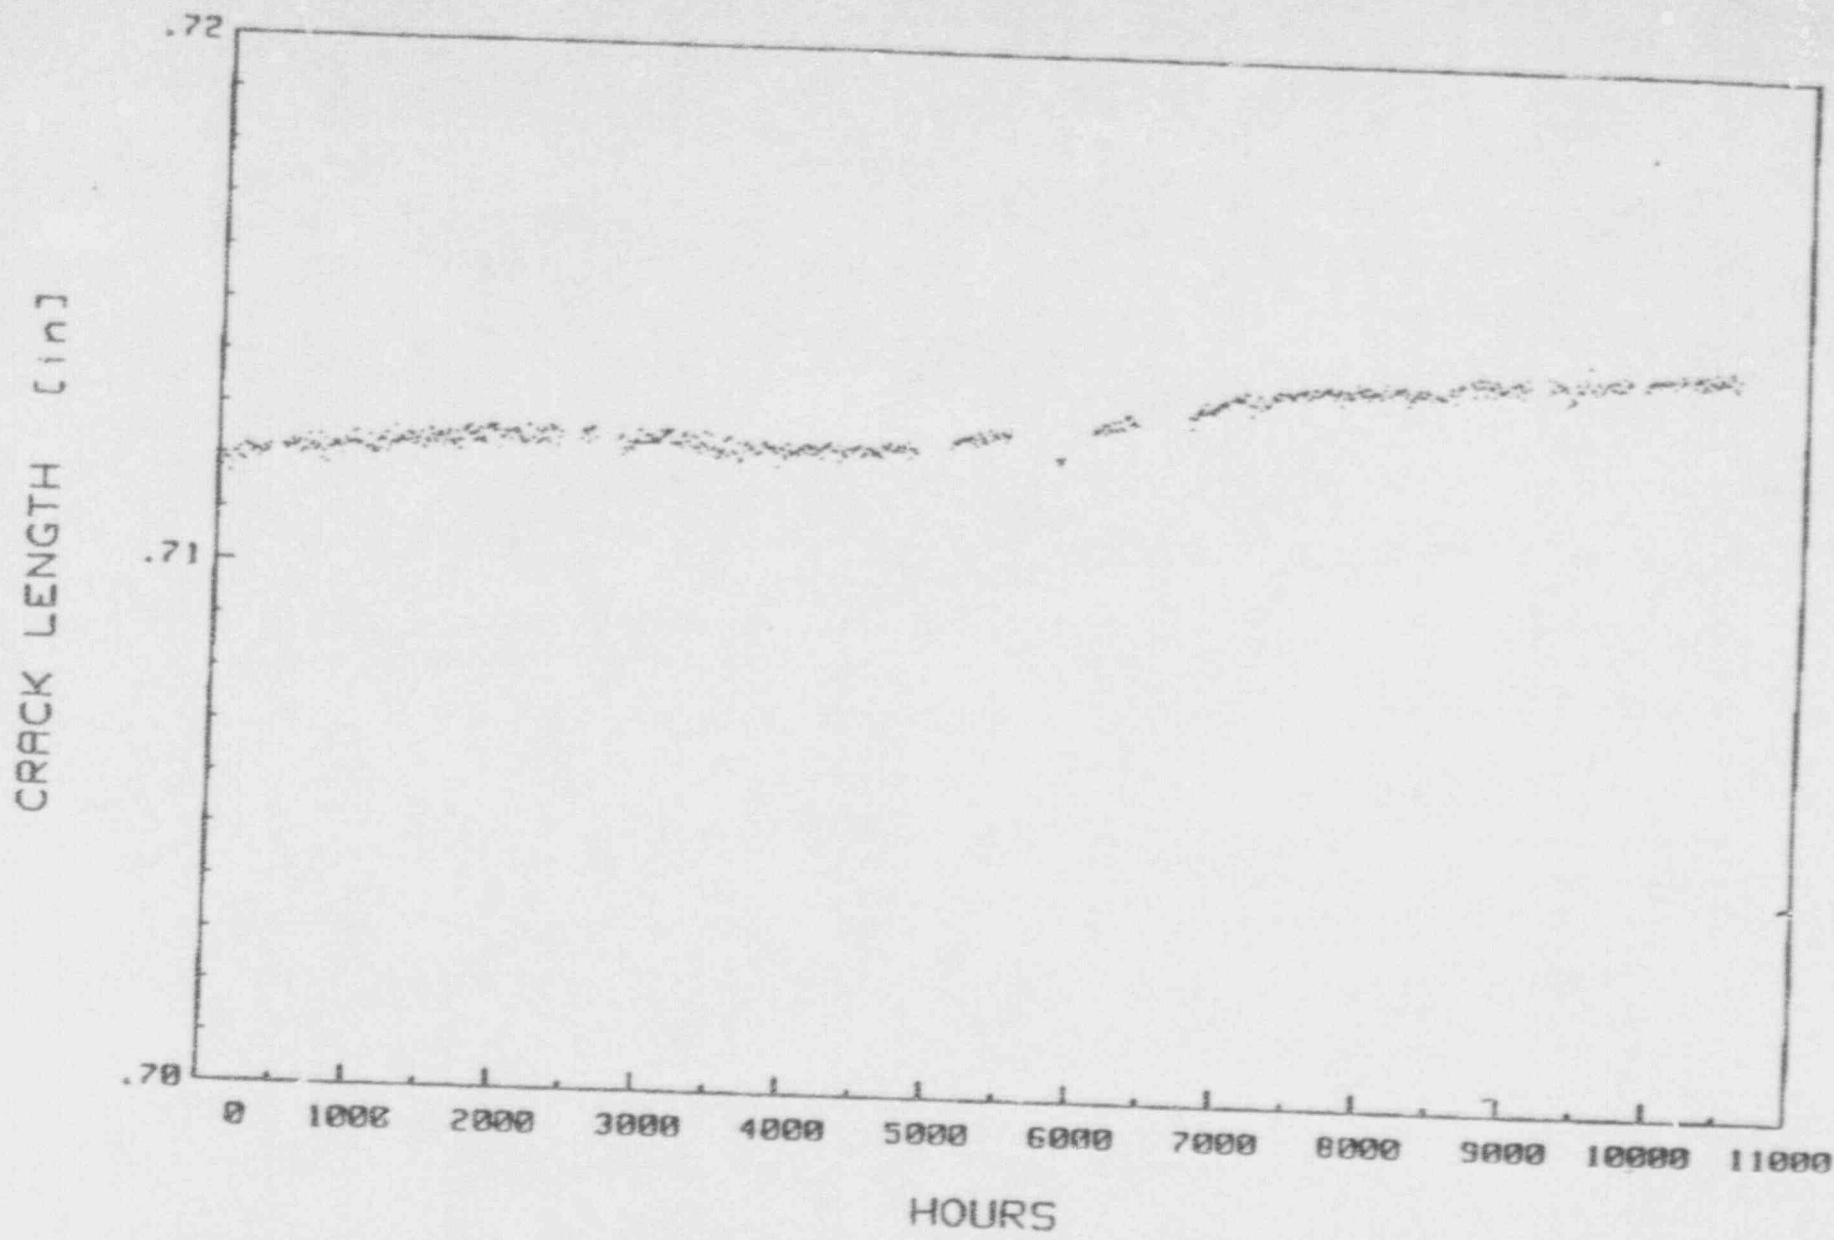
Figure 3. Plant Hatch Unit 1 CAV, Crack Length Versus Time Data, Fuel Cycle 13, Type 316NG Stainless Steel, Specimen SS-126, Stress Intensity 20 ksi/in.

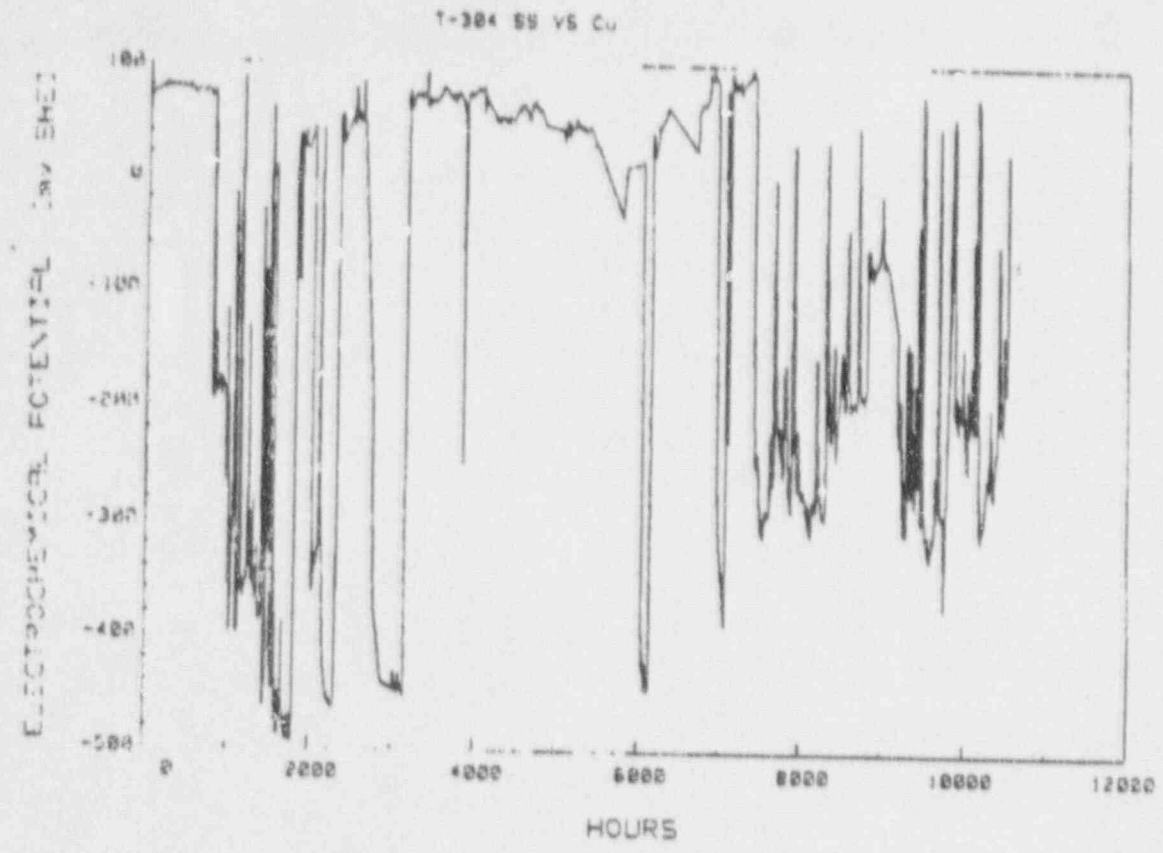
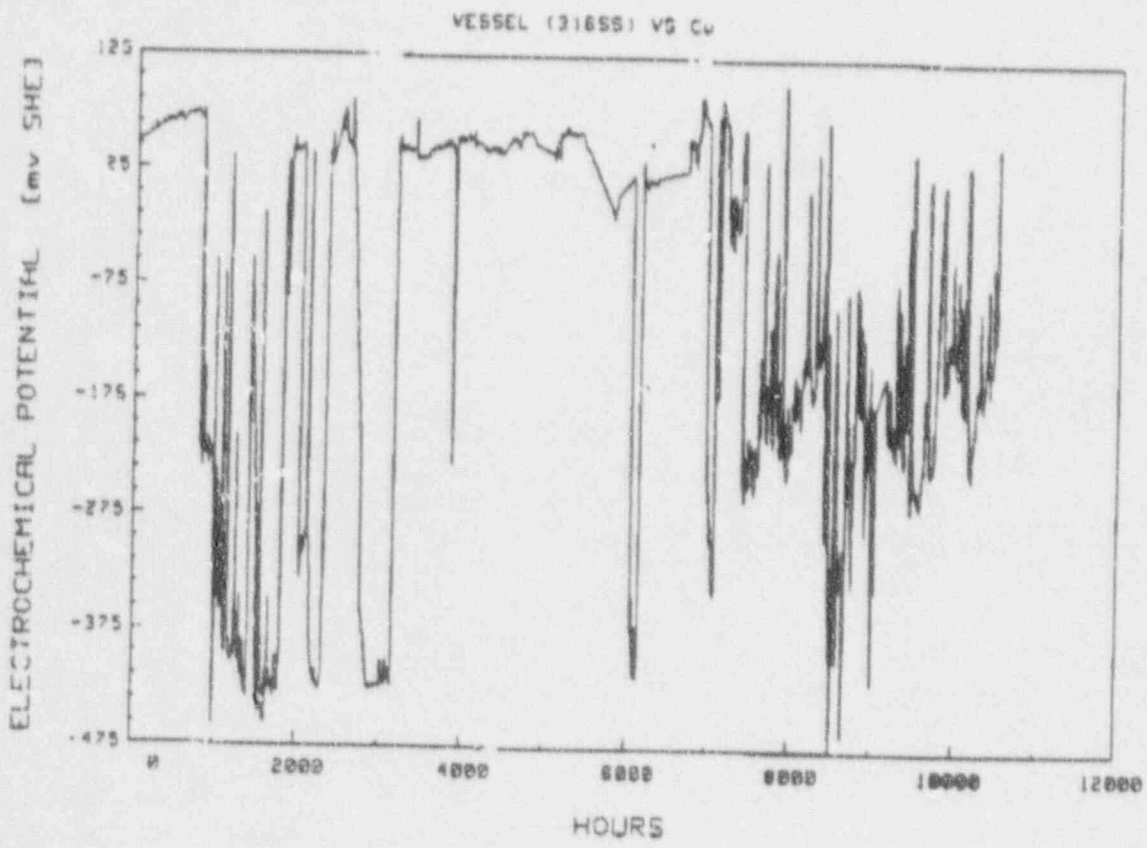
Figure 4. Plant Hatch Unit 1 CAV, Electrochemical Potential (ECP) Data, Fuel Cycle 13.
