Report No.: SIR-91-077  
Revision No.: 2  
Project No.: GPCO-20Q-2  
January 1992

IGSCC Flaw Evaluations and Weld Overlay  
Activities During the E. I. Hatch Unit 1  
Fall 1991 Outage

Prepared for:  
Georgia Power Company

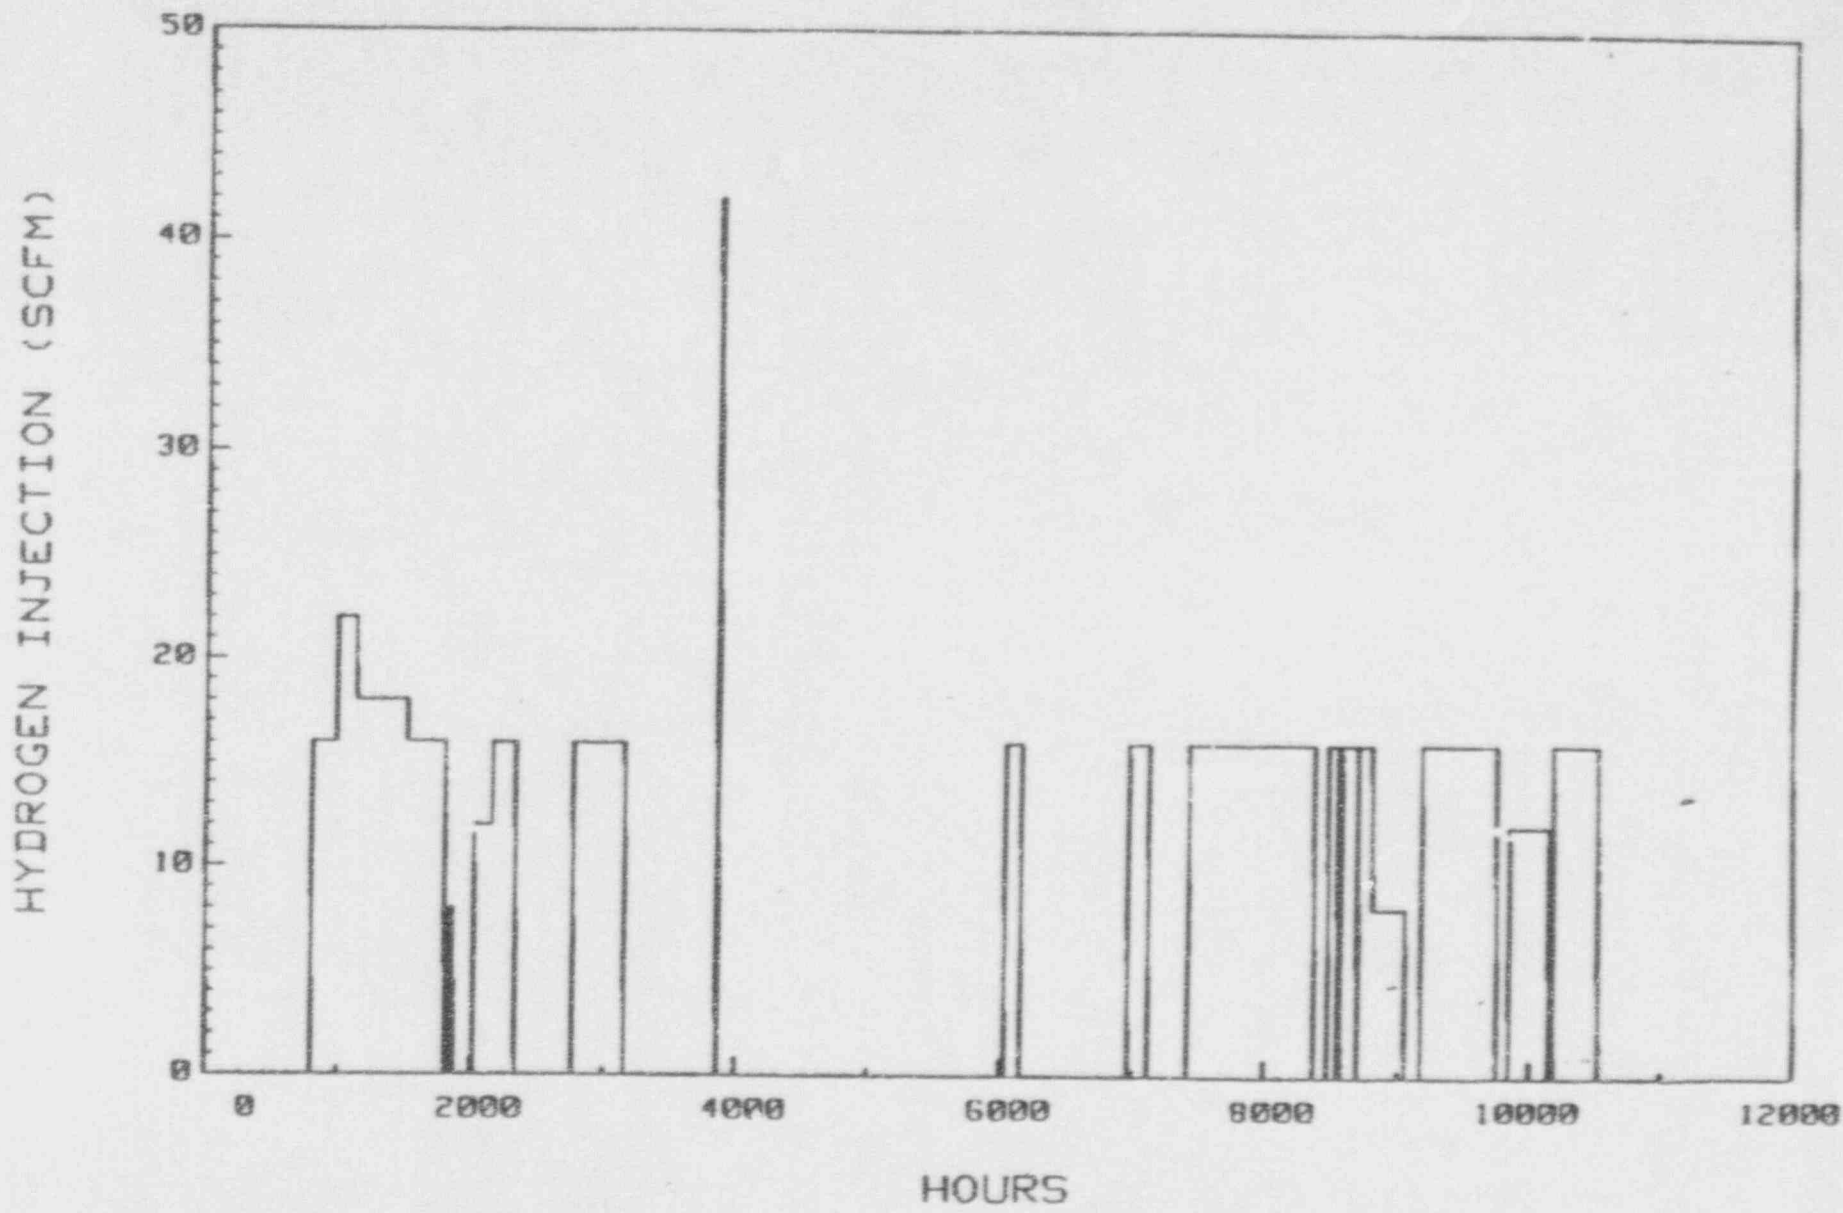
Figure 5. Plant Hatch Unit 1, Hydrogen Addition Rates, Fuel Cycle 13.

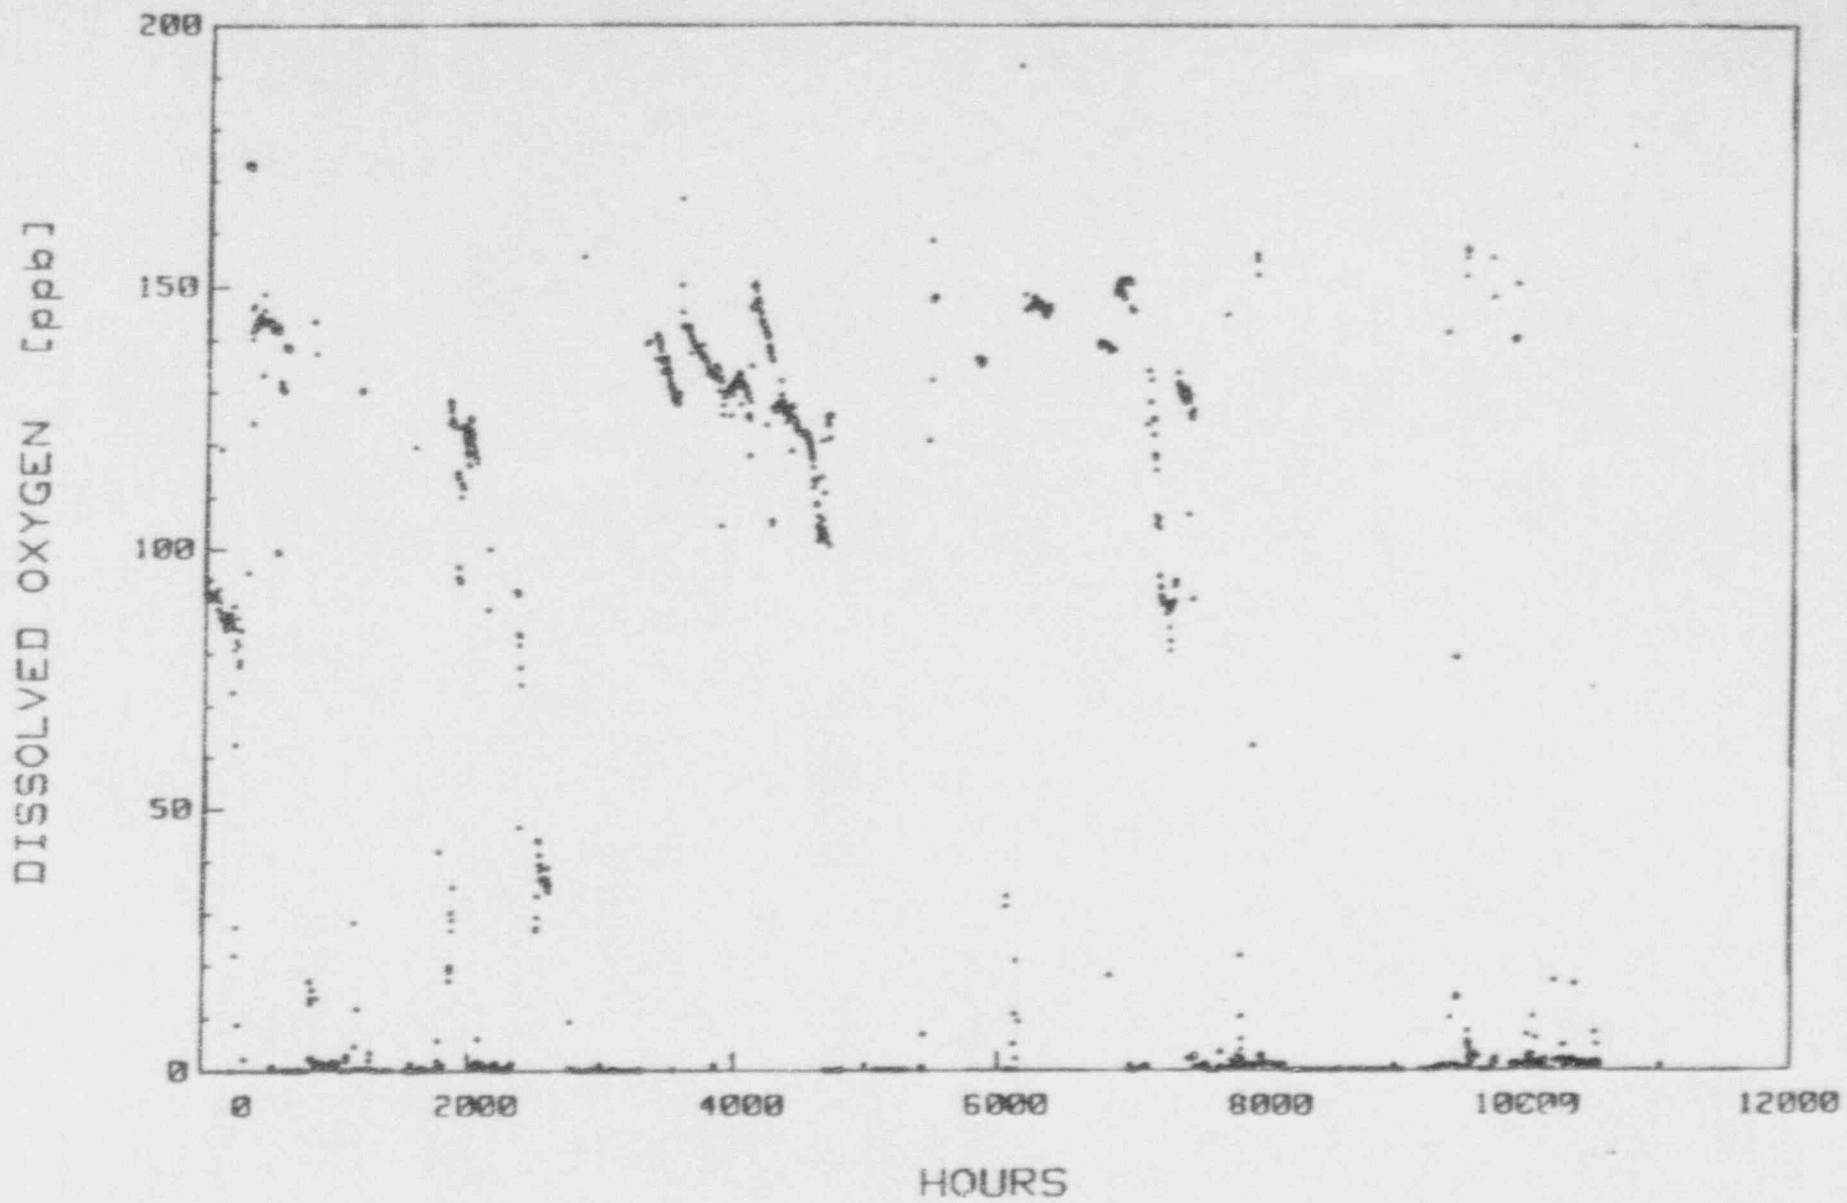
Figure 6. Plant Hatch Unit 1 CAV, Dissolved Oxygen Data, Fuel Cycle 13

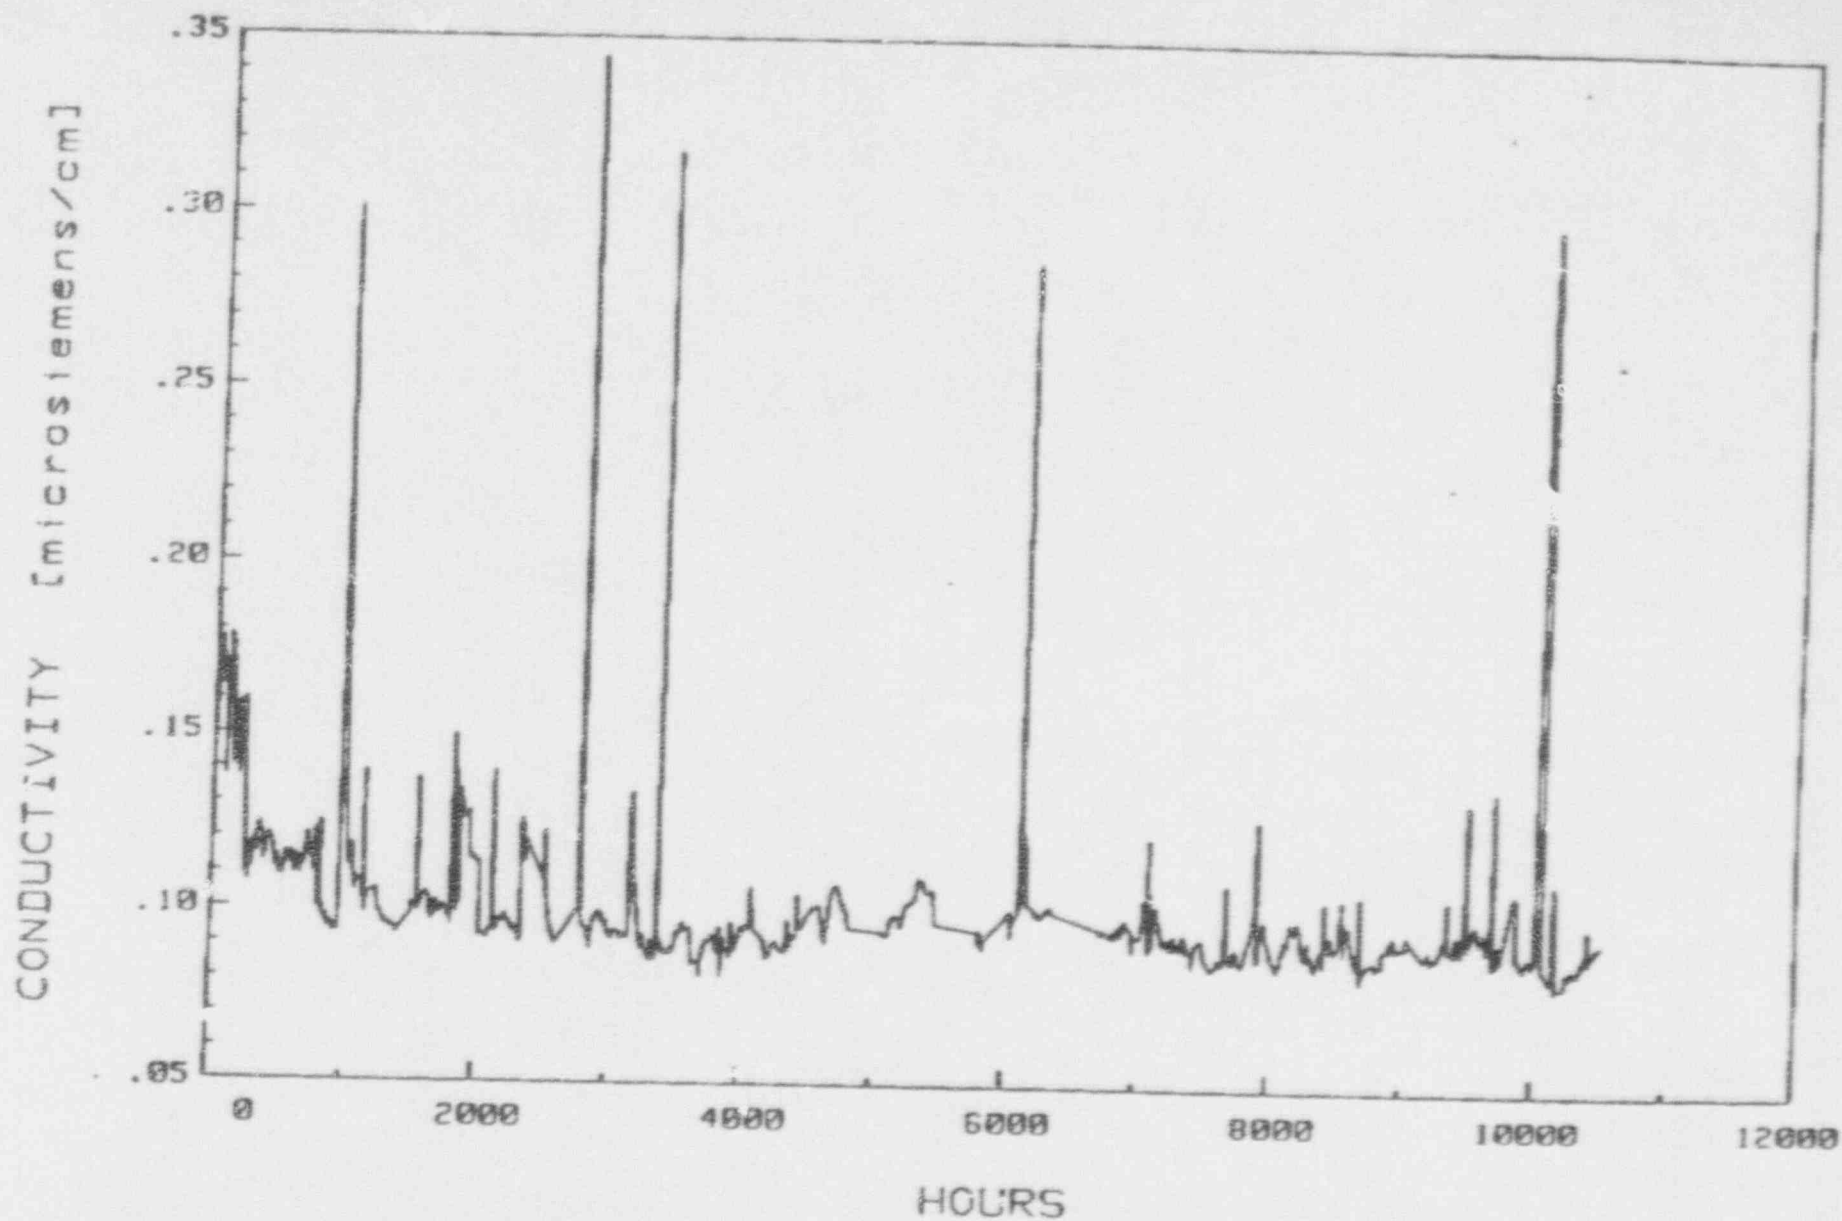
Figure 7. Plant Hatch Unit 1 CAV, Conductivity Data, Fuel Cycle 13.

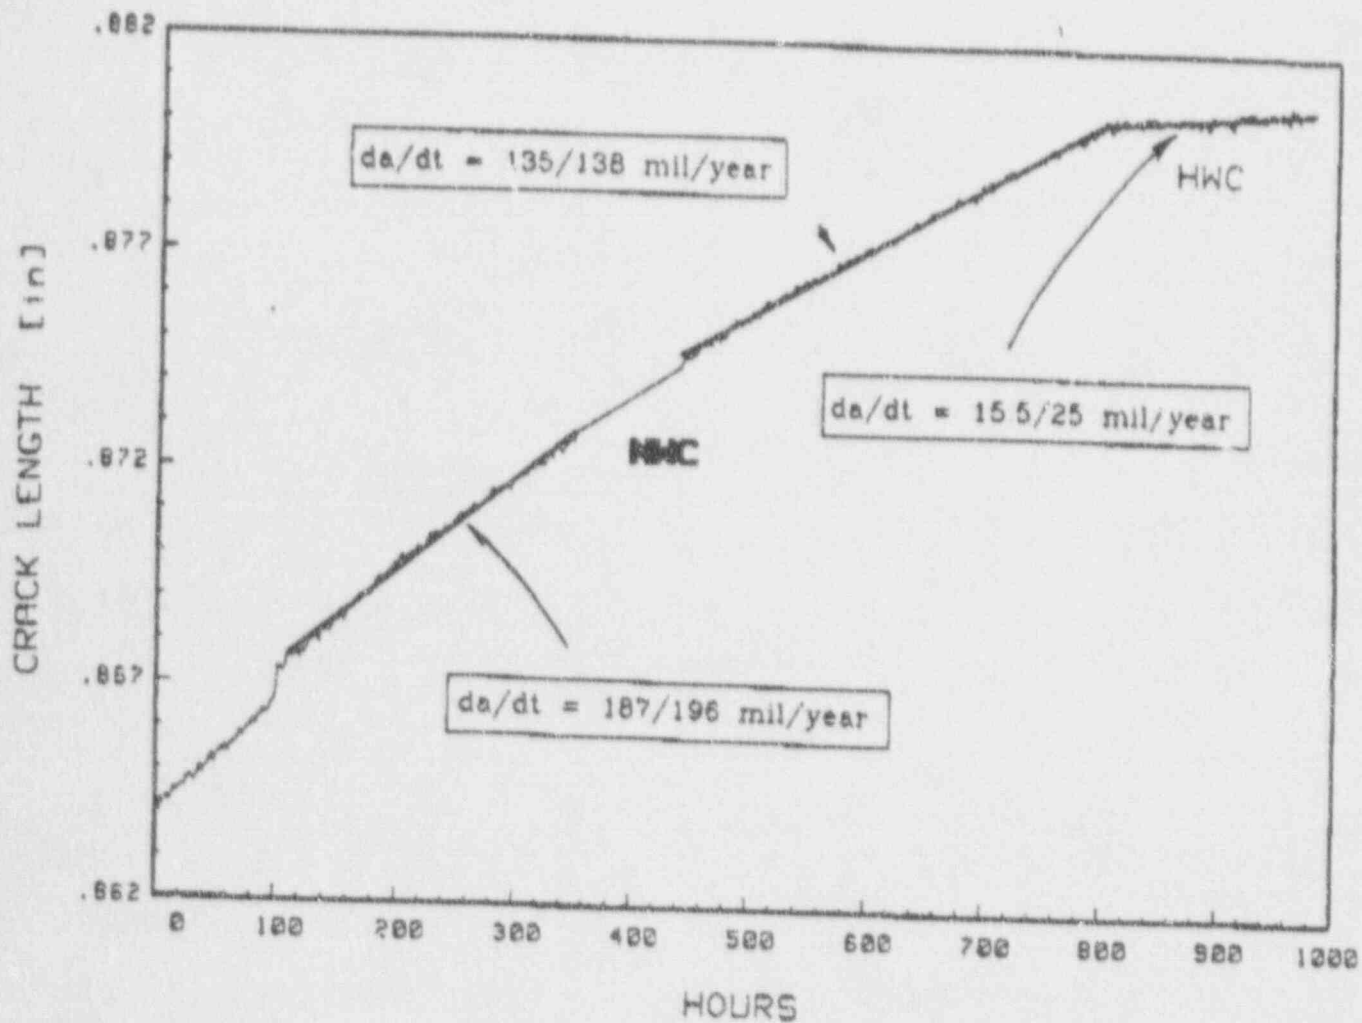
Figure 8. Plant Hatch Unit 1 CAV, Expanded View of Alloy 182 Crack Length Versus Time Data For Initial Application of Hydrogen Water Chemistry.

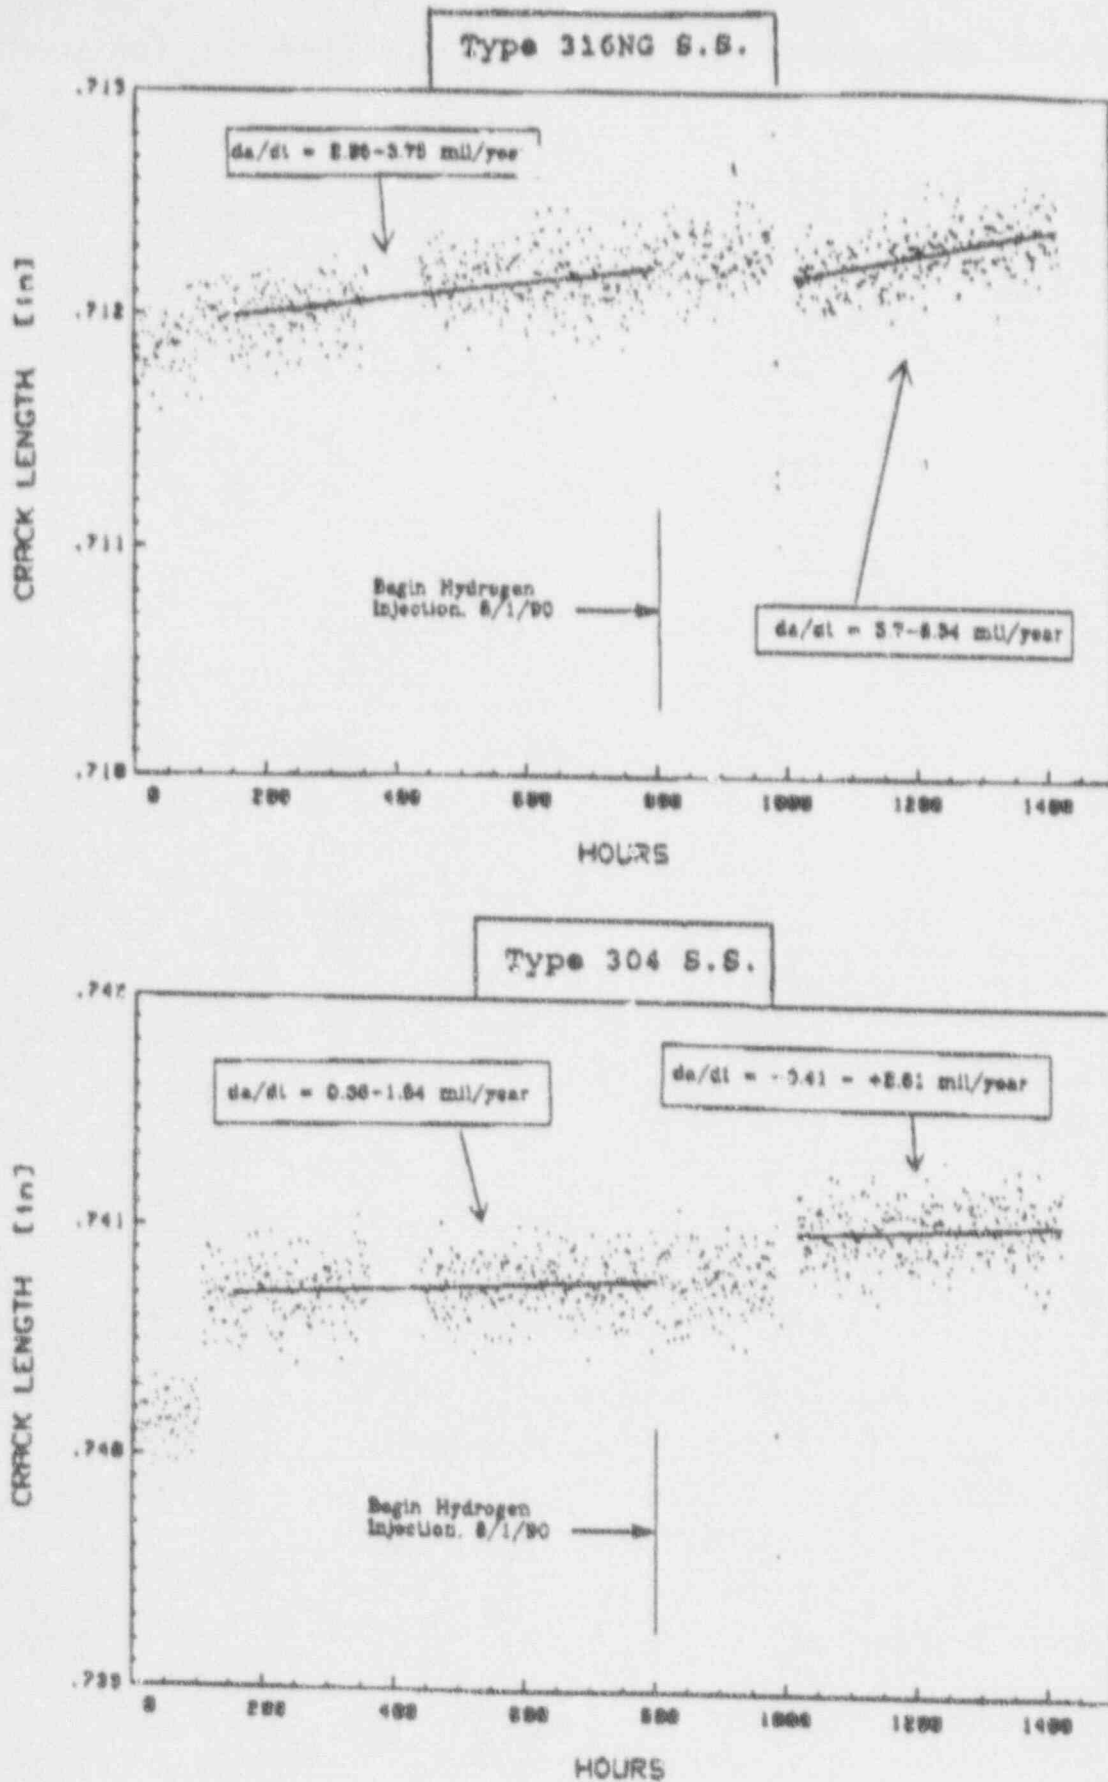
Figure 9. Plant Hatch Unit 1 CAV, Expanded View of Type 304 and 316NG Stainless Steel Crack Length Versus Time Data For Initial Application of Hydrogen Water Chemistry.

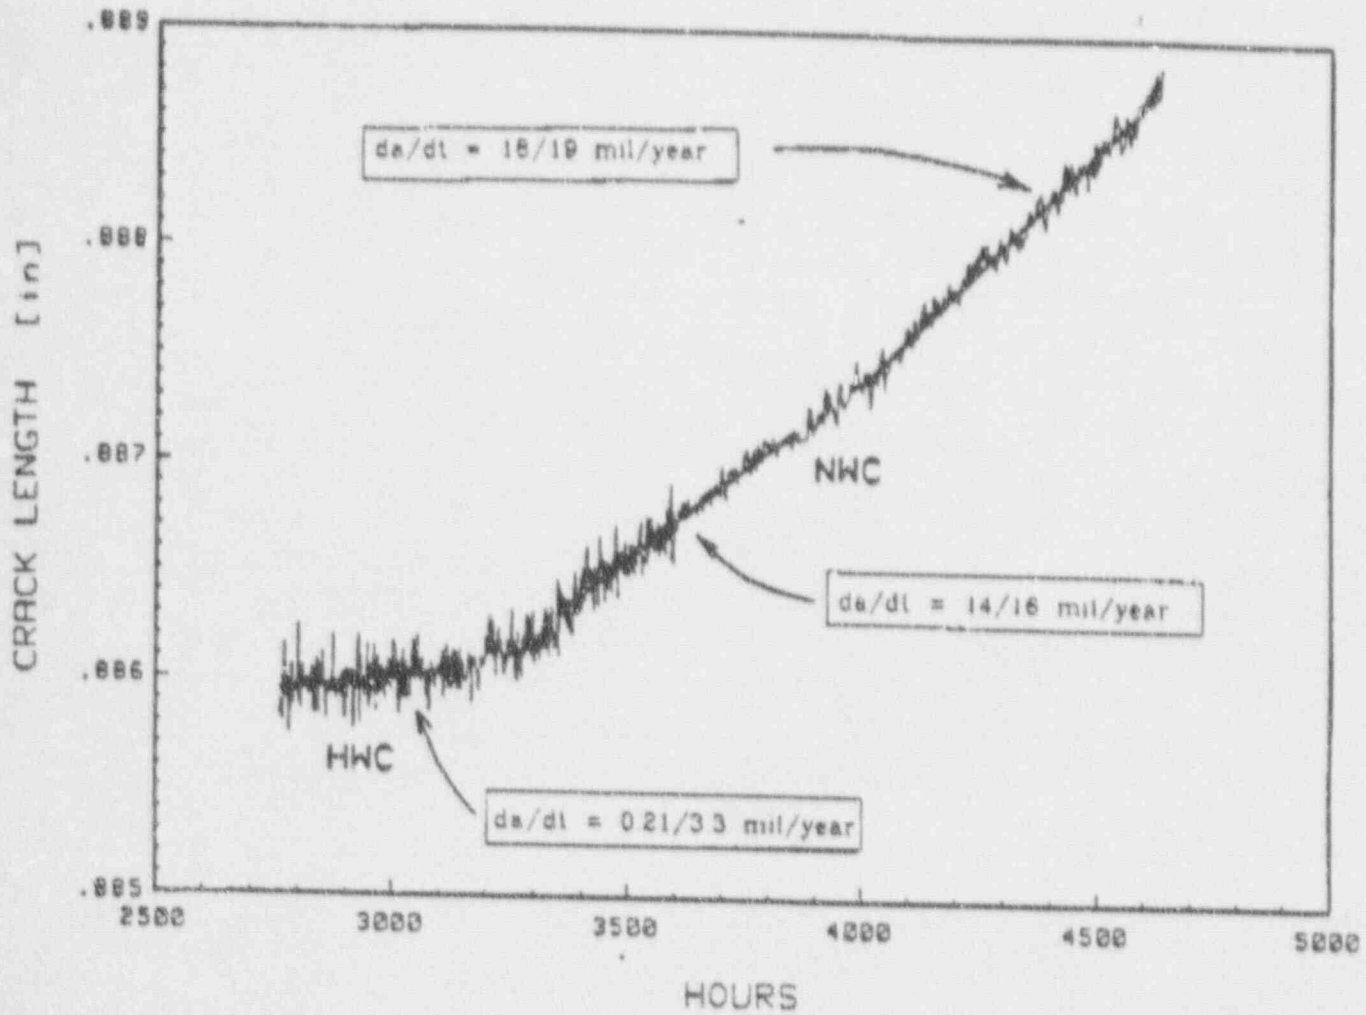
Figure 10. Plant Hatch Unit 1 CAV, Expanded View of Alloy 182 Crack Length Versus Time Data For Time Period After Resumption of Normal Water Chemistry, October/November 1990.

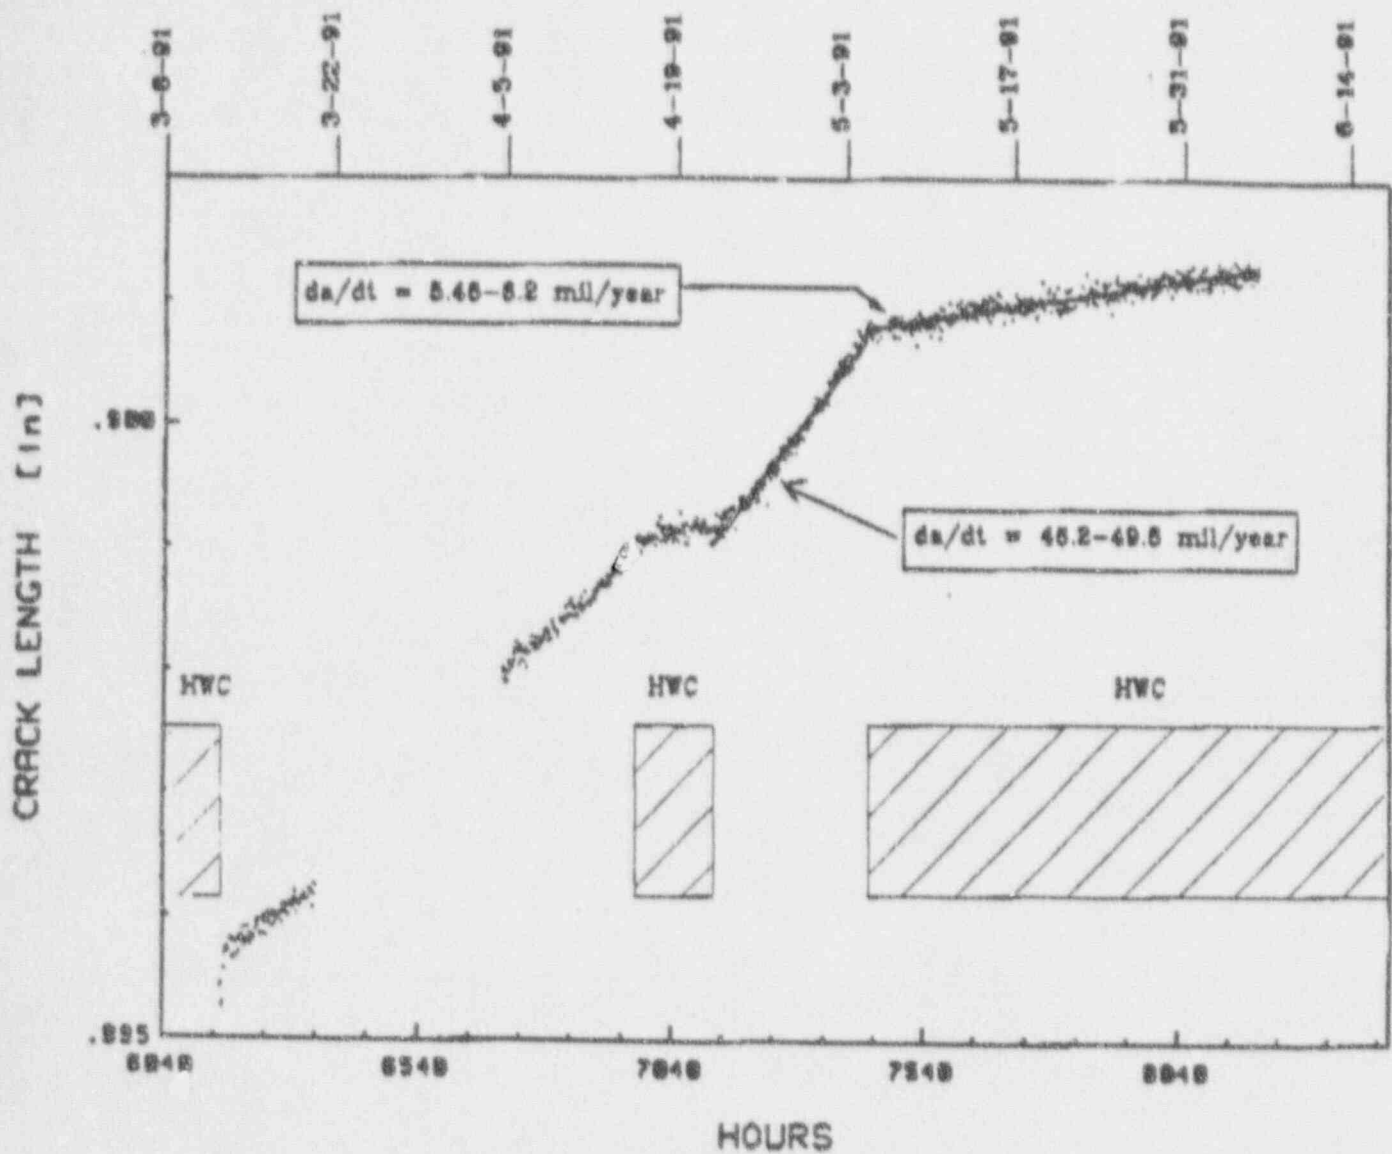
Figure 11. Plant Hatch Unit 1 CAV, Expanded View of Alloy 182 Crack Length Versus Time Data For Time Period After Resumption of Normal Water Chemistry, March/June 1991.

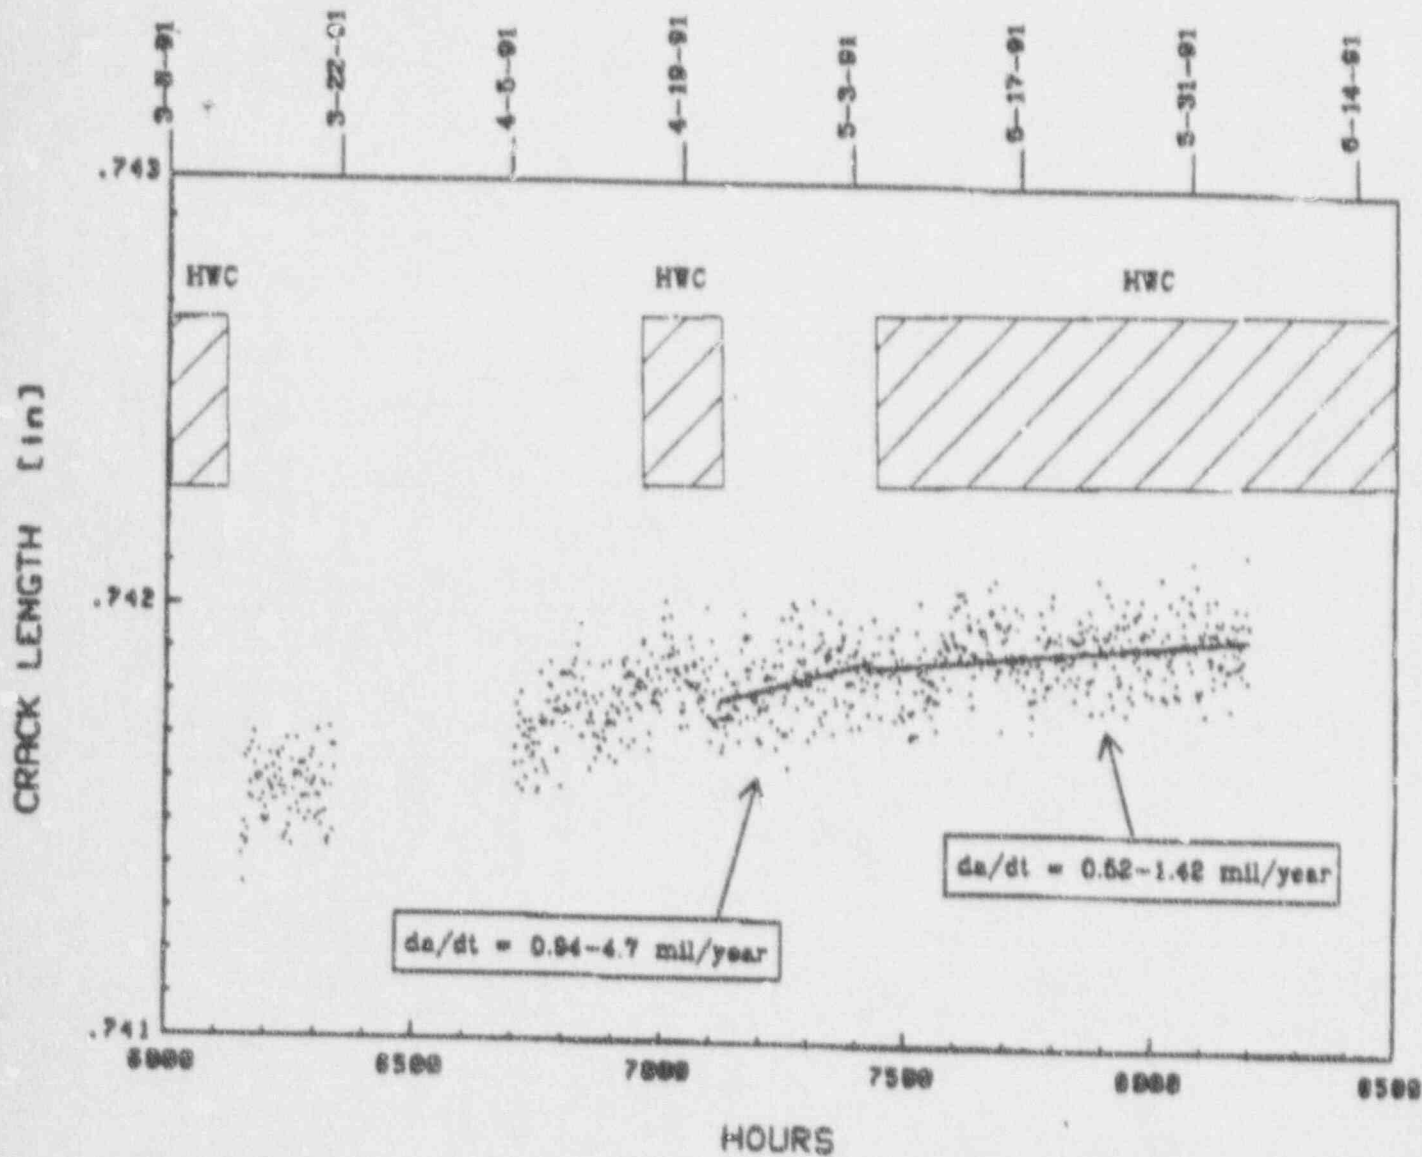
Figure 12. Plant Hatch Unit 1 CAV, Expanded View of Type 304 Stainless Steel Crack Length Versus Time Data For Time Period After Resumption of Normal Water Chemistry, March/June 1991.

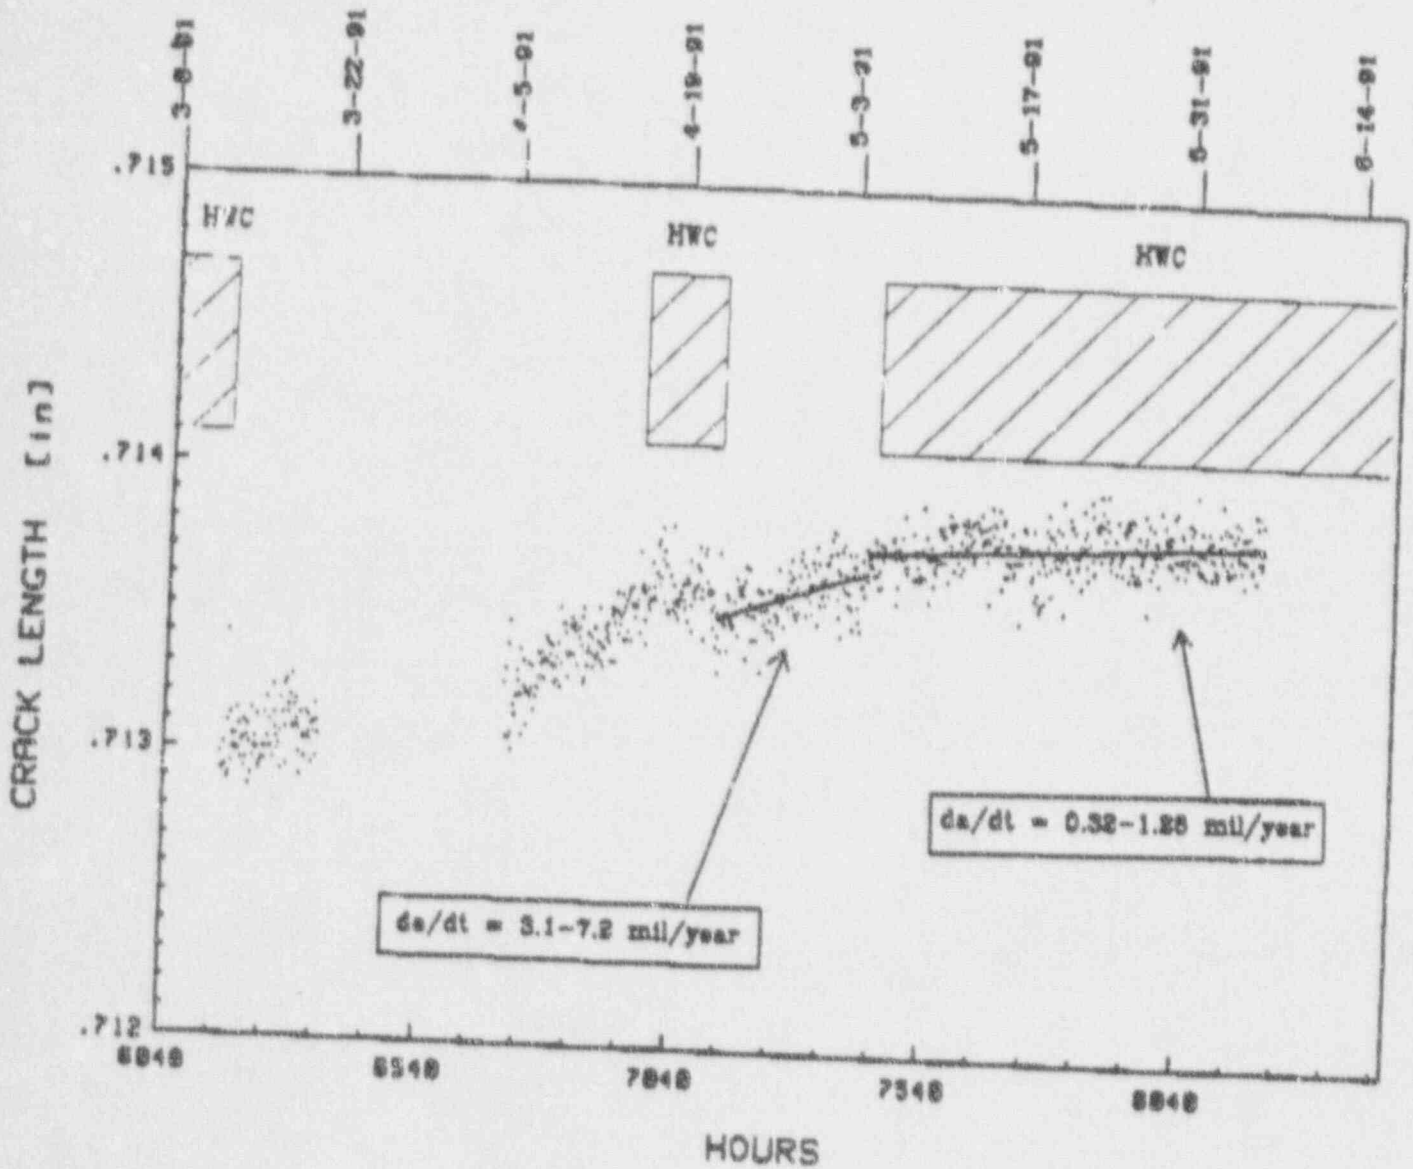
Figure 13. Plant Hatch Unit 1 CAV, Expanded View of Type 316NG Stainless Steel Crack Length Versus Time Data For Time Period After Resumption of Normal Water Chemistry, March/June 1991.
