FaAA-84-2-14
7396/PA0:R03341A

**INVESTIGATION OF TYPES AF AND AE
PISTON SKIRTS**

Prepared by
Failure Analysis Associates

Prepared for
TDI Diesel Generator Owners Group

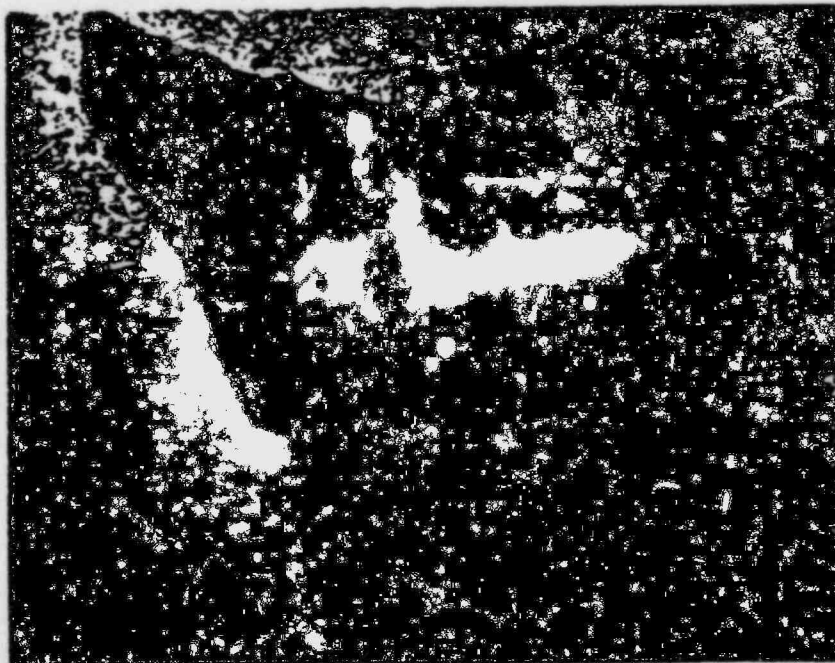
Figure 2-8. Macro photograph of a pre-existing crack cut out of EDG #103, No. 7 cylinder piston skirt and fractured open. This low magnification photograph shows both of the mating fracture surfaces after the ridge segment was opened.

Three AF-type piston skirts were examined by eddy current to confirm the presence of cracks; eleven of the twelve bosses contained one or two cracks. The cracks appeared on the inside of the skirt in the vertical ridges remaining after spot-facing of the bosses. A total of four linear indications, revealed by dye penetrant testing, were subsequently saw-cut and fractured out of the three skirts. These indications were opened by fracturing and proved to be cracks. All the cracks were located at the base of the vertical ridges approximately 0.1 inch above the spot-faced surface. The crack size varied from 0.3-inch deep by 0.9-inch long to 0.2-inch deep by 0.3-inch long. Location of these cracks is shown in Figures 2-3 and 2-4. Macrophotographs of the four opened cracks are given in Figures 2-5 to 2-9.

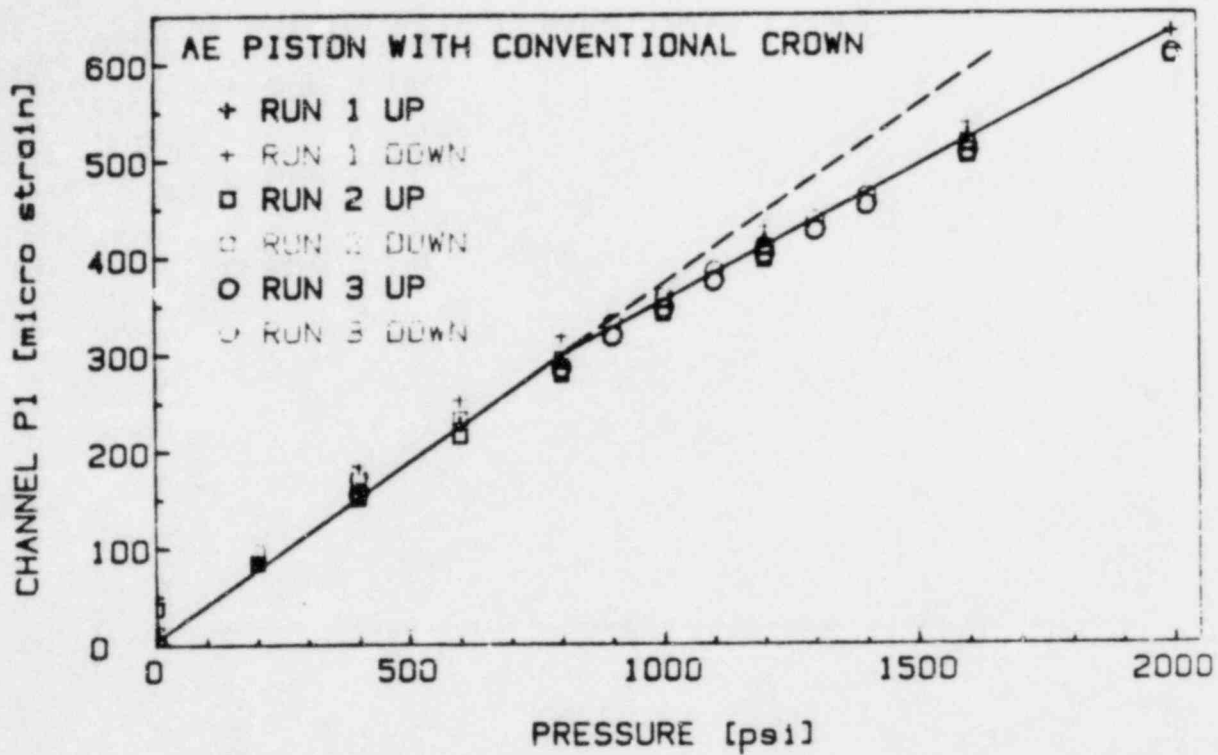
Figure 3-6. Axial strain as a function of pressure for strain gage rosette P located at inner portion of wrist pin cavity.

Further evidence of a gap closure pressure of about 1000 psig (at room temperature) is provided by considering the strain data from the rosettes in the wrist pin cavity (P at inner ring, R at outer ring) and at the top of the skirt 90° from the wrist pin (N). Figure 3-6 presents the axial strain (ϵ_2) measured in the inner part of the wrist pin cavity (P) with a conventional crown. Once again, a bilinear relation with pressure is observed, with the slope change occurring at about 1000 psig. In this instance, the slope change is not as large.

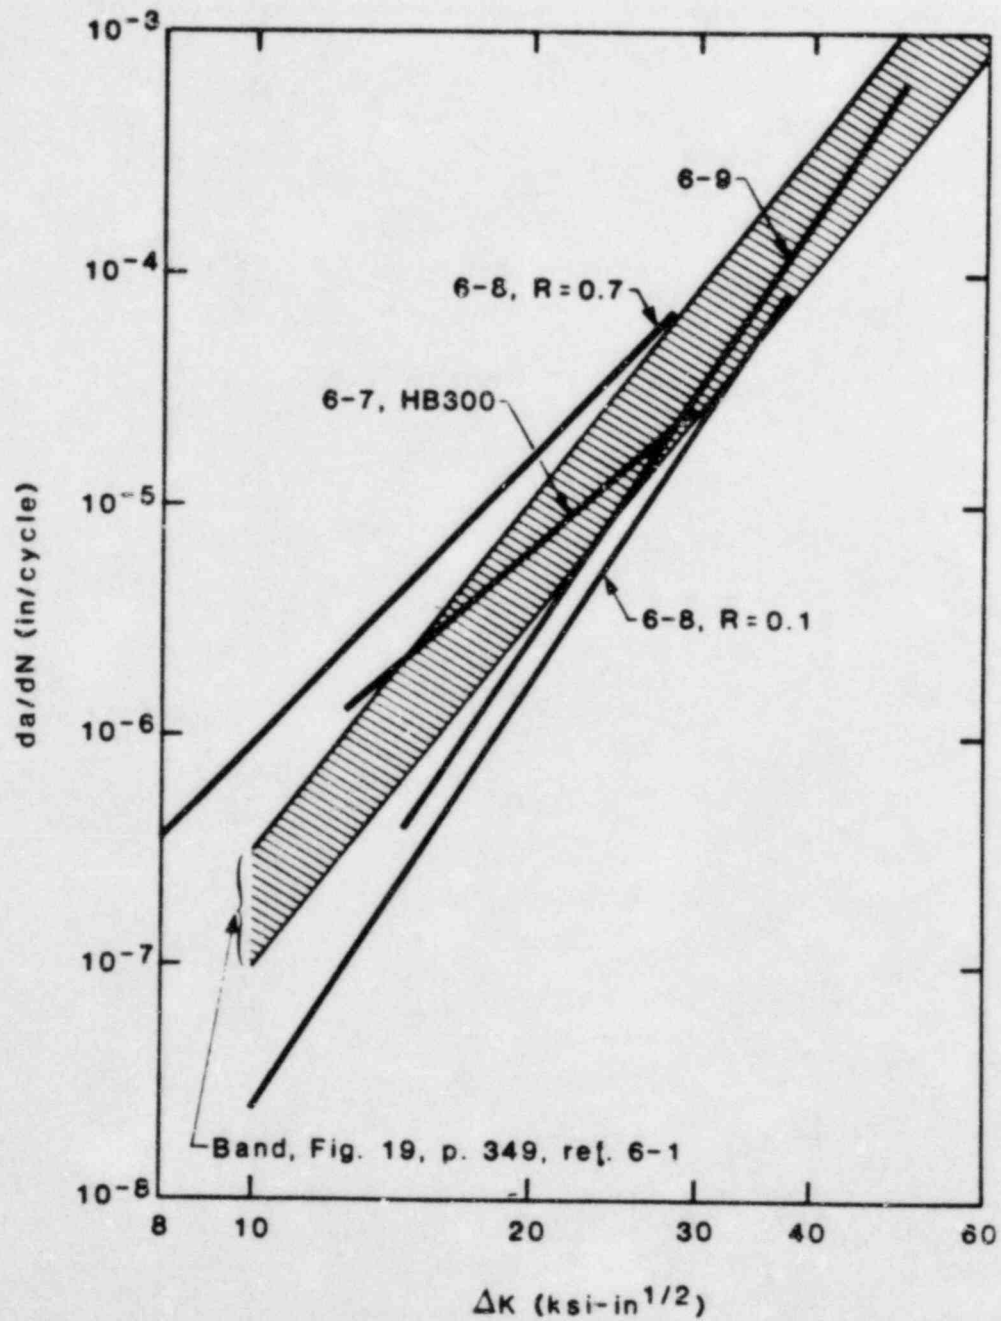
Figure 6-4. Representation of da/dN versus ΔK data for nodular condition.
