NUREG/CR-3263
SAND83-2622
RV
Printed April 1984

Status Report: Correlation of Electrical Cable Failure With Mechanical Degradation

Prepared by
Sandia National Laboratories
Albuquerque, New Mexico 87185 and Livermore, California 94550
for the United States Department of Energy
under Contract DE-AC04-76DP00789

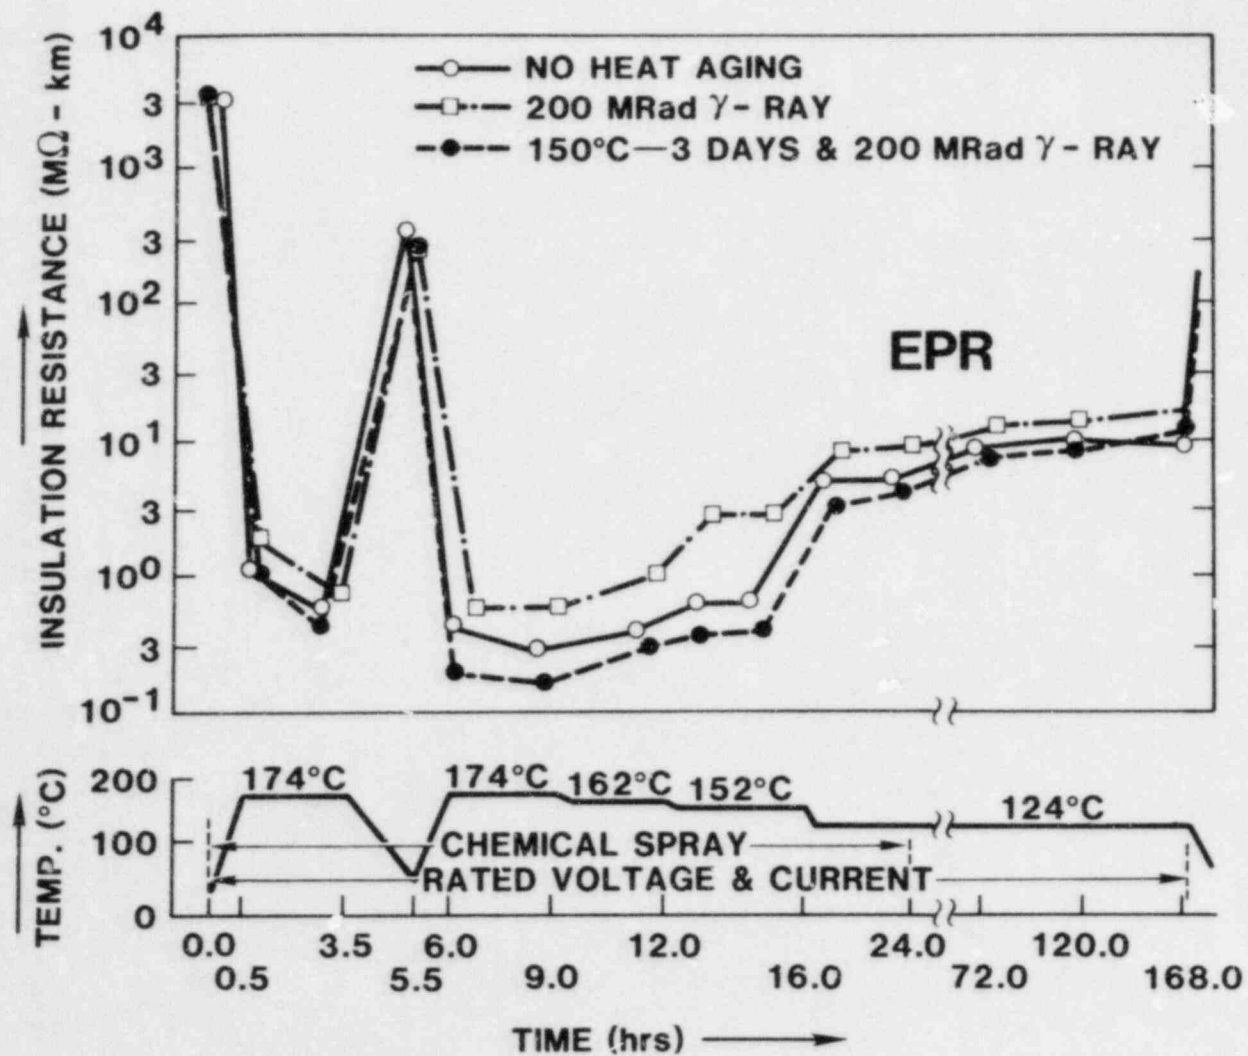
Figure 4. Insulation Resistance in Steam and Chemical Spray Environment (Flame Retardant EPR) (After Murata, Ref. 18)

Not many measurements in literature are made at temperatures as high as 225°C. If we wish to determine from such lower temperature measurements (e.g., Figure 4), the highest safe operational temperature, we may (for EPR) use the leakage current curve in Figure 5 for scaling. It is found, that a cable exhibiting 96 Mohm·m at 175°C would show 7.5 Mohm·m at 200°C and 0.24 Mohm·m, the critical value, at 225°C. The cables used for obtaining Figure 4 would therefore still be usable up to 225°C.

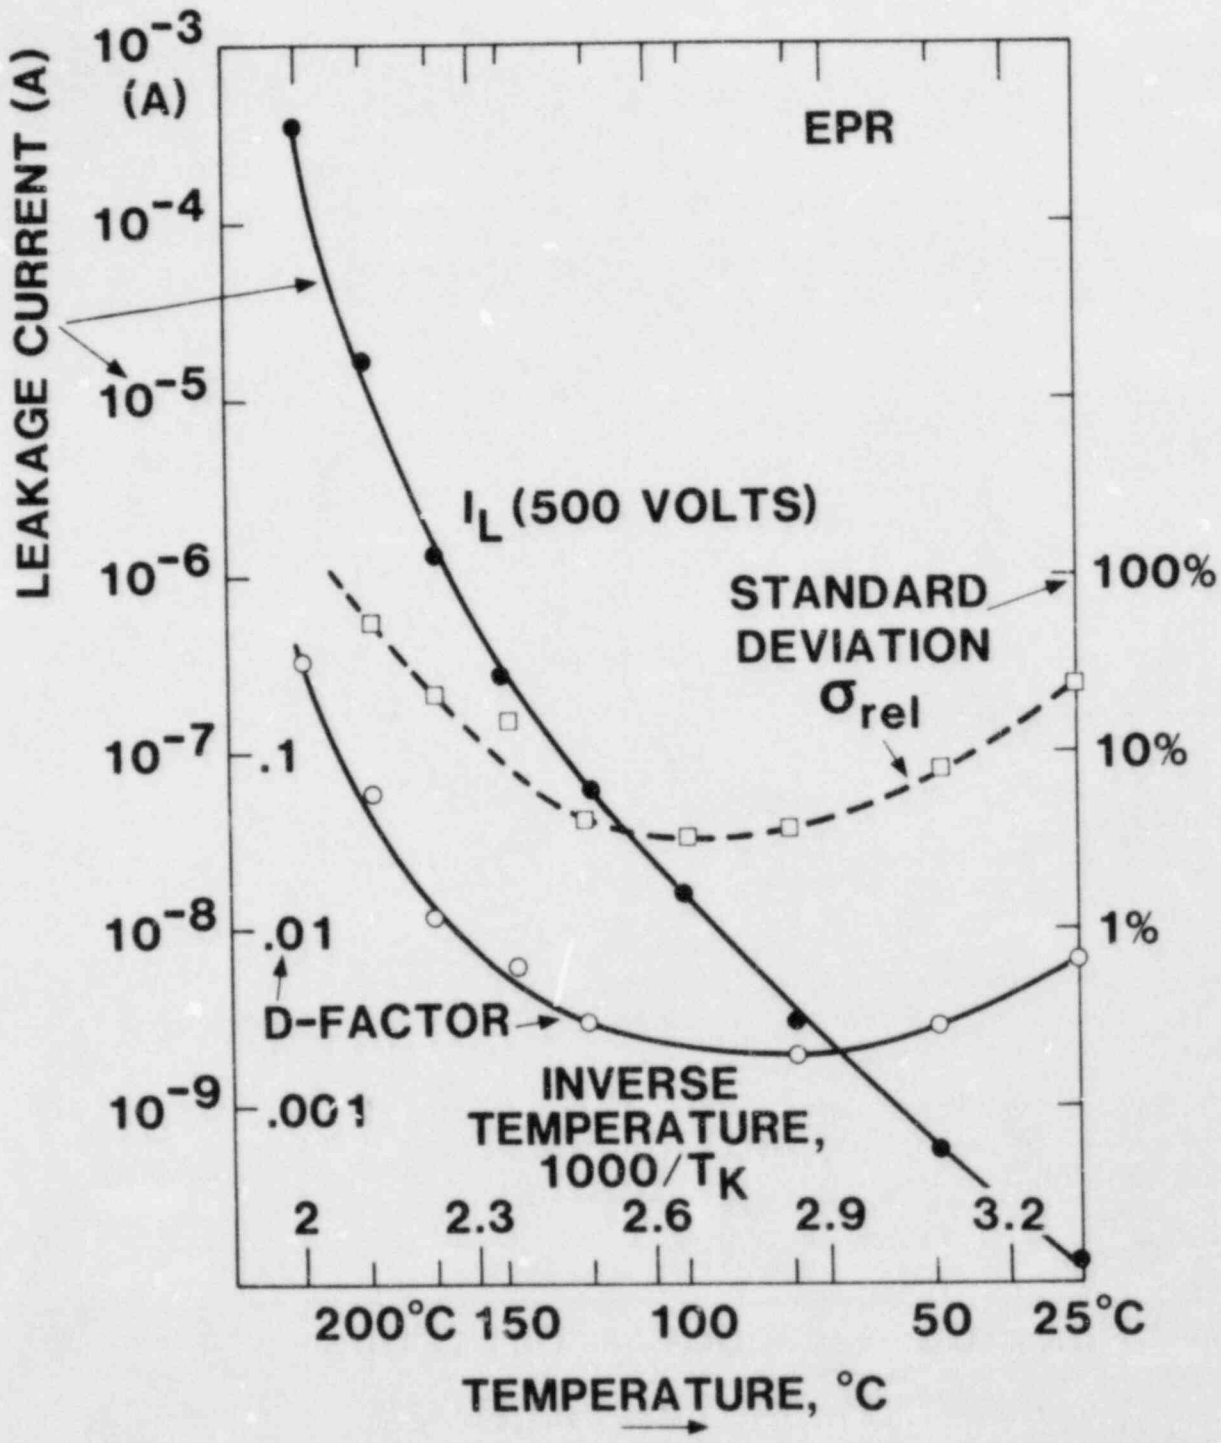
Figure 5. DC-Leakage Current I_L for 1-m Cable Length (Standard Deviation of I_L is σ_{rel} and Dissipation Factor is D)

Figure 5 gives an example of higher temperature measurements (up to 225°C) performed in our investigation. The dc leakage current (I_L), averaged over ten 1-m-long cable samples, is seen to increase by nearly 7 orders of magnitude over the current measured at room temperature. The ac dissipation factor (D) first decreases with increasing temperature (as additives perhaps diffuse out of the polymers) and then rises to not quite 0.35; dissipation factors were measured at operational ac voltages and frequencies.

The above deductions assume that the loss resistance and the D-factor are reasonably uniformly distributed along the cable, i.e., that there is no "bad spot" solely responsible for the leakage current. For the measurements in Figure 5, this is assured by the standard distribution value for the 10 leakage current measurements, which reaches only a factor of 2 for the highest temperatures. Unfortunately, many measurements in literature are made only with one or a very few cable samples.

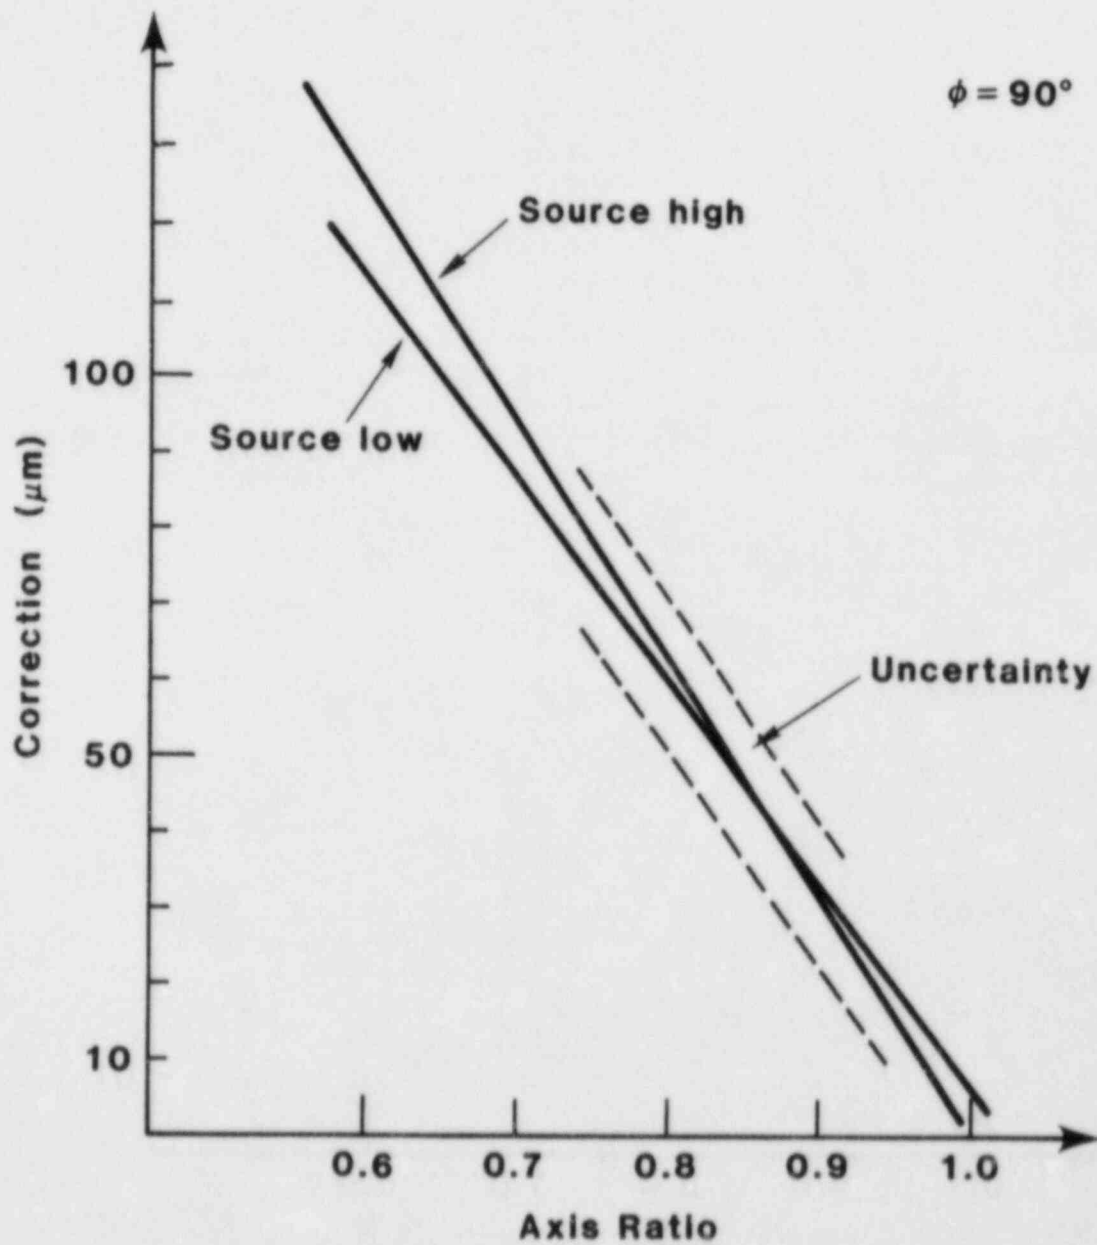
Figure 12. Correction for Creep Distance as Function of the Ratio Between Ellipse Axes (for cases where angle $\phi = 90^\circ$)

The analysis of the correction²² is straightforward although lengthy. Up to now, the corrections obtained were generally less than 20 μm . For the present dimensions of the gooseneck support diameter (4.76 mm), the alignment hole diameter (1 mm), and the distance to the light source (2 m), the correction for vertical distortion (angle $\phi = 90^\circ$) is shown in Figure 12. For angles ϕ less than 90° , the correction quantity is determined by multiplication with $\sin \phi$; pure horizontal motion of the gooseneck does not require a correction for y . In Figure 12, the expected "uncertainty" in the image as seen in the X-ray pictures is also indicated. This uncertainty is due to the finite size of the present source (2 mm).

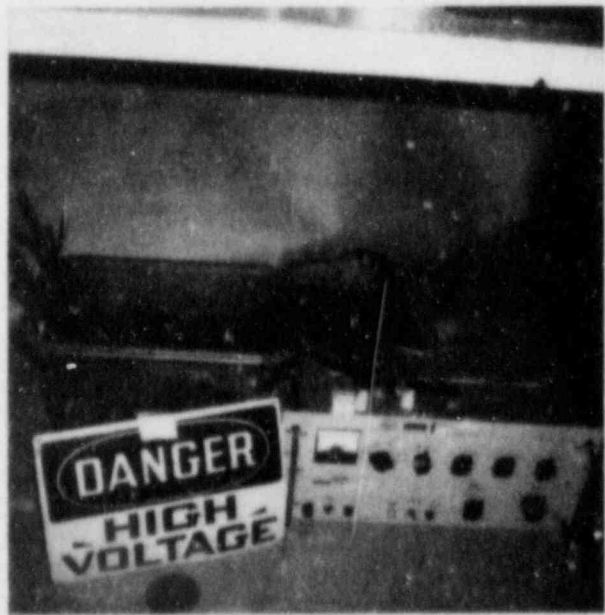
Figure 14. Setup for the Treeing Test

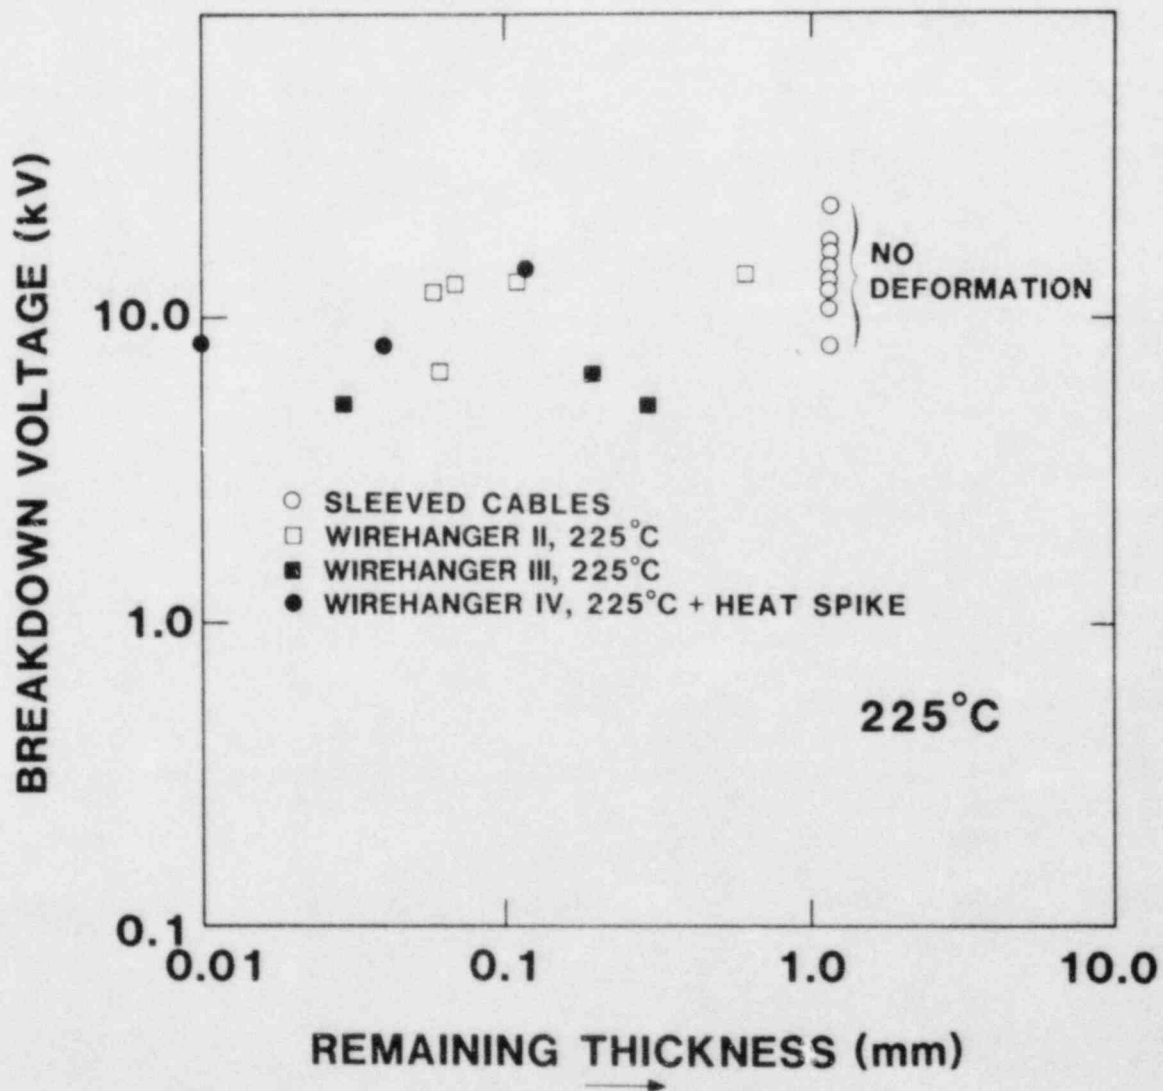
Figure 24. DC Breakdown Voltage vs Remaining Polymer Thickness at 225°C
