WCAP 13222

STEAM GENERATOR TUBE ALTERNATE
PLUGGING CRITERIA PRESENTATION MATERIALS

FEBRUARY, 1992

A meeting was held on February 6, 1992 in Rockville, Md. between Southern Nuclear Operating Company, Westinghouse and the NRR staff. An interim steam generator tube plugging criterion (1 cycle) for tube support plate elevation outer diameter stress corrosion cracking (OD SCC) for application at Farley Unit 2 was proposed at the meeting.

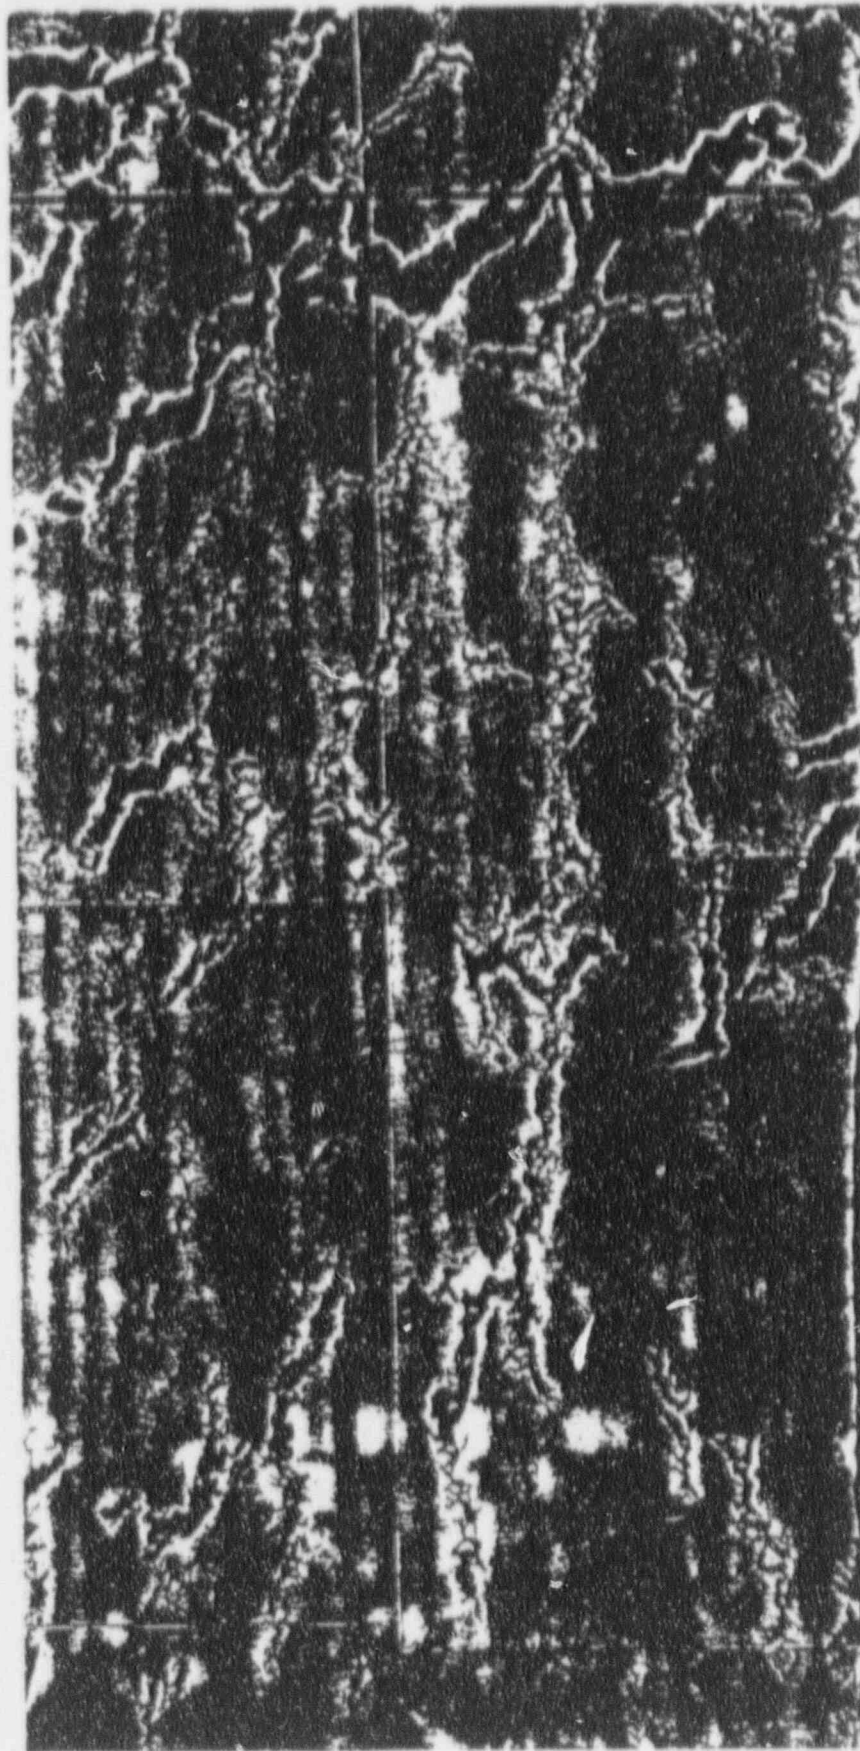
CHORD
SECTION

TRANSVERSE CROSSSECTION
SHADED AREAS INDICATE
INTERGRANULAR FRACTURE
APPEARANCE
