NUREG/CR-6154
SAND94-1711
Vol. 2

Experimental Results From Containment Piping Bellows Subjected to Severe Accident Conditions

Results from Bellows Tested in Corroded Conditions

Sandia National Laboratory

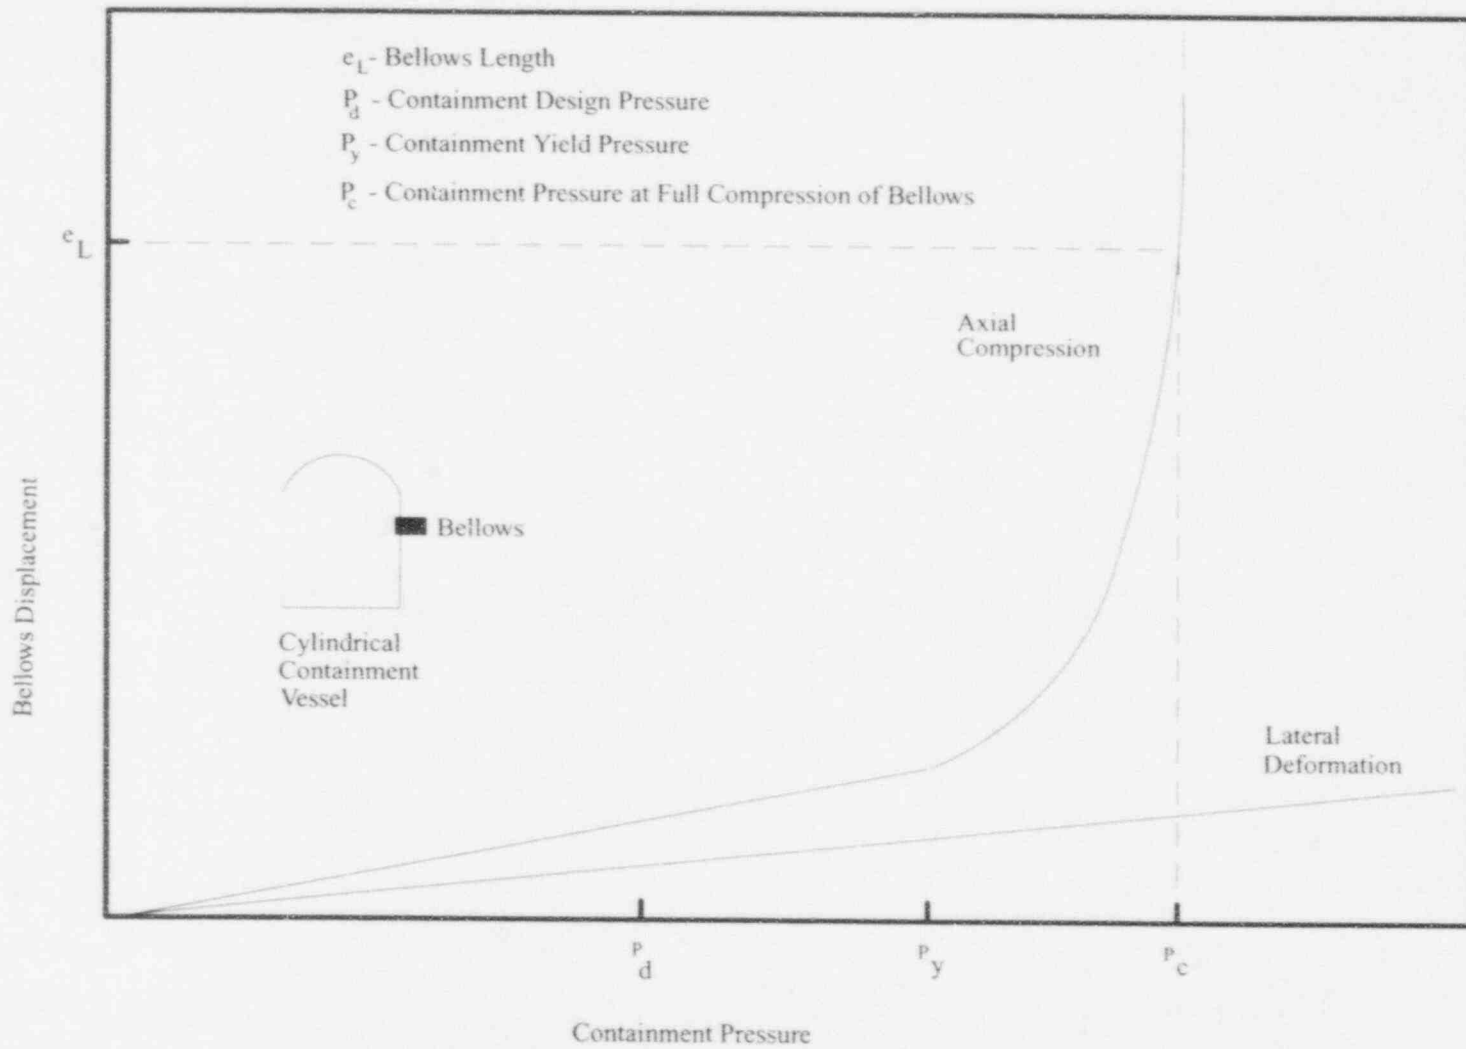
Figure 3. Typical Bellows Loadings Vs. Containment Response

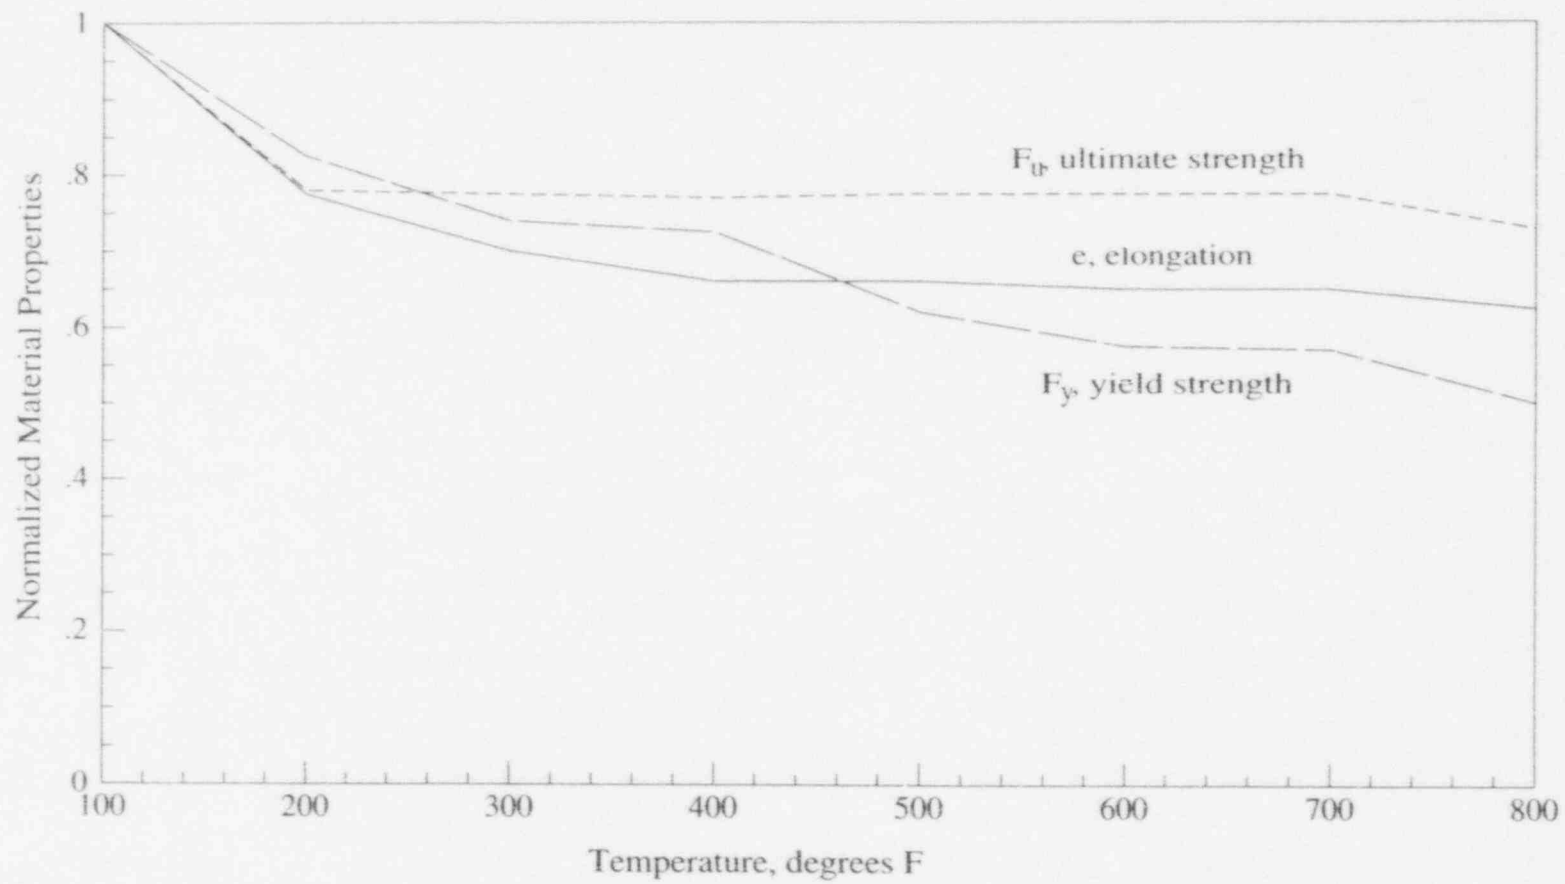
Figure 4. Effect of Elevated Temperature on F_u , F_y , and e of Type 304 Stainless Steel

The material properties of type 304 stainless steel, which is used in containment bellows construction, degrades with increasing temperature. The loss of elongation (or "ductility") is reportedly reduced by about 35% from ambient to 400°F. Figure 4 was generated using material data taken from several sources [9, 10, 11, 12].

Since ductility is the most important material property in determining bellows tearing, and the largest change occurred between room temperature and 400°F, all but one of the corroded specimens were tested at temperatures of 425 ± 25°F.

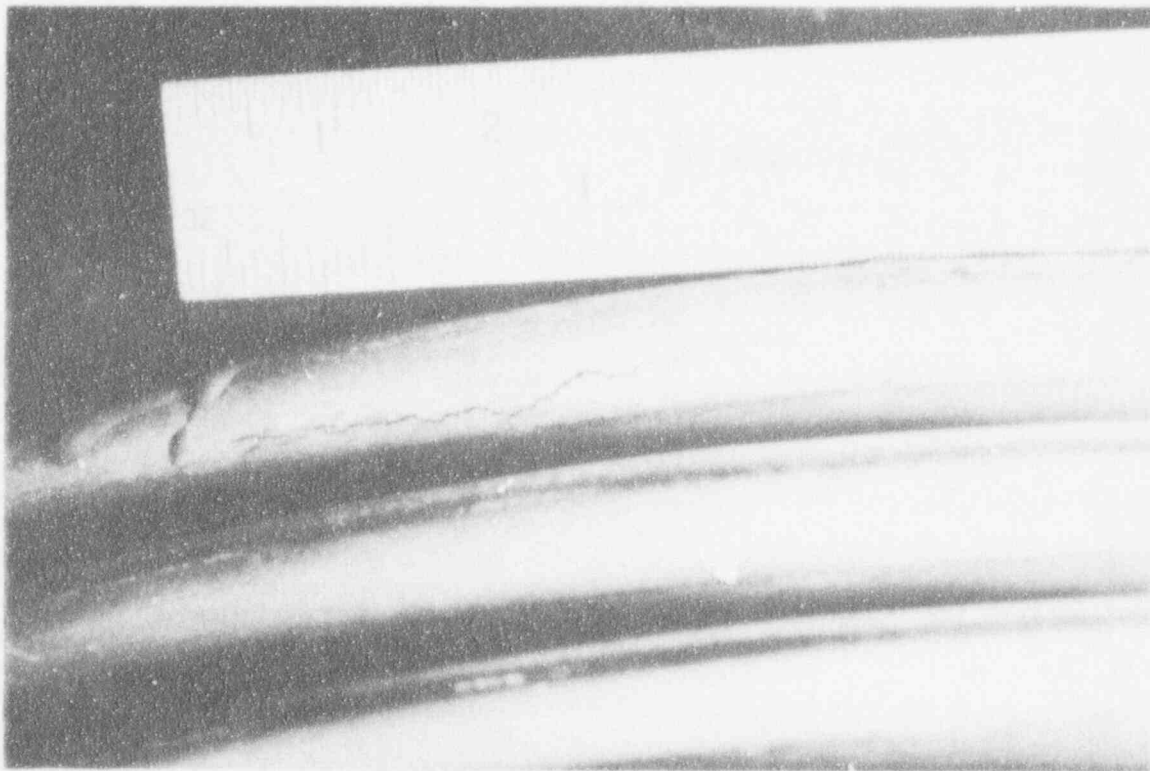
Figure 8. Test 1-7-SC. Specimen A-12-2-1 Showing Pretest Cracks.

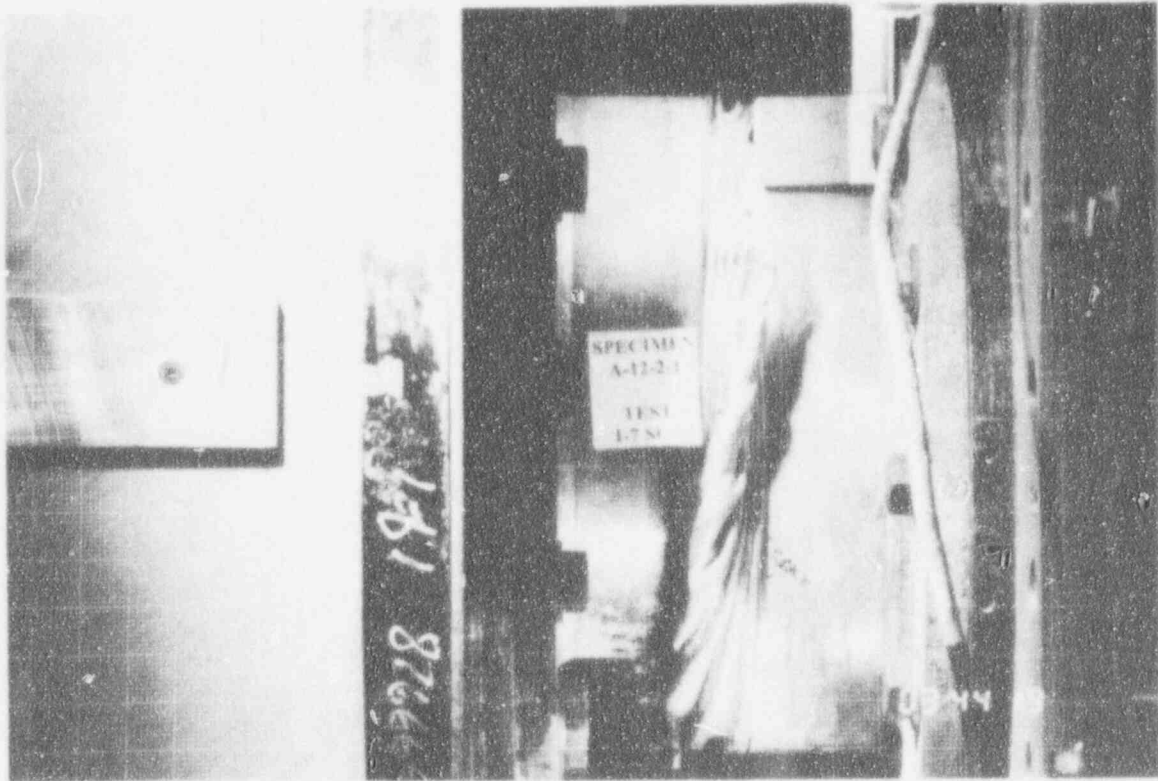
Figure 12. Test I-7-SC. Specimen A-12-2-1 Fully Compressed.

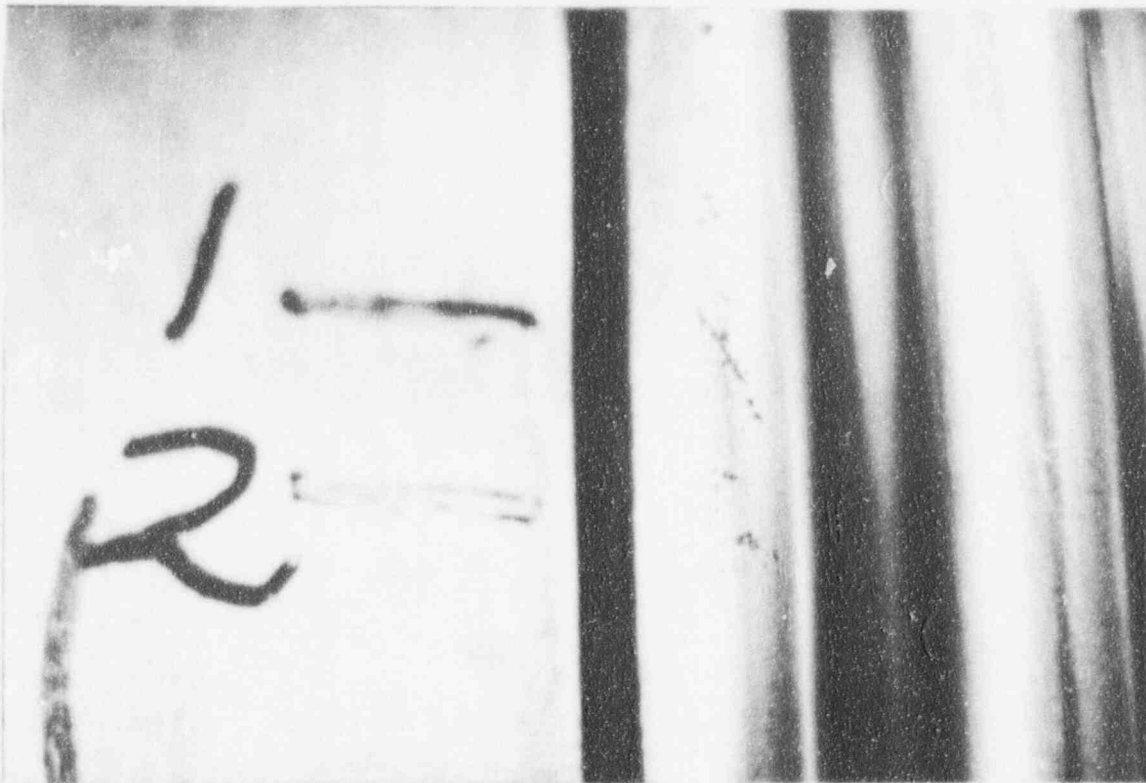
Figure 21. Test I-5-SCT. Specimen C-6-2 Showing Pretest Cracks.

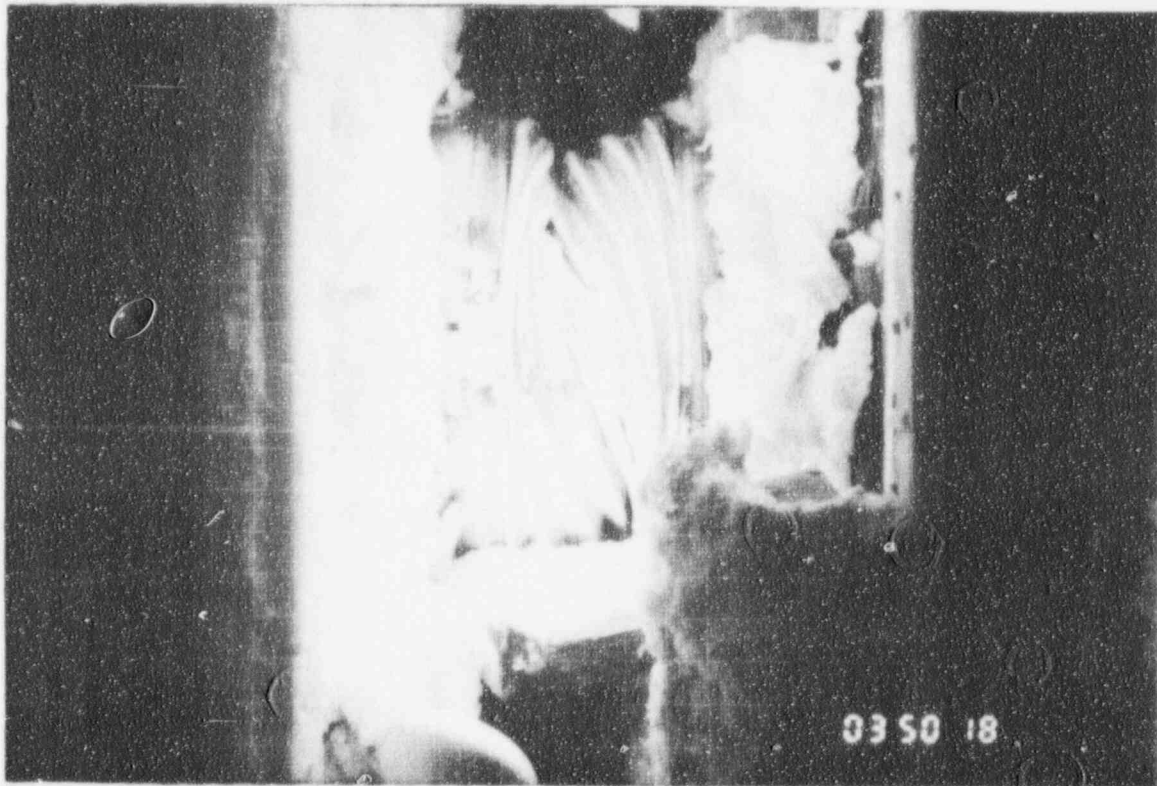
Figure 29. Test I-1-SCT Specimen A-8-2-4 Returned to Zero Displacement.
