Joseph M. Farley Nuclear Plant - Units 1 and 2
Steam Generator (SG) Tube Support Plate (TSP)
Alternate Plugging Criteria (APC)

In order to preclude unnecessarily removing significant numbers of SG tubes from service, Alabama Power Company has evaluated the possibility of utilizing a revised plugging criteria for SG tube cracks which are contained within the boundaries of the TSP. This evaluation has resulted in the development of the TSP APC.

1. WCAP-12871-J. M. Farley Units 1 and 2 SG Tube Plugging Criteria for ODSCC at Tube Support Plates (Proprietary).
2. WCAP-12872-J. M. Farley Units 1 and 2 SG Tube Plugging Criteria for ODSCC at Tube Support Plates (Non-Proprietary).

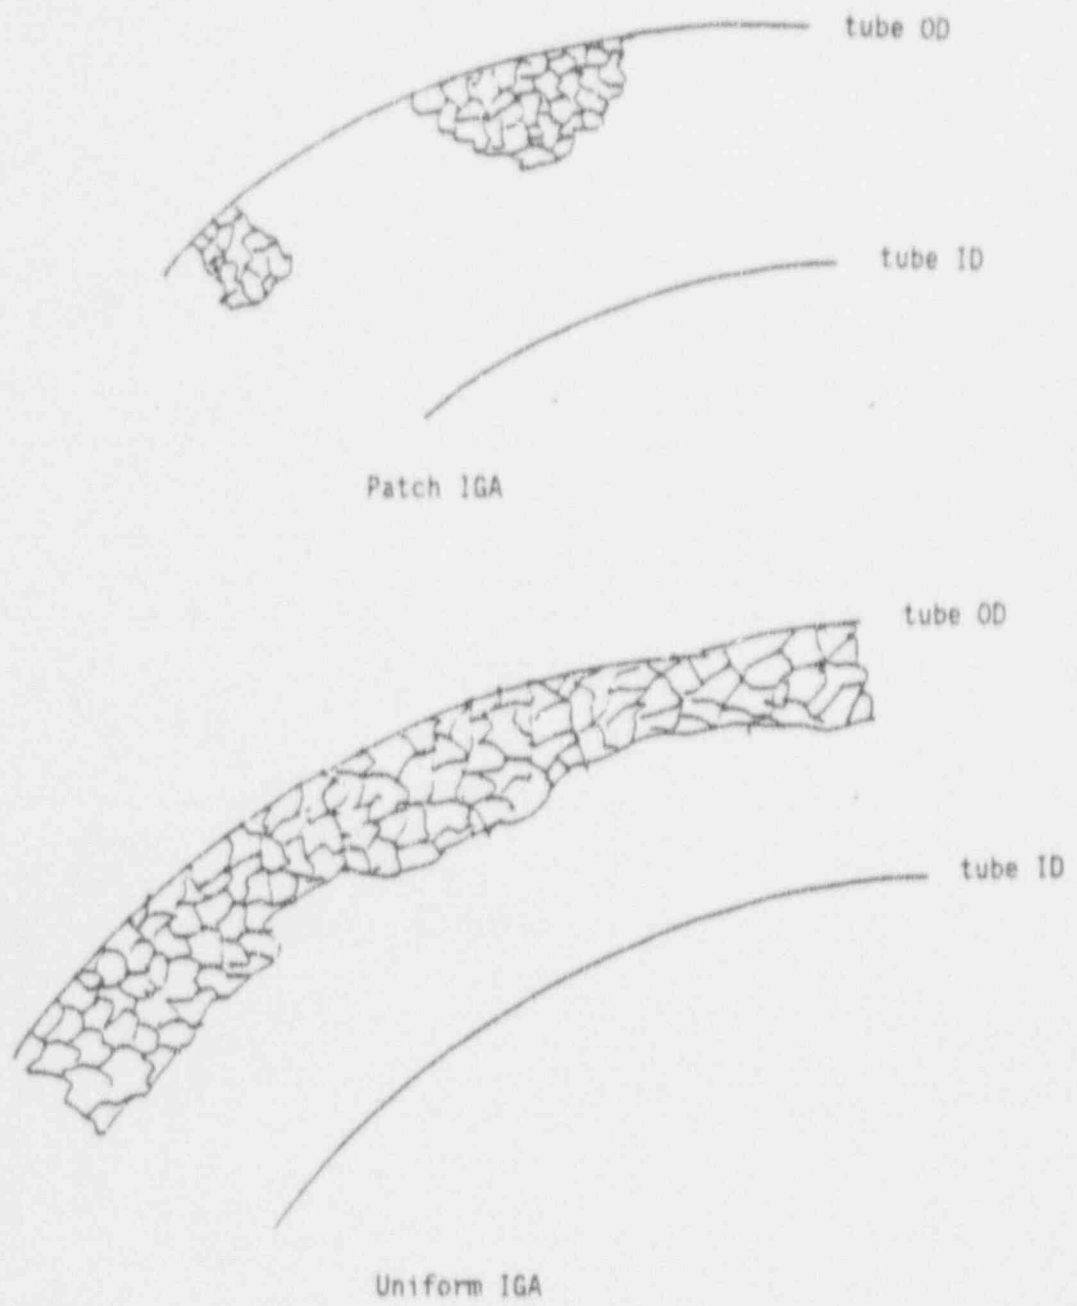
Figure 4-1 Patch and uniform IGA morphology as observed in a transverse tube section. (A similar observation would be made from a longitudinal section.)

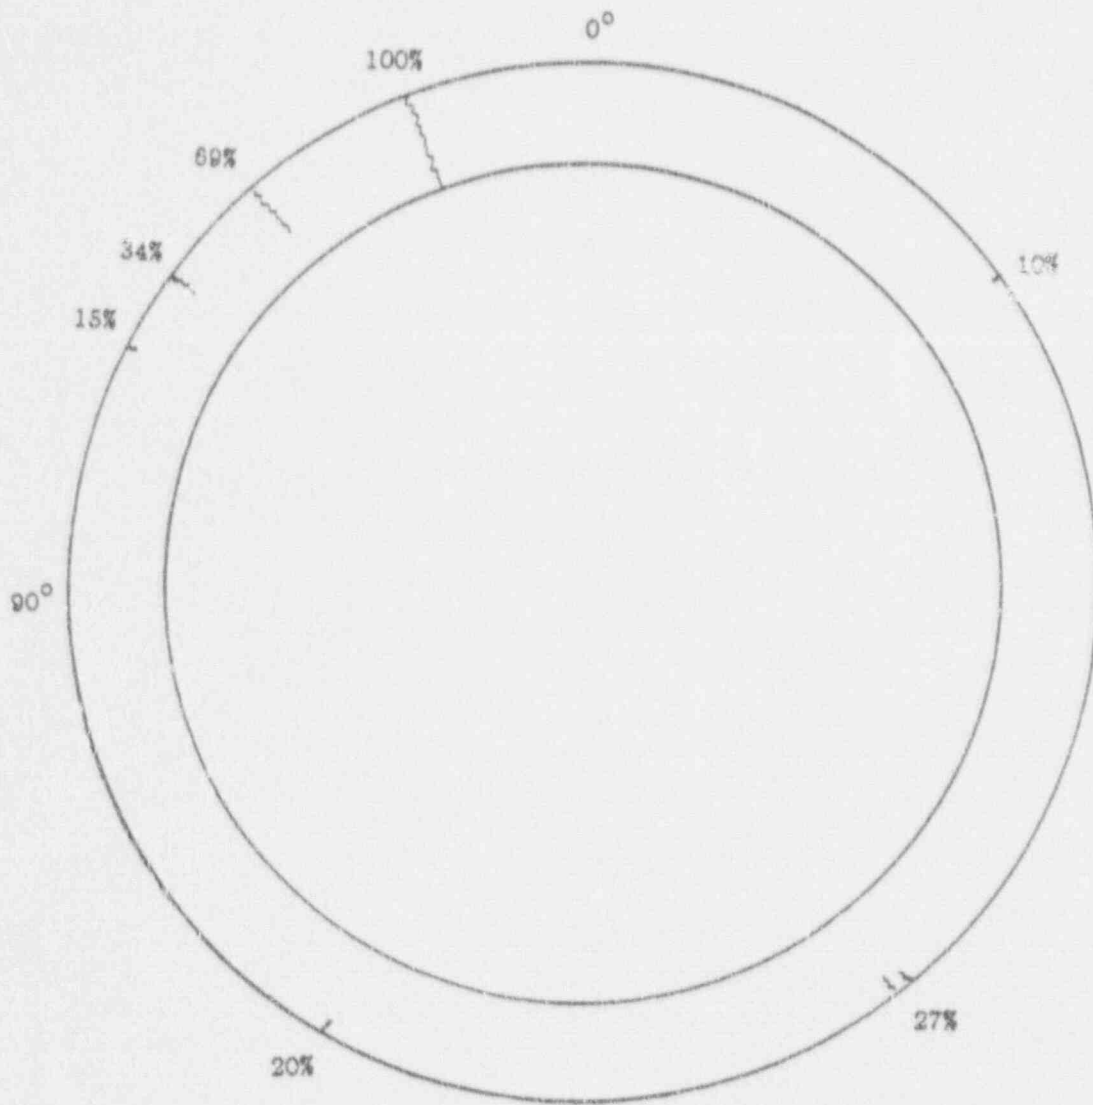
Figure 4 - 10. Sketch of crack distribution and depth within the center of the first support plate intersection in tube R4-C73.

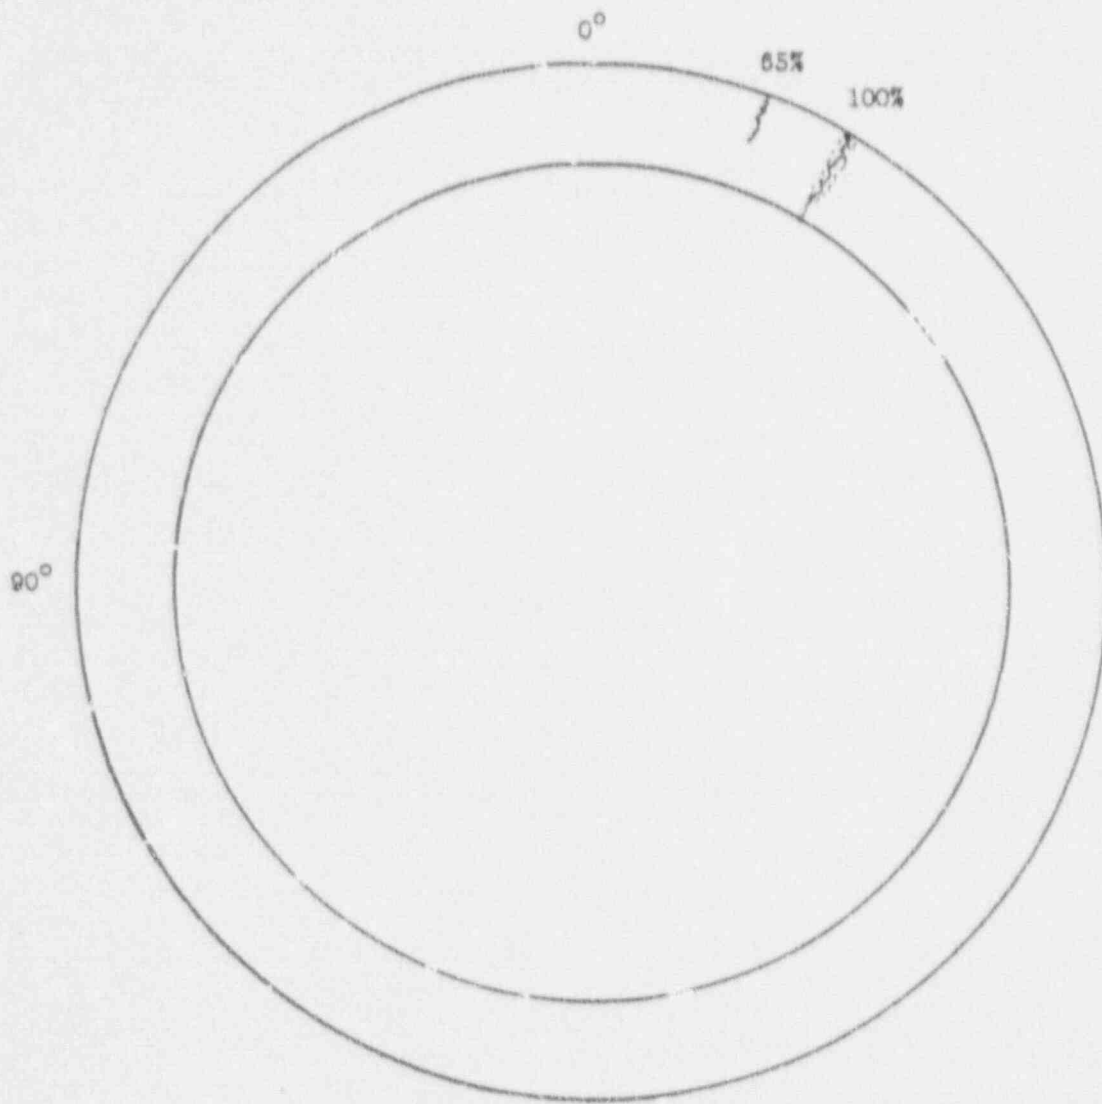
Figure 4 - 13. Sketch of crack distribution and depth within the first support plate crevice region in tube R21-C22.

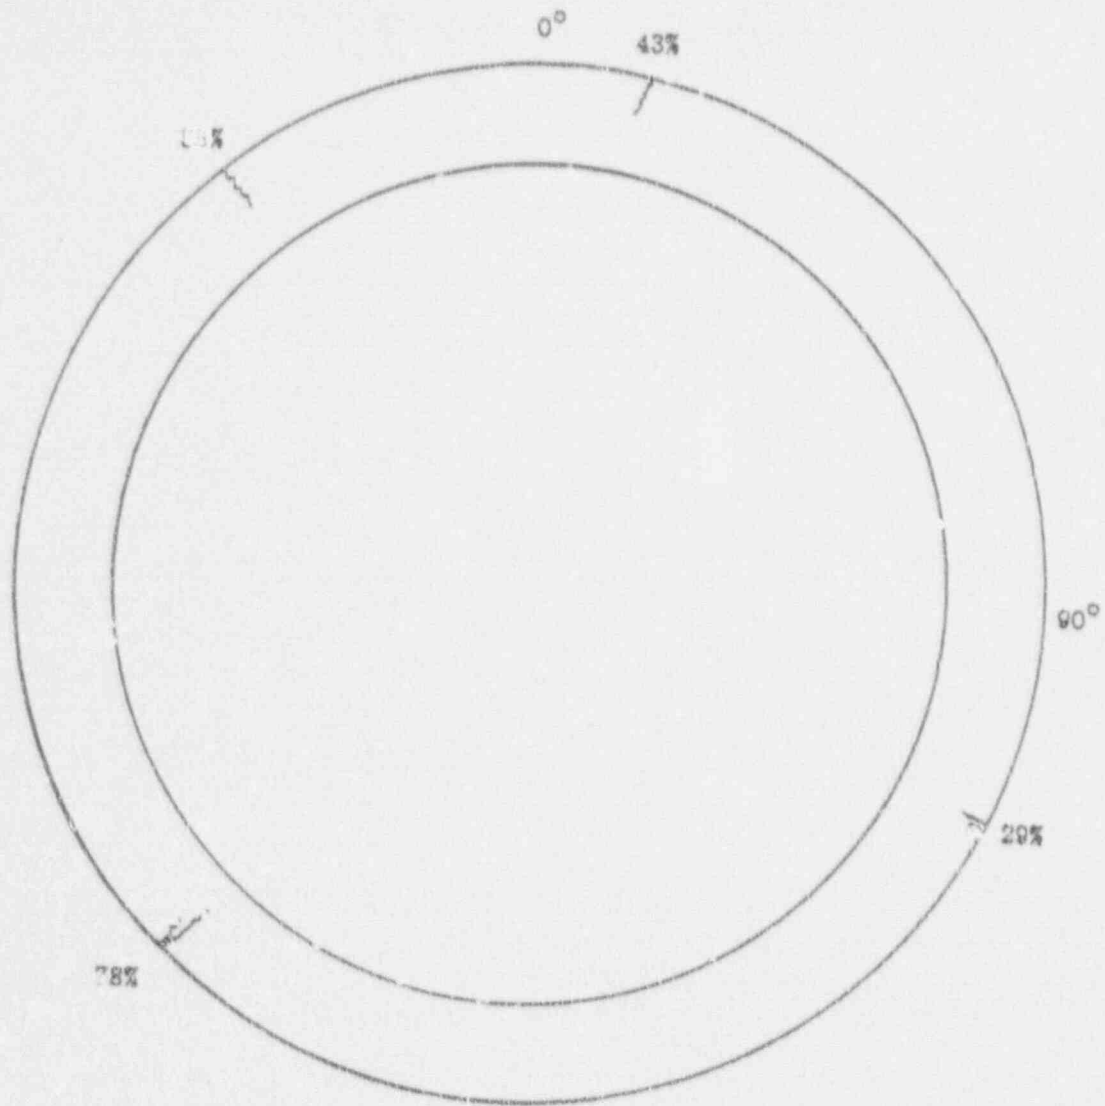
Figure 4 - 16. Summary of distribution and maximum depth of cracks found within the first support plate crevice region of tube R38-C46.

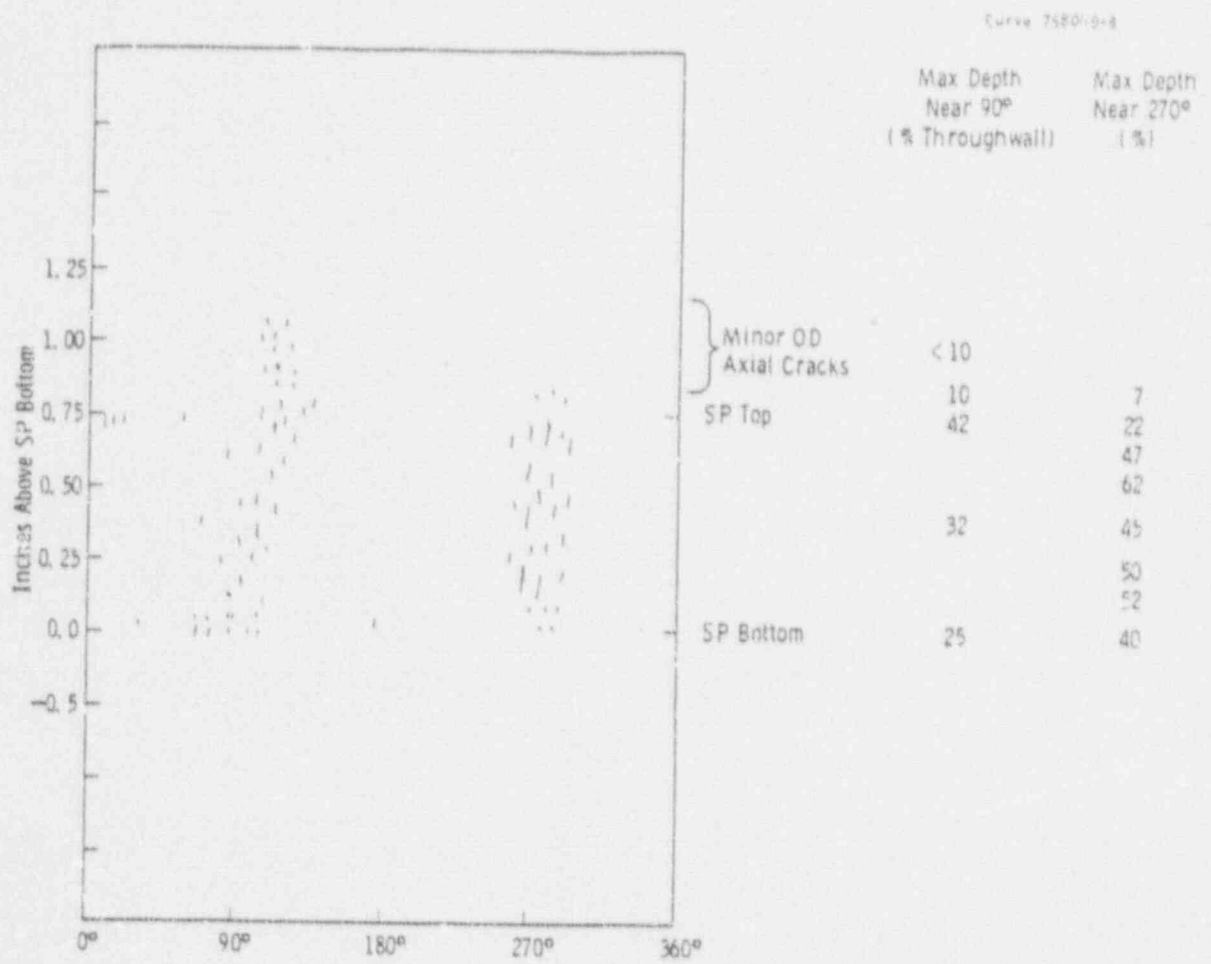
Figure 4 - 21. Crack network location at first support plate region on tube R20-C26 HL.

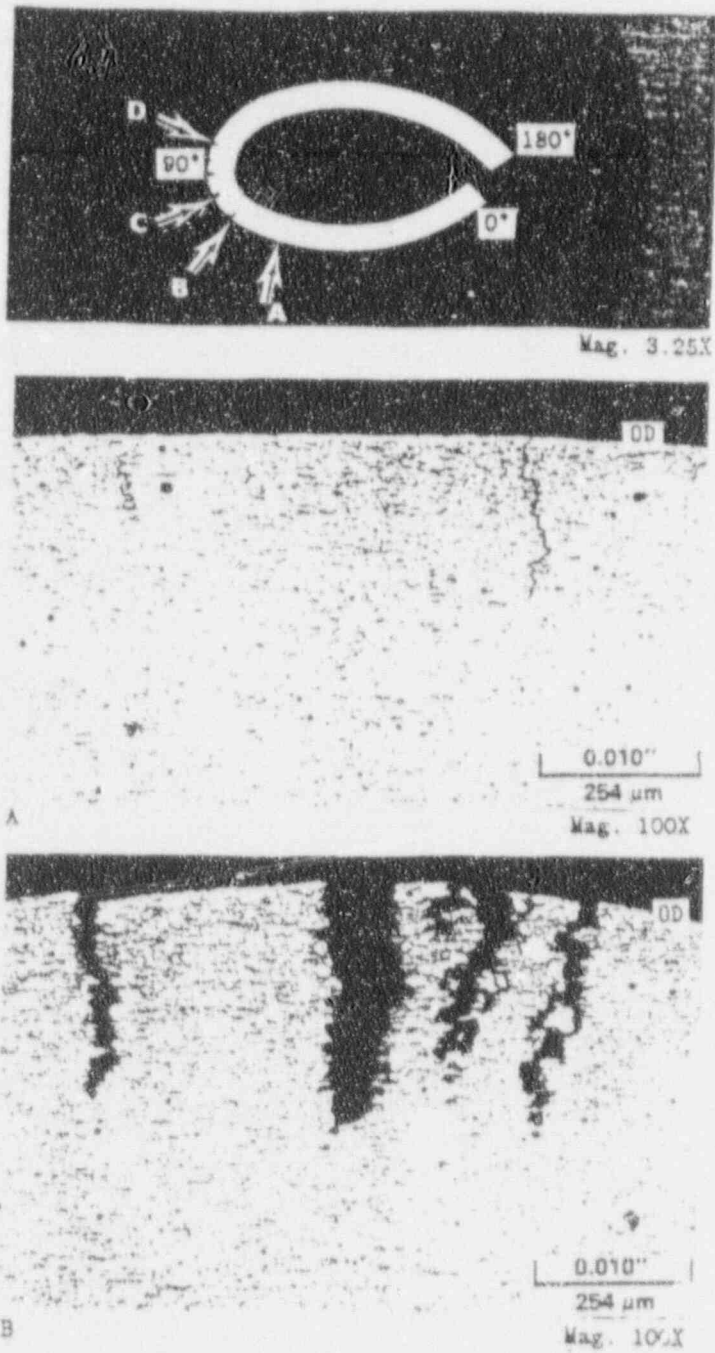
Figure 4 - 22. Transverse metallographic section through tube R20-C26 HL at the mid-point of the first support plate crevice region (90° deformed half) with crack details in Areas A and B.

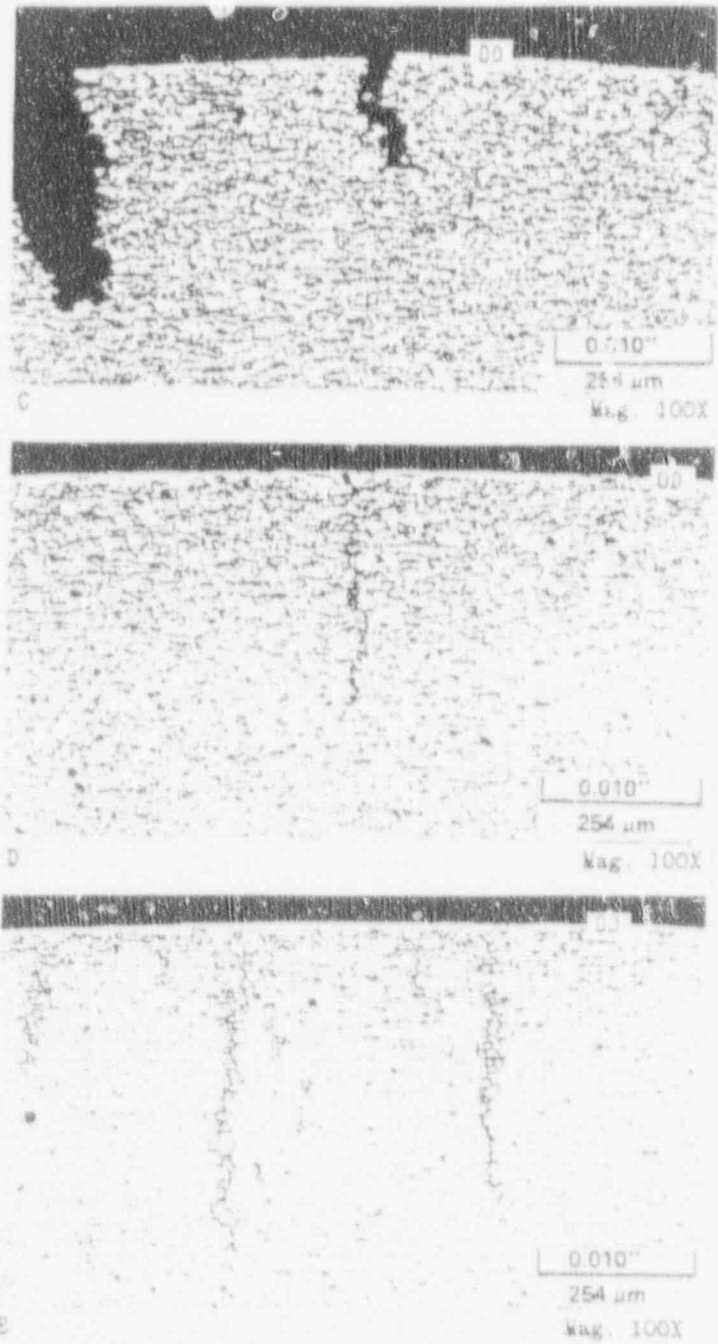
Figure 4 - 24. Crack details in Areas C, D, and E of metallographic cross section shown in previous figure, tube R20-C26 HL, Farley-1.

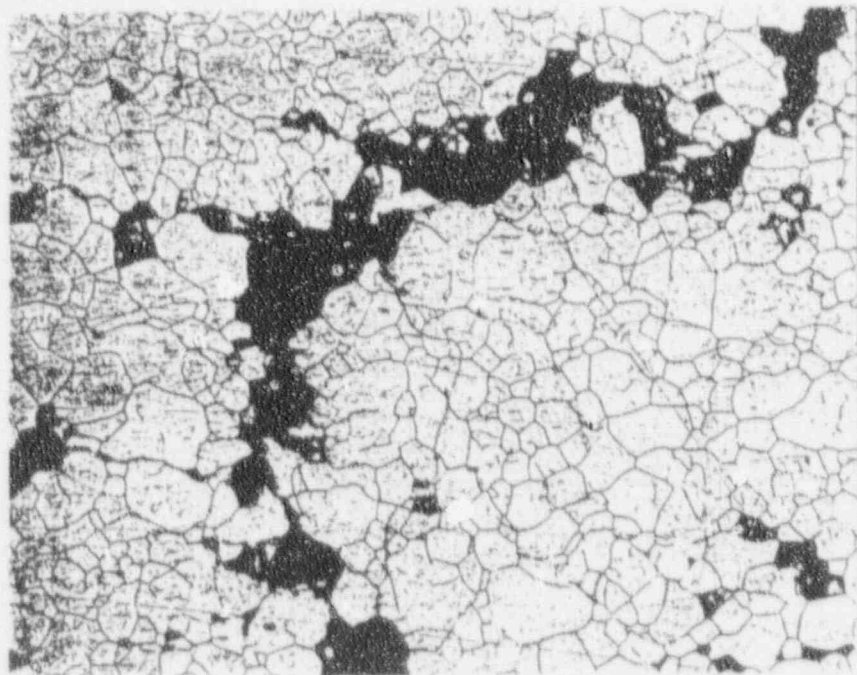
Figure 4 - 27. Higher magnification photomicrographs of the radial section shown in the previous figure. Top photo 50X, bottom 200X

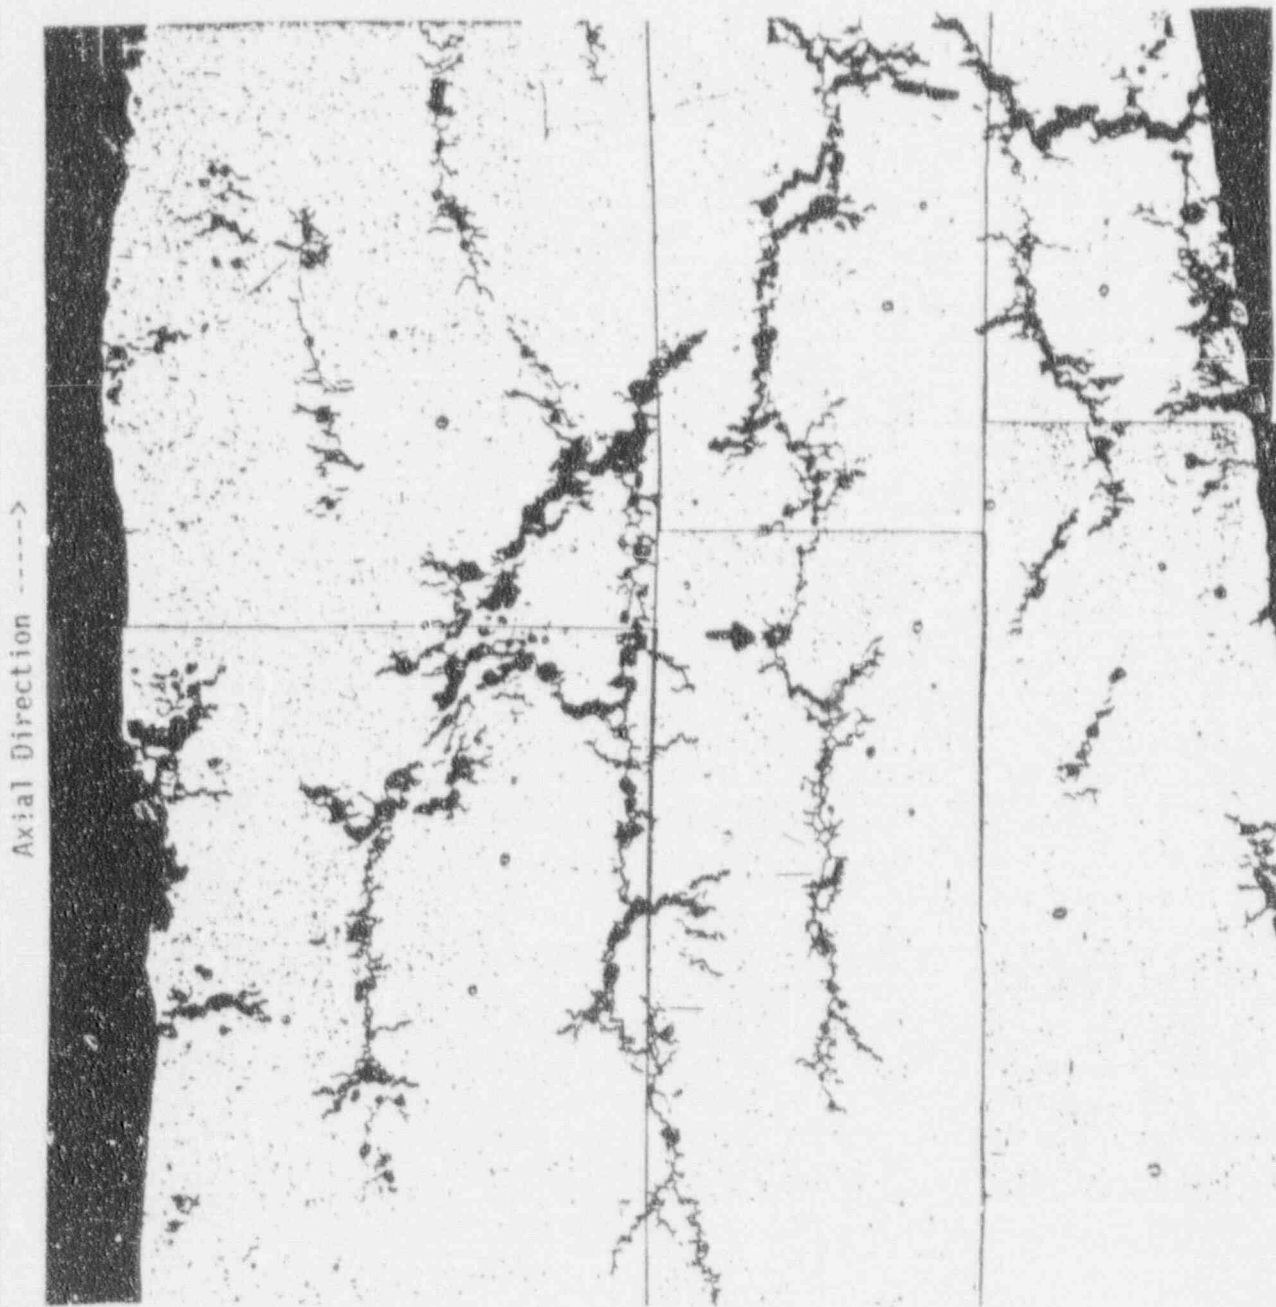
Figure 4-28 Radial metallographic section through a portion of the third support plate crevice region of tube R19-C35 from Plant E-4. A cellular IGA/SCC structure is observed. The depth of the section was not specified.

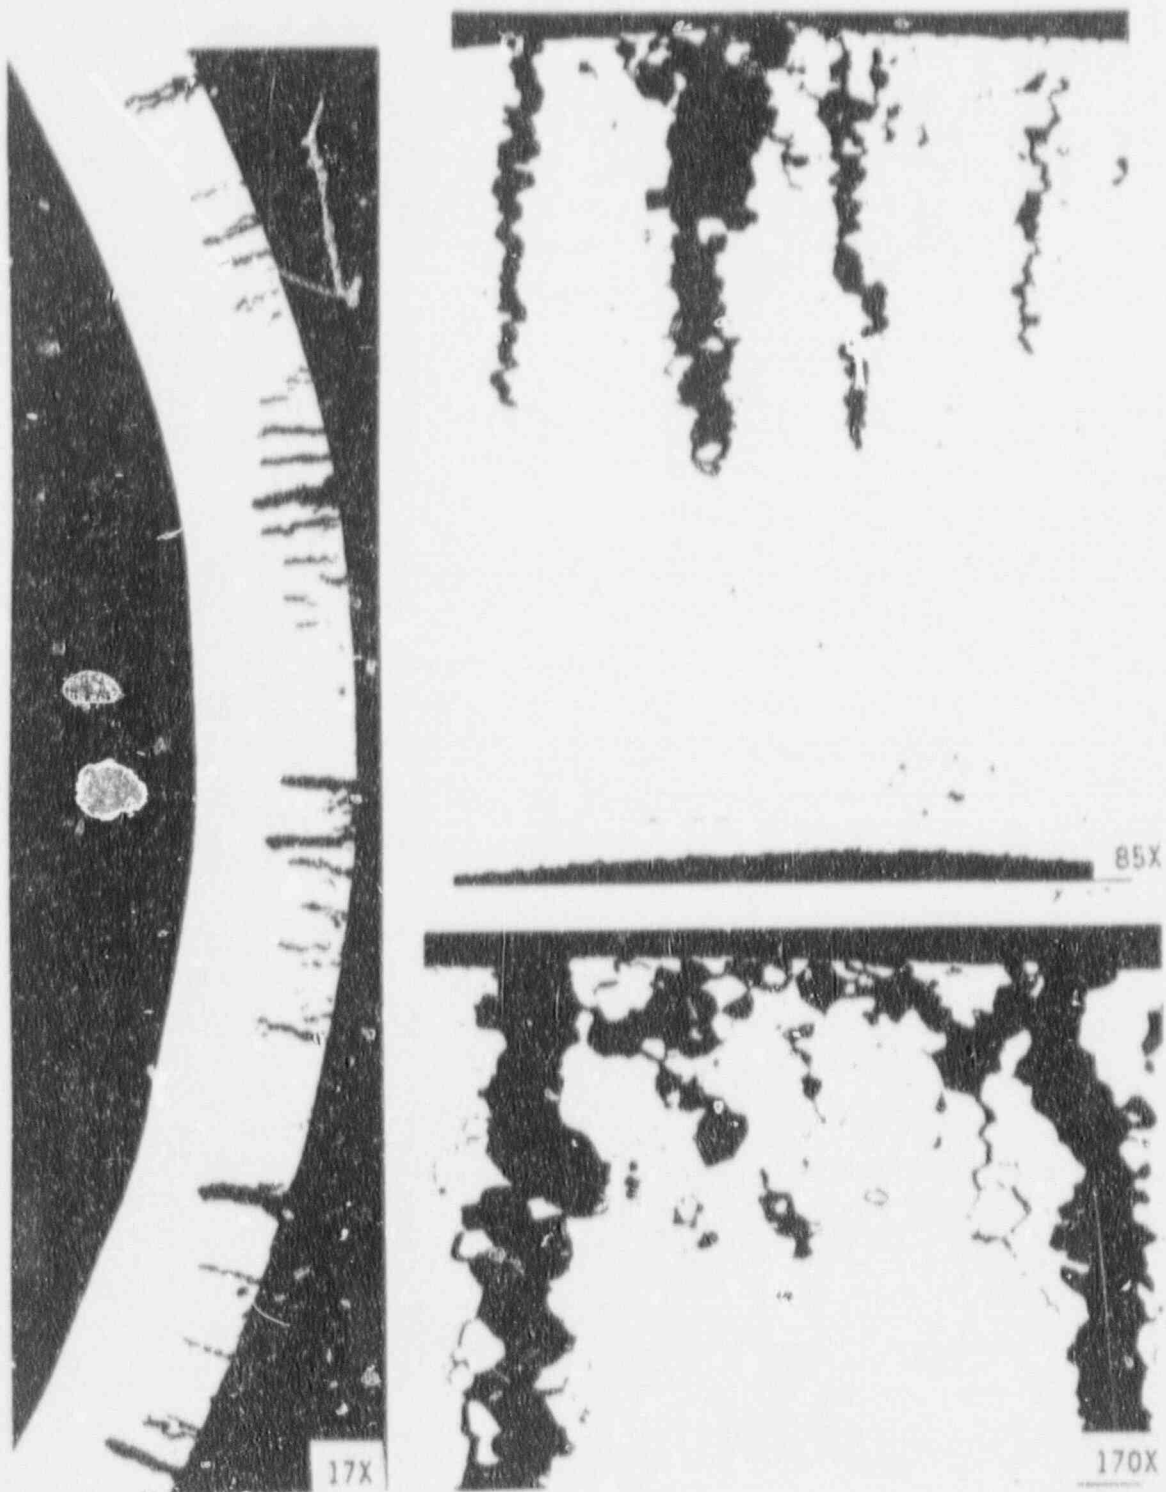
Figure 4 - 32. Transverse photomicrographs of intergranular corrosion at the second support plate region of tube LB-C74 from Plant J-1

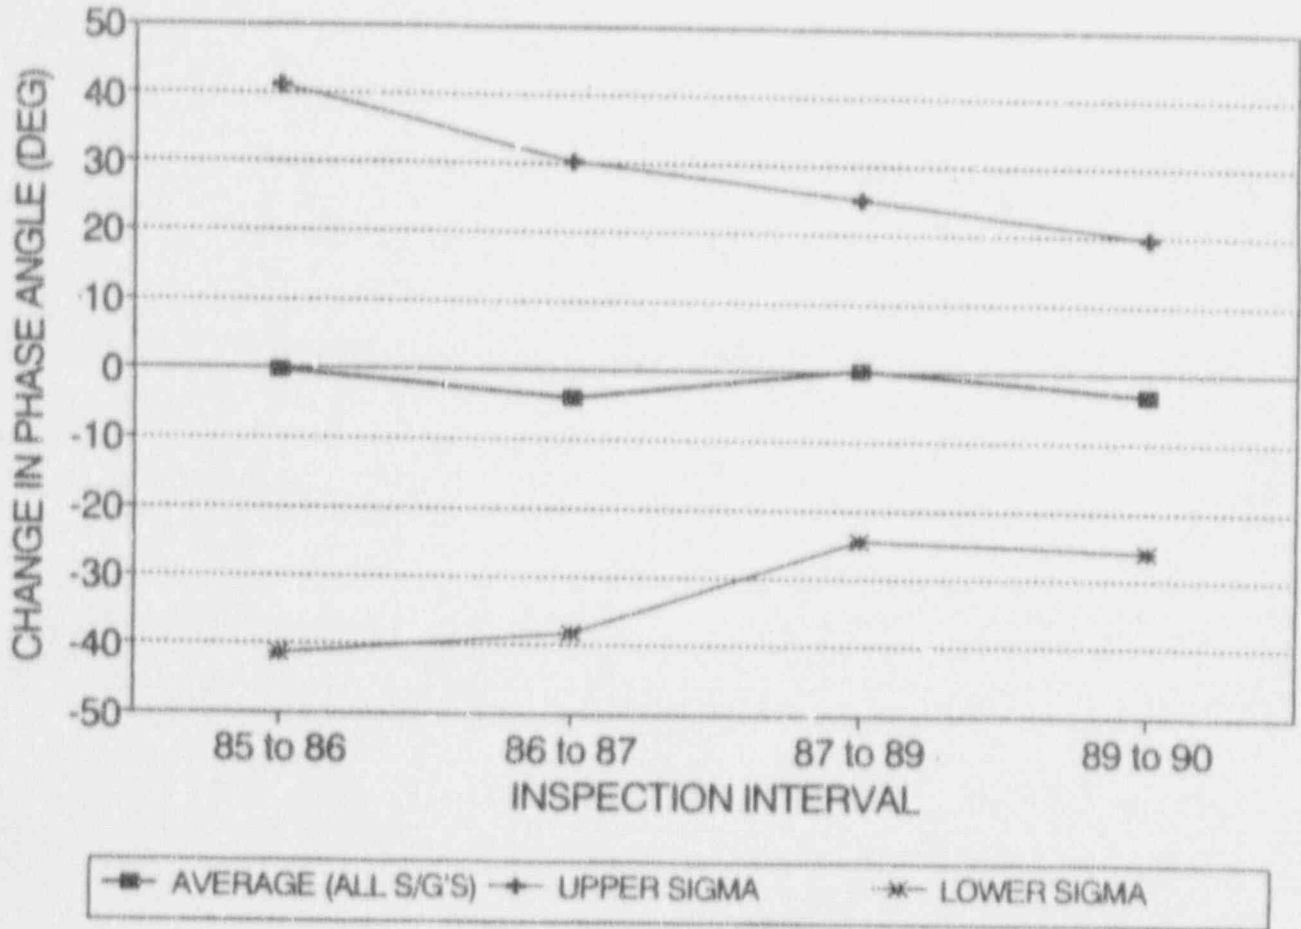
Figure 5-7

Cold Leg TSP Corrosion Assessment in Farley-1

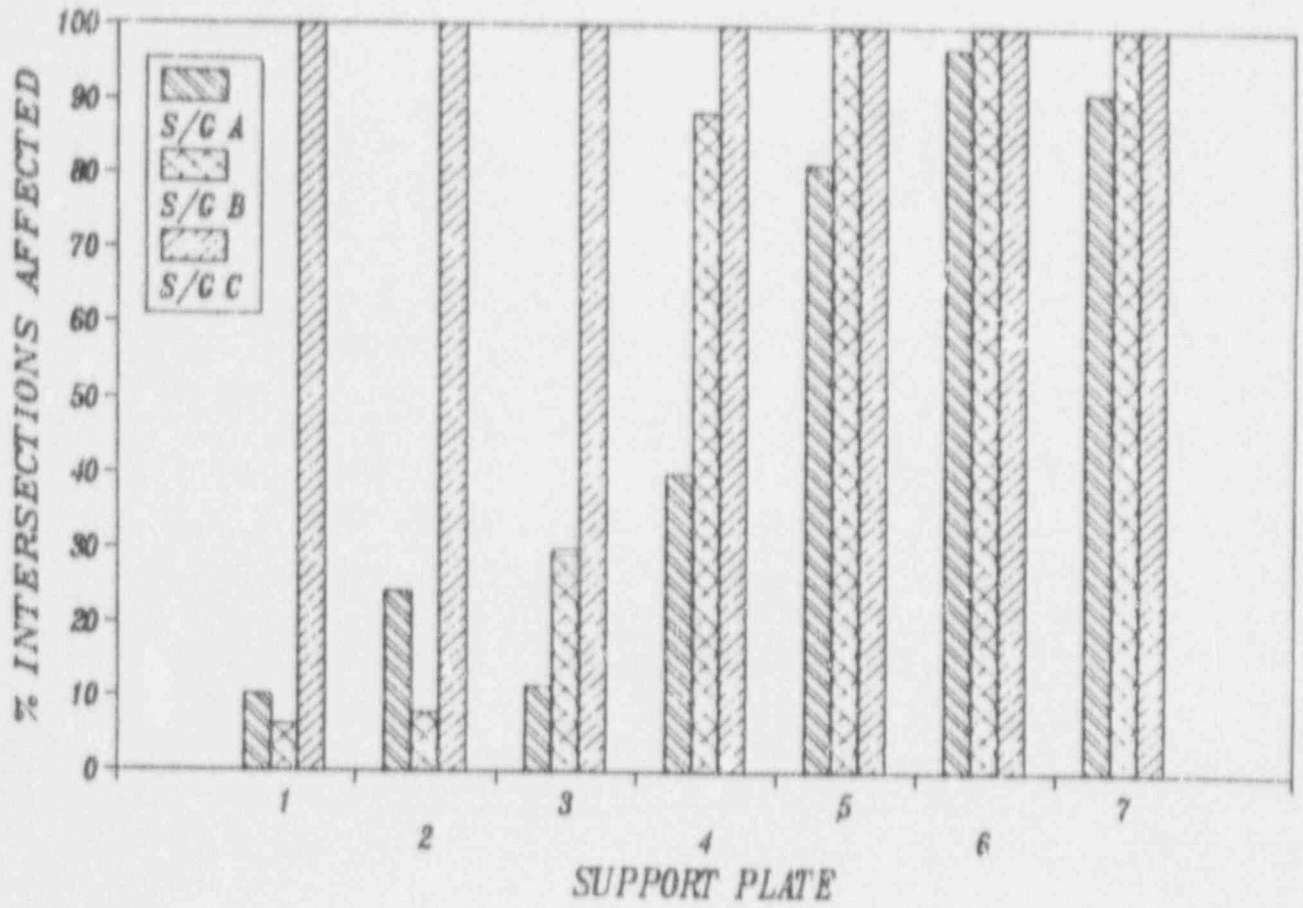
Figure 5-8

Farley-1 RPC Characterization (November 1989)

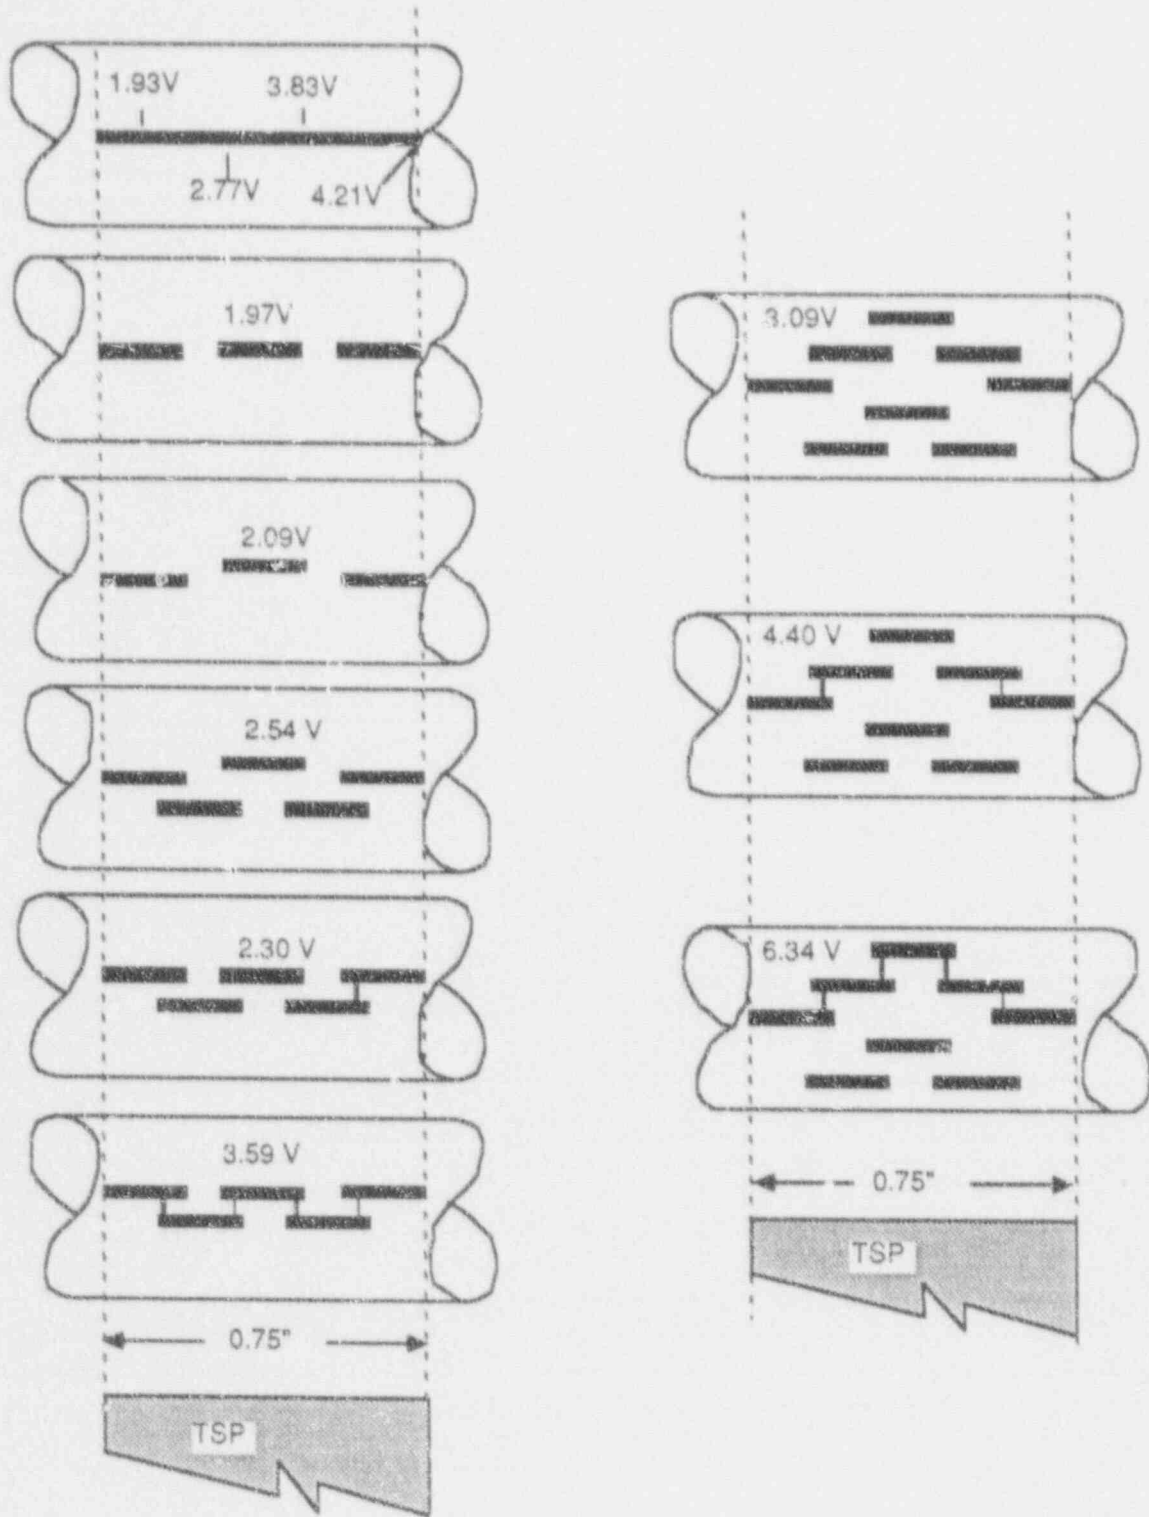
Figure 8-2

Bobbin Coil Voltage Dependence on Slot Length and Depth

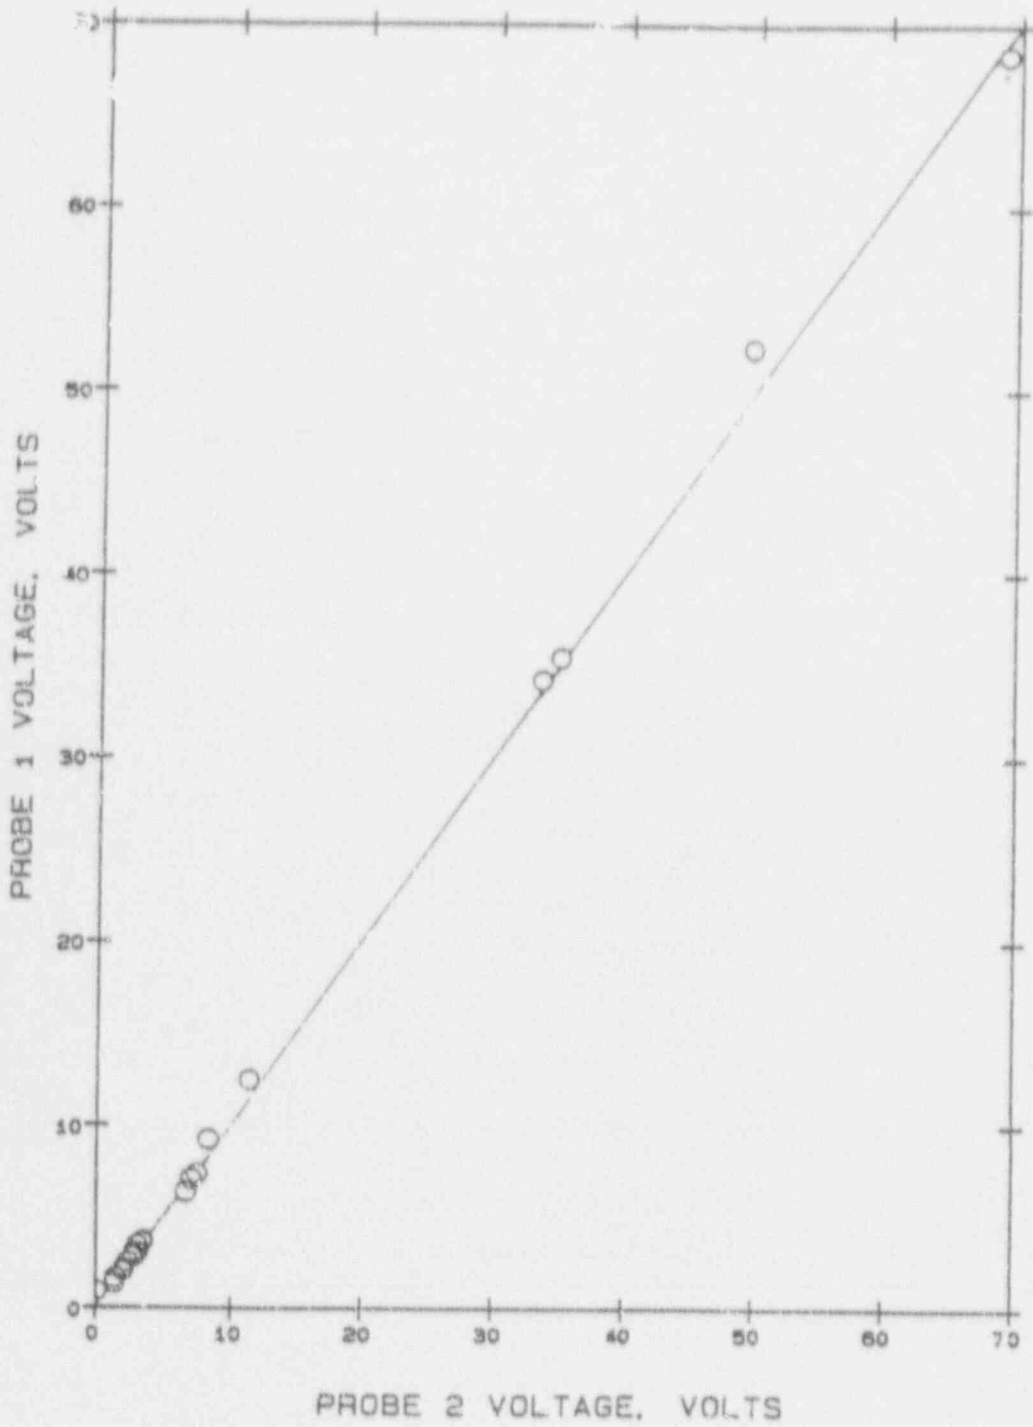
Figure 8-15

Comparison of 400/100 kHz Mix Amplitude Response from Two Probes (Model Boiler Sample)

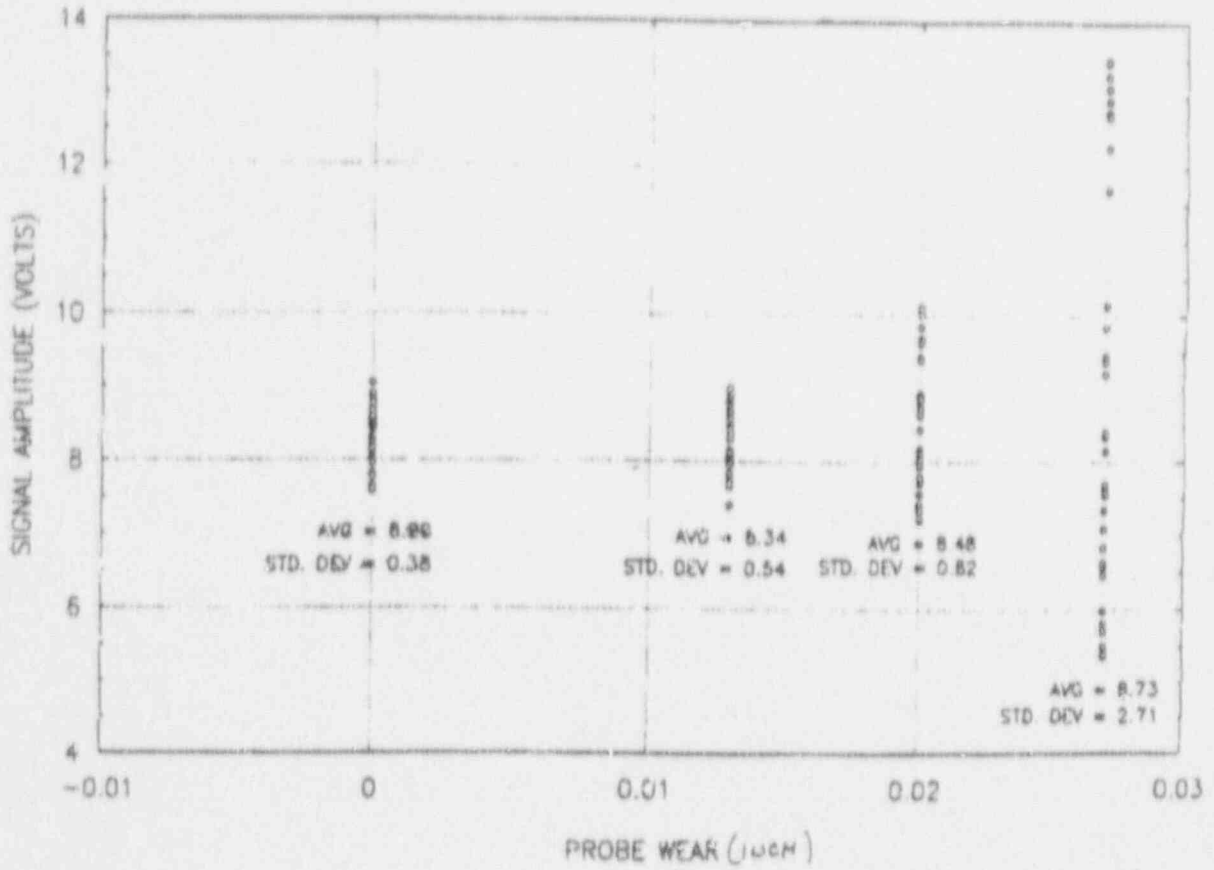
Figure 8-20

RPC Traces of Typical Model Boiler Specimens

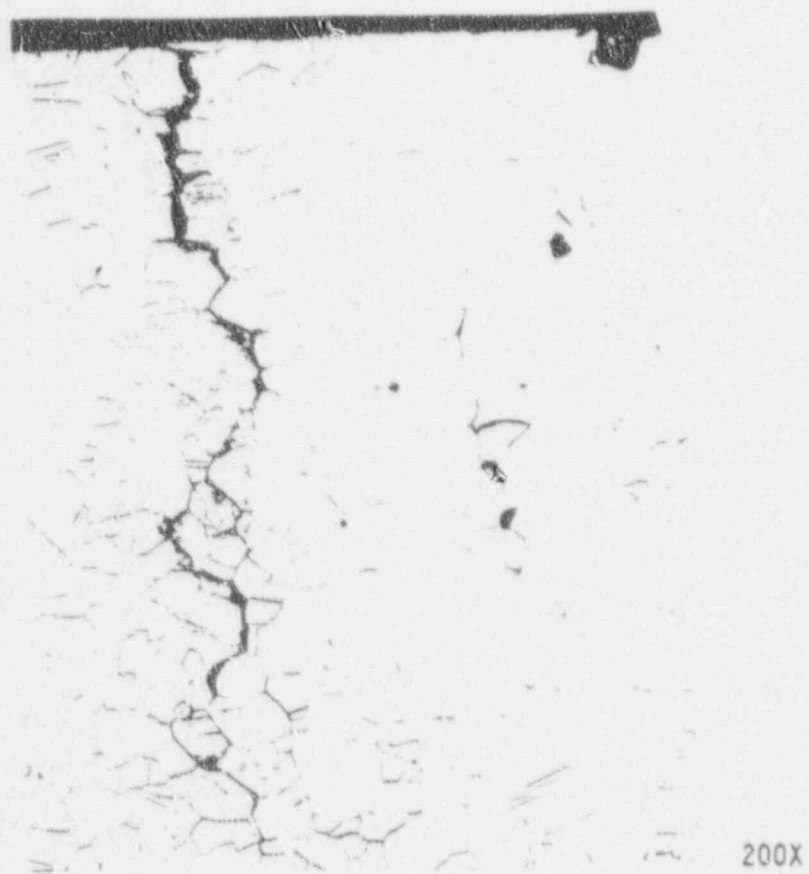
Figure 10-1 Sketch of a metallographic cross section through secondary support plate crevice cracks in Tube 543-4. A typical crack micrograph is also shown.

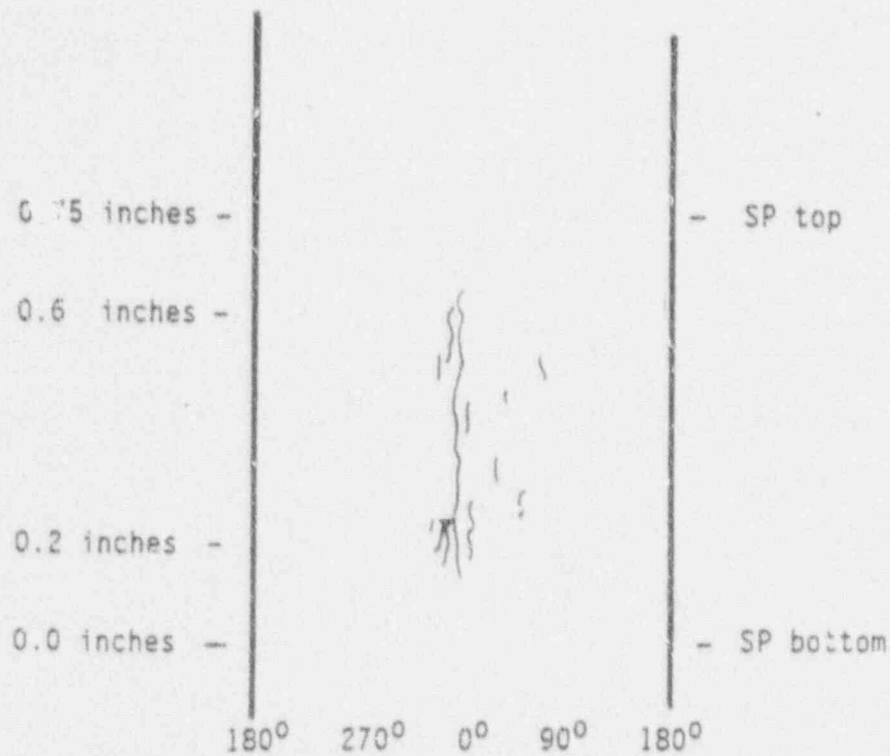
Figure 10-2 Summary of crack distribution and morphology observed on Tube 543-4.

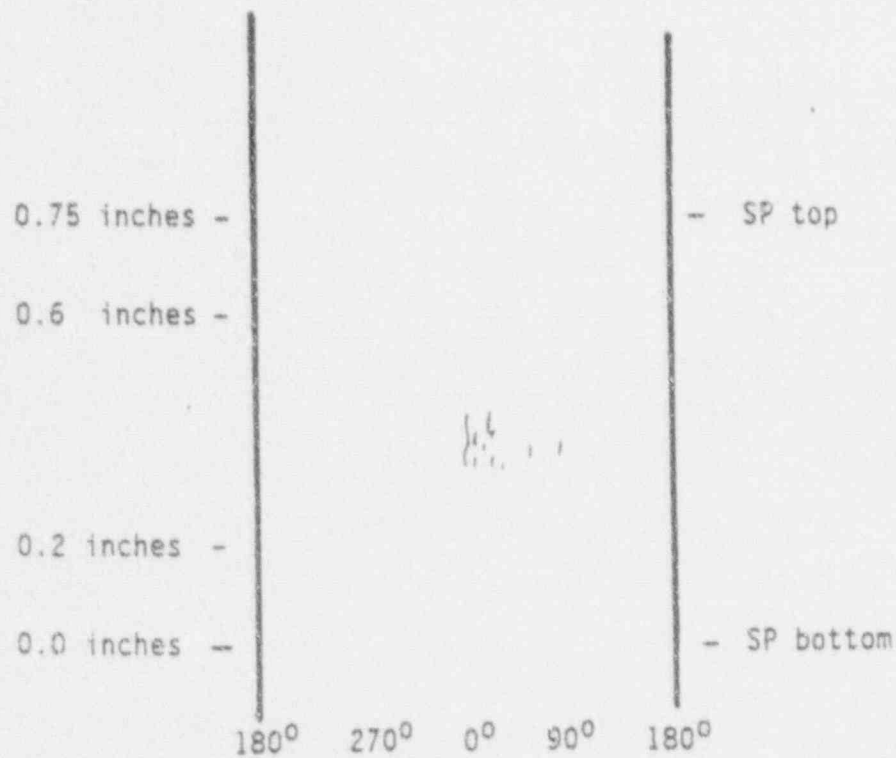
Figure 10-4 Summary of crack distribution and morphology observed on Tube 525.

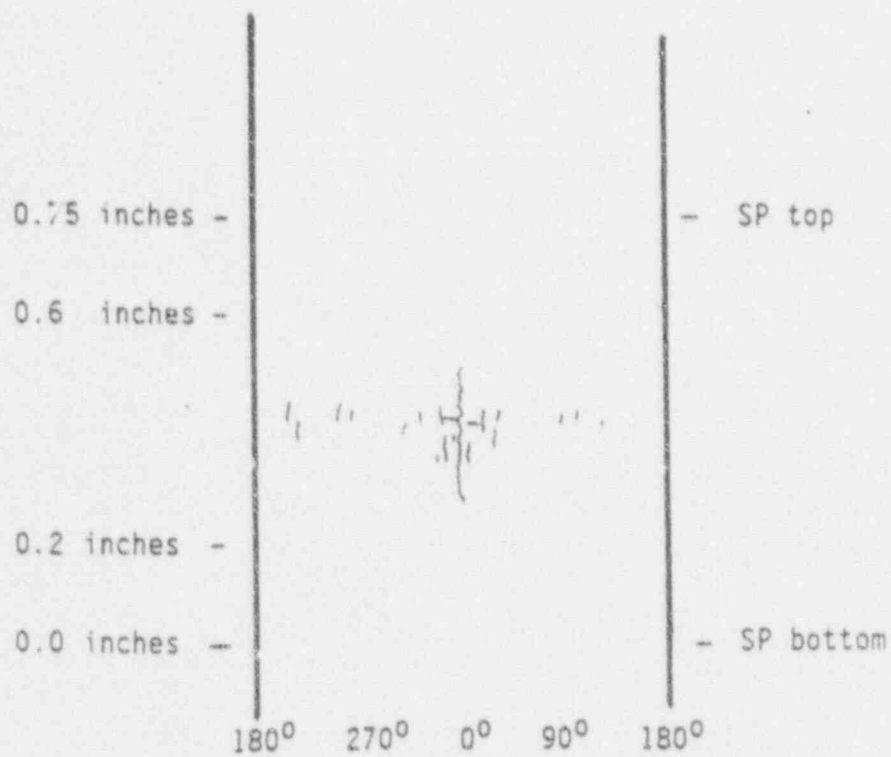
Figure 10-6 Summary of crack distribution and morphology observed on Tube 533-4.

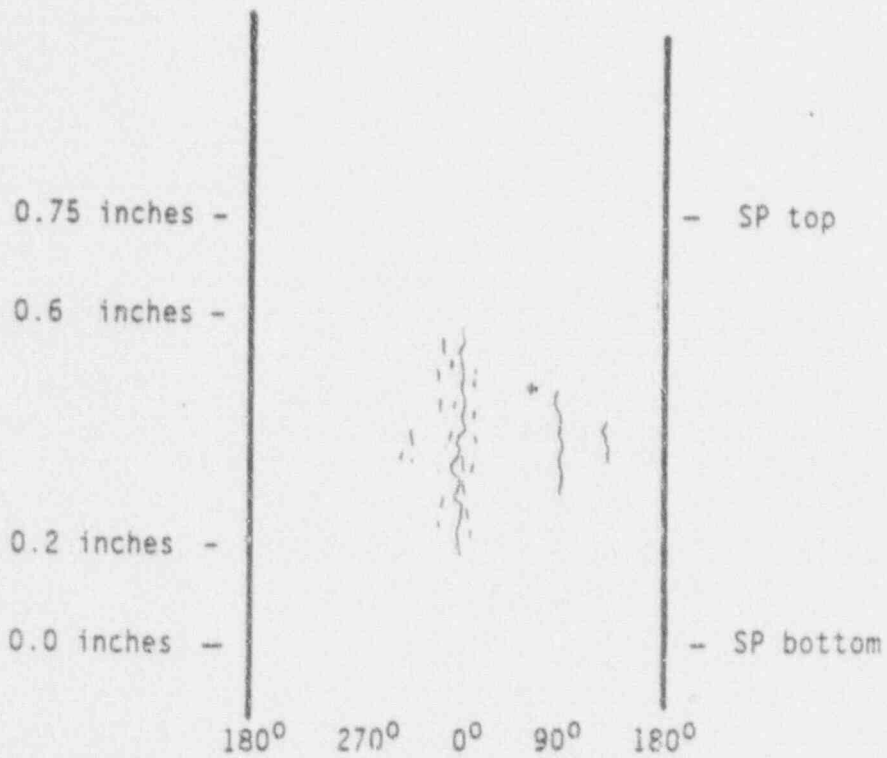
Figure 10-8 Summary of crack distribution and morphology observed on Tube 536-1.
