Joseph M. Farley Nuclear Plant - Units 1 and 2
Steam Generator (SG) Tube Support Plate (TSP)
Alternate Plugging Criteria (APC)

In order to preclude unnecessarily removing significant numbers of SG tubes from service, Alabama Power Company has evaluated the possibility of utilizing a revised plugging criteria for SG tube cracks which are contained within the boundaries of the TSP. This evaluation has resulted in the development of the TSP APC.

1. WCAP-12871-J. M. Farley Units 1 and 2 SG Tube Plugging Criteria for ODSCC at Tube Support Plates (Proprietary).
2. WCAP-12872-J. M. Farley Units 1 and 2 SG Tube Plugging Criteria for ODSCC at Tube Support Plates (Non-Proprietary).

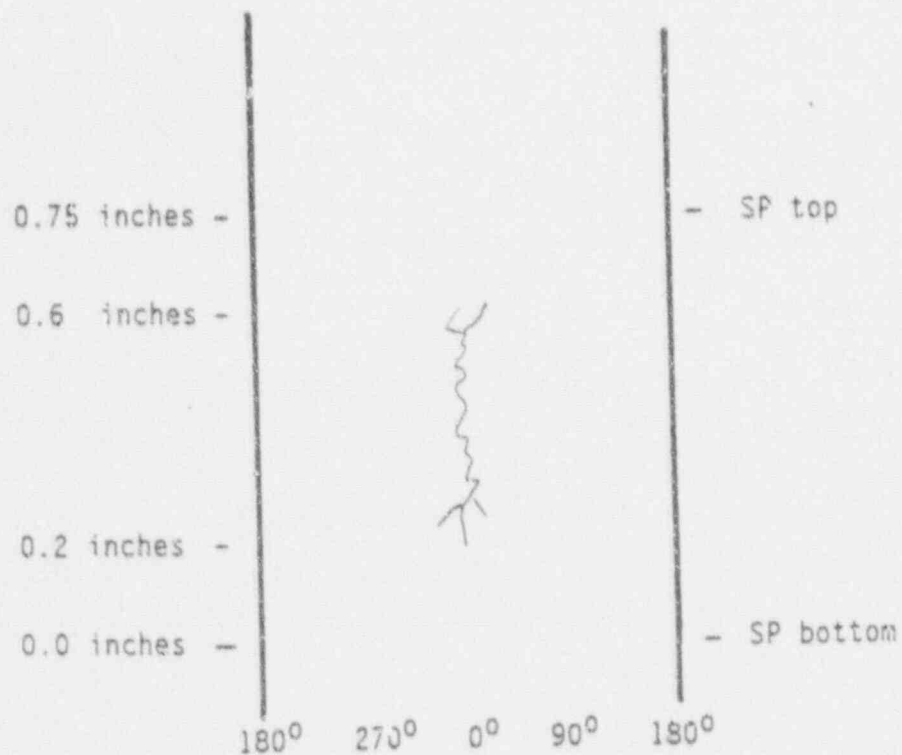
Figure 10-9 Summary of crack distribution and morphology observed on Tube 558-1.

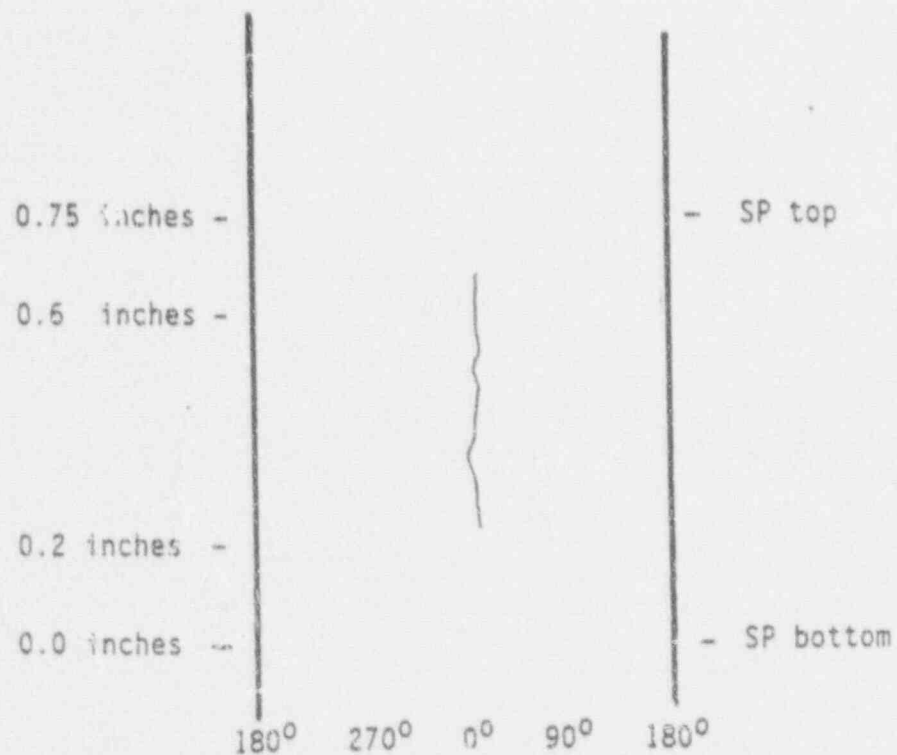
Figure 10-10 Summary of crack distribution and morphology observed on Tube 571-1.

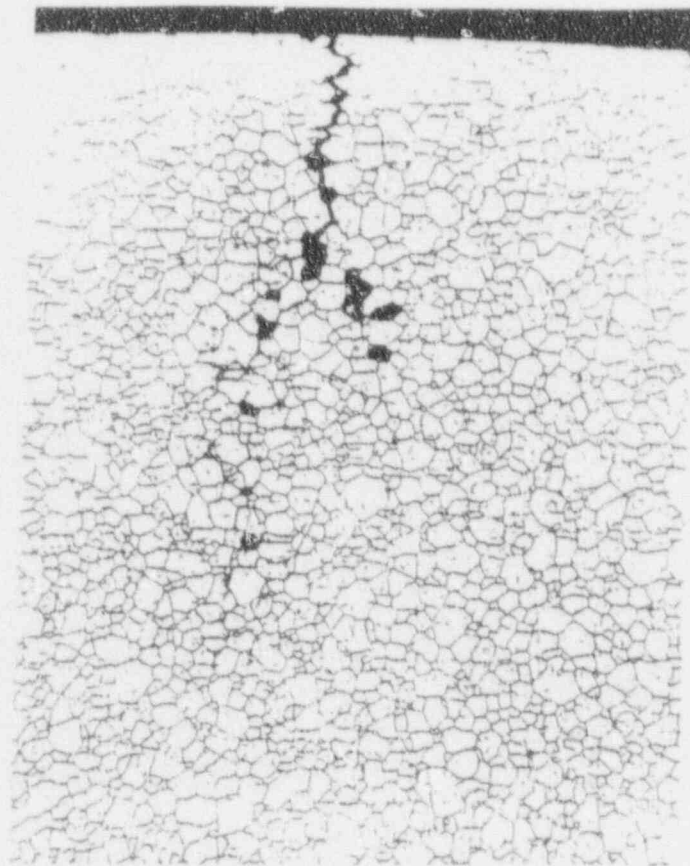
Figure 10-15 Crack distribution and a micrograph of one of these cracks in a metallographic cross section of Tube SL-FH-11 in Plane B.

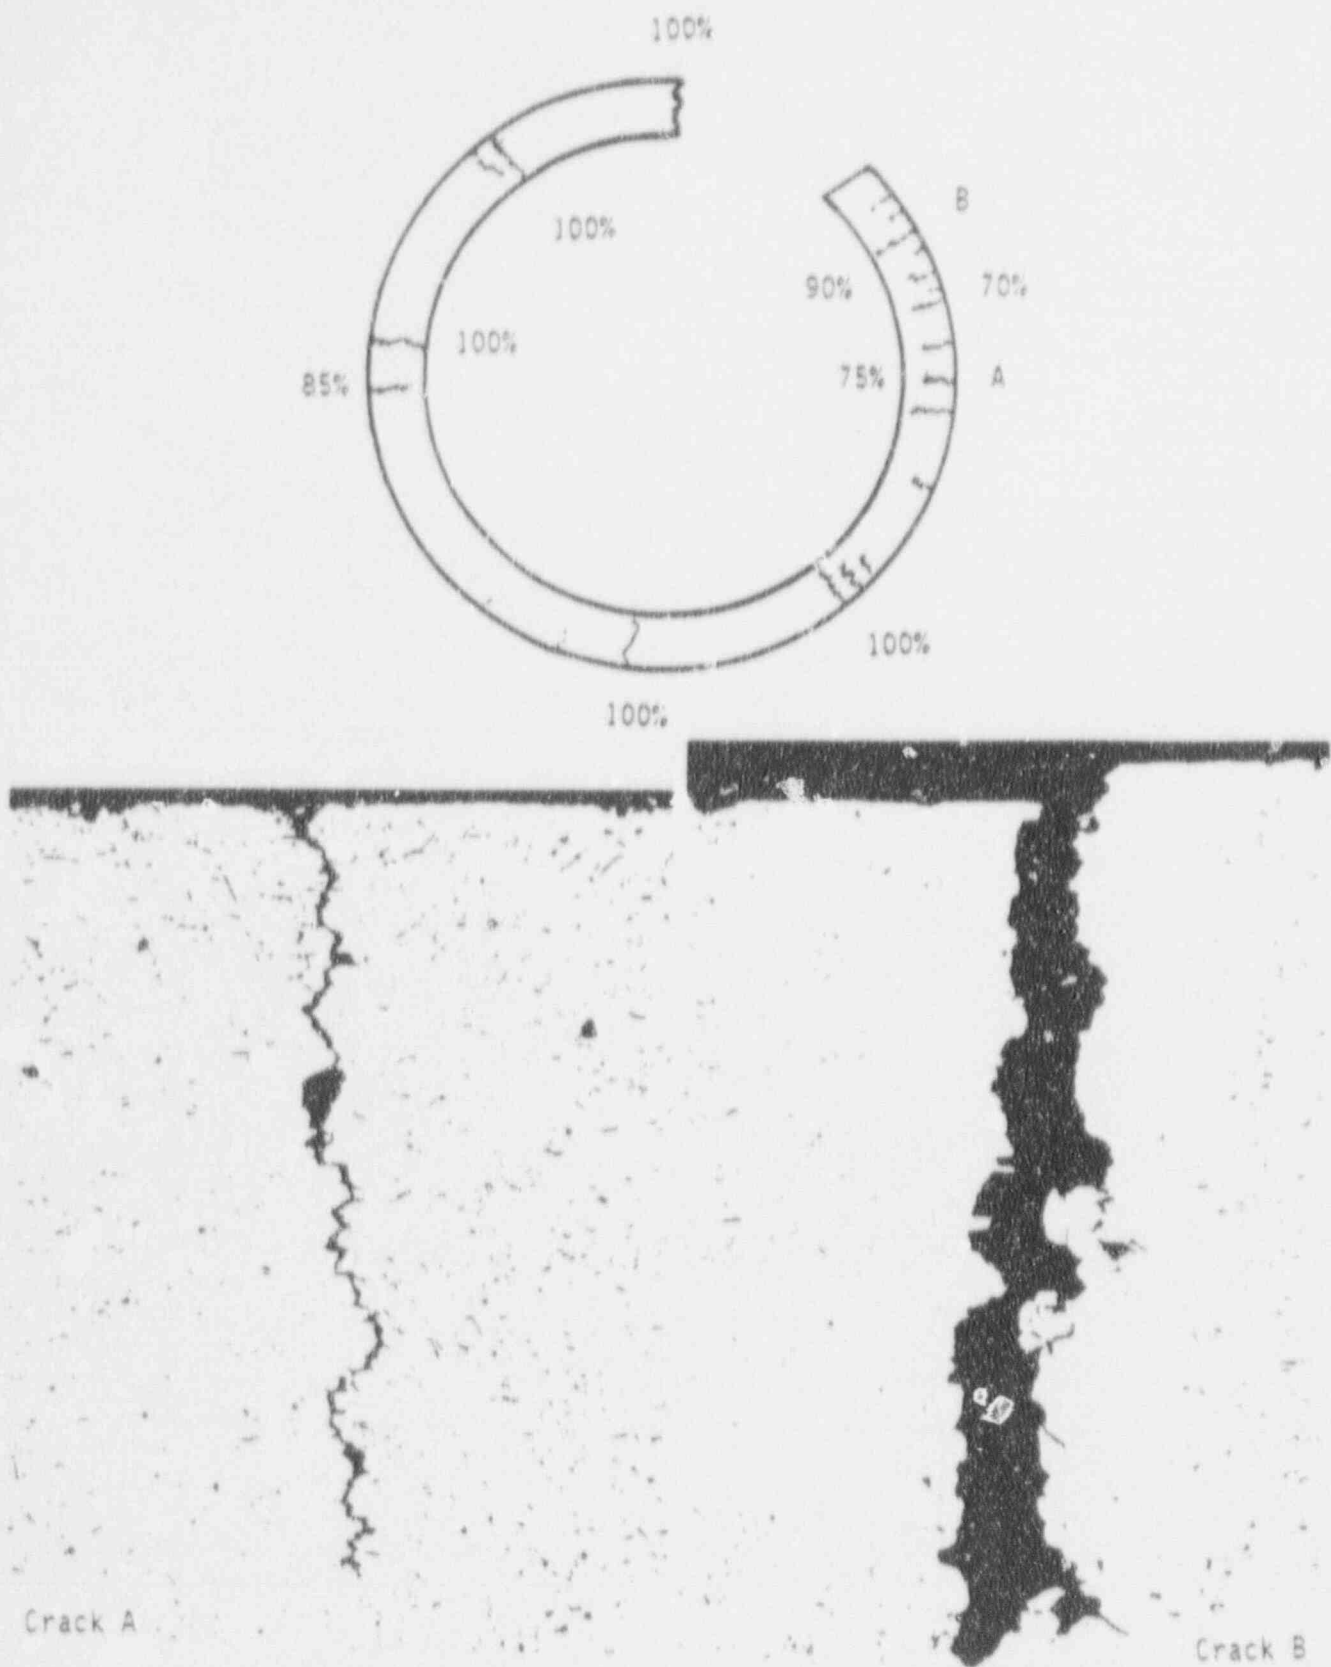
Figure 10-24 Sketch of crack distribution found by a metallographic cross section through the center of the crevice region of tube 532-1 and two photomicrographs of secondary cracks. Mag. 100X

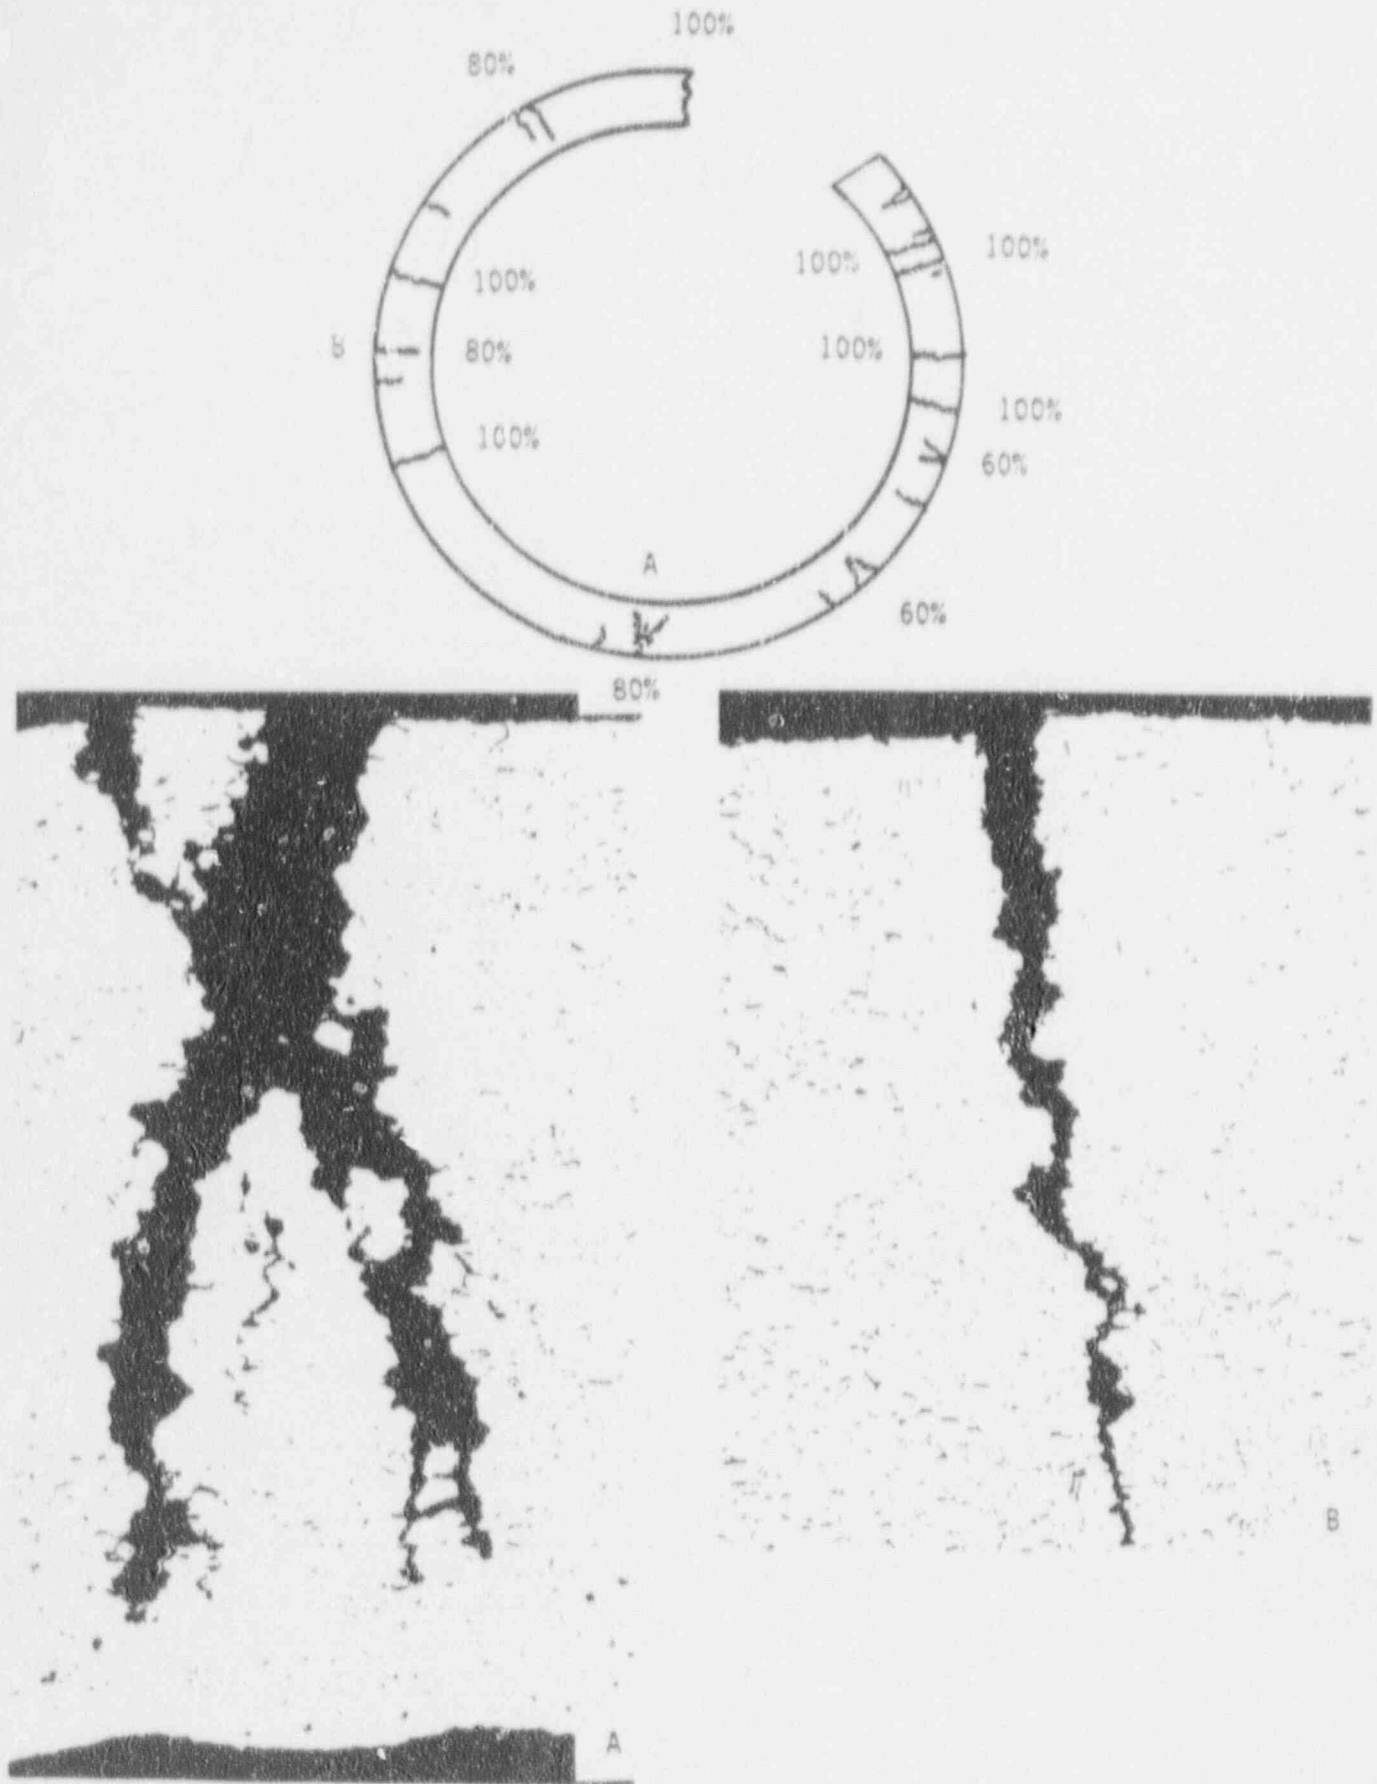
Figure 10-28 Crack distribution as revealed by a metallographic cross section through the center of the crevice of tube 532-2 and photomicrographs of secondary cracks A and B. Mag. 100X

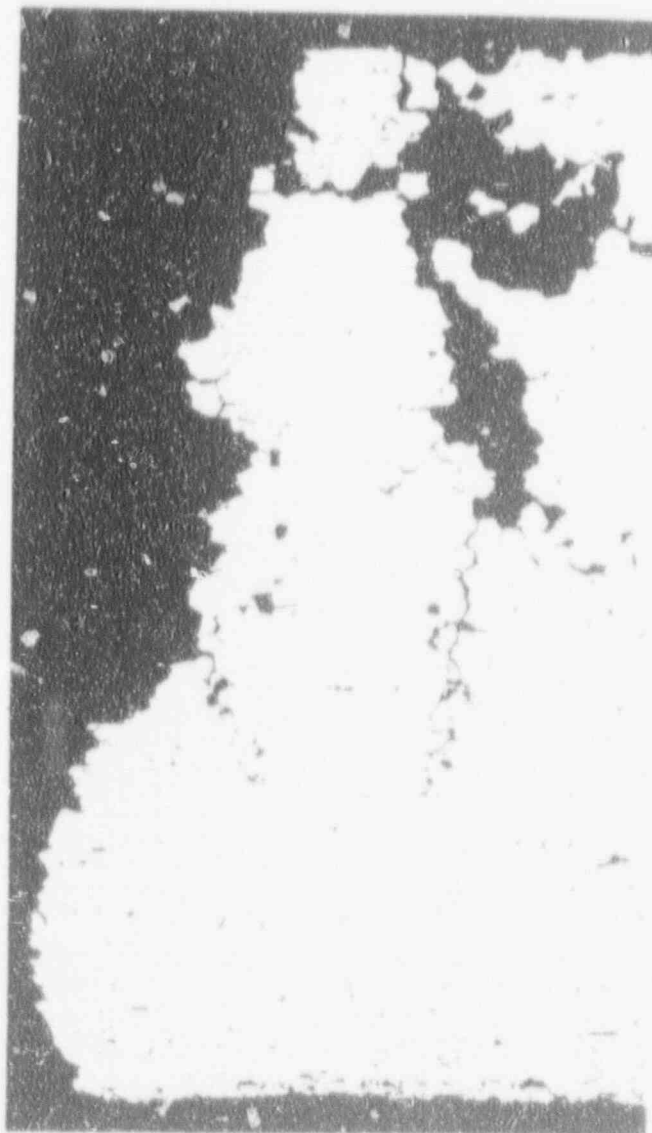
Figure 10-32 Photograph of the burst opening and a transverse photomicrograph of the burst fracture in tube 555-3. Mag. 100X

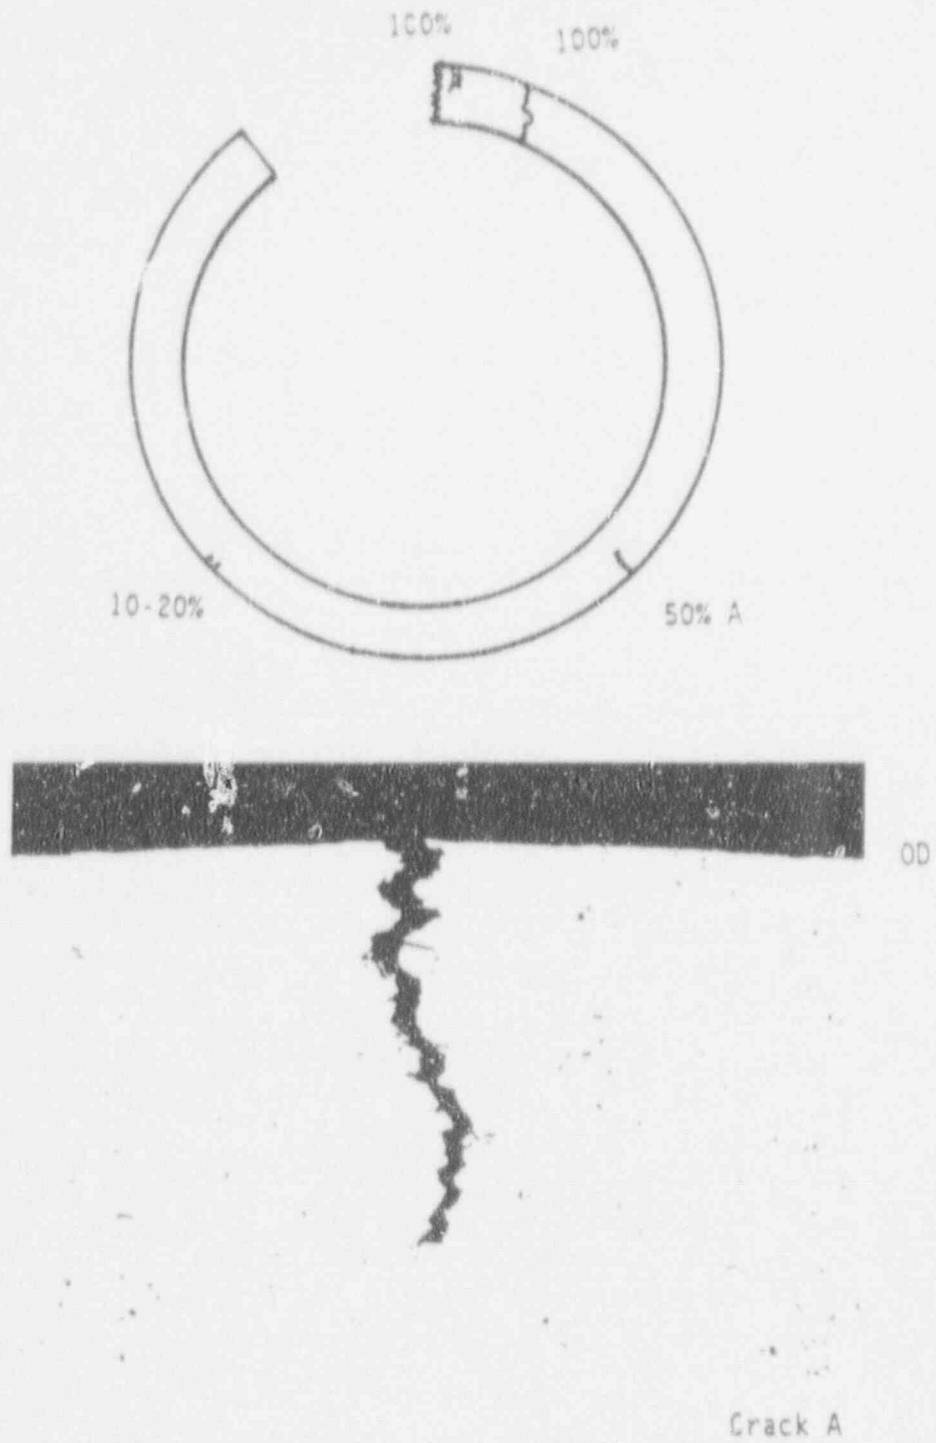
Figure 10-33 Sketch of the metallographic cross section through secondary crevice region cracks in tube 555-3. A photomicrograph of Crack A is also shown. Mag. 100X

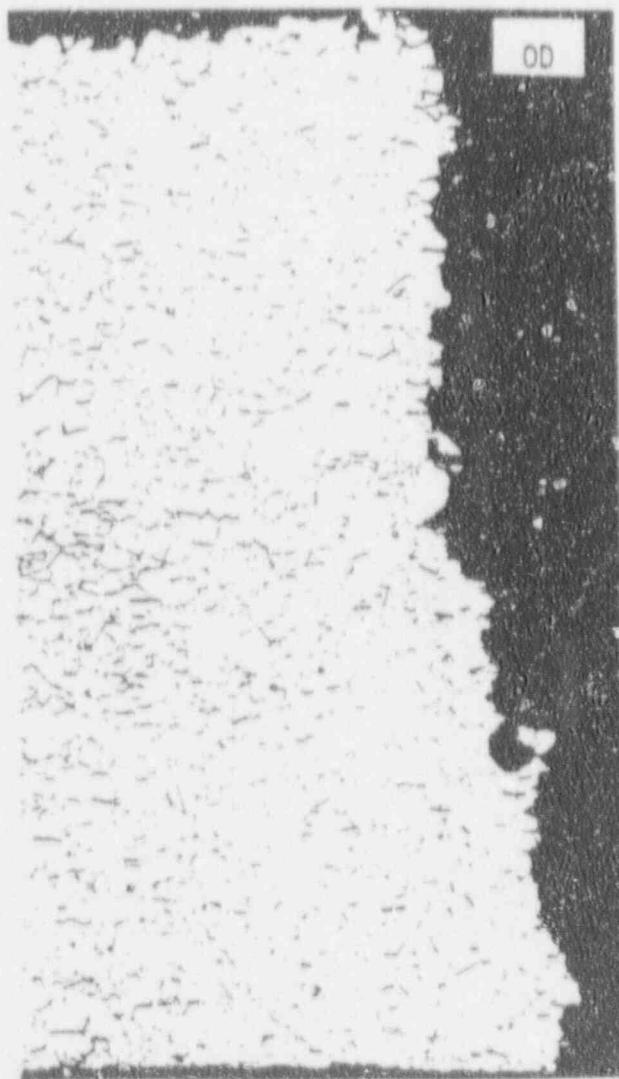
Figure 10-35 Sketch of a metallographic cross section through the center of the crevice region of tube 576-2, showing only the single burst crack, and a photomicrograph of the burst crack.
Mag. 100X

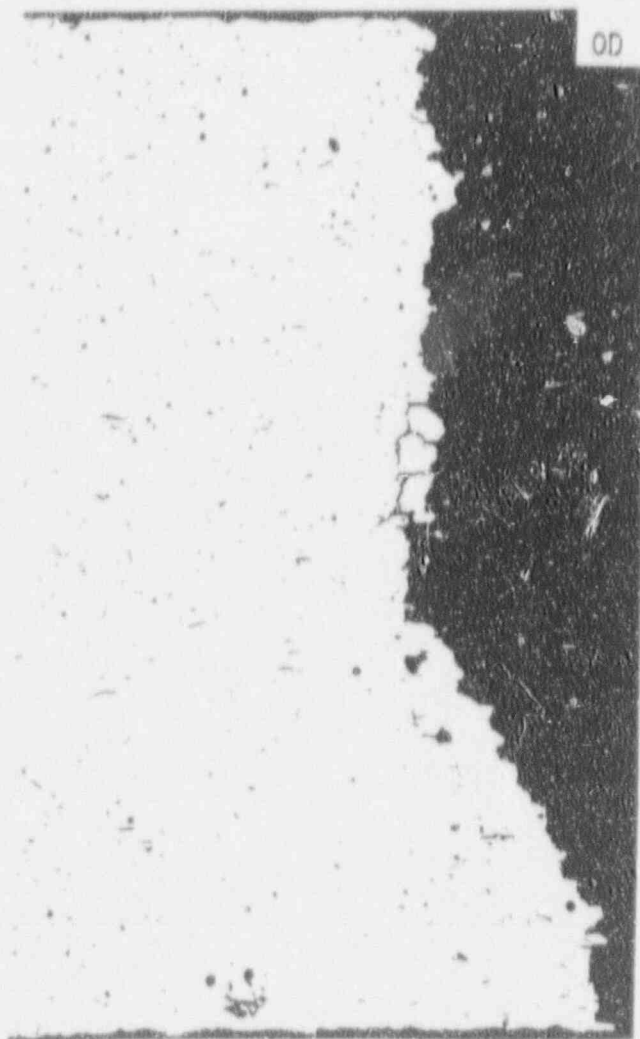
Figure 10-37 Sketch of a metallographic cross section through the center of the crevice region of tube 576-4, showing only the single burst crack, and a photomicrograph of the burst crack.
Mag. 100X

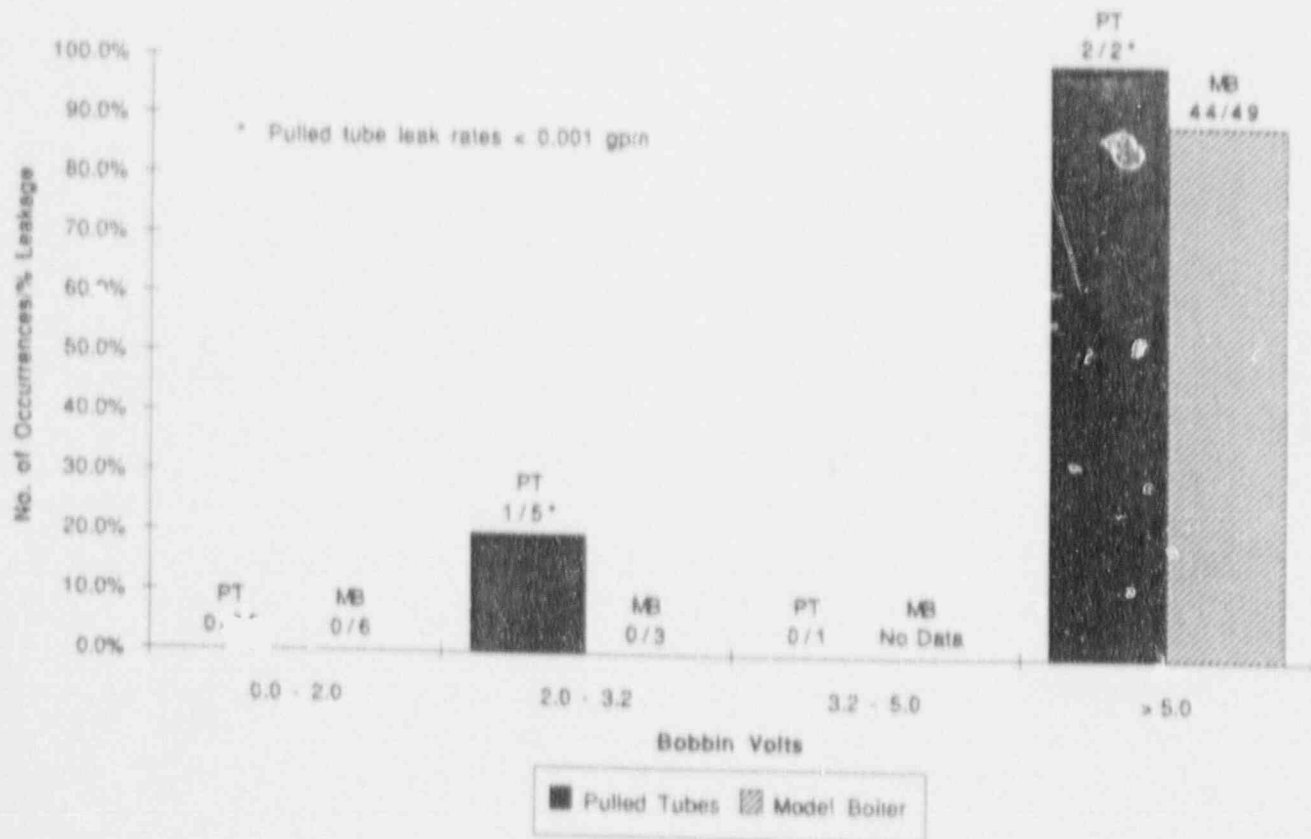
Chart Volt vs. SLB Leakage 2/11/92

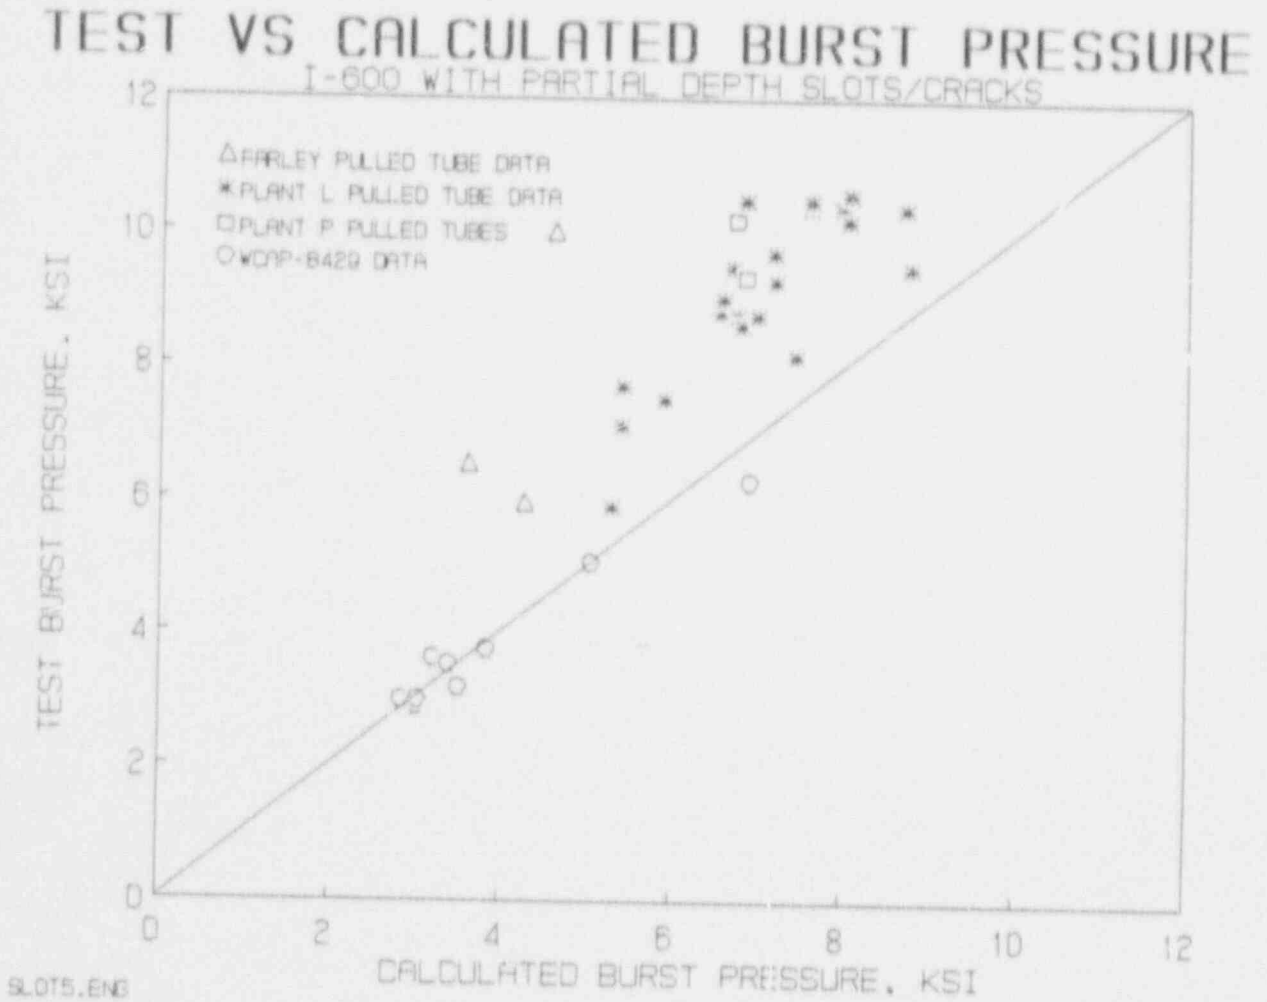
Figure B-11

Comparison of Measured Burst Pressures for Farley, Plant L and Plant P
With Calculated Burst Pressures Using Single Crack Model
